**Inchamore Wind Farm**

Inchamore, Co. Cork / Co. Kerry

App 8.1 - App A2 (01) SI - Peat Depth -

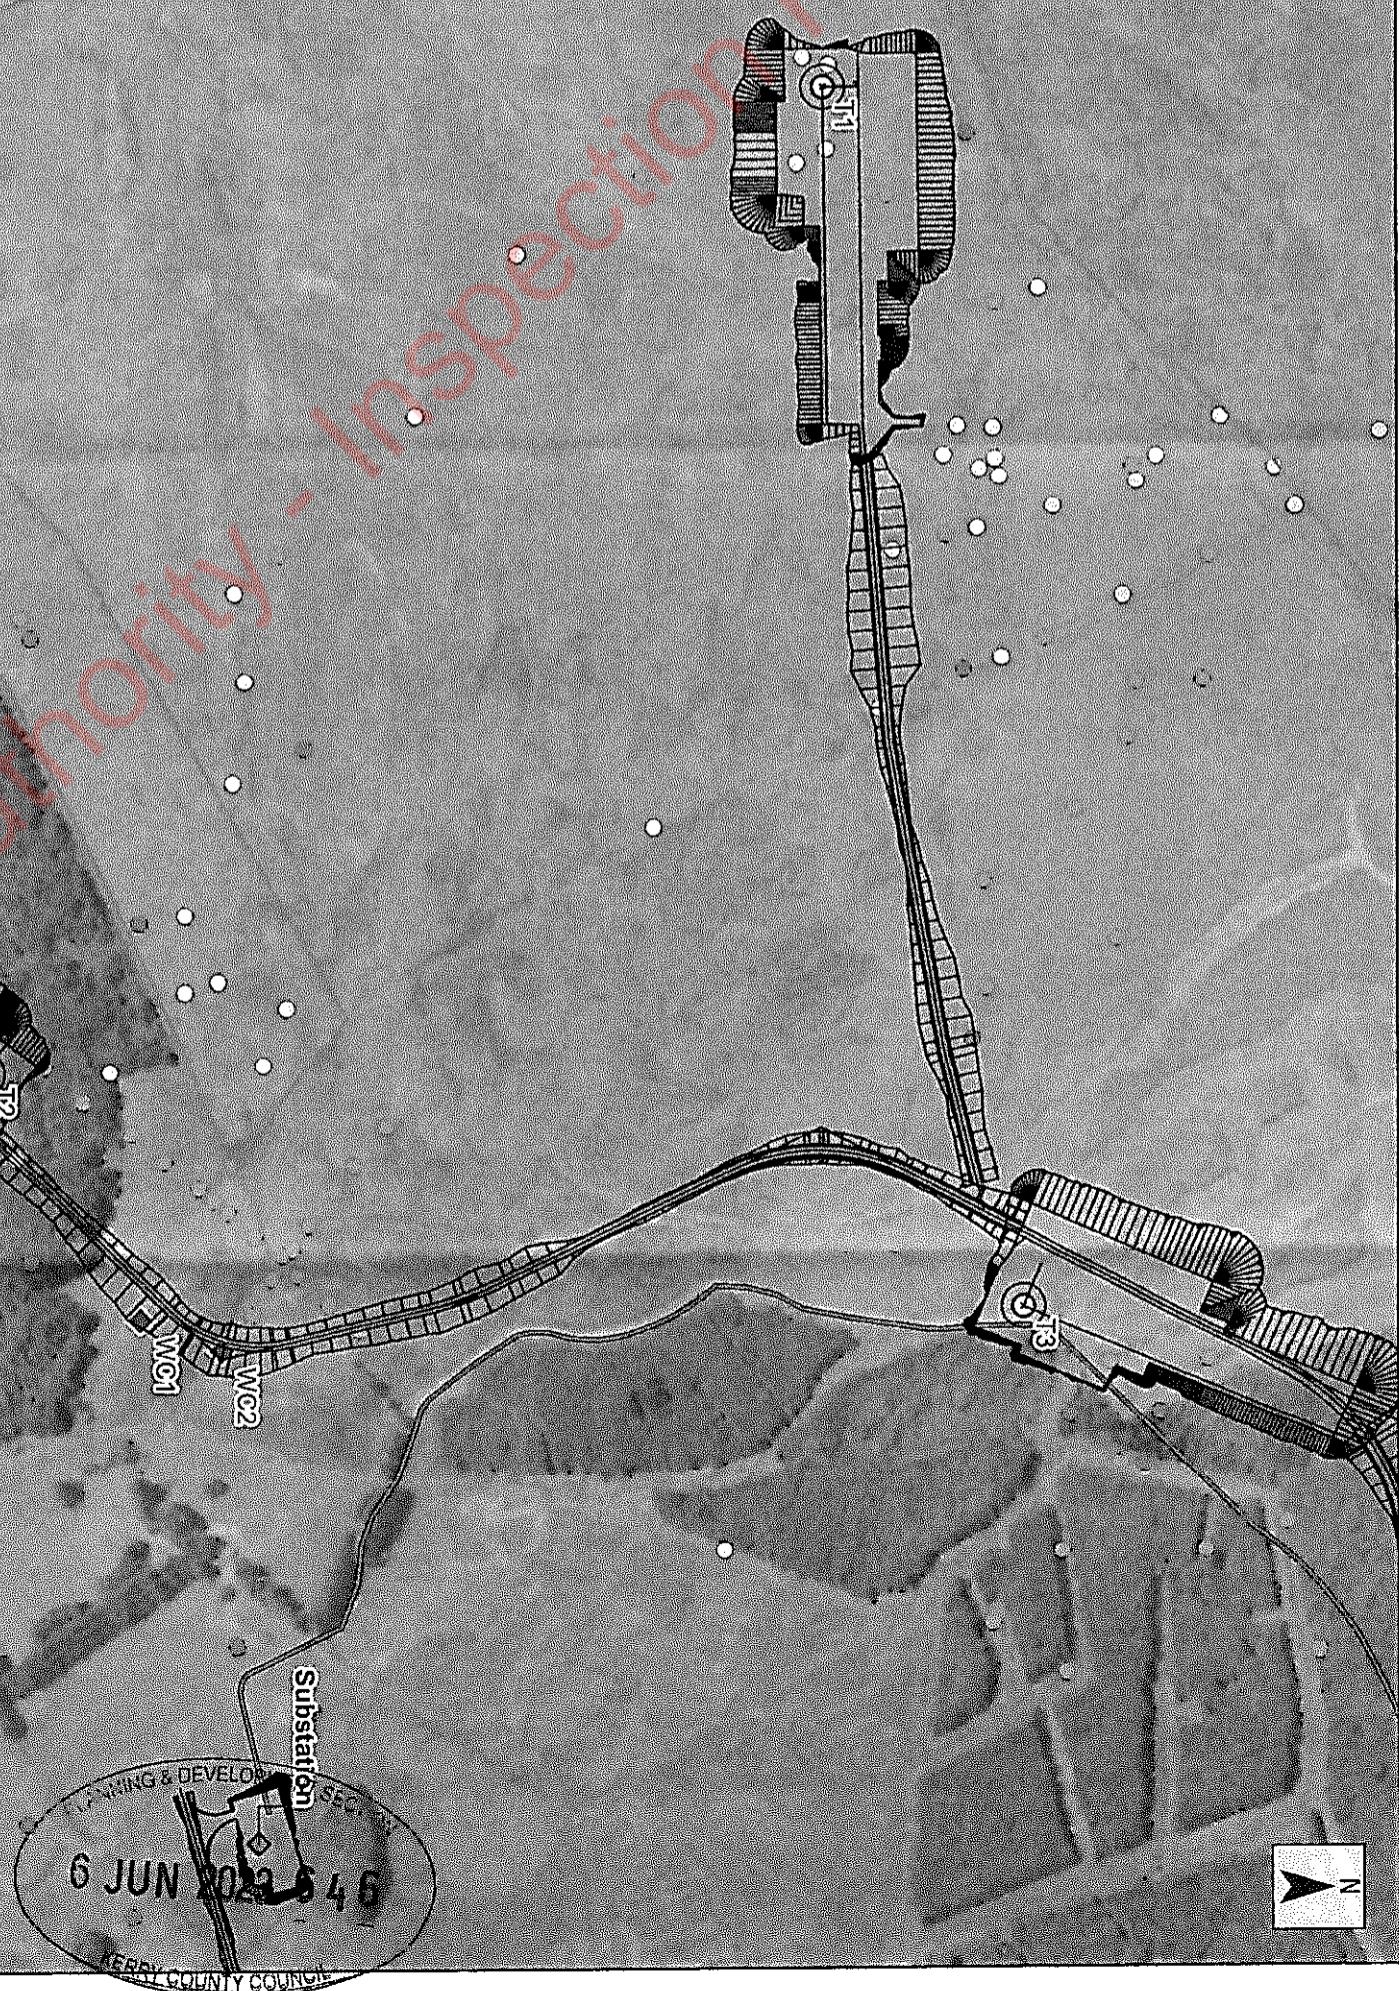
3188-A2-TWF Peat Depth Probe Data

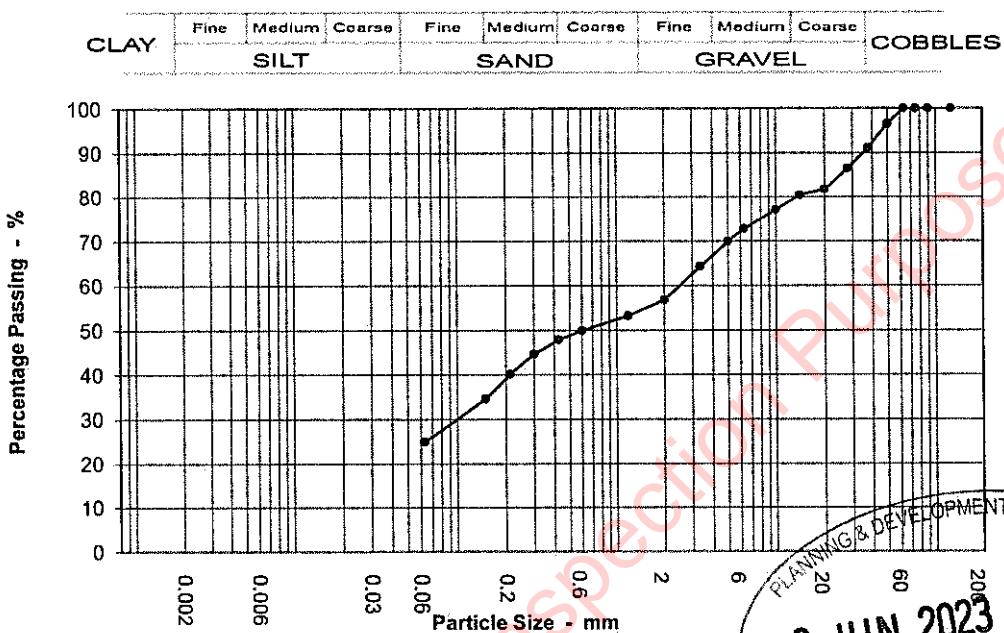
Job Ref	P21139
		Borehole / Pit No	TP03A2
Location	Gortyrahilly and Inchamore W.F	Sample No	
Soil Description	Very clayey very sandy GRAVEL	Depth	0.00 m
		Sample type	B

Sieving		Sedimentation	
Particle Size mm	% Passing	Particle Size mm	% Passing
125	100		
90	100		
75	100		
63	100		
50	97		
37.5	91		
28	87		
20	82		
14	80		
10	77		
6.3	73		
5	70		
3.35	64		
2	57		
1.18	53		
0.6	50		
0.425	48		
0.3	45		
0.212	40		
0.15	35		
0.063	25

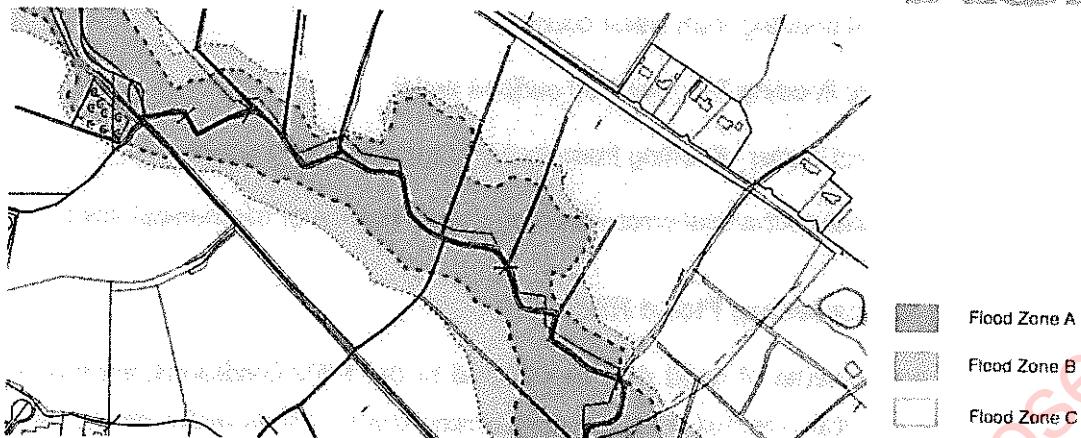
10.73595	0.19583	3.5	1.1	6.70	7.70	-16.50	1.0	2.83	0.0	0.0	-16.50	0.0	2.83	0.0	
10.73595	0.19583	3.5	1.1	6.80	7.80	-16.83	1.0	2.83	0.0	0.0	-16.83	0.0	2.83	0.0

In the FRM Guidelines, the likelihood of a flood occurring in an area is identified and separated into Flood Zones **Figure 4.1 - Indicative Flood Zone Map**, which indicate a high, moderate or low risk of flooding from fluvial or tidal sources, defined as follows:

- Flood Zone A - Where the probability of flooding is highest (greater than 1% Annual Exceedance Probability (AEP) or 1 in 100 for river flooding and 0.5% AEP or 1 in 200 for coastal flooding) and where a wide range of receptors would be located and therefore vulnerable.
- Flood Zone B - Where the probability of flooding is moderate (between 0.1% AEP or 1 in 1000 and 1% AEP or 1 in 100 for river flooding and between 0.1% AEP or 1 in 1000 year and 0.5% AEP or 1 in 200 for coastal flooding); and
- Flood Zone C - Where the probability of flooding is low (less than 0.1% AEP or 1 in 1000 for both river and coastal flooding).

**Figure 4.1: Indicative flood zone map (OPW, 2009)**

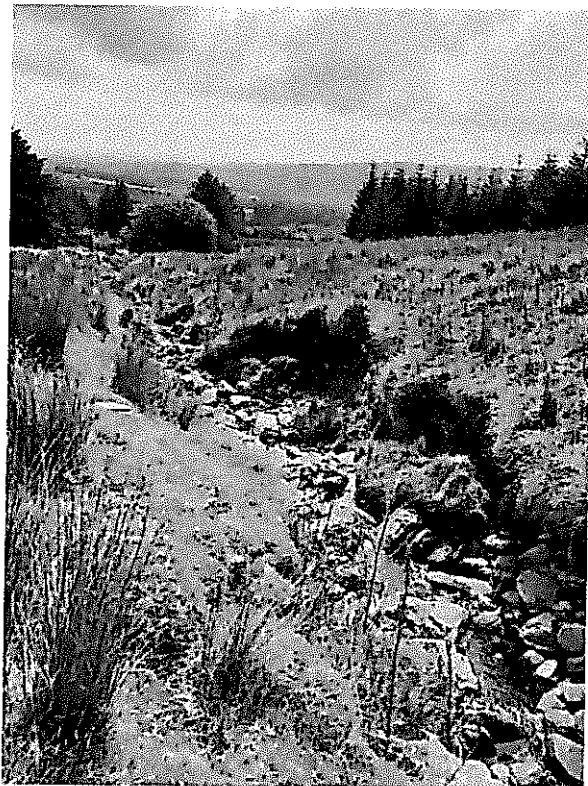
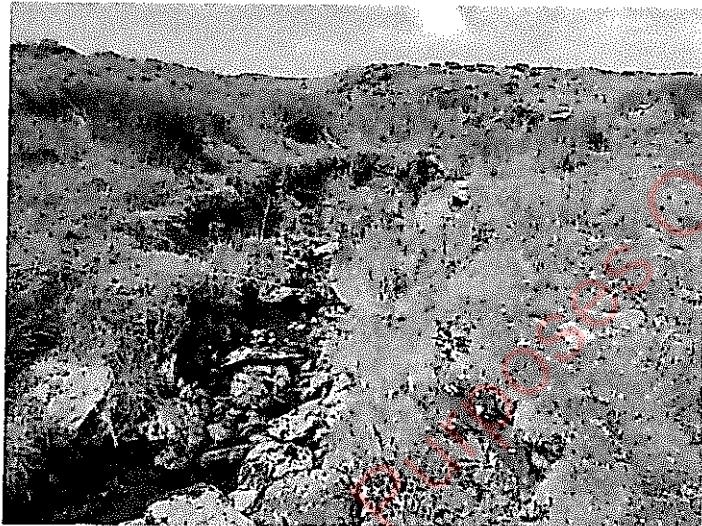
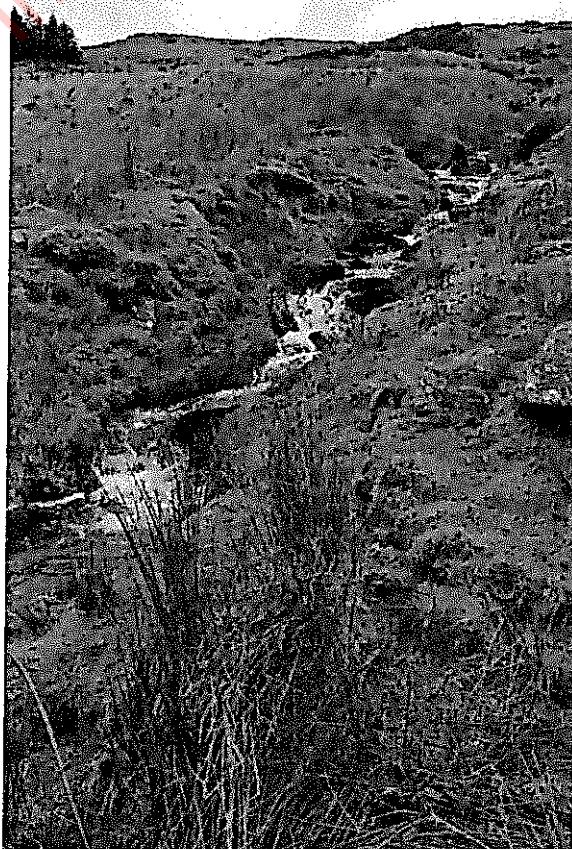
### **Subject: Baseline Surface Water Monitoring Location - SW1**

Surface Water Sampling R1 12/08/2020 (Dry)

Surface Water Sampling R3 24/02/2021 (Wet)

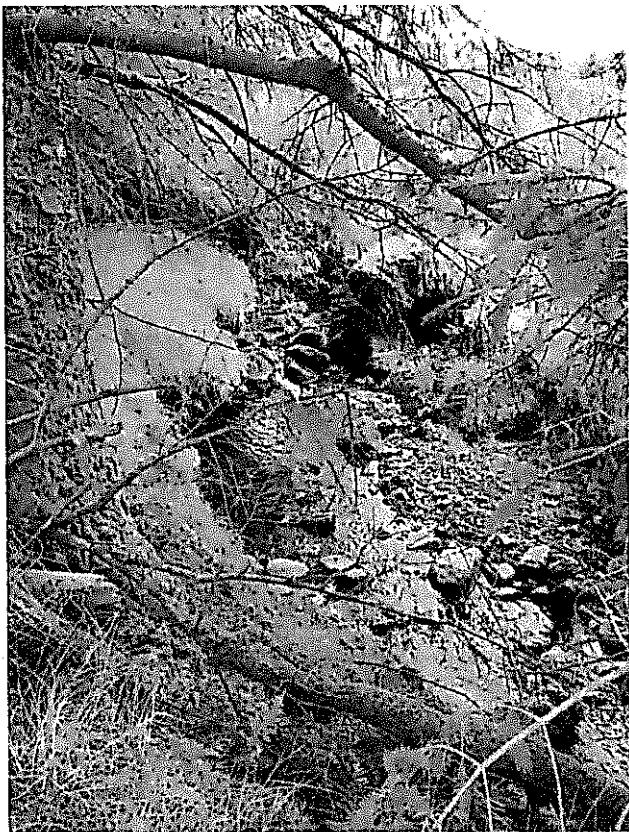
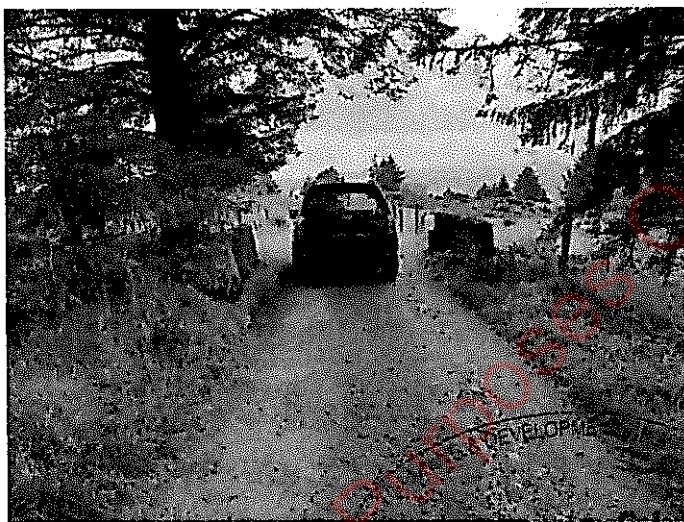
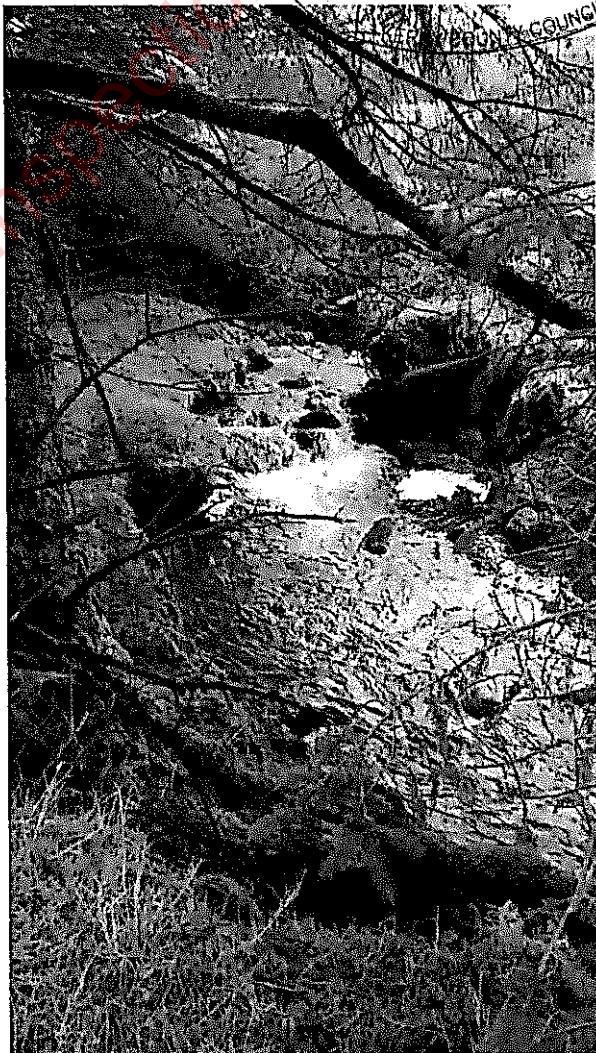
### Subject: Baseline Surface Water Monitoring Location - SW2

Surface Water Sampling R1 12/08/2020 (Dry)

Surface Water Sampling R1 12/08/2020 (Dry) 8 JUN 2023 646

Surface Water Sampling R3 24/02/2021 (Wet)

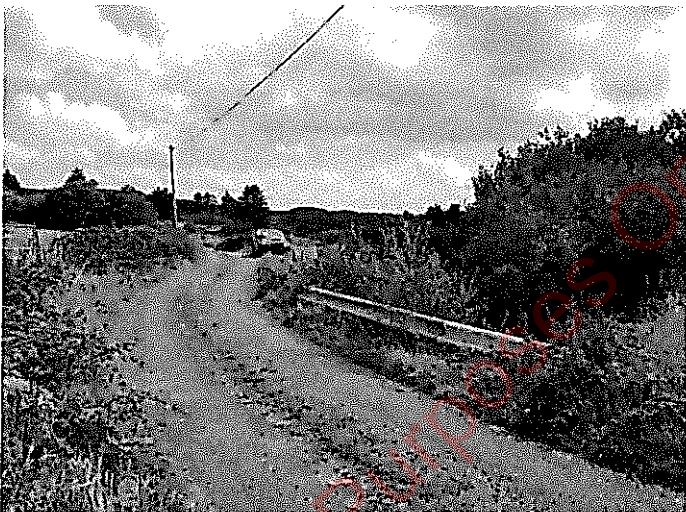
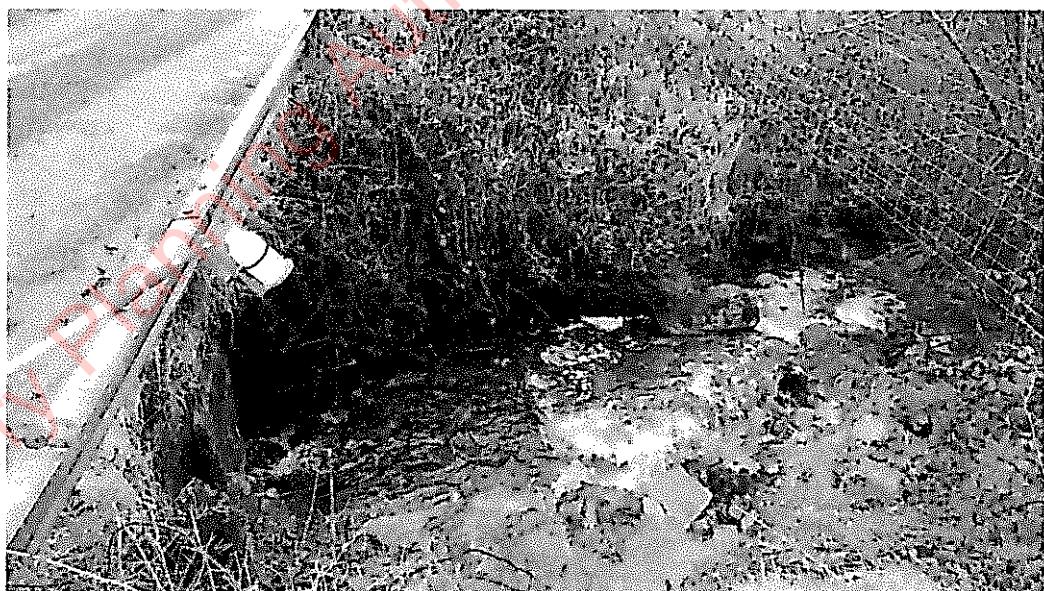
### Subject: Baseline Surface Water Monitoring Location - SW3

Surface Water Sampling R1 12/08/2020 (Dry)

Surface Water Sampling R3 24/02/2021 (Wet)

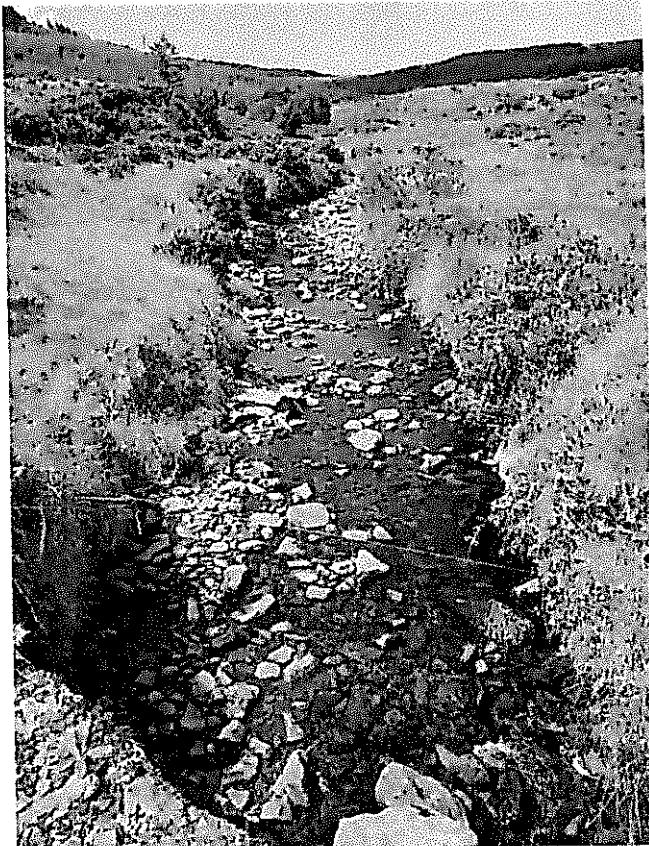
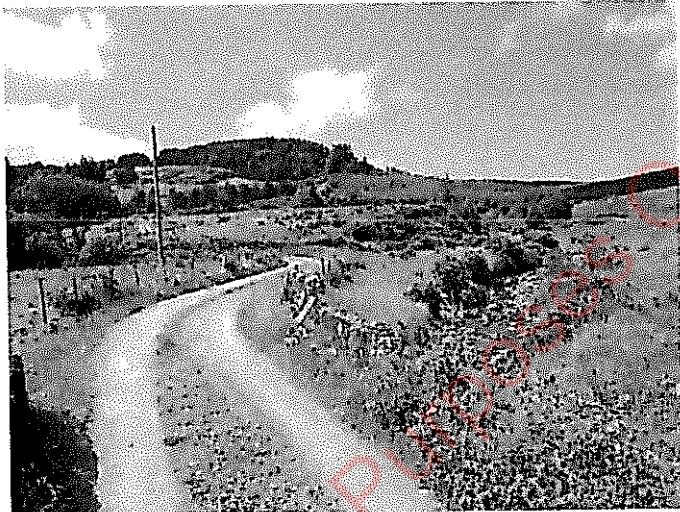
**Subject: Baseline Surface Water Monitoring Location - SW4**

Surface Water Sampling R1 12/08/2020 (Dry)

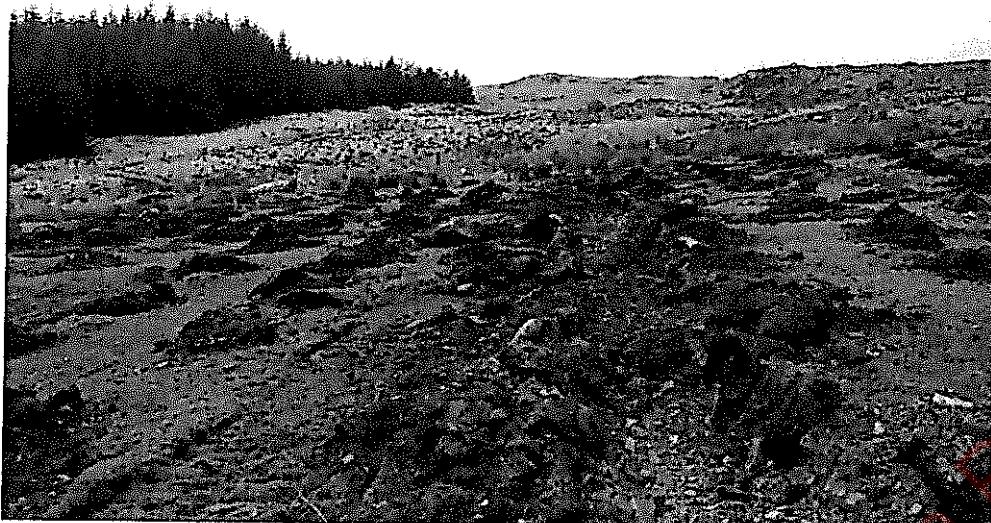
Preparation for forestry plantation observed during Surface Water Sampling R4 16/03/2021, near SW1.

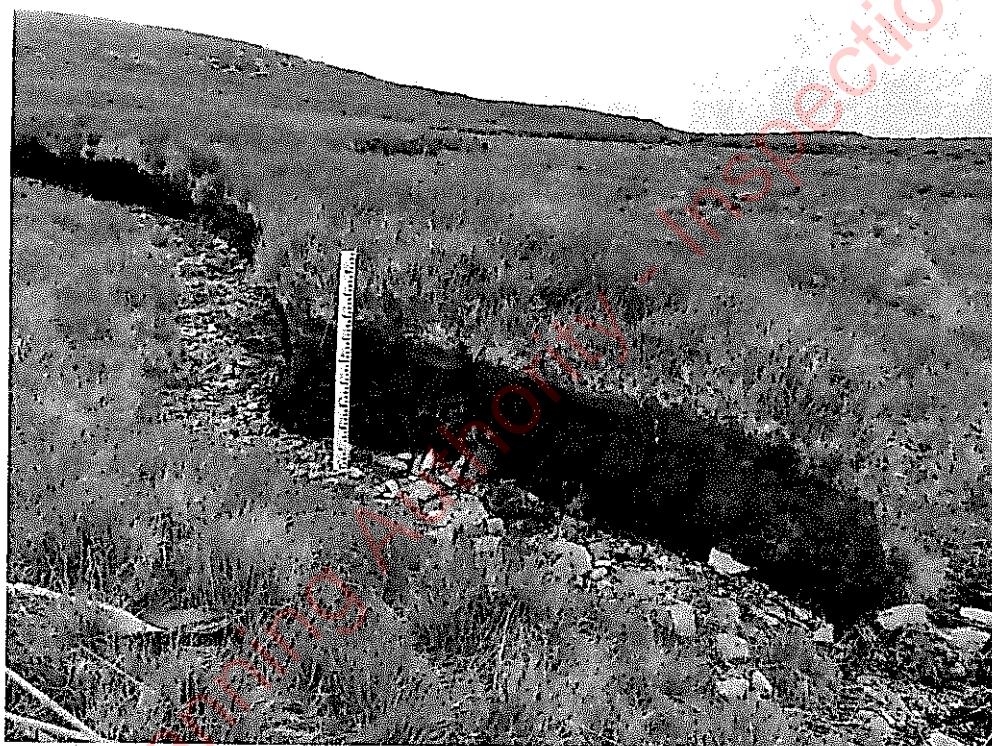
Evidence of peat cutting observed during site surveys 16/06/2020.

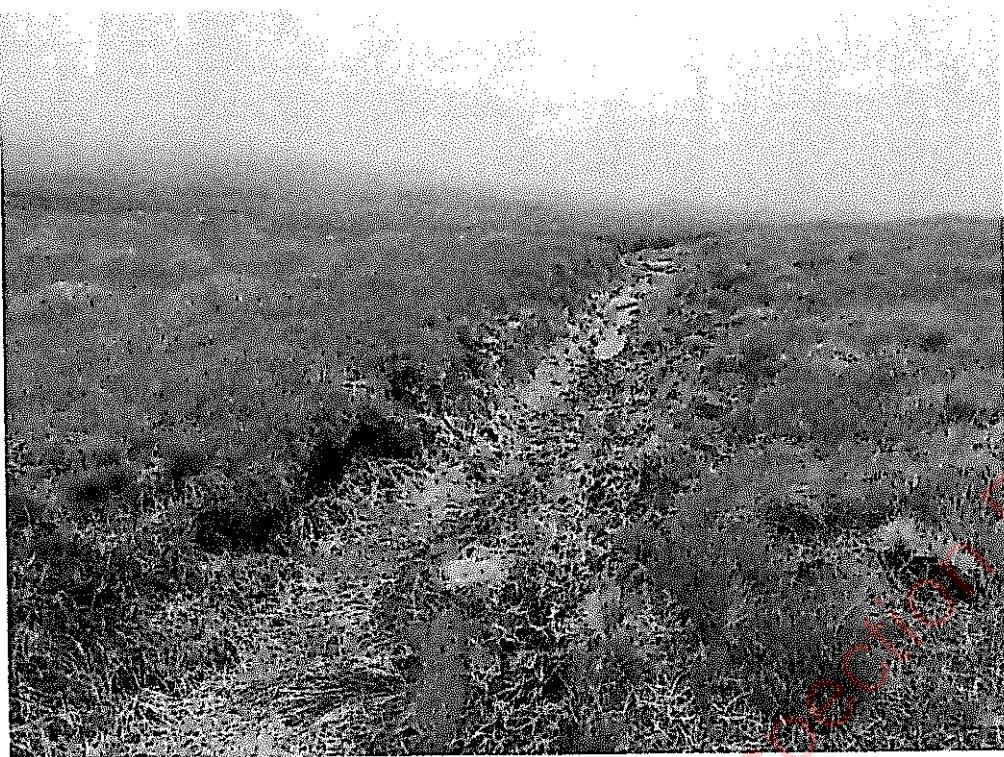
Existing artificial / modified drainage observed during site surveys 16/06/2020.

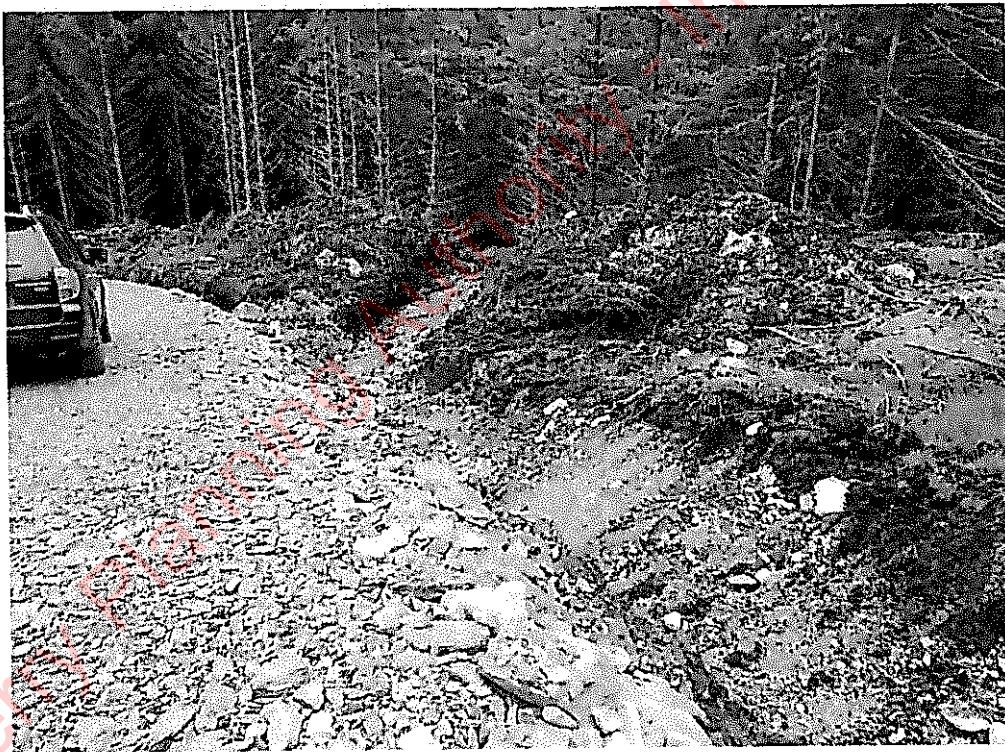
New access track and drainage associated with ongoing forestry activities observed during site surveys 16/06/2020.

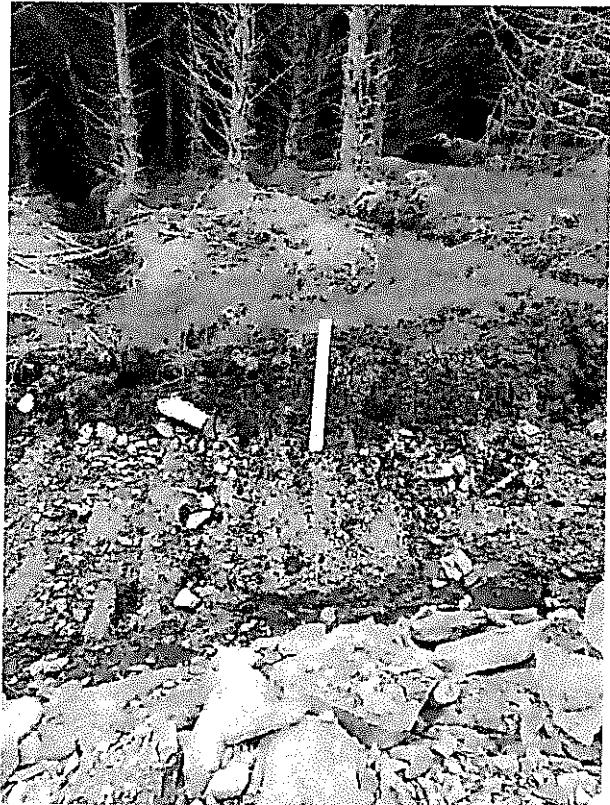
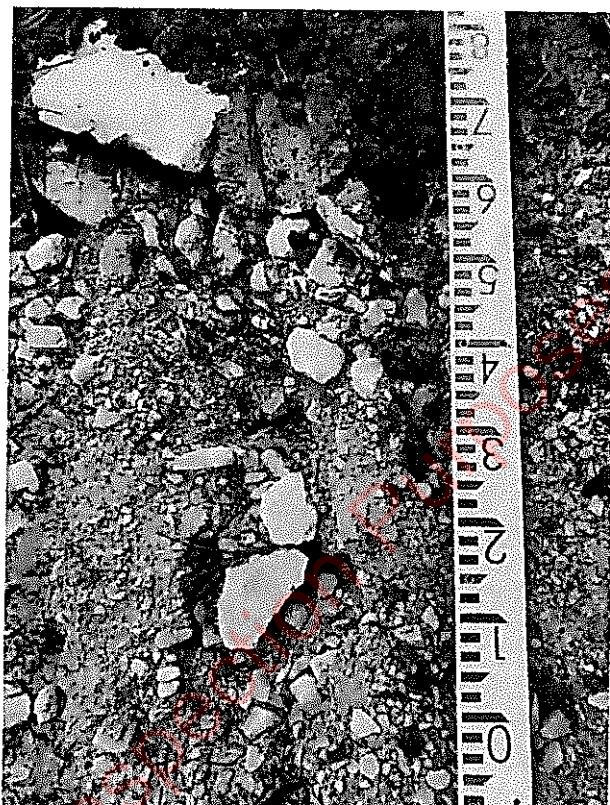
Peat and till exposed at new access track and drainage associated with ongoing forestry activities observed during site surveys 16/06/2020.

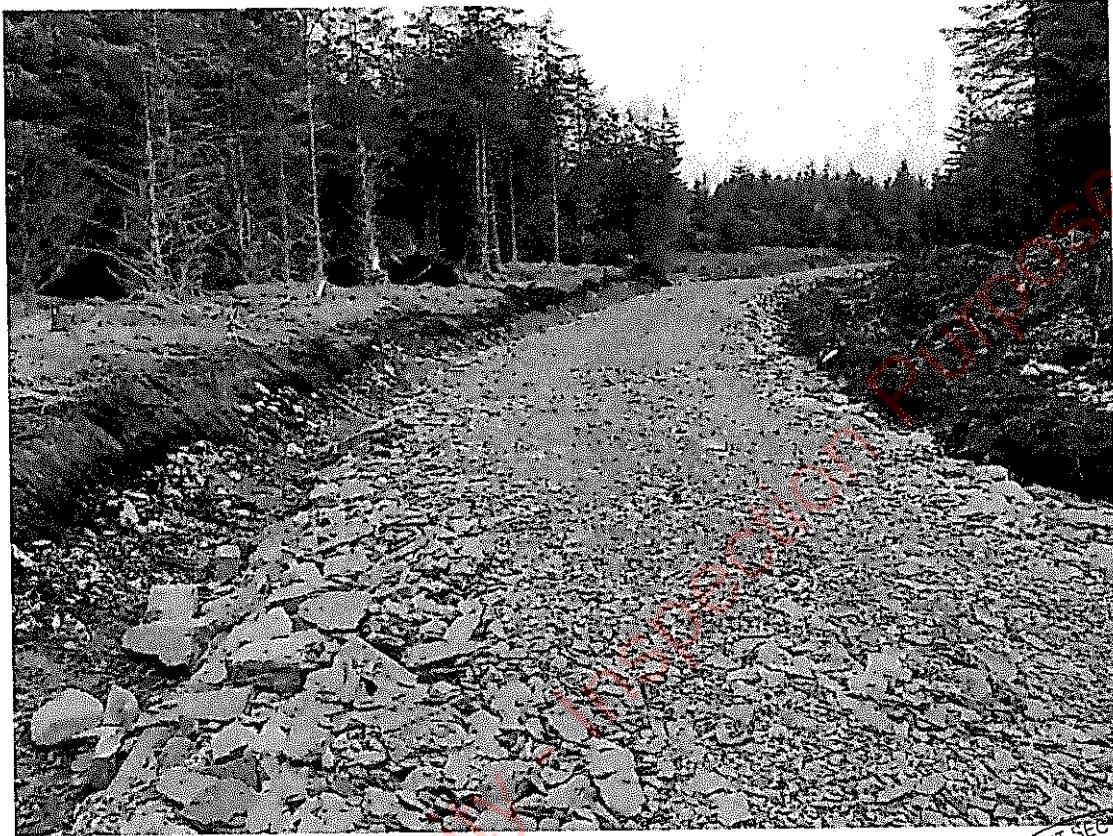
Peat and till exposed at new access track and drainage associated with ongoing forestry activities observed during site surveys.

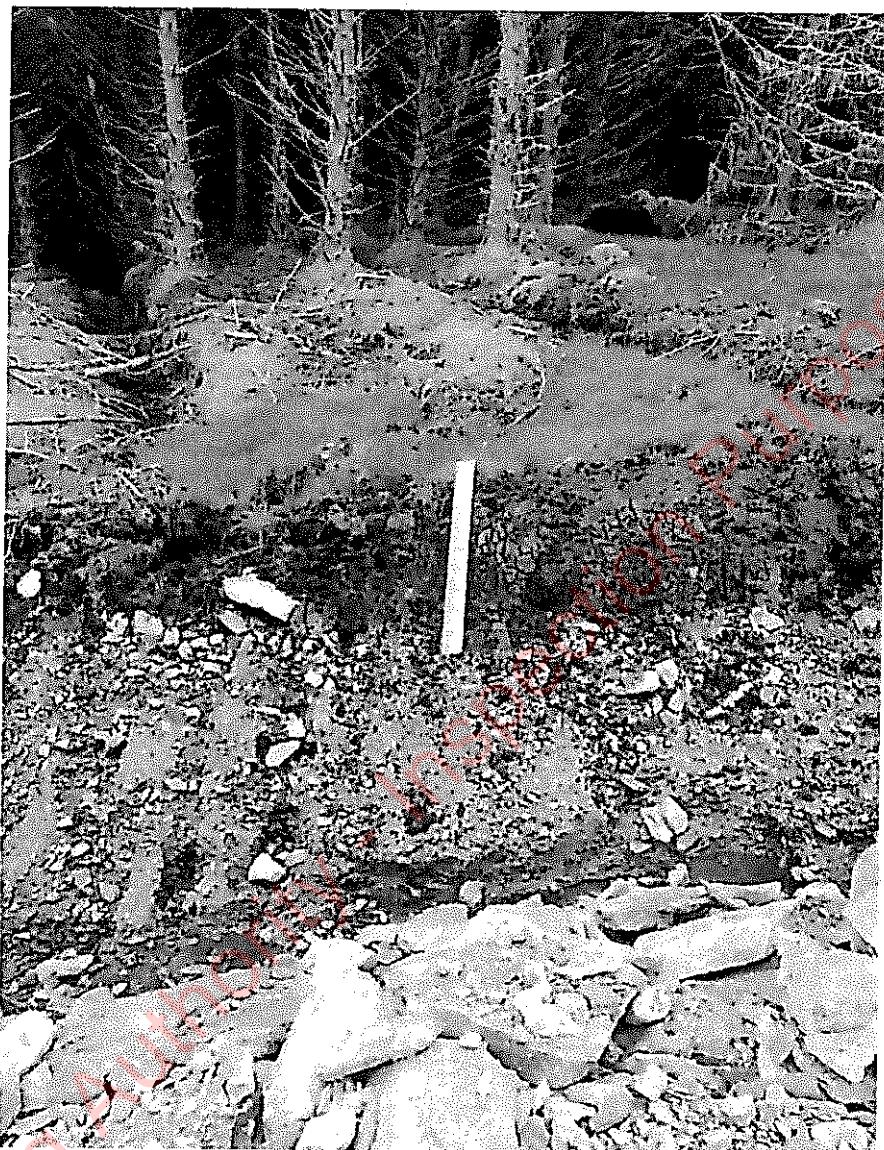
Peat and till exposed at new access track and drainage associated with ongoing forestry activities observed during site survey.

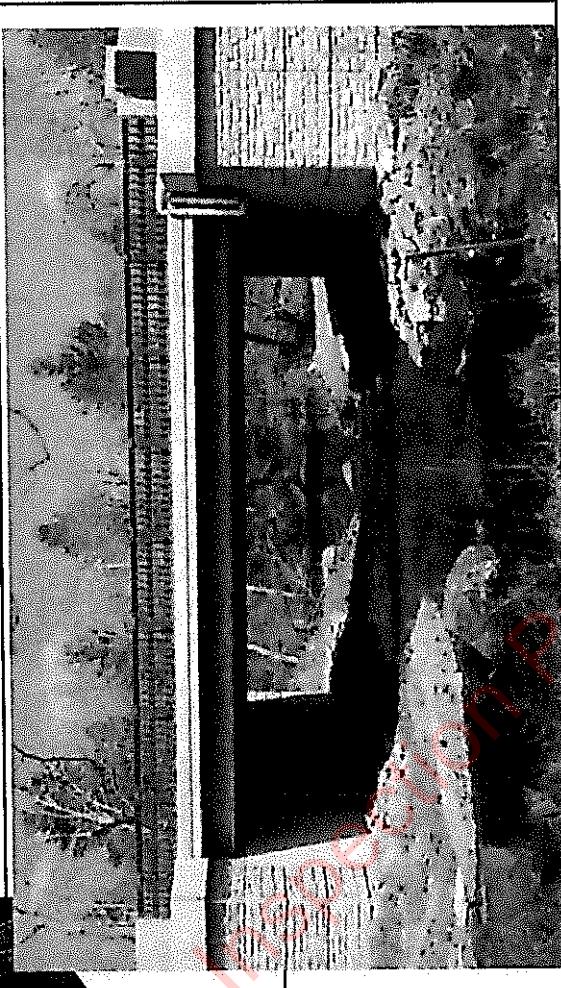
Example of a clear-span bridge, which retains the existing river channel and column set back from the river bank  
(National Roads Authority, 2008)

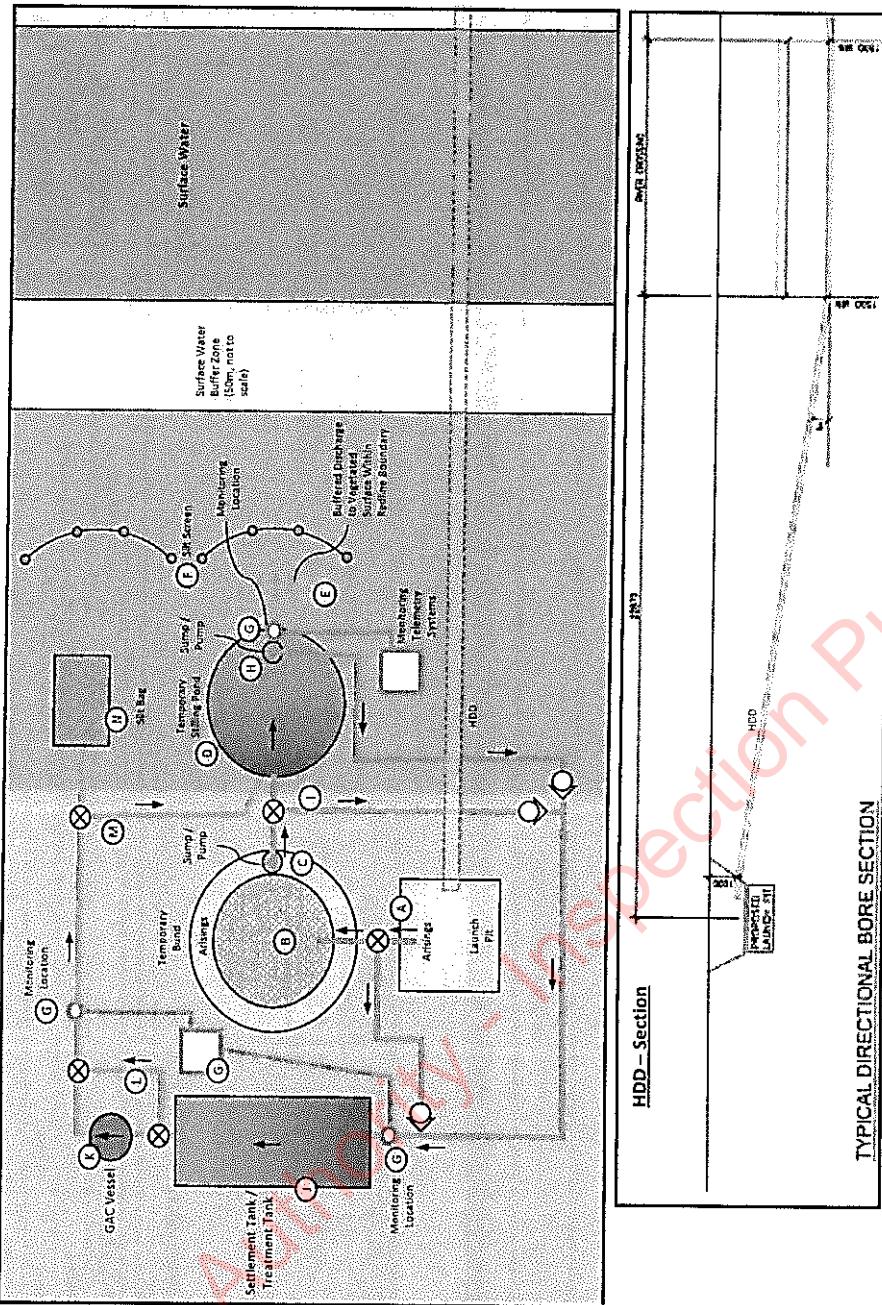
## TYPICAL DIRECTIONAL BOBE SECTION

The schematic presented here is a conceptual model of measures implemented to manage arisings and run-off.

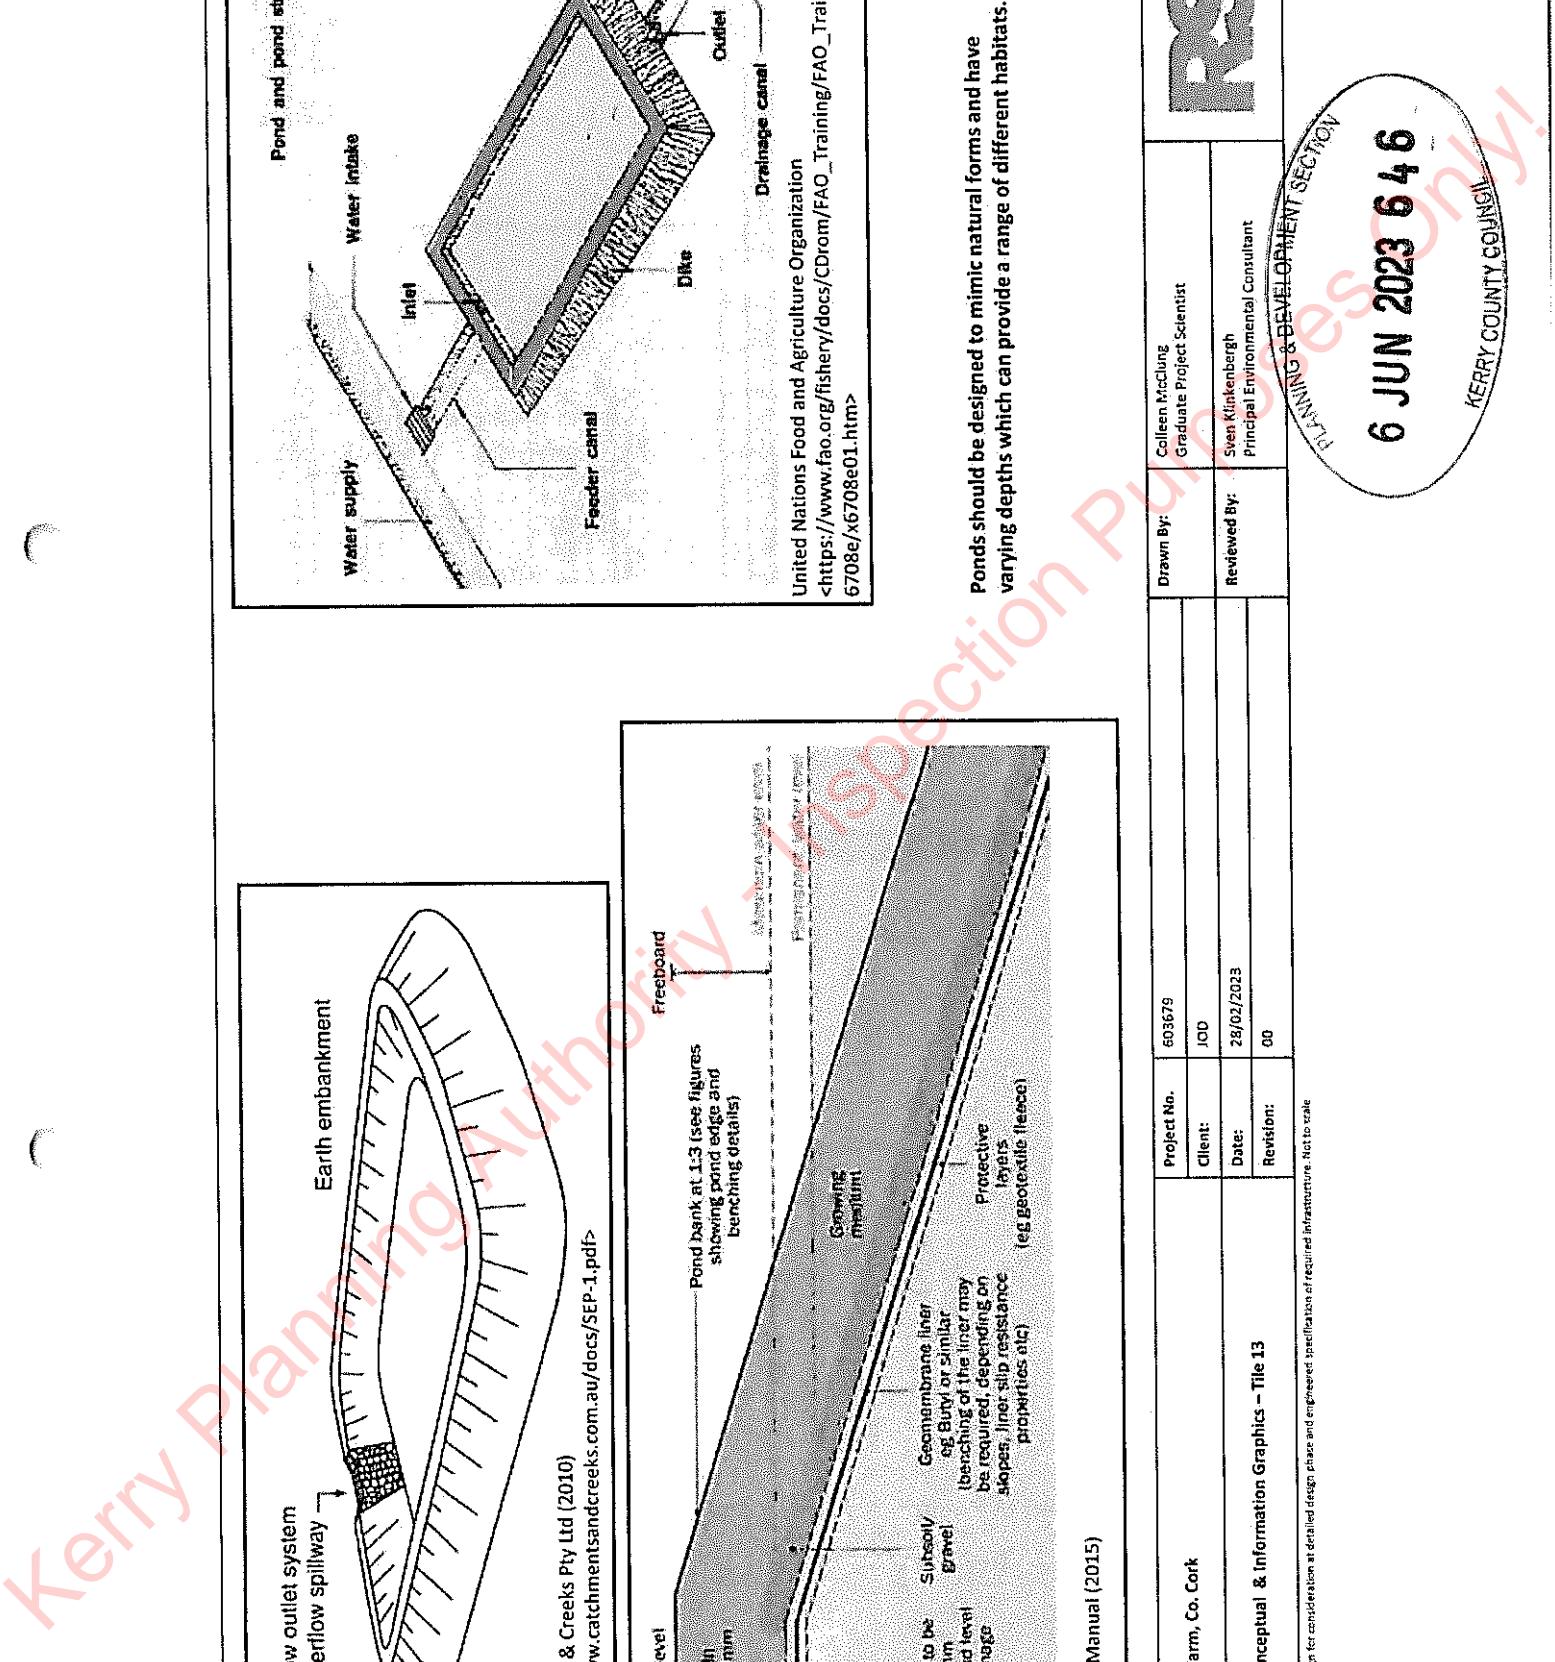
Low-flow outlet system  
with overflow spillway →

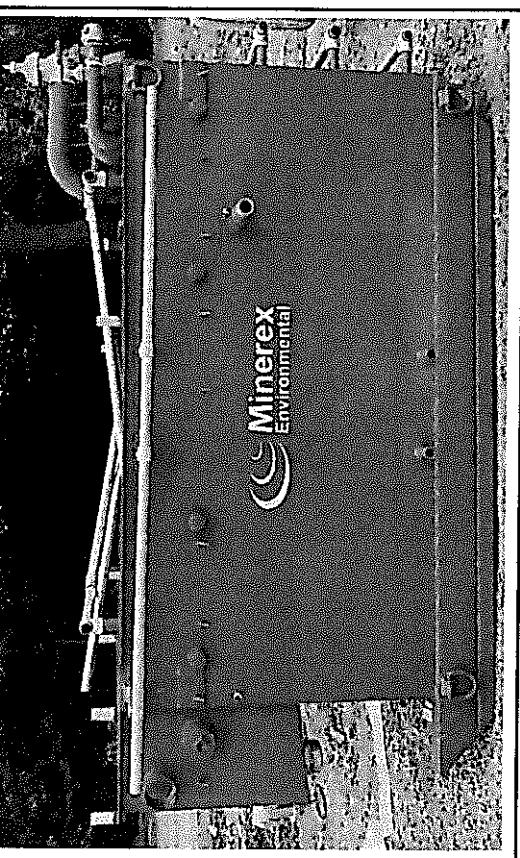
Example of an oil-water separator  
Minerex Environmental Limited, an RSK Group company

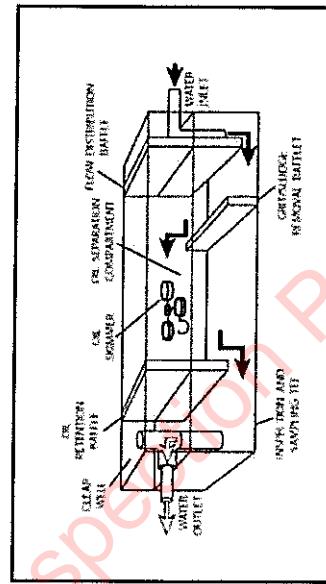
Cross-section of oil-water separator  
Mohr, Kirby S. (2014)

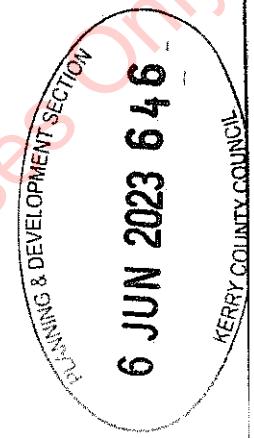
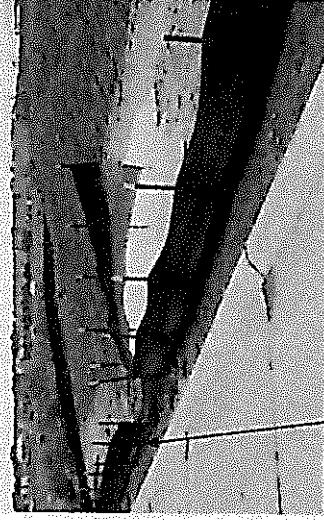
Example of Silt fencing in use  
Bowman Construction Supply (2023) Available  
at:<<https://www.bowmanconstructionsupply.com/products/silt-fence/>>

Silt fences control runoff by allowing water to pass through  
the fabric while collecting leftover sediment.

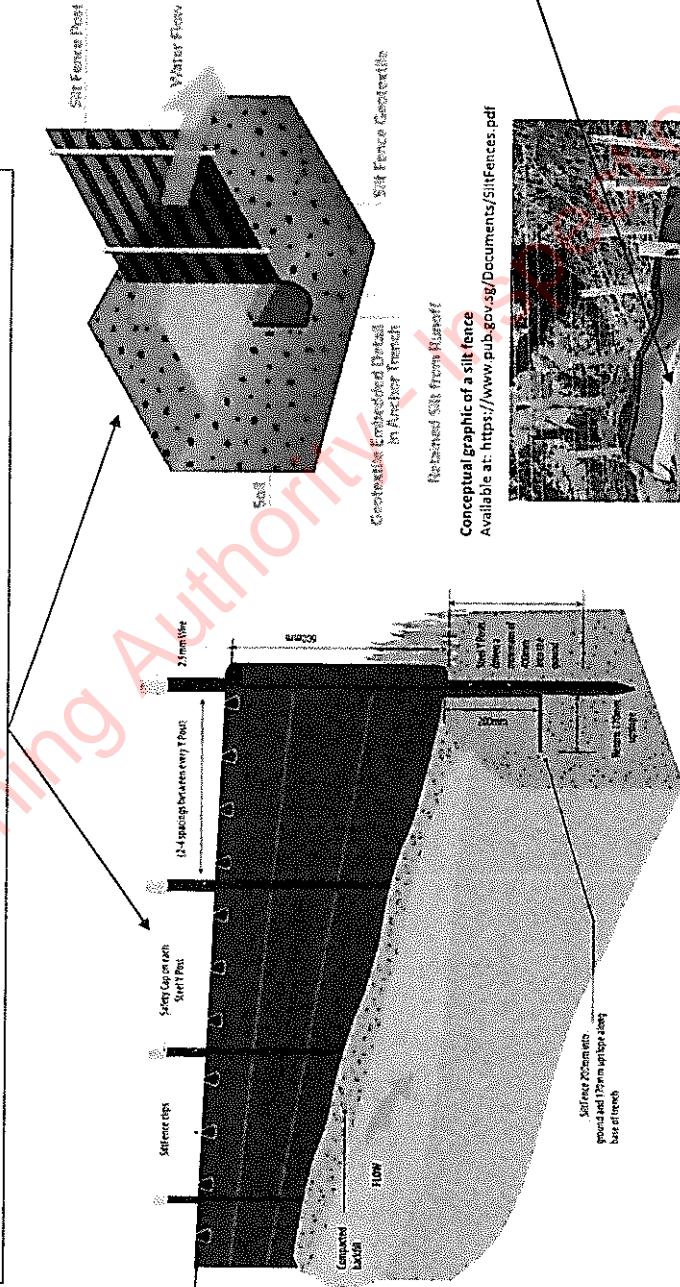
Conceptual graphic of a silt fence  
Available at: <https://www.pub.gov.sg/Documents/SiltFences.pdf>
