**BASELINE ORNITHOLOGICAL SURVEYS  
– INCHAMORE WIND FARM SUMMER 2020  
AND WINTER 2020/21.**

**SITE INVESTIGATION REPORT - STABILITY AND  
GEOTECHNICAL ASSESSMENT**

Site Investigation for the purposes of assessing ground conditions at EIA design phase of a proposed wind farm development, Inchamore Wind Farm, Co. Cork. Assessing ground conditions in terms of peat and slope stability risk, subsoil and geological characterisation and classification.

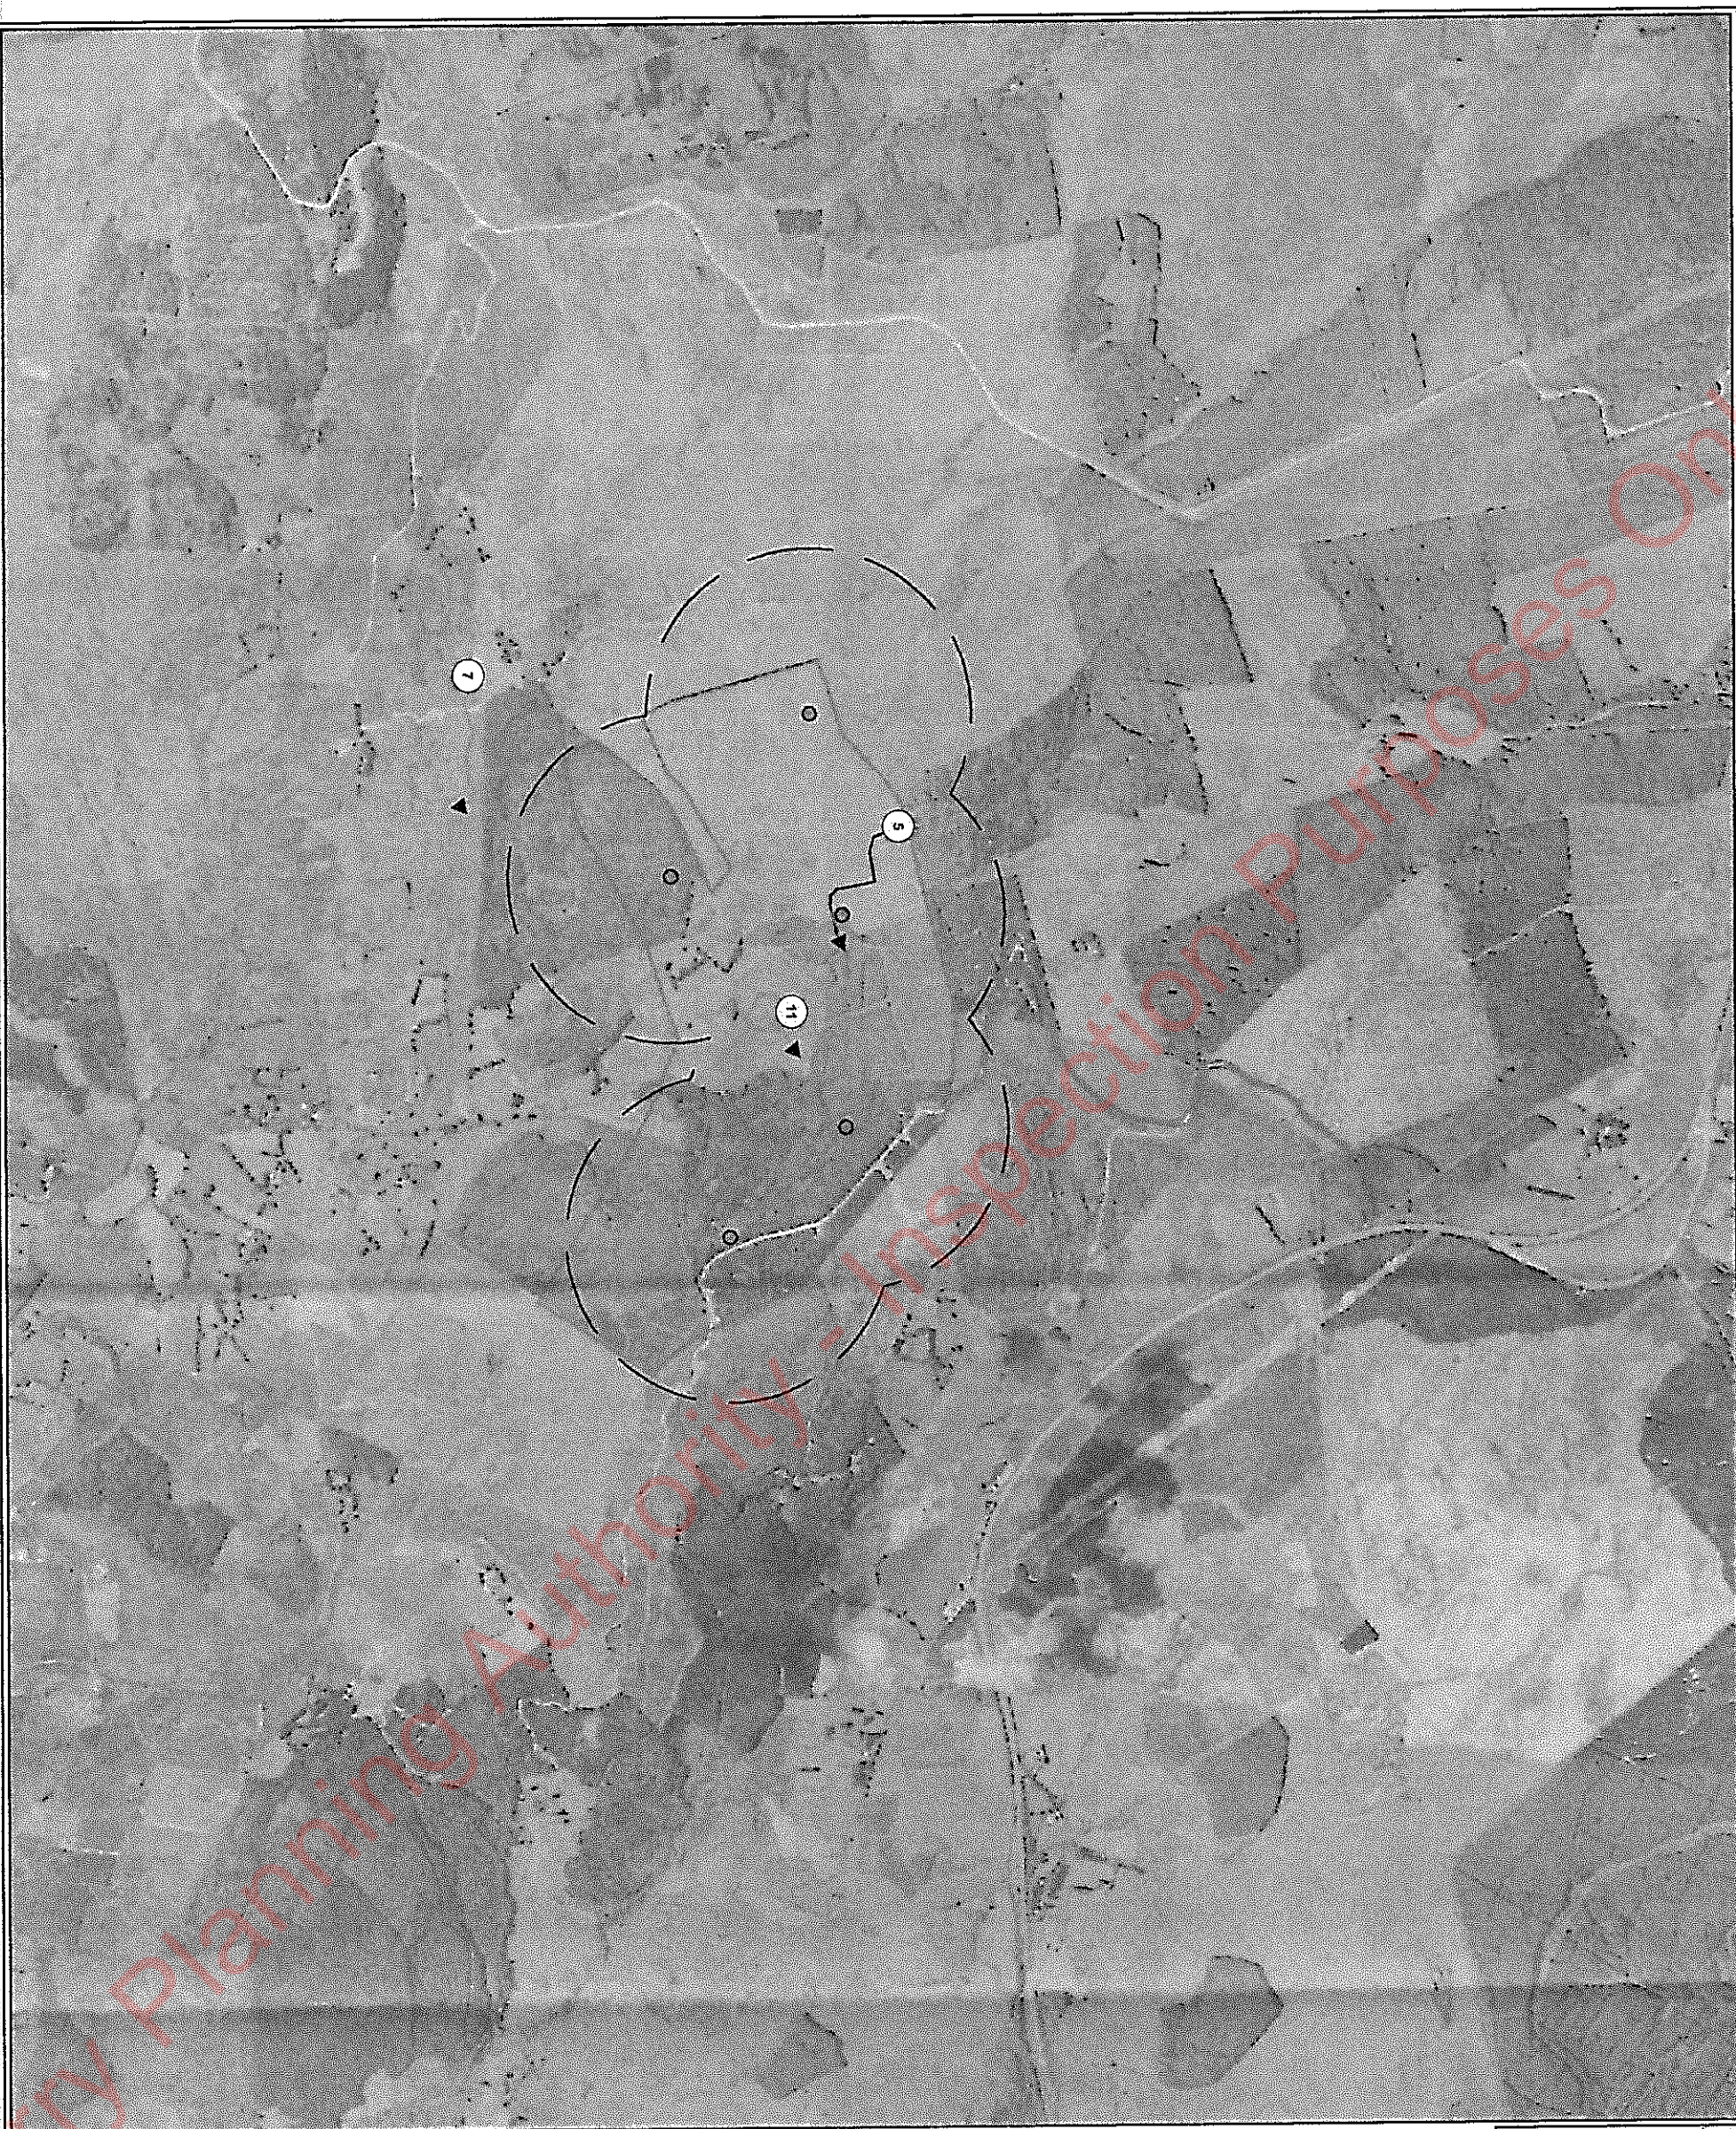
- Legend**
- Site Boundary
  - SNH Buffer
  - Turbine Locations
- Flightline, Date, Time**
- 5, 2/26/2021, 15:55
  - 7, 2/28/2021, 11:54
  - 11, 2/28/2021, 15:36

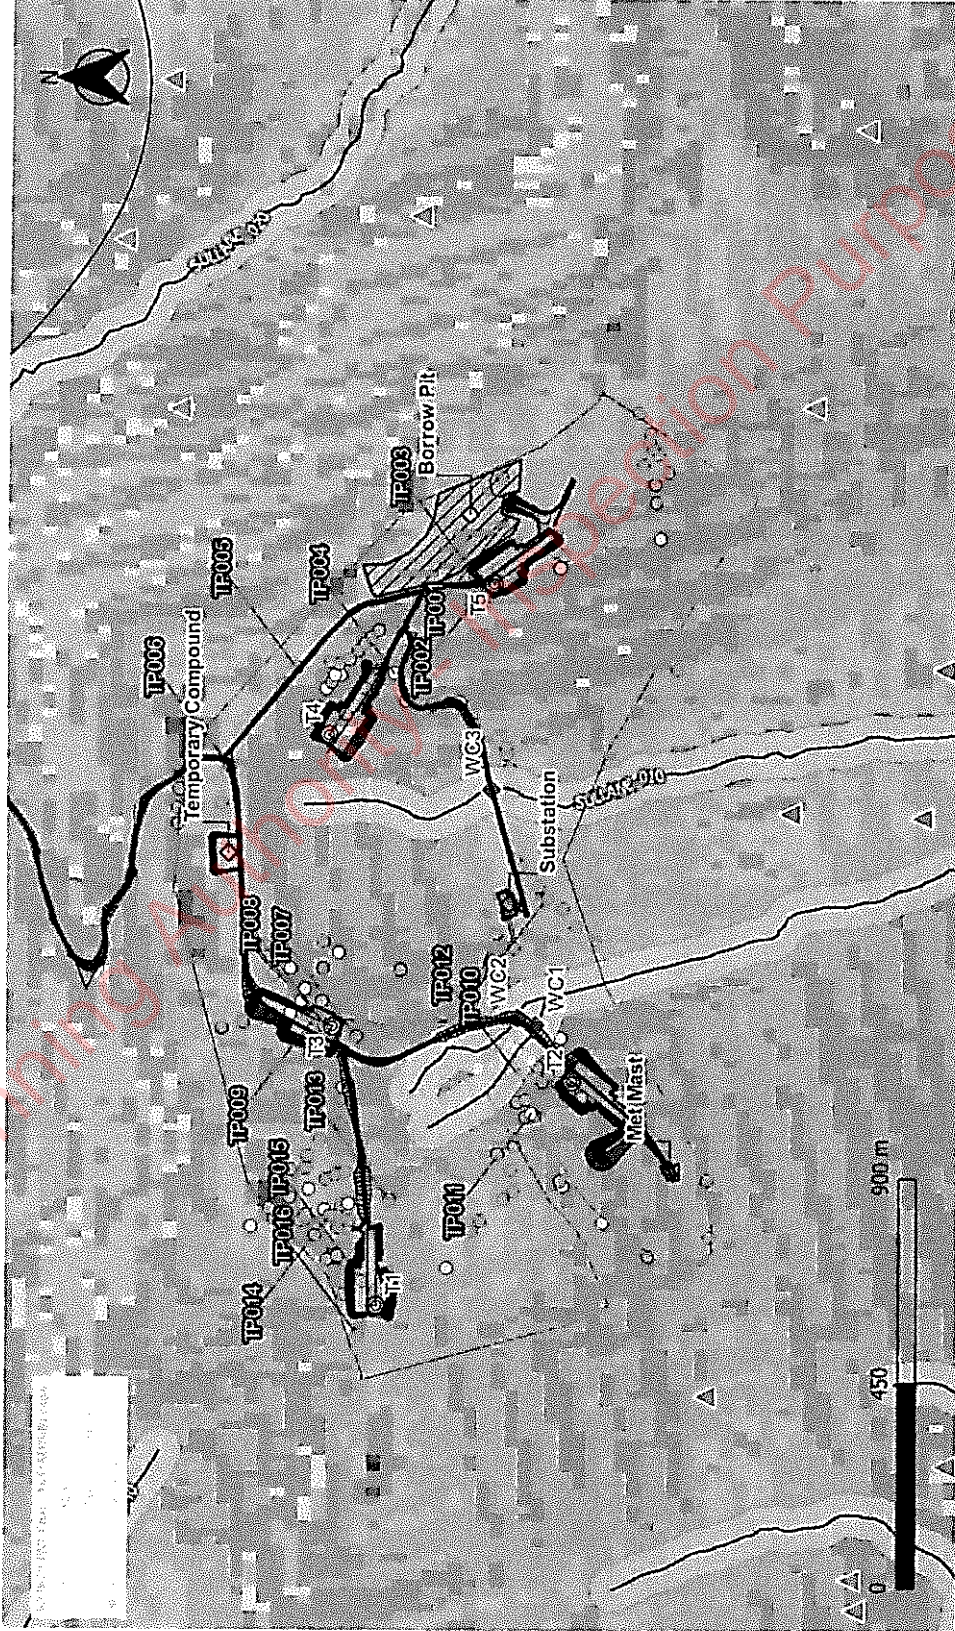
Plate 6: Peat Data - FoS (ADJ) (B) with Slope (GDEM) presents peat stability risk assessment Factor of Safety (FoS (ADJ) (Scenario B)) results, receptors and associated 50m buffer zones, and slope (GDEM).

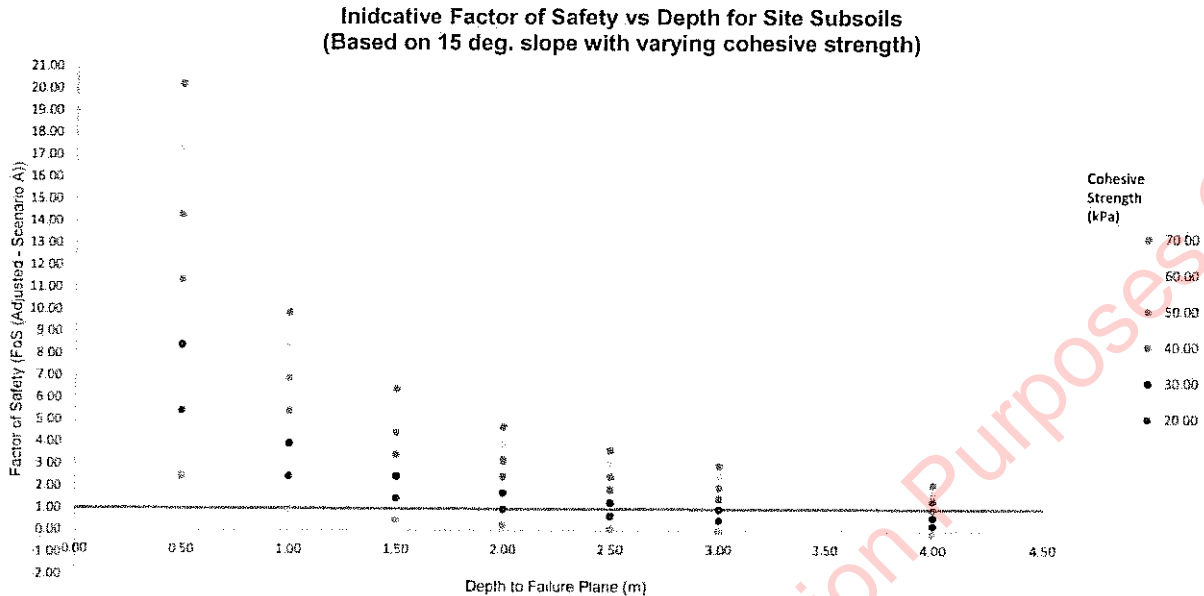
**Figure 2: Correlation Between Factor of Safety, Cohesive Strength and Depth of Subsoils**

Based on the inferred conservative values applied to the above stability risk assessment, the factor of safety is highly dependent on cohesive strength, which in turn is highly dependent on hydrogeological characteristics including pore water pressure. **Figure 2** presents potential varying Factors of Safety for subsoils at the Site depending on varying cohesive strength and depths to failure plane.
