GENERAL DETAILS	
SITE ADDRESS	DEVELOPMENT SITE @ MILLTOWN PARK, SANDFORD ROAD, DUBLIN 6
CLIENT DETAILS	SANDFORD LIVING LIMITED RIVERSIDE ONE SIR JOHN ROGERSON'S QUAY DUBLIN 2
	OWNERSHIP PUBLIC PRIVATE X
	TEL / MOB 01 2963660 / 087 4475660 EMAIL jmosullivan@lafferty.ie
CONSULTANTS / AGENTS	PROJECT MANAGERS – LAFFERTY, DUNDRUM TOWN CENTRE, SANDYFORD ROAD, DUNDRUM, DUBLIN, D16 A4W6 ARCHITECTS – O'MAHONY PIKE, THE CHAPEL, MOUNT ST. ANNE'S, MILLTOWN, DUBLIN, D06 XN52 PLANNING CONSULTANTS – THORNTON O'CONNOR, 1 KILMACUD ROAD UPPER, DUNDRUM, D14 EA89 ENVIRONMENTAL CONSULTANTS – JBA CONSULTING, GROVE ISLAND, LIMERICK, V94 312N ECOLOGICAL CONSULTANTS – JBA CONSULTING, GROVE ISLAND, LIMERICK, V94 312N
CURRENT SITE USAGE	AGRICULTURAL FORESTRY RESIDENTIAL COMMERCIAL INDUSTRIAL
	PUBLIC SPACE GREENFIELD BROWNFIELD OTHER X FORMER INSTITUTIONAL
SITE AREA	DEVELOPABLE SITE AREA = 4.26 Ha.
STATE AGENCIES INVOLVED	CO. COUNCIL NPWS I.F.I. I.W. BORD NA MONA

DESCRIPTION & EXTENT OF PRIMARY I.A.P.S. COLONISATIONS

I.A.P.S. MANAGEMENT PLAN

MILLTOWN PARK DEVELOPMENT SITE
SANDFORD ROAD
DUBLIN 6

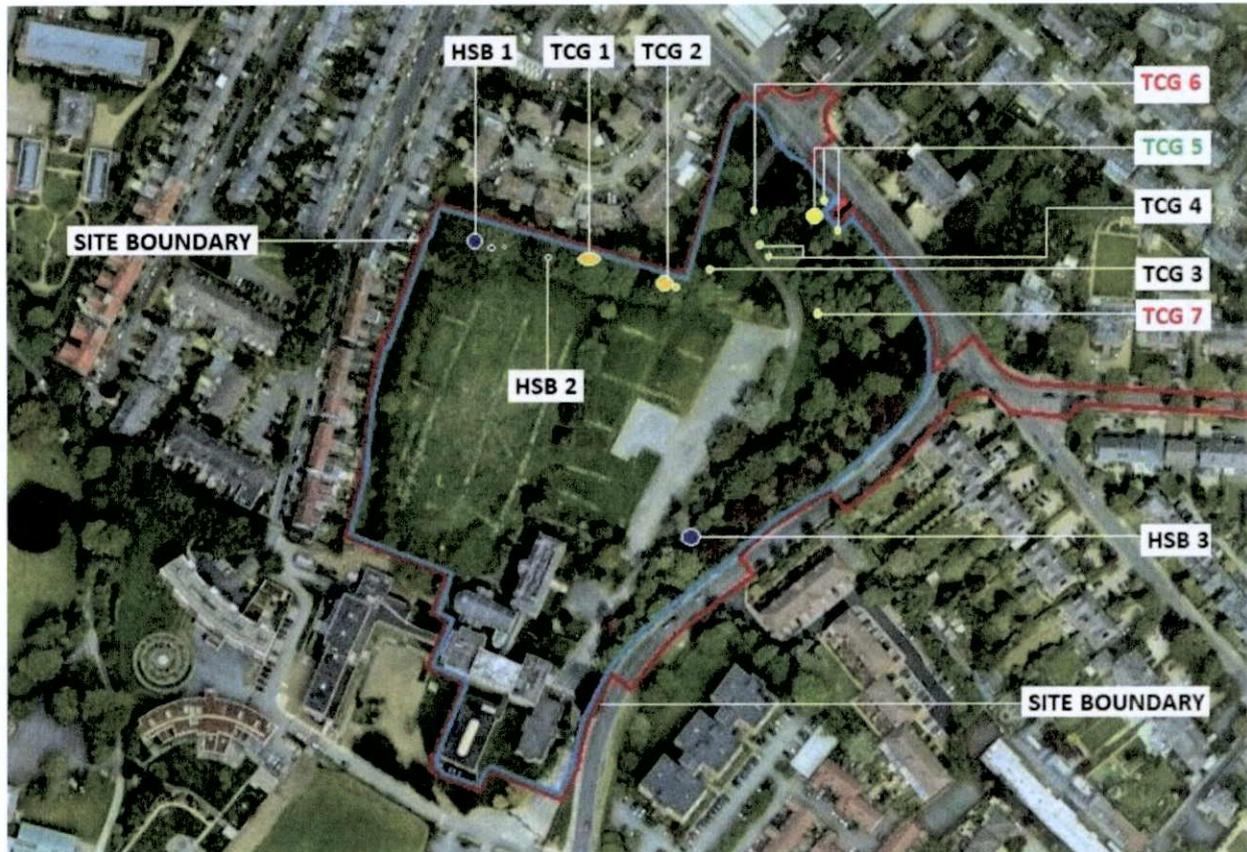
I.A.P.S. DISTRIBUTION MAP – MARCH 2023

TCG 1 - A LINEAR STAND OF THREE CORNERED GARLIC WITHIN THE WOODLAND FRINGE, WHICH RUNS ALONG THE NORTH WESTERN BOUNDARY OF THE PROPERTY. THE STAND IS LOCATED AT THE BASE OF THE FENCE ON THE BOUNDARY BETWEEN THE SUBJECT SITE AND THE REAR GARDEN OF NO. 6 NORWOOD PARK. SOME PLANTS STILL REMAIN. THEY ARE HEALTHY, WITH SOME CURRENTLY COMING INTO FLOWER

TCG 2 - A CIRCULAR STAND OF THREE CORNERED GARLIC WITHIN THE WOODLAND FRINGE, WHICH RUNS ALONG THE NORTH WESTERN BOUNDARY OF THE PROPERTY. THE STAND IS LOCATED CLOSE TO THE BOUNDARY BETWEEN THE SUBJECT SITE AND THE REAR GARDENS OF NO'S. 4 & 5 NORWOOD PARK. SOME PLANTS STILL REMAIN. THEY ARE HEALTHY, WITH SOME CURRENTLY COMING INTO FLOWER

TCG 3 - A SMALL SINGLE STAND OF THREE CORNERED GARLIC GROWING ON THE WESTERN FRINGE OF A STAND OF WINTER HELIOTROPE, ITSELF AROUND THE BASE OF A MATURE TREE, WEST OF THE MAIN DRIVEWAY. SOME PLANTS STILL REMAIN. THEY ARE HEALTHY, WITH SOME CURRENTLY COMING INTO FLOWER

TCG 4 - TWO SMALL SINGLE STANDS OF THREE CORNERED GARLIC GROWING IN THE GRASS MARGIN IMMEDIATELY BESIDE, AND TO THE NORTH OF, THE MAIN DRIVEWAY. REMAINING PLANTS ARE COMING INTO FLOWER

TCG 5 - A LARGE STAND OF PRIMARILY THREE CORNERED GARLIC, BUT WITH A FEW SPANISH BLUEBELL PLANTS ALSO PRESENT, LOCATED IN THE WOODLAND CLEARING IN THE NORTH EASTERN SECTOR OF THE SITE, CLOSE TO THE ELECTRICAL SUBSTATION STRUCTURE AND THE BOUNDARY WITH SANDFORD ROAD. THE STAND COMPRISES A SERIES OF GROUPS OF PLANTS DISTRIBUTED ACROSS THE CLEARING, PARTICULARLY WHERE IT WAS USED HISTORICALLY FOR THE DISPOSAL OF PLANT CUTTINGS AND GARDEN WASTE. PLANTS ARE CURRENTLY COMING INTO FLOWER *

TCG 6 - A SMALL SINGLE STAND OF THREE CORNERED GARLIC GROWING IN THE GRASSED MARGIN RUNNING ALONG THE EASTERN EDGE OF THE MAIN DRIVEWAY, NORTH OF TCG 4. PLANTS ARE CURRENTLY COMING INTO FLOWER **

TCG 7 - A SMALL STAND OF THREE CORNERED GARLIC GROWING AMONGST TREES WITHIN THE WOODLAND FRINGE RUNNING ALONG THE EASTERN EDGE OF THE MAIN DRIVEWAY. PLANTS ARE CURRENTLY COMING INTO FLOWER **

HSB 1 - A SCATTERED STAND OF HYBRIDISED SPANISH BLUEBELL WITHIN THE WOODLAND FRINGE, WHICH RUNS ALONG THE NORTH WESTERN BOUNDARY OF THE PROPERTY. THE STAND IS MIXED WITHIN NATIVE VEGETATION, CLOSE TO THE BOUNDARY BETWEEN THE SUBJECT SITE AND THE REAR GARDENS OF NO'S. 9 & 10 NORWOOD PARK. SOME PLANTS STILL REMAIN. THEY ARE HEALTHY, WITH SOME CURRENTLY COMING INTO FLOWER

HSB 2 - A SMALL SINGLE STAND OF HYBRIDISED SPANISH BLUEBELL WITHIN THE WOODLAND FRINGE ALONG THE NORTH WESTERN SITE BOUNDARY. SOME VIABLE PLANT MATERIAL STILL REMAINS, WHICH IS HEALTHY, AND CURRENTLY COMING INTO FLOWER

HSB 3 - A STAND OF HYBRIDISED SPANISH BLUEBELL ON THE EDGE OF THE WOODLAND FRINGE, NEAR THE EASTERN BOUNDARY OF THE PROPERTY. THE STAND IS LOCATED AT THE JUNCTION BETWEEN THE MAIN DRIVEWAY TO THE WEST, AND THE BEGINNING OF A WOODLAND PATH TO THE EAST, BELOW A MATURE TREE, AND MIXED WITHIN NATIVE VEGETATION. THERE IS A SMALL SECONDARY STAND JUST NORTH OF THE MAIN STAND, ON THE EASTERN SIDE OF THE WOODLAND PATH. SOME PLANTS STILL REMAIN. THEY ARE HEALTHY, WITH SOME CURRENTLY COMING INTO FLOWER

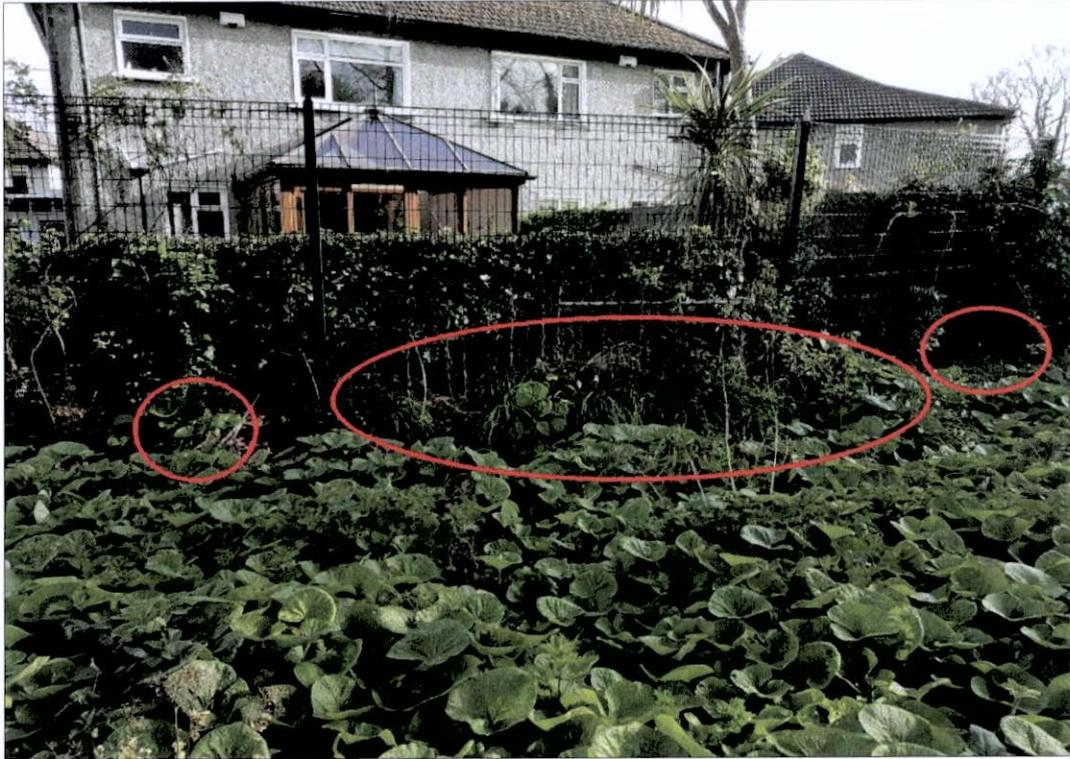
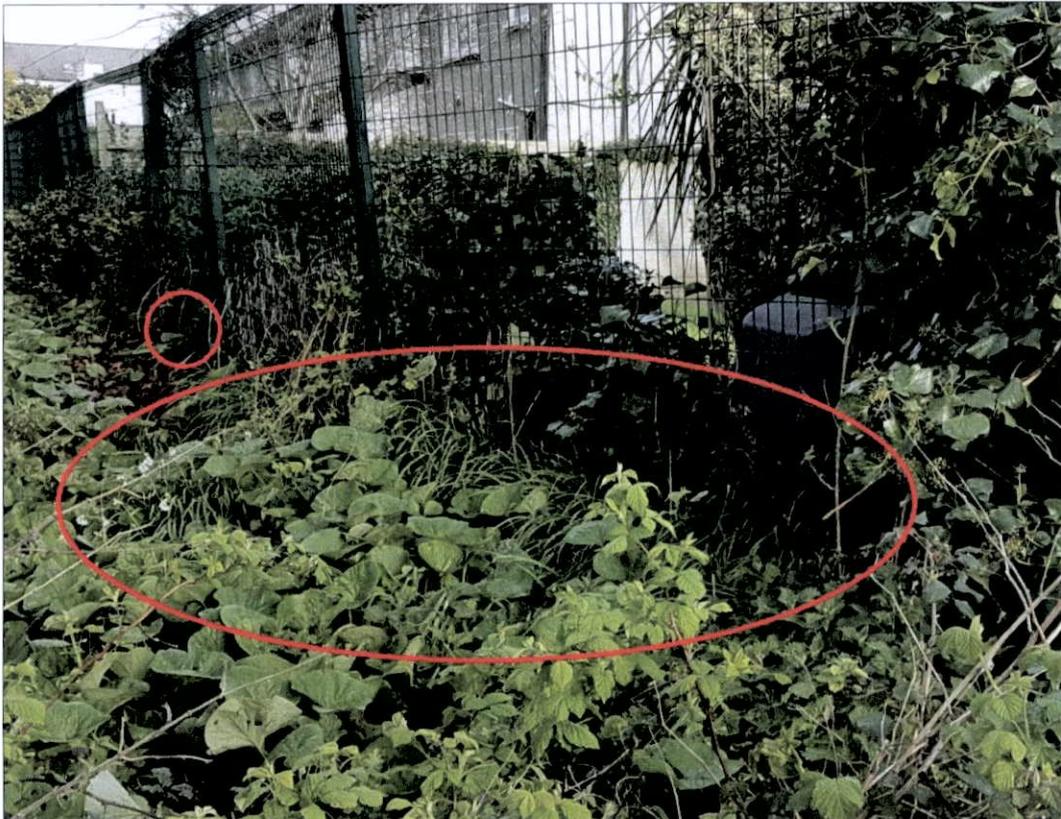
THREE CORNERED GARLIC – TCG 1

LINEAR STAND RUNNING ALONG BOUNDARY LINE – LOOKING NORTH EAST

LINEAR STAND RUNNING ALONG BOUNDARY LINE – LOOKING NORTH WEST

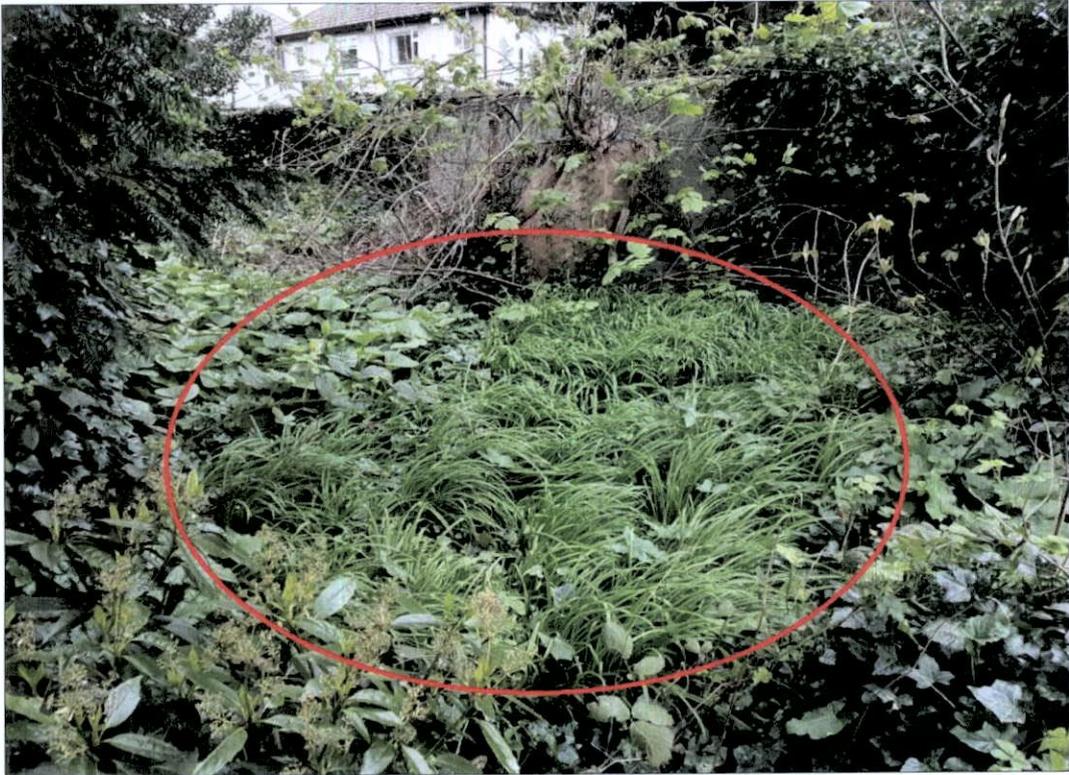
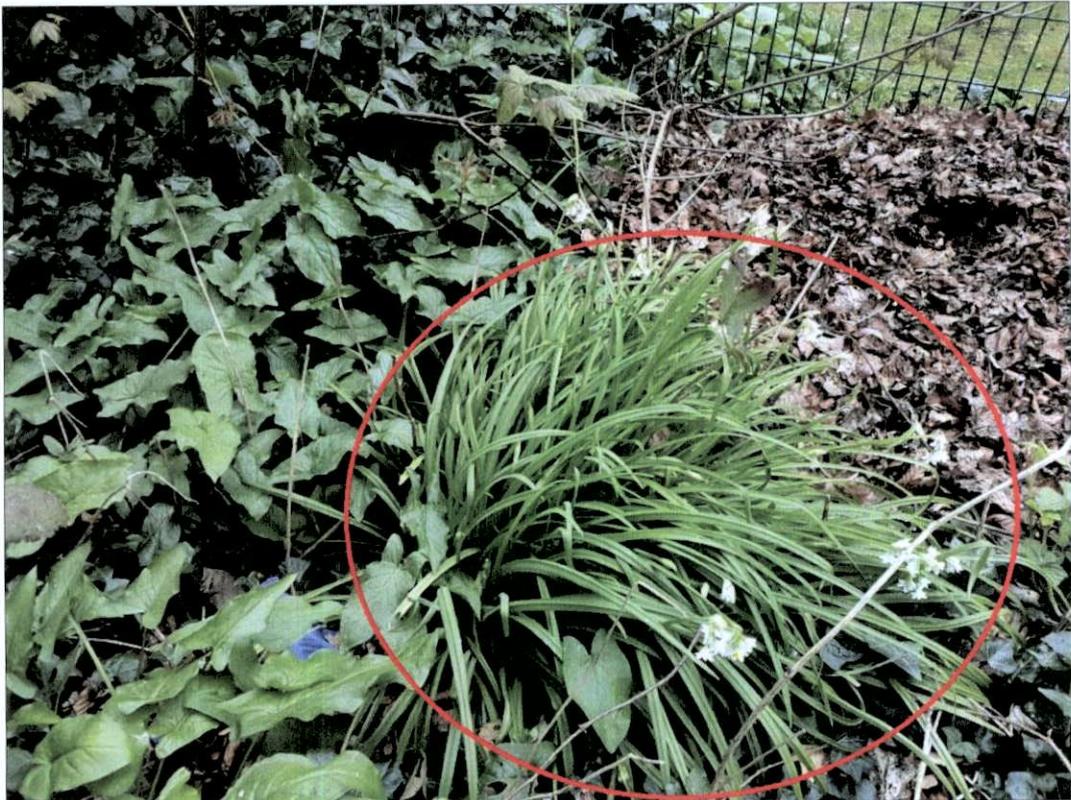
THREE CORNERED GARLIC – TCG 2

MAIN BODY OF STAND NEAR NORTH WESTERN BOUNDARY LINE – LOOKING NORTH

SECONDARY GROWTH TO THE EAST OF MAIN STAND, COMING INTO FLOWER – LOOKING NORTH

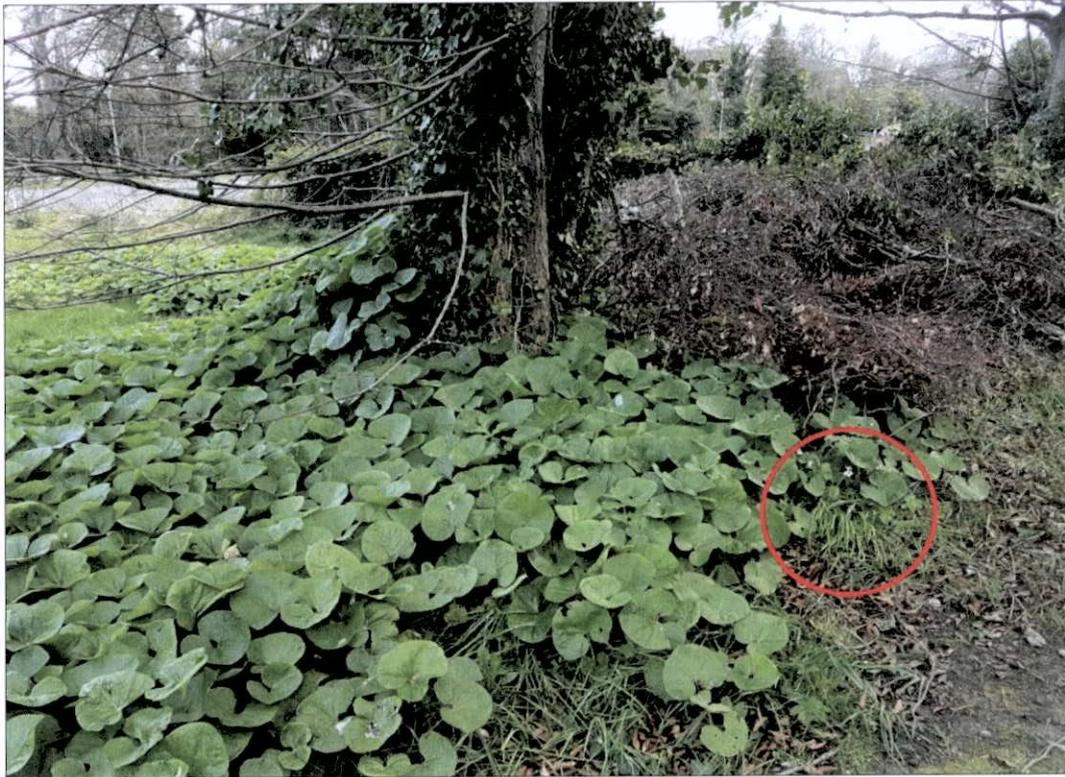
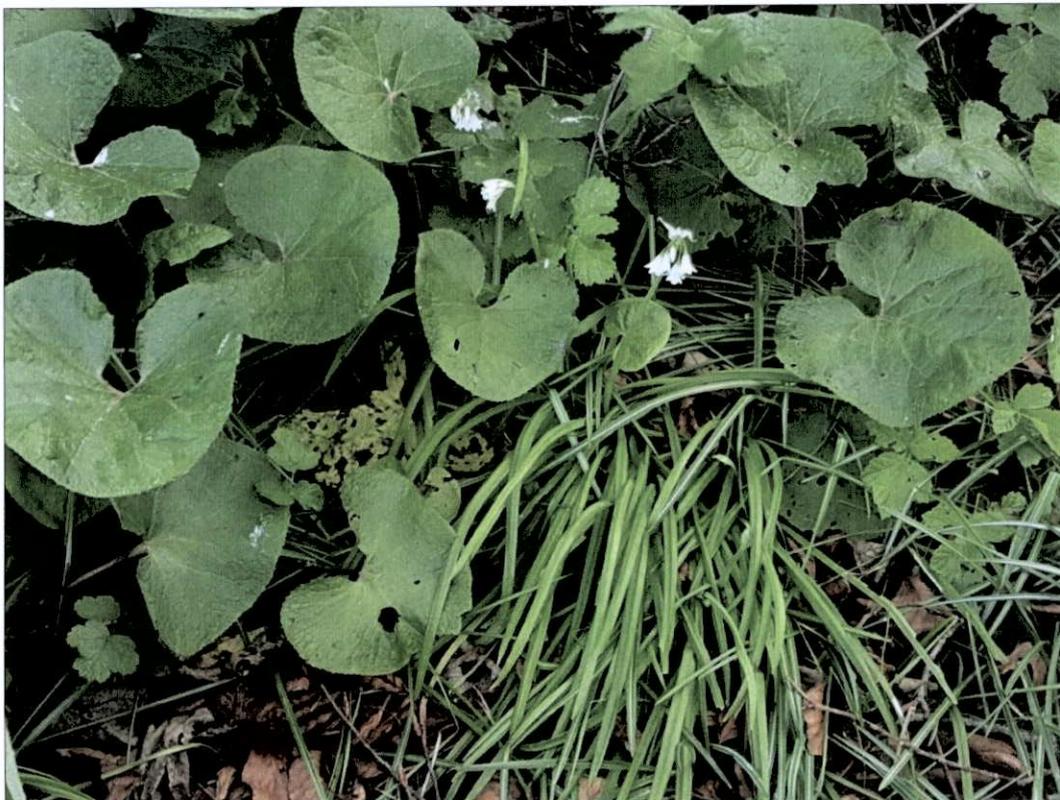
THREE CORNERED GARLIC – TCG 3

SINGLE STAND ON FRINGE OF WINTER HELIOTROPE – LOOKING SOUTH

CLOSE UP OF STAND ON FRINGE OF WINTER HELIOTROPE – LOOKING SOUTH

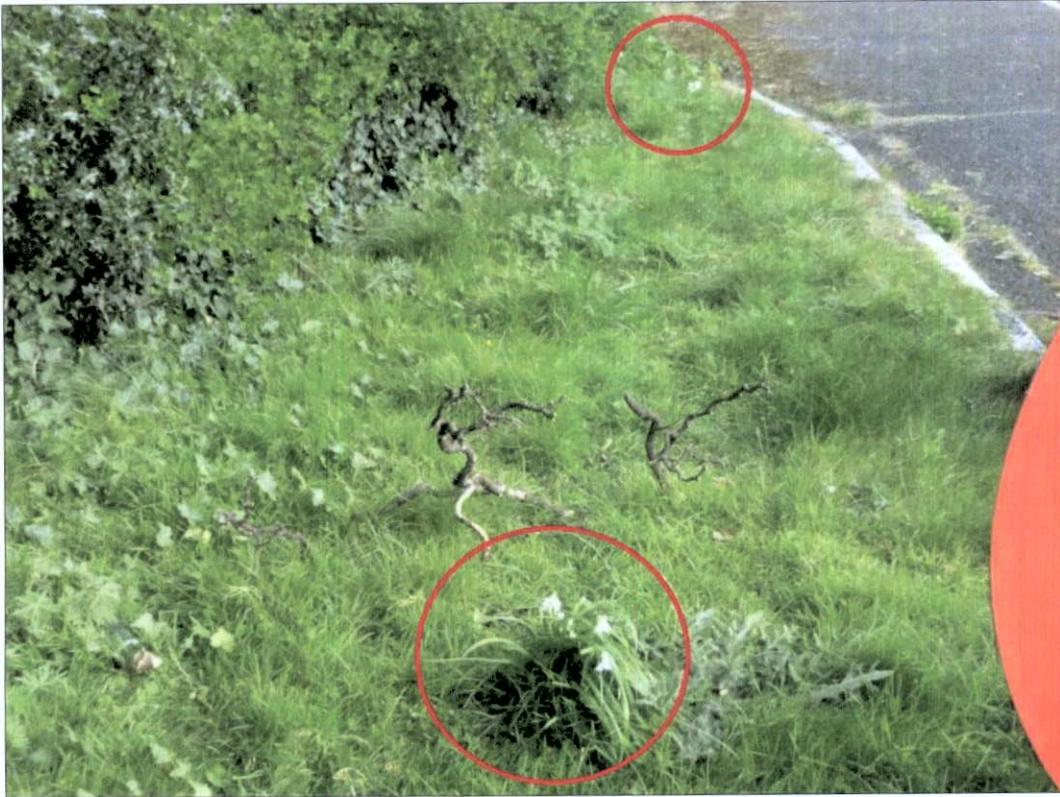
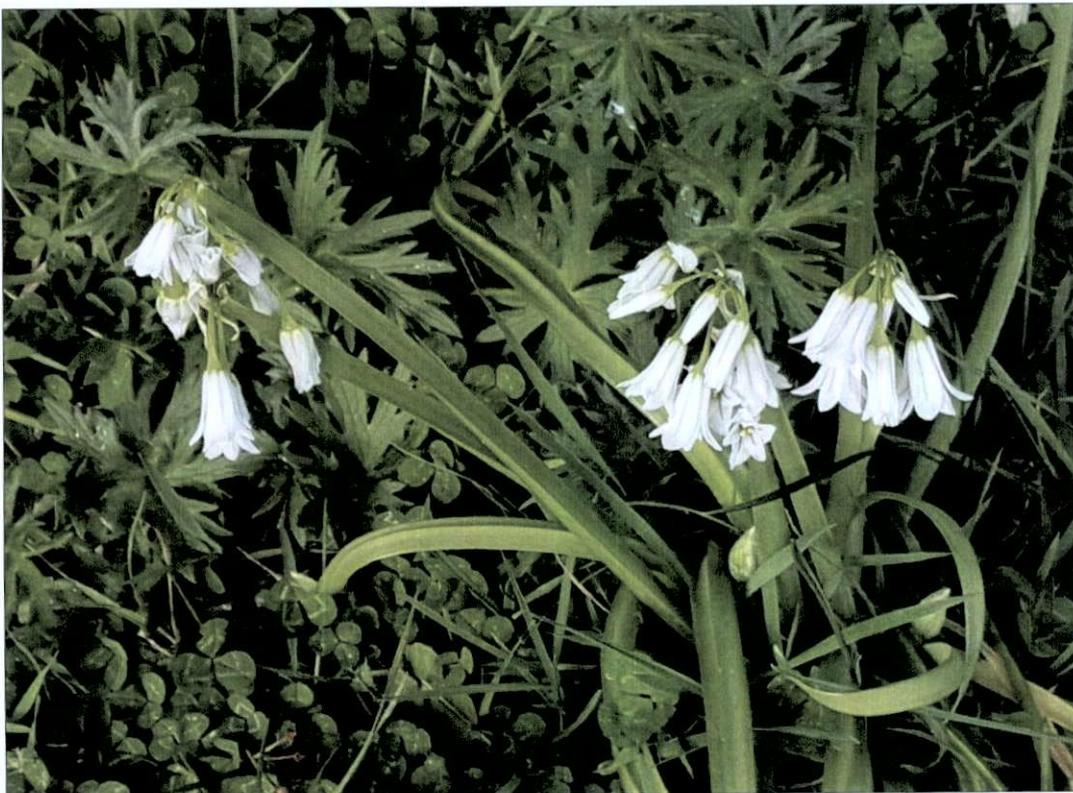
THREE CORNERED GARLIC – TCG 4

TWO STANDS IN THE NORTH EASTERN DRIVEWAY GRASSED MARGIN – LOOKING SOUTH EAST

CLOSE UP OF NORTHERNMOST STAND – LOOKING NORTH EAST

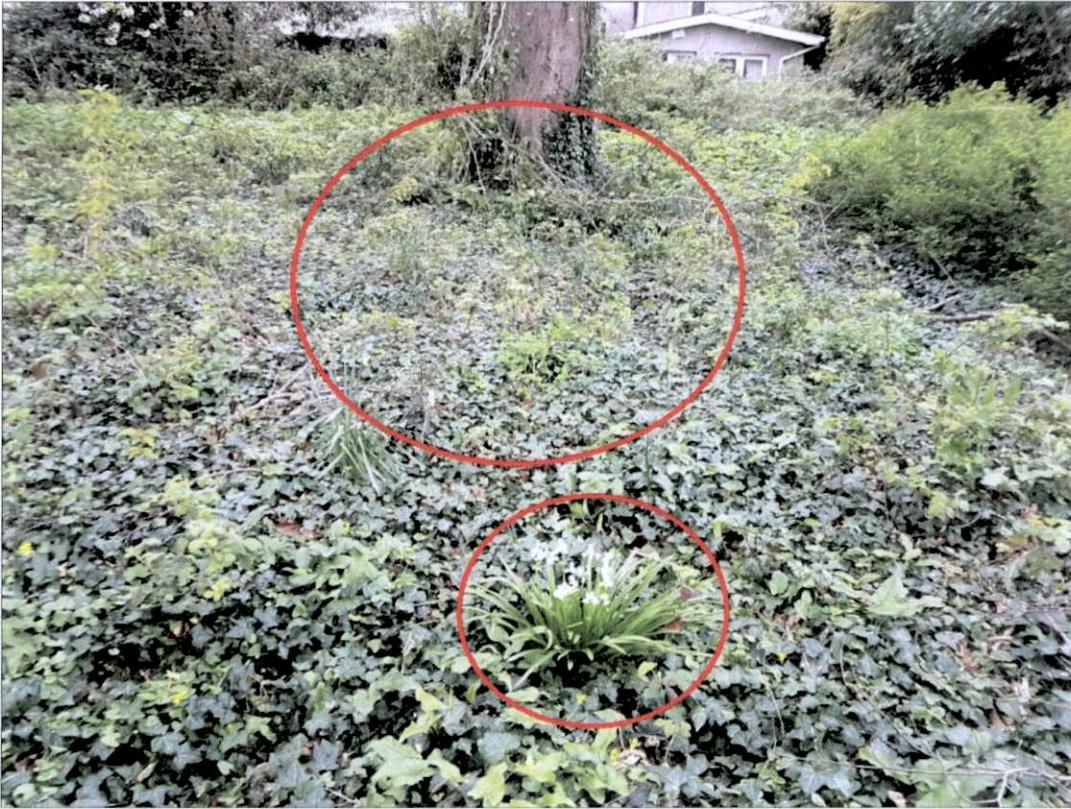
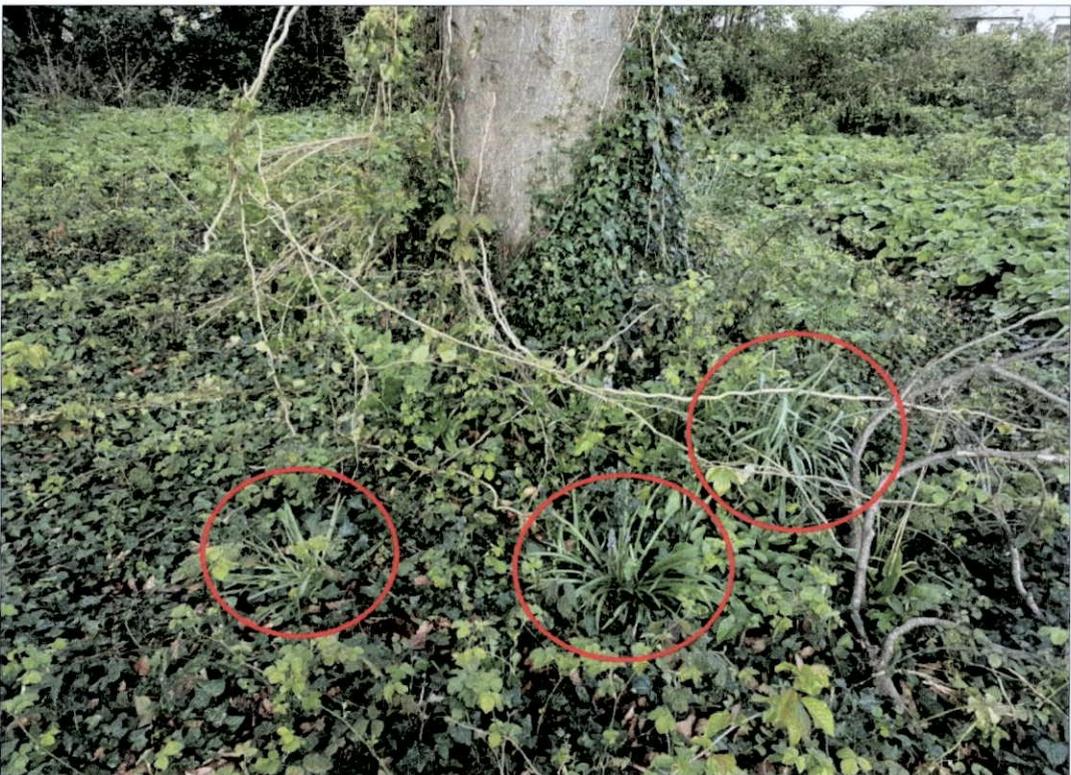
HYBRIDISED SPANISH BLUEBELL - HSB 1

OVERALL ZONE OF INFESTATION – LOOKING WEST

STANDS AROUND BASE OF TREE – LOOKING WEST

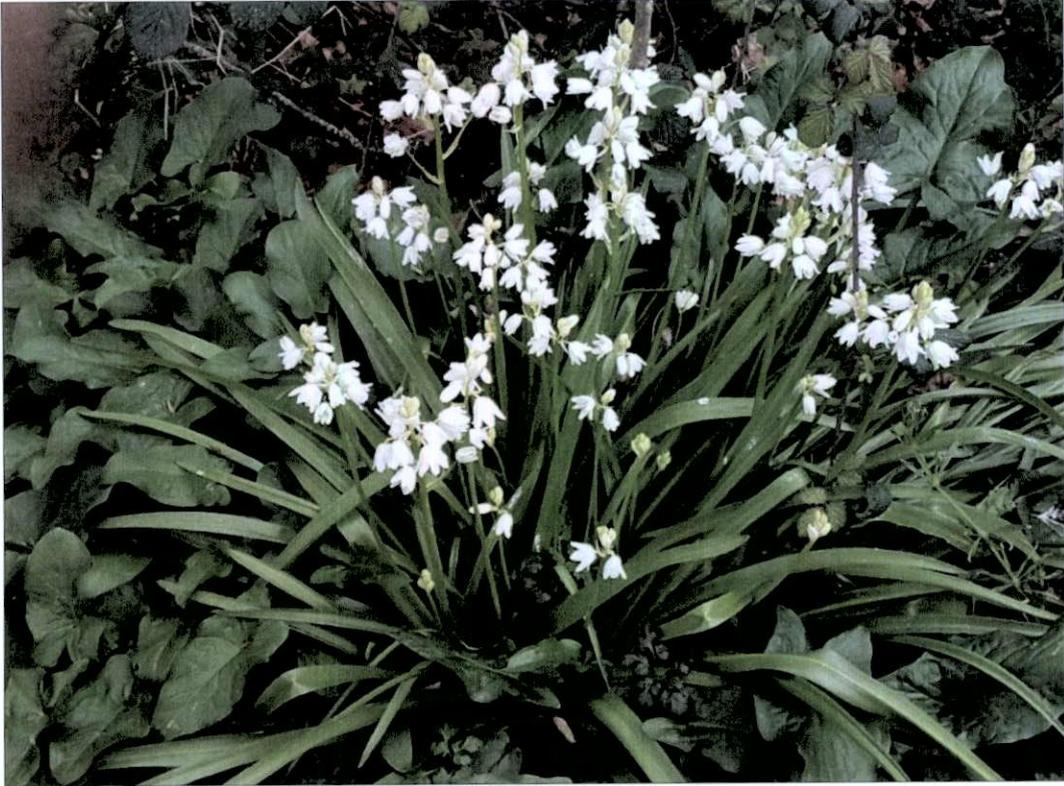
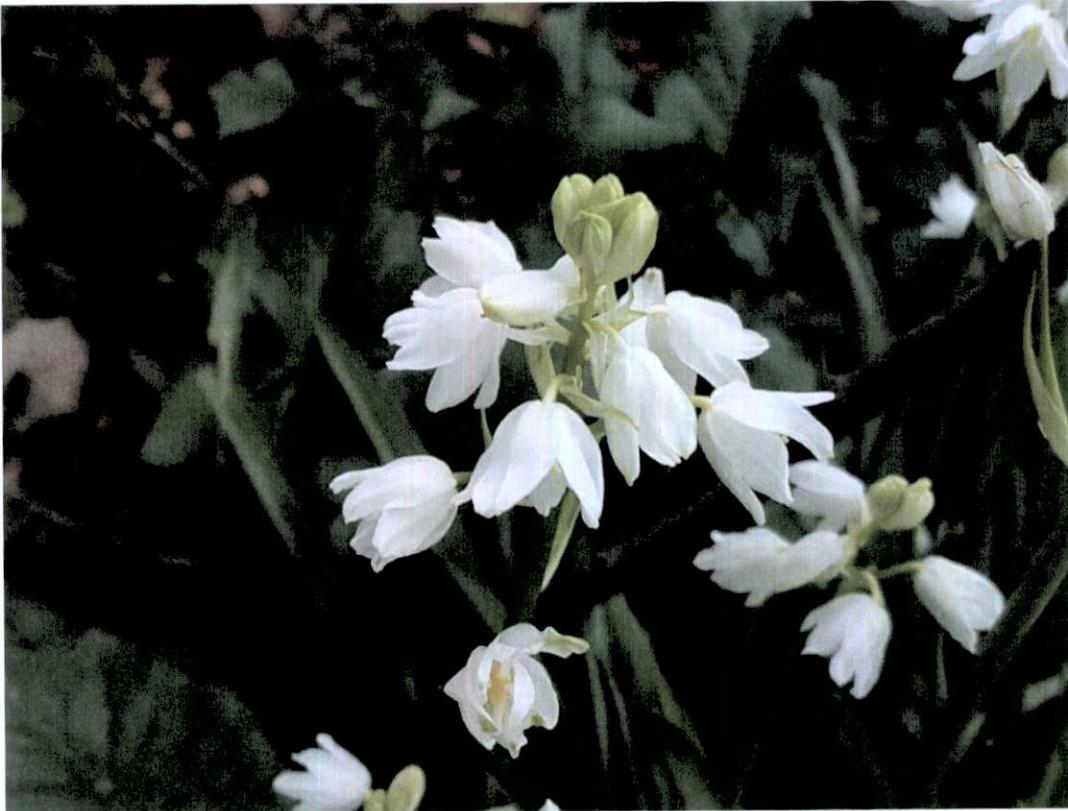
HYBRIDISED SPANISH BLUEBELL - HSB 2

SINGLE STAND OF HYBRIDISED SPANISH BLUEBELL WITH WHITE FLOWERS – LOOKING NORTH

DETAIL OF WHITE FLOWERS OF HYBRIDISED SPANISH BLUEBELL

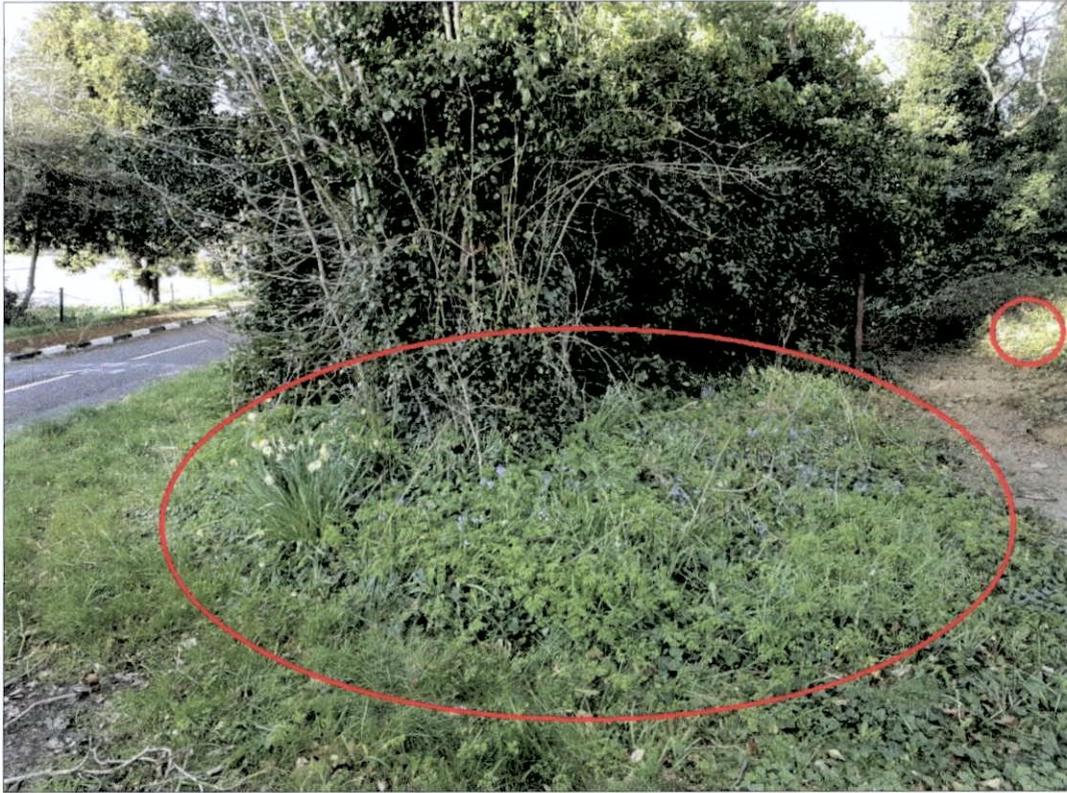
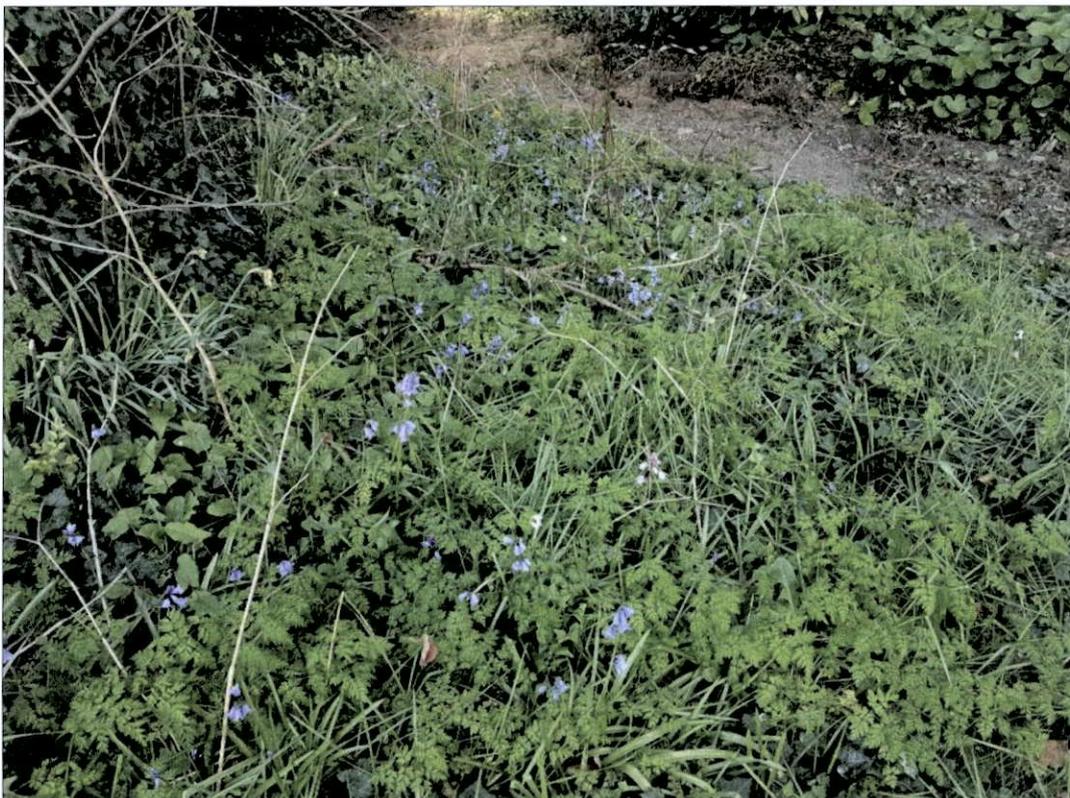
HYBRIDISED SPANISH BLUEBELL - HSB 3

MAIN STAND, WITH SECONDARY STAND TO THE RIGHT AND BEYOND – LOOKING NORTH

CLOSER VIEW OF MAIN STAND – LOOKING NORTH

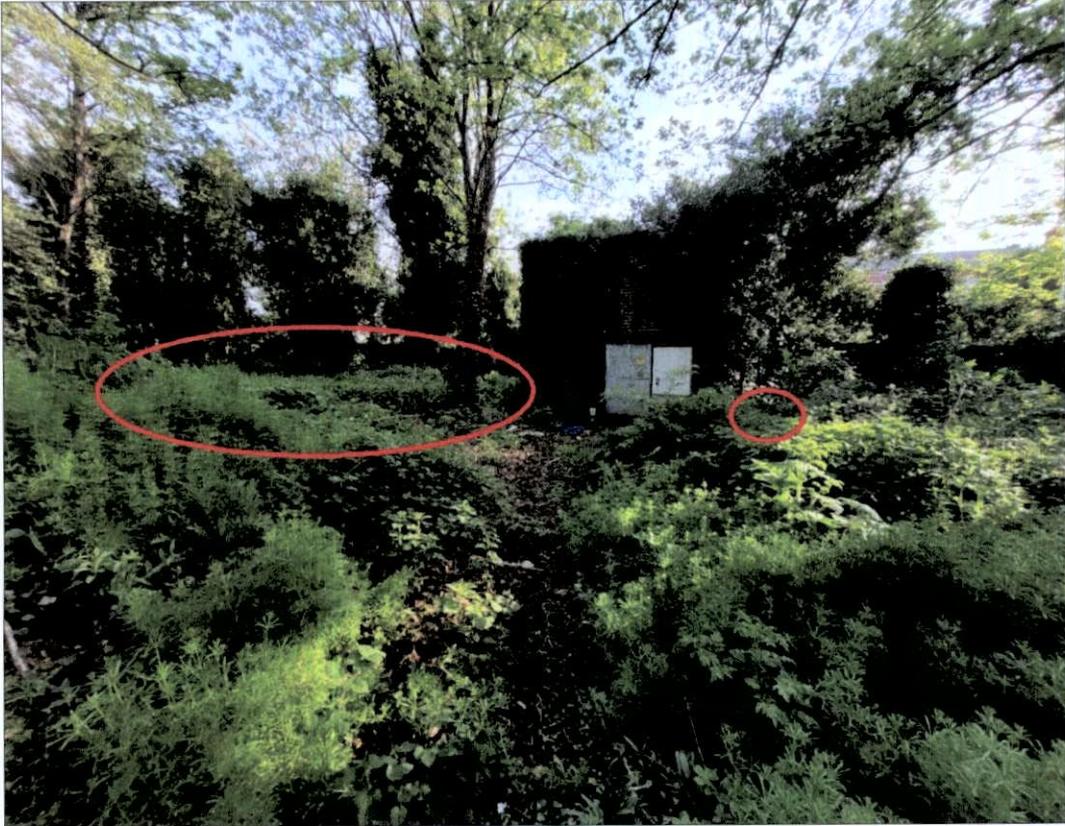
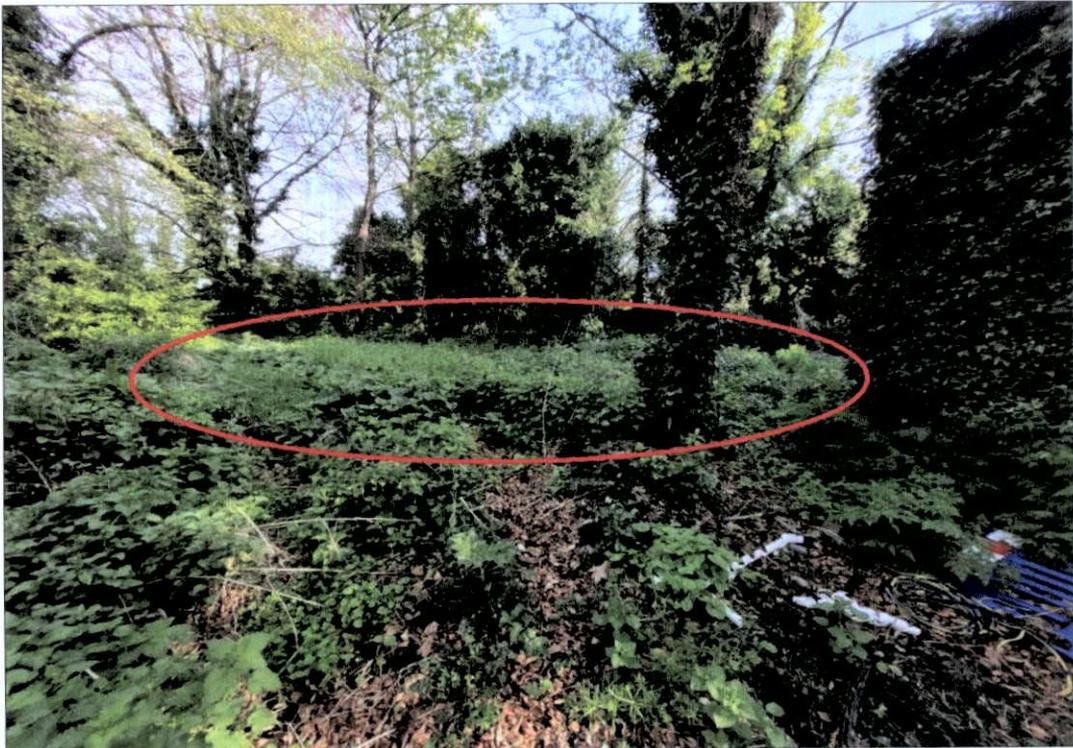
NEW I.A.P.S. STAND – TCG 5

LOCATION OF STANDS IN RELATION TO THE E.S.B. SUB-STATION

MAIN STAND, WEST OF THE E.S.B. SUB-STATION

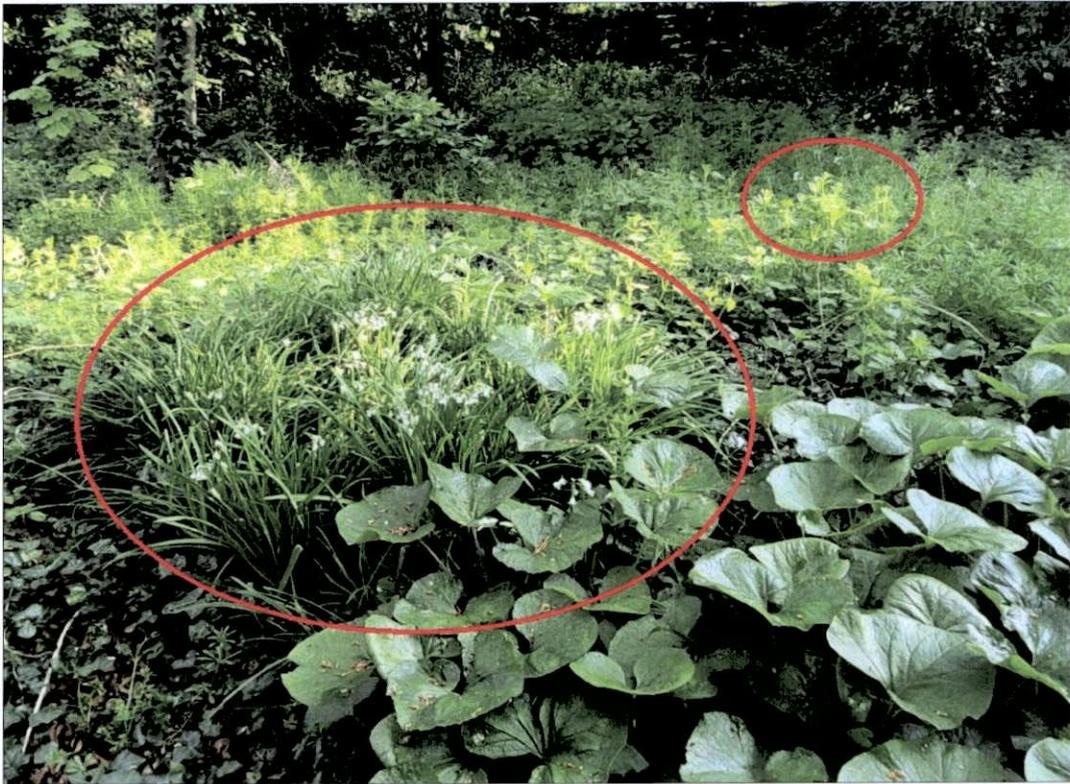
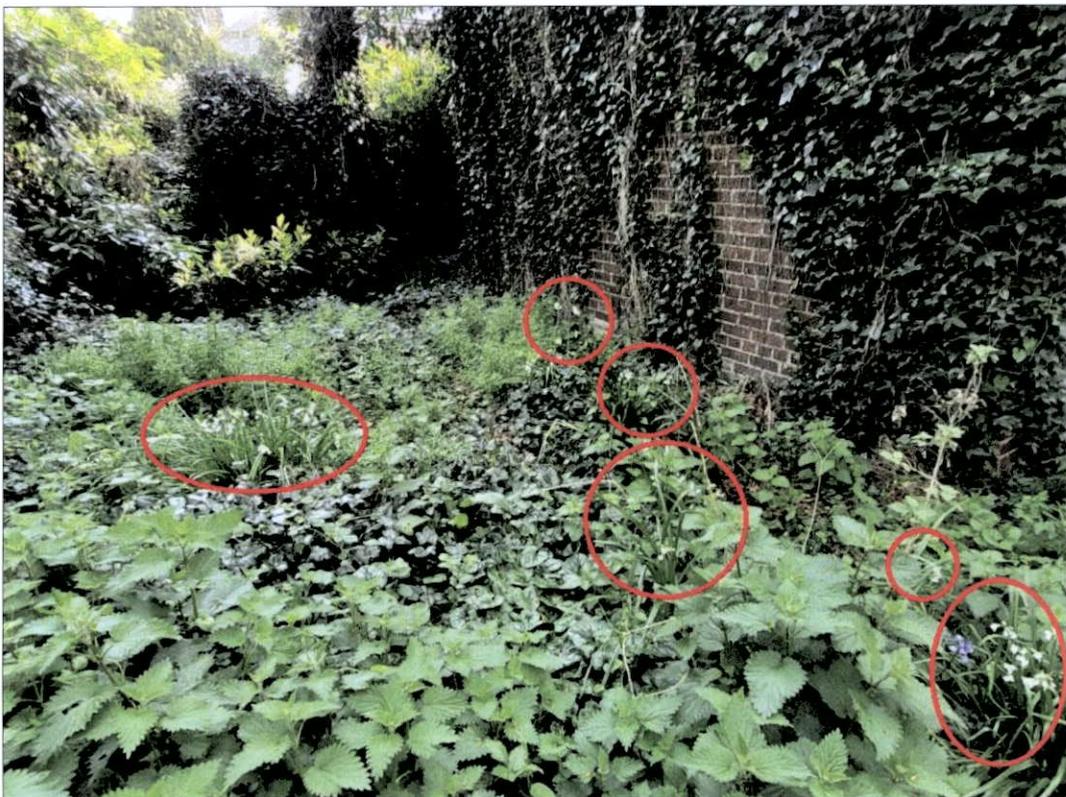
NEW I.A.P.S. STAND – TCG 5

DISTRIBUTION OF PLANTS IN MAIN STAND, LOOKING SOUTH WEST

SECONDARY STANDS, IMMEDIATELY WEST OF THE E.S.B. SUB-STATION

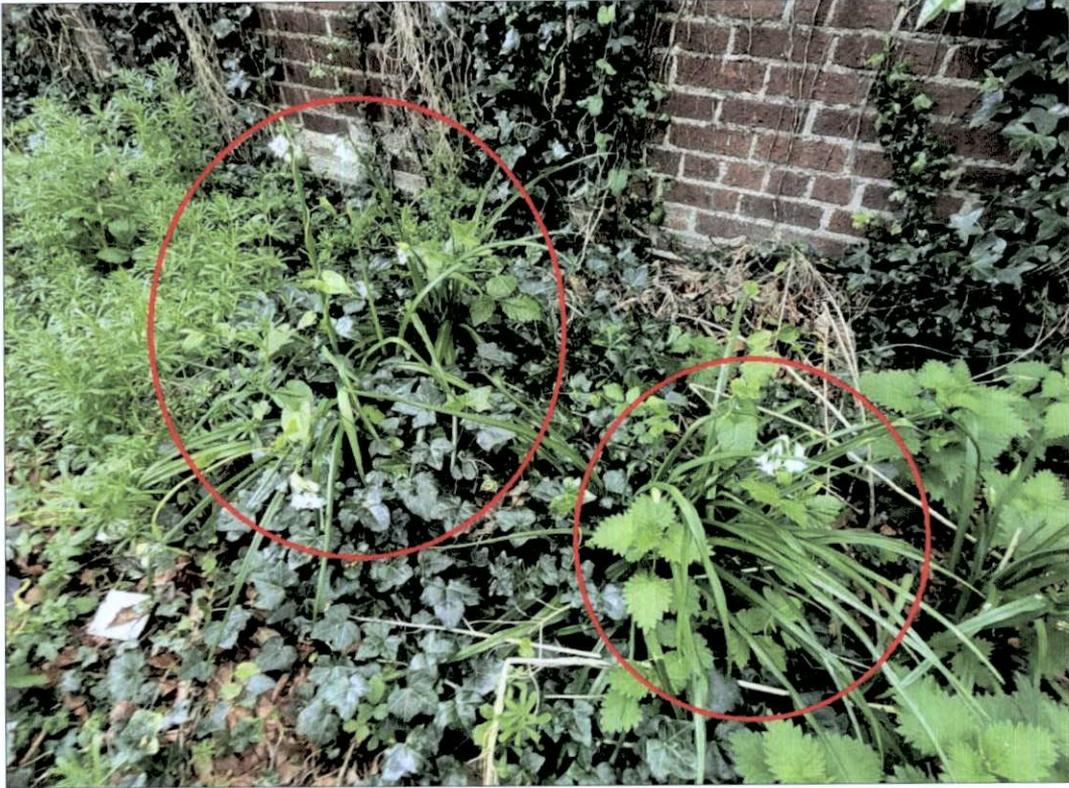
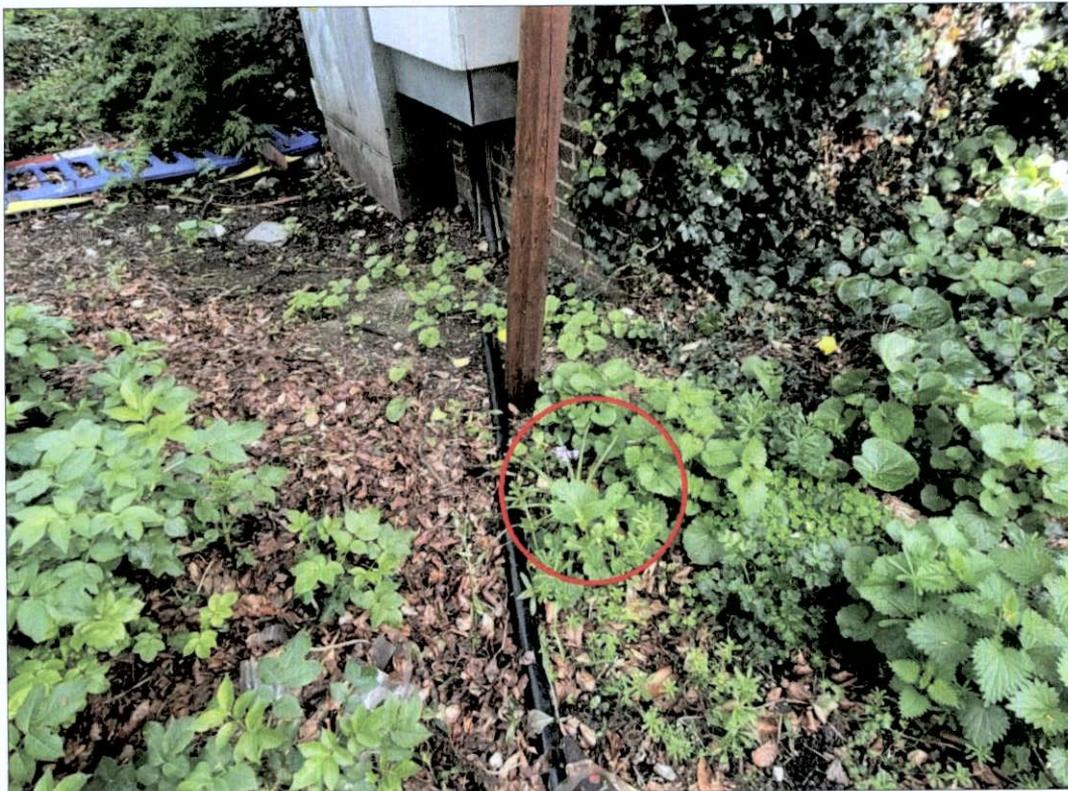
SECONDARY STANDS, IMMEDIATELY EAST OF THE E.S.B. SUB-STATION

SECONDARY STAND, EAST OF THE E.S.B. SUB-STATION

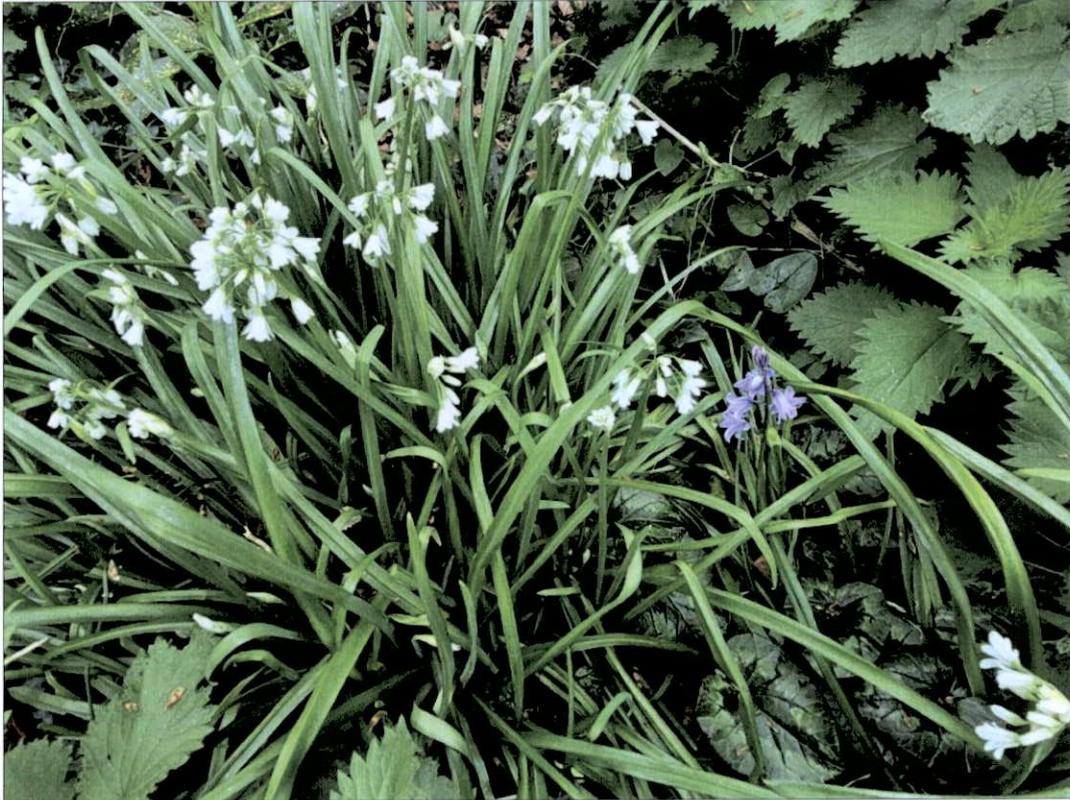
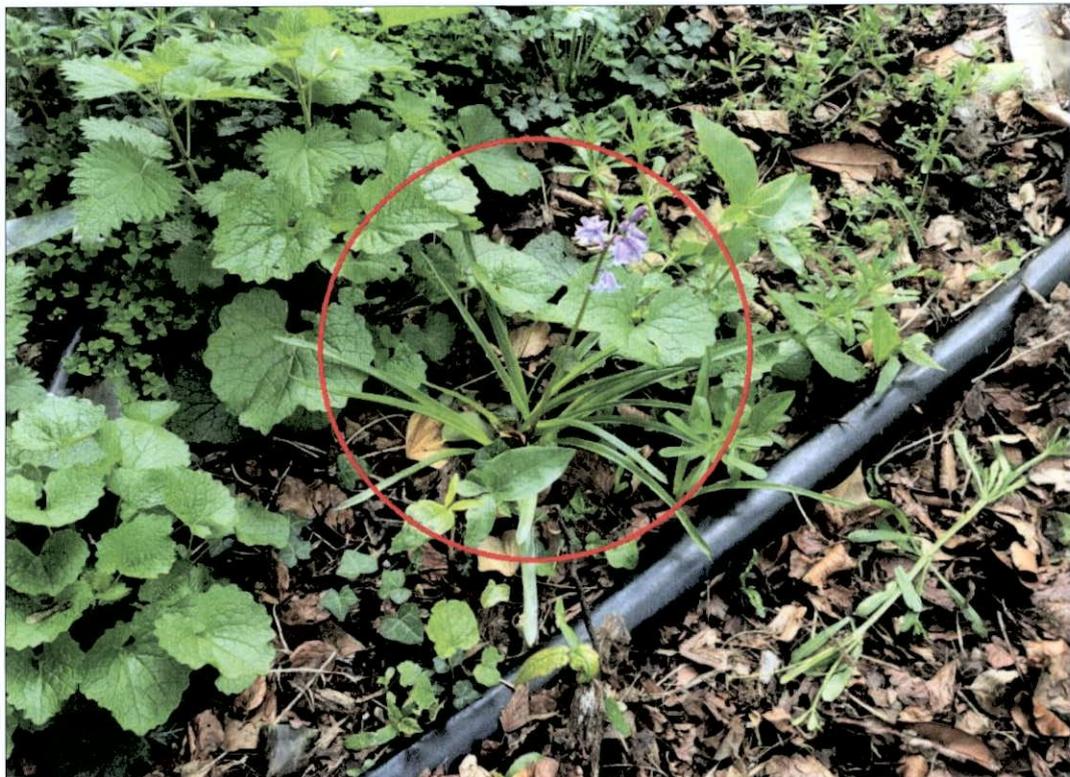
NEW I.A.P.S. STAND – TCG 5

THREE CORNERED GARLIC PLANTS, WITH A SPANISH BLUEBELL PLANT ADJACENT ON THE RIGHT

TYPICAL INDIVIDUAL SPANISH BLUEBELL PLANT

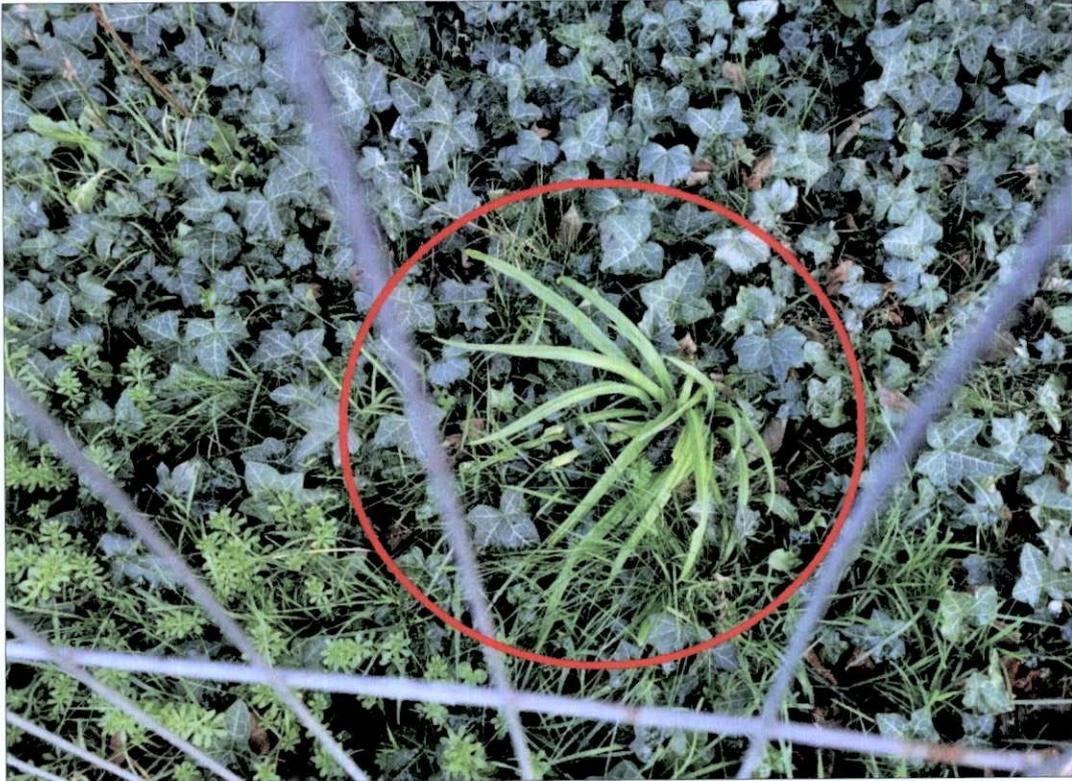
TCG 6 – IN EASTERN ROADSIDE GRASS MARGIN NORTH OF TCG 4

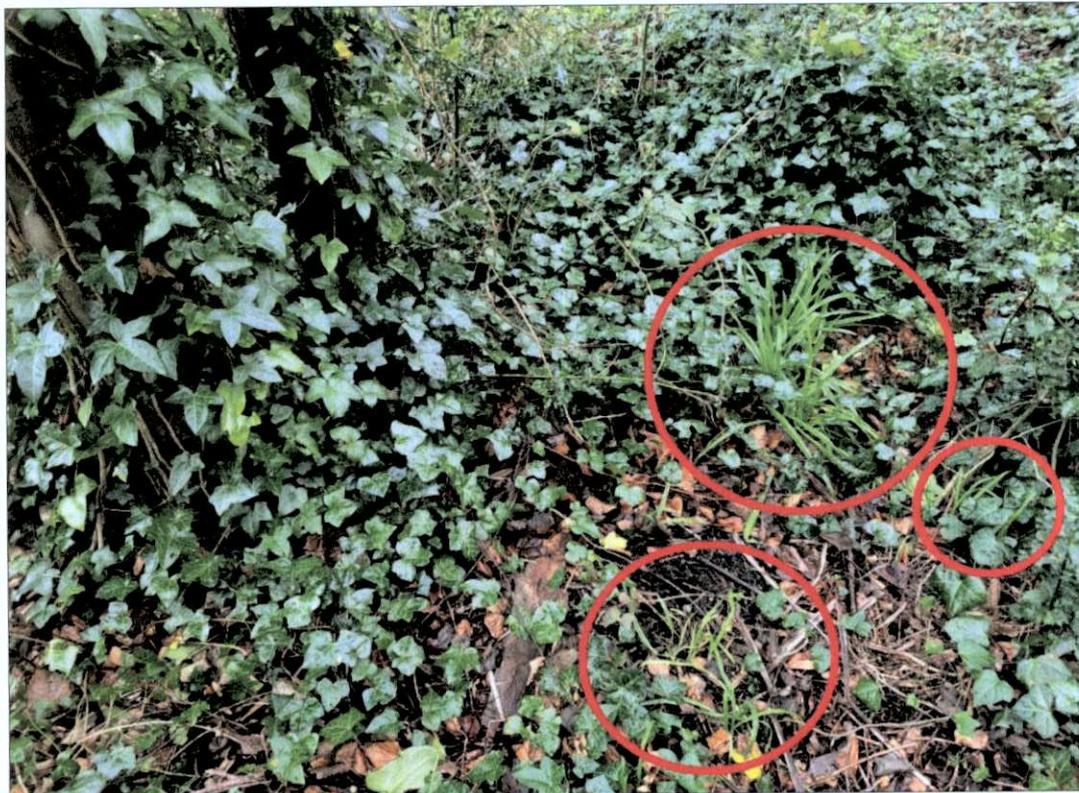
TCG 7 – IN WOODLAND FRINGE ON EASTERN ROADSIDE SOUTH OF TCG 4
