GENERAL DETAILS	
SITE ADDRESS	DEVELOPMENT SITE @ MILLTOWN PARK, SANDFORD ROAD, DUBLIN 6
CLIENT DETAILS	SANDFORD LIVING LIMITED RIVERSIDE ONE SIR JOHN ROGERSON'S QUAY DUBLIN 2
	OWNERSHIP PUBLIC PRIVATE X
	TEL / MOB 01 2963660 / 087 4475660 EMAIL jmosullivan@lafferty.ie
CONSULTANTS / AGENTS	PROJECT MANAGERS – LAFFERTY, DUNDRUM TOWN CENTRE, SANDYFORD ROAD, DUNDRUM, DUBLIN, D16 A4W6 ARCHITECTS – O'MAHONY PIKE, THE CHAPEL, MOUNT ST. ANNE'S, MILLTOWN, DUBLIN, D06 XN52 PLANNING CONSULTANTS – THORNTON O'CONNOR, 1 KILMACUD ROAD UPPER, DUNDRUM, D14 EA89 ENVIRONMENTAL CONSULTANTS – JBA CONSULTING, GROVE ISLAND, LIMERICK, V94 312N ECOLOGICAL CONSULTANTS – JBA CONSULTING, GROVE ISLAND, LIMERICK, V94 312N
CURRENT SITE USAGE	AGRICULTURAL FORESTRY RESIDENTIAL COMMERCIAL INDUSTRIAL
	PUBLIC SPACE GREENFIELD BROWNFIELD OTHER X FORMER INSTITUTIONAL
SITE AREA	DEVELOPABLE SITE AREA = 4.26 Ha.
STATE AGENCIES INVOLVED	CO. COUNCIL NPWS I.F.I. I.W. BORD NA MONA

DESCRIPTION & EXTENT OF PRIMARY I.A.P.S. COLONISATIONS

I.A.P.S. MANAGEMENT PLAN

MILLTOWN PARK DEVELOPMENT SITE
SANDFORD ROAD
DUBLIN 6

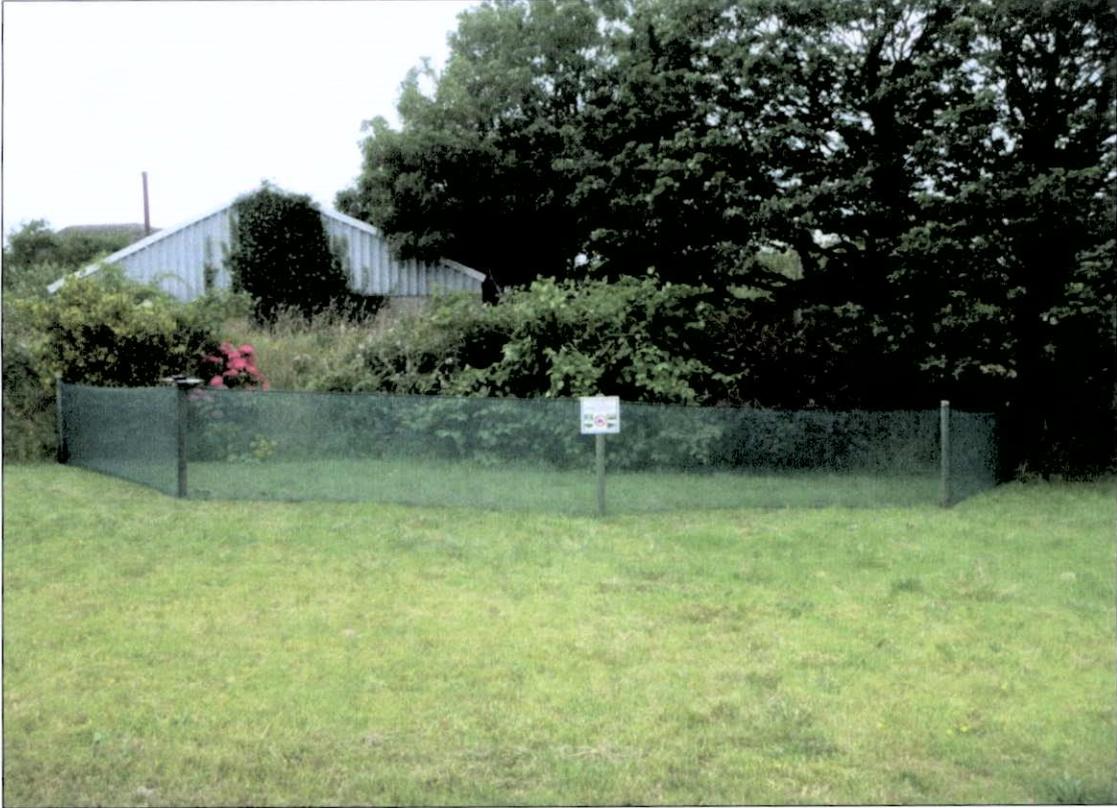
SAMPLE FENCING 1 – POST AND WOVEN MESH FENCING

4. ALL AREAS OF KNOWN, AND NEW, INFESTATION SHOULD REMAIN SECURELY FENCED OFF, INCLUDING A 5 – 7m BUFFER ZONE WHERE APPROPRIATE. FENCING SHOULD BE STURDY AND INCORPORATE WARNING / ADVISORY SIGNAGE. WHERE STANDS ARE SMALL, OR JUST INDIVIDUAL STEMS, OR HAVE BEEN PREVIOUSLY TREATED AND ARE DEAD STEMS, THEN ADVISORY SIGNAGE ON STURDY TIMBER POSTS MAY SUFFICE

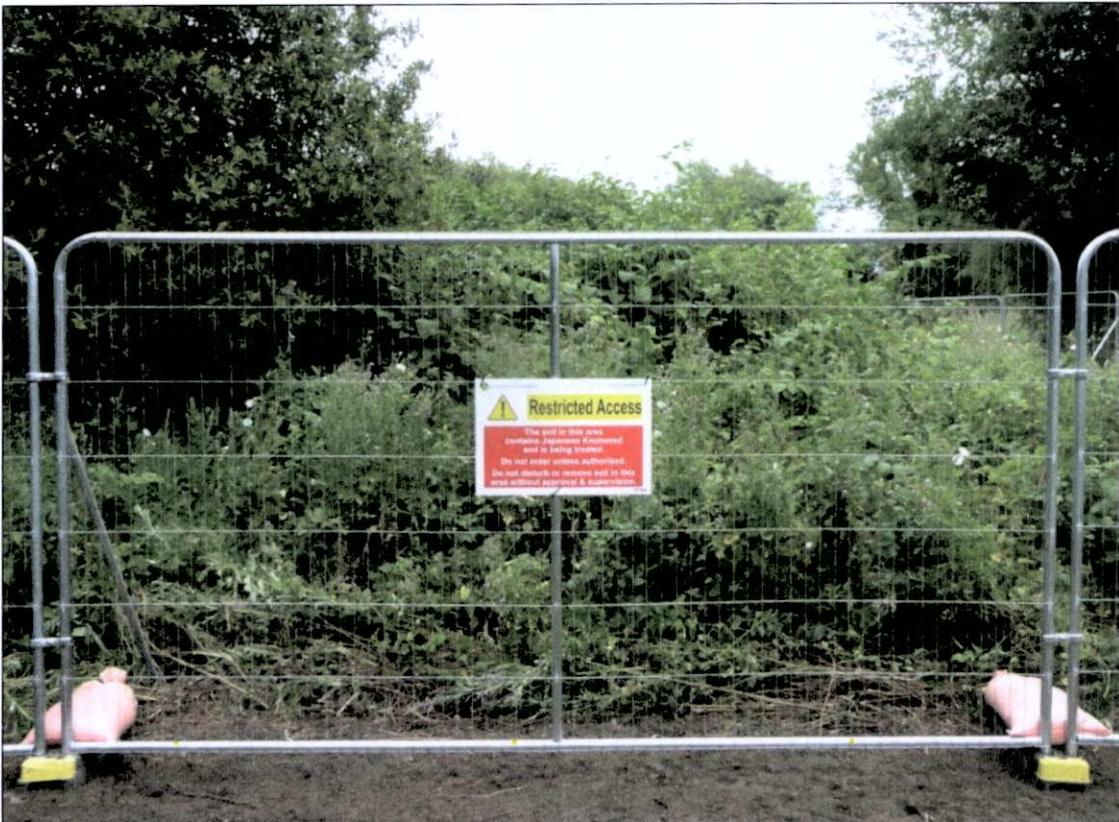
SAMPLE FENCING 2 – HEAVY DUTY HERRAS FENCING
