Fig. 1 Outline of building range- identifying each building element

Appendix 7.1.2. BRIEF HISTORY OF THE EVOLUTION OF MILLTOWN PARK

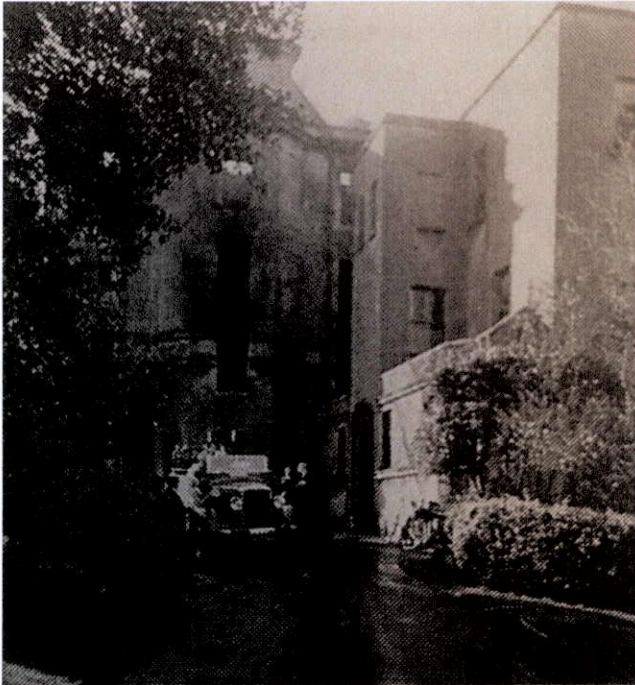
Fig. 16 *The fire damaged exterior of the Finlay Wing, indicating its original height of three storey over basement with pitched roof over.*

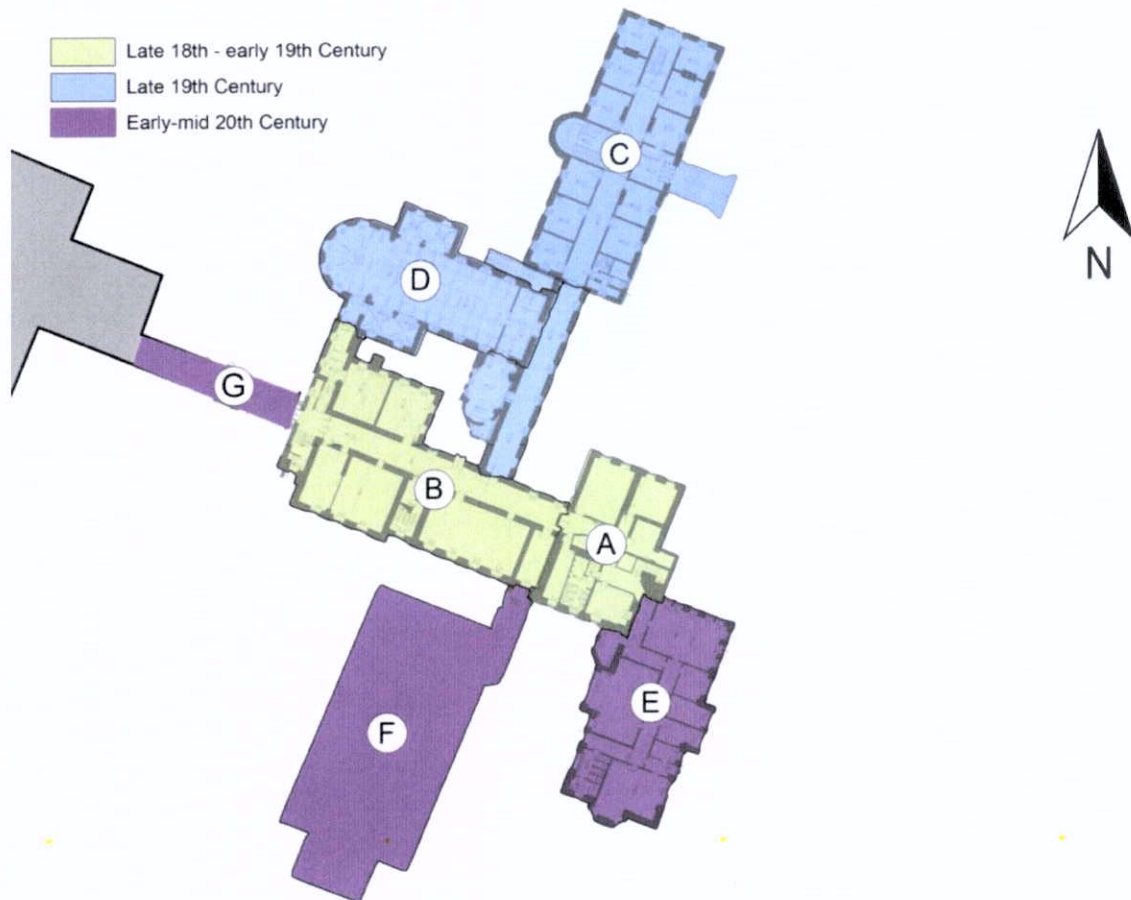
Figure 20 below depicts the general era of construction of each element of the existing building range.

Fig. 19 Approximate chronology of each building element cited in Fig. 2 above

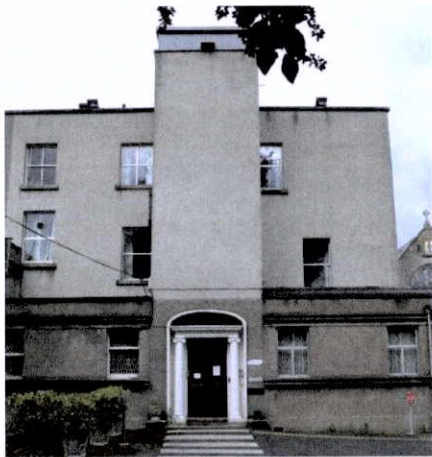
Fig. 21 Present day configuration of east (front) elevation of Milltown Park, with the vertically extended entrance lobby; vertical extension to south (denoted by higher level windows) and repositioning of first floor windows

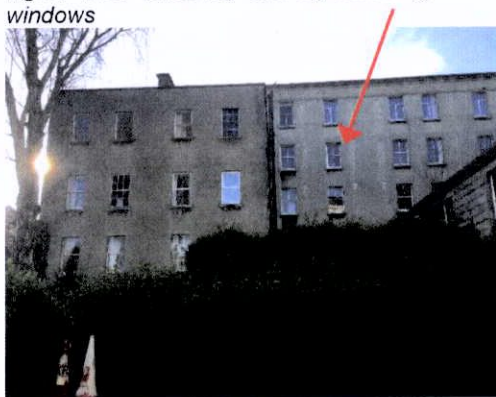
Fig. 23 North elevation of Milltown Park, which was vertically extended in the late 19th century. The north elevation of its rear, higher, extension was constructed in the 20th century.

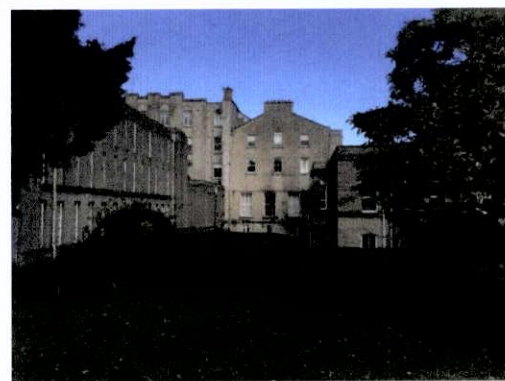
Fig. 24 Southern elevation, comprising an extension, with its expressed gable. Note the uncomfortable connection with its rear, later, extension, at a storey higher.

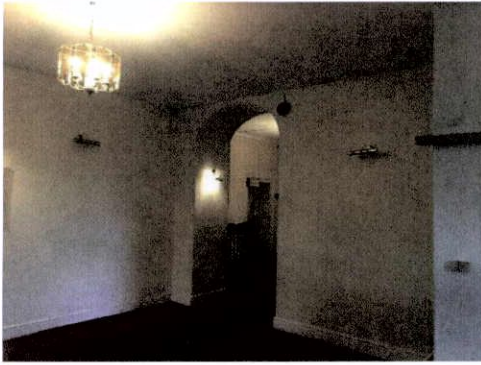
The most significant alteration internally is the removal of the central staircase and infilling of what would have originally comprised a grand double height entrance hall.

Fig. 29 *Infilied entrance hall at entry level with modest access to rear inner hall, leading to the late 19th century extension block. Stair visible through the arch accessing upper floors.*

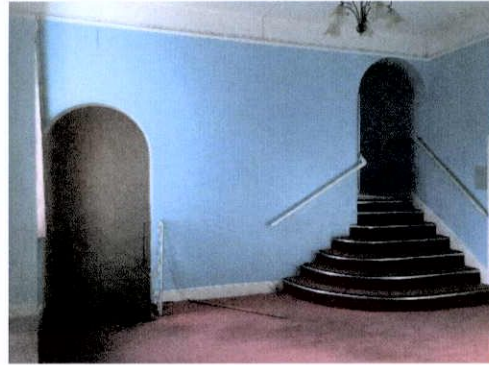
Fig. 30 *First floor level infilled entrance hall with later wall painted blue. Curved stair leads to vertical extension wing above a former orangerie.*

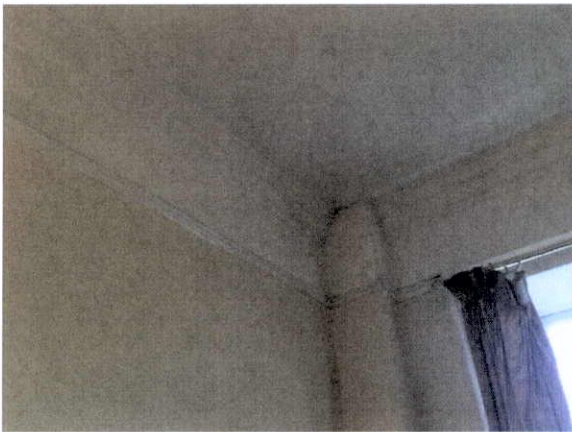
Much of the plasterwork and joinery throughout the house has been replaced, with a single original, excessively overpainted stucco cornice surviving at entrance level in the former reception room to the northeast. Surviving chimney pieces originate from the late 19th century, and may comprise relocated original pieces, given the later origin of some tiled insets.

Fig. 31 *Overpainted stucco cornice, with services riser in corner.*

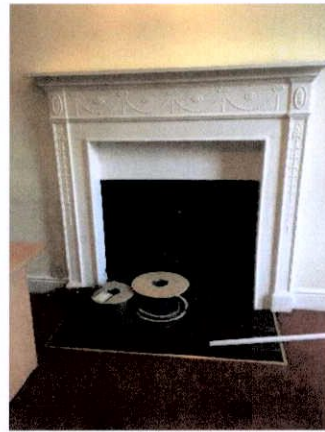
Fig. 32 *Early chimney piece with later tiled inset and hearth, in same room.*

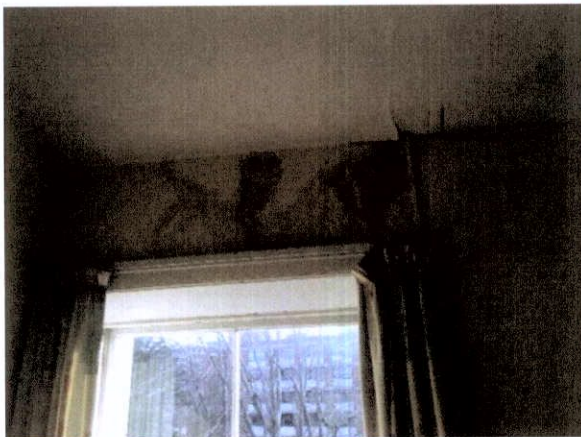
The property is in poor condition, with extensive roof breaches causing decay internally, extending from 2nd floor level down through the building.

Fig. 35 Example of decay due to water ingress from breaches in roof coverings, at 2nd floor (later intervention) level

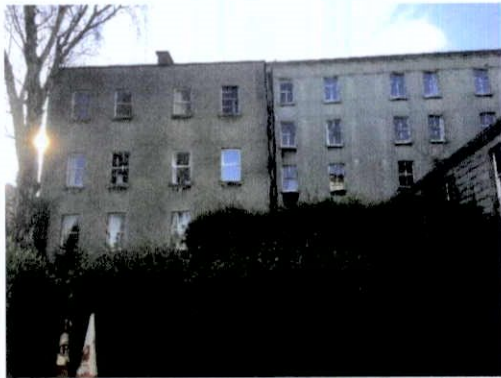
Fig. 36 *The extension's later northern infilled section in context with the north elevation of the main house, with the two storey Chapel link to the RHS of the image.*

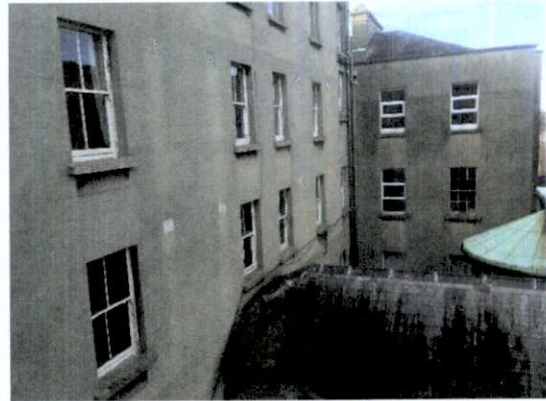
Fig. 40 *View of the (later) northern extension from a rear 1st floor window of Milltown Park house, towards the opposing (original) H form building comprising a lower building, possibly intended to align with MPH.*

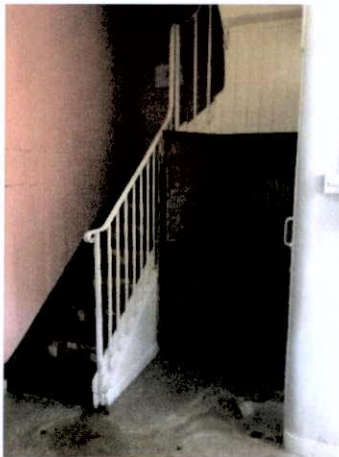
Fig. 70 Secondary steel stair of interest
