## Chapter 15:

# LANDSCAPE & RESTORATION

This Chapter of the remedial Environmental Impact Assessment Report (rEIAR) will establish potential landscape and visual impacts/effects arising from the existing extraction and ancillary operations associated with this quarry site at Drumbeagh, Mountcharles, Co. Donegal. It aims to identify and assess the effects on the appearance and character of the local environs arising from the existing development. A landscaping plan is proposed which will be implemented during the operational lifetime of the extraction site with a restoration plan to be implemented upon closure of the quarry.

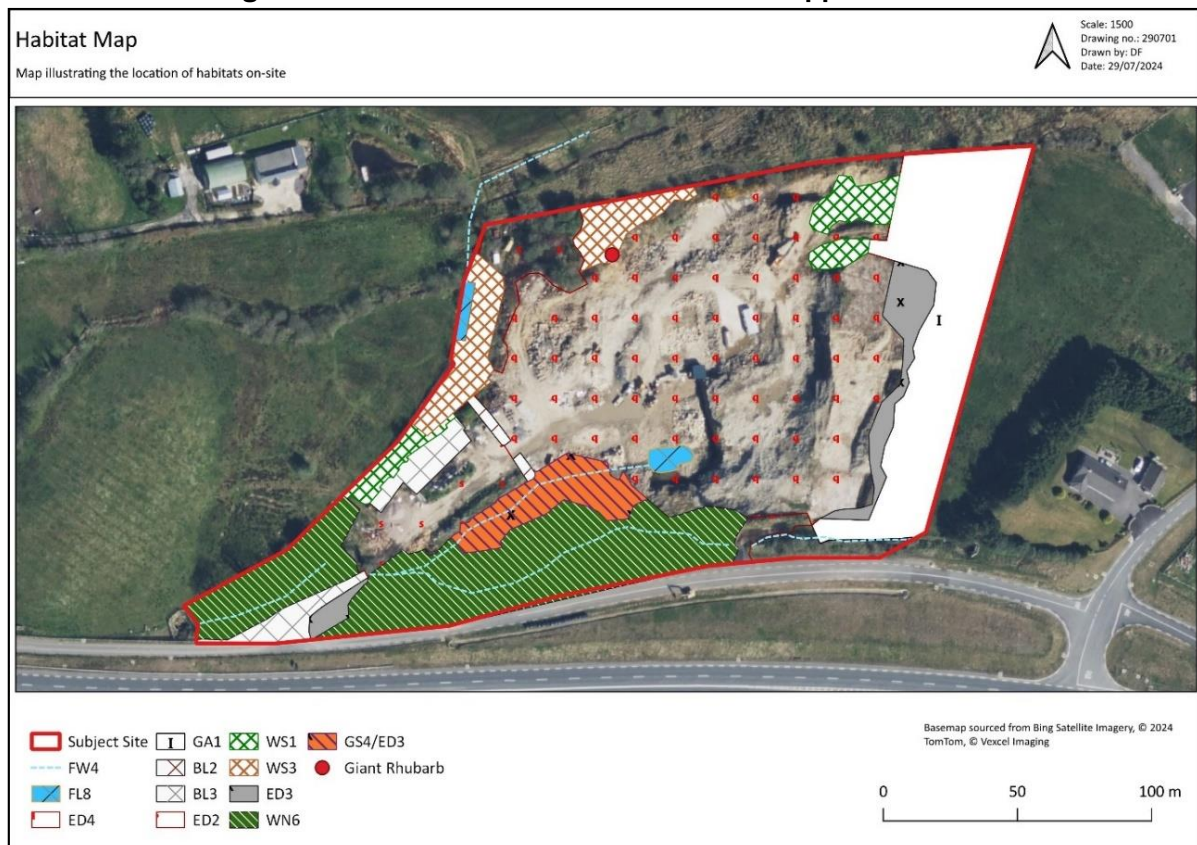
**Figure 15.2: Location of habitats within the application site**

The application site is located in an area detailed as an area of high scenic amenity (HAS) in the Donegal County Development plan 2018-2024. A detailed habitat assessment of the subject site and surrounding environs was conducted as part of Chapter 6, *Biodiversity*, of this rEIAR. Figure 15.2 demonstrates the locations of woodland (WN6) and scrub (WS1) within the site. Also worth noting is the proportion of recolonised bare ground (ED3) which aids screening of the quarry from the east. The woodland area along the southern and southwestern boundaries provides exceptionally good screening. These are the areas of the quarry that historically would have been worked out over 100 years ago and have now formed mature woodland.

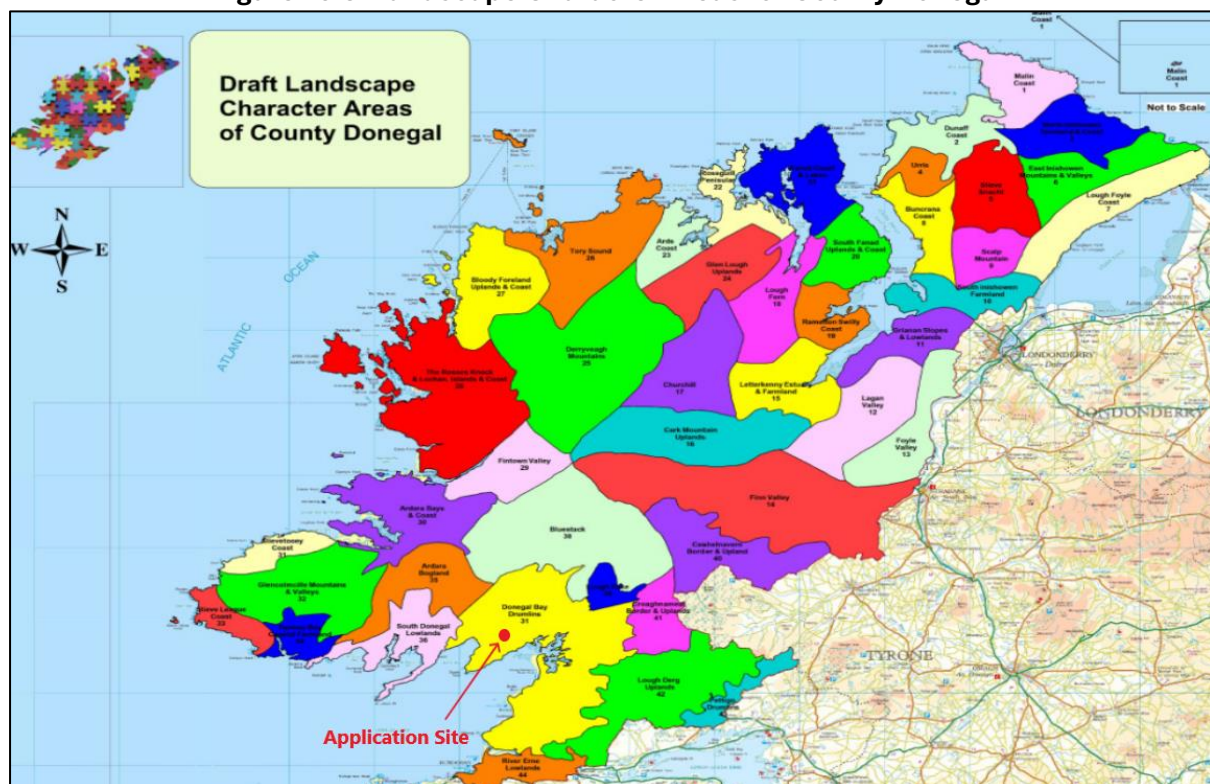
**Figure 15.3: Landscape Character Areas for County Donegal**

The Landscape Character Assessment for Donegal is a document that identifies and describes the landscape character of each part of the county. Landscape Character Types are the physical attributes that make up a landscape; they are generic in nature and not specific to an area so are present throughout the County. Landscape Character types were identified following a desk-based examination of various layers of spatial data on the physical attributes of the County, in combination with historical mapping, photography surveys, 3D photography and aerial photography. The application site is located in the Donegal Bay Drumlins Landscape Character Area (LCA) which is shown in Figure 15.3 below.

Donegal Bay Drumlins Landscape Character Area (LCA) consists of a large distinctive drumlin belt that flow along a northeast-southwest axis from the Blue Stack Mountains and the Pettigo Plateau east towards Donegal Bay. The drumlin formation is more prominent in the north converging at the head of Donegal Bay becoming less prominent and obvious towards the south. The drumlins are draped in a patchwork of fertile agricultural fields of various sizes bound by deciduous hedgerow and trees that are interspersed with patches of woodlands and conifer plantations. Loughs are a common feature amongst the drumlins and a large number of streams and rivers rise in higher lands to the north and east and course along valleys through the drumlins towards the sea.

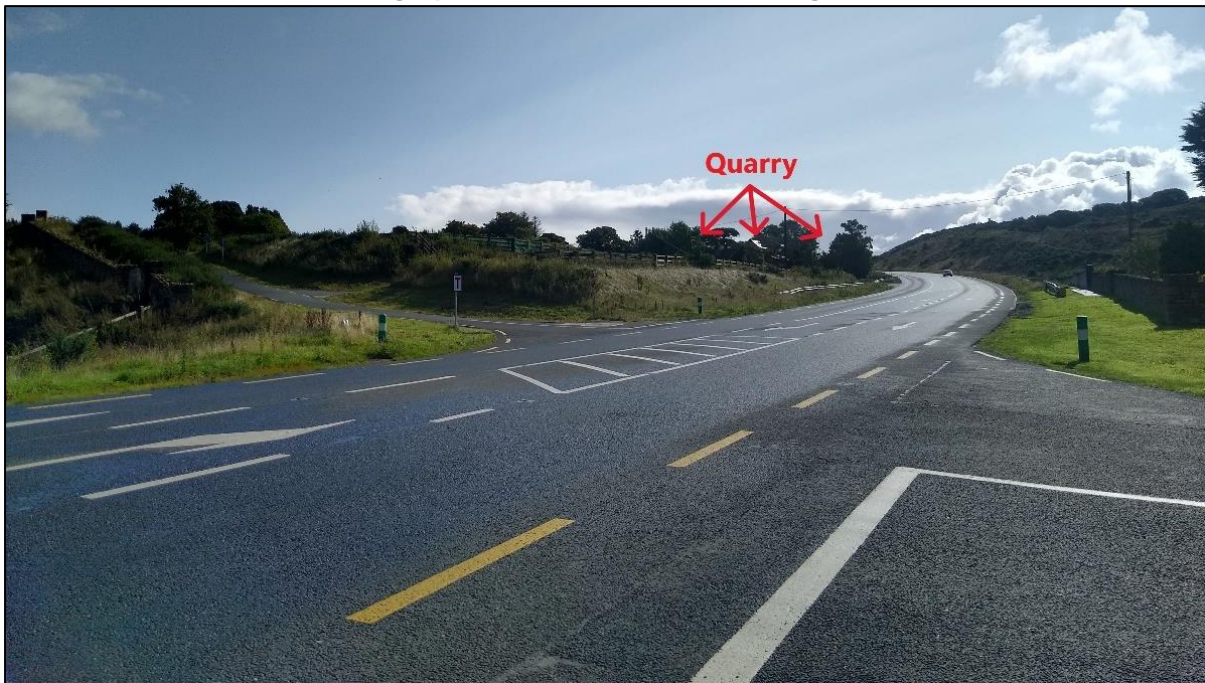
**Photograph 15.1: View from P1 looking east.**

The quarry is not visible on approach from the west of the N56 due to the extensive scrub and tree cover on the southern and south-western boundaries of the site. The quarry is also not visible from the nearest dwelling to the site south of the N56 as Photograph 15.2 shows, and from the slip road to the south the quarry only the quarry entrance is visible and some machinery but none of the active faces are visible.

| Viewpoint | Location of Viewpoint | Description of View from Viewpoint |
|---|---|---|
| 1 | View from N56 290m west from the subject site nearest boundary | No aspect of the development is visible from this position due to the existing trees which screen the site very well |

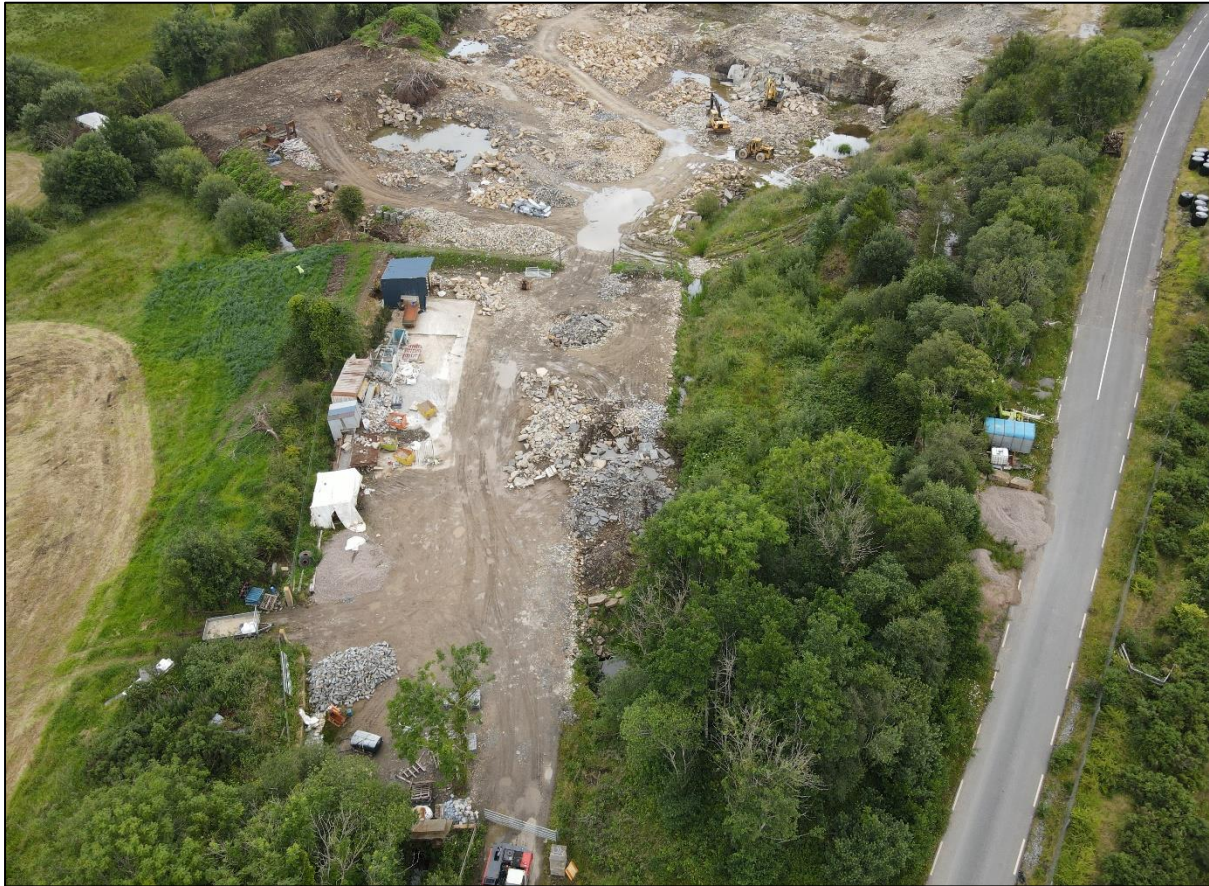
The quarry is not visible from the approaches on the slip road or on the approach from the east on the N56. The screening is due to the scrub, semi-mature and mature trees located on the southern boundary of the site. These provide excellent screening for the development. There is likely to have been a similar boundary historically along the southern edge of the quarry. Searches of historical aerial images on Google Earth Pro™ would suggest a significant vegetated boundary going back at least 20 years. Photograph 15.9 below is an elevated photograph taken from within the quarry showing the extent of scrub and tree cover along the southern boundary of the site.

**Photograph 15.9: Extent of scrub and tree cover along southern boundary of the site (looking east).**
