## Chapter 7: LAND, SOILS & GEOLOGY

## 7 LAND, SOILS AND GEOLOGY

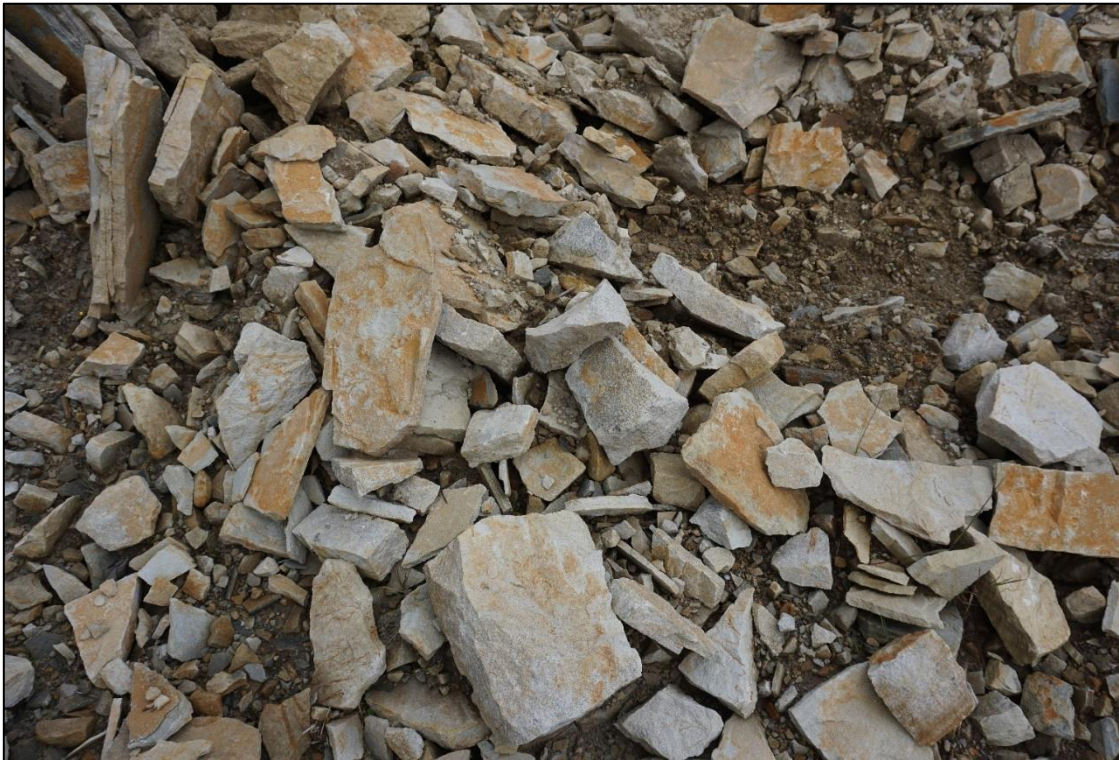
**Photograph 7.1: Typical stone on site**

Photograph 7.1 below shows typical stone found on site exhibiting strong cleavage patterns. Photograph 7.2 below shows a redundant quarry face with strong bedding features.
