EIAR Chapter 15 Cultural Heritage (Architectural)

Dublin Central Project – Site 2 & No.61 O’Connell Street Upper

Appendix 15.2 Chronology Drawings

Appendix 15.3 Building inventory, record and description for No.43 O'Connell Street Upper

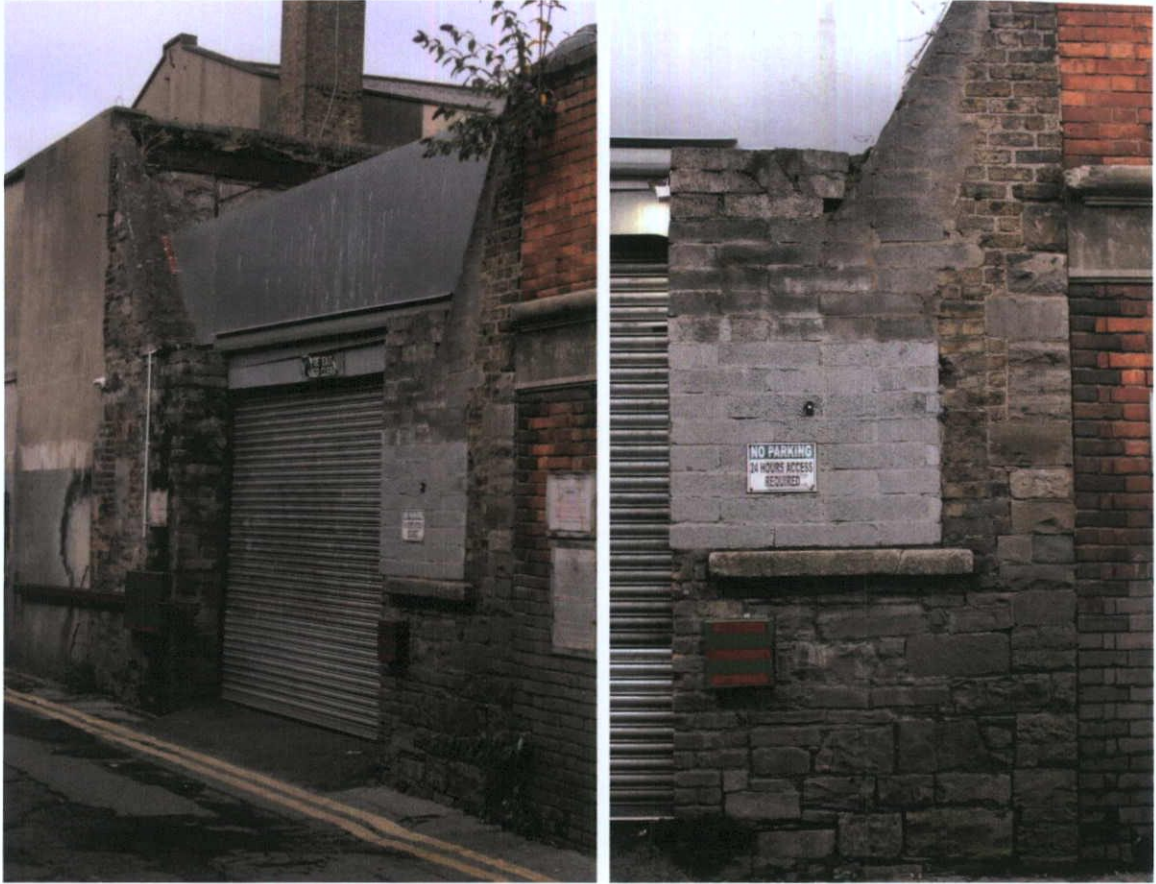
Fig.5.4.3: Detail of coursed hewn Calp masonry and brick fabric.

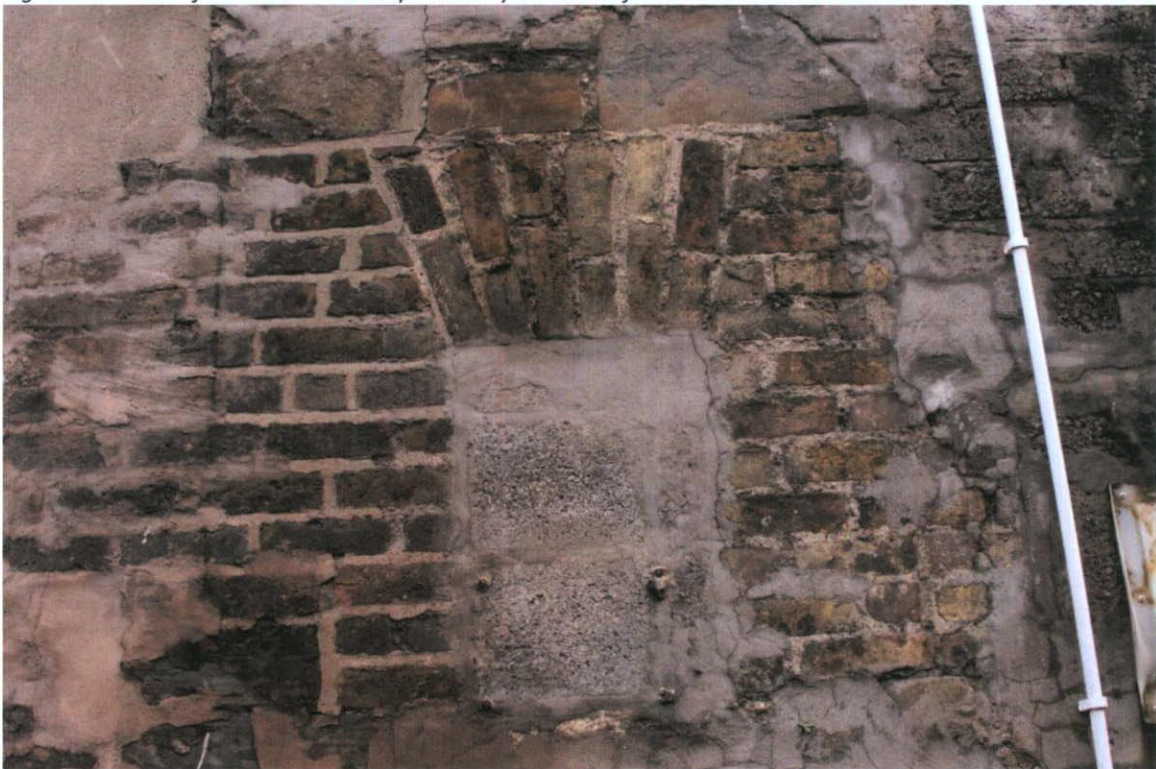
Fig.5.4.4: Detail of the yellow stock brick window.

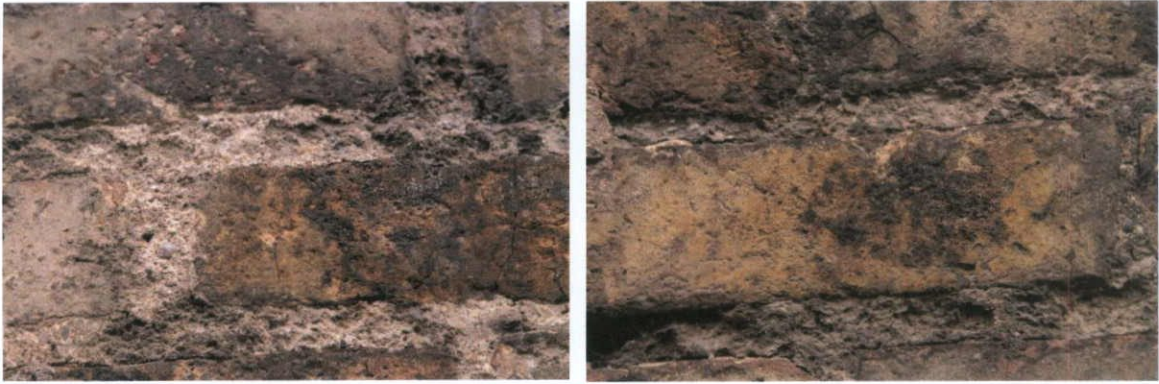
Fig.5.4.5: Clamp-fired yellow stock brick from the north window.

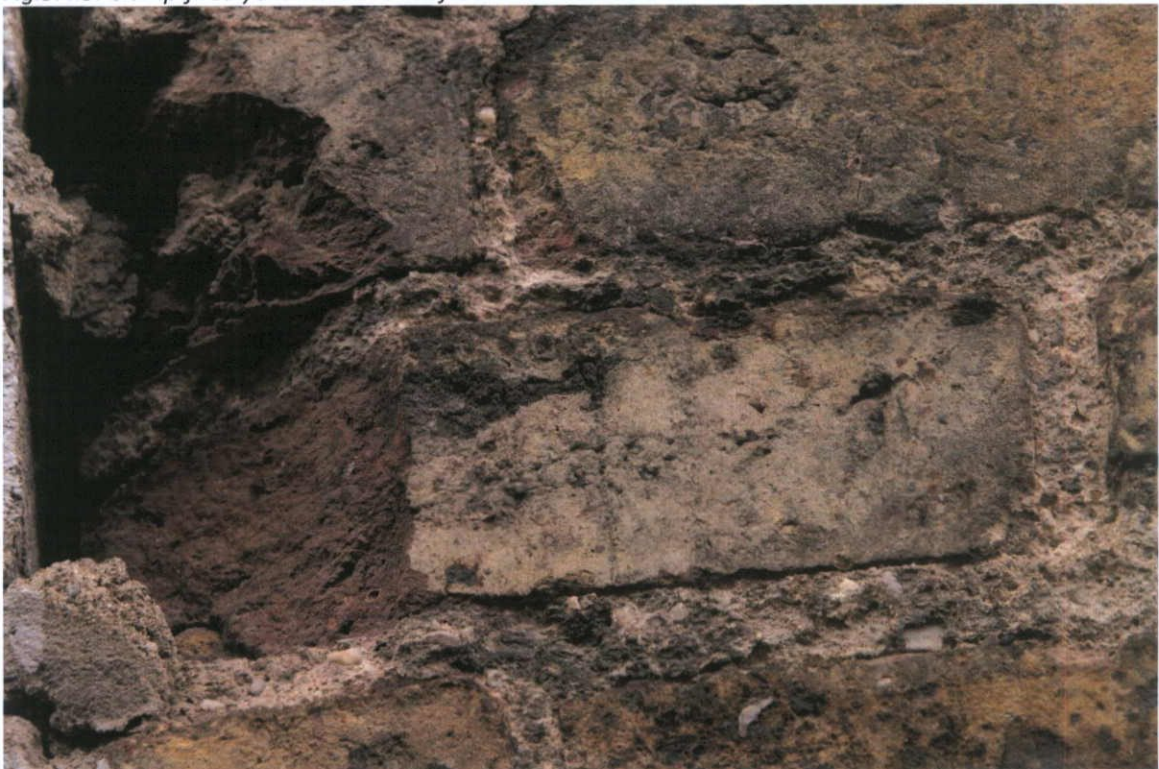
Fig.5.4.6: The yellow colour is confined to the surface, with a spall revealing the red brick core.

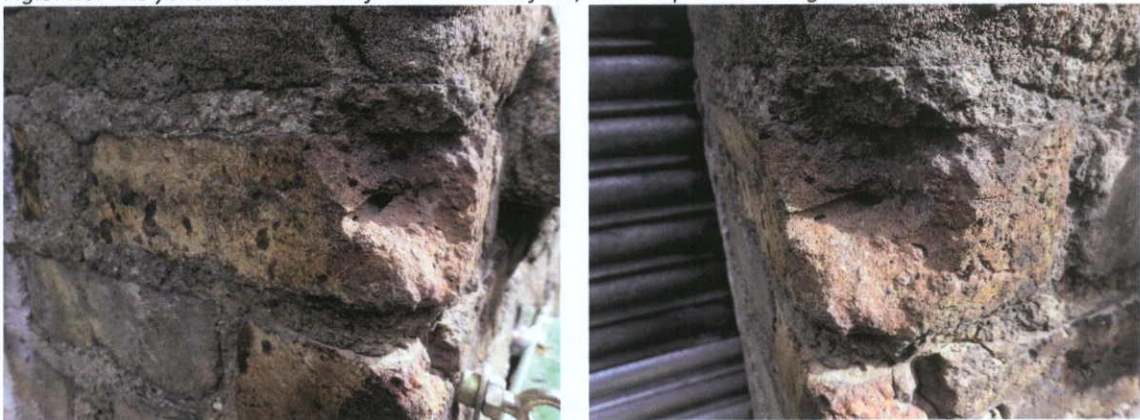
Fig.5.4.7: Groove in the brick jamb; said to be from a bullet during the 1916 Easter Rising.

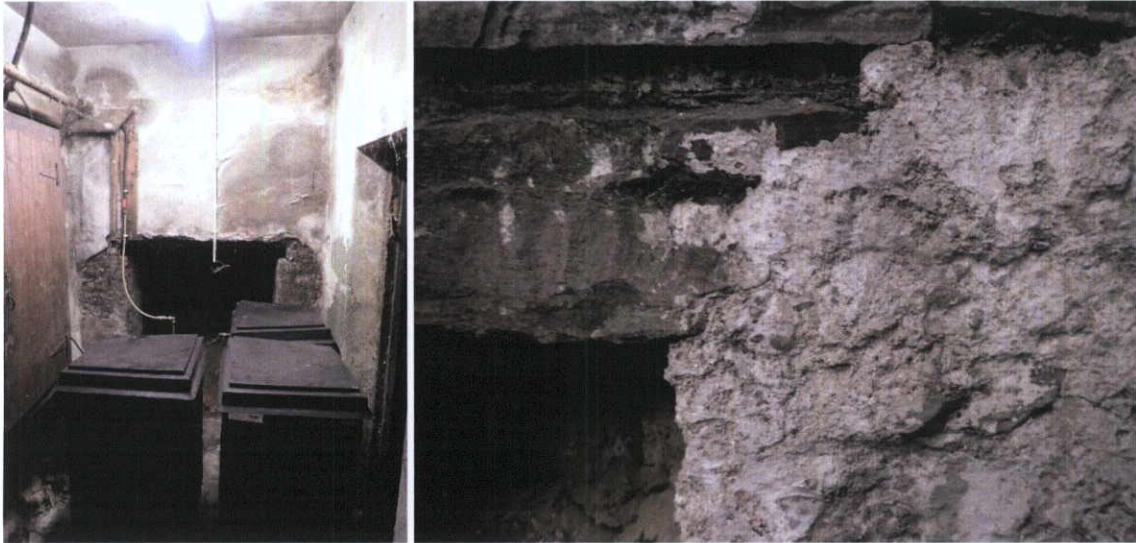
Fig.5.4.8: Calp limestone masonry at basement level at the front of No.57 O'Connell Street.

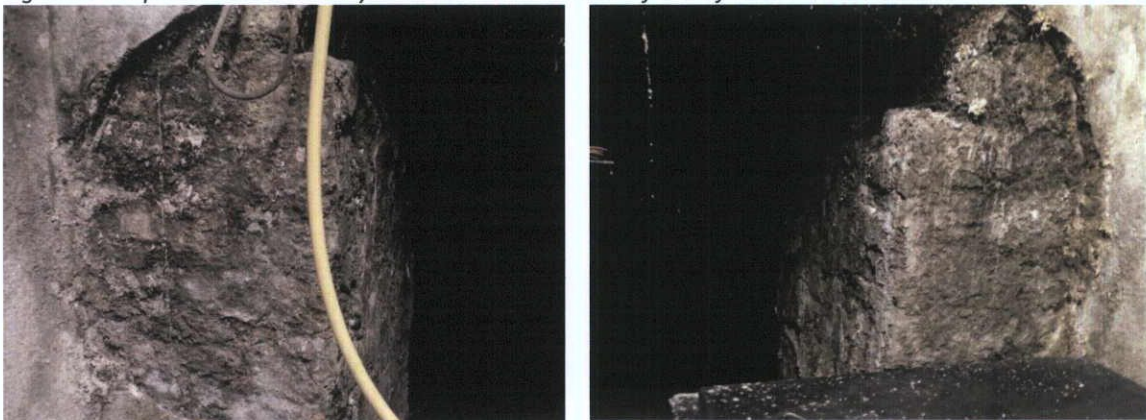
Fig.5.4.9: Detail of Calp limestone bedded in lime mortar at the front of No.57 O'Connell Street.

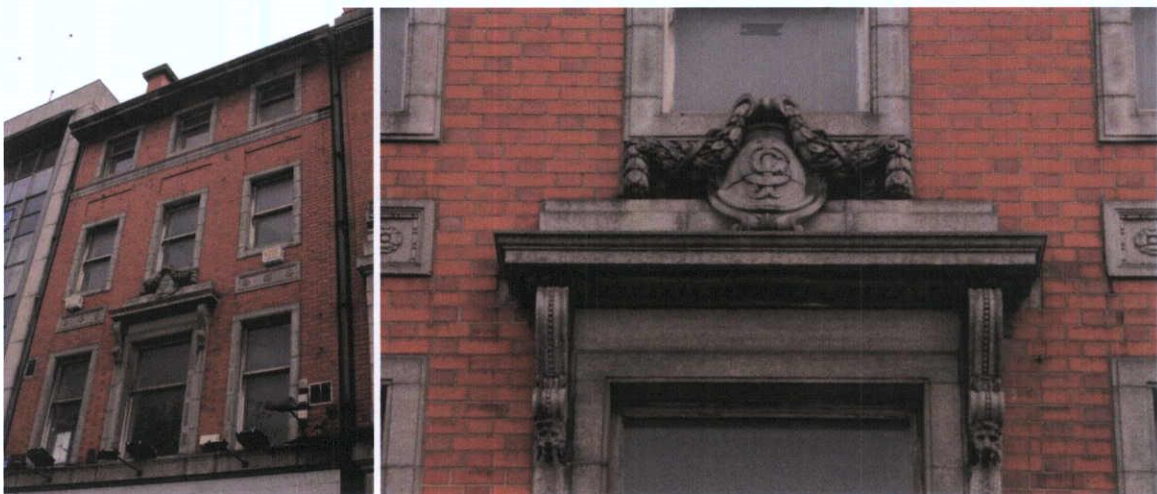
5.5 58 O'Connell Street: The four-storey three-bay building has a modern shopfront with an earlier moulded granite course above, and modern kiln-fired brickwork in a cement-lime mortar consistent with a 1920s build.

Fig.5.5.1: Granite and brick at the façade.

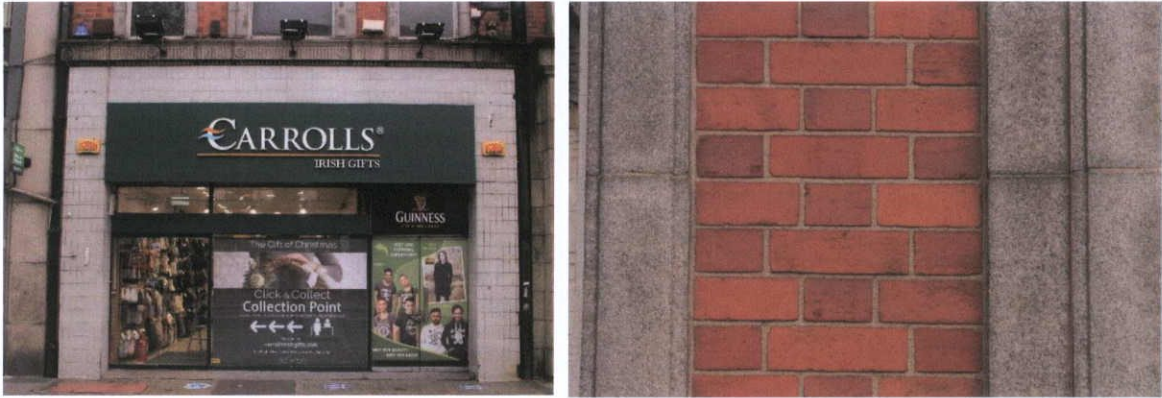
Fig.5.5.2: Modern shopfront with earlier granite course above (left); and a detail showing kiln-fired c.1920s brick in flush mortar joints (right).

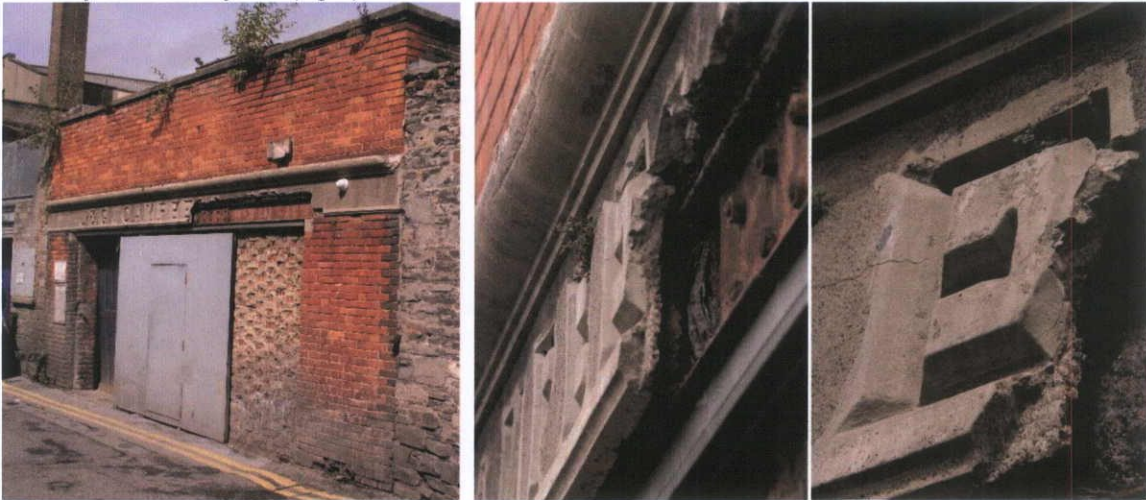
The rear of the building is a single-storey extruded red brick wall bedded in a medium-grained lime mortar with no evidence of an original pointing finish; and with red salt glazed brick used at the doorway. The

Fig.5.5.3: Campbell's store at the rear on Moore Lane.

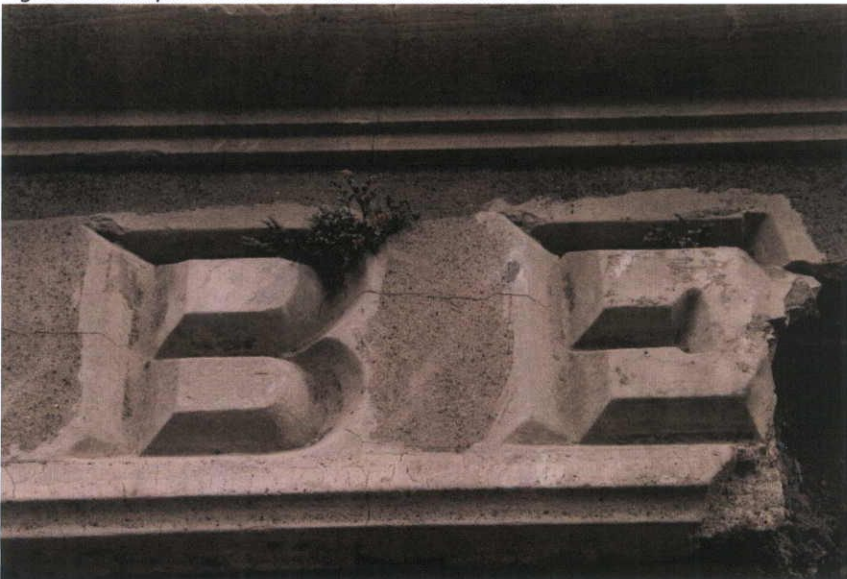
building has a brick chimney stack surviving along the south wall. The I-beam lintel bears a damaged Portland Cement stucco sign for “J & G Campbe[ll]”; with the flatwork medium-grained with fine-grained binder-only stucco used to form the letters. The use of polychrome brick and moulded specials is surprisingly ornate for a ‘back-of-house’ finish onto Moore Lane. One of the bricks bears a stamp for ‘DAVISON’, a Welsh brickmaker active between 1933 and 1951.

Fig.5.5.4: Detail of stucco signage.

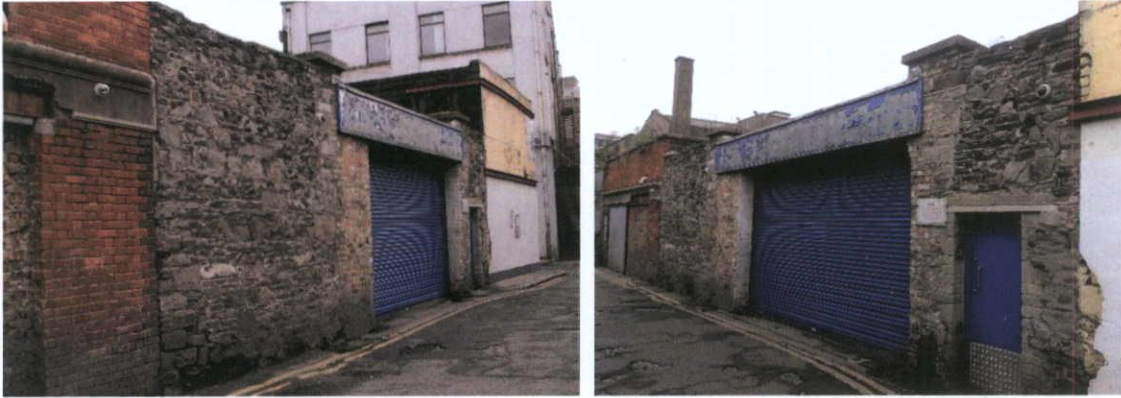
The Moore Lane rear entrance consists of Calp limestone masonry containing some fragments of Georgian brick and tile with a well-developed black gypsum crust across the face of the masonry. The deeply folded black soiling crust attests to very long exposure from airborne pollutants. The wall has two gate piers in brick with concrete caps toothed-in to the Calp limestone wall. The lime-based bedding mortars contain abundant crushed brick pozzolan and poorly-sorted coarse-grained aggregate of limestone, quartz, sandstone, chert

Fig.5.6.1: General view of the Calp limestone masonry wall at the rear of No.59 O'Connell St.

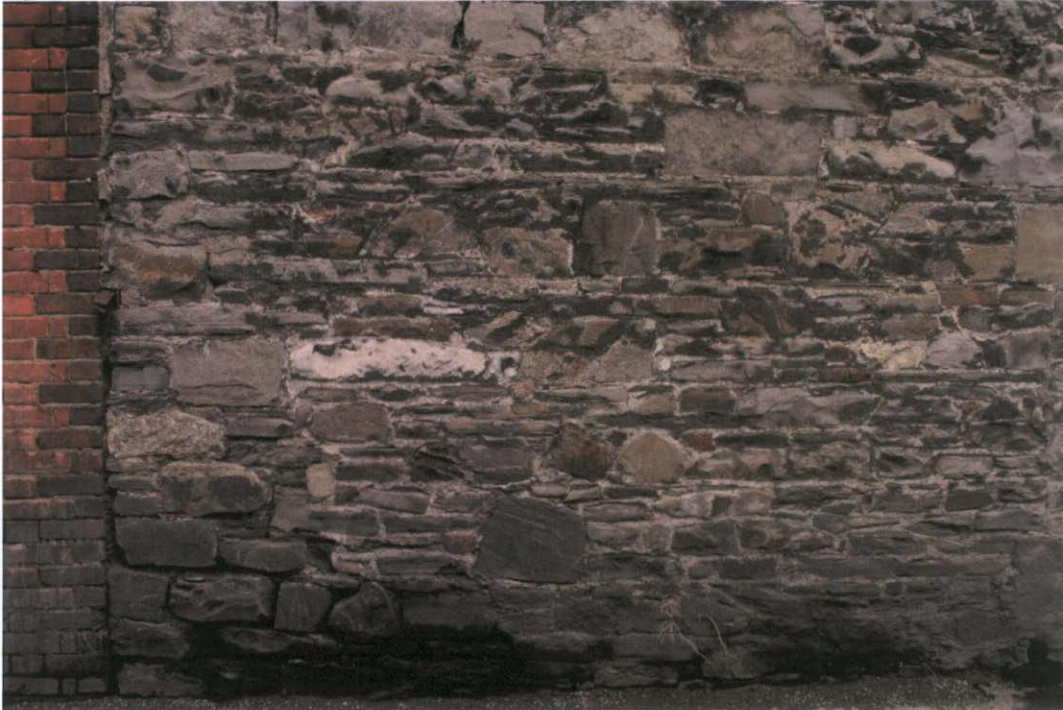
Fig.5.6.2: View of the wall showing flaggy Calp.

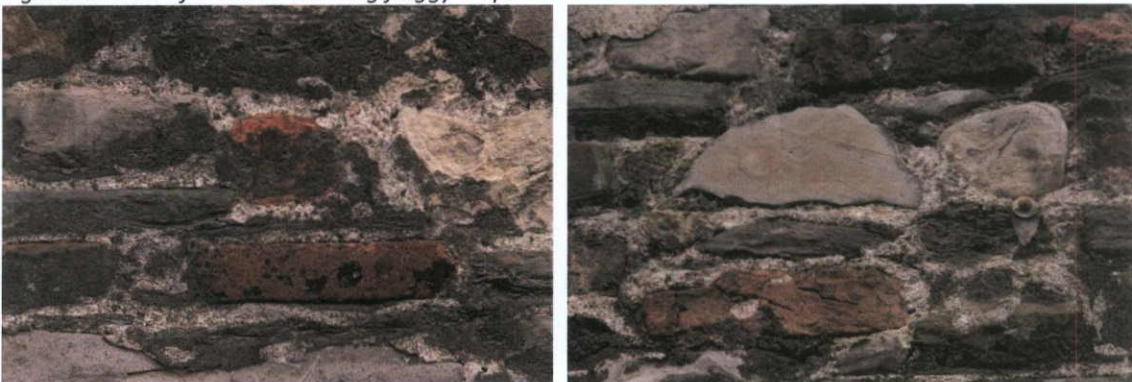
Fig.5.6.3: Thin irregular probably Georgian brick.

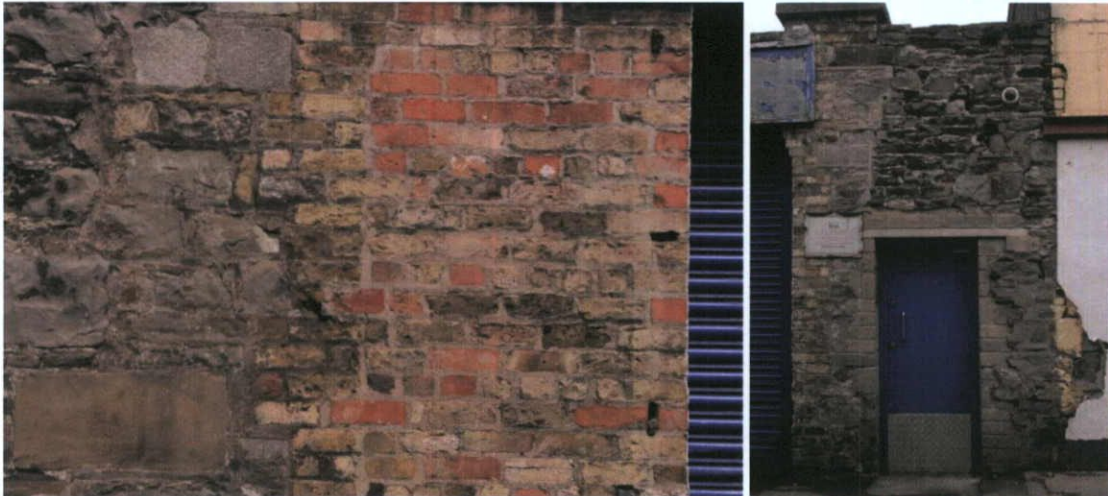
Fig.5.6.4: Later brick gate pier toothed-in to the Calp limestone masonry.

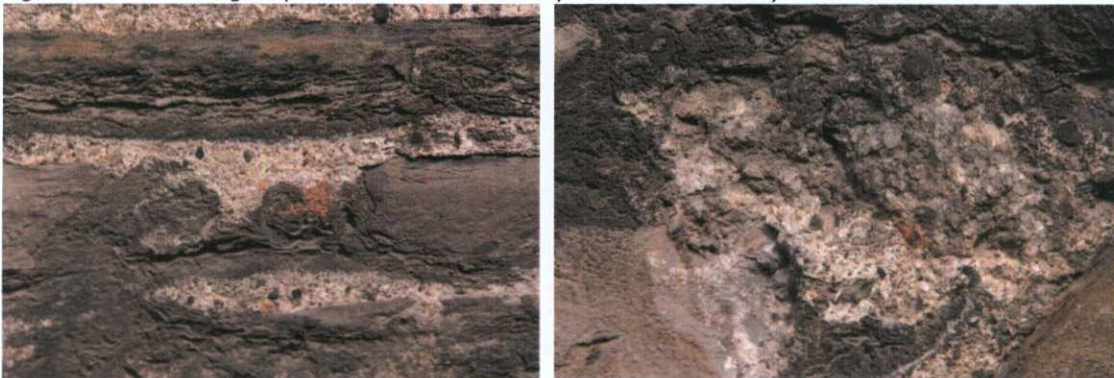
Fig.5.6.5: Crushed brick in the Calp limestone bedding mortars.

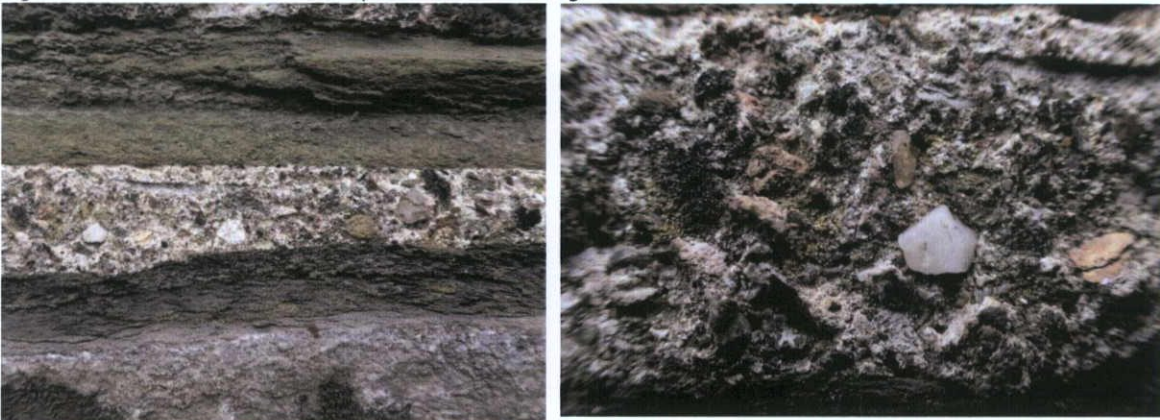
Fig.5.6.6: Detail of a gritty lime-based mortar between greenwacke and Calp limestone (left) and a microscope detail of the soiled surface of the mortar showing quartz and partially calcined limestone.

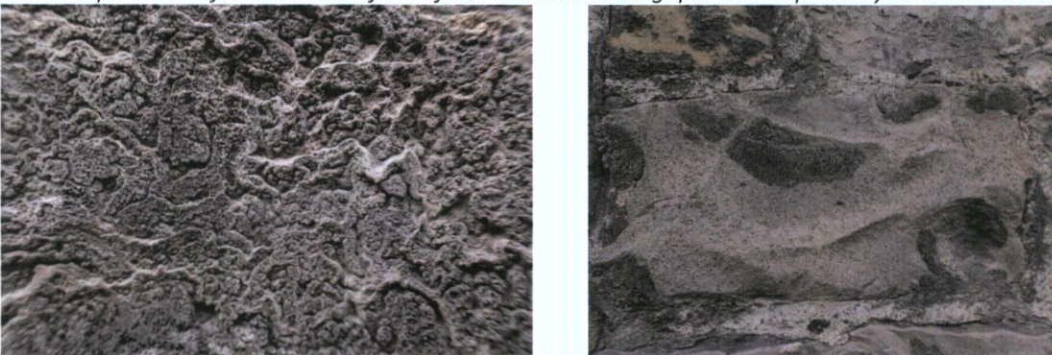
Fig.5.6.7: Black gypsum soiling crusts on the surface of the mortar and stone.

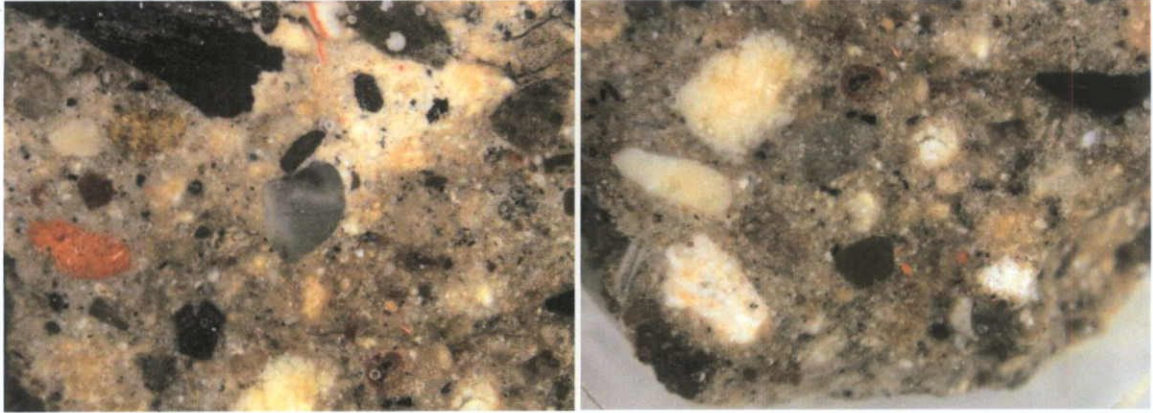
Fig.5.6.8: Cross section in visible light (magnification x13) showing natural stone aggregate with brick pozzolan in a lime binder.

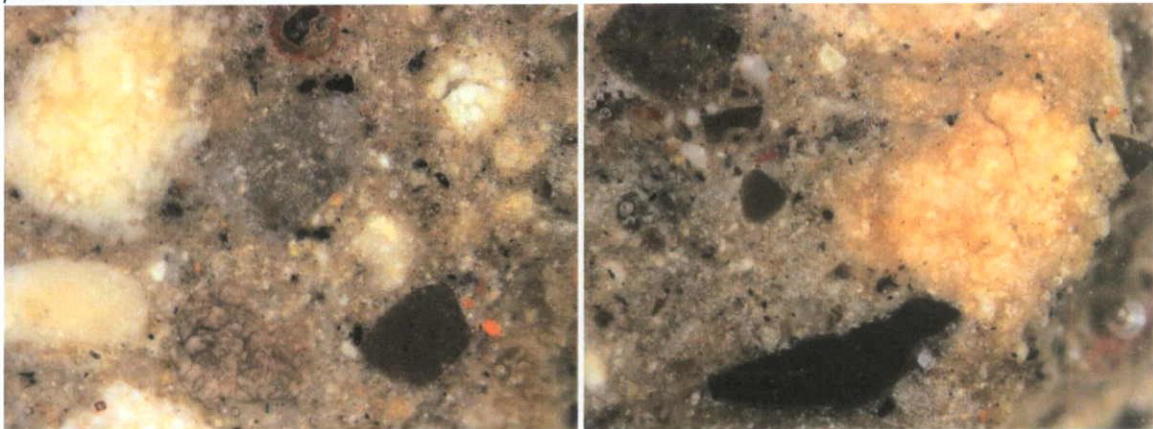
Fig.5.6.9: Cross section in visible light (magnification x24) showing reactive aggregate, coarse lime lumps and fine brick pozzolan in a lime binder.

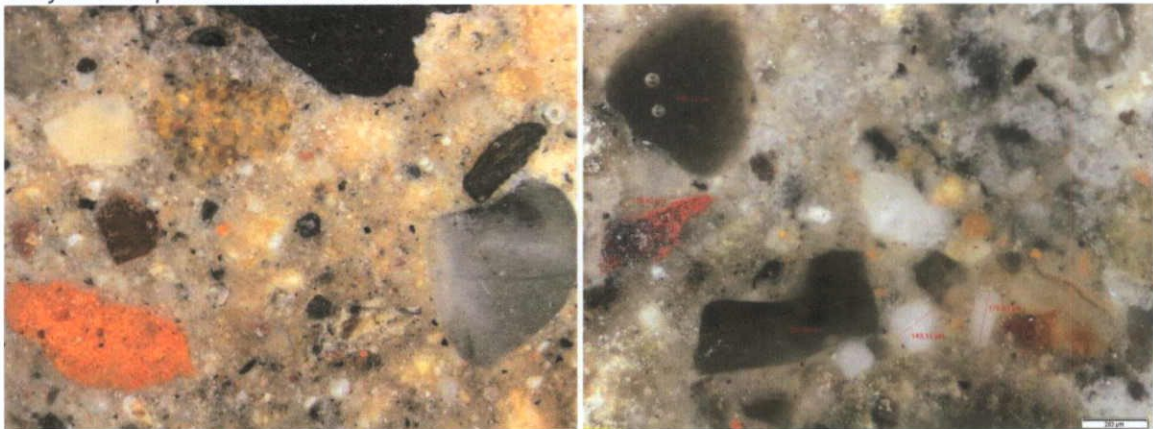
Fig.5.6.10: Cross section in visible light (magnification x40) showing limestone, quartz, chert, crushed brick aggregate and fine brick pozzolan.

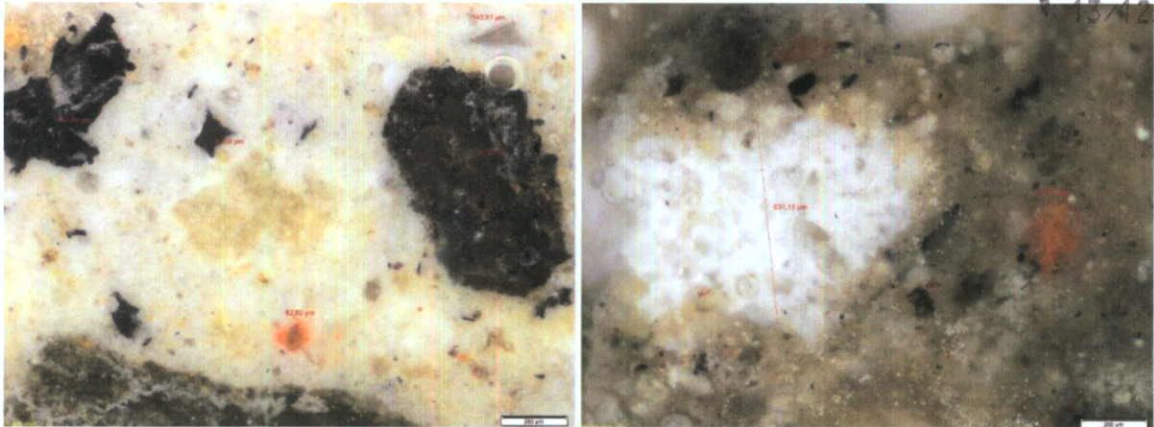
Fig.5.6.11: The lime binder is not homogenous and contains abundant lime lumps and occasionally partially fired limestone fragments, with fine brick dust pozzolan found throughout. Cross section in visible light (magnification x40).

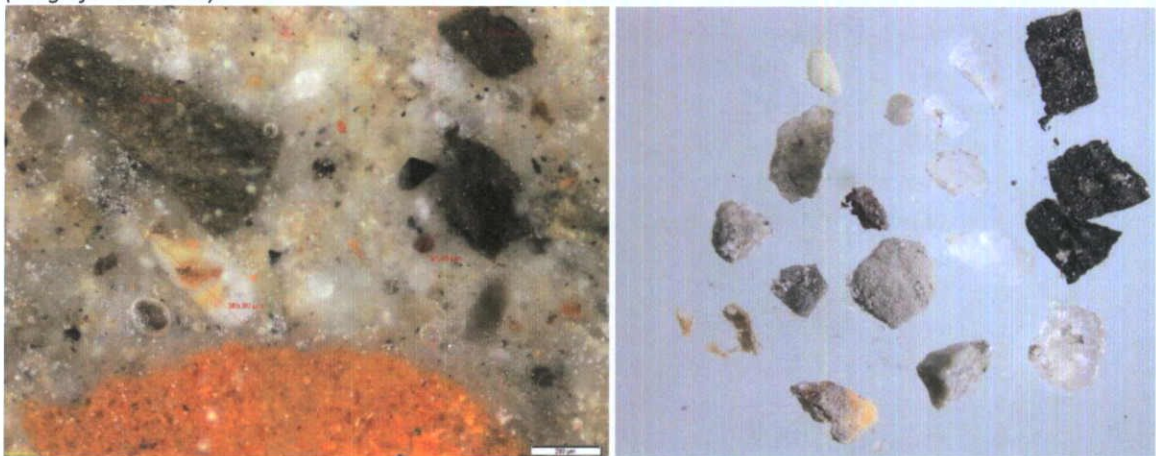
Fig.5.6.12: Brick is present throughout the mortars as coarse brick shards acting as porous aggregate (left, cross section in visible light magnification x40); while the majority of the aggregate is composed of limestone, quartz and chert (right, magnification x13.5).

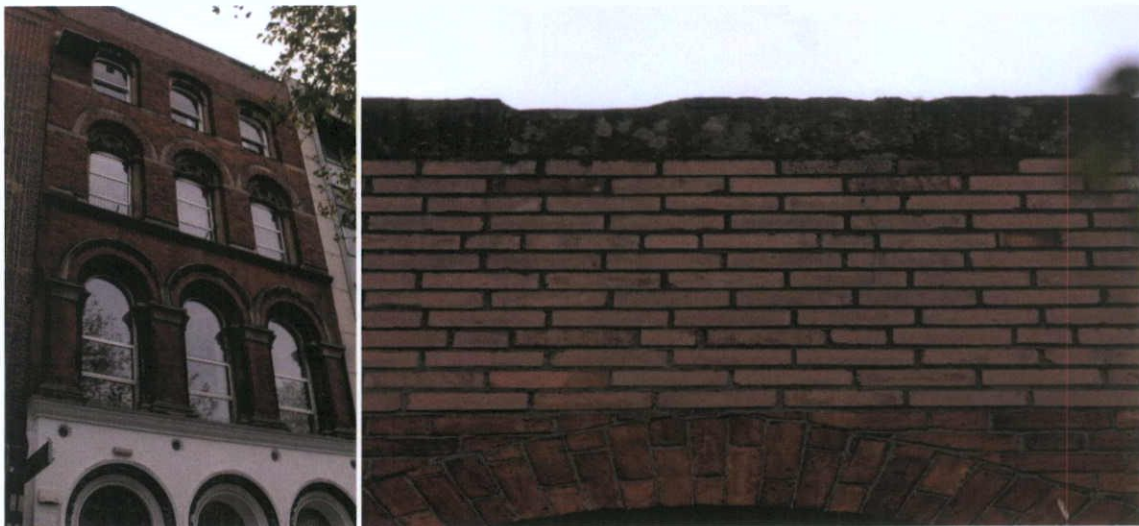
Fig.5.7.1: Façade of 60 O'Connell Street with a detail showing the more recent mid-to late twentieth century brick at parapet level; with repointed nineteenth century brickwork seen below.

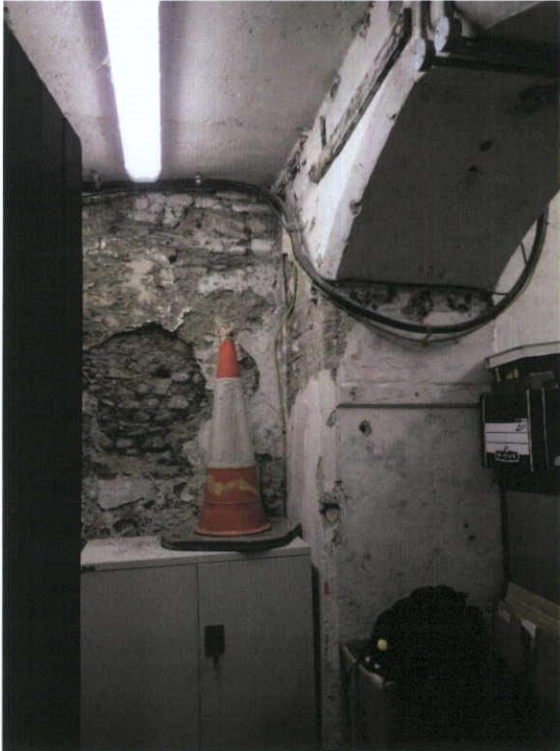
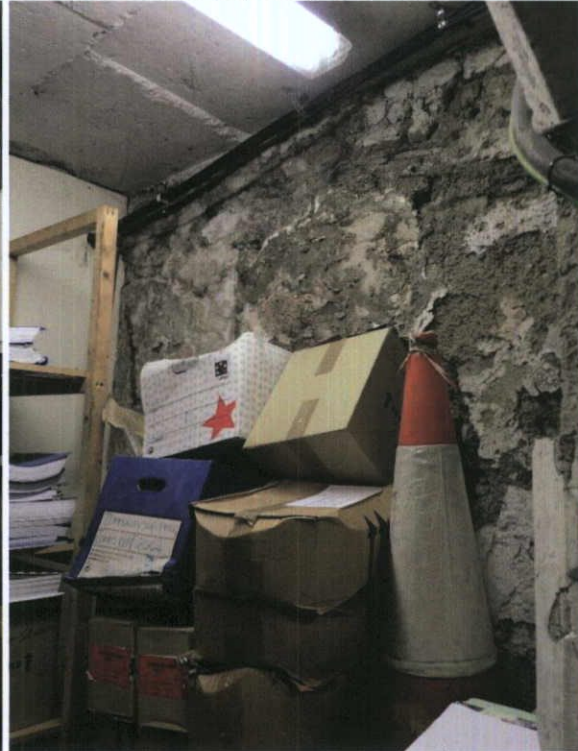
- **Possible Georgian Renders at Basement Level:** The basement shows a great deal of alteration, but early Calp limestone masonry with decaying lime plaster survives at the front of the building at basement level at the streetfront level. The Calp limestone masonry wall appears early as it is composed of a significant amount of sub-rounded cobbles which is very different in character from the hews squared Calp limestone blocks forming part of the brick-edged pier dating to the time of William Murray’s alterations. The Calp ‘cobble’ wall contains coarse burnt fuel fragments, partially calcined limestone and coarse lime lumps among the poorly sorted rounded gravelly aggregate. The plaster basecoat contains abundant crushed brick, presumably added as a pozzolan, and is

Fig.5.7.3: View of a brick pier at the front of the property at basement level, with a rendered Calp limestone masonry wall.

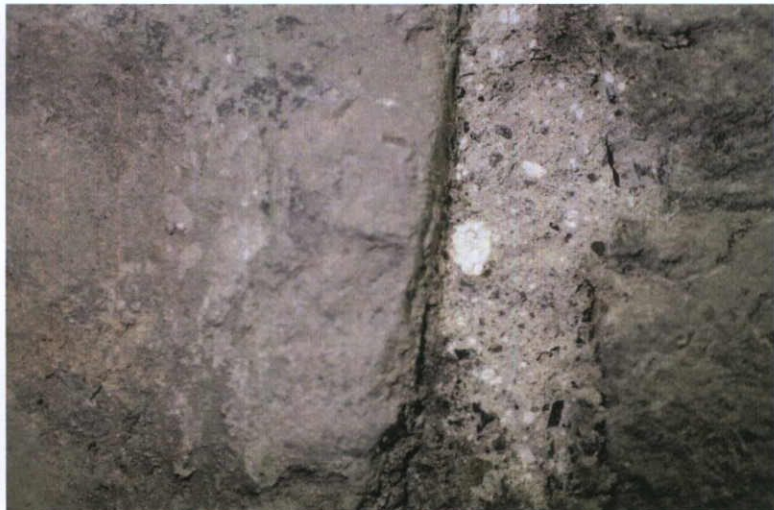
- **19th Century Brick Arch at Basement Level:** The mortar used for the 'William Murray' arch is very different in composition, lacking brick pozzolan and uses finer aggregate of limestone, chert and quartz with abundant coarse lime lumps. The north party wall at the entrance to the basement vault is composed of a very similar render to that seen at the south-east and contains rounded aggregate of limestone, quartz and crushed brick pozzolan, burnt inclusions and lime lumps.

Fig.5.7.4: Detail of a mid-nineteenth century brick arch at basement level of No.60, with sharp limestone sand and coarse lime lumps in the bedding mortar (beneath the Portland Cement pointing).

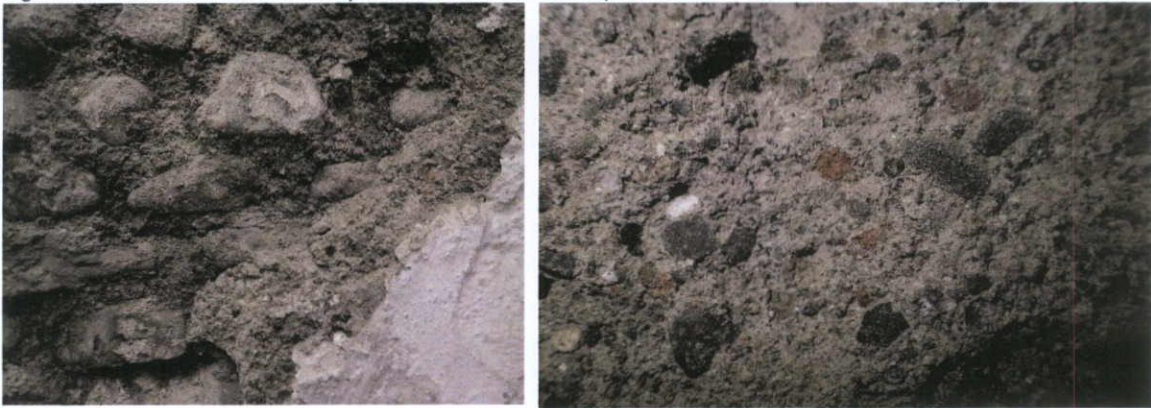
Fig.5.7.6: The south wall of the basement well is formed from Calp limestone masonry, many of which consist of rounded and sub-rounded cobbles which are indicative of Georgian building. The lime render laid on top of the wall is in poor condition; but contains poorly-sorted predominantly limestone aggregate with large coarse lime lumps and crushed brick and brick dust pozzolan.

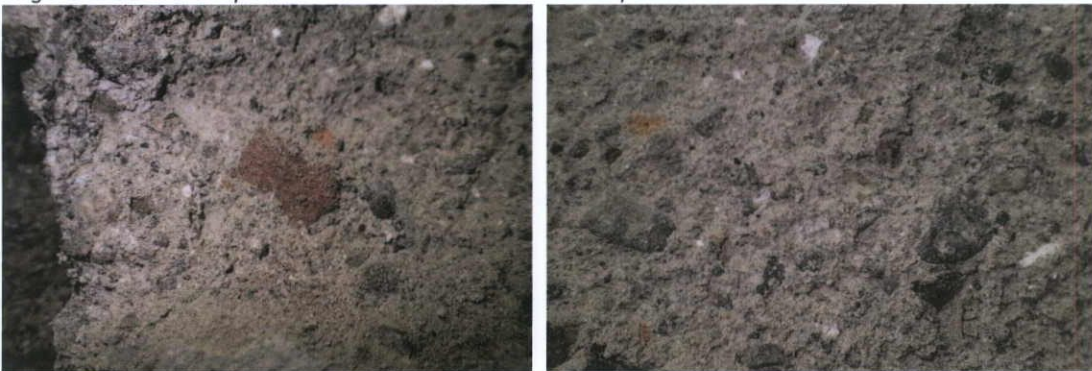
Fig.5.7.7: Limestone aggregate with large coarse lime lumps and crushed brick and brick dust pozzolan on the lime render over the southern basement Calp limestone wall at the front of the building.

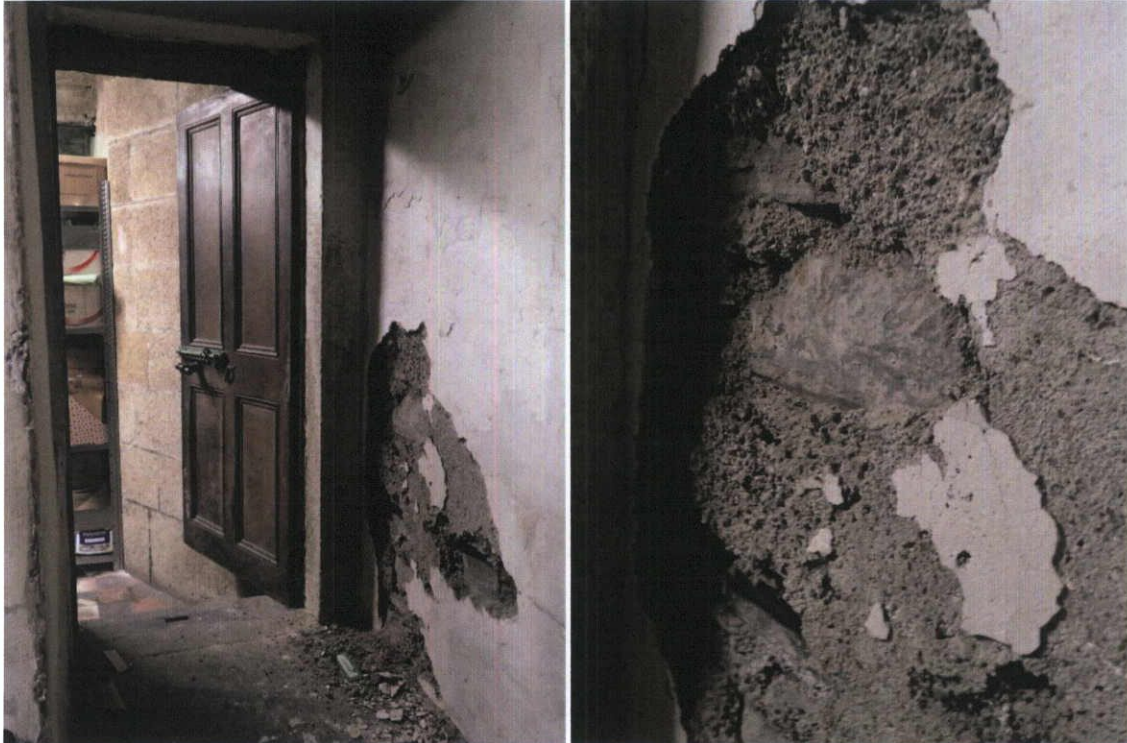
Fig.5.7.8: Detail of the entrance to the granite-lined strongroom at the rear of the building, and the Calp limestone masonry forming the north wall at basement level (right).

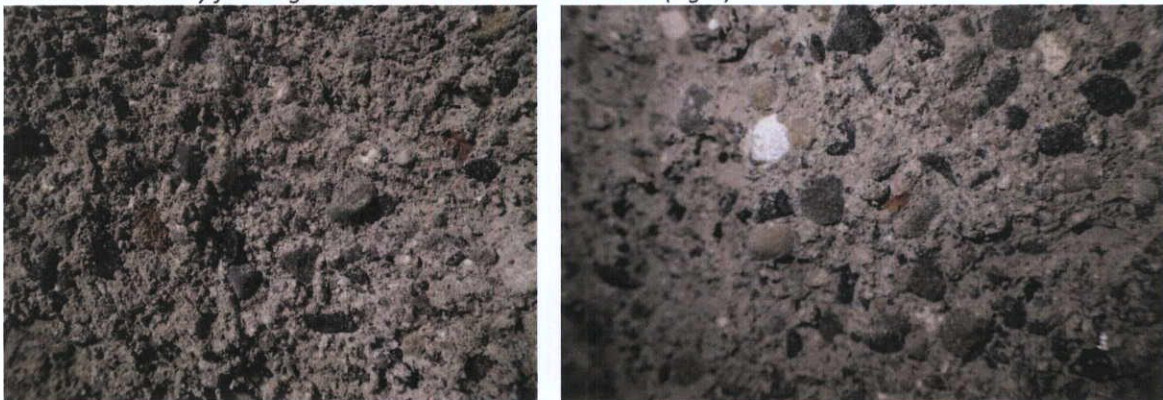
Fig.5.7.9: The render on the north wall of the building is reasonably similar in texture and composition to that found on the south wall. These may be Georgian period building.

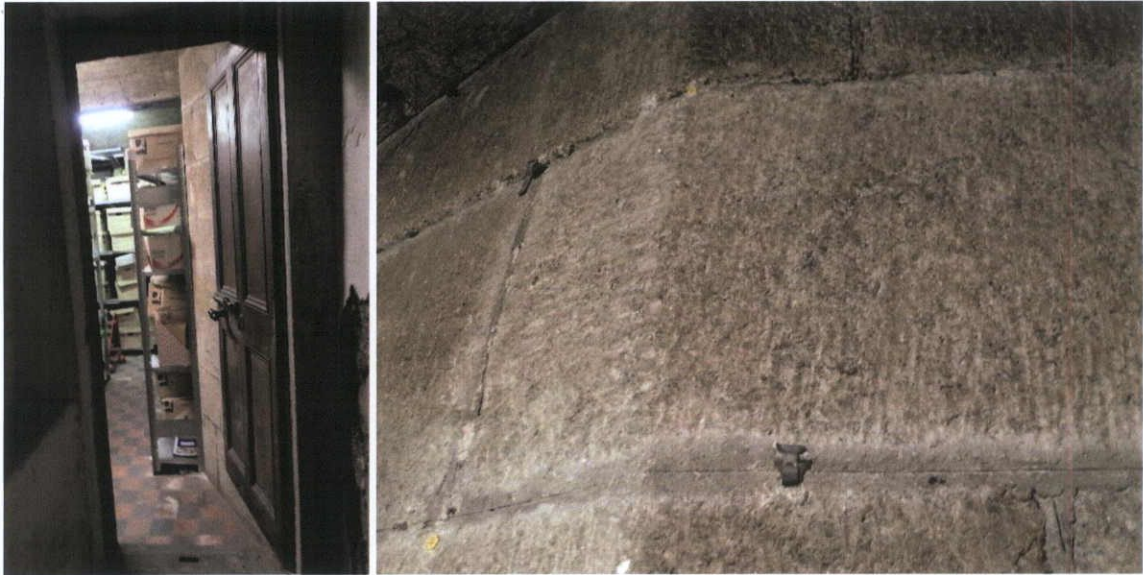
- **Granite Vault:** The rear granite ashlar vault has been bedded in a fine-grained lime-based mortar with some areas repointed in Portland Cement. The original bedding contains brick pozzolan, burnt inclusions and fine lime lumps.

Fig.5.7.10: The strong room is lined with granite laid in a lime putty mortar, and pointed with a Portland Cement-based mortar with an incised line.

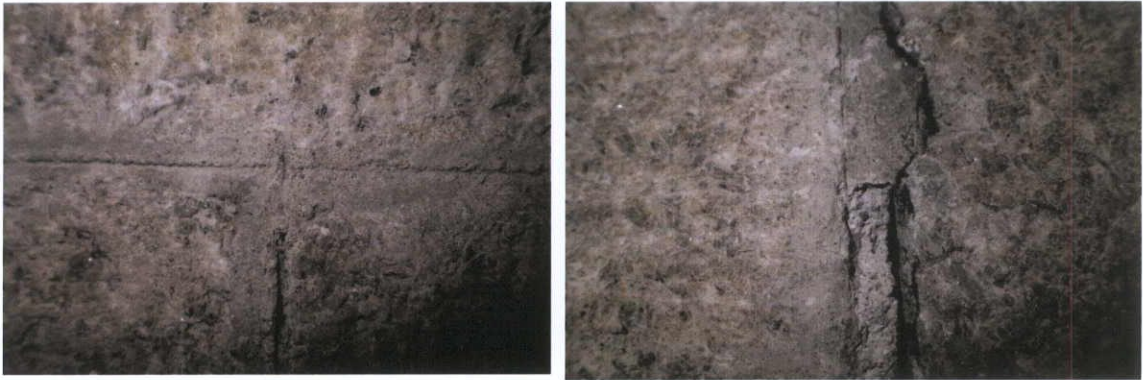
Fig.5.7.11: Detail of the joints of the granite ashlar in the strong room showing the lime bedding mortar beneath the later Portland Cement pointing.

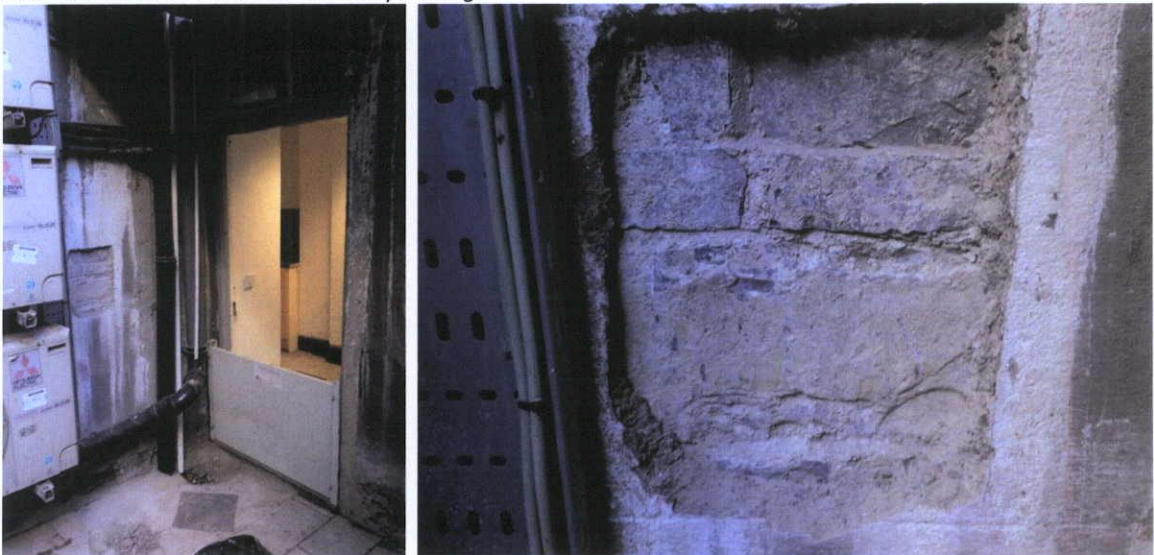
Fig.5.7.12: The rear wall of the building is composed of squared hewn Calp limestone masonry overlain with a Portland Cement render and repointed throughout.

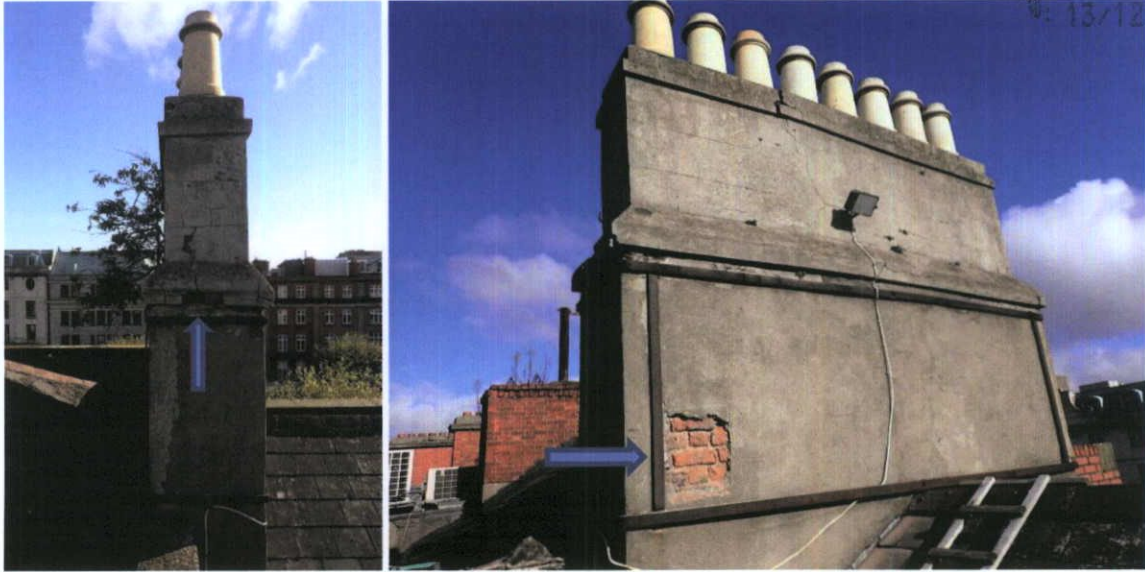
Chimney A was built with hand-made clamp-fired brick with shell and coarse inclusions in the partially vitrified matrix (Figs.5.7.13-14). The shell is an important indicator, as this type of 'shell brick' was also seen at Nos.10, 13 and 18 Moore Street. Some of the brick is over-fired with black burnt vitrified 'hotspots' while other bricks contain limestone pebbles, partially calcined limestone and internal structures arising from poor/no mixing of the raw clay. Some of the brick is under-fired and easily scratched. The mortar contains brick pozzolan.

Fig.5.7.13: The eastern chimney (Chimney A) with the render removed at two locations to reveal the underlying brick masonry fabric.

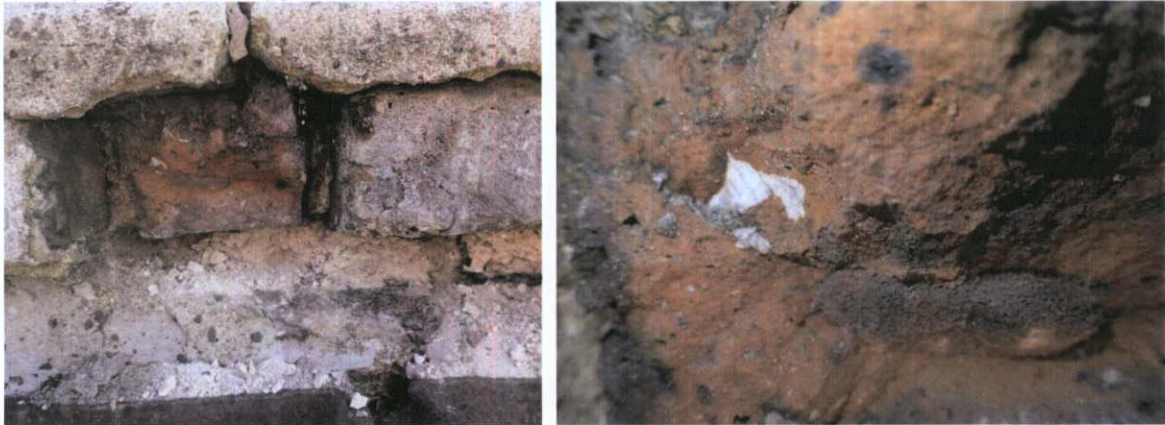
Fig.5.7.14: Shell contained in the brick of the eastern chimney stack.

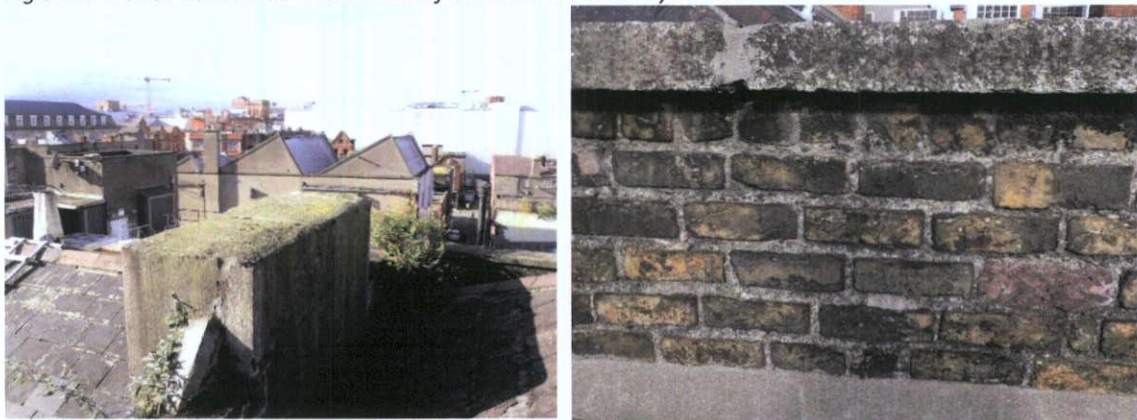
- **Chimneys:** There are two chimneys: A. an eight-pot rendered brick stack with fine-grained ashlar-lined stucco repairs; and B. a cut-down and rendered stack capped with Portland Cement; both linked by a soiled yellow stock brick parapet wall with granite capping stones bedding in a coarse-grained lime mortar with coarse gravelly limestone, sandstone, chert and quartz aggregate with partially calcined stone and crushed brick. The two stacks are linked by a party wall of yellow and red stock brick laid in a pozzolan lime mortar with a granite capping.

Fig.5.7.15: The cut-down Chimney B on the west side of the roof (left) and the granite-capped stock brick wall linking the two chimneys (right).
