EIAR Chapter 15 Cultural Heritage (Architectural)

Dublin Central Project – Site 2 & No.61 O’Connell Street Upper

Appendix 15.2 Chronology Drawings

Appendix 15.3 Building inventory, record and description for No.43 O'Connell Street Upper

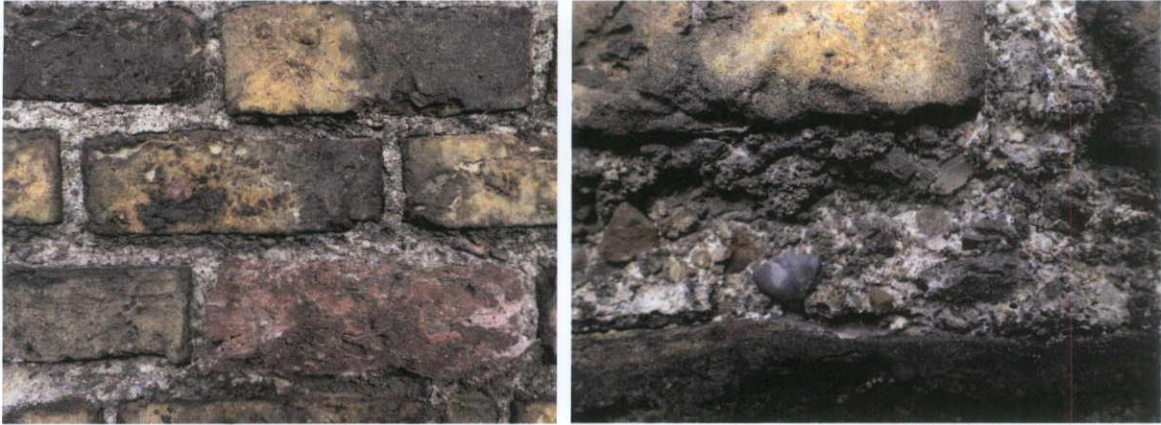
Fig.5.7.16: The soiled party wall is composed of hand-made clamp-fired yellow stock brick bedded in deep coarse-grained lime mortars with scarce crushed brick. This brick is very similar to that transported to Dublin City along the canal networks, and probably mid-nineteenth century.

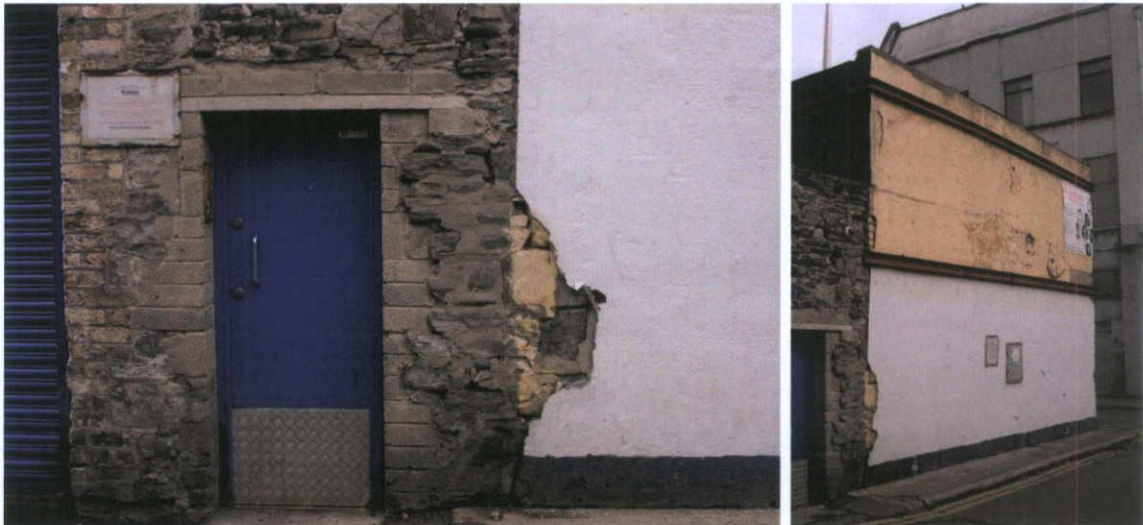
5.8 60a O’Connell Street / 19 Henry Place: Calp limestone masonry fabric is visible beneath the two-coat Portland Cement render. The Calp limestone masonry extends beyond the rendered flat-roofed structure and merges into the Calp limestone boundary wall of the adjacent No.59 O’Connell Street – indicating that the rear walls to both properties were built at the same time. The masonry is of hewn Calp limestone bedded in coarse-grained lime bedding mortar with brick pozzolan similar in composition to that seen at the rear of Nos.58 and 59 O’Connell Street. It is likely that these three walls are of eighteenth century date.

Fig.5.8.1: The rear boundary Calp limestone wall (60a O’Connell Street) is set in a pozzolanic lime mortar similar to others seen along the lane, and is probably eighteenth century Georgian fabric.

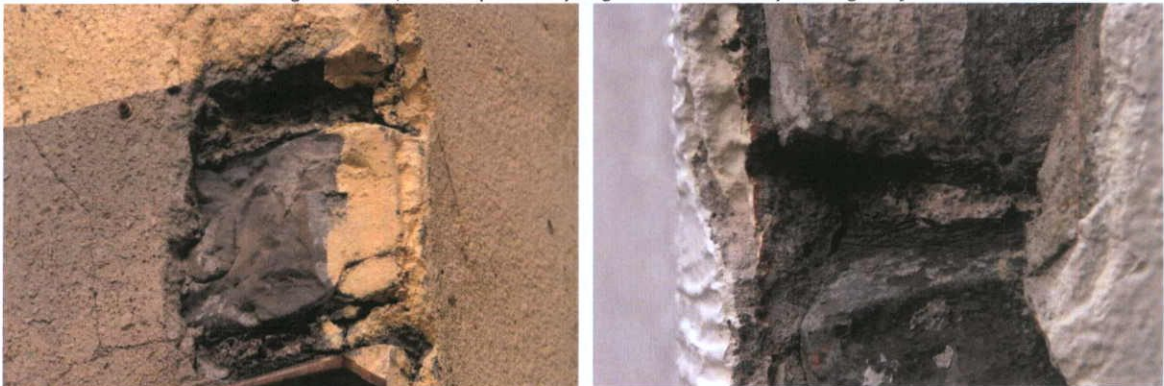
Fig.5.8.2: Detail of the Calp and lime bedding mortar beneath the twentieth century render.

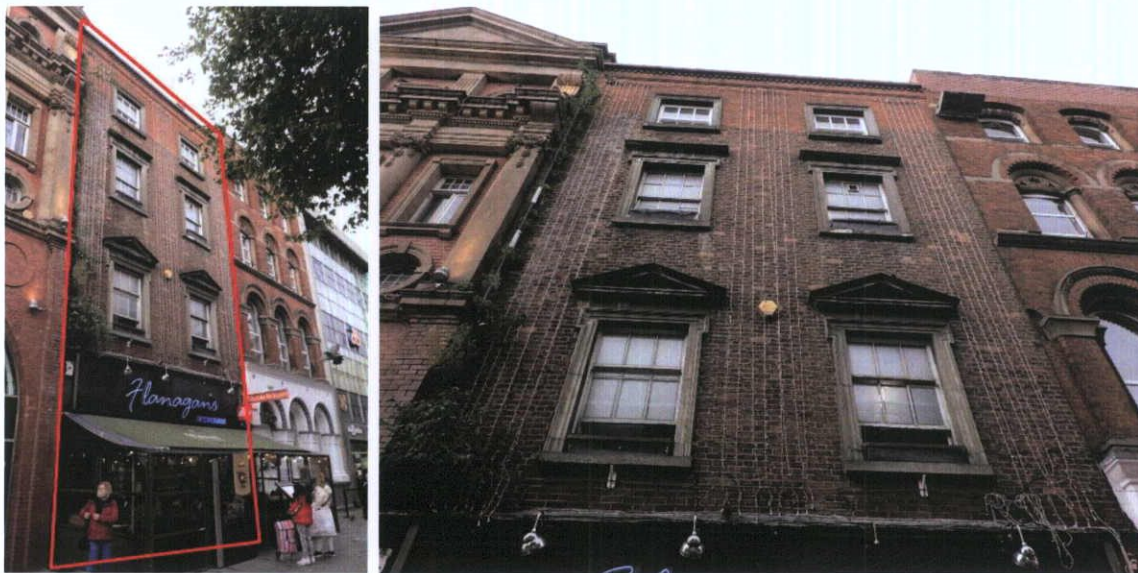
Façade: The façade consists of a modern shopfront with a brick superstructure punctuated by granite windows, with later brick above cill level on the third floor terminating in dentil brickwork below the coping. The façade has been repointed throughout in Portland Cement with gritty Portland Cement pointing applied to the earliest red stock facing brick. The façade also shows ‘plastic’ repair mortars and poor quality modern brickwork repairs below concrete window cills at first floor level.

Fig.5.9.1: General view showing the altered upper floor level.

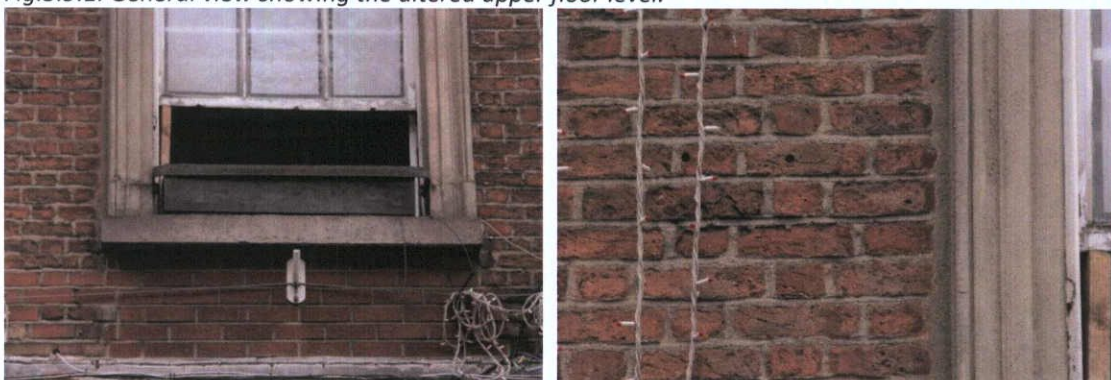
Fig.5.9.2: Modern brickwork below the window cill, and original brick repointed in Portland Cement.

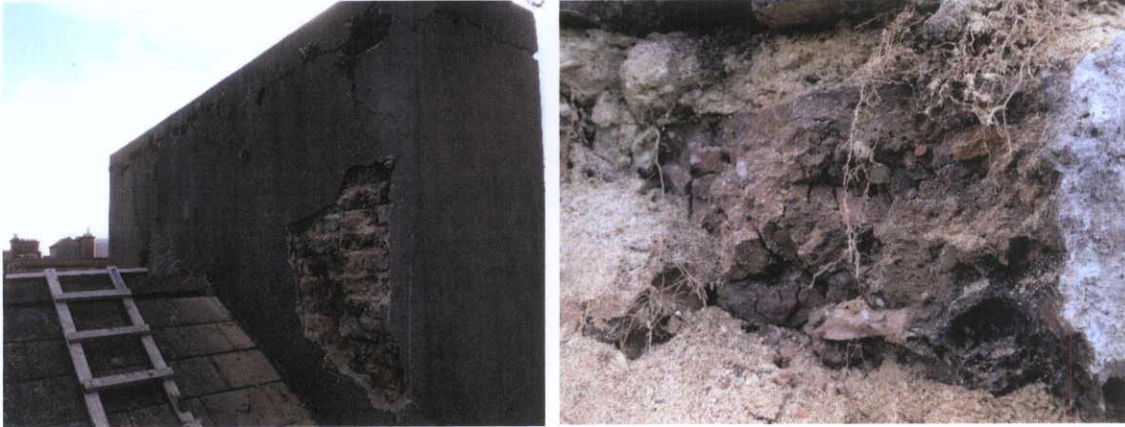
Georgian Chimney: The Portland Cement render was removed from the front (east) chimney stack at roof level; and the stack was found to be made of hand-made clamp-fired brick fired from unprocessed raw clay containing coarse limestone aggregate and with abundant partially calcined limestone and areas of vitrified matrix. The mortar has been affected by water penetration, saturation and invasive vegetation and is in poor condition but contains rounded gravel aggregate and brick pozzolan suggesting an early date. Internally, the brick chimney stack has been concealed behind modern partitioning and kitchen fixtures at all floor levels.

Fig.5.9.3: The chimney contains hand-made clamp fired brick very similar to that seen in No.42 O'Connell Street and likely to be Georgian fabric.

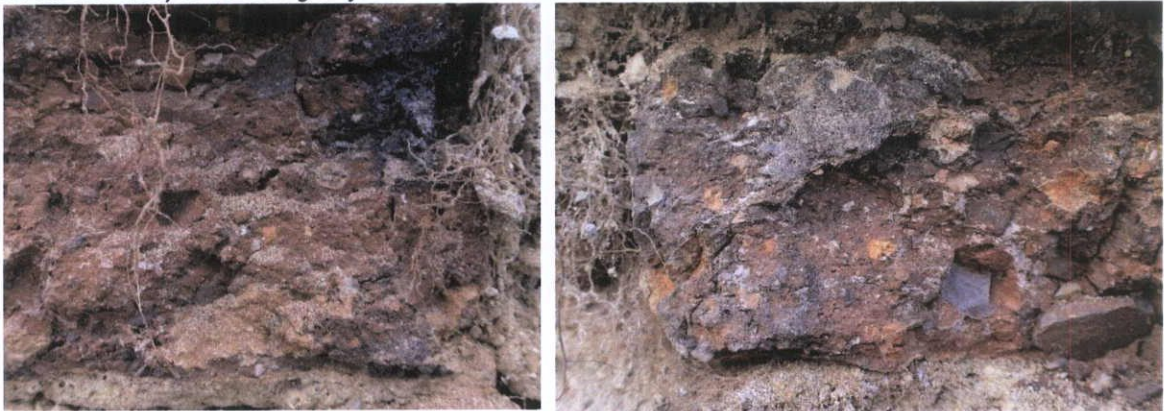
Fig.5.9.4: Hand-made clamp fired brick forming the chimney - similar to that seen in No.42 O'Connell Street and likely to be Georgian fabric.

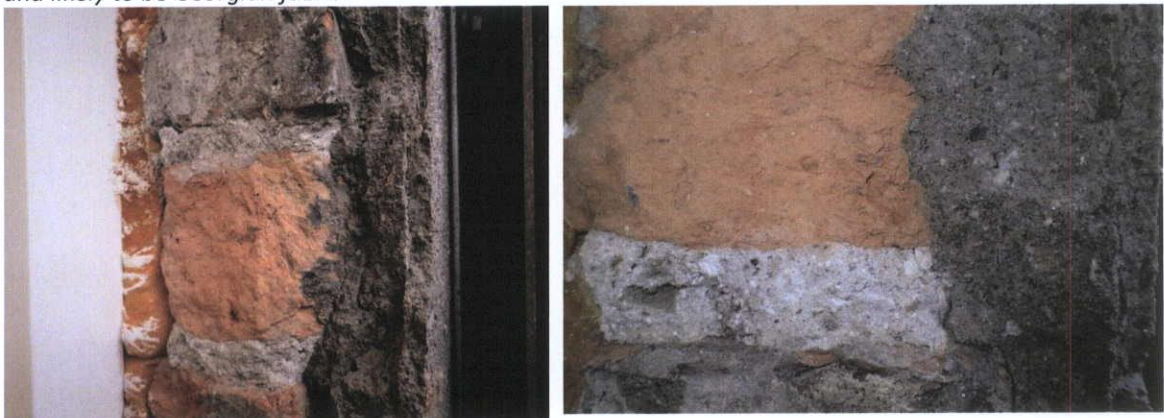
The rear wall of the building is coated in a Portland Cement render laid in two to three coats over a fine-grained solid red facing brick. Some of the brick is early clamp-fired brick with pebbly inclusions and voids, shrinkage cracks and fired from unprocessed clay. However, only a limited amount was visible and it would be necessary to remove further sections of render from the rear of the building to determine whether these were isolated salvaged and reused bricks, or whether these are representative of the rear elevation.

Fig.5.9.5: The rear elevation is coated with multiple layers of Portland Cement render above red stock brick.

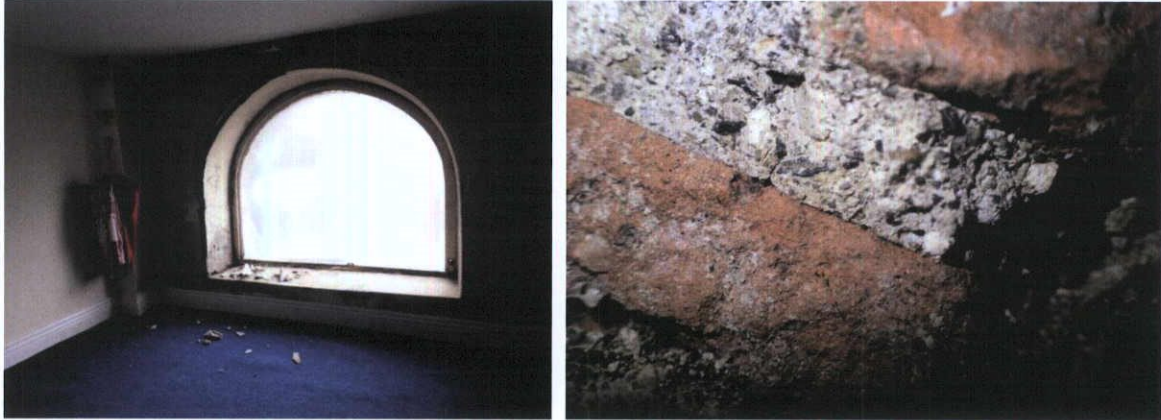
Fig.5.9.6: Arched window opening in the stairs. The arch is formed by brick with a ‘pennystruck’ lime bedding mortar using aggregate similar to that seen on the rear elevation, but differing from the aggregate used to bed the chimney stacks.

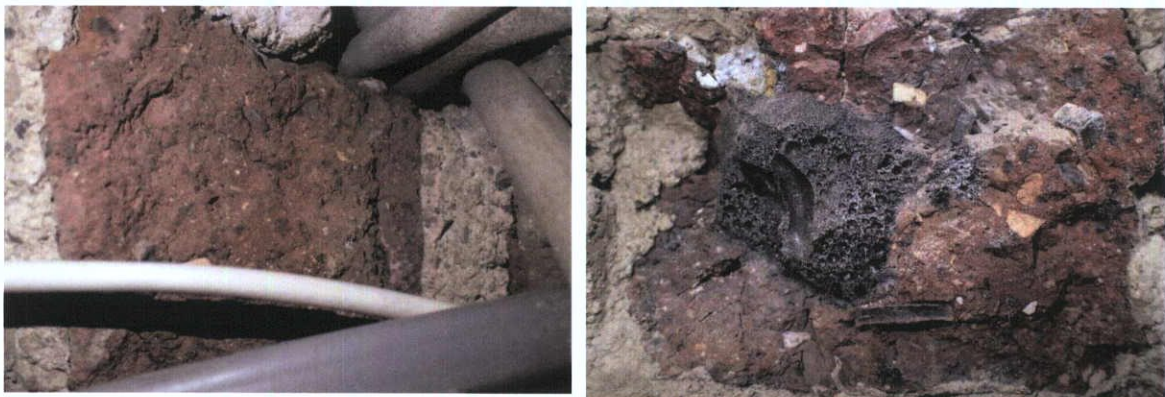
6.1 Early Hand-made Brick: There are a number of types of hand-made clamp-fired bricks found among the buildings of the Dublin Central Project. No.42 O’Connell Street (see Section 4.3) provides a useful ‘point in time’ reference. The façade of this building is composed of red facing brick (Fig.4.3.4), but the internal wall linings are composed of a coarser rich red-coloured stock brick containing sharp angular limestone inclusions which are seen in brick in other building on O’Connell Street and Parnell Street (Fig.9.1.1). Some of this early brick is also found in ‘Building C’ at 50-51 O’Connell Street (Figs.5.3.19-20). This is a good contender for brick burnt on the ‘Old Brick Field’ marked on John Rocque’s mid-eighteenth century map of Dublin. These are found bedded in pozzolanitic lime mortars (where fine brick dust was added to the mix) and lime mortars using only local coarse rounded aggregate with no intentional inclusions.

Fig.9.1.1: Brick with coarse angular limestone inclusions from the basement of No.43 O’Connell Street (left), and seen in the internal walls of No.71 Parnell Street (right).

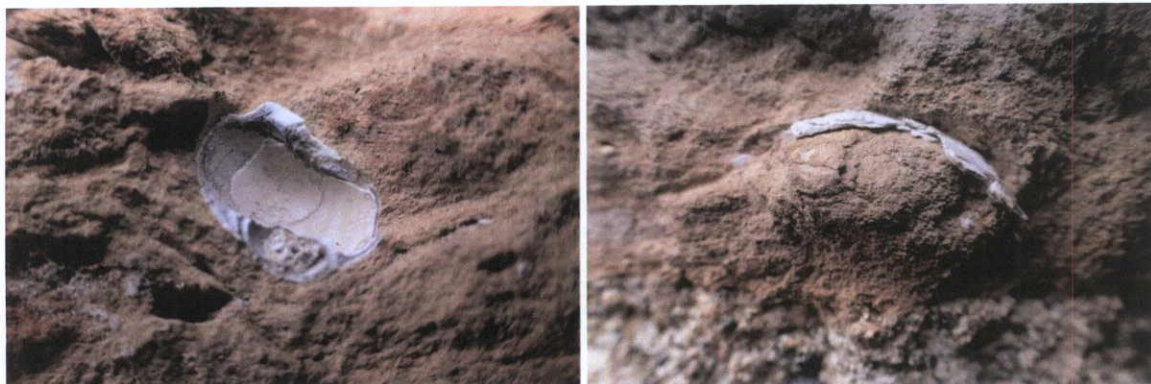
A second early brick in the area is a relatively soft hand-made clamp-fired mostly pale red-coloured ‘place’ brick found on internal wall linings along Moore Street and in the chimney of No.60 O’Connell Street. This brick would have little resistance to external weathering stresses and was intended to be concealed by a plaster or render. A proportion of these bricks contain shell (Fig.9.1.2) which is likely to be a by-product of shellfish consumption rather than indicative of brickmaking along the coast. These bricks are found on internal and external walls along Moore Street, on buildings which were built on the grounds of the ‘Old Brick Field’ marked on John Rocque’s mid-eighteenth century map of Dublin. These are likely to be of late eighteenth or early nineteenth century date.

Fig.9.1.2: 'Shell brick' is found at a number of buildings on Moore Street including No.10 Moore

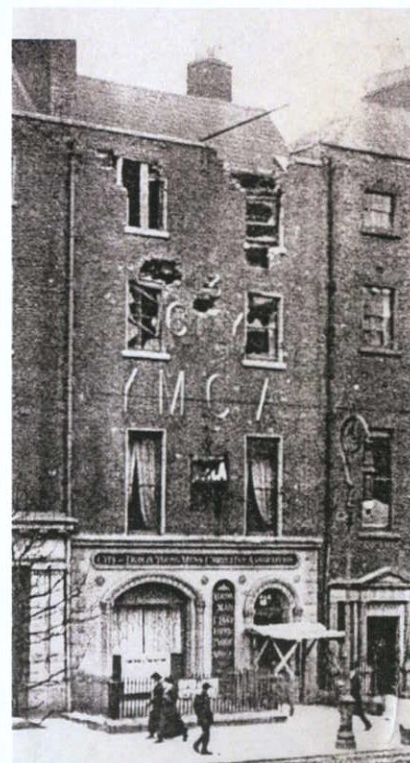
Figure 3: Damage to 43 Sackville Street Upper from fighting in July 1922 (National Library of Ireland)

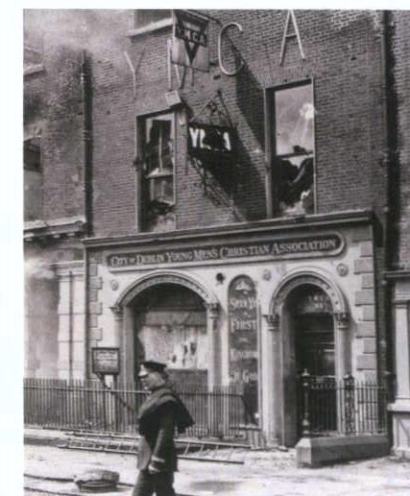
Figure 4: Damage to façade in July 1922 (Irish Architectural Archive)

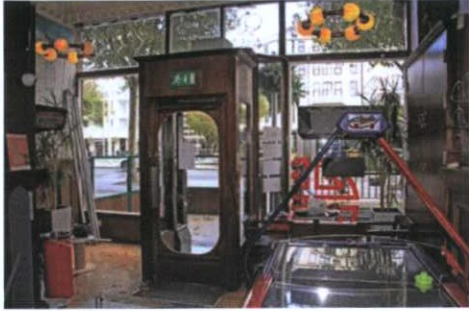
Room G-1: Accessed from external entrance from O'Connell Street Upper. Chimney breast to south wall, now blocked up. Lath-and-plaster ceiling with heavily moulded modillion coving and decorative plaster panels, partially hidden from view by bulkheads of modern ceiling fixtures. Most walls finished in modern plaster and wallpaper. Full-height glazed commercial entrance to east wall, with bowed entrance lobby and timber mullions forming flanking shop windows and overlights. Modern joinery throughout, including curved bar to north wall and built-in presses to chimney niche. Modern timber dado rail and dado panelling. Original timber skirting to south wall. Parquet timber flooring.

Plate 38: G-1 – View to east towards commercial entrance from O'Connell Street Upper

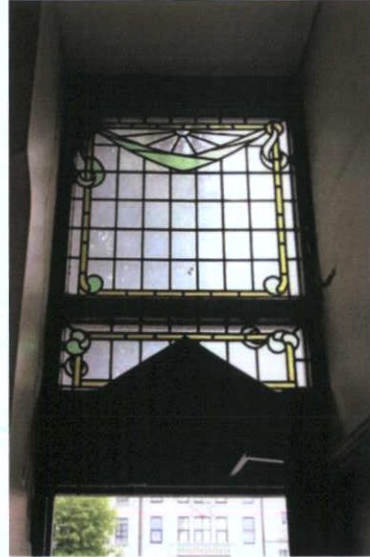
Room F-4: Accessed from external entrance from O'Connell Street; level access with staircase accessing upper floors. Modern plaster ceiling with downstand service bulkhead to north. Archway to west over stairwell, with carved timber surrounds and moulded keystone, supported on engaged pier to north. Boxed-out service risers projecting from walls. Entry door to east having original timber door surround with carved timber, pedimented overdoor, surmounted by leaded stained glass overlights with timber mullions. Plaster finish to walls. Closed-string, straight flight of stairs with half-landing, having nosed treads with rubber contrast strips; treads and risers finished in vinyl. Carved timber handrail to flanking walls. Original skirting boards / stair stringers with ovolo profile. Original mosaic tile to entryway floor with lettering, "43" encircled in dark mosaic pattern. Some surface-mounted services.

Plate 67: F-4 – Stained glass overlight
