Appendix 15.13 Building inventory, record and description for

No.60a 60b 60c O'Connell Street Upper

Dublin Central Project – Site 2 & No.61 O'Connell Street Upper

Appendix 15.14 Building inventory, record and description for No.61 O'Connell Street Upper

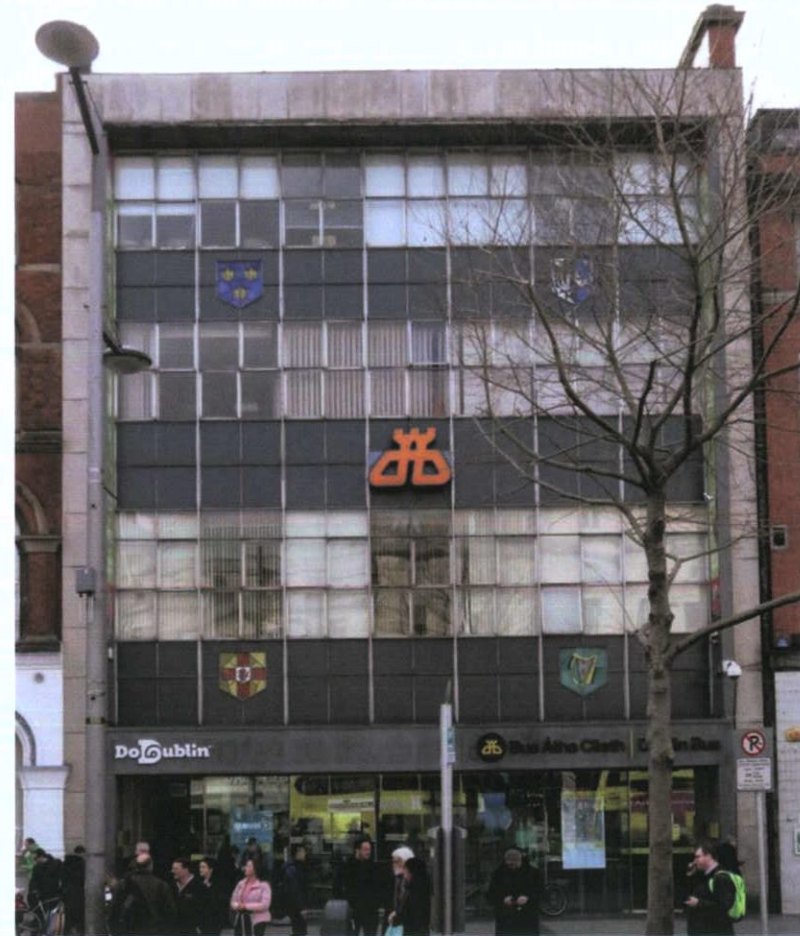
Plate 1: Front façade, 59 O'Connell Street Upper

The street façade of number 59 O'Connell Street Upper consists of a concrete frame to the sides and across the parapet, within which the façade is glazed, divided into small rectangles and alternating horizontally with coloured panels and glazed areas. The ground-floor façade is glazed across the full width between the margins of the frame.

This frontage extends back about two to three metres from the street, to the rear of which is a building dating from the 1920s with a fine staircase with turned balusters and newels and with a heavy handrail. There are some surviving overdoors based on classical designs.

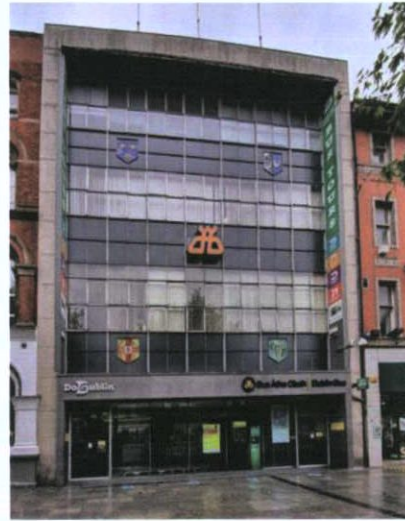
Seven-bay, four-storey-over-basement attached building. Flat roof, with rendered chimney stack to north and pop-up vertical plant room extension with curved roof. Concrete frame to parapet and to projecting piers flanking front (east) elevation. Recessed façade comprising horizontal bands of paired aluminium casement windows at each floor, surmounting blind band of spandrel panels. Modern shop front to ground floor, having full-width curtain wall glazing.

Plate 3: Front (east) elevation built c.1959

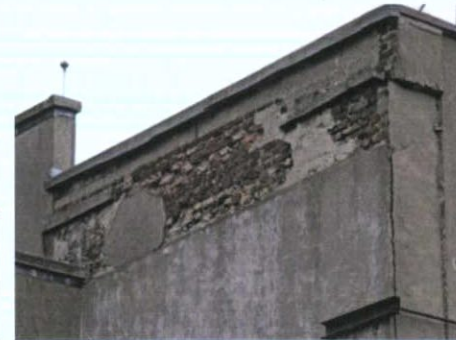
Plate 8: Red brick substrate to cementitious render to main building; view from north-west

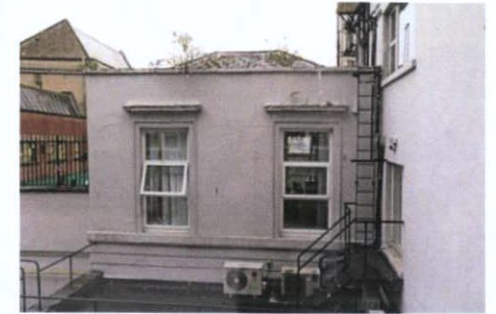
Plate 13: View of extension from east; original hood mouldings

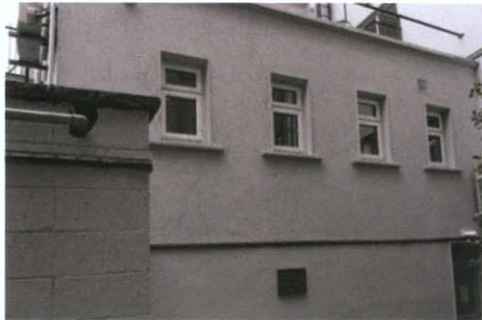
Plate 14: View west to extension; projecting ground and basement levels

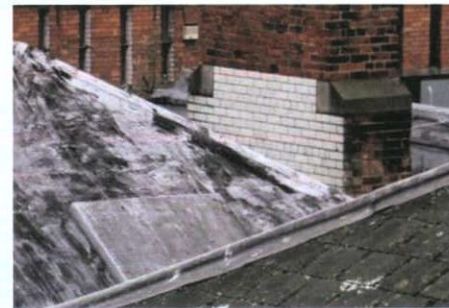
Plate 24: Glazed brick to base of chimney stack to north of Reading Room to reflect light into north-facing rooflight

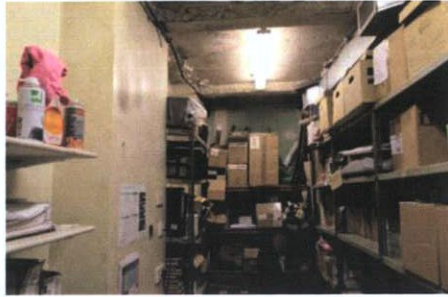
Plate 26: B-1 – View to south; former basement well

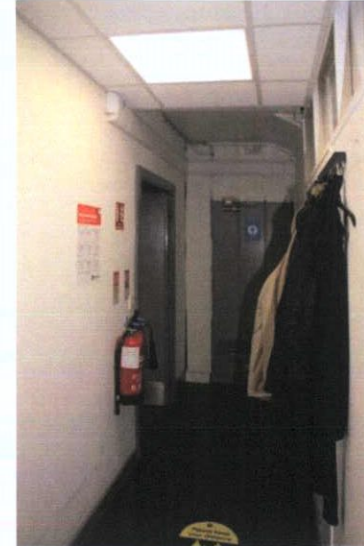
Room B-2: Accessed from Room B-4. Corridor on east-west axis; subdivision of former north room. Suspended ceiling finished with ceiling tiles. Modern plaster finish to walls; plasterboard finish to timber stud partition to south, having modern clerestory windows inset. Modern rectangular-section skirting boards. Flush timber doors and carved timber architraves. Ceramic tile finish to floors. Surface-mounted services.

Plate 28: B-2 – View to east towards entrance to Room B-1

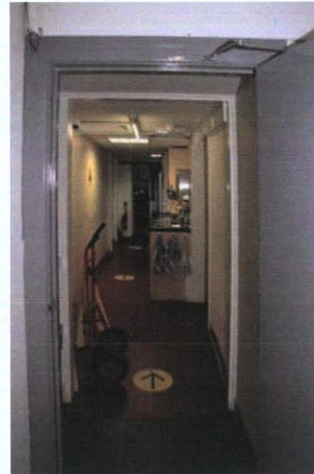
Plate 31: B-4 – View to west

Room B-4: Accessed from Rooms B-2, B-5 and B-7. Corridor on east-west axis. Suspended ceiling finished in plasterboard. Plaster finish to walls. Modern rectangular-section skirting boards. Flush timber doors and carved timber architraves. Vinyl finish to floors. Surface-mounted services. Tea station facilities to north.

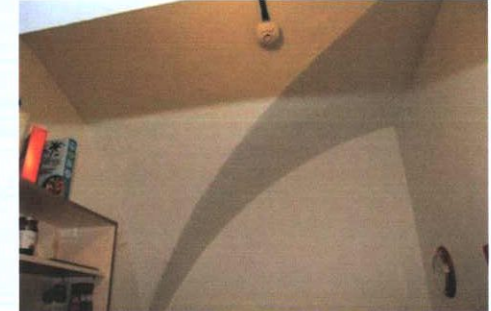
Room B-5: Accessed from Room B-4. Groin-vaulted ceiling finished in plaster. Plaster finish to walls; recessed niche at low level to north. Modern rectangular-section skirting boards. Flush timber doors and carved timber architraves. Ceramic tile finish to floors. Surface-mounted services.

Plate 33: B-5 – Groin vault to ceiling

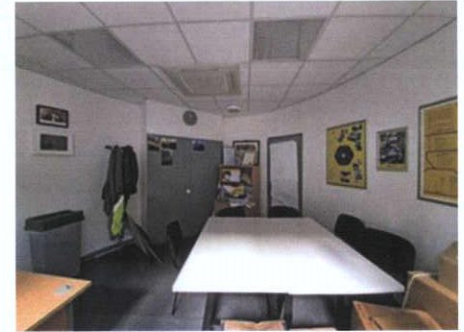
Plate 37: B-7 – View to north

Room B-7: Accessed from Room B-4. Room forms pointed-arch footprint on plan, with apex of arch at northern end; likely owing to corner fireplaces behind modern linings to north-west and north-east corners; projecting masonry appearing as corner fireplace, now enclosed with modern double-leaf doors, to north-west corner. Modern plaster and plasterboard finishes to walls. Suspended ceiling finished with ceiling tiles. Glazed wall with uPVC frame to south overlooking rear courtyard. Modern rectangular-section skirting boards. Flush, part-glazed timber doors and flat timber architraves. Ceramic tile finish to floors. Surface-mounted services.

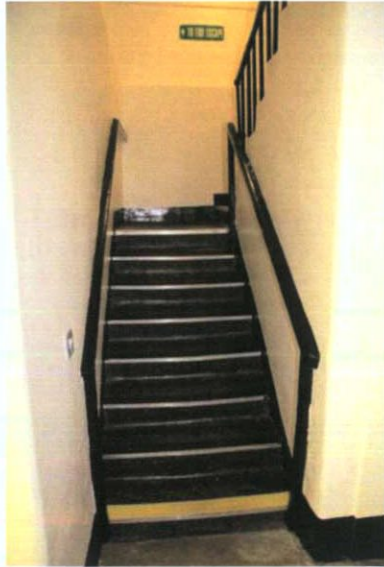
Room B-9: Accessed from Rooms B-8, B-10 and B-11. Stairwell to upper floors connecting to corridor on east-west axis. Closed-string, dog-leg stair; treads and risers finished in vinyl with rubber and steel contrast strips. Rectangular-section skirting boards / stringers. Modestly carved timber handrail supported on square-section newel posts; handrail and balustrade embedded to rising walls to lower flight; balustrade infilled with square-section timber balusters to upper flight. Modern plaster finish to ceiling and walls to stairwell; plasterboard ceiling to corridor. Flush timber doors and flat timber architraves. Vinyl floor finish to landings; limestone and sandstone pavements to corridor. Surface-mounted services.

Plate 42: B-9 – View to north

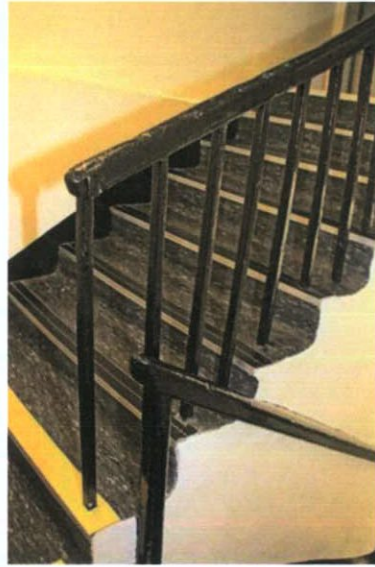
Plate 43: B-9 – Detail to balustrade

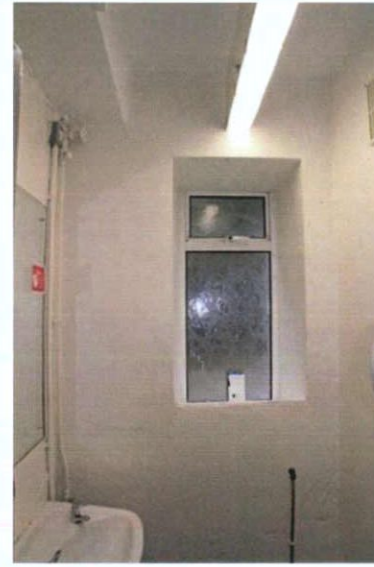
Room B-10: Accessed from Room B-9. Toilet room. Painted cast concrete ceiling; downstand bulkhead at height to south wall and downstand cross brace on north-south axis. Modern plaster finish to walls. Square-headed window opening to west wall with uPVC casement window. Surface-mounted services. Sanitaryware throughout.

Plate 44: B-10 – View to west

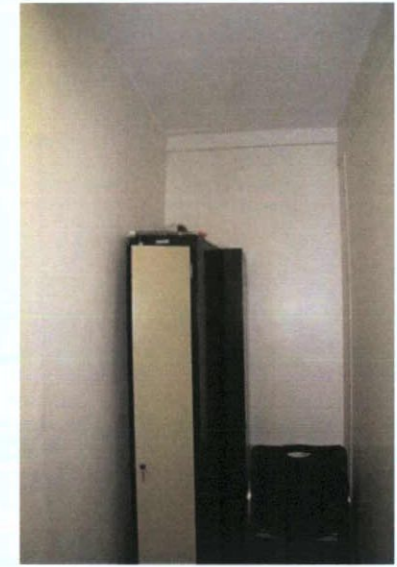
Plate 45: B-10 – View to east

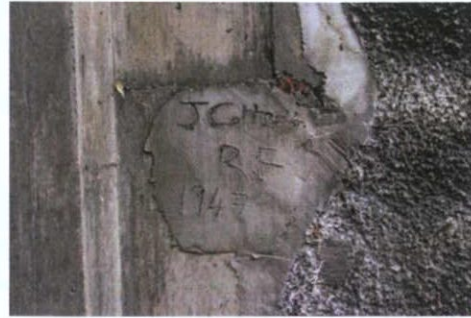
Plate 51: B-11 – 20th century graffiti to south elevation of extension

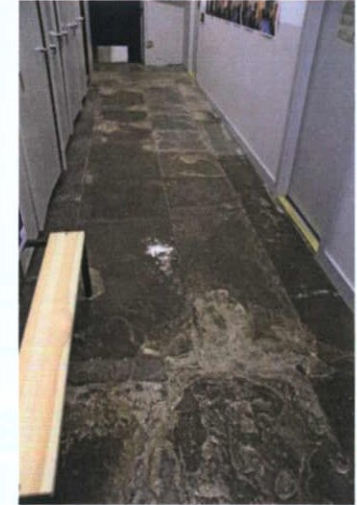
Plate 53: B-12 – Limestone flagstones

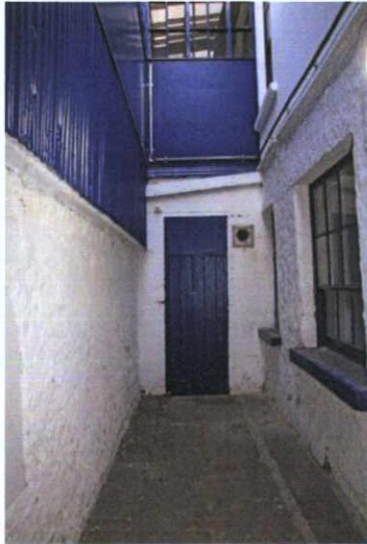
Room B-15: Accessed from Rooms B-12 and B-15. Double-height space. Pitched roof over having timber rafters on matching wall plate with corrugated sheeting forming lightwell. Walls comprised of painted rubble Calp limestone to east and west at low level; painted brickwork to north wall; plastered finished to east wall at high level and timber boarded finished at high level to remainder; blocked-up round-headed ope in west wall. Timber boarded doors with flat timber architraves. Eight-over-eight timber sash window and timber casement window to east wall at basement level; six-over-six timber sash windows to ground floor level; painted masonry sills throughout. Fixed multi-pane cast-iron windows at height to west wall. Limestone paviers.

Plate 58: B-15 – View to north

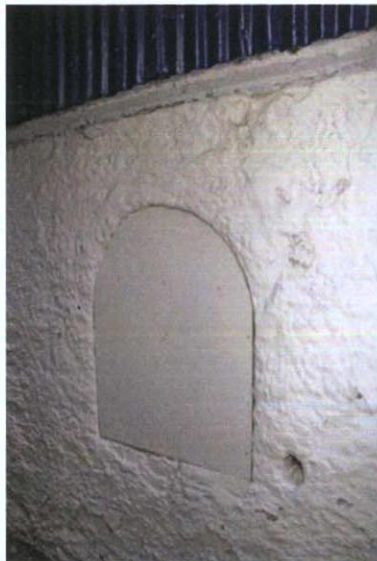
Plate 62: B-15 – Round-headed opening, now blind, to west

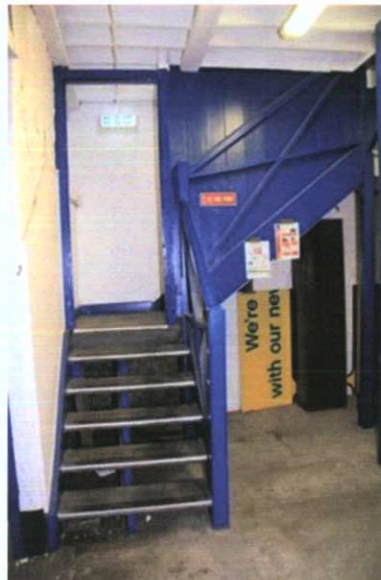
Room B-16: Accessed from Room B-15. Closed-string, L-plan staircase with quarter landing; steel, nosed treads with rectangular-section stringer / skirting boards. Lower flight having balustrade forms of rectangular-section timber handrail set to square-section newel posts with infill of diagonal cross braces; upper section of flight has matching balustrade alongside vertical tongue-and-groove panelled enclosure, supported on timber posts. Soffits of steps exposed to room below. Exposed soffits of rectangular-section ceiling joists to ceiling; exposed painted soffits of timber floorboards above. Walls comprised of painted rubble calp limestone; recessed niche to north wall. Timber boarded doors with flat timber architraves and integrated transoms, now blind. Limestone paviers.

Plate 63: B-16 – View to west

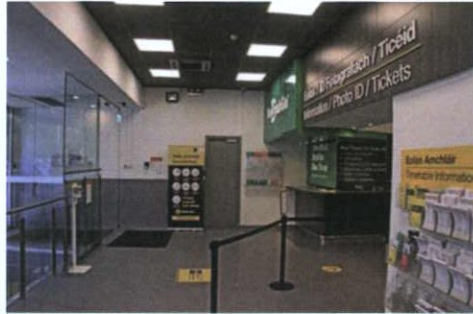
Plate 66: G-1 – View to south

Room G-1: Accessed from Room G-2 and from external entrance from O'Connell Street Upper. Suspended ceiling finished in ceiling tile. Downstand bulkheads to east and west over commercial entrance and over access passage to rear (west). Modern plaster finishes to walls; glazed screen forming commercial frontage to east wall. Steel-framed multi-pane window to west wall. Timber and steel-framed glazed ticket desks to west. Glazed balustrade with steel frame around staircase leading downward to Room B-6; closed-string, straight flight of stairs with squared treads and risers having vinyl covering; modern steel and glazed balustrade; steel-framed multi-pane rooflight adjacent to stair forming lightwell to basement level. Vinyl finish to floor.

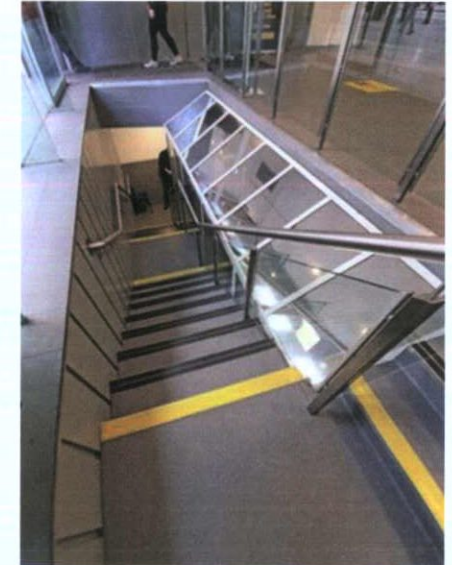
Plate 73: G-1 – View to staircase leading to basement level

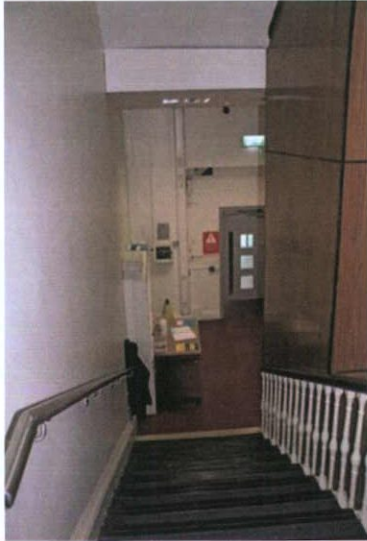
Room G-2: Accessed from Rooms G-1 and F-1. Stairwell accessing upper floors. L-plan, open-string staircase, now with timber-clad lift shaft infill to former open well, having nosed timber treads with rubber and steel contrast strips and timber risers, covered in carpet, with balustrade formed of carved timber handrail, formerly continuous at landings, with infill of carved timber balusters with collars. Plaster finish to soffit of rising staircase; downstand bulkhead finished in plasterboard to portions of ceiling; remainder of ceiling is suspended and finished in ceiling tiles. Modern part-glazed flush timber doors with flat timber architraves. Timber skirting boards with ovolo profile. Carpet finish to landings. Surface-mounted services.

Plate 74: G-2 – View to east

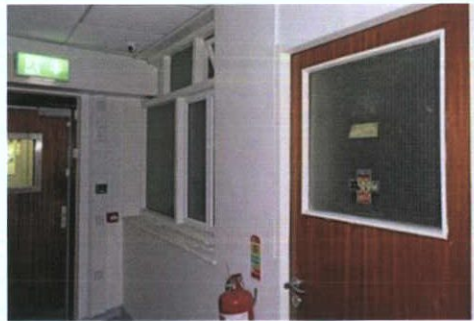
Plate 78: G-4 – View to north-west

Room G-4: Accessed from Rooms G-3, G-5 and G-7. Corridor on east-west axis. Suspended ceiling finished with ceiling tiles. Modern plaster finish to walls; plasterboard finish to timber stud partition to north, having internalised timber casement windows with timber mullion and nosed internal timber sill. Two uPVC timber casement windows to south wall, with side lights and squared internal timber sill. Modern rectangular-section skirting boards. Flush, part-glazed timber doors and flat timber architraves. Carpet finish to floors.

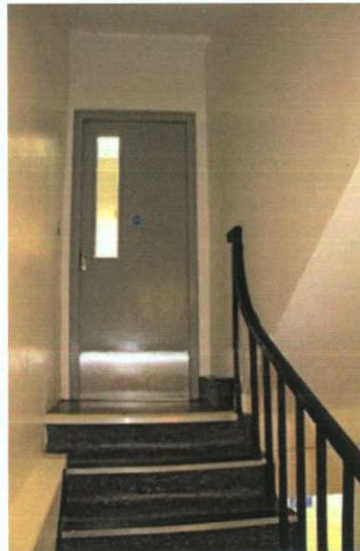
Room G-5: Accessed from Rooms G-4, G-6 and G-7. Stairwell to upper and lower floors. Closed-string, dog-leg stair; treads and risers finished in vinyl with rubber and steel contrast strips. Rectangular-section skirting boards / stringers. Modestly carved timber handrail supported on square-section newel posts, with infill of square-section timber balusters. Modern plaster finish to ceiling and walls to stairwell. Flush, part-glazed timber doors and flat timber architraves. Vinyl floor finish to landings. Surface-mounted services.

Plate 79: G-5 – View to south

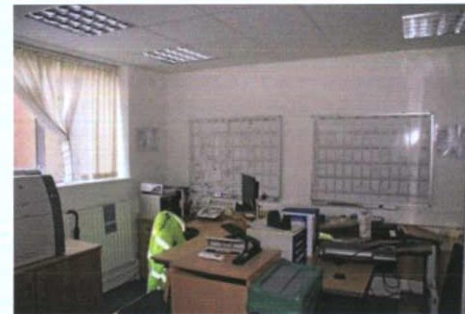
Plate 80: G-6 – View to west

Room G-6: Accessed from Room G-5. Suspended ceiling finished with ceiling tiles. Modern plaster finish to walls. Modern rectangular-section skirting boards. Flush, part-glazed timber door and carved timber architraves. Square-headed window opens to west and south walls, having uPVC casement windows and nosed internal timber sills. Carpet finish to floor. Surface-mounted services.

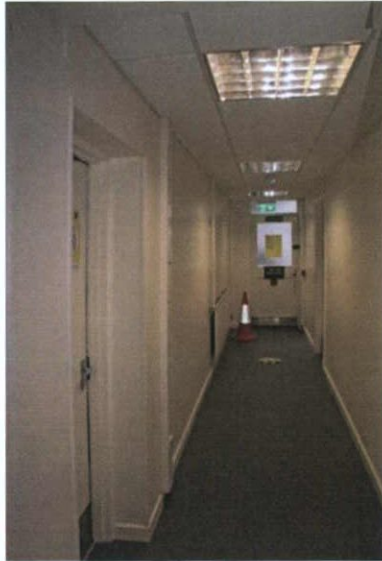
Room G-7: Accessed from Room G-5, G8, G-9 and G-10. Suspended ceiling finished with ceiling tiles. Modern plaster finish to walls. Modern rectangular-section skirting boards. Flush, part-glazed timber doors and carved timber architraves. Carpet finish to floor. Surface-mounted services.

Plate 82: G-7 – View to south

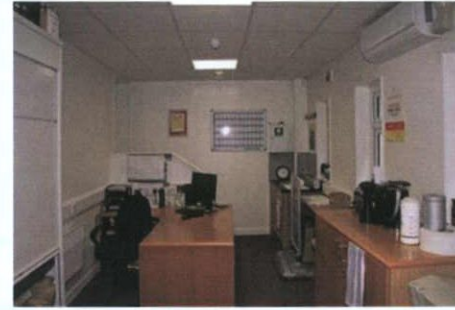
Plate 84: G-8 – View to north

Room G-8: Accessed from Room G-7. Suspended ceiling finished with ceiling tiles. Modern plaster finish to walls. Modern rectangular-section skirting boards. Flush timber door and carved timber architraves. Square-headed window opes to east and south walls, having uPVC casement windows and nosed internal timber sills. Carpet finish to floor. Surface-mounted services.

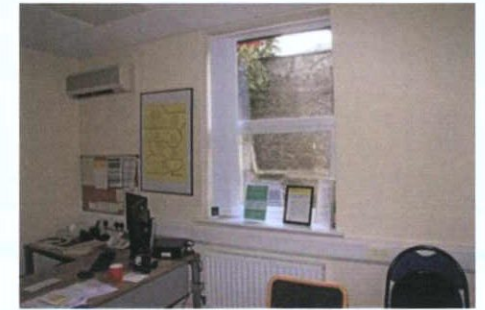
Plate 85: G-9 – View to south-west

Room G-9: Accessed from Rooms G-7 and G-10. Suspended ceiling finished with ceiling tiles. Modern plaster finish to walls. Modern rectangular-section skirting boards. Flush, part-glazed timber doors and carved timber architraves. Square-headed window ope to west wall, having uPVC casement window and nosed internal timber sill. Carpet finish to floor. Surface-mounted services.

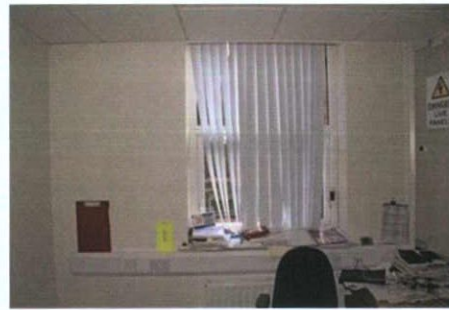
Plate 87: G-10 – View to west

Room G-10: Accessed from Rooms G-7 and G-9. Suspended ceiling finished with ceiling tiles. Modern plaster finish to walls. Modern rectangular-section skirting boards. Flush timber door and carved timber architraves. Square-headed window ope to west wall, having uPVC casement window and nosed internal timber sill. Carpet finish to floor. Surface-mounted services.

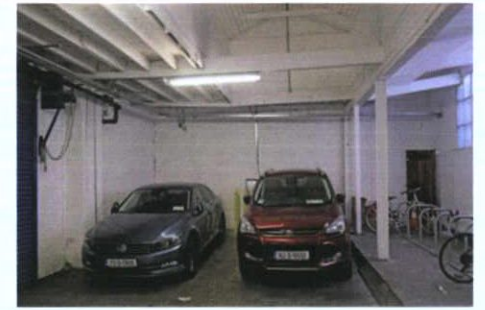
Plate 89: G-11 – View to north

Room G-11: Accessed from Rooms B-15 and G-12. Partial double-height, open-plan space formed of square-section cast-iron columns supporting wall plate onto which are bearing timber tie beams, with perpendicular rectangular-section timber floor joists to west and timber decking above. Cast-iron strut between ridge board and tie beams, with additional timber tying members over; timber tongue-and-groove decking to soffit of roof pitches articulated to interior. Closed-string, L-plan staircase with quarter landing to south-east corner; steel, nosed treads with rectangular-section stringer / skirting boards. Balustrade formed of rectangular-section timber handrail set to square-section newel posts with infill of diagonal crossbraces alongside vertical tongue-and-groove panelled enclosure, supported on timber posts. Walls comprised of painted rubble Calp limestone, with some brickwork to west and tongue-and-groove vertical cladding to north and east. Timber boarded doors with flat timber architraves. Steel roller shutter to west. Fixed multi-pane cast-iron windows to east wall. Concrete floor finish.

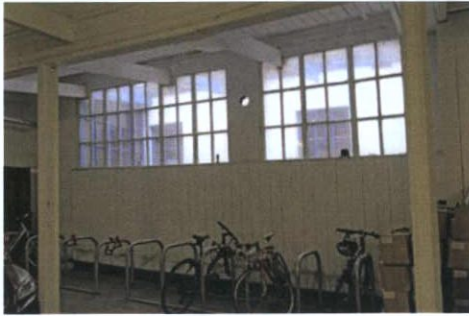
Plate 90: G-11 – View to east

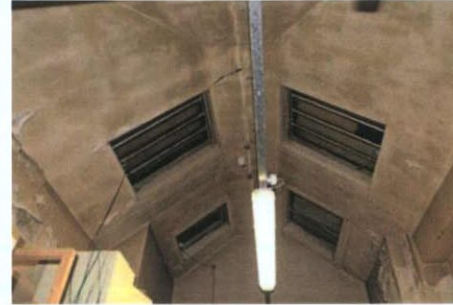
Plate 92: G-12 – View to east; ceiling in original Reading Room

Room G-12: Accessed from Room G-11. Part of original Reading Room. Double-height space. Roof pitches and hips articulated to interior. Lath-and-plaster finish to ceiling. Plastered finish to walls. Former rooflight openings now blinded externally, having wrought-iron frames. Roof supported on downstand bulkhead to north, bearing on projecting masonry nib to west. Surface-mounted services.

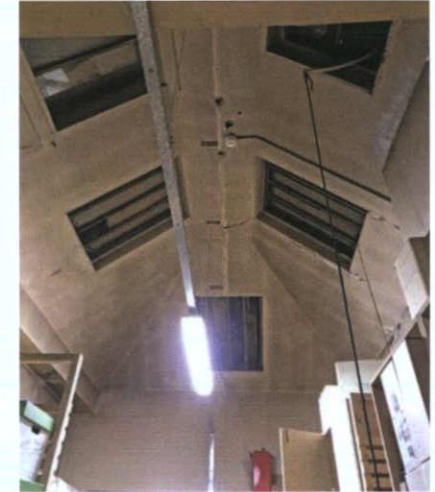
Plate 93: G-12 – View to west; ceiling in original Reading Room

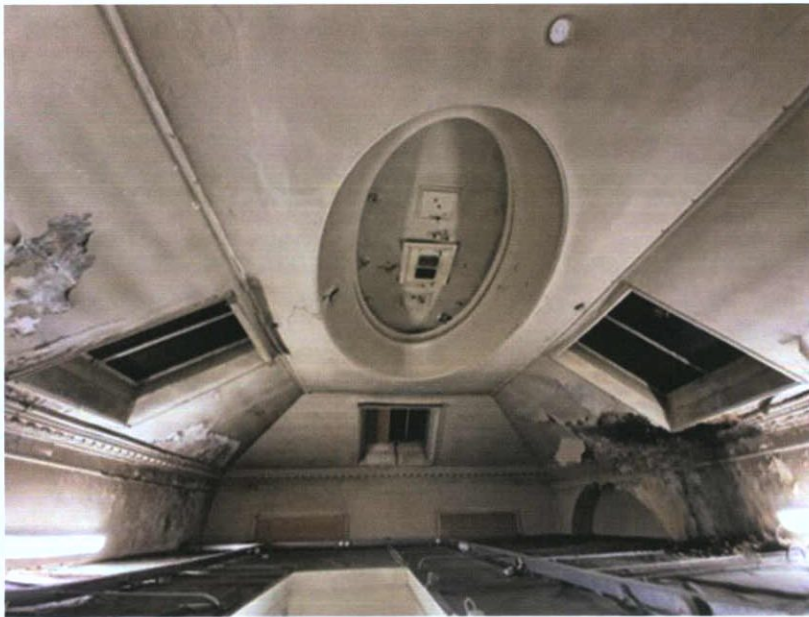
Roof G-13: Accessed from Room G-12. Part of original Reading Room. Area over suspended ceiling below. Roof pitches and hips articulated to interior, with flat ceiling to centre having expansive oval-shaped recessed rooflight, now blinded. Lath-and-plaster finish to ceiling. Former flanking rooflight openings now blinded externally, having cast-iron mullions. Heavily moulded modillion cornice to perimeter of ceiling. Plastered finish to walls. Square-headed window opes, now blinded and interrupted by suspending ceiling noted to north wall; additional round-headed ope, now blinded, to east wall.

Plate 94: G-13 – Original ceiling over suspended ceiling in Reading Room

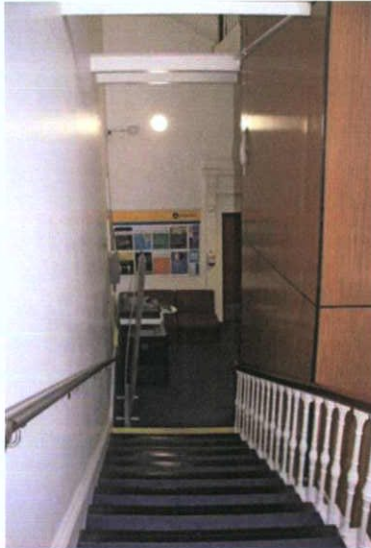
Plate 97: F-1 – View to east towards first floor

Room F-1: Accessed from Rooms G-2 and S-1. Stairwell accessing upper and lower floors. Open well, open-string staircase, now with timber-clad lift shaft infill to open well, having nosed timber treads with rubber and steel contrast strips and timber risers, covered in carpet, with balustrade formed of carved timber handrail, formerly continuous at landings, with infill of carved timber balusters with collars. Additional modern steel handrail to outer walls. Plaster finish to soffit of rising staircase; remainder of ceiling is finished in plasterboard. Modern part-glazed / flush timber doors set to doorcases having panelled pilasters on plinth blocks, surmounted by fluted corbel brackets with frieze and carved timber cornices. Original timber skirting boards with ovolo profile. Carpet finish to landings. Surface-mounted services.

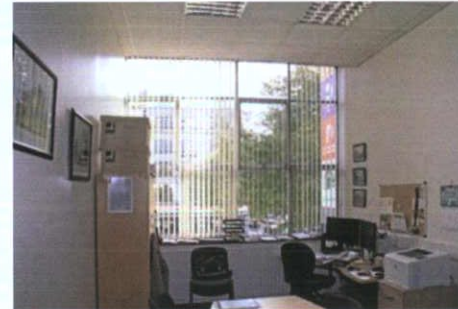
Plate 103: F-3 – View to east

Room F-3: Accessed from Room F-2. Suspended ceiling finished with ceiling tiles. Modern plaster finish to walls; plasterboard finish to timber stud partition north. Modern rectangular-section skirting boards. Flush, part-glazed timber door and flat timber architraves. Carpet finish to floors. Surface-mounted services.

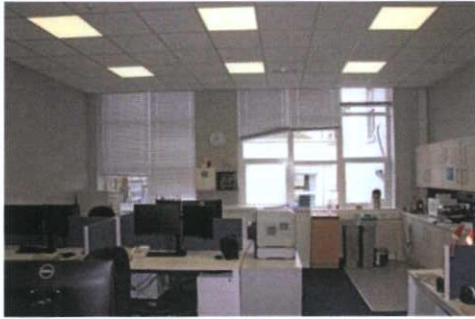
Plate 105: F-4 – View to west

Room F-4: Accessed from Room F-1. Suspended ceiling finished with ceiling tiles. Modern plaster finish to walls; plasterboard finish to timber stud partition east. Modern chamfered skirting boards. Flush timber door and flat timber architraves; original panelled door reveal partially retained to doorway to Room F-1. Large, square-headed window opens to west wall with uPVC casement windows, partially concealed by suspended ceiling, having squared internal timber sills. Carpet finish to floors. Kitchenette facilities to north-west.

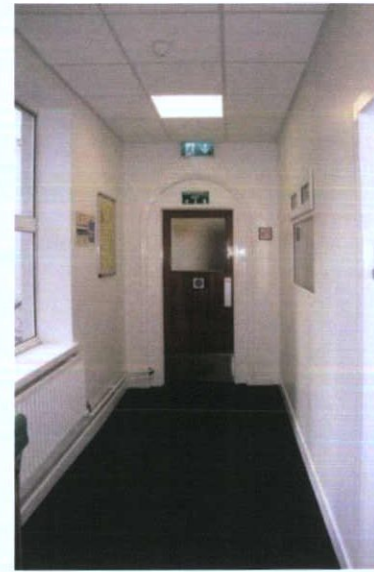
Plate 111: F-5 – View to west

Room F-5: Accessed from Rooms F-1, F-6 and F-7. Corridor on east-west axis. Suspended ceiling finished with ceiling tiles. Modern plaster finish to walls; plasterboard finish to timber stud partition to north, having integrated uPVC casement window. Modern rectangular-section skirting boards. Flush, part-glazed timber doors and flat timber architraves; doorway to west set to round-headed niche with carved timber surrounds. Square-headed window opens to west wall having uPVC casement windows and squared internal timber sills. Carpet finish to floors.

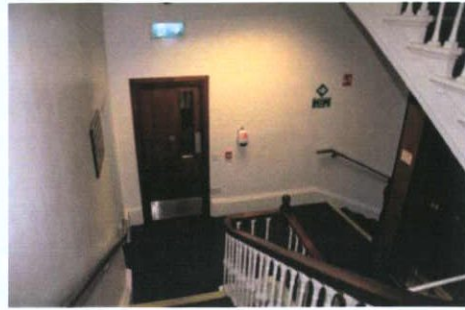
Plate 121: S-1 – View to south towards second floor landing

Room S-1: Accessed from Rooms F-1 and T-1. Stairwell accessing upper and lower floors. Open well, open-string staircase, now with timber-clad lift shaft infill to open well, having nosed timber treads with rubber and steel contrast strips and timber risers, covered in carpet, with balustrade formed of carved timber handrail, formerly continuous at landings, now set to carved newel posts with spherical finials, with infill of carved timber balusters with collars. Additional section of balustrade forms guarding to east of lift shaft and continues to additional open-well staircase, matching in design and orientated on north-south axis, rising to third floor. Additional modern steel handrail to outer walls. Plaster finish to soffit of rising staircase; remainder of ceiling is finished in plasterboard. Modern part-glazed / flush timber doors set to flat timber architraves. Large square-headed window opening to west wall forming lightwell to staircase, having multi-pane timber sashes and carved timber reveals with carved timber architraves and nosed internal timber sill. Round-headed niche to north wall at first floor half-landing. Timber skirting boards with ovolo profile. Carpet finish to landings.

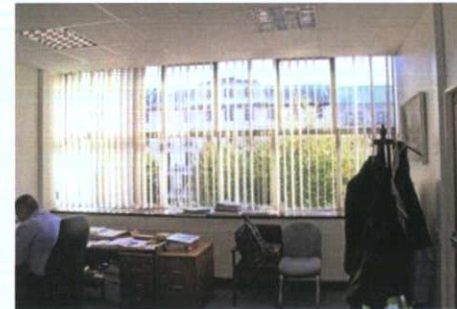
Plate 127: S-2 – View to east

Room S-2: Accessed from Rooms S-1 and S-3. Suspended ceiling finished with ceiling tiles. Modern plaster finish to walls; plasterboard finish to timber stud partition south. Square-headed window ope to front elevation with multi-pane aluminium casement windows. Modern rectangular-section skirting boards. Flush / part-glazed timber doors. Carpet finish to floors. Surface-mounted services.

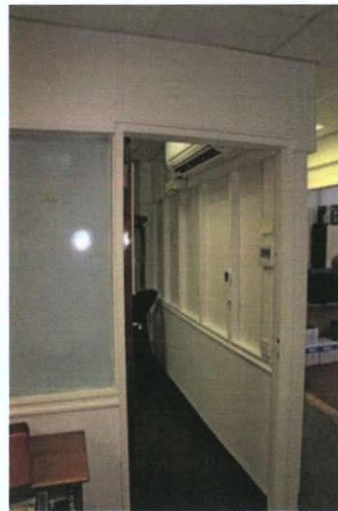
Plate 134: S-5 - View into Room S-6

Room S-5: Accessed from Rooms S-1, S-3, S-4 and S-7. U-shaped corridor with timber stud enclosure, clad in plasterboard, forming Room S-6 to centre, having blinded windows inset. Suspended ceiling finished with ceiling tiles. Modern plaster finish to walls; plasterboard finish to timber stud partitions to Room S-6 and to west and north. Modern rectangular-section skirting boards. Flush / part-glazed timber doors; doorway in south wall accessing Number 60 O'Connell Street Upper. Carpet finish to floors.

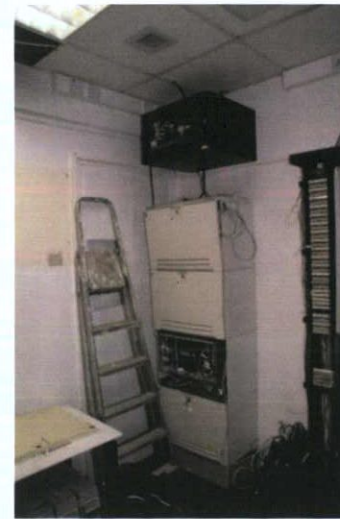
Plate 135: S-6 – View to south-east

Room S-6: Accessed from Room S-5. Suspended ceiling finished with ceiling tiles. Plasterboard finish to timber stud partitions forming enclosure, with blinded windows inset to north and west walls. Modern rectangular-section skirting boards. Flush / part-glazed timber door with flat timber architraves. Carpet finish to floors. Surface-mounted services.

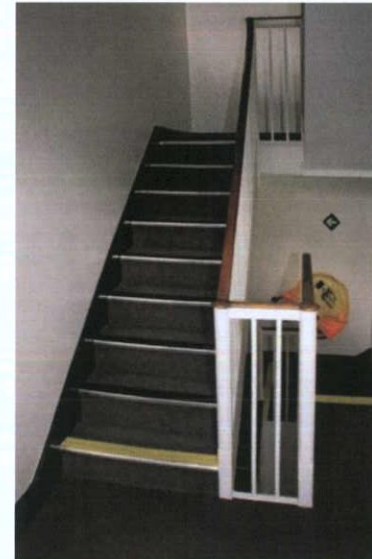
Plate 151: S-13 – View to north

Room S-13: Stairwell to upper and lower floors. Closed-string, dog-leg stair, formerly winder stair at second floor half-landing returning to original configuration; treads and risers finished in carpet with rubber and steel contrast strips. Rectangular-section stringer. Modestly carved timber handrail, ramped at upper landings, supported on square-section newel posts with stop-chamfer details, paired at landings, with infill of square-section timber balusters. Modern plaster finish to ceiling and walls to stairwell. Flush, part-glazed timber doors and flat timber architraves. Square-headed window opening to south wall to landing, having uPVC casement windows with squared internal timber sill. Timber skirting boards with ovolo profile. Carpet floor finish to landings.

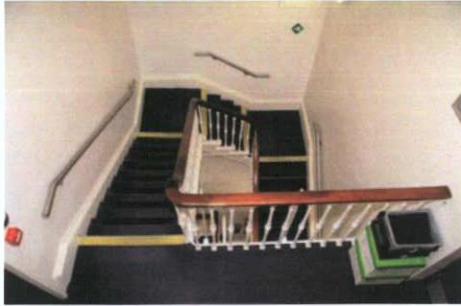
Plate 153: T-1 – View to north

Room T-1: Accessed from Room S-1. Stairwell accessing lower floors. Open well, open-string staircase, having nosed timber treads with rubber and steel contrast strips and timber risers, covered in carpet, with balustrade formed of carved timber handrail, continuous and ramped at landings, with infill of carved timber balusters with collars. Balustrade continues to east at third floor landing to form guarding. Additional modern steel handrail to outer walls. Plaster finish to soffit of rising staircase; remainder of ceiling is finished in plasterboard. Modern flush timber doors. Timber skirting boards with ovolo profile. Carpet finish to landings.

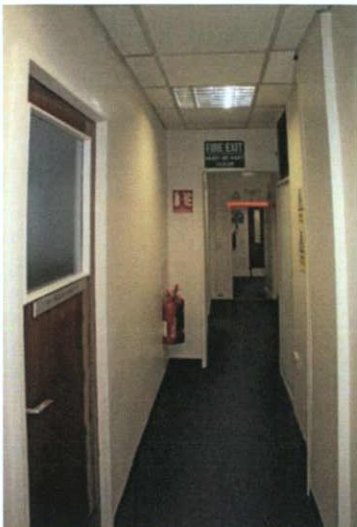
Plate 161: T-5 – View to south

Room T-5: Accessed from Rooms T-1, T-6, T-7 and T-8. Corridor on north-south axis. Suspended ceiling finished with ceiling tiles. Modern plaster finish to walls; plasterboard finish to timber stud partitions to east, west and north. Modern rectangular-section skirting boards. Flush, part-glazed timber doors and flat timber architraves. Door opening in south party wall provides access into Number 60 O'Connell Street Upper. Carpet finish to floors.

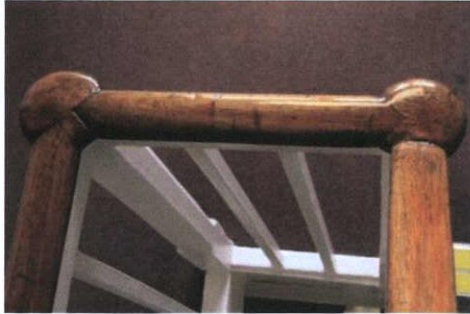
Room T-9: Accessed from Room S-13. Stairwell to lower floors. Closed-string, dog-leg stair; treads and risers finished in carpet with rubber and steel contrast strips. Rectangular-section stringer. Modestly carved timber handrail, ramped at upper landings, supported on square-section newel posts with stop-chamfer details, paired at landings, with infill of square-section timber balusters. Modern plaster finish to ceiling and walls to stairwell. Flush timber doors. Square-headed window opening to south wall to landing, having uPVC casement windows with squared internal timber sill. Timber skirting boards with ovolo profile. Carpet floor finish to landings.

Plate 169: T-9 – Detail to balustrade

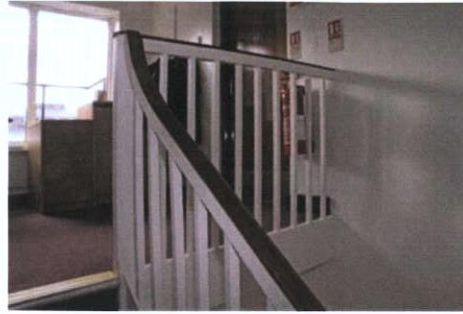
Plate 170: T-9 – View to south-west

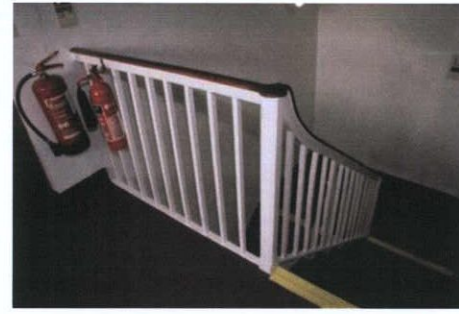
Plate 171: T-9 – Detail to balustrade

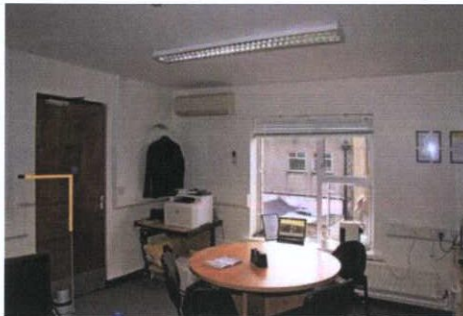
Room T-10: Accessed from Room T-9. Plasterboard finish to ceiling. Modern plaster finish to walls. Flush timber door. Square-headed window open to south wall with uPVC casement windows and squared internal timber sill. Modern rectangular-section skirting boards. Carpet finish to floors. Surface-mounted services.

Plate 174: T-10 – View to south-east

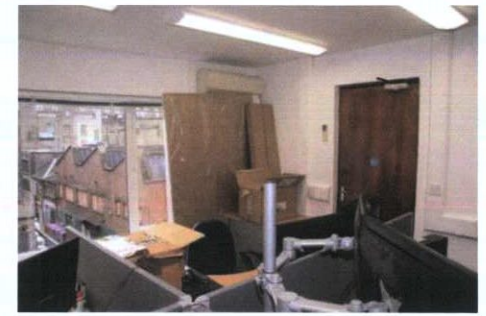
Room T-11: Accessed from Room T-9. Plasterboard finish to ceiling. Modern plaster finish to walls. Flush timber door. Square-headed window open to south wall with uPVC casement windows and squared internal timber sill. Modern rectangular-section skirting boards. Carpet finish to floors. Surface-mounted services.

Plate 176: T-11 – View to south-west

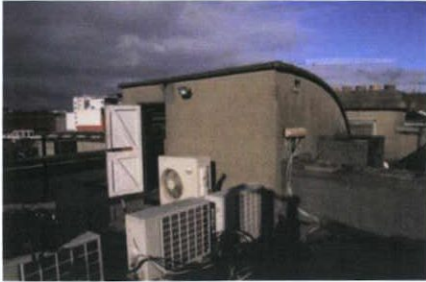
Room FO-1: Enclosure to flat roof of main building. Cementitious render to external walls. Enclosure is half-round in section, with curvilinear roof continuing to wall on north side. Formed internally by timber joists on east-west axis and infill of timber battens, with timber decking over. Exposed timber studs internally to flanking walls to east and west, with exposed rendered infill panels. Single square-headed window to west wall with flat timber architrave and clear plastic infill. Plant noted throughout.

Plate 177: FO-1 – View to north-west

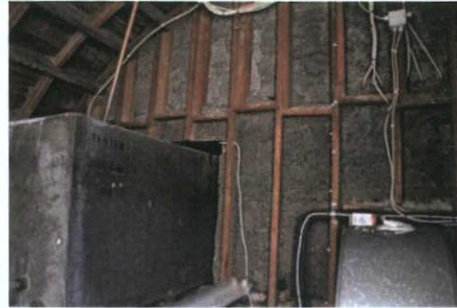
Plate 178: FO-1 – View to east

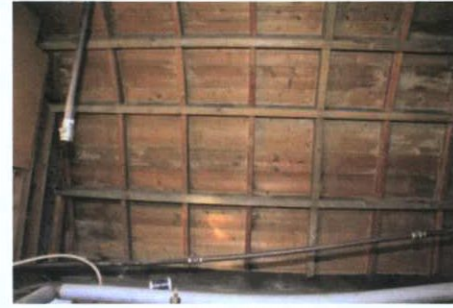
Plate 179: FO-1 - Ceiling

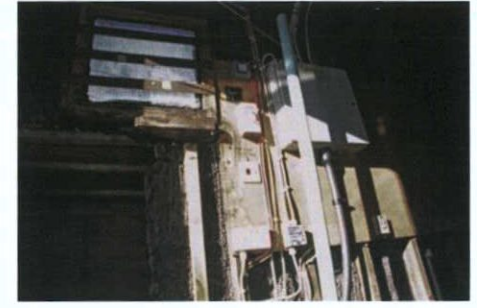
Plate 180: FO-1 – View to west

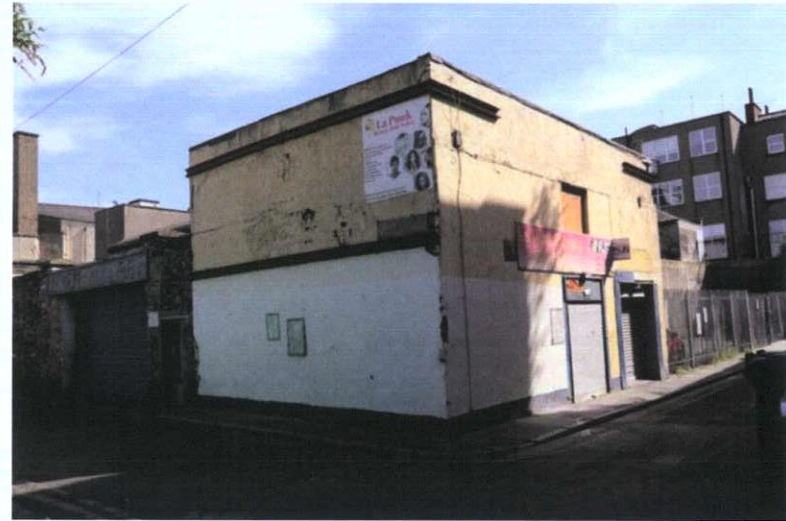
Plate 1: Exterior of 60A O'Connell Street Upper

Two-bay, two-storey former mews building. Flat roof. Rubble Calp limestone external walls, finished with cementitious render. External walls supported by steel braces. Blind elevation to north. Former, original cruciform ventilation opening to high level, west elevation, now blocked-up. Square-headed window ope to first floor to south elevation, now blocked-up and flanked by blocked-up original, vertical ventilation slit openings. Evidence of two former window openings to ground floor to south elevation, blocked-up and concealed with render. Two square-headed shop entrances to south elevation, with eastern ope forming infill to possible former carriage openings. Eastern ope supported by exposed lintel, and having exposed bulkhead concealing roller shutter, forming fascia. Both opes now infilled with modern-glazed timber doors with glazed sidelights / shop windows over timber stall risers. Raised, rendered surrounds to openings.

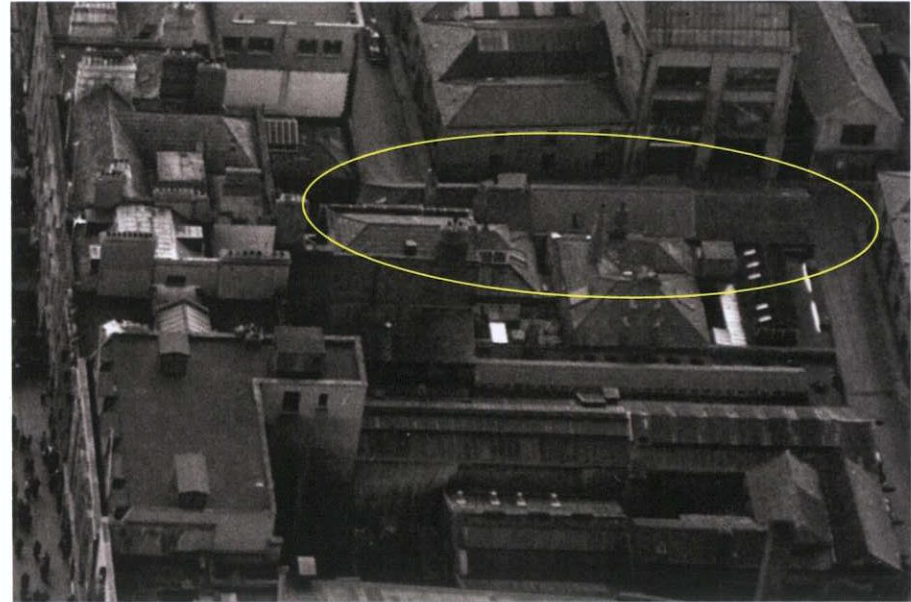
Figure 1: Aerial view showing roofs of 60a, 61a and 62a O'Connell Street Upper, 1959
(National Library of Ireland, Morgan collection)

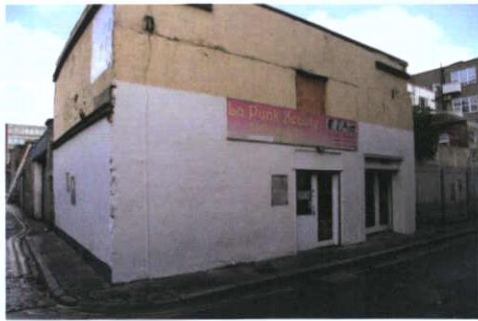
Plate 2: South elevation

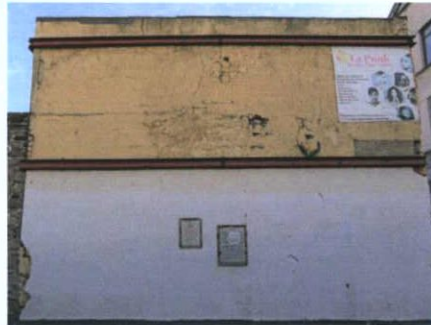
Plate 3: West elevation; former cruciform ventilation opening to high level

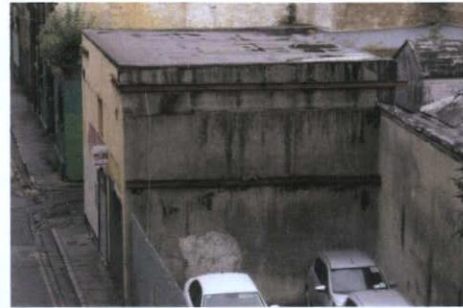
Plate 4: East elevation

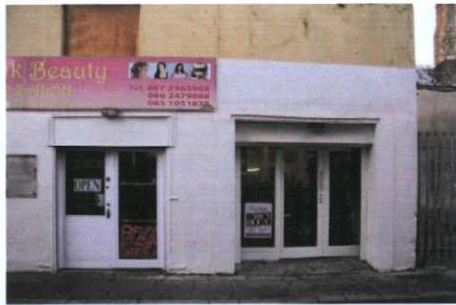
Plate 6: Possible former carriage opening to east (right)

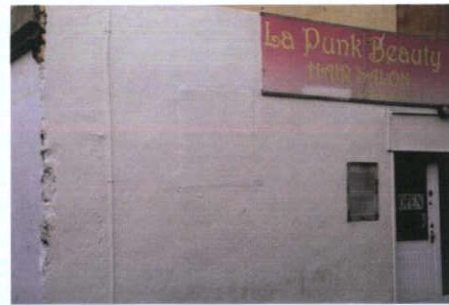
Plate 7: Ghost mark of former window opening

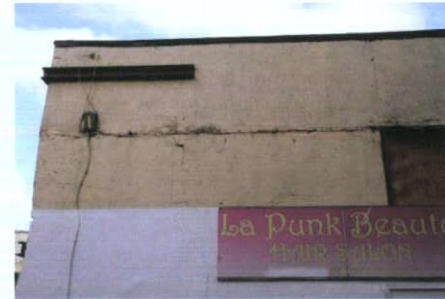
Plate 8: Former slit window, now blocked-up, noted to first floor to south elevation

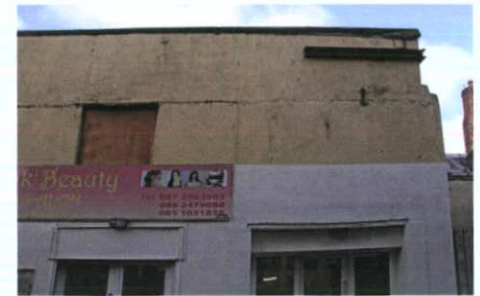
Plate 9: Former slit window, now blocked-up, noted to first floor to south elevation

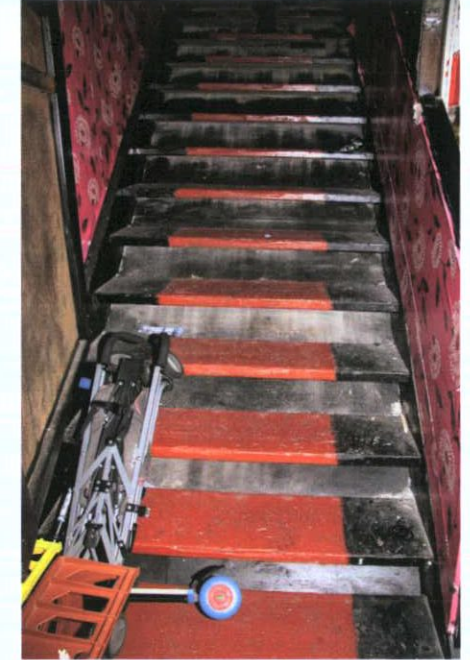
Plate 17: G-3 – Staircase to first floor

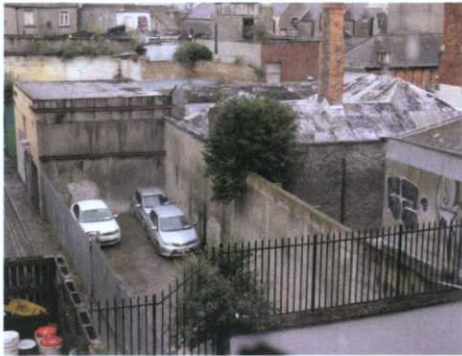
The site of numbers 61a and 62a O'Connell Street Upper lies on the northern side of Henry Place. The site is bounded to the south, on the street frontage, by a steel palisade fence. The site is enclosed to the west by the end wall of number 60a, to the north partly by the southern wall of the reading room and another building at the rear of 59 O'Connell Street Upper and partly by a concrete block wall. The eastern end is separated from the rear of number 60 O'Connell Street Upper by a high concrete wall topped with a steel railing. The site is paved with concrete.

Plate 26: View of site from the east

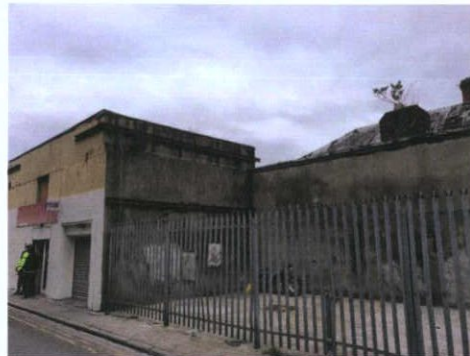
Plate 27: Site of 61a O'Connell Street Upper

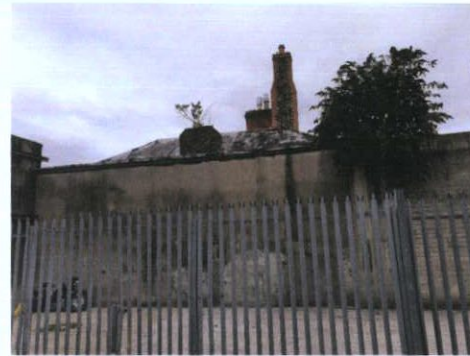
Plate 28: Centre of site

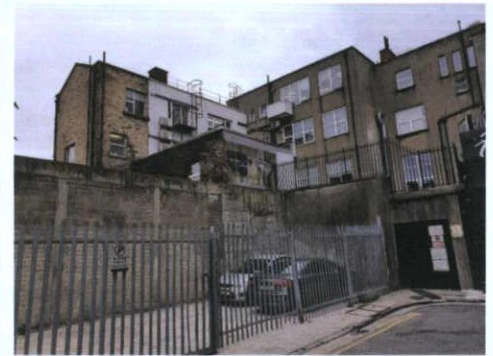
Plate 29: Site of 62a O'Connell Street Upper

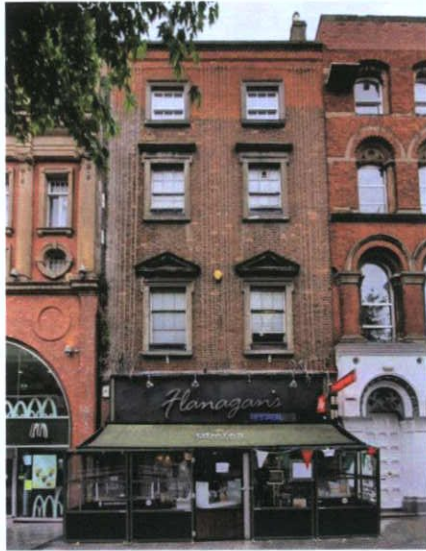
Two-bay, four-storey-over-basement attached building. M-profile roof, having mix of natural and synthetic slate, and lead central and parapet valleys. Rendered chimney stacks to north. Granite copings over rebuilt red brick parapet wall having later dentillated eaves cornice. Rebuilt red brick to third floor. Front (east) façade comprised of red brick laid in Flemish bond. Three-over-six timber sash windows to first floor and six-over-six timber sash windows to second floor, having lugged, Roman cement architraves and hood mouldings, repaired with cement, pedimented to first floor; recent three-over-three timber sash windows to third floor, having moulded cement architraves; granite sills with later rendered finish throughout. Modern shop front.

Plate 2: Front (east) elevation

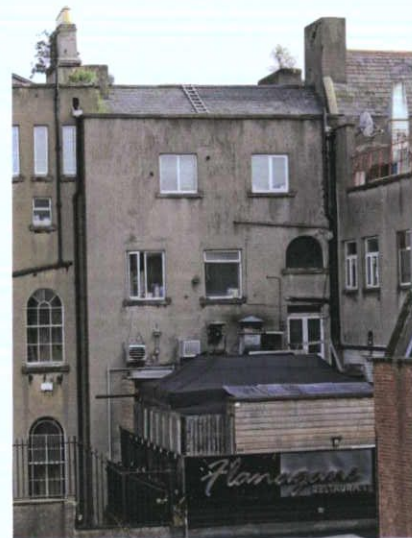
Granite coping over cementitious render to rear (west) elevation. Square-headed window openings with uPVC casement windows throughout. Remnant of original round-headed window to second floor half-landing, with later granite sill and infilled with wired glass. Three-storey extensions to rear, having modern timber and steel cladding and fabric canopy / awning to first floor roof. uPVC rainwater goods.

Plate 7: Rear (west) elevation

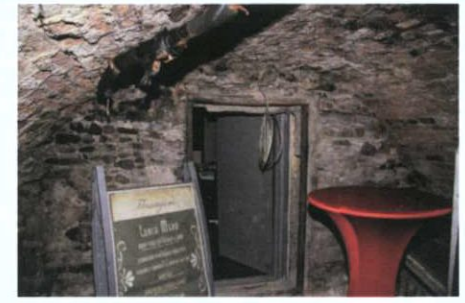
Room B-2: Accessed from Room B-1. Original 18th century cellar. Red brick, barrel-vaulted ceiling, continuous with walls. Circular coal hole opening to centre plan, blocked up above. Low-level, irregularly shaped opening in north wall accessing Room B-3, blocked up to north side. Rubble calp limestone walls to east and west. Square-headed door opening to west, with cut timber door frame; modern steel door. Concrete floor finish. Surface-mounted services.

Plate 11: B-2 - View to west "no 11 photo key".

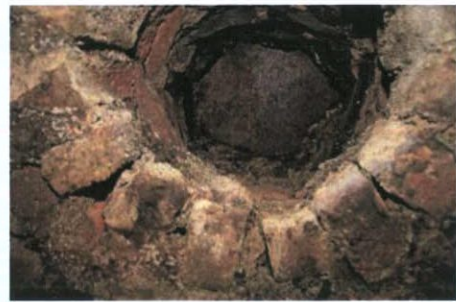
Plate 12: B-2 - Coal hole to soffit of vault

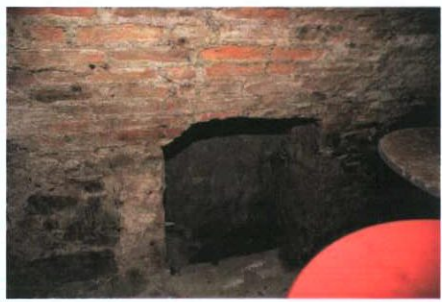
Plate 13: B-2 - View to north towards Room B-3

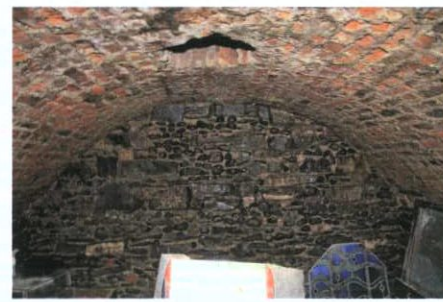
Plate 14: B-3 - View to east

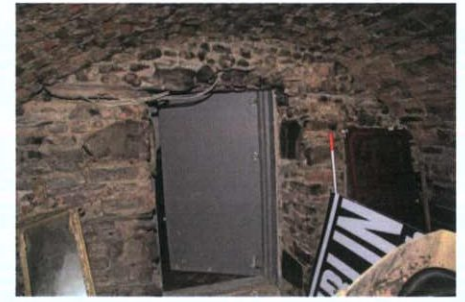
Plate 15: B-3 - View to west

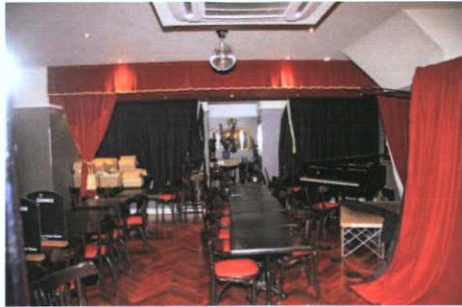
Room B-4: Accessed from Rooms B-1 and B-5. Projecting nibs of former chimney breast retained to north wall. Plasterboard finish to ceiling. Downstand bressummer to centre plan under spine wall on north-south axis, bearing on projecting nibs / piers. Square-section column to south-west supporting ceiling. Downstand building service bulkheads and exposed soffit of rising staircase to south-east; timber stud partition to south enclosing stairwell to ground floor. Plaster finish to walls; some ceramic tile finishes to north-west. Flush timber doors and flat timber architraves, timber skirting boards and carved timber picture rail. Modern parquet timber floor. Modern timber bar and backbar to north-west.

Plate 16: B-4 – View to east
