Appendix 15.13 Building inventory, record and description for

No.60a 60b 60c O'Connell Street Upper

Dublin Central Project – Site 2 & No.61 O'Connell Street Upper

Appendix 15.14 Building inventory, record and description for No.61 O'Connell Street Upper

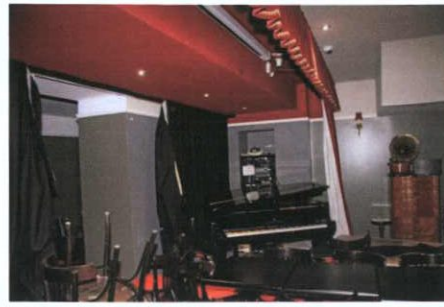
Room B-4: Accessed from Rooms B-1 and B-5. Projecting nibs of former chimney breast retained to north wall. Plasterboard finish to ceiling. Downstand bressummer to centre plan under spine wall on north-south axis, bearing on projecting nibs / piers. Square-section column to south-west supporting ceiling. Downstand building service bulkheads and exposed soffit of rising staircase to south-east; timber stud partition to south enclosing stairwell to ground floor. Plaster finish to walls; some ceramic tile finishes to north-west. Flush timber doors and flat timber architraves, timber skirting boards and carved timber picture rail. Modern parquet timber floor. Modern timber bar and backbar to north-west.

Plate 17: B-4 – View to south-east

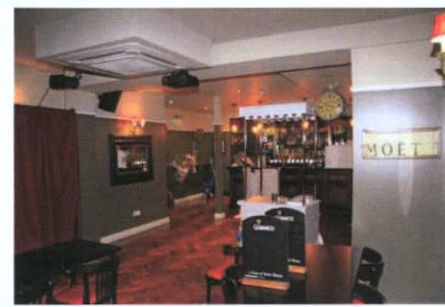
Plate 18: B-4 – View to south-west

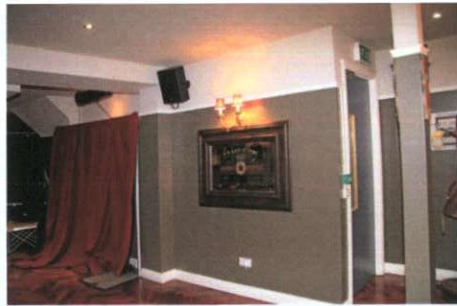
Plate 20: B-4 – View to south-east

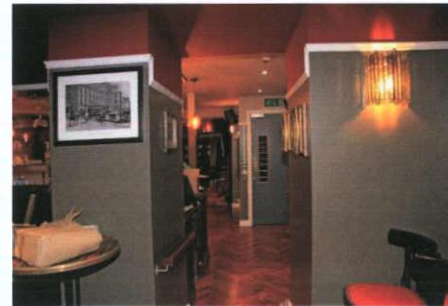
Room B-5: Accessed from Rooms B-4 and B-6. Plasterboard finish to ceiling. Plaster finish to walls; some ceramic tile finishes to north. Square-headed openings in rear elevation of main building former partition to east, leading into Room B-4. Flush timber doors and flat timber architraves, timber skirting boards and carved timber picture rail. Modern parquet timber floor.

Plate 22: B-5 – View to east towards Room B-4

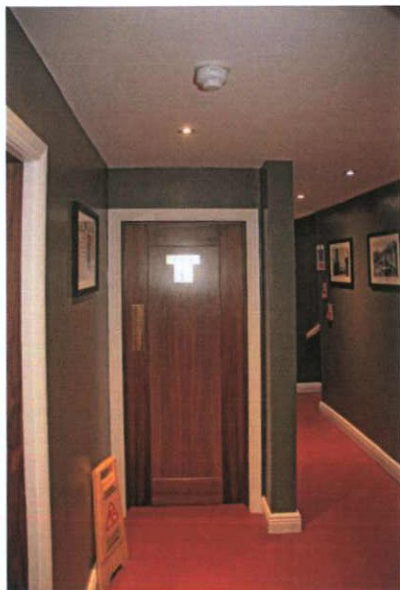
Plate 24: B-6 – View to west

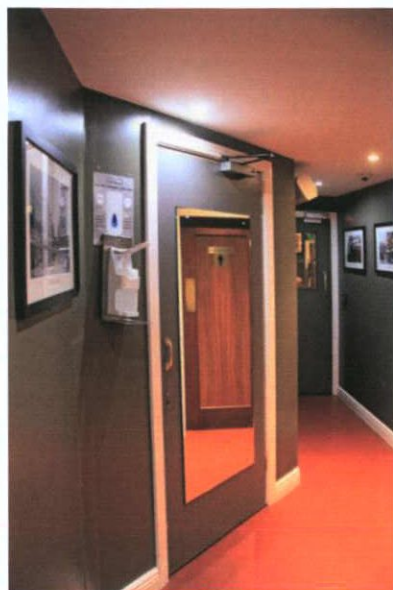
Plate 25: B-6 – View to east

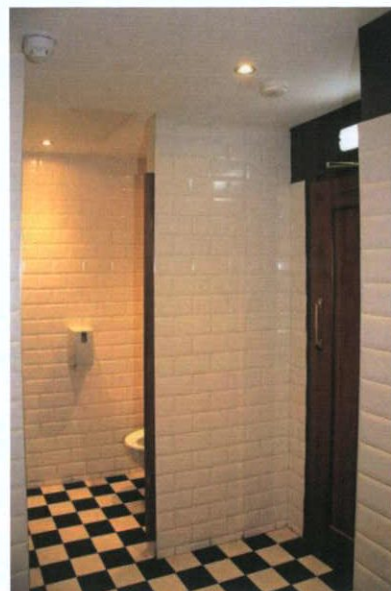
Plate 26: B-7 – View to west

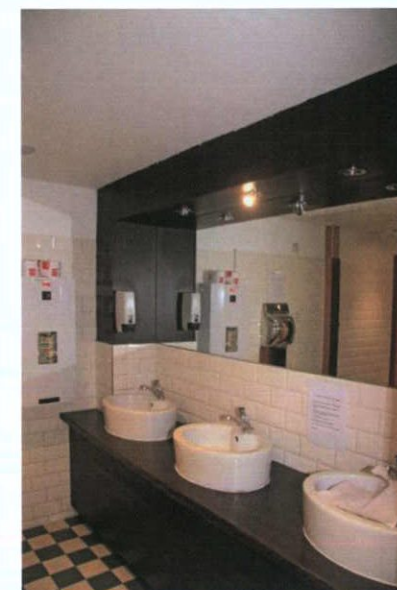
Room B-8: Accessed from Room B-6. Toilet room. Plasterboard finish to ceiling. Ceramic tile finish to walls and timber stud toilet cubicle partitions. Flush timber doors and flat timber architraves. Ceramic tile finish to floor. Sanitaryware throughout.

Plate 27: B-8 – View to west

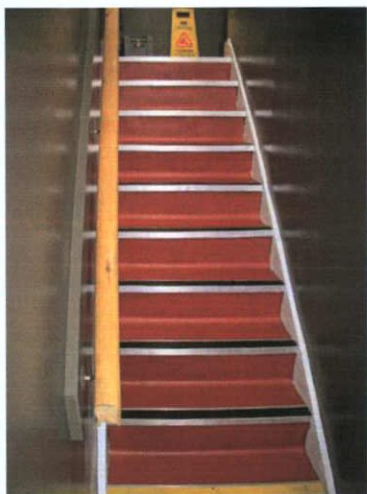
Room B-9: Accessed from Room B-6. Stairwell to ground floor. Straight flight, closed-string staircase having treads and risers with rubber contrast strips, finished with carpet; rectangular-section stringers. Modern carved timber handrail affixed to wall to east. Plasterboard finish to ceiling. Plaster finish to walls. Modern skirting boards to landings having beaded profile. Carpet finish to landings.

Plate 28: B-9 – View to south towards ground floor landing
