APPENDIX 16.1 SUMMARY OF NATIONAL MONUMENTS LEGISLATION

FIGURES

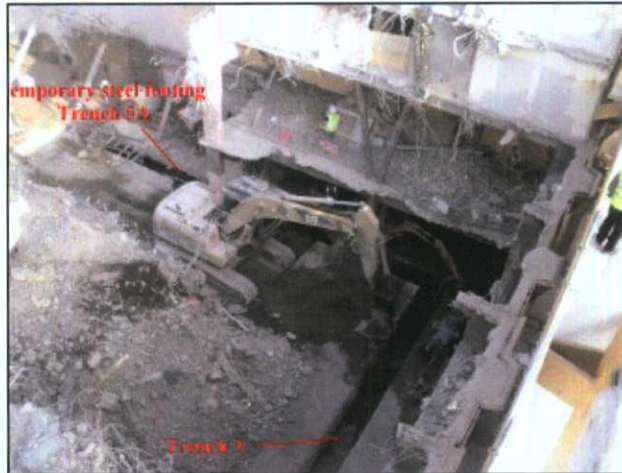
Figure 23 Overview of steel footing trench

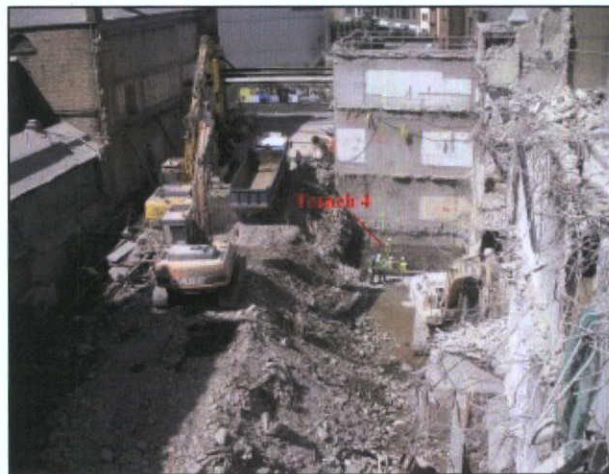
Figure 24 The site from the north, 2009

The monitoring programme established that the original concrete floor of the basement of the hotel was very substantial and still in position, made of reinforced concrete and measuring over 1m in depth (Figs 24-26). This basement was cut into deep gravel and silt deposits, presumably originally riverine deposits associated with the River Liffey, before it was reclaimed between 1678 and 1728. The gravels were carefully examined but no archaeological features or artefacts found. In April 2009, three (nos 1-3) additional engineering test-trenches were excavated in the basement area of no. 40 and this was followed in May, after the complete demolition of the hotel (nos 40-41), by the casting of a temporary crane base (no. 4) (Fig. 27). In early June, the remaining trenches (nos 5-9) were excavated, with most of the excavation works taking place in the eastern half of the site close to the O'Connell street frontage. The basement floor slab was located at approximately 3m below (2.40m O.D) below present road level of O'Connell Street (5.40m O.D.).

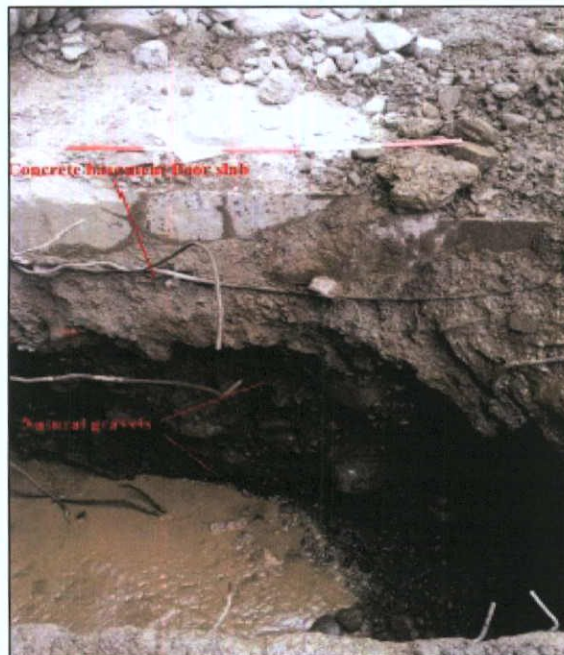
Figure 25 Trench B, concrete and natural gravels

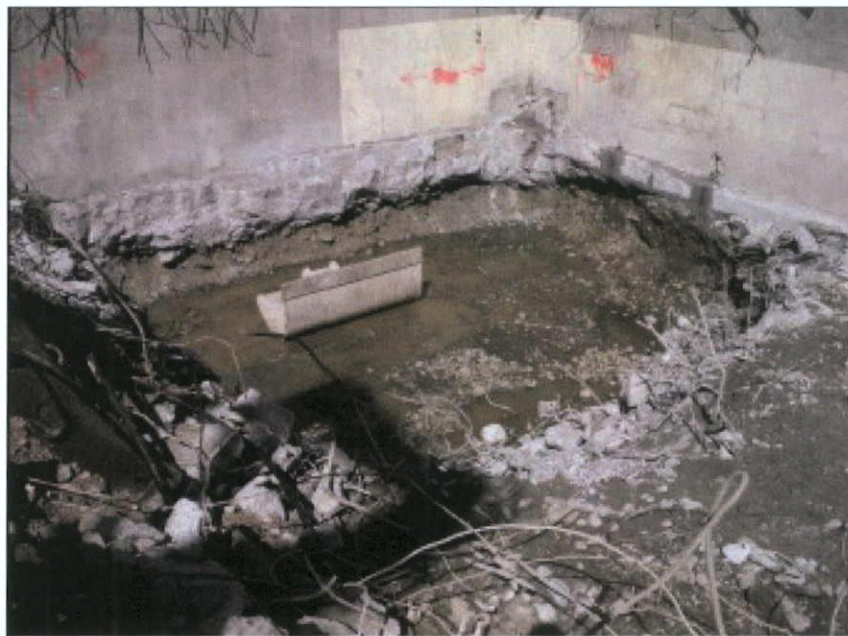
Figure 27 Trench 4, temporary crane base

- 1.10. In the site under discussion, five trenches were attempted in Site A but each established the presence of a very deep slab, which was impossible to remove, as there were two layers of concrete, sitting over reinforced concrete. While two layers of concrete were removed as this part of the works using a breaker, the third layer could not be removed because of vibrations caused in close proximity to the Protected Structure, no. 42 O'Connell Street. These concrete surfaces are associated with the recently demolished hotel and the enabling works carried out at this time, in 2009. Thus, the depth of the surfaces is known to be up to 1m in depth, sitting over natural coarse gravels. The investigations also located the temporary crane base put in in 2009, in the central area of the site on the northern side.
