9. Gardens, Landscape and the Surface of the Public Realm

Appendix A4 The Urban Battlefield

A4.5.2 Damage to building fabric during and in the aftermath of the Easter Rising 1916

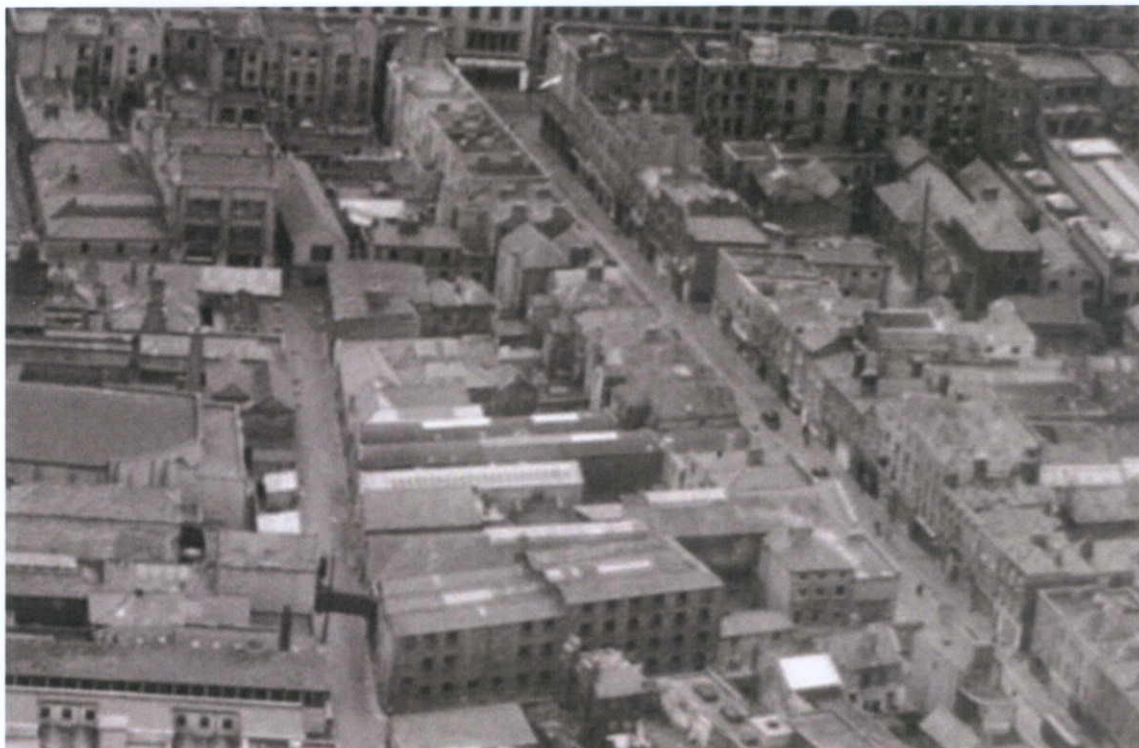
Figure 8.11 Looking south over Moore Street on the right and Moore Lane to the left, 1949. (Britain from Above ref. XAW027121)

Behind Moore Street the plots had been filled with buildings, warehouses and other supports for the enterprises. (Figure 8.11) Where the urban block is widest (bottom centre of the photograph), there were supporting industries for the commercial activity on O'Connell Street. Prominent are the three- and four-storey buildings onto O'Rahilly Parade and one-time printers and bookbinders serving the publisher, Gill's. The properties on Moore Street were rebuilt or adjusted to support the retail and wholesale activities. (Figures 8.10 & 8.12) Independent industries emerged around the junction of Moore Lane and Henry Place, taking up some of the depth of the Moore Street plots. (Figure 8.13 & 8.14)

O'Rahilly Parade (previously Sackville Lane) had been bounded with substantial industrial buildings until the 1970s. (Figures 8.11 & 8.21) Today, a single building occupies the north side of O'Rahilly Parade; the all-but-blank bulk of the hotel contributes little to the street, instead dominating it. (Figure 8.22) A palisade-fence enclosed yard occupies the south side. The view east along the street is terminated by the rear block of 46 to 49 O'Connell Street. (Figure 8.23)

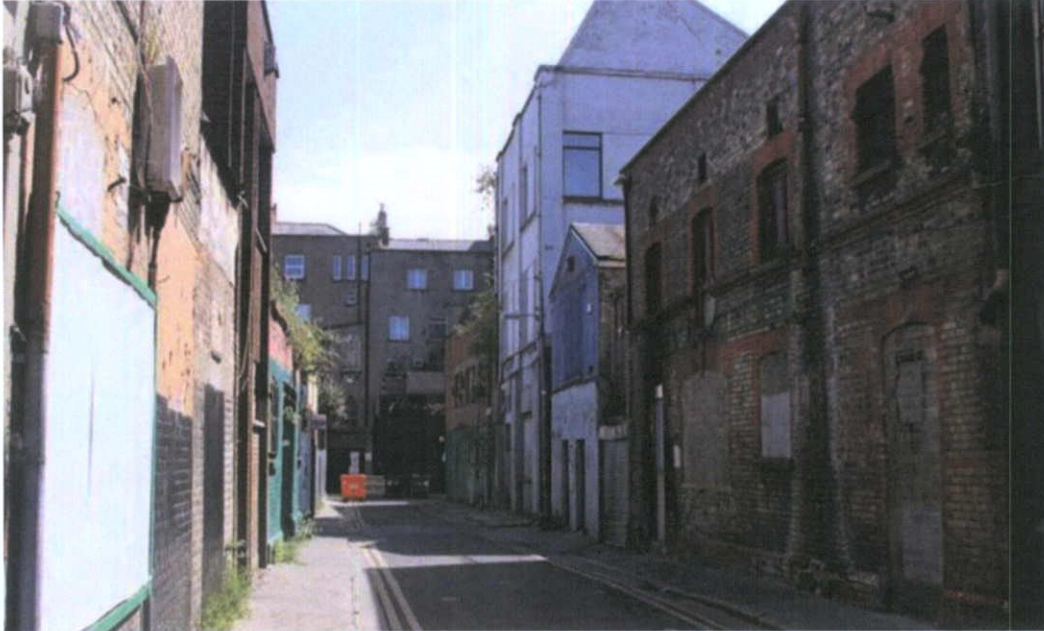
Figure 8.13 Looking east down Henry Place, 2020.

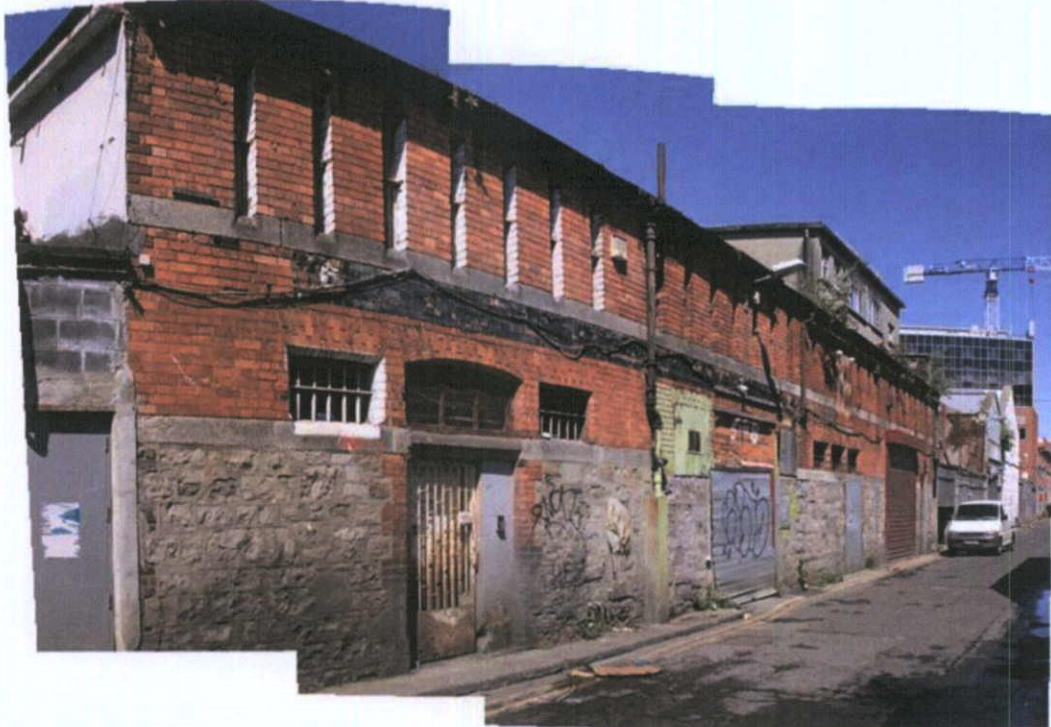
Figure 8.14 Looking north along the west side of Moore Lane, showing the remnants of the commercial buildings developed in the rears of the Moore Street plots. 2020

Today, the east and west sides of Moore Lane consist of remnants of nineteenth-century buildings related to the commercial and institutional transformation of Moore Street and O'Connell Street. Some of the façades and buildings are distinguished but all is overlaid with ad hoc, aggressive security measures. (Figures 8.14 & 8.20)

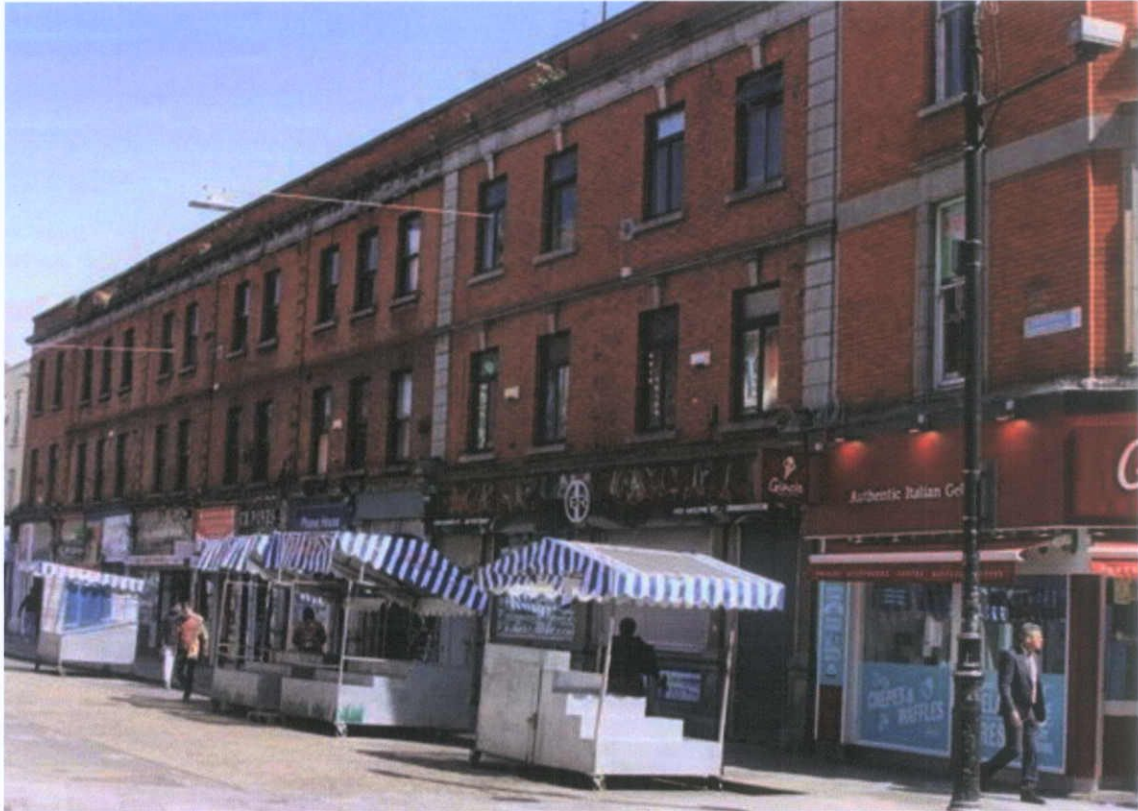
Figure 8.15 Numbers 1 to 7 Moore Street, 2020

Numbers 1 to 7 Moore Street were destroyed in 1916. Their rebuilding as a co-ordinated terrace relates to the rebuilding of the section of Henry Street round the corner. (Figure 8.15) After the corner plot, the terrace along Moore Street picks up some of the language of the Henry Street facades, initially with stone articulation and then continues in a modest fashion in brick and minimal stone detail from numbers 1 through 6. The ground floor shop/pub fronts also reflect this gradation, changing from the elaborate pub façade at numbers 1 & 2 with polished granite pilasters, to the limestone framing of the archway into the court and stone beyond, now painted and obscured.

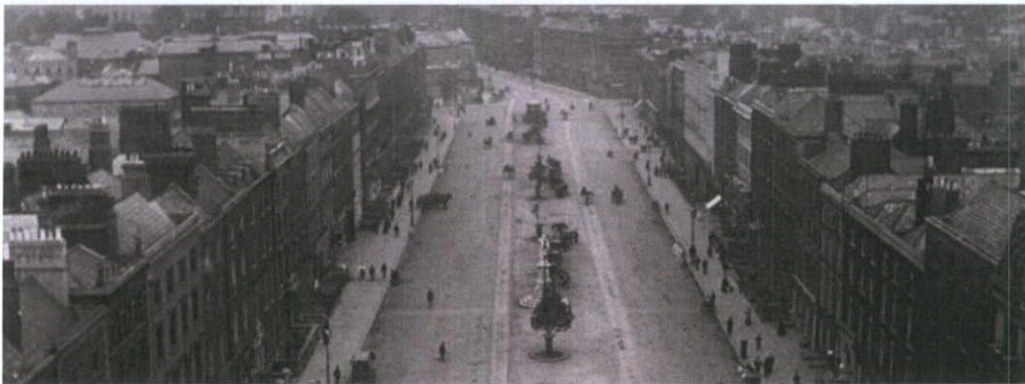
Figure 9.9 Late nineteenth-century photograph, (after 1894 and before 1898), showing the appearance of trees in the centre of Sackville Street Upper. (IAA) (This photograph shows no gantries for the electrification of the trams, which began in Sackville Street in 1898.)

inside instead of, as now, outside the kerbstone.”²³ Although these conditions were removed, still nothing appears to have been done. The original planting was located in the street to avoid the vaults under the pavement. In 1884, the Council again resolved to replant Sackville Street and in 1894 a limited planting of a variety of species was to be carried out to determine which fared best in the urban environment.²⁴ Many the late-nineteenth century photographs of Sackville Street show soot and/or gypsum crust on buildings, so the concern was justified. Late-nineteenth and early twentieth century photographs reveal very few trees down the centre of the street, and these mostly, if not wholly on Sackville/O’Connell Street Upper, seemingly planted in the 1890s. (Figures 9.8, 9.9, 9.10 & 9.11) Over a century was to lapse before the pavements were widened and the street was lined with trees.

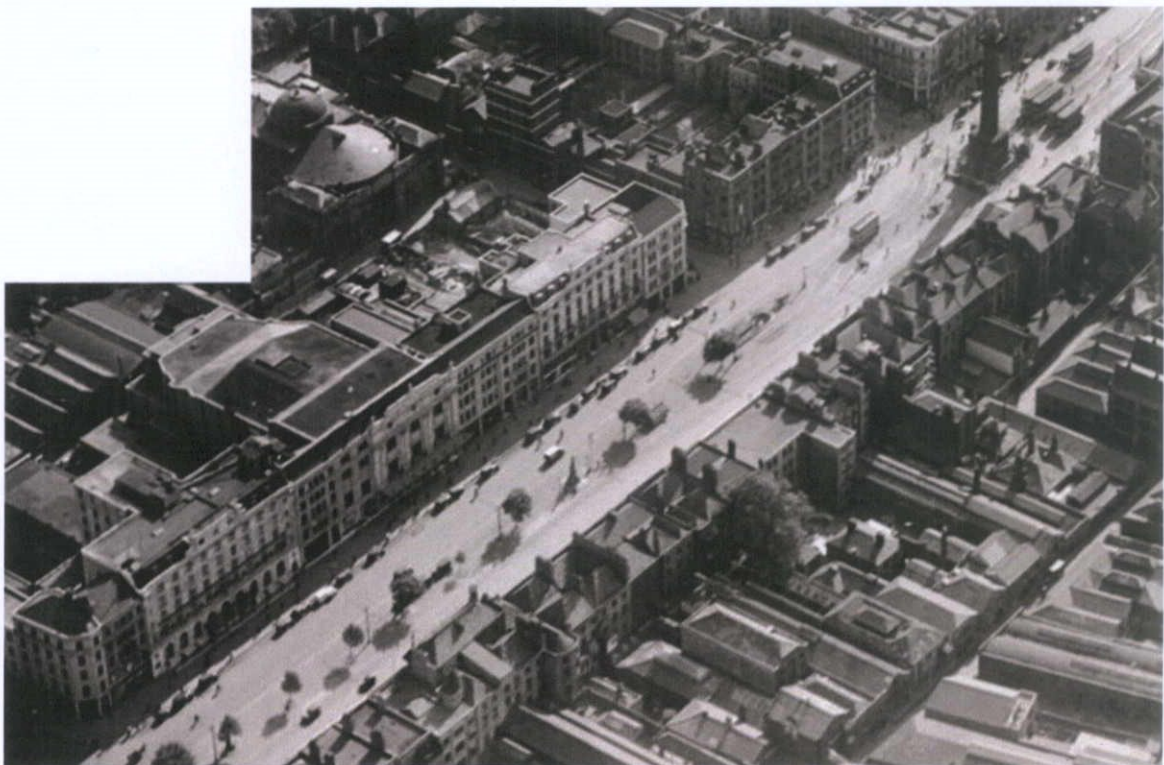
Figure 9.11 1933: The trees are on O'Connell Street Upper only. There appears to have been some recent replacements. Note also the sole, overgrown surviving tree in a garden on the west side. (Britain from Above, photograph ref XPW043448).

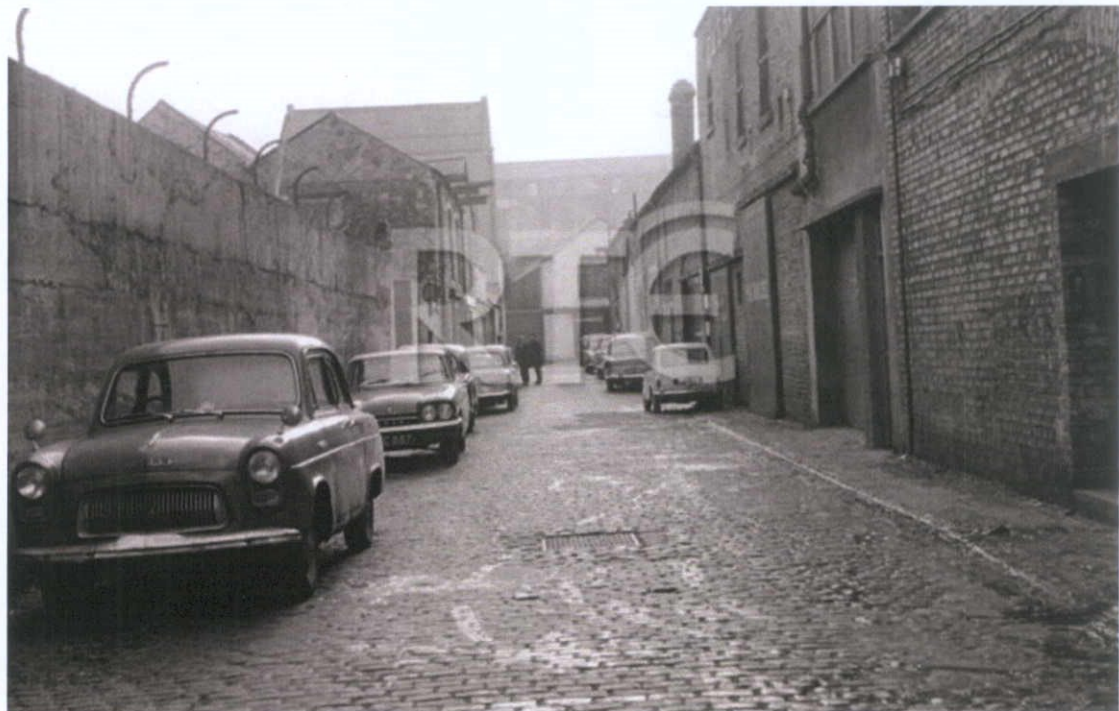
Figure 9.14 Looking south down Moore lane paved with setts and grade to drain to gutters either side. (RTE Archive)

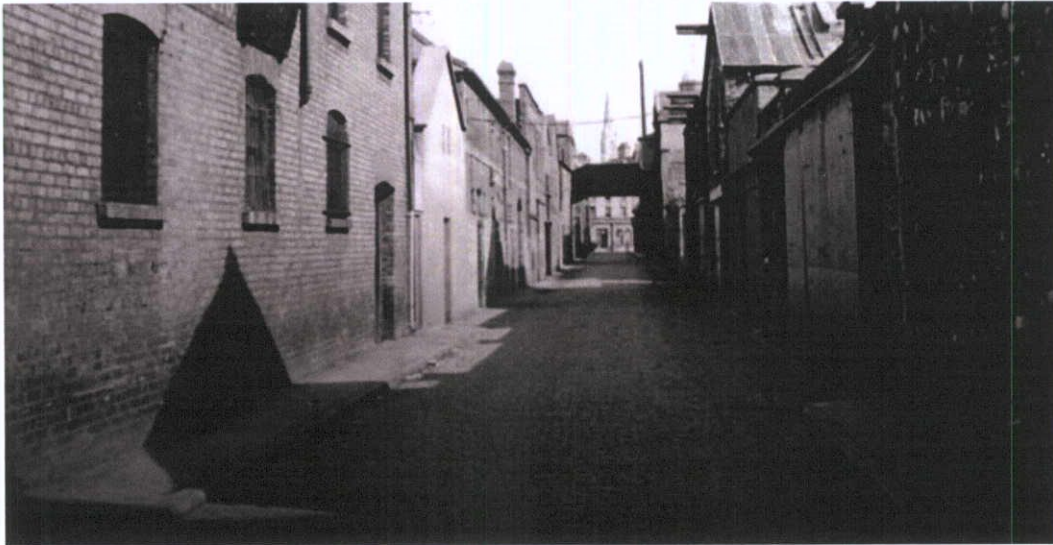
Figure 9.15 Looking north along Moore Lane with short stretches of kerbed paving on either side. 1952 (Military Archive)

elbow of the lane on the north side. By 1891, pavements were complete in Henry Place and may have been present all the way down both sides of Moore Lane to join up with those at the junction with Sackville Lane (now O'Rahilly Parade) and beyond. (Figures 9.13 & 14) However this stretch may have existed as a gully now that the lane had been regraded to drain to each side. At the Henry Place end of Moore Lane there is a short run of pavement still extant but from there to O'Rahilly Parade the lane is without pavements. (Figures 15 & 16)

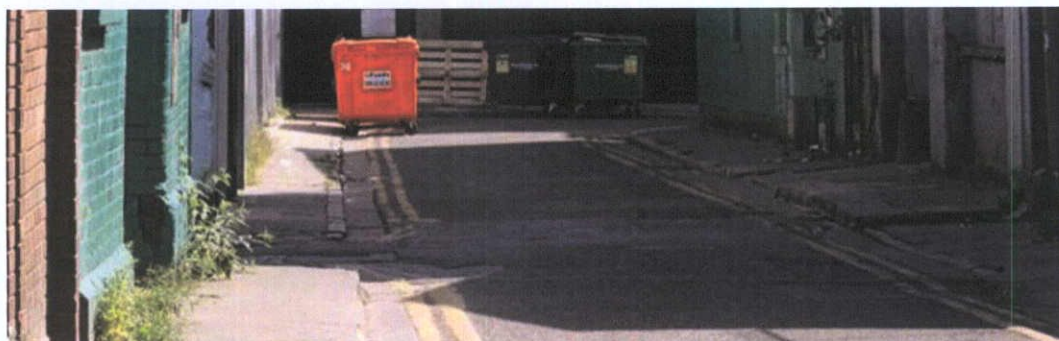
there may be surviving fragments of stone sets in the roadway of Moore Lane and on Henry Place there are stretches of pavements with their kerbs, although some granite kerbstones vary in width. (Figure 9.17)

Figure 9.17 Henry Place some surviving sections of pavement. A section on the right has larger width granite kerbstones. 2020

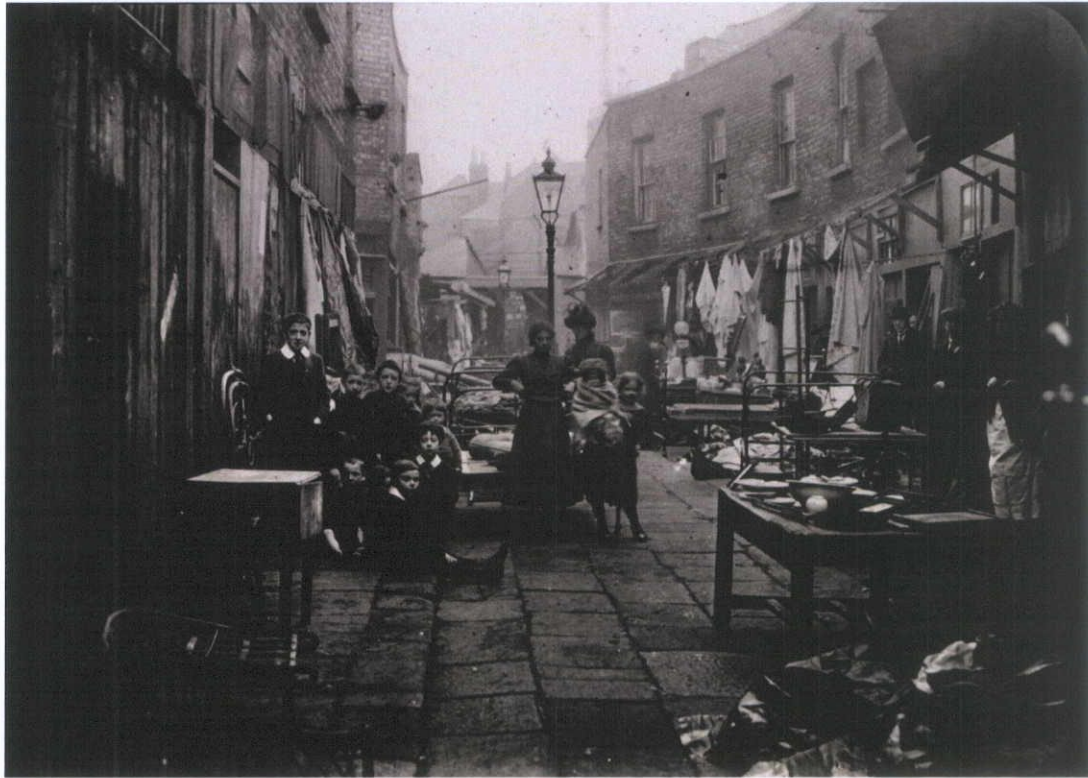
Figure 9.18 Anglesea Market completely paved with stone flags, c.1910. (RSAI)

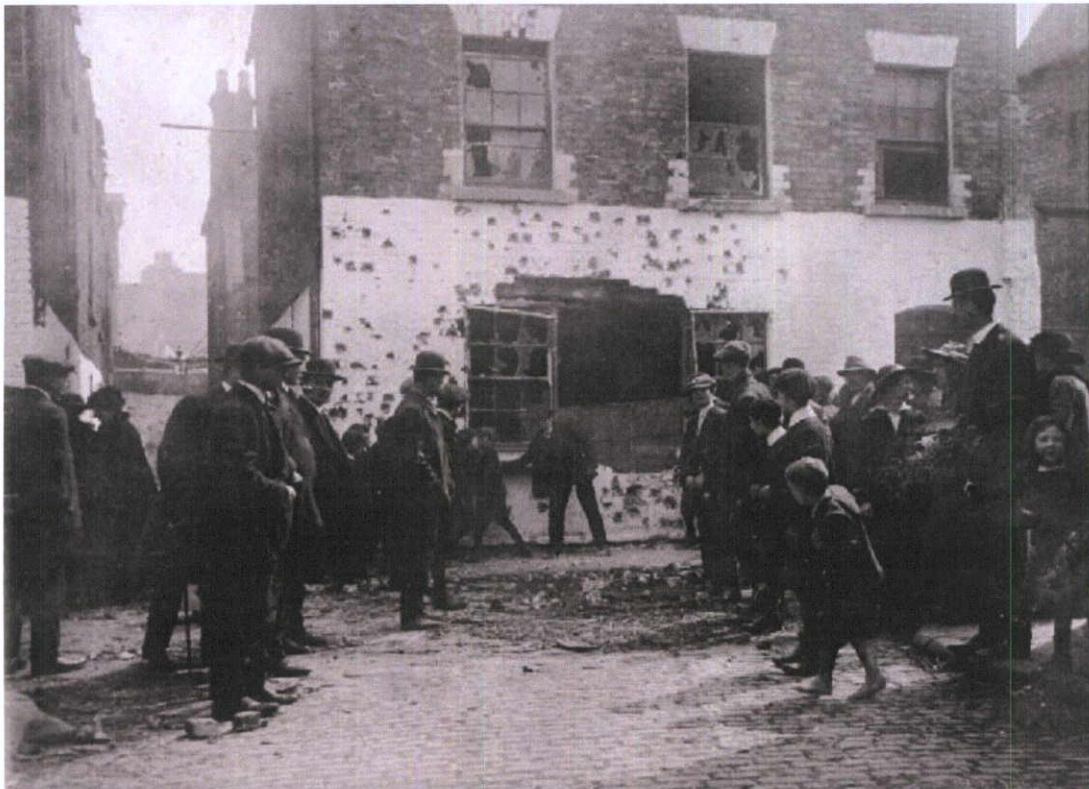
Figure 10.2 The 'White House', No. 10 Henry Place, showing bullet marks in that part of the elevation that was exposed to fire power from within and beyond Moore Place. (Military Archive)

The almost iconic photograph of the so-called White House, No. 10 Henry Place, shows the consequences of the three-dimensional landscape of the battlefield. (Figures 10.1, 10.2 & 10.3) That part of the elevation that was exposed to fire power from within and beyond Moore Lane is pock-marked with bullet marks. There is a distinct absence of bullet damage on the right-hand side of the elevation, being outside the line of sight along Moore Lane and hence, beyond the narrow tunnel of exposure to distance rifle fire. To the left in the image is Moore Place, its entrance just in sight along Moore Lane, but at an angle to the line of Moore Lane. However, fire entering the court would have ricocheted to reach the end wall.

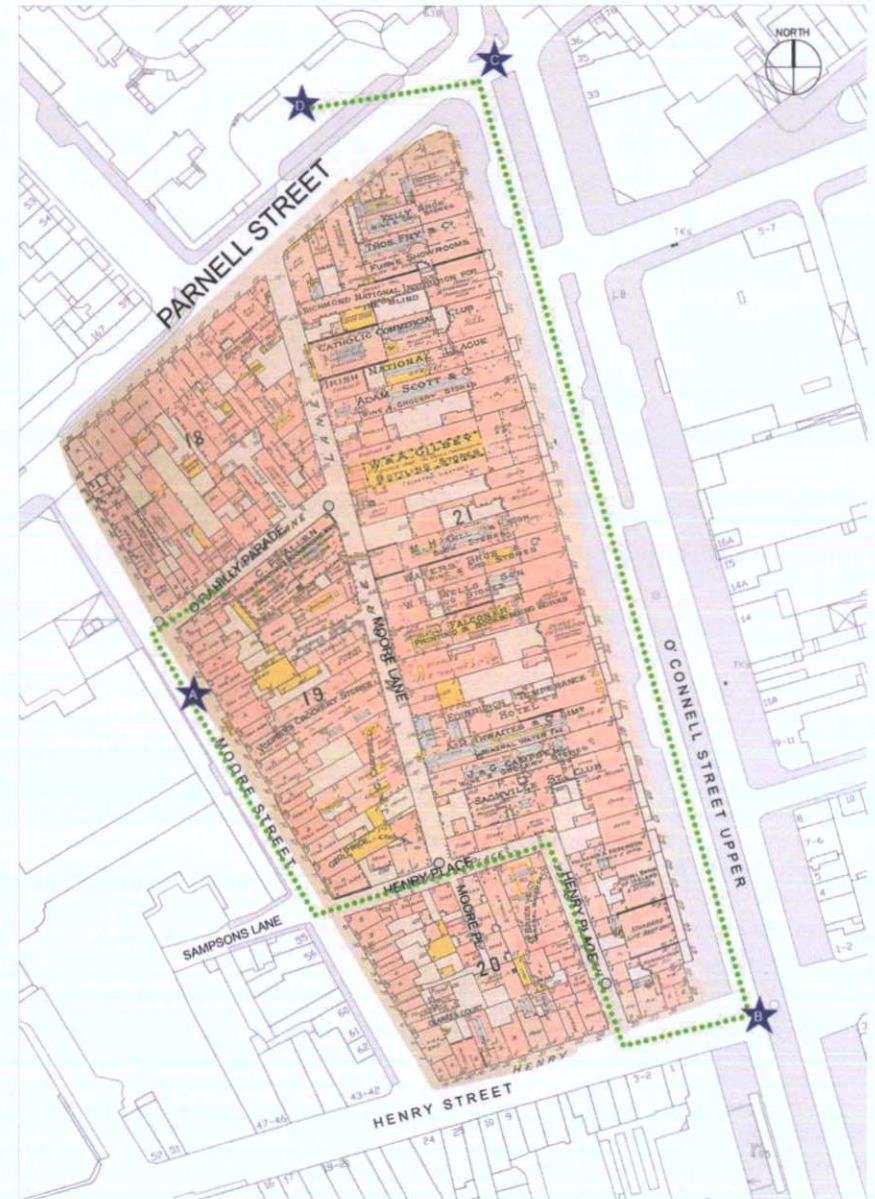
Fig. 3 Route taken by the volunteers post surrender, as described in the witness statements in the Military Archive

The Republican forces were corralled down Moore Street, into Henry Place, out onto Henry Street and instructed to lay their arms at the foot of the Parnell Monument on Sackville Street (O'Connell Street). The prisoners then spent the night in the open on the grounds of the Rotunda Hospital.

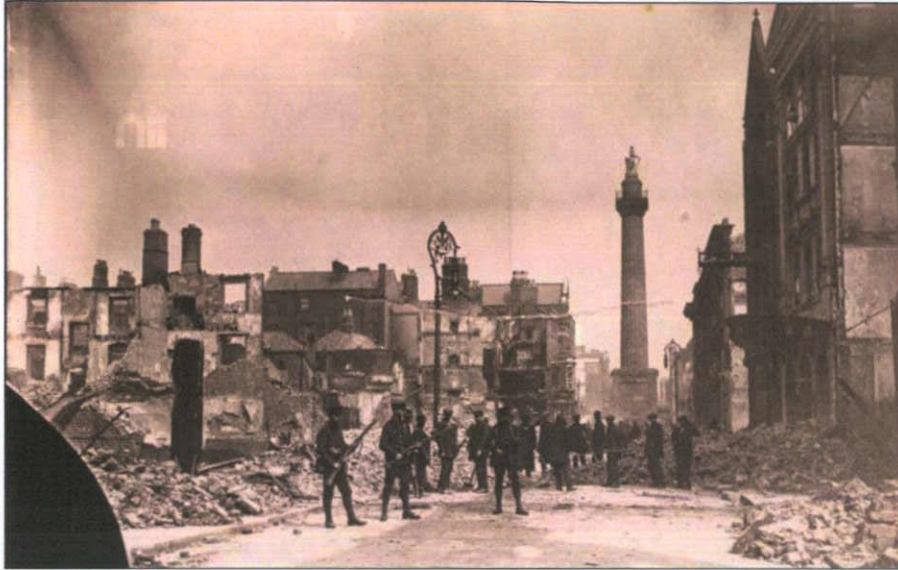
P 7 Destroyed buildings at the junction of Henry Street and Moore Street, looking towards Nelson's Pillar 1916, Source: National Library of Ireland.

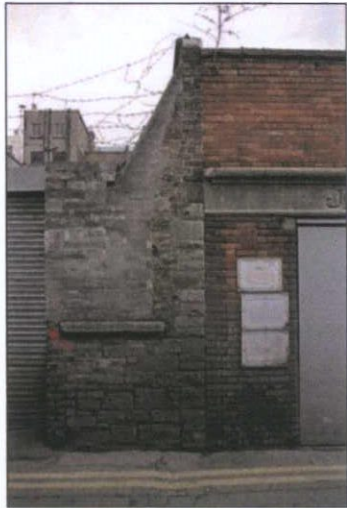
P 12 Evidence of possible bullet damage at rear of 57 O'Connell Street Upper

(Possibly) bullet damaged brickwork on Moore Lane is thus far the sole surviving evidence of conflict found in the public realm. The Myles report identifies the rear of 63 O'Connell Street as the location. A photograph of the fractured brick suggests that this is actually the rear of No 57 O'Connell Street.

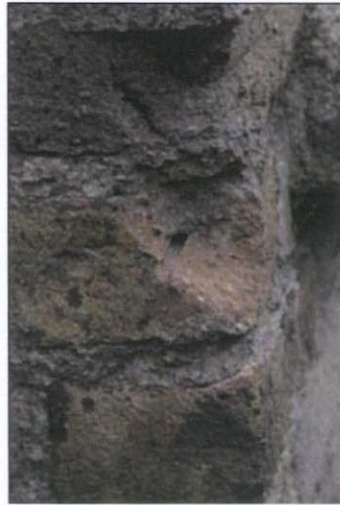
P 13 Possible bullet damage at rear of 57 O'Connell Street Upper

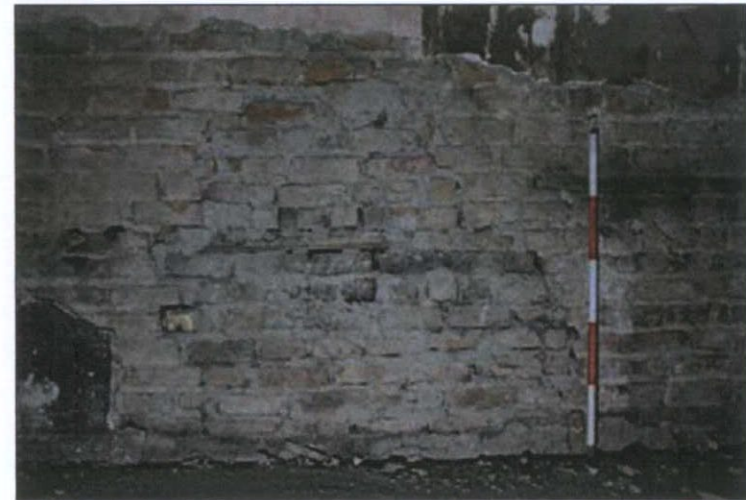
P 14 Infilled opening recorded in 10 Moore Street, Extract: Myles Report.

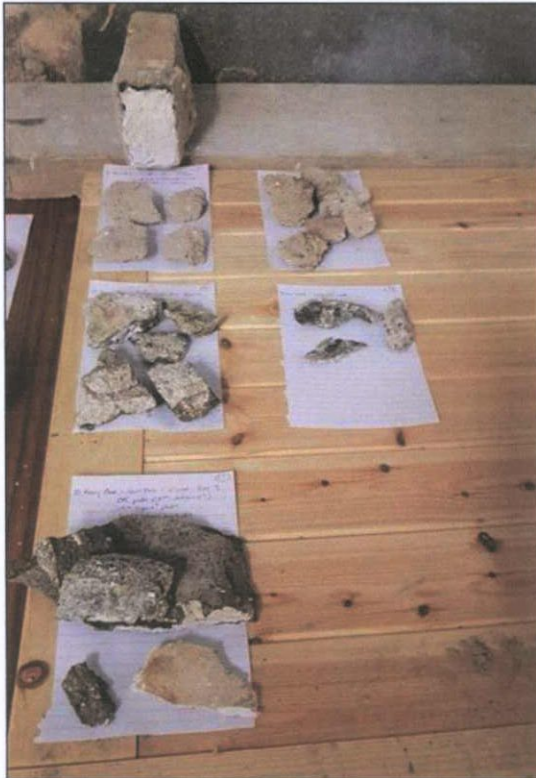
P 19 Samples of mortar collected on site by Dr. Jason Bolton for analysis.

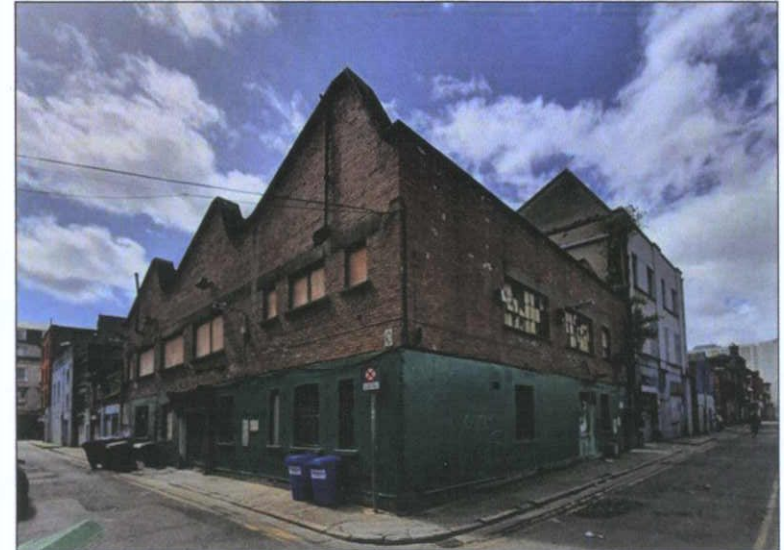
P 20 Exterior of 5-8 Henry Place, the site of the O'Brien's Mineral Waters at the bend in Henry Place.

O'Brien's Mineral Waters premises was broken into by the Volunteers, to find material to form a barricade across the south end of Moore Lane to provide cover from the fire from crown forces. The witness statements recount attempts to forcibly enter the locked building.⁹ Harry Coyle died just outside, and a number of Volunteers were wounded outside in Henry Place. Some of the witness statements suggest that he was killed by the accidental discharge of his rifle, Thomas Leahy (W.S.660), stated that Coyle was killed by a sniper's bullet while trying to open the side door of a shop on the lane.

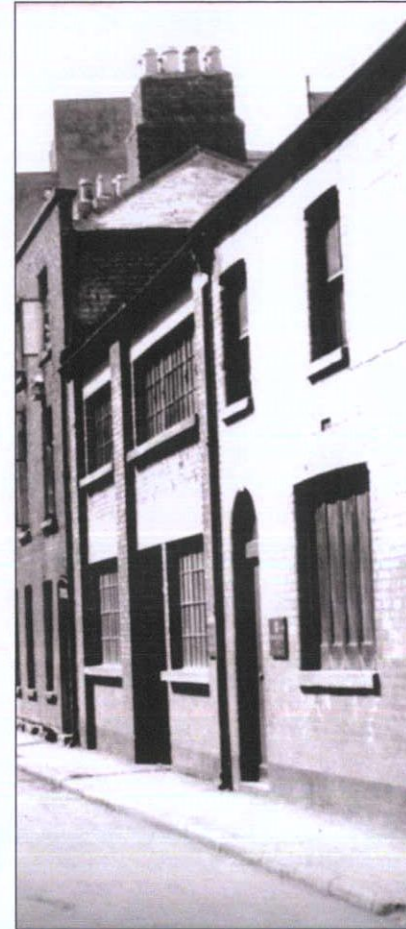
P 21 Eastern façade of 6-8 Henry Place, 1952, depicting lower floor and arched headed doorway which survives, though blocked up. Source: Military Archives.

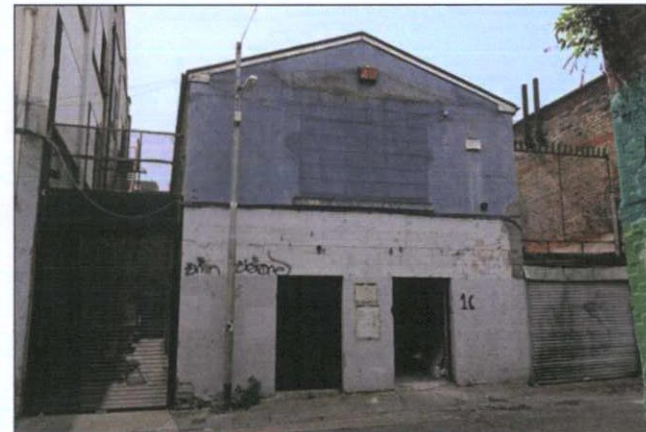
P 23 Northern façade of 10 Henry Place, facing Moore Lane. (2020)

The 'White House' is generally understood to refer to 10 Henry Place, positioned on the south side of Henry Place, facing onto the junction at Moore lane. One of the Volunteers, Joseph Good, describes firing from the White House preventing the group advancing from Henry Place. He believed it to be occupied by the Republican forces, firing at them in error. When O'Rahilly left to assemble his group he initially wondered if he was intending to charge the White House. After O'Rahilly's charge, Good attempted to find a grenade to charge the white house himself but then he returned to Henry Place, by which time the firing from the White House had stopped and he observed Michael Collins assembling a barricade at the end of Moore lane to shelter the passing Volunteers. Collins acted as an aide-de-camp to Plunkett in the GPO. He survived this Rising and became a key figure leading the Irish forces in the War of Independence (1919) and provisional government forces in the Civil War (1922).

At the junction of Henry Place and Moore Lane, there was a house which we called the "White House". It was a small one-storeyed slated house, as far as I remember, and was being hit by machine gun fire and rifle fire from the top of Moore Lane.

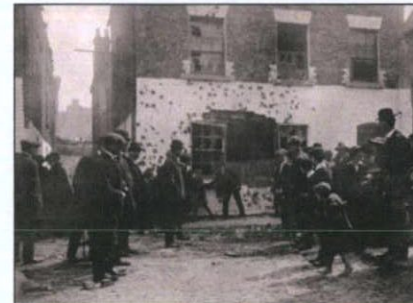
P 24 Unknown Building 1916, thought to be on the site of 10 Henry Place, depicting significant damage from fire on the front.

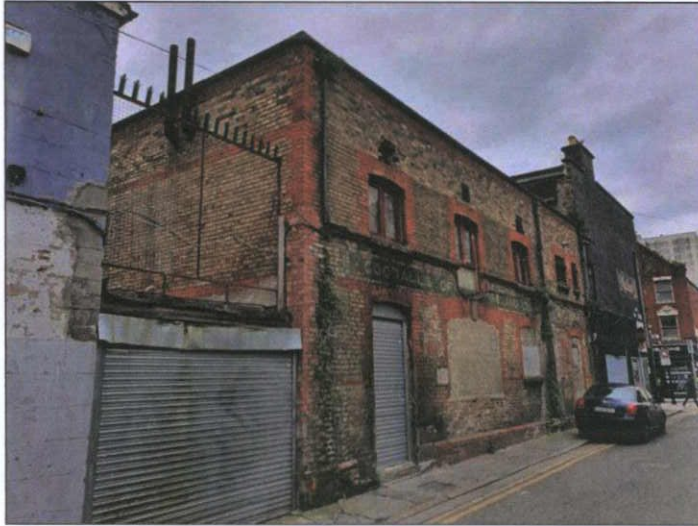
P 27 Henry Place elevation of 11-13 Henry Place.

The lower part of the brick façade on Henry place may predate 1916. 'O'Briens' signage is visible under later Goodall's sign. Goodall's (Ireland) Ltd occupied the site in the 1940s.

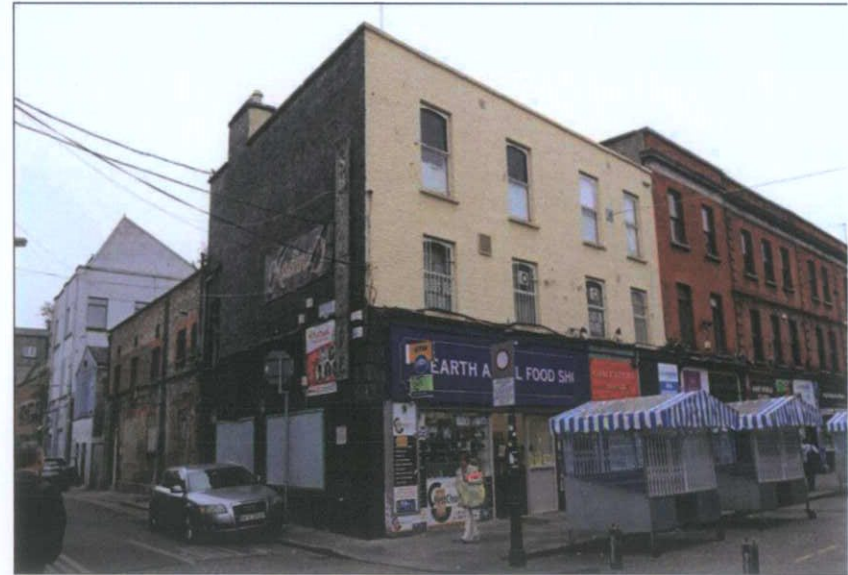
P 29 8-9 Moore Street.

No.9 Moore Street was occupied for a time by a group led by Diarmuid Lynch. There may have been about a dozen men in this group.¹¹ Under Pearse's orders they bored through the walls in the direction of Henry Street, until the fire which had taken hold on the Henry Street buildings became more intense.
