## EIA Chapter 15 Cultural Heritage (Architectural)

Dublin Central Project – Site 2 & No.61 O’Connell Street Upper

**Appendix 15.3** Building inventory, record and description for No.43 O’Connell Street Upper

### 43 O'Connell Street Upper, Dublin 1

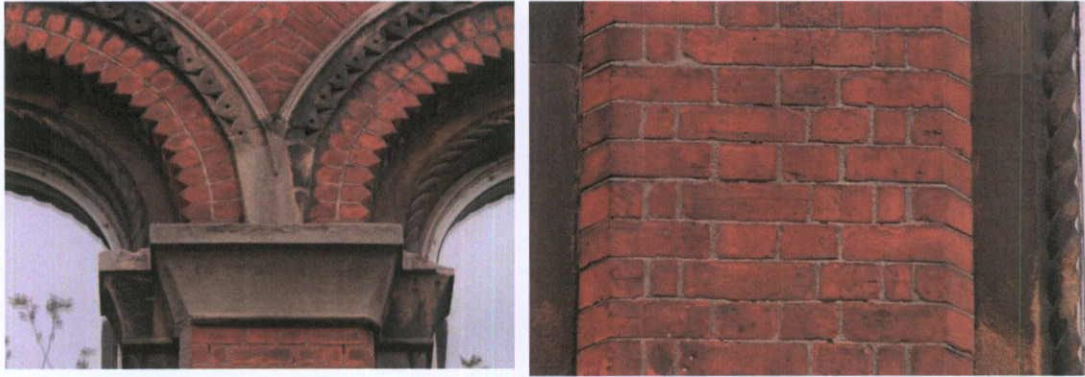
Fig.5.7.2: Mid-nineteenth century Victorian brick and stonework on the façade of 60 O’Connell Street.

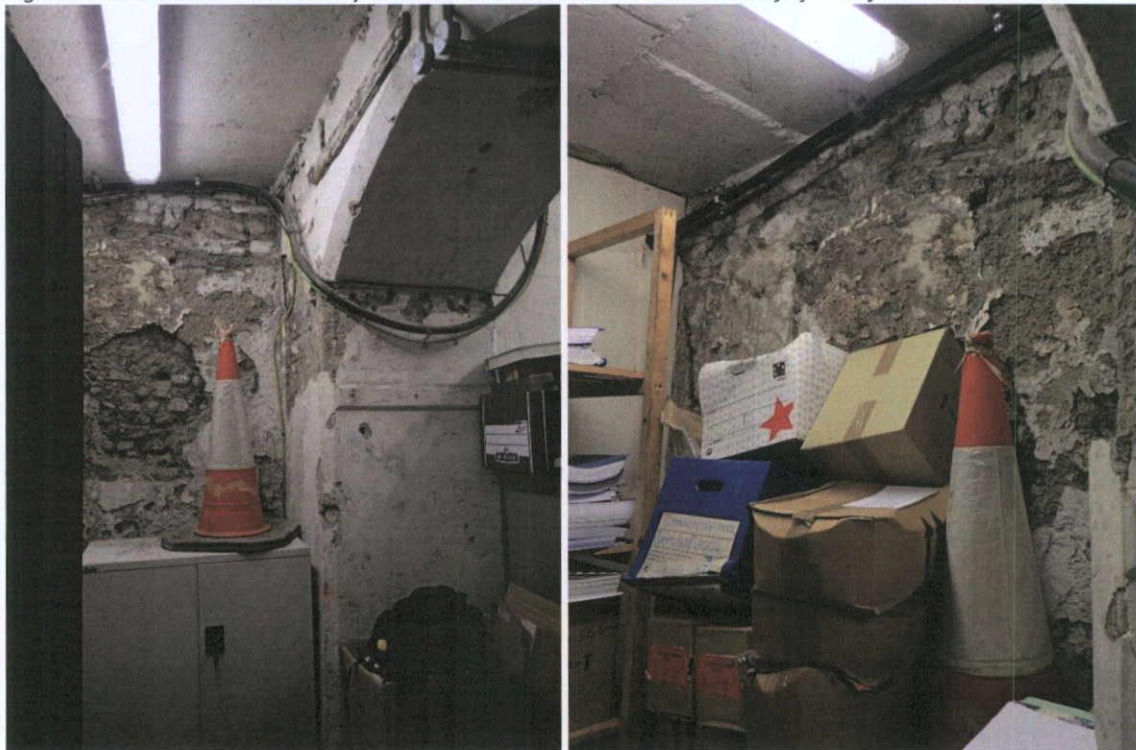
Fig.5.7.3: View of a brick pier at the front of the property at basement level, with a rendered Calp limestone masonry wall.

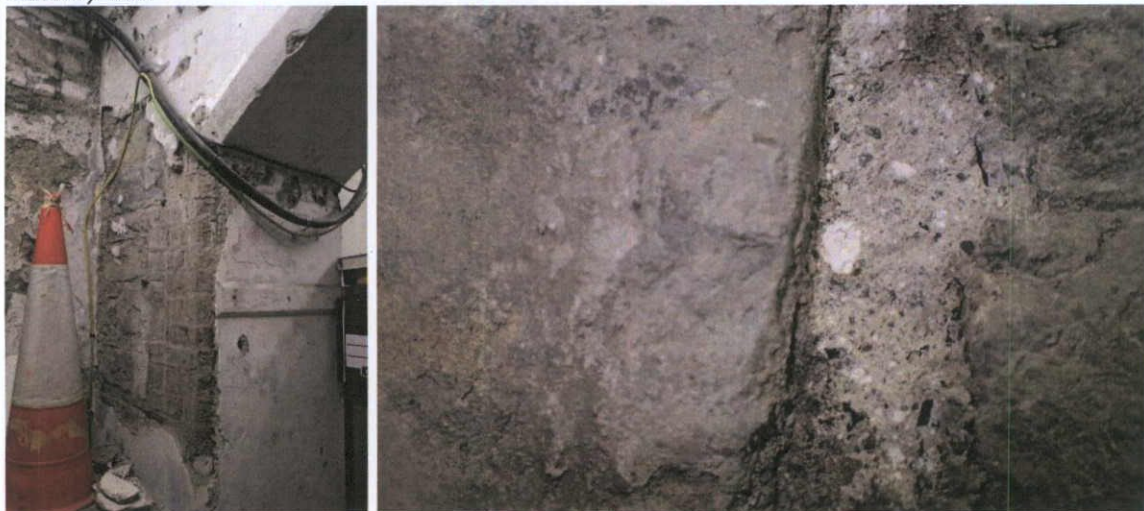
Fig.5.7.4: Detail of a mid-nineteenth century brick arch at basement level of No.60, with sharp limestone sand and coarse lime lumps in the bedding mortar (beneath the Portland Cement pointing).

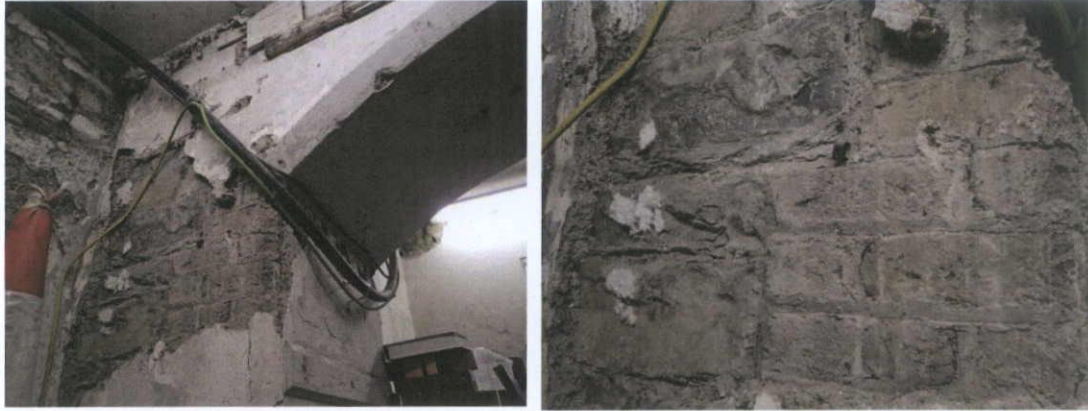
*Fig.5.7.5: The nineteenth century brick arch has been repointed in Portland Cement and painted.*

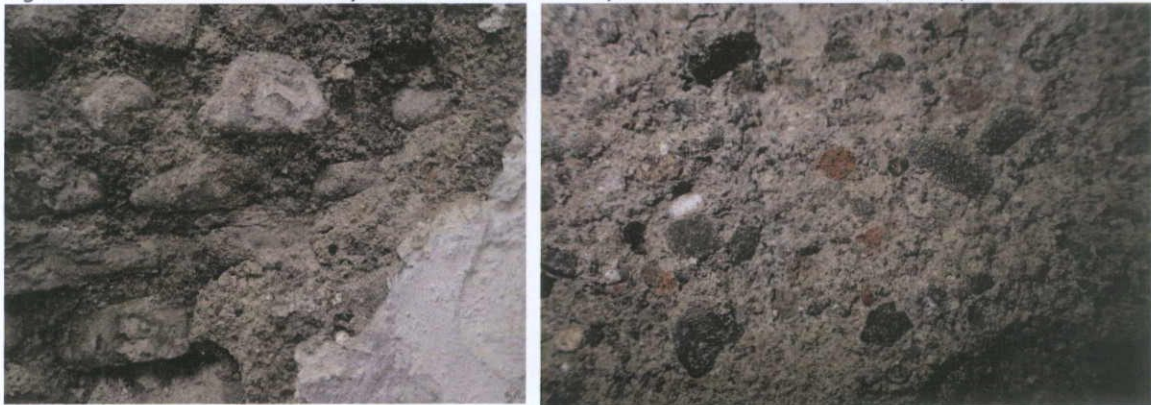
*Fig.5.7.6: The south wall of the basement well is formed from Calp limestone masonry, many of which consist of rounded and sub-rounded cobbles which are indicative of Georgian building. The lime render laid on top of the wall is in poor condition; but contains poorly-sorted predominantly limestone aggregate with large coarse lime lumps and crushed brick and brick dust pozzolan.*

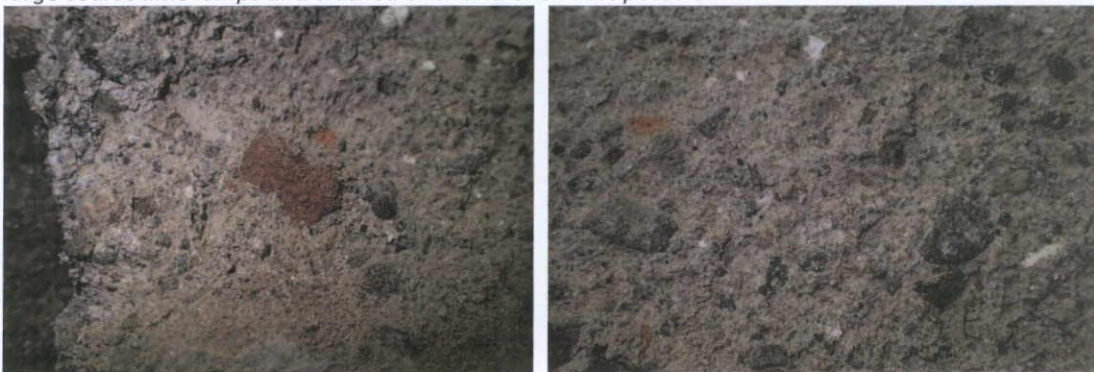
*Fig.5.7.7: Limestone aggregate with large coarse lime lumps and crushed brick and brick dust pozzolan on the lime render over the southern basement Calp limestone wall at the front of the building.*

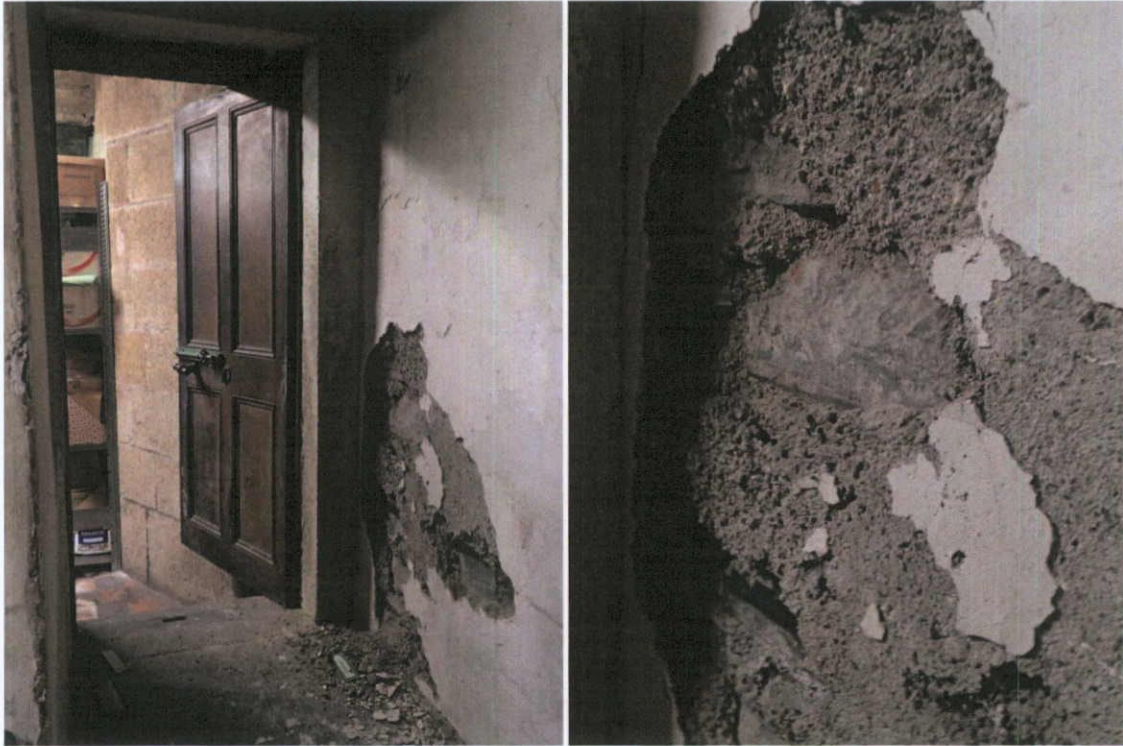
*Fig.5.7.8: Detail of the entrance to the granite-lined strongroom at the rear of the building, and the Calp limestone masonry forming the north wall at basement level (right).*

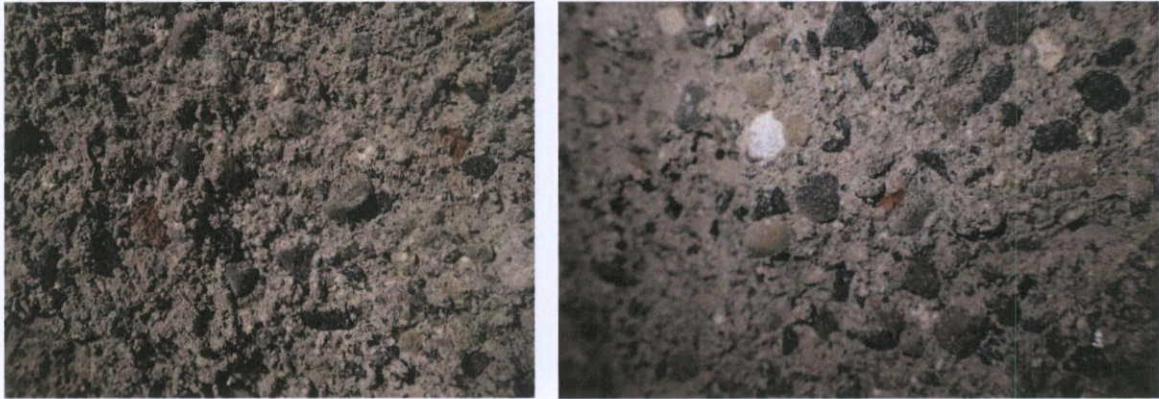
*Fig.5.7.9: The render on the north wall of the building is reasonably similar in texture and composition to that found on the south wall. These may be Georgian period building.*

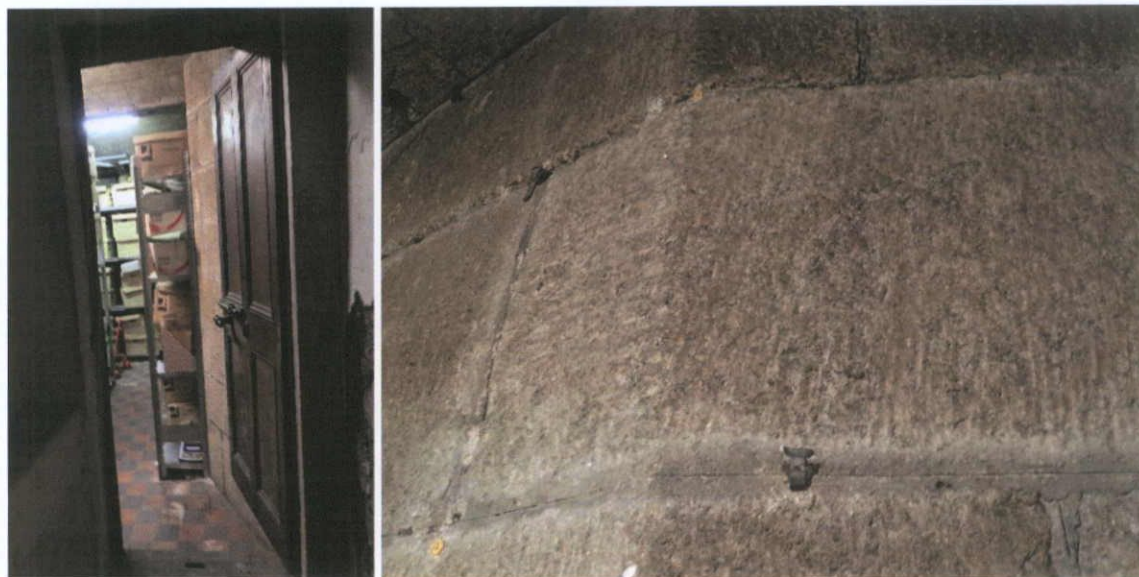
Fig.5.7.10: The strong room is lined with granite laid in a lime putty mortar, and pointed with a Portland Cement-based mortar with an incised line.

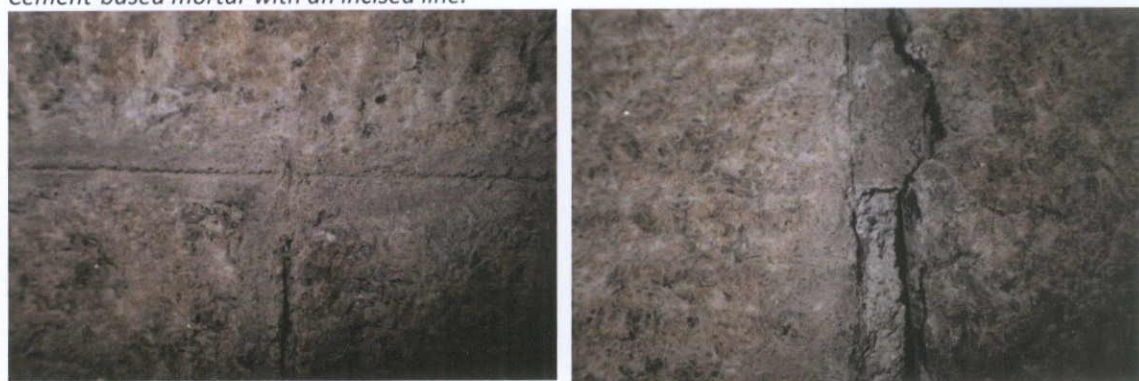
Fig.5.7.11: Detail of the joints of the granite ashlar in the strong room showing the lime bedding mortar beneath the later Portland Cement pointing.

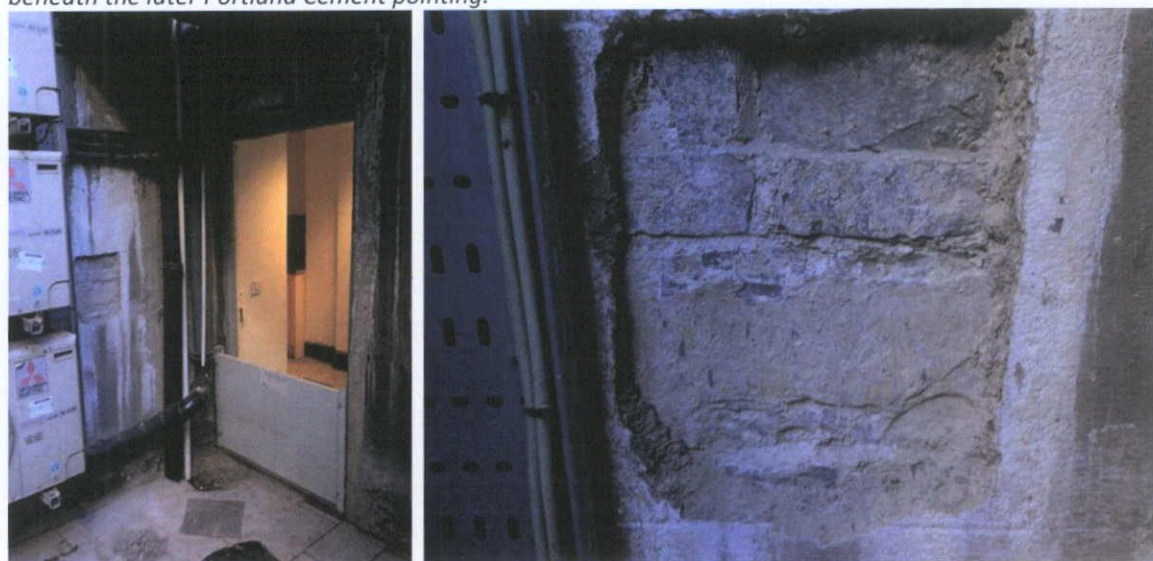
Fig.5.7.12: The rear wall of the building is composed of squared hewn Calp limestone masonry overlain with a Portland Cement render and repointed throughout.

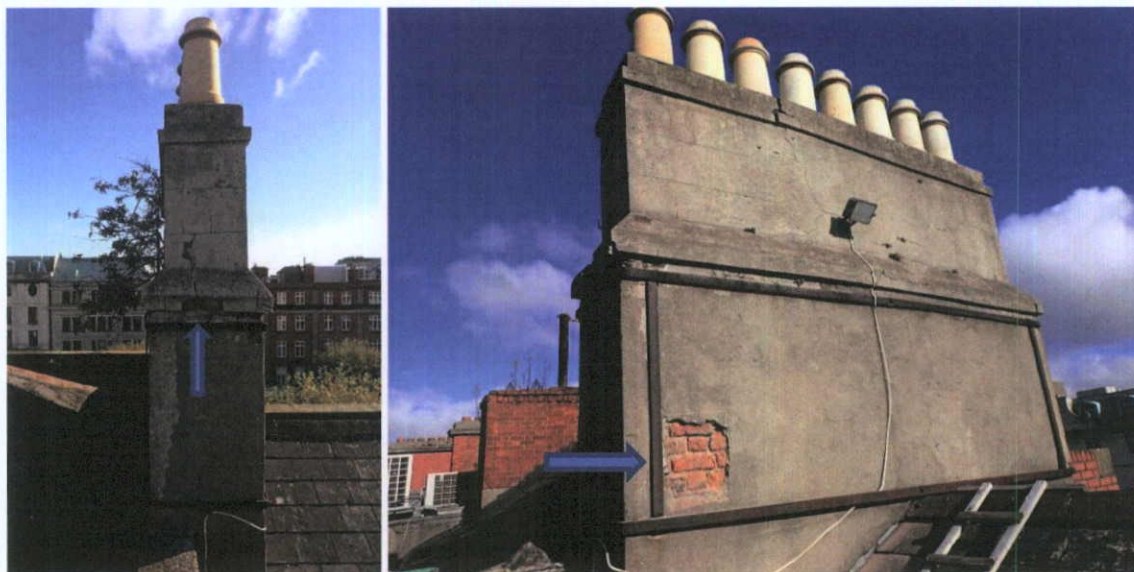
Fig.5.7.13: The eastern chimney (Chimney A) with the render removed at two locations to reveal the underlying brick masonry fabric.

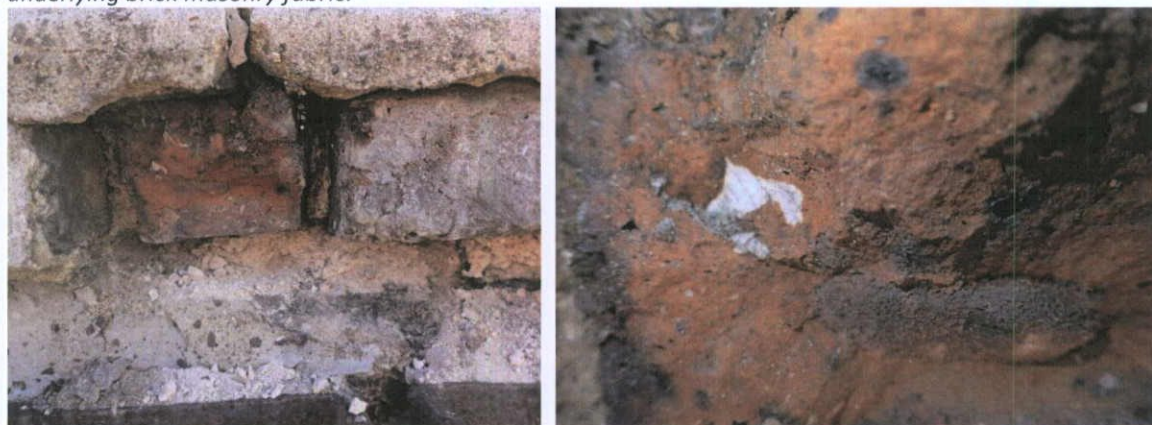
Fig.5.7.14: Shell contained in the brick of the eastern chimney stack.

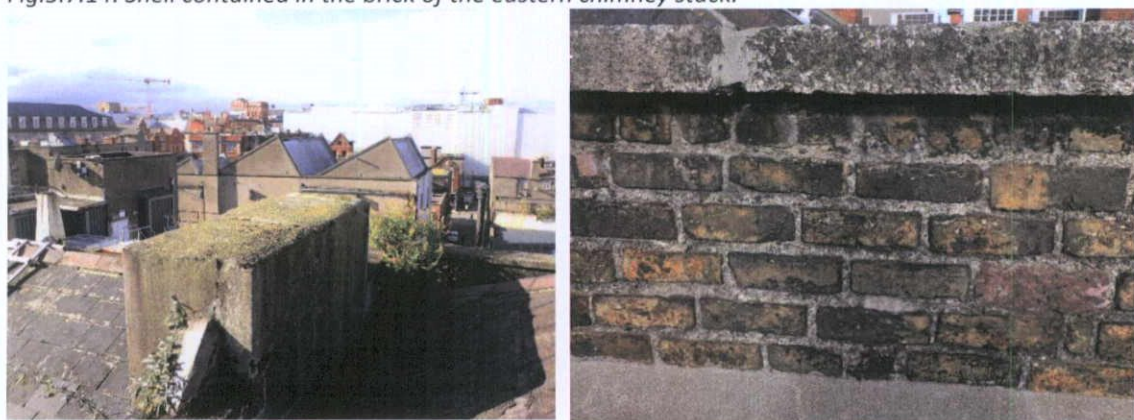
Fig.5.7.15: The cut-down Chimney B on the west side of the roof (left) and the granite-capped stock brick wall linking the two chimneys (right).

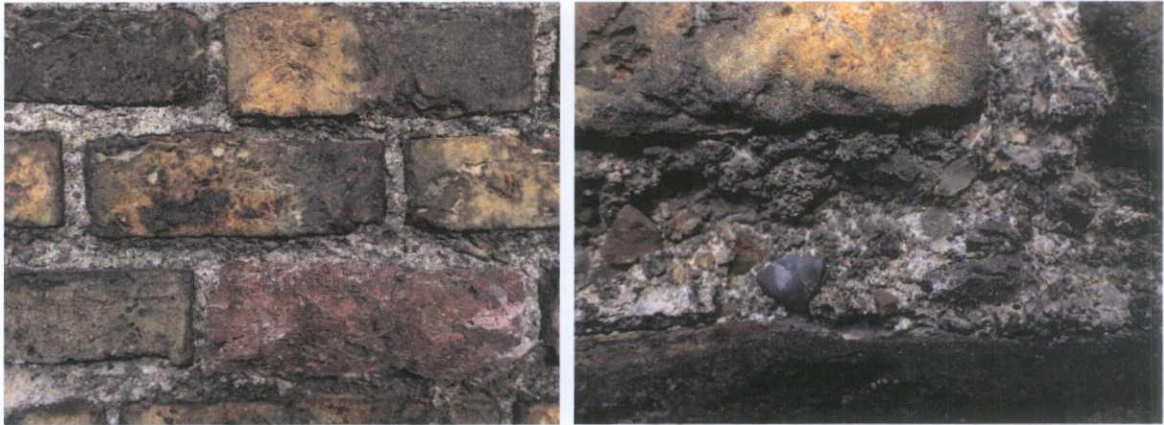
Fig.5.7.16: The soiled party wall is composed of hand-made clamp-fired yellow stock brick bedded in deep coarse-grained lime mortars with scarce crushed brick. This brick is very similar to that transported to Dublin City along the canal networks, and probably mid-nineteenth century.

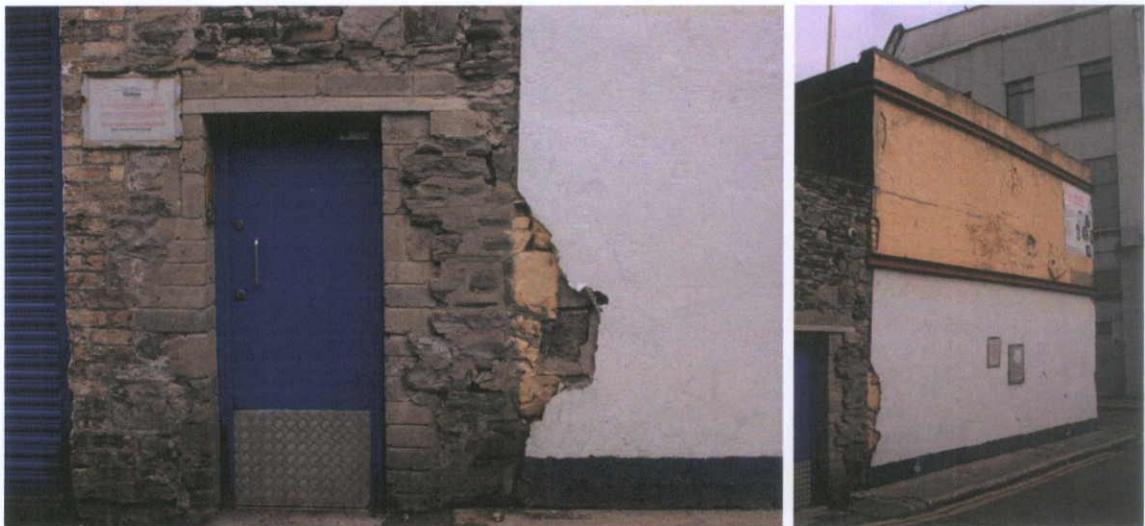
Fig.5.8.1: The rear boundary Calp limestone wall (60a O’Connell Street) is set in a pozzolanic lime mortar similar to others seen along the lane, and is probably eighteenth century Georgian fabric.

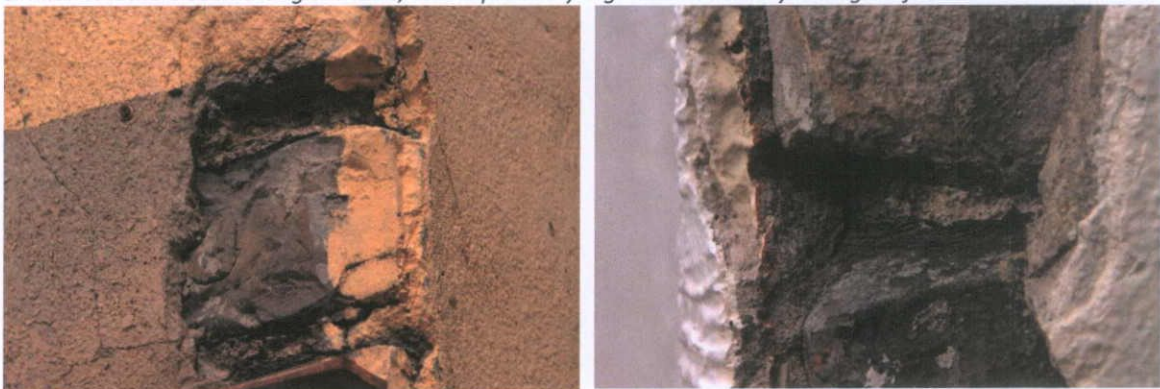
Fig.5.8.2: Detail of the Calp and lime bedding mortar beneath the twentieth century render.

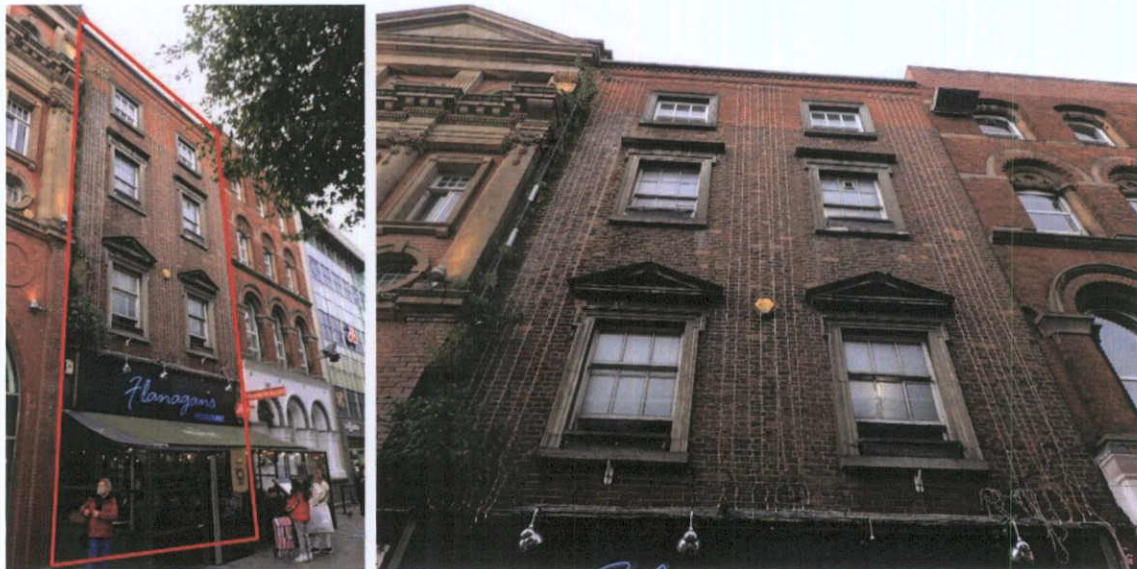
Fig.5.9.1: General view showing the altered upper floor level.

**Façade:** The façade consists of a modern shopfront with a brick superstructure punctuated by granite windows, with later brick above cill level on the third floor terminating in dentil brickwork below the coping. The façade has been repointed throughout in Portland Cement with gritty Portland Cement pointing applied to the earliest red stock facing brick. The façade also shows 'plastic' repair mortars and poor quality modern brickwork repairs below concrete windows cills at first floor level.

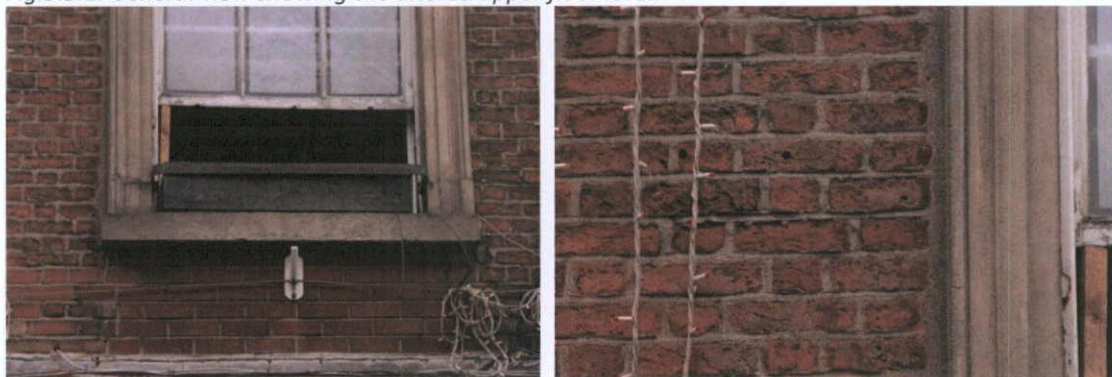
Fig.5.9.2: Modern brickwork below the window cill, and original brick repointed in Portland Cement.

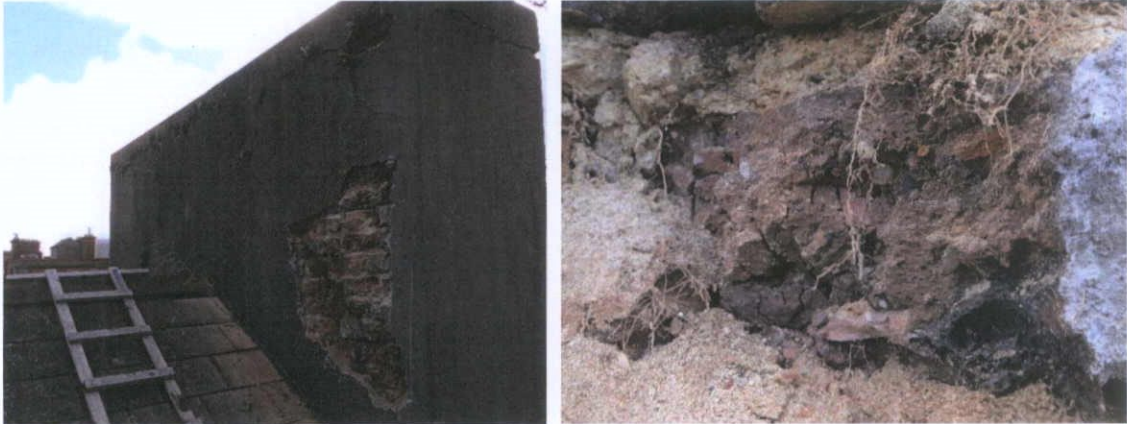
**Georgian Chimney:** The Portland Cement render was removed from the front (east) chimney stack at roof level; and the stack was found to be made of hand-made clamp-fired brick fired from unprocessed raw clay containing coarse limestone aggregate and with abundant partially calcined limestone and areas of vitrified matrix. The mortar has been affected by water penetration, saturation and invasive vegetation and is in poor condition but contains rounded gravel aggregate and brick pozzolan suggesting an early date. Internally, the brick chimney stack has been concealed behind modern partitioning and kitchen fixtures at all floor levels.

Fig.5.9.3: The chimney contains hand-made clamp fired brick very similar to that seen in No.42 O'Connell Street and likely to be Georgian fabric.

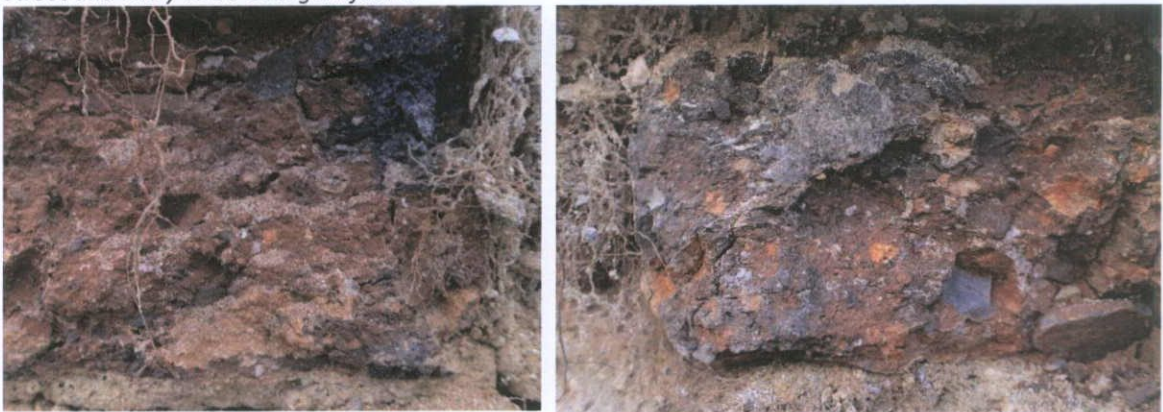
Fig.5.9.4: Hand-made clamp fired brick forming the chimney - similar to that seen in No.42 O'Connell Street and likely to be Georgian fabric.

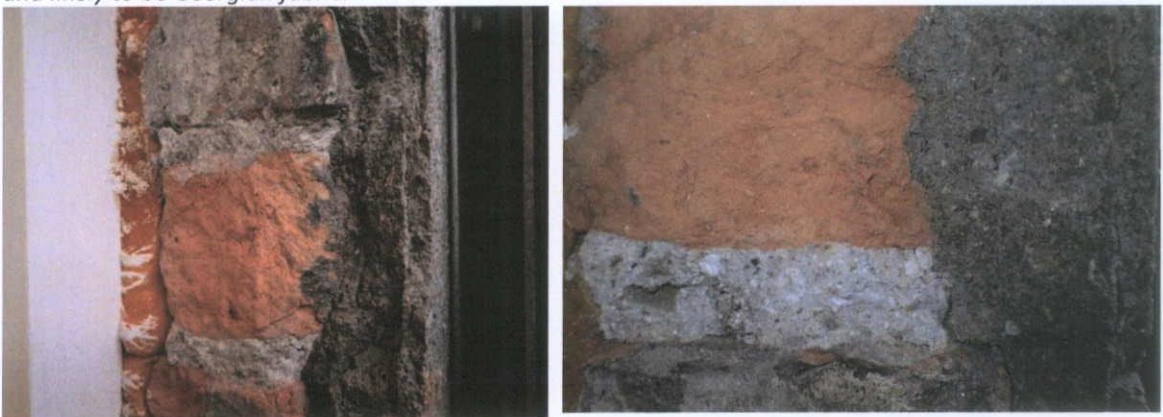
The rear wall of the building is coated in a Portland Cement render laid in two to three coats over a fine-grained solid red facing brick. Some of the brick is early clamp-fired brick with pebbly inclusions and voids, shrinkage cracks and fired from unprocessed clay. However, only a limited amount was visible and it would be necessary to remove further sections of render from the rear of the building to determine whether these were isolated salvaged and reused bricks, or whether these are representative of the rear elevation.

Fig.5.9.5: The rear elevation is coated with multiple layers of Portland Cement render above red stock brick.

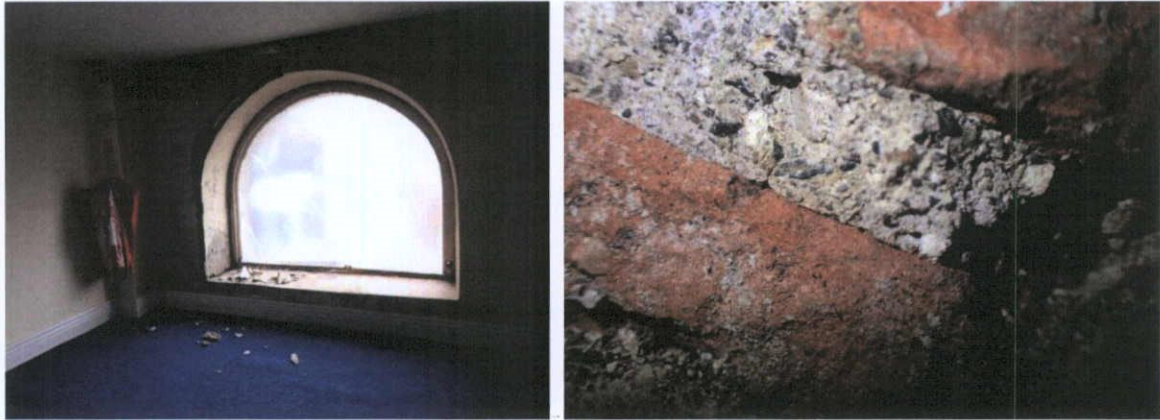
Fig.5.9.6: Arched window opening in the stairs. The arch is formed by brick with a ‘pennystruck’ lime bedding mortar using aggregate similar to that seen on the rear elevation, but differing from the aggregate used to bed the chimney stacks.

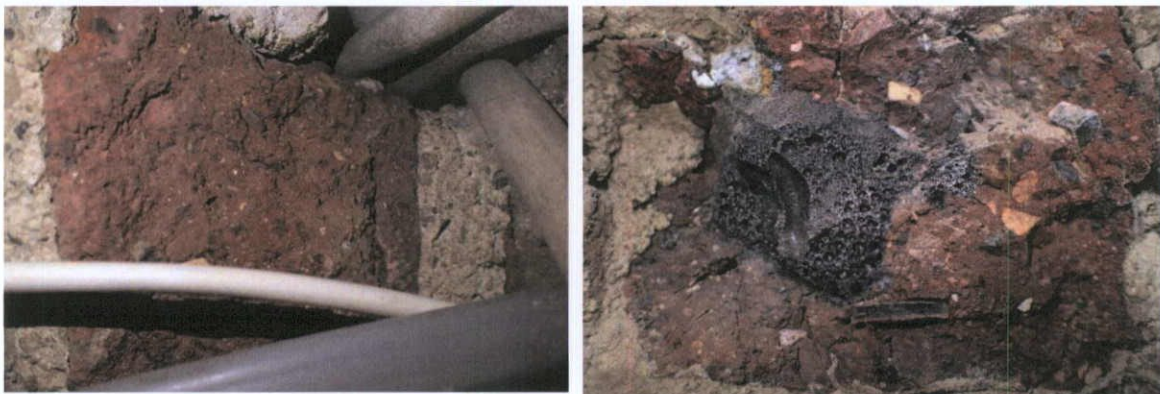
Fig.9.1.1: Brick with coarse angular limestone inclusions from the basement of No.43 O’Connell Street (left), and seen in the internal walls of No.71 Parnell Street (right).

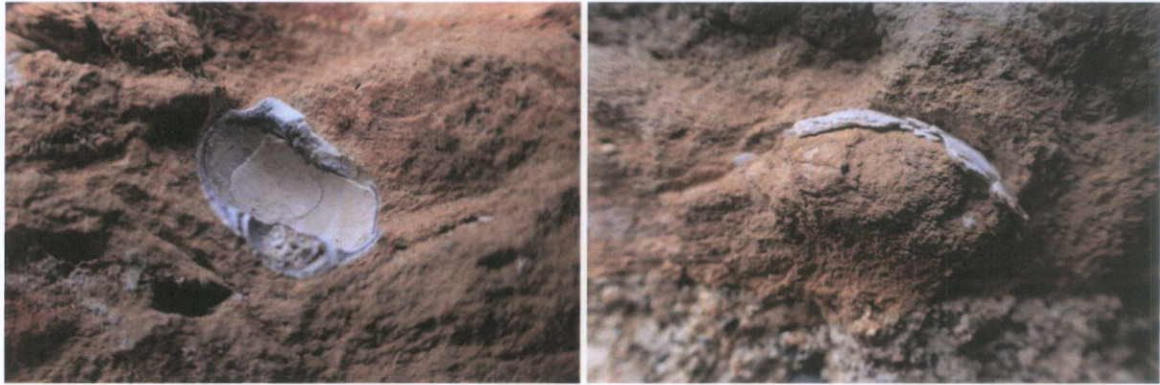
Fig.9.1.2: 'Shell brick' is found at a number of buildings on Moore Street including No.10 Moore

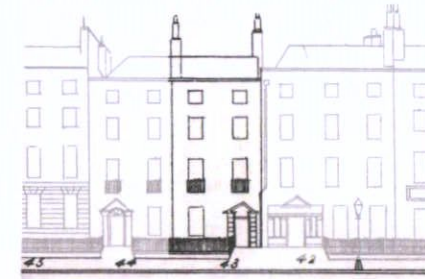
Figure 2: Elevation of 43 Sackville Street Upper from Shaw's Directory of 1850

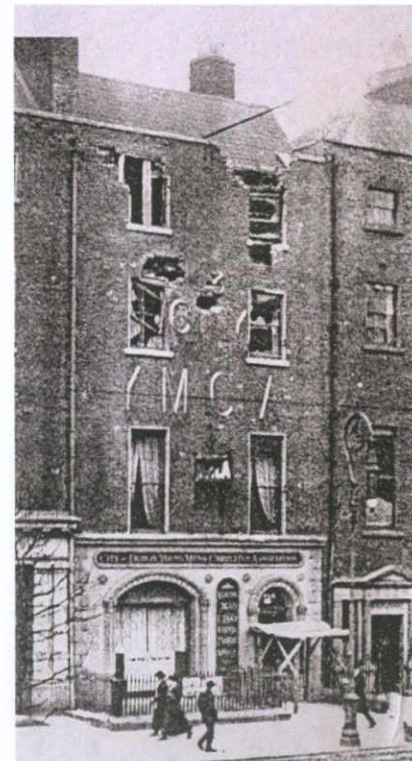
Figure 3: Damage to 43 Sackville Street Upper from fighting in July 1922 (National Library of Ireland)

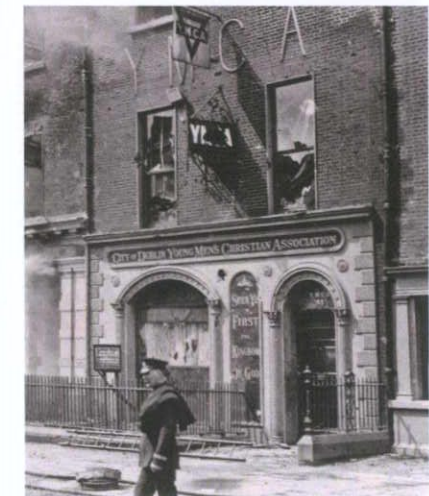
Figure 4: Damage to façade in July 1922 (Irish Architectural Archive)

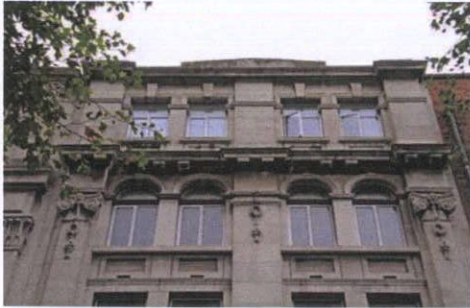
Plate 2: Detail to third and fourth floors

Four-bay, five-storey-over-basement attached building. Flat roof with red brick chimney stacks having granite copings to south and to north-east. Carved granite eaves cornice with central, raised pediment or blocking course bearing inscription date, "1925." Front (east) elevation comprised of coursed Portland stone, with recessed bays of paired windows flanked to corners and to centre by projecting piers. Giant order Ionic, engaged pilasters flanking first, second and third floors. Oversailing, modillion cornice to third floor. Square-headed window opens to first, second and fourth floors. Carved string courses to recessed bays to first and second floors. Round-headed window openings springing from Portland stone cornice, having carved surrounds to third floor. Panelled window aprons to second and third floors, with decorative swags to former. Carved hood mouldings and keystones to fourth floor. uPVC casement windows throughout upper floors, replacing original inward-opening timber casements. Limestone sills throughout. Original shop front to ground floor, comprising pink granite pilasters with Ionic capitals supporting Portland stone frieze and carved cornice; canted bay to shop entrance, flanked by large, glazed windows on granite stall risers, having overlights with timber glazing bars. Terrazzo threshold to entrance. Open basement well to south, encircled by wrought-iron railings on cut granite plinth, having cast-iron corner posts with cast-iron urn finials. Basement area was open in 1893 and was shown on Goad insurance plan; the area was covered over during the 1920s reconstruction and is not shown as open in the 1926 Goad plan. Part of the basement area has been reopened to provide access to the basement level from the street.

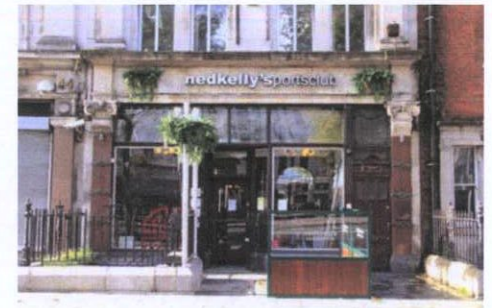
Plate 5: Shop front

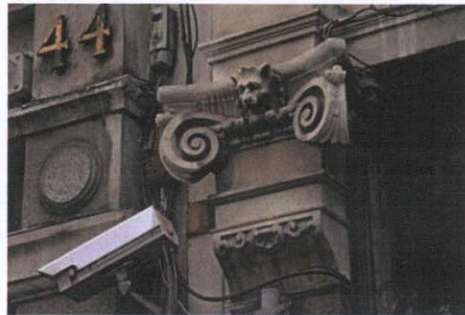
Plate 7: Stylised Ionic capital

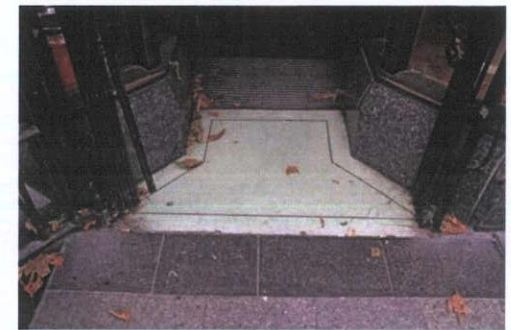
Plate 9: Original finish to commercial entrance threshold

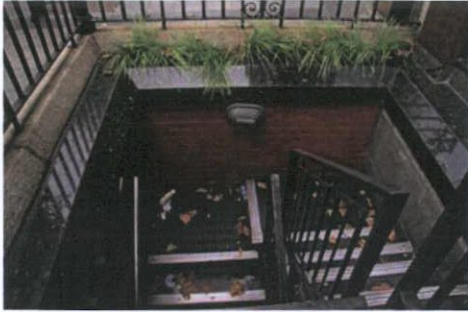
Plate 10: B-1 – View south into basement well

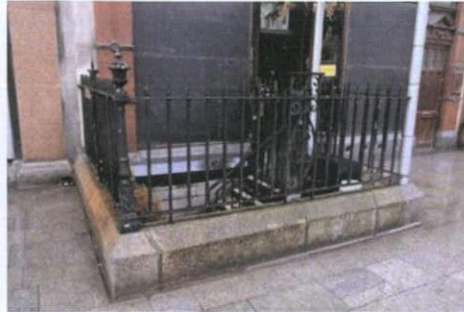
Plate 11: Railings to basement well

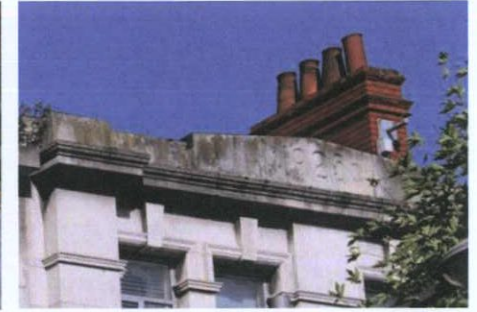
Plate 13: Date plaque to blocking course

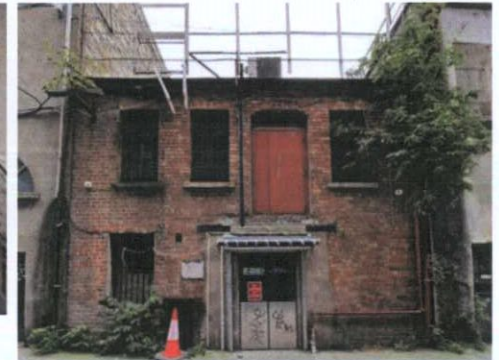
Plate 17: West elevation of extension onto Moore Lane

Single-storey-over-basement extensions to rear, with flat roofs and pop-up rooflights. Extension connected to two-storey-over-basement structure to rear, facing onto Moore Lane, and having flat roof. External walls comprised of red brick laid in English garden wall bond. Square-headed window openings at first-floor level with fixed multi-pane timber windows and granite sills. Door opening to first floor to west elevation, with decorative brick surrounds and enclosed with timber boarded door. Square-headed opening to ground floor is modern alteration as is window to west of door, which has no apparent arch or lintel and no sill. This is consistent with 1926 Goad insurance map, which shows no windows flanking the ground-floor doorway, in contrast to the 1893 Goad plan, which shows windows on either side of a central door, suggesting that this rear section is part of the 1920s reconstruction.

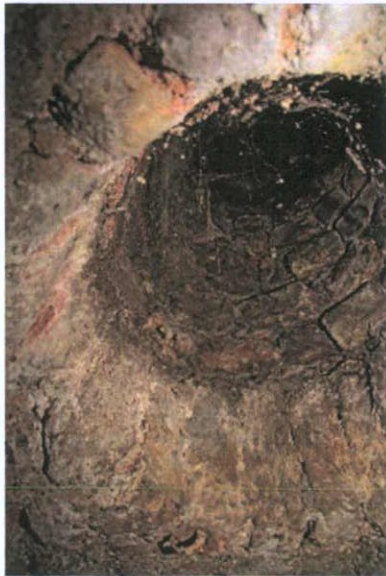
Plate 37: B-9 – Coal hole access to ceiling

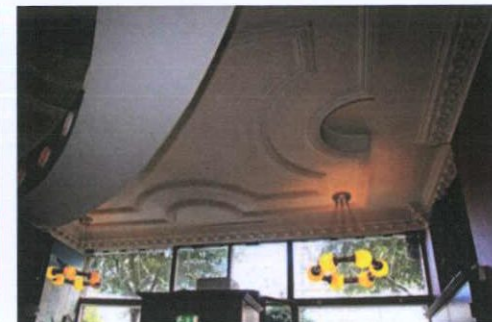
Plate 41: G-1 – Decorative coving and panelling to ceiling

Room G-1: Accessed from external entrance from O'Connell Street Upper. Chimney breast to south wall, now blocked up. Lath-and-plaster ceiling with heavily moulded modillion coving and decorative plaster panels, partially hidden from view by bulkheads of modern ceiling fixtures. Most walls finished in modern plaster and wallpaper. Full-height glazed commercial entrance to east wall, with bowed entrance lobby and timber mullions forming flanking shop windows and overlights. Modern joinery throughout, including curved bar to north wall and built-in presses to chimney niche. Modern timber dado rail and dado panelling. Original timber skirting to south wall. Parquet timber flooring.

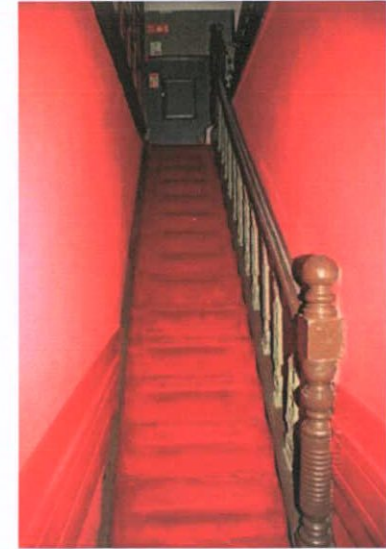
Plate 57: G-7 – View to south; original staircase to first floor

Room G-7: Accessed from Room G-4. Stairwell to first floor. Straight flight of closed-string stairs. Treads and risers covered in carpet. Carved timber handrail to west with robust newel posts having collars and spherical finials. Decorative balusters formed of scrolled cast-iron panels. Original timber skirting boards with ovolo profile. Plasterboard finish to ceiling. Plaster finishes to walls. Modern joinery. Carpet finish to floors.

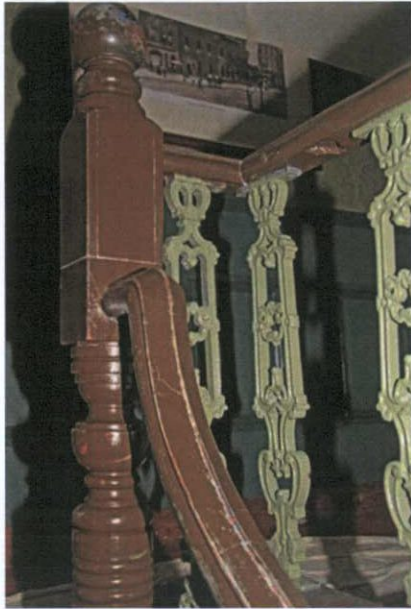
Plate 58: F-1 – Newel post and cast-iron balusters

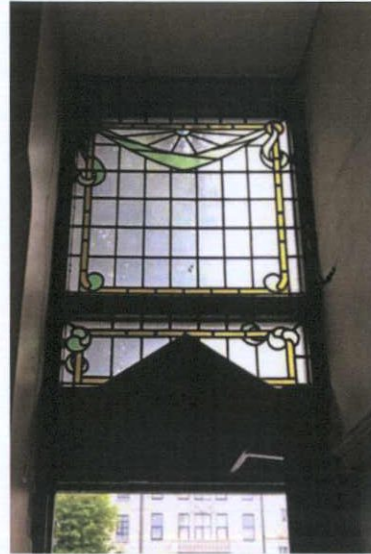
Plate 67: F-4 – Stained glass overlight

Room F-4: Accessed from external entrance from O'Connell Street; level access with staircase accessing upper floors. Modern plaster ceiling with downstand service bulkhead to north. Archway to west over stairwell, with carved timber surrounds and moulded keystone, supported on engaged pier to north. Boxed-out service risers projecting from walls. Entry door to east having original timber door surround with carved timber, pedimented overdoor, surmounted by leaded stained glass overlights with timber mullions. Plaster finish to walls. Closed-string, straight flight of stairs with half-landing, having nosed treads with rubber contrast strips; treads and risers finished in vinyl. Carved timber handrail to flanking walls. Original skirting boards / stair stringers with ovolo profile. Original mosaic tile to entryway floor with lettering, "43" encircled in dark mosaic pattern. Some surface-mounted services.

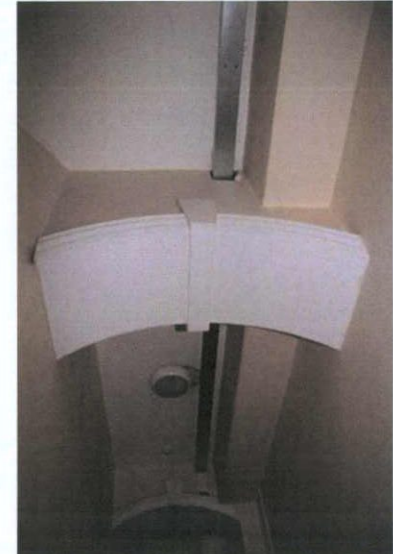
Plate 69: F-4 – Archway over entry hall

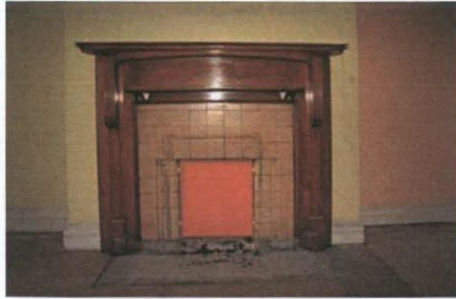
Plate 82: F-8 – Historic timber chimney piece with later ceramic fire surrounds

Room F-8: Accessed from Rooms F-5 and F-7. Chimney breast projecting to south wall, now blocked up with plasterboard, having historic carved timber chimney piece with ceramic tile to fire surround. Limestone hearth. Lath-and-plaster ceiling with simple moulded coving. Plaster finish to walls. Original skirting boards with ovolo profile and carved timber picture rail. Original timber panelled doors with carved timber architraves. Square-headed window openings to east wall, having uPVC casement windows with nosed internal timber sills and carved timber architraves. Hardboard floor covering. Surface-mounted service trunking.

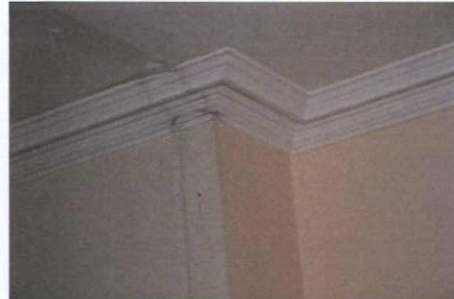
Plate 83: F-8 – Detail to coving

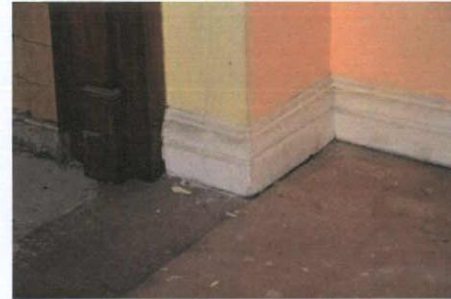
Plate 84: F-8 – Detail to skirting

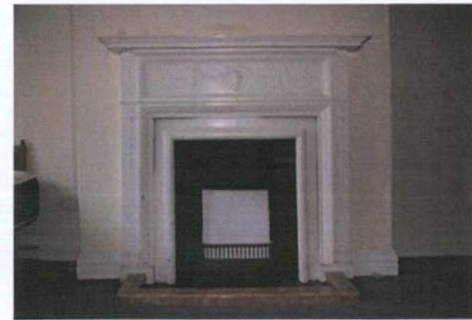
Plate 104: S-4 – Cast-iron chimney piece

Room S-4: Accessed from Rooms S-3 and S-5. Chimney breast projecting to south wall, now blocked up with plasterboard, having original cast-iron chimney piece and cast-iron fire surround. Ceramic tile to hearth. Lath-and-plaster ceiling with simple moulded coving. Plaster finish to walls. Original skirting boards with ovolo profile and carved timber picture rail. Original timber panelled doors with carved timber architraves. Square-headed window openings to east wall, having uPVC casement windows with nosed internal timber sills and carved timber architraves. Carpet finish to floor. Surface-mounted service trunking.

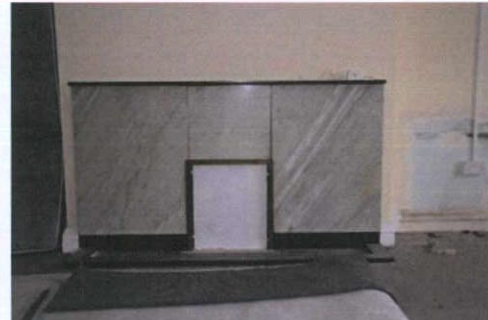
Plate 108: S-5 – Non-original chimney piece

Room S-5: Accessed from Rooms S-1 and S-4. Chimney breast projecting to south wall, now blocked up with plasterboard, having modern marble chimney piece. Lath-and-plaster ceiling with simple moulded coving. Plaster finish to walls. Former opening in east wall now blocked up and finished in modern plaster. Original skirting boards with ovolo profile and carved timber picture rail. Original timber panelled doors with carved timber architraves. Square-headed window opening to west wall, having uPVC casement windows with nosed internal timber sills and carved timber architraves. Carpet finish to floor. Surface-mounted service trunking.

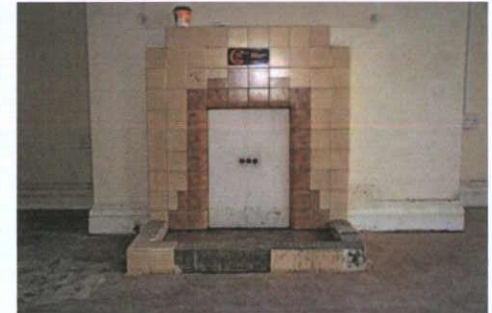
Plate 117: T-3 – Non-original chimney piece

Room T-3: Accessed from Rooms T-1 and T-4. Chimney breast projecting to north wall, now blocked up with plasterboard, having non-original ceramic tiled chimney piece and hearth. Lath-and-plaster ceiling. Plaster finish to walls. Former opening in west wall now blocked up and finished in modern plaster. Engaged pilaster to west wall and timber-stud partition forming press to north-west corner. Original skirting boards with ovolo profile and carved timber picture rail. Original timber panelled doors with carved timber architraves; flush timber door to press. Round-headed window openings to east wall, having uPVC casement windows with nosed internal timber sills and carved timber architraves. Vinyl floor covering. Surface-mounted service trunking.

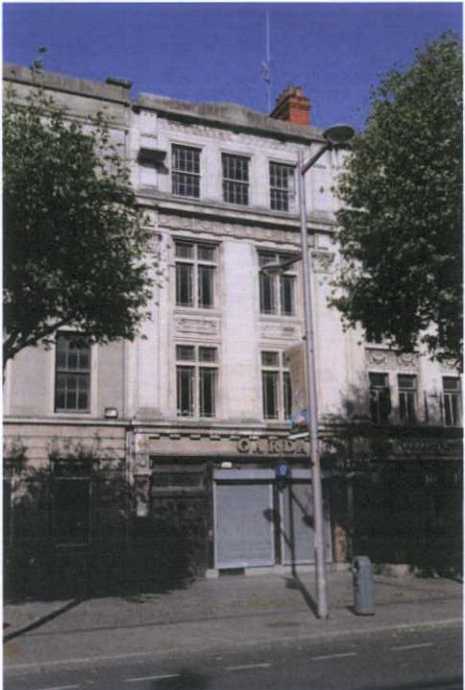
Plate 1: Front façade, 44 O’Connell Street Upper

Three-bay, four-storey building with granite ashlar façade with plain granite parapet and with modillion cornice and plain frieze in Portland stone between second and third floors. The windows are three-over-six sashes on the top floor and six-over-six at first- and second-floor levels. The ground floor is faced with channelled granite ashlar.

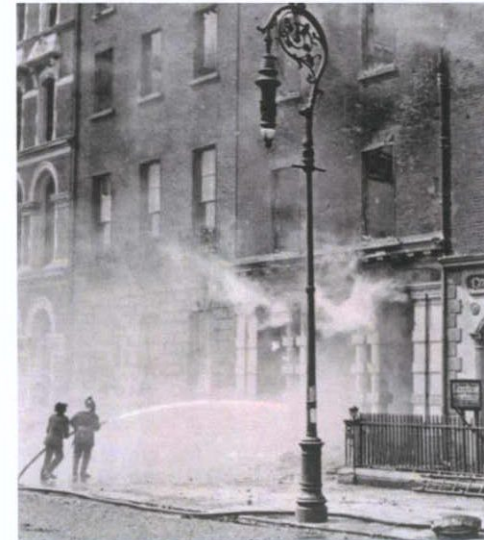
Figure 3: Fighting the fire at 44 Sackville Street Upper, July 1922

The building was damaged during the second battle of O’Connell Street in 1922 due to the fire in the building next door and was subsequently demolished.<sup>5</sup> In 1925 a new building was erected for Adam Scott & Co. and this is seen on the 1826 Goad insurance map as resembling the previous building.<sup>6</sup> The front section is depicted as four-storey, with a flat roof of cement or asphalt, while there was a three-storey building on the Moore Lane frontage. The central part of the site was part single-storey and part two-storey building. While the structures to the rear stretching back to Moore Lane appear not to have changed between the 1893 and 1926 Goad insurance plans, the present layout with alternating buildings and light wells differs significantly from the structures shown on those plans. The three-storey structure at the Moore Lane frontage shown on the Goad plans has a different layout of windows and door to the two-storey structure at the rear today.

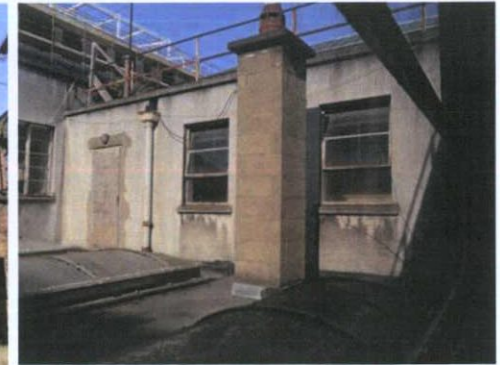
Plate 9: External elevation of extensions within depth of site

Single- and two-storey extensions to rear, with flat roofs and pop-up rooflights. Extension connected to two-storey structure to rear, facing onto Moore Lane, and having flat roof. External walls finished in cementitious render. Square-headed window openings with multi-pane steel casement windows having concrete sills. Square-headed door opening to ground floor with modern timber doors.
