Dublin Central Project – Site 2 & No.61 O'Connell Street Upper

Appendix 15.7 Building inventory, record and description for No.50-51 O'Connell Street Upper

Appendix 15.8 Building inventory, record and description for No.52-54 O'Connell Street Upper

Appendix 15.9 Building inventory, record and description for No.55-56 O'Connell Street Upper

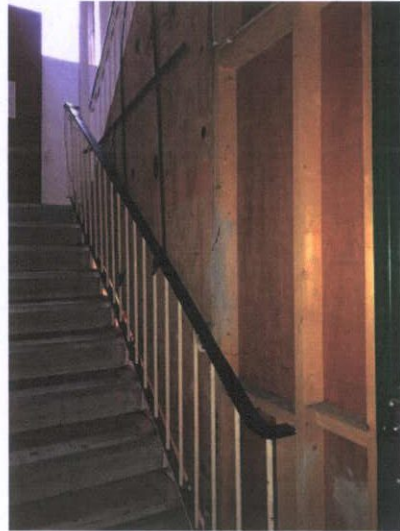
Plate 516: Stair wall to block upper levels

The stair is still usable but shows signs of wear. It is not suitable for use as a fire escape as it is blocked by a locked door at level 1.

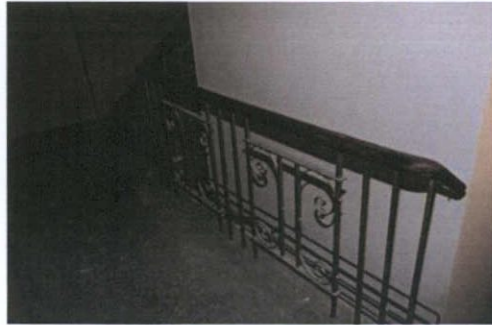
Room T-1: Accessed from Rooms S-1 and FO-1. Stairwell accessing all floors. Open-string, U-plan staircase with squared concrete treads and risers, with replacement nosings, having original balustrade formed of oval-section timber continuous handrail, with square-section, painted cast-iron balusters alternated with cast-iron scrollwork panels at regular intervals, set to concrete steps. Modern plaster finish to walls. Single square-headed steel casement window to north wall at second floor landing. Concrete floor finish to landings.

Plate 48: T-1 – View to north-east; original balustrade
