Appendix 15.13 Building inventory, record and description for

No.60a 60b 60c O'Connell Street Upper

Appendix 15.14 Building inventory, record and description for No.61 O'Connell Street Upper

EIAR Chapter 15 Cultural Heritage (Architectural)

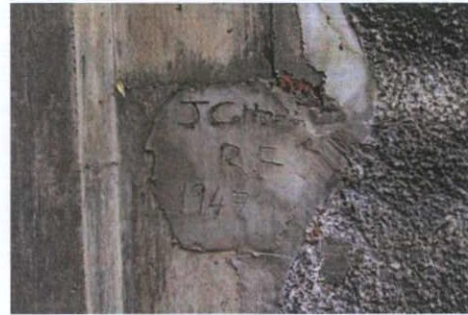
Plate 51: B-11 – 20th century graffiti to south elevation of extension

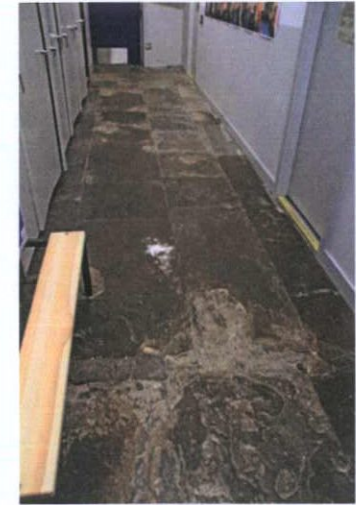
Plate 53: B-12 – Limestone flagstones

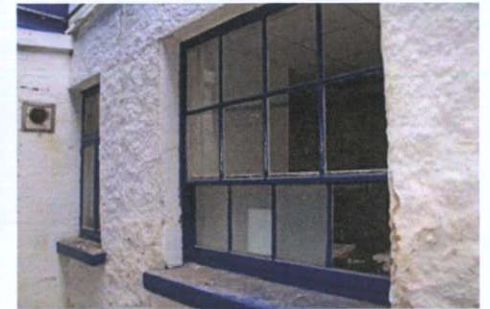
Plate 61: B-15 – Historic timber sash window to east

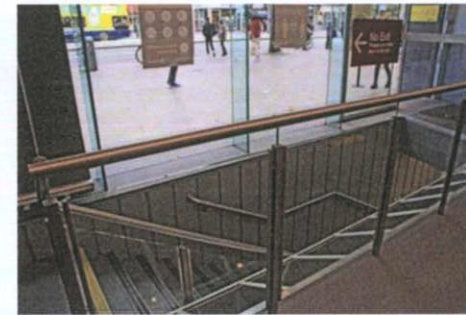
Plate 72: G-1 – View to staircase to east, accessing basement level

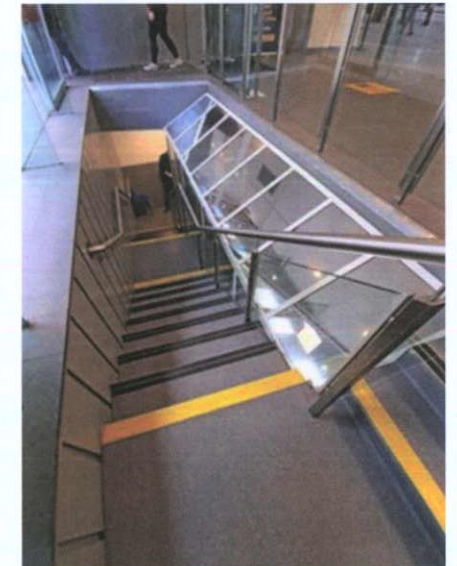
Plate 73: G-1 – View to staircase leading to basement level

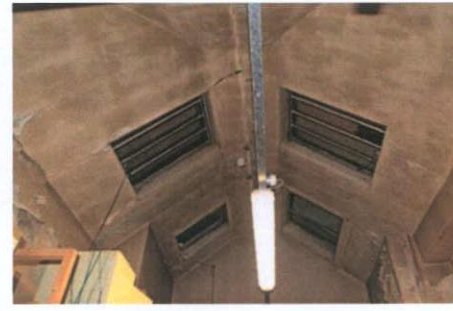
Room G-12: Accessed from Room G-11. Part of original Reading Room. Double-height space. Roof pitches and hips articulated to interior. Lath-and-plaster finish to ceiling. Plastered finish to walls. Former rooflight openings now blinded externally, having wrought-iron frames. Roof supported on downstand bulkhead to north, bearing on projecting masonry nib to west. Surface-mounted services.

Plate 92: G-12 – View to east; ceiling in original Reading Room

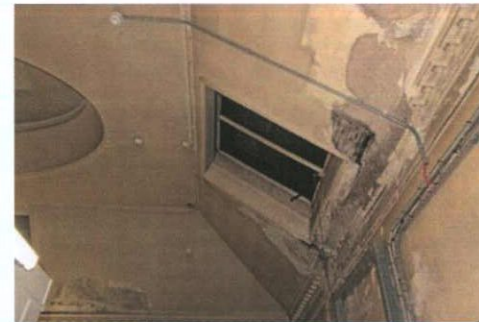
Room G-13: Accessed from Room G-12. Part of original Reading Room. Area over suspended ceiling below. Roof pitches and hips articulated to interior, with flat ceiling to centre having expansive oval-shaped recessed rooflight, now blinded. Lath-and-plaster finish to ceiling. Former flanking rooflight openings now blinded externally, having cast-iron mullions. Heavily moulded modillion cornice to perimeter of ceiling. Plastered finish to walls. Square-headed window opens, now blinded and interrupted by suspending ceiling noted to north wall; additional round-headed opening, now blinded, to east wall.

Plate 95: G-13 – Rooflight over Reading Room

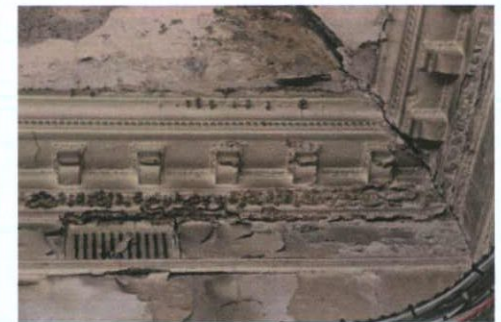
Plate 96: G-13 - Modillioned cornice to original Reading Room

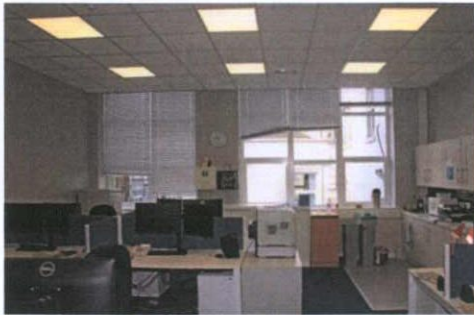
Plate 105: F-4 – View to west

Room F-4: Accessed from Room F-1. Suspended ceiling finished with ceiling tiles. Modern plaster finish to walls; plasterboard finish to timber stud partition east. Modern chamfered skirting boards. Flush timber door and flat timber architraves; original panelled door reveal partially retained to doorway to Room F-1. Large, square-headed window opens to west wall with uPVC casement windows, partially concealed by suspended ceiling, having squared internal timber sills. Carpet finish to floors. Kitchenette facilities to north-west.

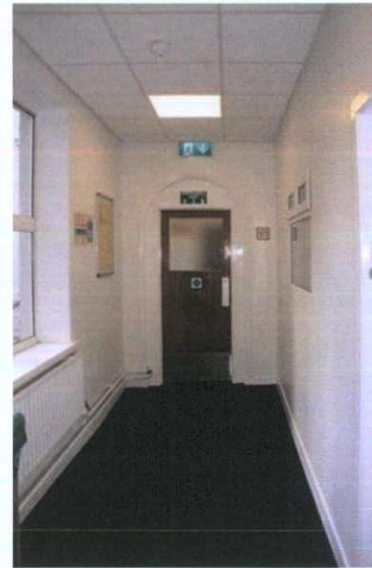
Plate 111: F-5 – View to west

Room F-5: Accessed from Rooms F-1, F-6 and F-7. Corridor on east-west axis. Suspended ceiling finished with ceiling tiles. Modern plaster finish to walls; plasterboard finish to timber stud partition to north, having integrated uPVC casement window. Modern rectangular-section skirting boards. Flush, part-glazed timber doors and flat timber architraves; doorway to west set to round-headed niche with carved timber surrounds. Square-headed window opens to west wall having uPVC casement windows and squared internal timber sills. Carpet finish to floors.

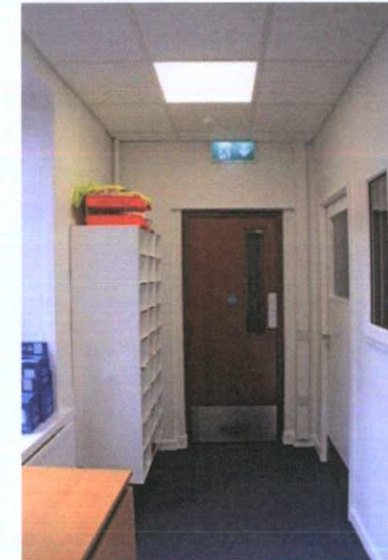
Plate 112: F-6 – View to west

Room F-6: Accessed from Rooms F-5, F-7 and F-9. Corridor on east-west axis. Suspended ceiling finished with ceiling tiles. Modern plaster finish to walls; plasterboard finish to timber stud partition to north, having integrated uPVC casement window. Modern rectangular-section skirting boards. Flush, part-glazed timber doors and flat timber architraves. Square-headed window opens to west wall having uPVC casement windows and squared internal timber sills. Carpet finish to floors.

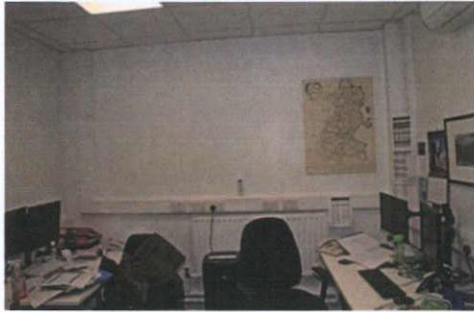
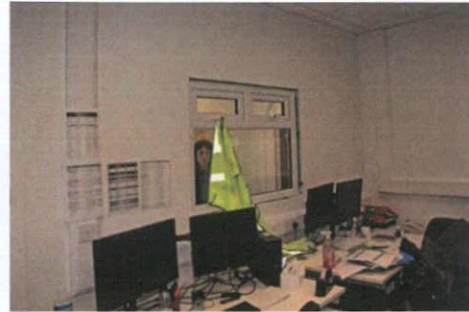
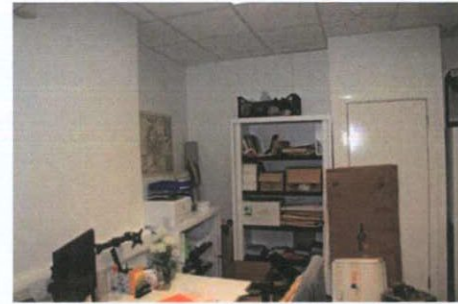
Room F-7: Accessed from Room F-5. Suspended ceiling finished with ceiling tiles. Modern plaster finish to walls; plasterboard finish to timber stud partition to south, having integrated uPVC casement window. Modern rectangular-section skirting boards. Flush, part-glazed timber doors and flat timber architraves. Timber stud and plasterboard enclosure forming press to east. Carpet finish to floors.

Plate 113: F-7 – View to west

Plate 114: F-7 – View to south-west

Plate 115: F-7 – View to east

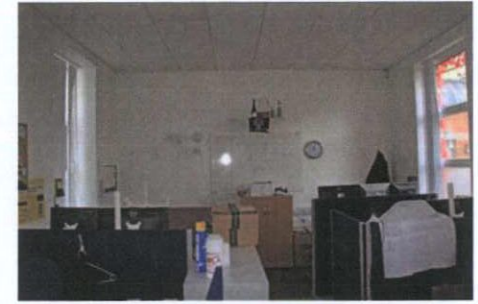
Plate 116: F-8 – View to south

Room F-8: Accessed from Room F-9. Suspended ceiling finished with ceiling tiles. Modern plaster finish to walls. Modern rectangular-section skirting boards. Flush, part-glazed timber doors and flat timber architraves. Square-headed window opens to east and west walls having uPVC casement windows and squared internal timber sills. Carpet finish to floors.

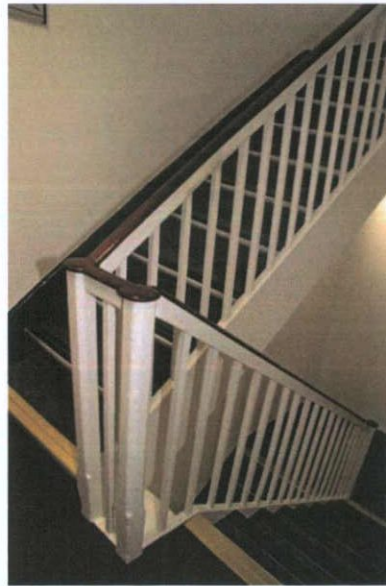
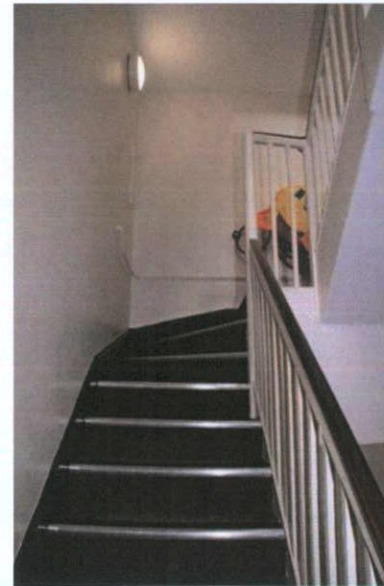
Room F-9: Accessed from Rooms F-5, F-6, F-8 and S-13. Stairwell to upper and lower floors. Closed-string, dog-leg stair becoming winder stair at second floor half-landing; treads and risers finished in carpet with rubber and steel contrast strips. Rectangular-section stringer. Modestly carved timber handrail supported on square-section newel posts with stop-chamfer details, paired at landings, with infill of square-section timber balusters. Modern plaster finish to ceiling and walls to stairwell. Flush, part-glazed timber doors and flat timber architraves. Timber skirting boards with ovolo profile. Carpet floor finish to landings.

Plate 118: F-9 – View to north-west

Plate 119: F-9 – View to north

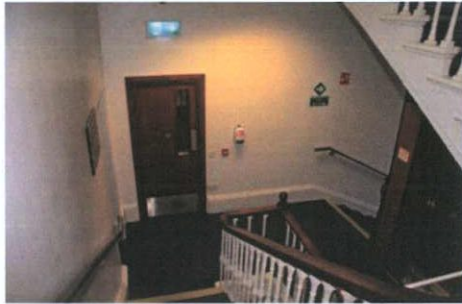
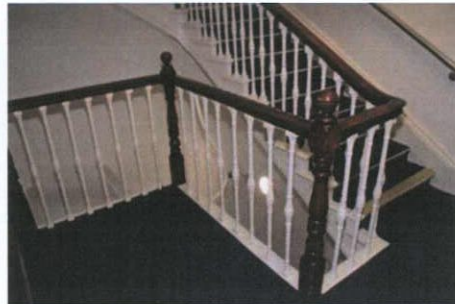
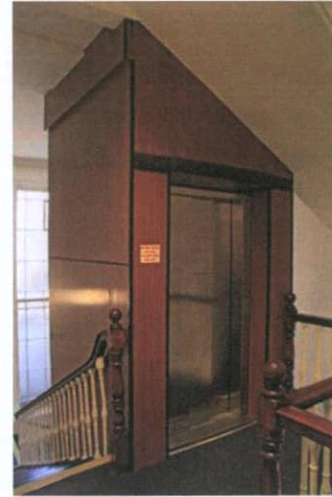
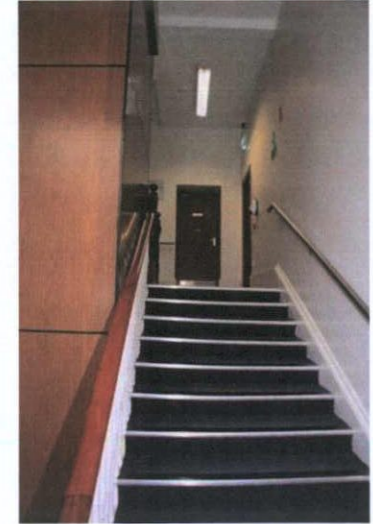
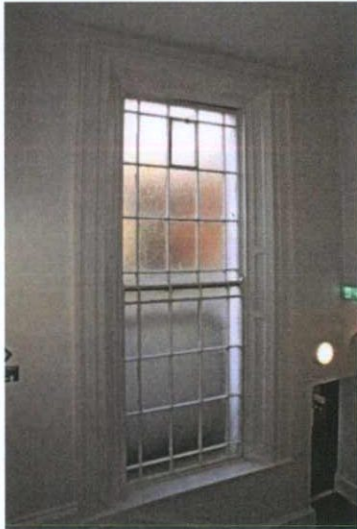
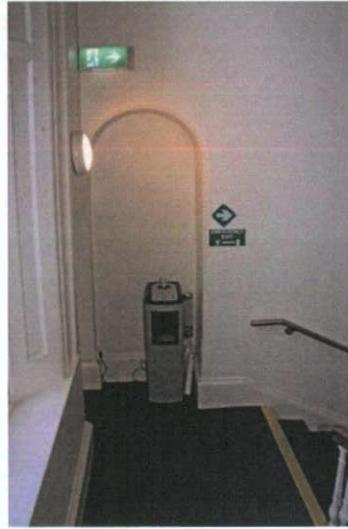
Room S-1: Accessed from Rooms F-1 and T-1. Stairwell accessing upper and lower floors. Open well, open-string staircase, now with timber-clad lift shaft infill to open well, having nosed timber treads with rubber and steel contrast strips and timber risers, covered in carpet, with balustrade formed of carved timber handrail, formerly continuous at landings, now set to carved newel posts with spherical finials, with infill of carved timber balusters with collars. Additional section of balustrade forms guarding to east of lift shaft and continues to additional open-well staircase, matching in design and orientated on north-south axis, rising to third floor. Additional modern steel handrail to outer walls. Plaster finish to soffit of rising staircase; remainder of ceiling is finished in plasterboard. Modern part-glazed / flush timber doors set to flat timber architraves. Large square-headed window opening to west wall forming lightwell to staircase, having multi-pane timber sashes and carved timber reveals with carved timber architraves and nosed internal timber sill. Round-headed niche to north wall at first floor half-landing. Timber skirting boards with ovolo profile. Carpet finish to landings.

Plate 121: S-1 – View to south towards second floor landing

Plate 122: S-1 – View of second floor balustrade

Plate 123: S-1 – View to lift shaft within open-well staircase

Plate 124: S-1 – View to east towards second floor landing

Plate 125: S-1 – View to west

Plate 126: S-1 – View to north

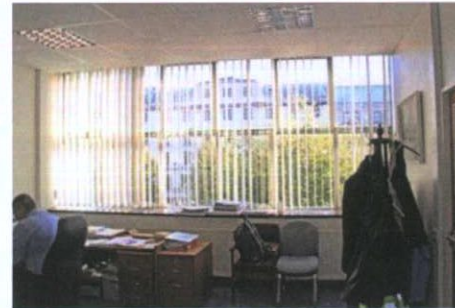
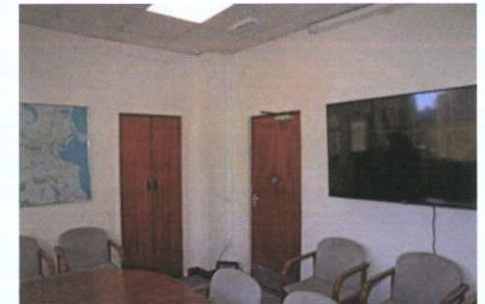
Room S-2: Accessed from Rooms S-1 and S-3. Suspended ceiling finished with ceiling tiles. Modern plaster finish to walls; plasterboard finish to timber stud partition south. Square-headed window open to front elevation with multi-pane aluminium casement windows. Modern rectangular-section skirting boards. Flush / part-glazed timber doors. Carpet finish to floors. Surface-mounted services.

Plate 127: S-2 – View to east

Plate 128: S-2 – View to south-west

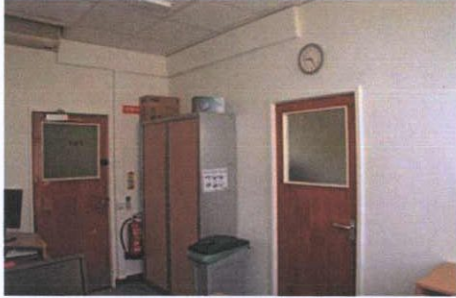
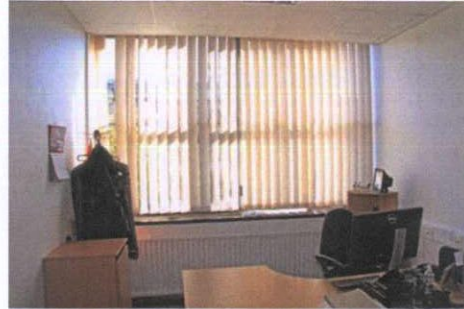
Room S-3: Accessed from Rooms S-2 and S-5. Suspended ceiling finished with ceiling tiles. Modern plaster finish to walls; plasterboard finish to timber stud partitions to west, north and south. Square-headed window ope to front elevation with multi-pane aluminium casement windows. Modern rectangular-section skirting boards. Flush, part-glazed timber door and flat timber architraves. Carpet finish to floors. Surface-mounted services.

Plate 129: S-3 – View to north-west

Plate 130: S-3 – View to east

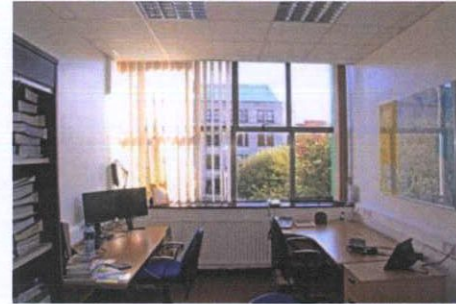
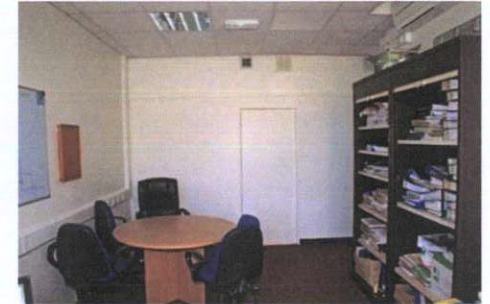
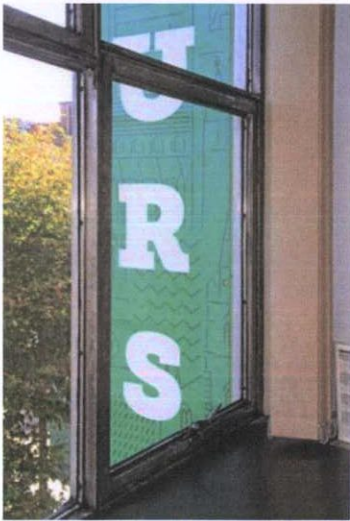
Room S-4: Accessed from Room S-5. Suspended ceiling finished with ceiling tiles. Modern plaster finish to walls; plasterboard finish to timber stud partitions to north and west. Blocked up door ope to west wall. Square-headed window ope to front elevation with multi-pane aluminium casement windows. Modern rectangular-section skirting boards. Flush, part-glazed timber door and flat timber architraves. Carpet finish to floors. Surface-mounted services.

Plate 131: S-4 – View to east

Plate 132: S-4 – View to west

Plate 133: S-4 – View of steel window to east

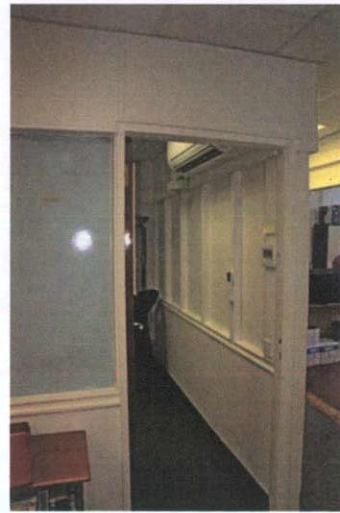
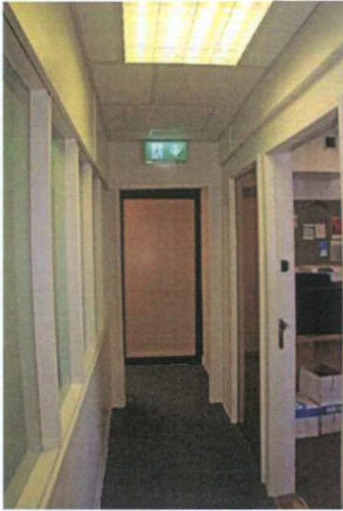
Room S-5: Accessed from Rooms S-1, S-3, S-4 and S-7. U-shaped corridor with timber stud enclosure, clad in plasterboard, forming Room S-6 to centre, having blinded windows inset. Suspended ceiling finished with ceiling tiles. Modern plaster finish to walls; plasterboard finish to timber stud partitions to Room S-6 and to west and north. Modern rectangular-section skirting boards. Flush / part-glazed timber doors; doorway in south wall accessing Number 60 O'Connell Street Upper. Carpet finish to floors.

Plate 134: S-5 - View into Room S-6

Plate 137: S-5 – View to south

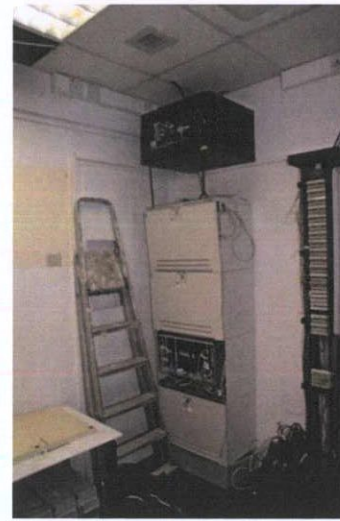
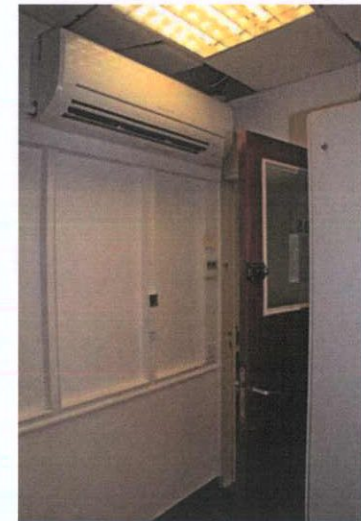
Room S-6: Accessed from Room S-5. Suspended ceiling finished with ceiling tiles. Plasterboard finish to timber stud partitions forming enclosure, with blinded windows inset to north and west walls. Modern rectangular-section skirting boards. Flush / part-glazed timber door with flat timber architraves. Carpet finish to floors. Surface-mounted services.

Plate 135: S-6 – View to south-east

Plate 136: S-6 – View to north-west

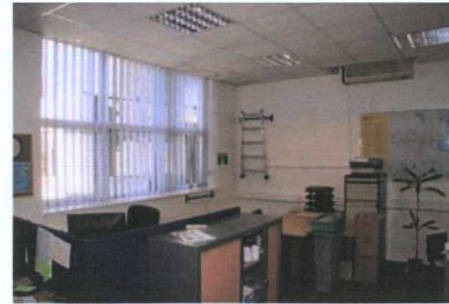
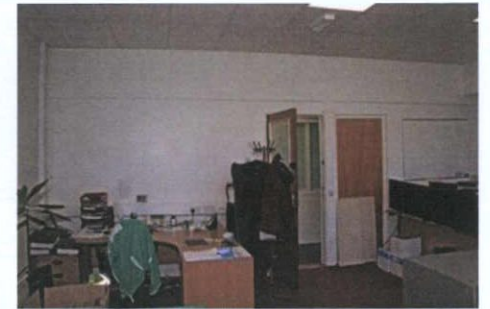
Room S-7: Accessed from Room S-5. Suspended ceiling finished with ceiling tiles. Modern plaster finish to walls; plasterboard finish to timber stud partition east. Modern rectangular-section skirting boards. Flush, part-glazed timber doors and flat timber architraves. Large, square-headed window ope to west wall with uPVC casement windows, partially concealed by suspended ceiling, having squared internal timber sills. Carpet finish to floors. Surface-mounted services.

Plate 139: S-7 – View to north-west

Plate 140: S-7 – View to east

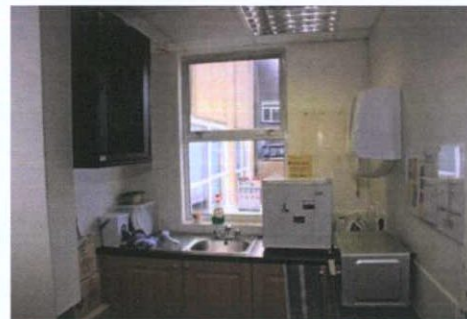
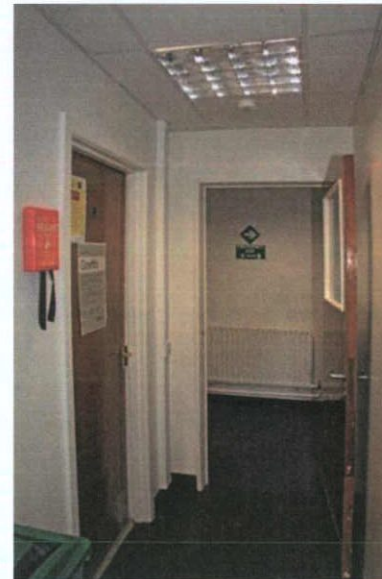
Room S-8: Accessed from corridor to north. Suspended ceiling finished with ceiling tiles. Modern plaster finish to walls; plasterboard finish to timber stud partition to west. Modern rectangular-section skirting boards. Flush, part-glazed timber door. Square-headed window ope to south wall with uPVC casement window. Carpet finish to floors. Surface-mounted services. Kitchenette facilities to south.

Plate 142: S-8 – View to south

Plate 143: S-8 – View to north

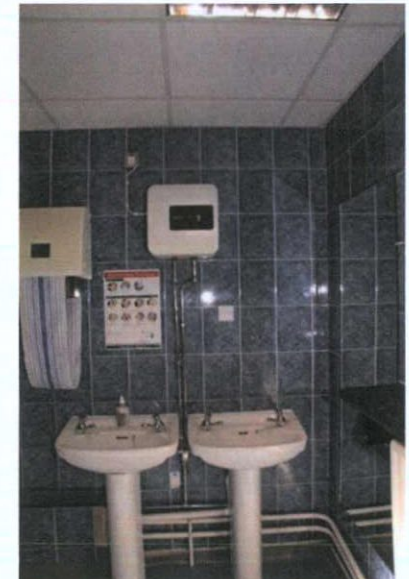
Plate 144: S-9 – View to west

Room S-9: Accessed from Room S-8. Toilet room. Suspended ceiling finished with ceiling tiles. Ceramic tile finish to walls and to timber stud partitions forming toilet cubicles. Flush timber doors. Square-headed window ope to south wall with uPVC casement window. Vinyl floor finish. Surface-mounted services. Sanitaryware throughout.

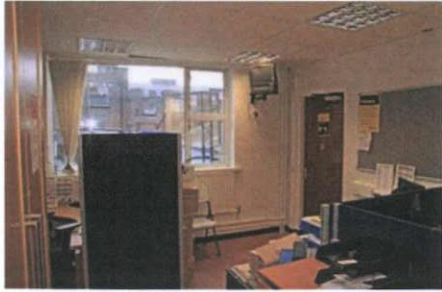
Plate 145: S-10 – View to south-west

Room S-10: Accessed from corridor to east. Suspended ceiling finished with ceiling tiles. Modern plaster finish to walls. Flush, part-glazed timber door. Square-headed window ope to south wall with uPVC casement window and squared internal timber sill. Modern rectangular-section skirting boards. Linoleum finish to floors. Surface-mounted services.

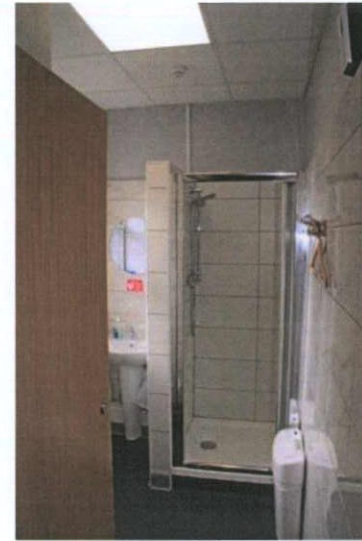
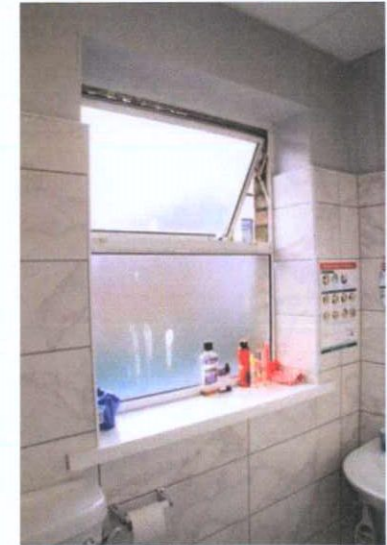
Room S-11: Accessed from lobby to east. Toilet room. Suspended ceiling finished with ceiling tiles. Ceramic tile finish to walls with modern plaster finish at height. Flush timber door. Square-headed window ope to south wall with uPVC casement window and squared internal timber sill. Vinyl floor finish. Surface-mounted services. Sanitaryware throughout.

Plate 147: S-11 – View to west

Plate 148: S-11 – View to south

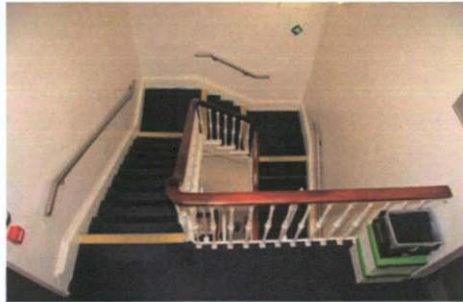
Plate 153: T-1 – View to north

Room T-1: Accessed from Room S-1. Stairwell accessing lower floors. Open well, open-string staircase, having nosed timber treads with rubber and steel contrast strips and timber risers, covered in carpet, with balustrade formed of carved timber handrail, continuous and ramped at landings, with infill of carved timber balusters with collars. Balustrade continues to east at third floor landing to form guarding. Additional modern steel handrail to outer walls. Plaster finish to soffit of rising staircase; remainder of ceiling is finished in plasterboard. Modern flush timber doors. Timber skirting boards with ovolo profile. Carpet finish to landings.

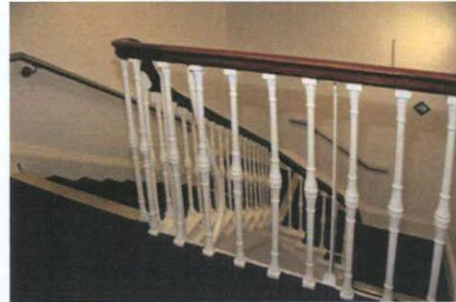
Plate 154: T-1 – Detail to balustrade at third floor landing

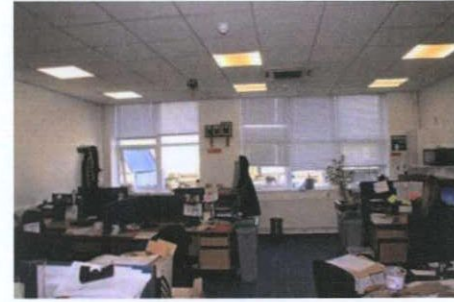
Plate 155: T-2 – View to west

Room T-2: Accessed from Room T-1. Suspended ceiling finished with ceiling tiles. Modern plaster finish to walls; plasterboard finish to timber stud partition east. Flush, part-glazed timber doors and flat timber architraves. Large, square-headed window opens to west wall with uPVC casement windows, partially concealed by suspended ceiling, having squared internal timber sills. Modern rectangular-section skirting boards. Carpet finish to floors.

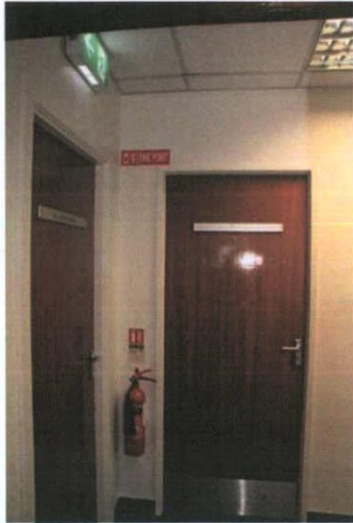
Plate 157: T-3 – View to east

Room T-3: Accessed from Room T-1. Suspended ceiling finished with ceiling tiles. Modern plaster finish to walls; plasterboard finish to timber stud partition to north. Flush timber doors and flat or modestly carved timber architraves. Modern rectangular-section skirting boards. Carpet finish to floors.

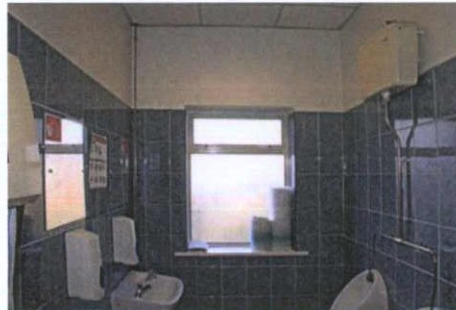
Plate 158: T-4 – View to west

Room T-4: Accessed from Room T-3. Toilet room. Suspended ceiling finished with ceiling tiles. Ceramic tile finish to walls, with modern plaster finish at height, and to toilet cubicles. Flush timber doors. Square-headed window opens to west wall with uPVC casement windows and squared internal timber sill. Vinyl floor finish. Surface-mounted services. Sanitaryware throughout.

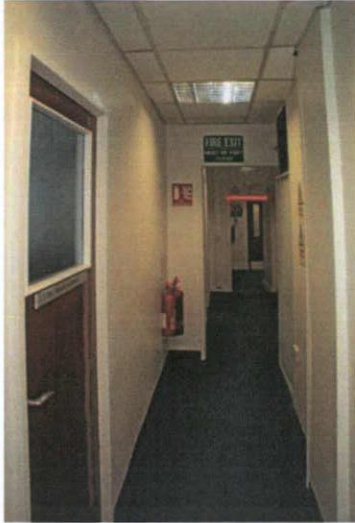
Plate 161: T-5 – View to south

Room T-5: Accessed from Rooms T-1, T-6, T-7 and T-8. Corridor on north-south axis. Suspended ceiling finished with ceiling tiles. Modern plaster finish to walls; plasterboard finish to timber stud partitions to east, west and north. Modern rectangular-section skirting boards. Flush, part-glazed timber doors and flat timber architraves. Door opening in south party wall provides access into Number 60 O'Connell Street Upper. Carpet finish to floors.

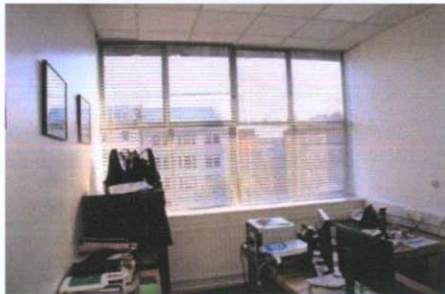
Plate 165: T-7 – View to east

Room T-7: Accessed from Room T-5. Suspended ceiling finished with ceiling tiles. Modern plaster finish to walls; plasterboard finish to timber stud partitions to west, north and south. Square-headed window ope to front elevation with multi-pane aluminium casement windows. Modern rectangular-section skirting boards. Flush, part-glazed timber door. Carpet finish to floors. Surface-mounted services.

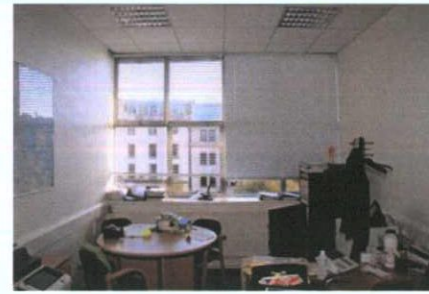
Plate 167: T-8 – View to east

Room T-8: Accessed from Room T-5. Suspended ceiling finished with ceiling tiles. Modern plaster finish to walls; plasterboard finish to timber stud partitions to west and north. Square-headed window ope to front elevation with multi-pane aluminium casement windows. Modern rectangular-section skirting boards. Flush timber door. Carpet finish to floors. Surface-mounted services.

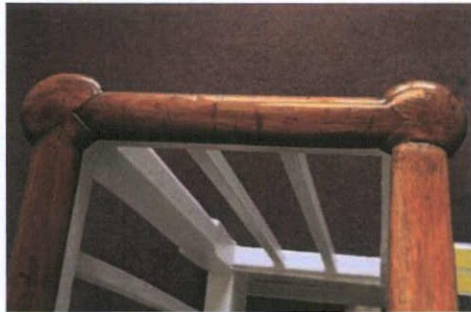
Plate 169: T-9 – Detail to balustrade

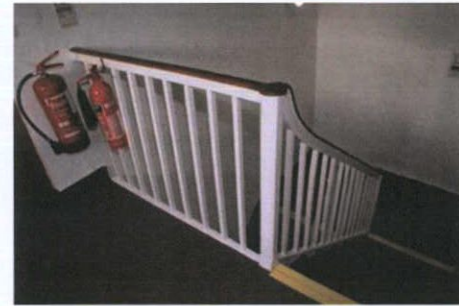
Plate 171: T-9 – Detail to balustrade

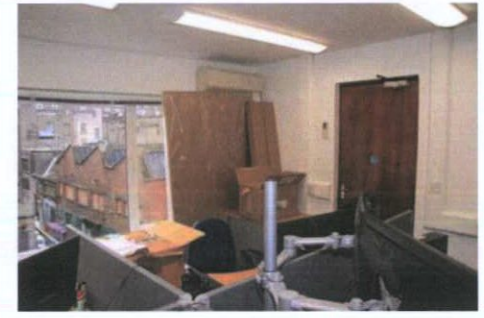
Plate 176: T-11 – View to south-west

Room T-11: Accessed from Room T-9. Plasterboard finish to ceiling. Modern plaster finish to walls. Flush timber door. Square-headed window open to south wall with uPVC casement windows and squared internal timber sill. Modern rectangular-section skirting boards. Carpet finish to floors. Surface-mounted services.

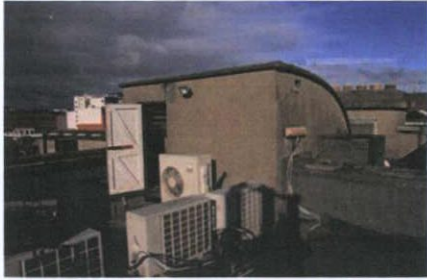
Plate 177: FO-1 – View to north-west

Room FO-1: Enclosure to flat roof of main building. Cementitious render to external walls. Enclosure is half-round in section, with curvilinear roof continuing to wall on north side. Formed internally by timber joists on east-west axis and infill of timber battens, with timber decking over. Exposed timber studs internally to flanking walls to east and west, with exposed rendered infill panels. Single square-headed window to west wall with flat timber architrave and clear plastic infill. Plant noted throughout.

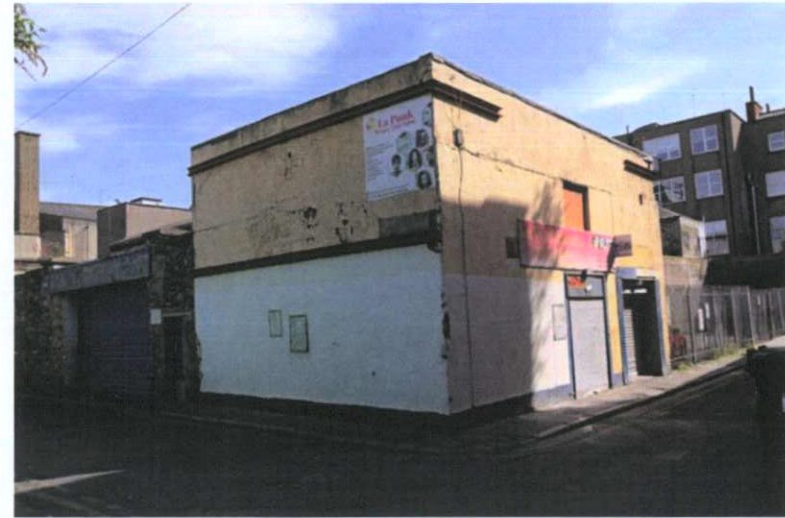
Plate 1: Exterior of 60A O'Connell Street Upper

Two-bay, two-storey former mews building. Flat roof. Rubble Calp limestone external walls, finished with cementitious render. External walls supported by steel braces. Blind elevation to north. Former, original cruciform ventilation opening to high level, west elevation, now blocked-up. Square-headed window ope to first floor to south elevation, now blocked-up and flanked by blocked-up original, vertical ventilation slit openings. Evidence of two former window openings to ground floor to south elevation, blocked-up and concealed with render. Two square-headed shop entrances to south elevation, with eastern ope forming infill to possible former carriage openings. Eastern ope supported by exposed lintel, and having exposed bulkhead concealing roller shutter, forming fascia. Both opes now infilled with modern-glazed timber doors with glazed sidelights / shop windows over timber stall risers. Raised, rendered surrounds to openings.

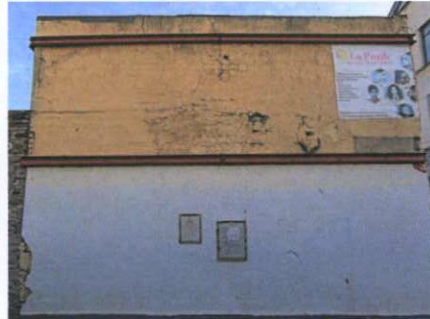
Plate 3: West elevation; former cruciform ventilation opening to high level

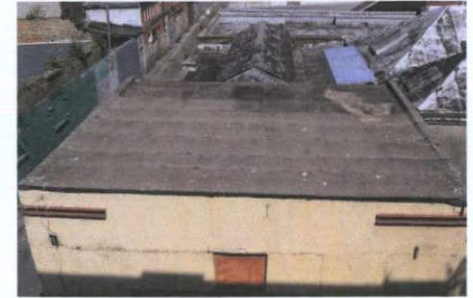
Plate 5: Flat roof as viewed from south

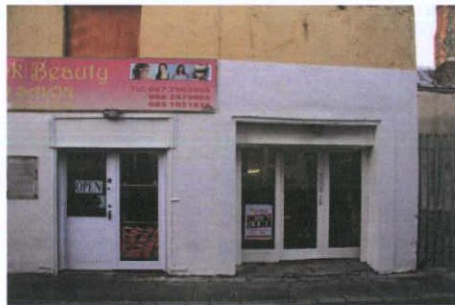
Plate 6: Possible former carriage opening to east (right)

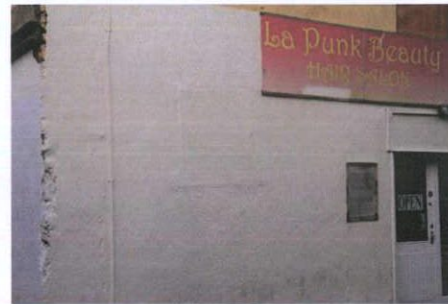
Plate 7: Ghost mark of former window opening

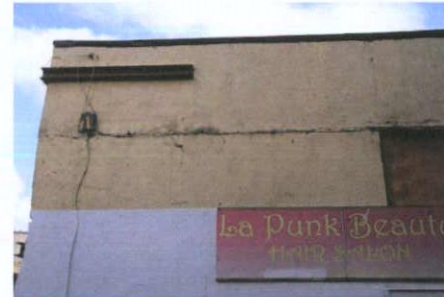
Plate 8: Former slit window, now blocked-up, noted to first floor to south elevation

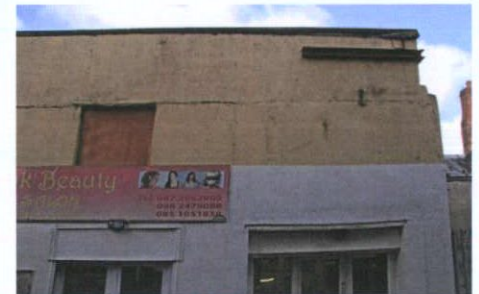
Plate 9: Former slit window, now blocked-up, noted to first floor to south elevation

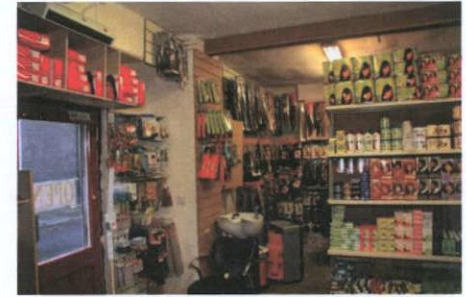
Plate 13: G-2 – View to west

Room G-2: Accessed from external commercial entrance from Henry Place and from Rooms G-2 and G. Plaster-board finish to ceiling, supported by downstand steel bressummer, bearing onto rendered nib to south wall. Modern plaster finish to walls, with some commercial fit-out timber linings; exposed stringer / enclosure to stairwell forming Room G-3 to north, finished in modern timber linings and fibreboard. Evidence of large former opening in east wall, now blocked up and plastered. Modern part-glazed timber doors and shop windows to south wall. Square-headed doorway with plastered reveals accessing Room G-1 to east. Concrete finish to floor. Surface-mounted services.

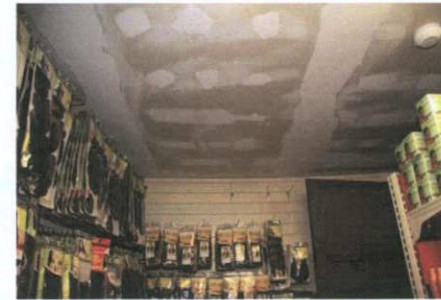
Plate 16: G-2 – View to north with ceiling finish; access to Room G-3 to east (right)

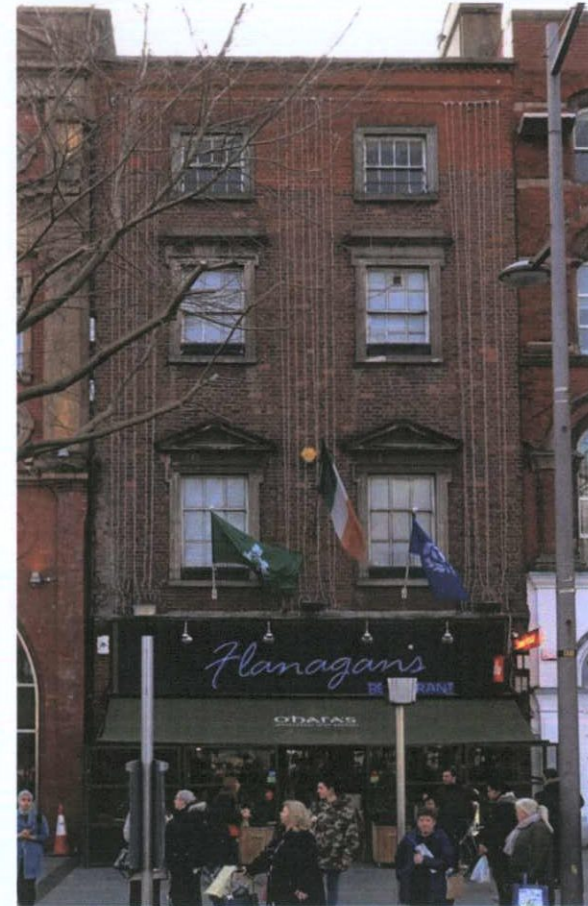
Plate 1: Front façade, 61 O'Connell Street Upper

Four-storey, two-bay building with red-brick upper façade. The shopfront is modern. The brickwork has a newer section above sill level on the third floor, indicating reconstruction and the dentil brickwork beneath the copings are part of this later work. The brickwork on first and second floors appears to be handmade and given the proportions of the building it is likely that the façade is a survival from an earlier period. The windows have moulded architraves and have pediments at first-floor level and cornices on the second floor. The sills are skimmed with sand and cement and appear to be of granite and lime washed beneath.

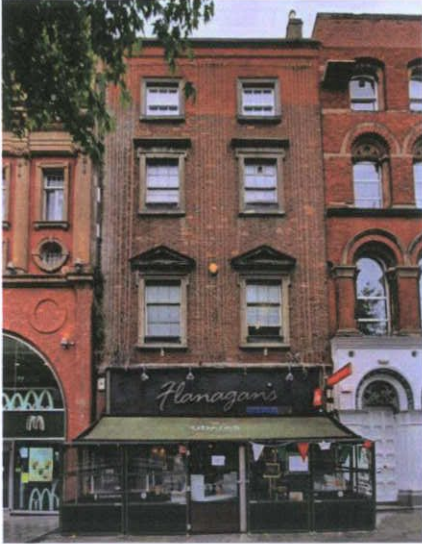
Plate 2: Front (east) elevation

Two-bay, four-storey-over-basement attached building. M-profile roof, having mix of natural and synthetic slate, and lead central and parapet valleys. Rendered chimney stacks to north. Granite copings over rebuilt red brick parapet wall having later dentillated eaves cornice. Rebuilt red brick to third floor. Front (east) façade comprised of red brick laid in Flemish bond. Three-over-six timber sash windows to first floor and six-over-six timber sash windows to second floor, having lugged, Roman cement architraves and hood mouldings, repaired with cement, pedimented to first floor; recent three-over-three timber sash windows to third floor, having moulded cement architraves; granite sills with later rendered finish throughout. Modern shop front.

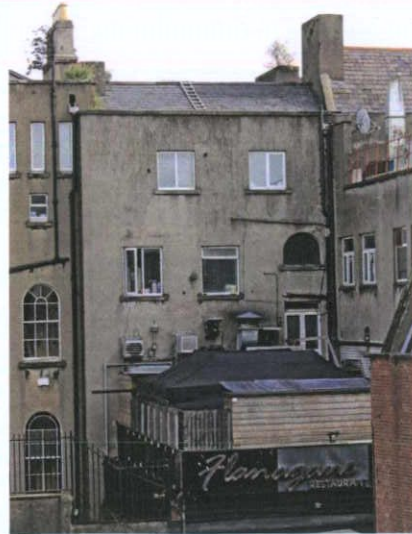
Plate 7: Rear (west) elevation

Granite coping over cementitious render to rear (west) elevation. Square-headed window openings with uPVC casement windows throughout. Remnant of original round-headed window to second floor half-landing, with later granite sill and infilled with wired glass. Three-storey extensions to rear, having modern timber and steel cladding and fabric canopy / awning to first floor roof. uPVC rainwater goods.

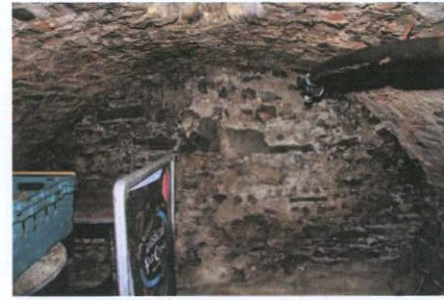
Room B-2: Accessed from Room B-1. Original 18th century cellar. Red brick, barrel-vaulted ceiling, continuous with walls. Circular coal hole opening to centre plan, blocked up above. Low-level, irregularly shaped opening in north wall accessing Room B-3, blocked up to north side. Rubble calp limestone walls to east and west. Square-headed door opening to west, with cut timber door frame; modern steel door. Concrete floor finish. Surface-mounted services.

Plate 10: B-2 - View to east; 18th century cellar

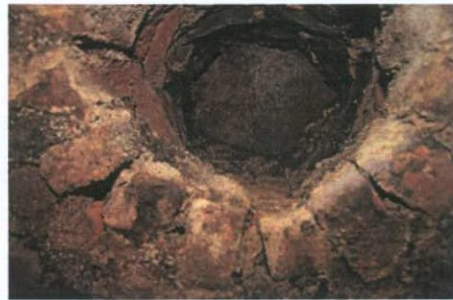
Plate 12: B-2 - Coal hole to soffit of vault

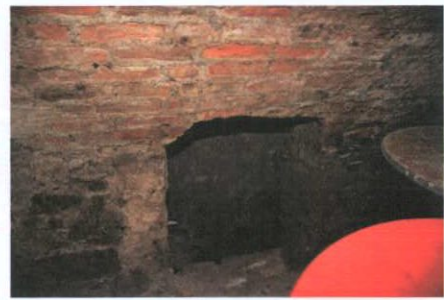
Plate 13: B-2 - View to north towards Room B-3

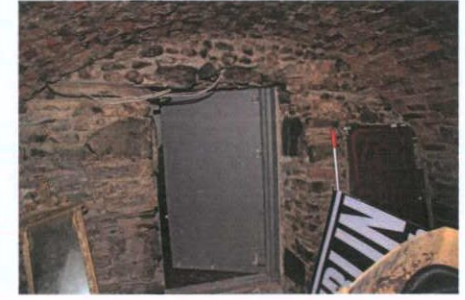
Room B-3: Accessed from Room B-1. Original 18th century cellar. Red brick, barrel-vaulted ceiling, continuous with walls. Circular coal hole opening to centre plan, blocked up above. Rubble calp limestone walls to east and west. Square-headed door opening to west, with cut timber door frame; modern steel door. Concrete floor finish. Surface-mounted services.

Plate 15: B-3 - View to west

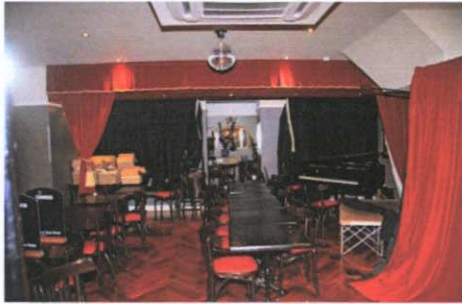
Plate 16: B-4 – View to east

Room B-4: Accessed from Rooms B-1 and B-5. Projecting nibs of former chimney breast retained to north wall. Plasterboard finish to ceiling. Downstand bressummer to centre plan under spine wall on north-south axis, bearing on projecting nibs / piers. Square-section column to south-west supporting ceiling. Downstand building service bulkheads and exposed soffit of rising staircase to south-east; timber stud partition to south enclosing stairwell to ground floor. Plaster finish to walls; some ceramic tile finishes to north-west. Flush timber doors and flat timber architraves, timber skirting boards and carved timber picture rail. Modern parquet timber floor. Modern timber bar and backbar to north-west.

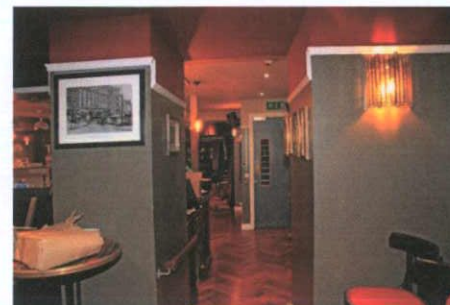
Room B-5: Accessed from Rooms B-4 and B-6. Plasterboard finish to ceiling. Plaster finish to walls; some ceramic tile finishes to north. Square-headed openings in rear elevation of main building former partition to east, leading into Room B-4. Flush timber doors and flat timber architraves, timber skirting boards and carved timber picture rail. Modern parquet timber floor.

Plate 22: B-5 – View to east towards Room B-4

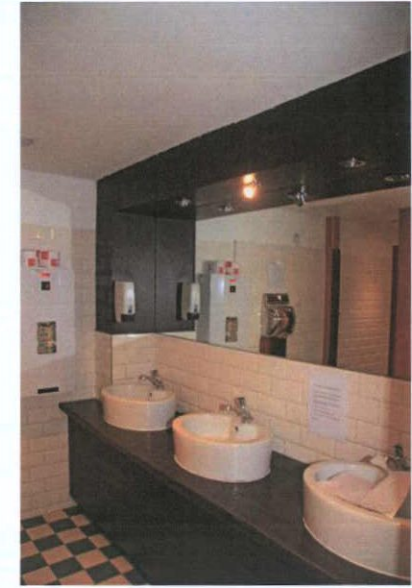
Plate 27: B-8 – View to west

Room B-8: Accessed from Room B-6. Toilet room. Plasterboard finish to ceiling. Ceramic tile finish to walls and timber stud toilet cubicle partitions. Flush timber doors and flat timber architraves. Ceramic tile finish to floor. Sanitaryware throughout.

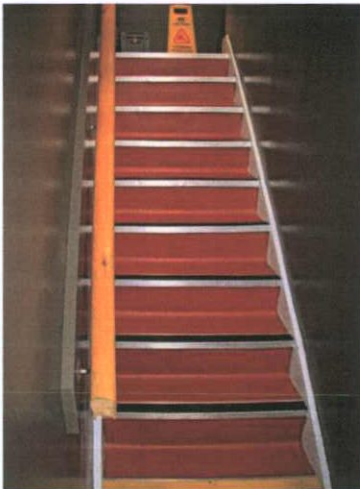
Room B-9: Accessed from Room B-6. Stairwell to ground floor. Straight flight, closed-string staircase having treads and risers with rubber contrast strips, finished with carpet; rectangular-section stringers. Modern carved timber handrail affixed to wall to east. Plasterboard finish to ceiling. Plaster finish to walls. Modern skirting boards to landings having beaded profile. Carpet finish to landings.

Plate 28: B-9 – View to south towards ground floor landing

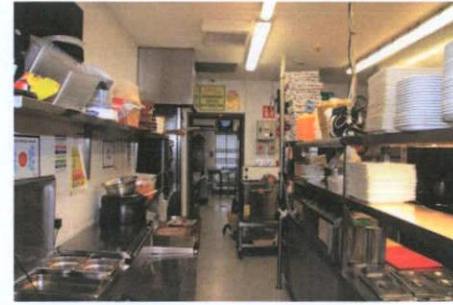
Plate 39: F-2 – View to east

Room F-2: Accessed from Rooms F-1, F-3 and F-4. Chimney breast to north wall remains legible on plan; fireplace now blocked up. Plasterboard finish to ceiling. Plaster finish to walls, with some areas to west and south finished in stainless steel cladding / splashbacks. Flush timber door; modern timber joinery. Vinyl finish to floor. Surface-mounted services.

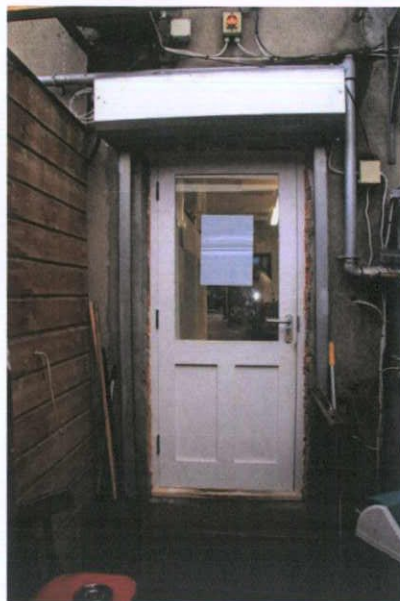
Plate 46: F-5 – View to east

Room F-5: Accessed from Room F-2. Outdoor seating area to flat roof, now enclosed. Fabric awning/roof covering supported on retractable canopies. External screens / walls clad in timber boarding. Modern timber doors and joinery. Brickwork / tile flooring covered in synthetic coverings.

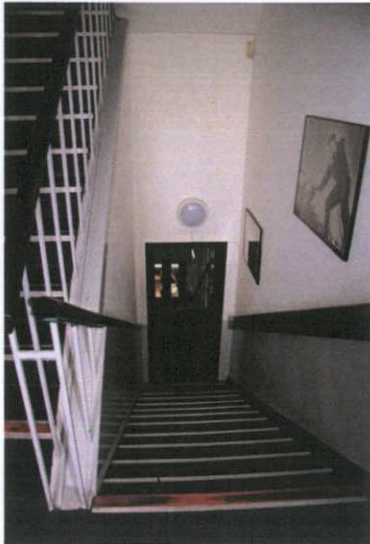
Plate 49: S-1 – View to east towards first floor

Room S-1: Accessed from Room F-1. Stairwell accessing second and third floors. Replacement dog-leg, closed-string flight of stairs, with treads and risers finished in vinyl, rubber contrast strips to treads. Balustrade comprised of carved timber handrail with infill of square-section cast-iron balusters; handrails are divided at landings. Additional rectangular-section handrail affixed to south wall of rising flight. Plasterboard finish to ceilings and to soffit of rising staircase. Modern plaster finishes to walls and to partitions enclosing flights above and below. Replacement rectangular-section skirting boards / stringers. Flush timber doors and flat timber architraves; modern double-leaf doors to west wall at half-landing accessing fire escape. Vinyl finish to landings. Surface-mounted services.

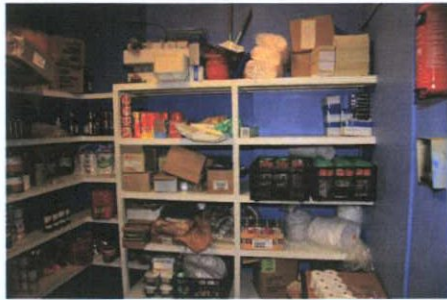
Plate 61: S-7 – View to north

Room S-7: Accessed from Room S-6. Projecting chimney breast to north wall; now blocked up, interrupted by non-original partition to east. Plasterboard finish to ceiling. Modern plaster finish to walls; timber stud partitions to east and south finished in plasterboard and timber boarding with exposed frames. Flush timber doors and flat timber architraves. Modern skirting boards. Modern floor finishes.

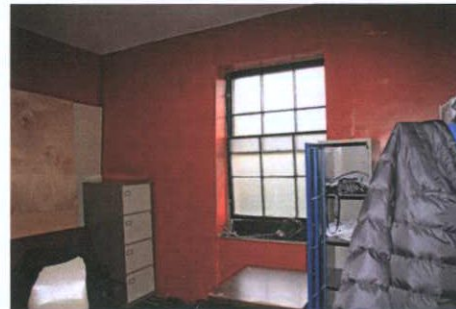
Plate 62: S-8 – View to north-east

Room S-8: Accessed from Room S-6. Plasterboard finish to ceiling. Modern plaster finish to walls; timber stud partitions to west and north finished in plasterboard and timber boarding with exposed frames. Flush timber doors and flat timber architraves. Six-over-six timber sash window to east wall with nosed internal timber sill. Modern skirting boards. Modern floor finishes. Surface-mounted services.

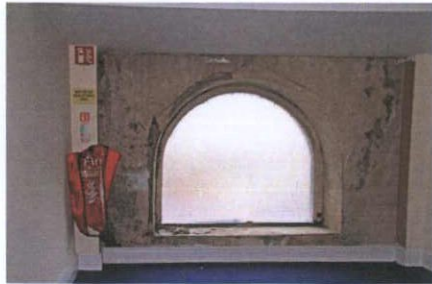
Plate 68: T-1 – View to west

Room T-1: Accessed from Room S-1. Stairwell accessing lower floors. Replacement dog-leg, closed-string flight of stairs, with treads and risers finished in carpet, rubber contrast strips to treads. Balustrade comprised of carved timber handrail with infill of square-section cast-iron balusters; handrails are divided at landings. Plasterboard finish to ceilings and to soffit of rising staircase. Modern plaster finishes to walls and to partitions enclosing flights above and below. Replacement rectangular-section skirting boards / stringers. Flush timber doors and flat timber architraves; remnant of original round-headed window to west wall at half-landing, enclosed with wired glass; flat plastered reveals and vestige of simple moulding to surround. Carpet finish to landings.

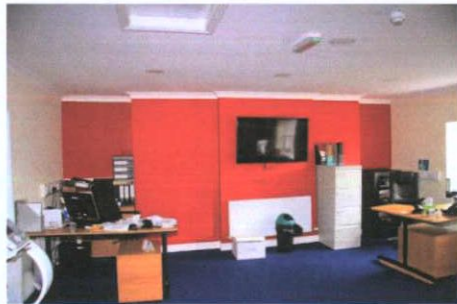
Plate 72: T-2 – View to north

Room T-2: Accessed from Rooms T-1 and T-3. Projecting chimney breast to north wall; now blocked up. Plasterboard finish to ceiling; non-original coving to ceiling perimeter. Modern plaster finish to walls. Modern timber doors and flat timber architraves. Opening in west spine wall enclosed with modern part-glazed timber panelled door flanked by mullioned screen with opaque glazing. Three-over-three timber sash windows to east wall with nosed internal timber sills. Modern skirting boards. Carpet finish to floor. Surface-mounted services

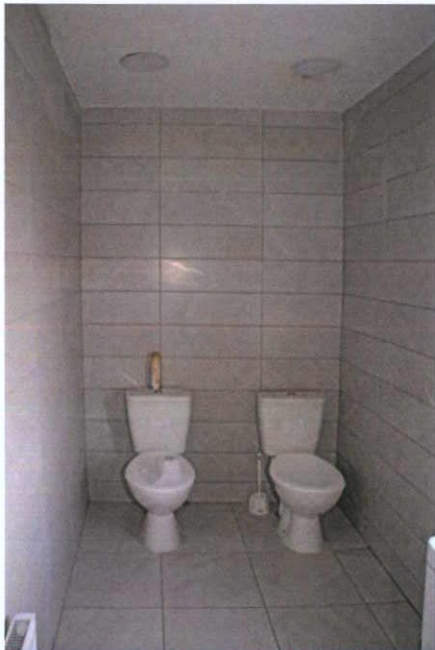
Plate 80: T-4 – View to south

Room T-4: Accessed from Rooms T-3 and T-5/ Toilet room. Plasterboard finish to ceiling. Ceramic tile finish to walls; timber stud partitions east and north finished in ceramic tile. Modern timber doors and flat timber architraves. Square-headed window opening to west wall with uPVC casement window. Ceramic tile finish to floor. Sanitaryware throughout.

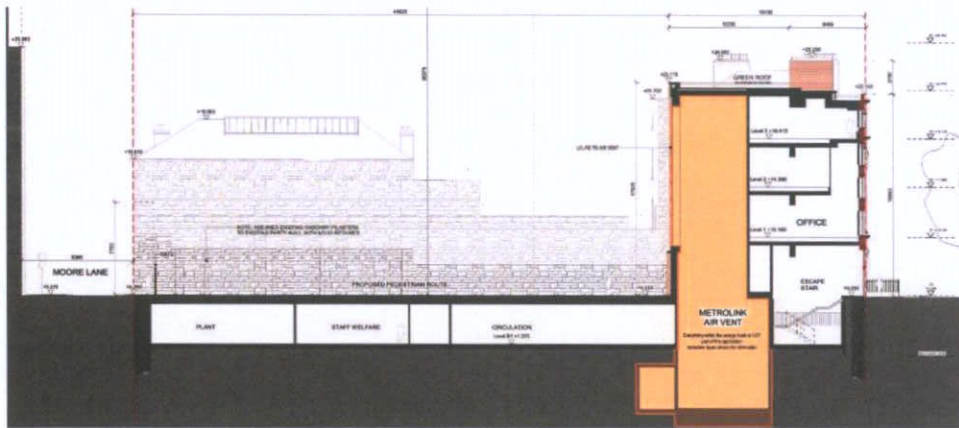
Fig. 2 Section, facing towards north boundary wall between Nos.42 and 43 O'Connell Street Upper Underpinning – lining

18th century brickwork was identified in the basement of No. 43, but the present structure was largely reconstructed in the 1920's. The rear wall of No.42 O'Connell Street Upper, and the areas of the party wall exposed above the roof of No.43 have been rendered in a Portland Cement-based mortar. The party wall between No.42 and No.43 O'Connell Street Upper is largely concealed behind later wall linings and Investigative opening up works are required to determine the precise composition of the existing party wall and to establish how the structural relationship between the two entities.

It is proposed to remove the building behind the façade of No.43 and to subsequently reconstruct a four storey-over-basement office building on the site. A ventilation shaft for the Metrolink will be incorporated at the rear of the new building as illustrated in Fig.1 above. Subsequent to further site investigations, detailed proposal for the interfaces between the proposed building and No.42 will be prepared, addressing the sensitivities of this structure to changes to environmental conditions.

An outline demolition strategy has been prepared by Waterman Moylan consulting engineers to ensure the structural integrity of the party wall during both the temporary works and permanent work phases. If the structures are found to require temporary support, raking shores will be positioned within the existing buildings within Site 2 in advance of demolitions. The raking shores will be supported on temporary pad foundations located below the level of the proposed basements. Localised temporary works will be required to protect the existing foundations of No.42

The proposed basement is at a similar level to the existing basement within No.42 O'Connell Street Upper. Trial pits will be required to establish the depth and construction of the existing foundations of No.42 O'Connell Street Upper, and if they are found to be at a significantly higher level than the proposed evacuation level, underpinning may be required along this boundary.
