Site 2 – Site Setup

Site 2 – Construction Sequencing

Site 2 – Temporary Works

Dublin Central

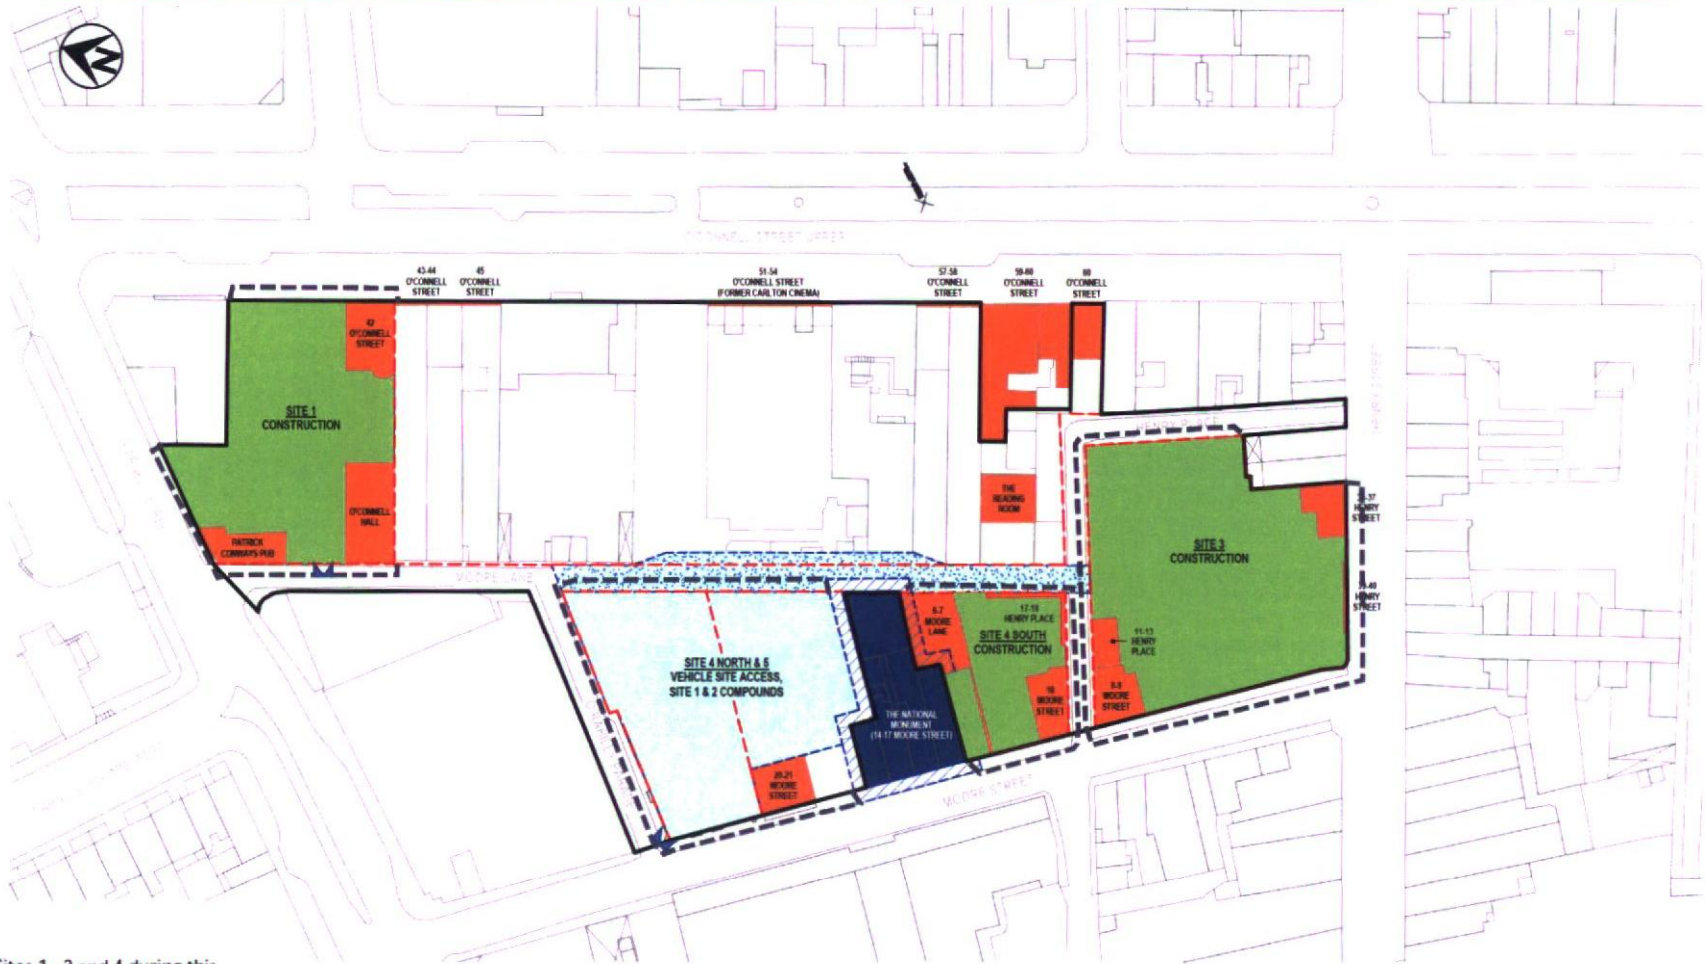
Construction work commences on Sites 1, 3 and 4 during this period, and Site 5 is hoarded off to provide the necessary vehicle unloading area to service all of the construction sites.

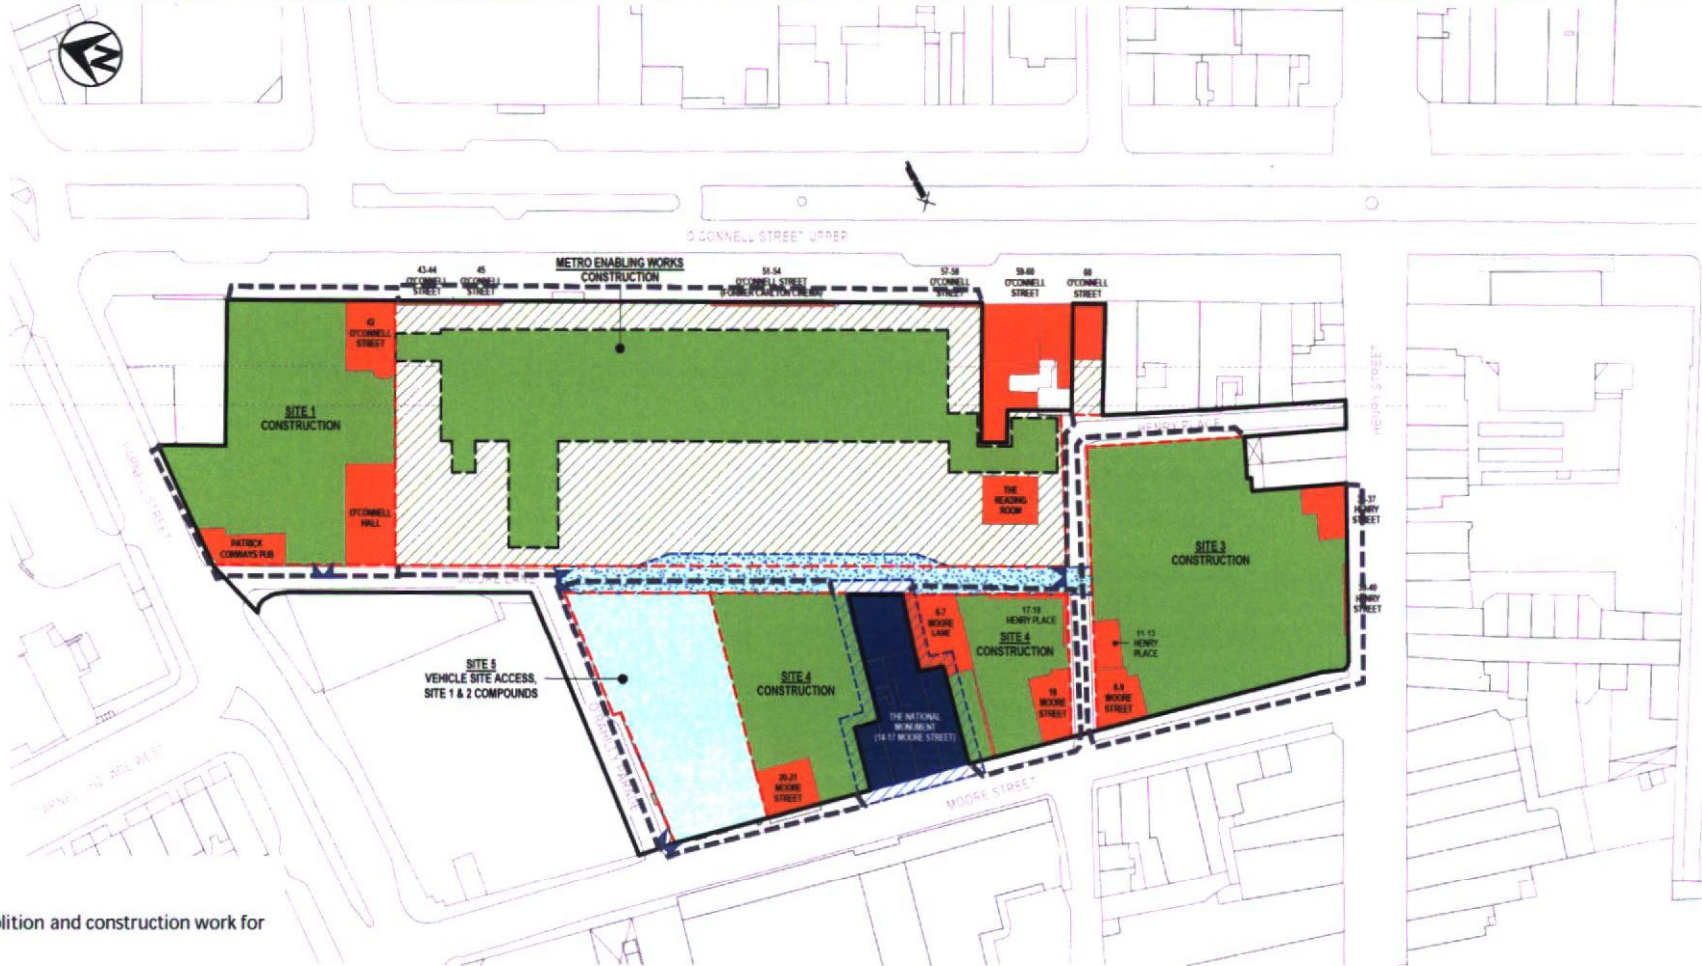
At the start of this period the demolition and construction work for the MEW commences.

Construction work continues on Sites 1, 3 and 4 during this period, and Site 5 remains hoarded off to provide the necessary vehicle unloading area to service all of the construction sites.

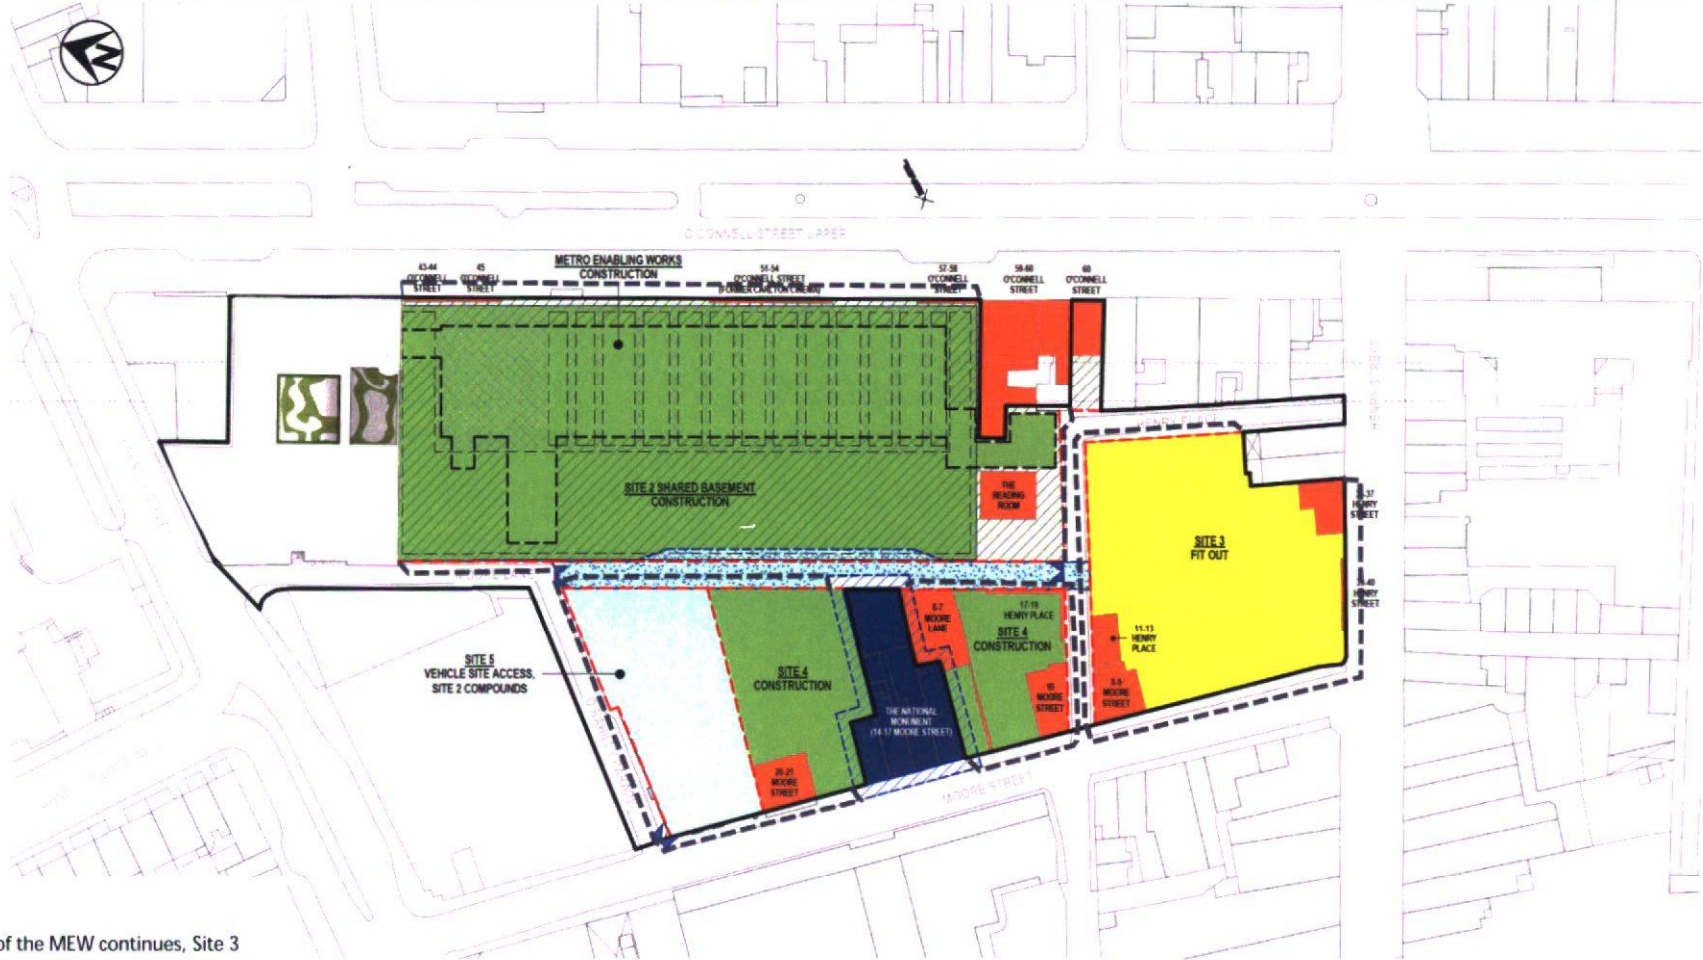
Site 1 completes, the construction of the MEW continues, Site 3 enters its fitting out phase, and Site 4 remains under construction.

Site 5 remains hoarded off to provide the necessary vehicle unloading area to service all of the construction sites.

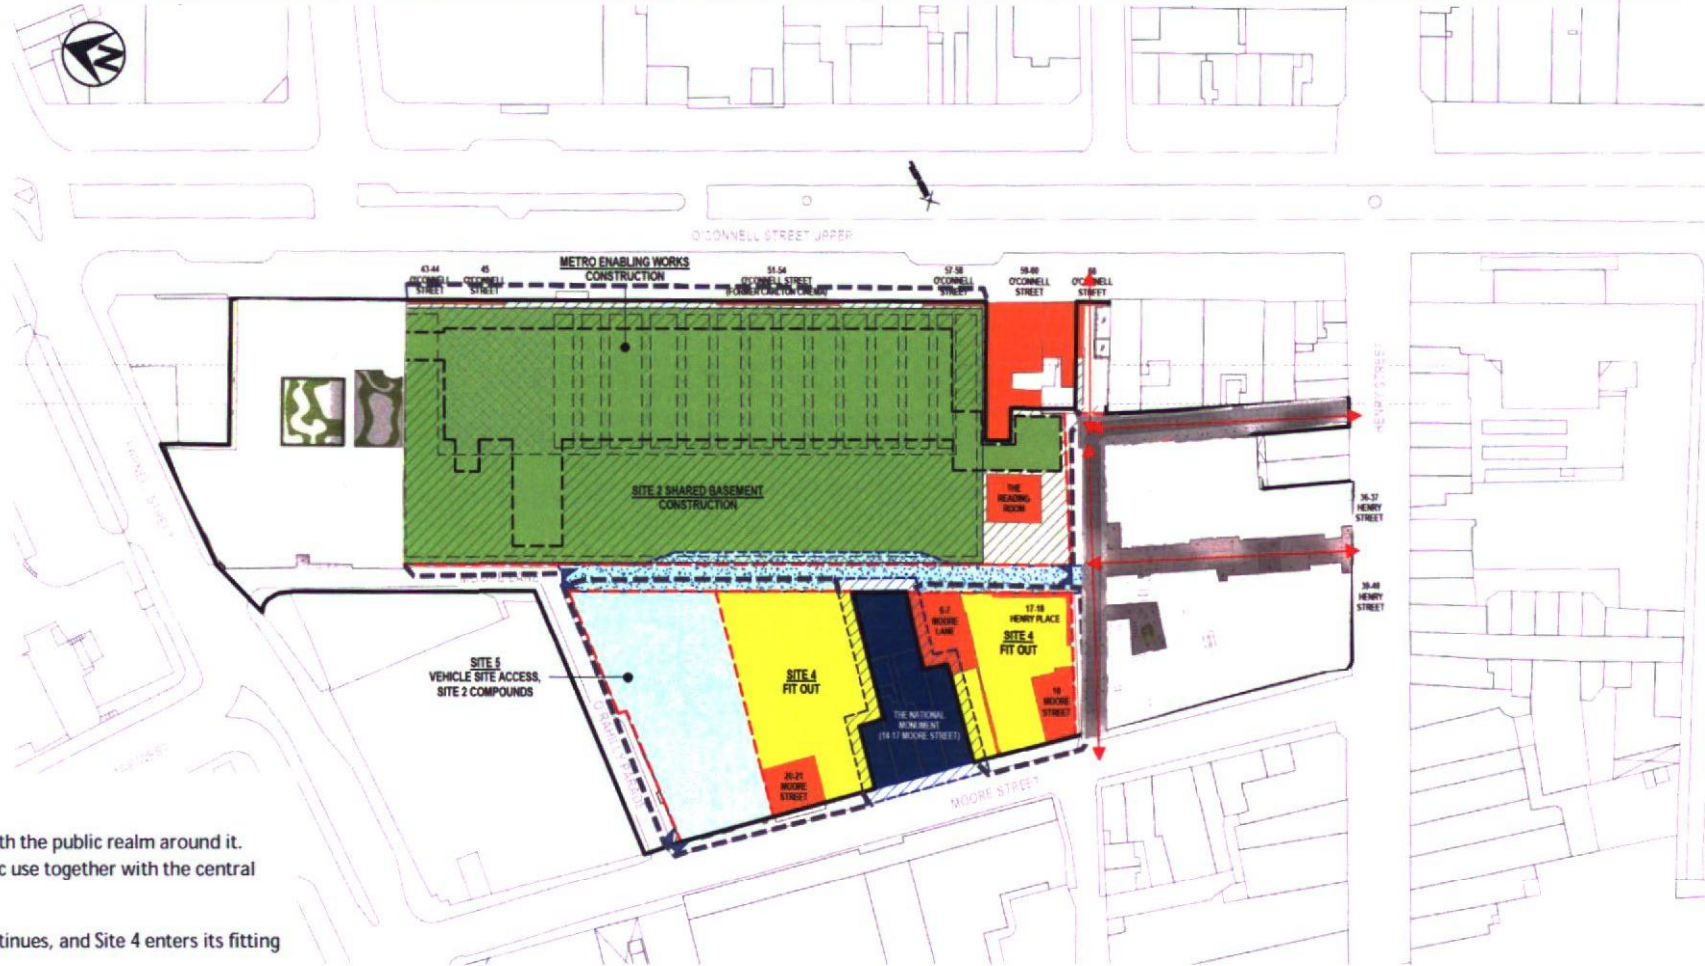
Site 3 now completes together with the public realm around it. Henry Place is opened up to public use together with the central passageway through Site 3.

The construction of the MEW continues, and Site 4 enters its fitting out phase.

Site 5 remains hoarded off to provide the necessary vehicle unloading area to service all of the construction sites.

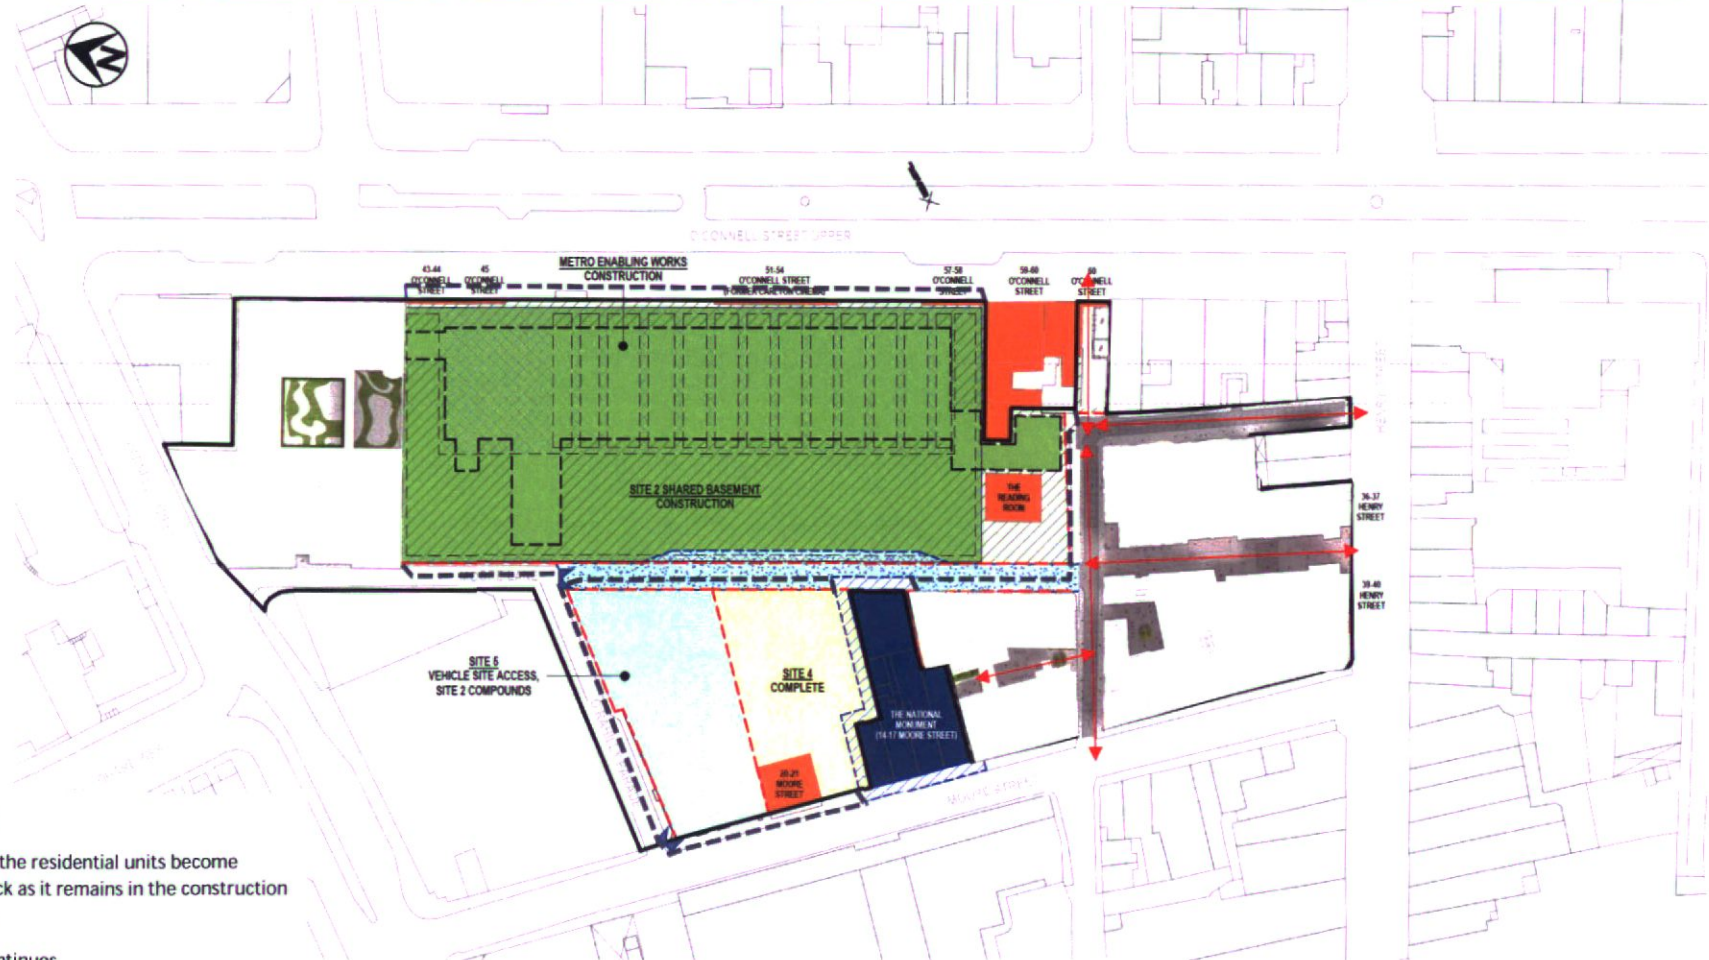
Site 4 South now completes and the residential units become occupied. Site 4 North is held back as it remains in the construction zone without safe public access.

The construction of the MEW continues.

Site 5 remains hoarded off to provide the necessary vehicle unloading area to service all of the construction sites.

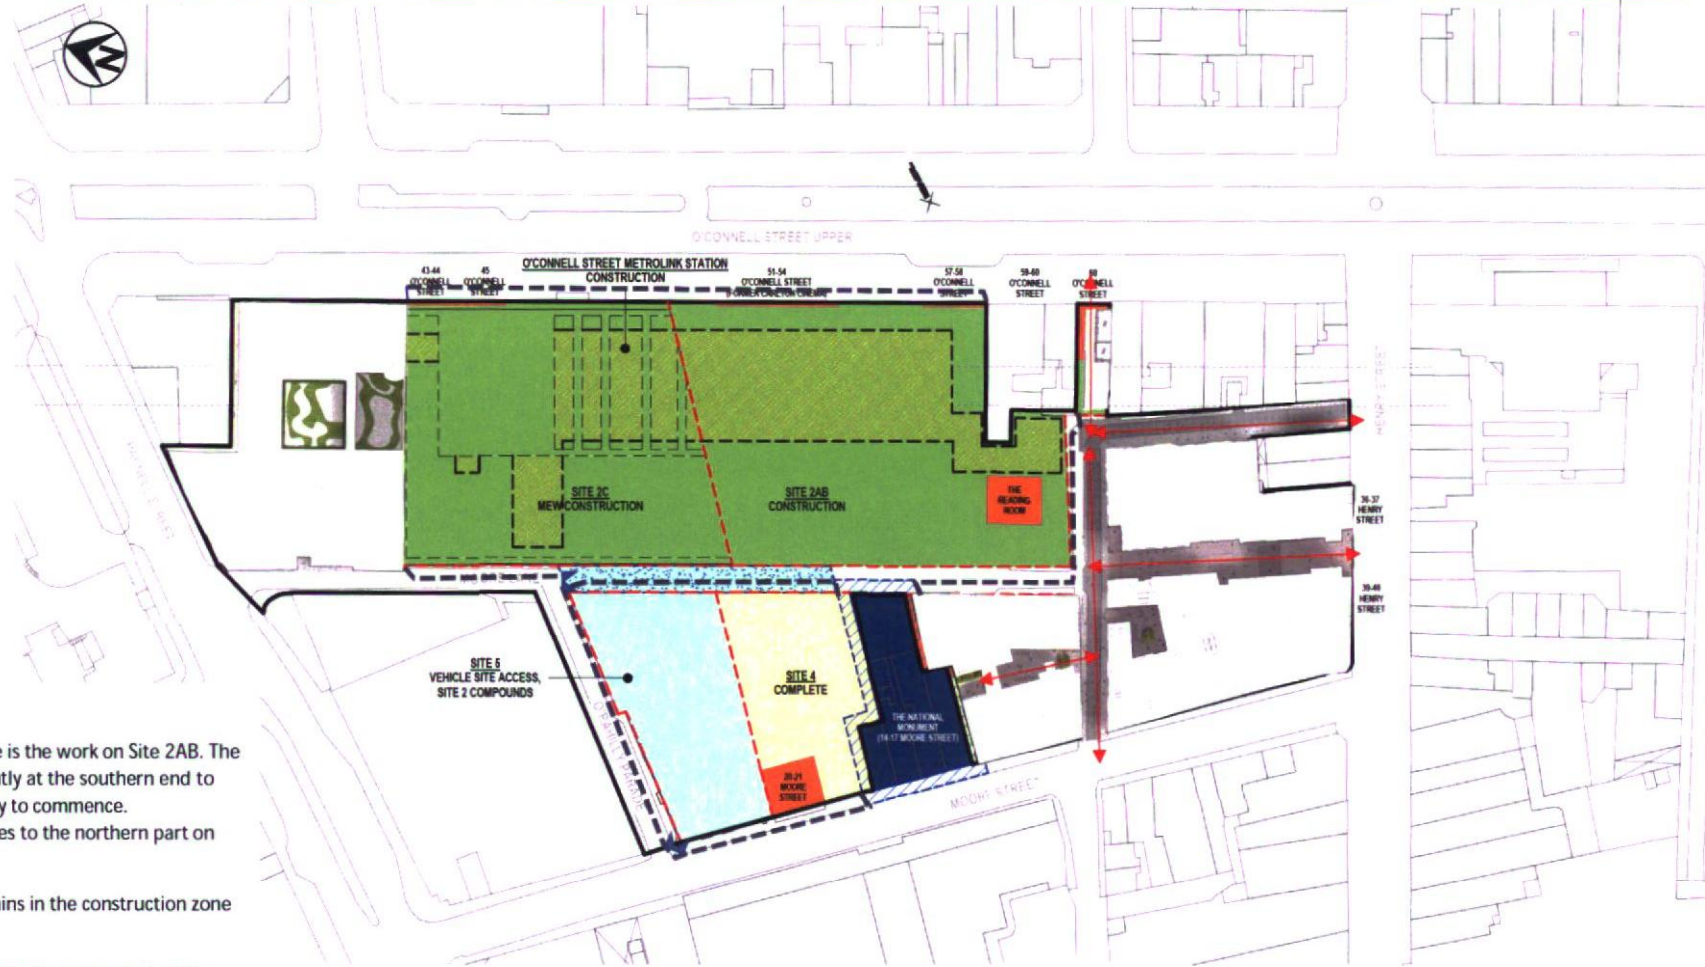
The principal change on this image is the work on Site 2AB. The MEW are now completed sufficiently at the southern end to allow Site 2AB construction activity to commence. Construction on the MEW continues to the northern part on Site 2C.

Site 4 North is held back as it remains in the construction zone without safe public access.

Site 5 remains hoarded off to provide the necessary vehicle unloading area to service all of the construction sites.

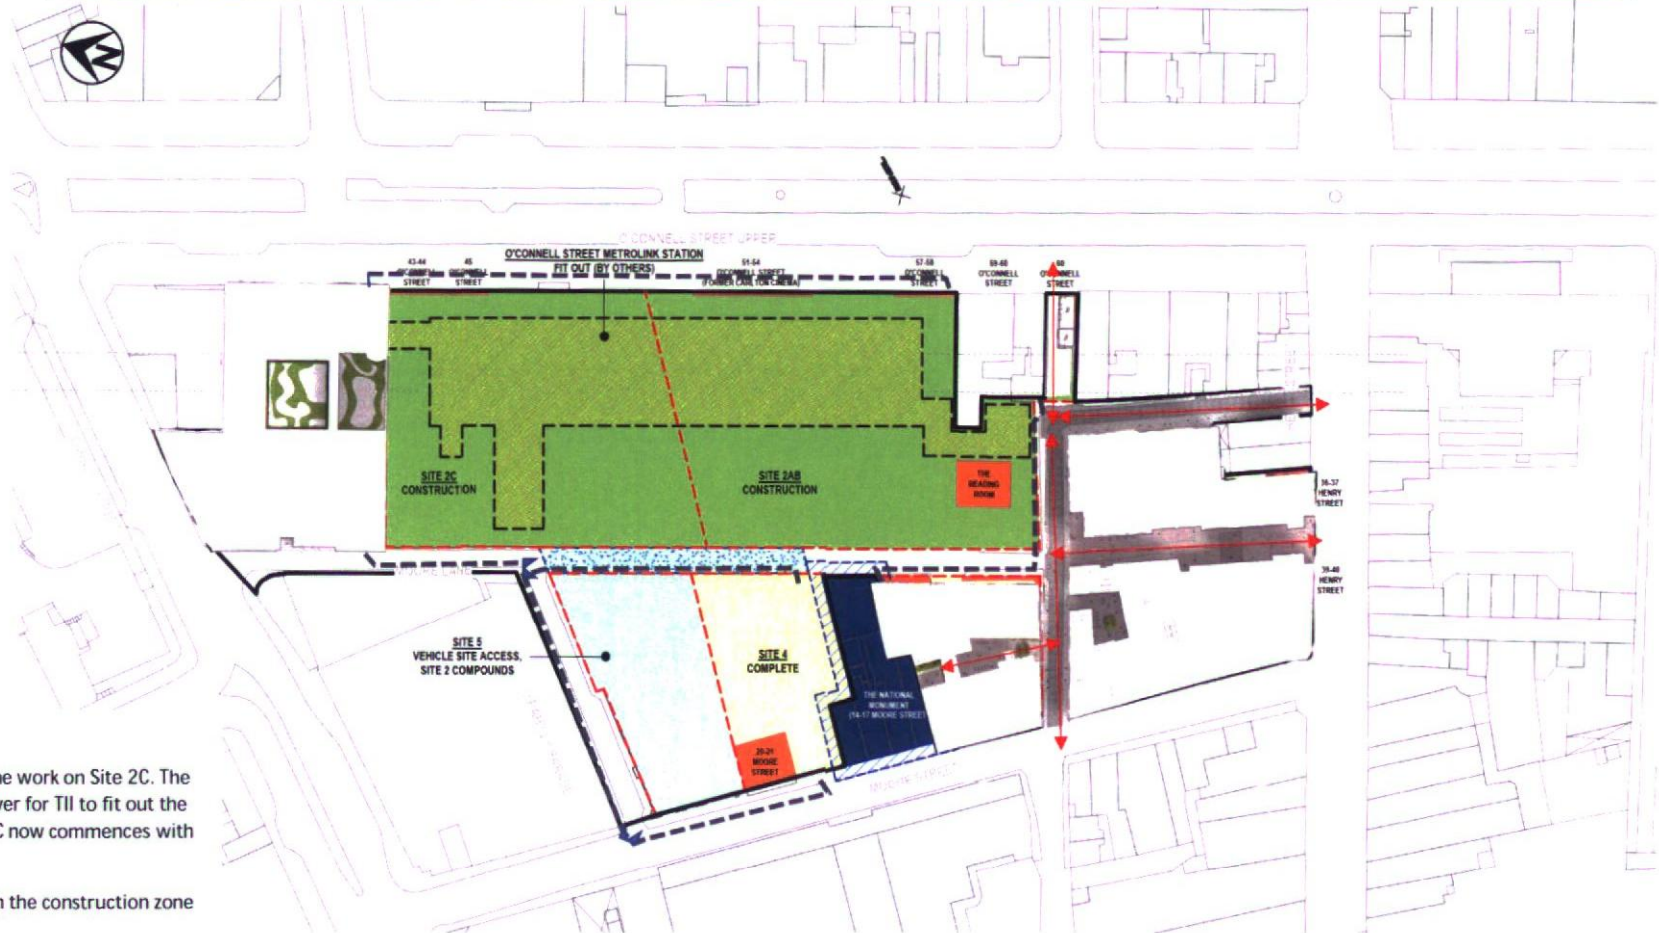
The principal change on this image is the work on Site 2C. The MEW are now complete and handed over for TII to fit out the station, connect the tunnels etc. Site 2C now commences with its construction activity.

Site 4 North is held back as it remains in the construction zone without safe public access.

Site 5 remains hoarded off to provide the necessary vehicle unloading area to service all of the construction sites.

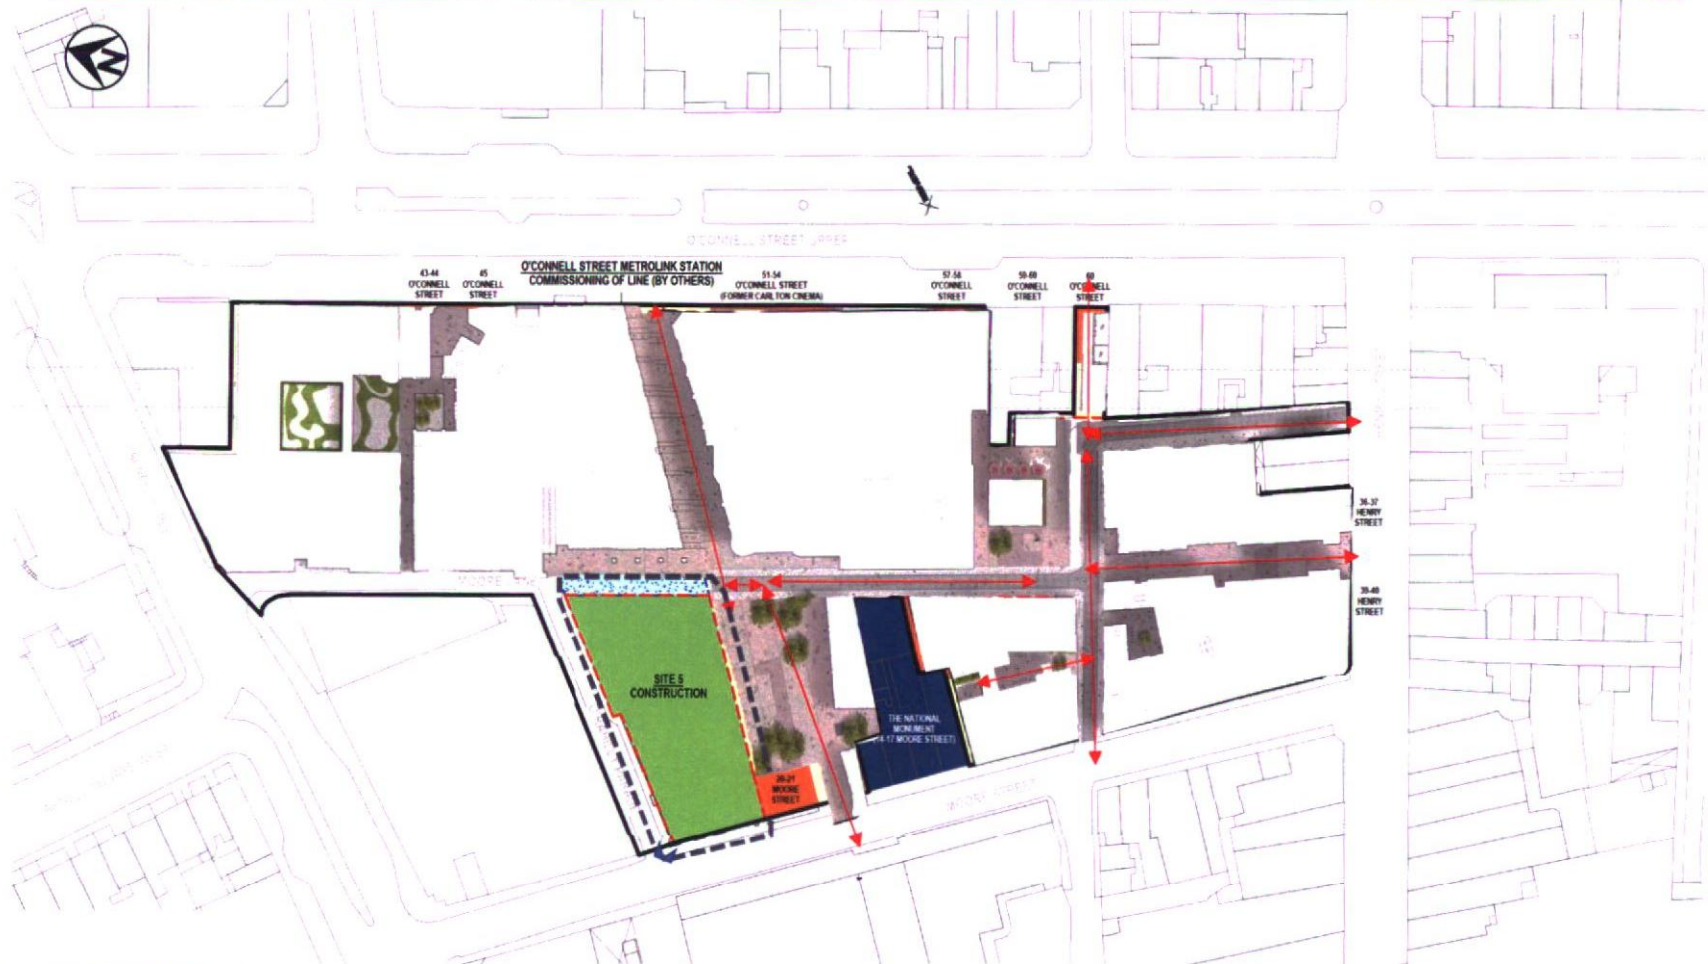
This image shows the works continuing with the construction of Site 5

The Station is now being commissioned.

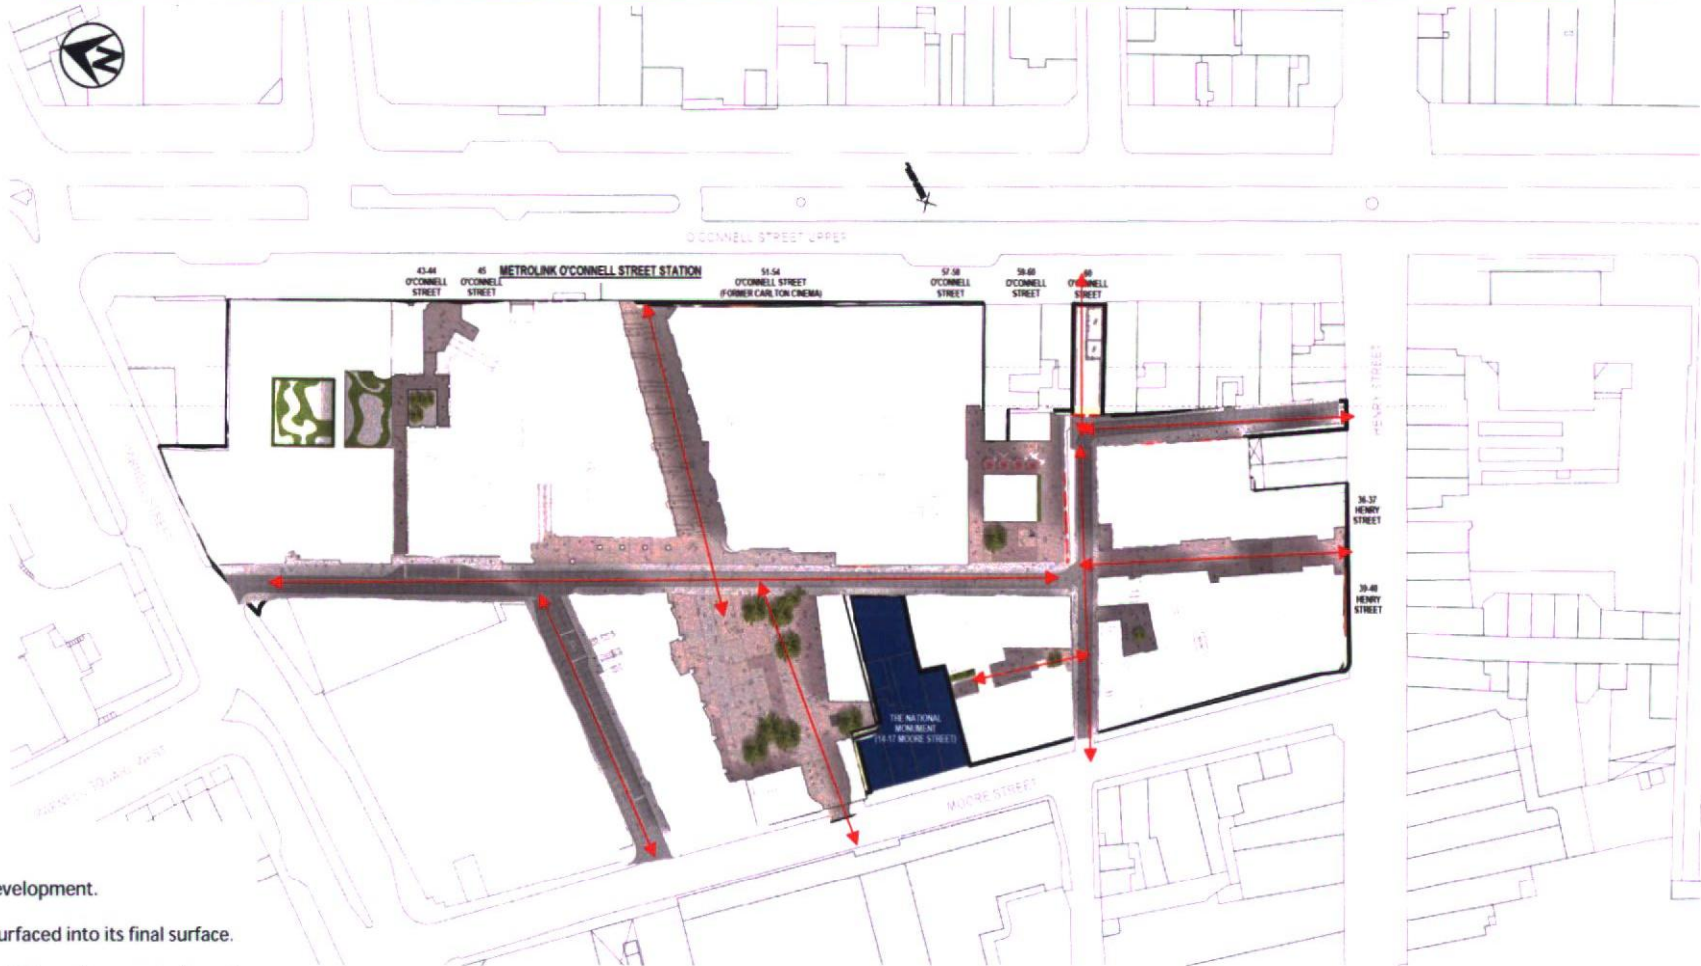
This image shows the completed development.

O'Rahilly Parade will have been resurfaced into its final surface.

Resurfacing the northern section of Moore Lane up to Parnell Street will have been completed.

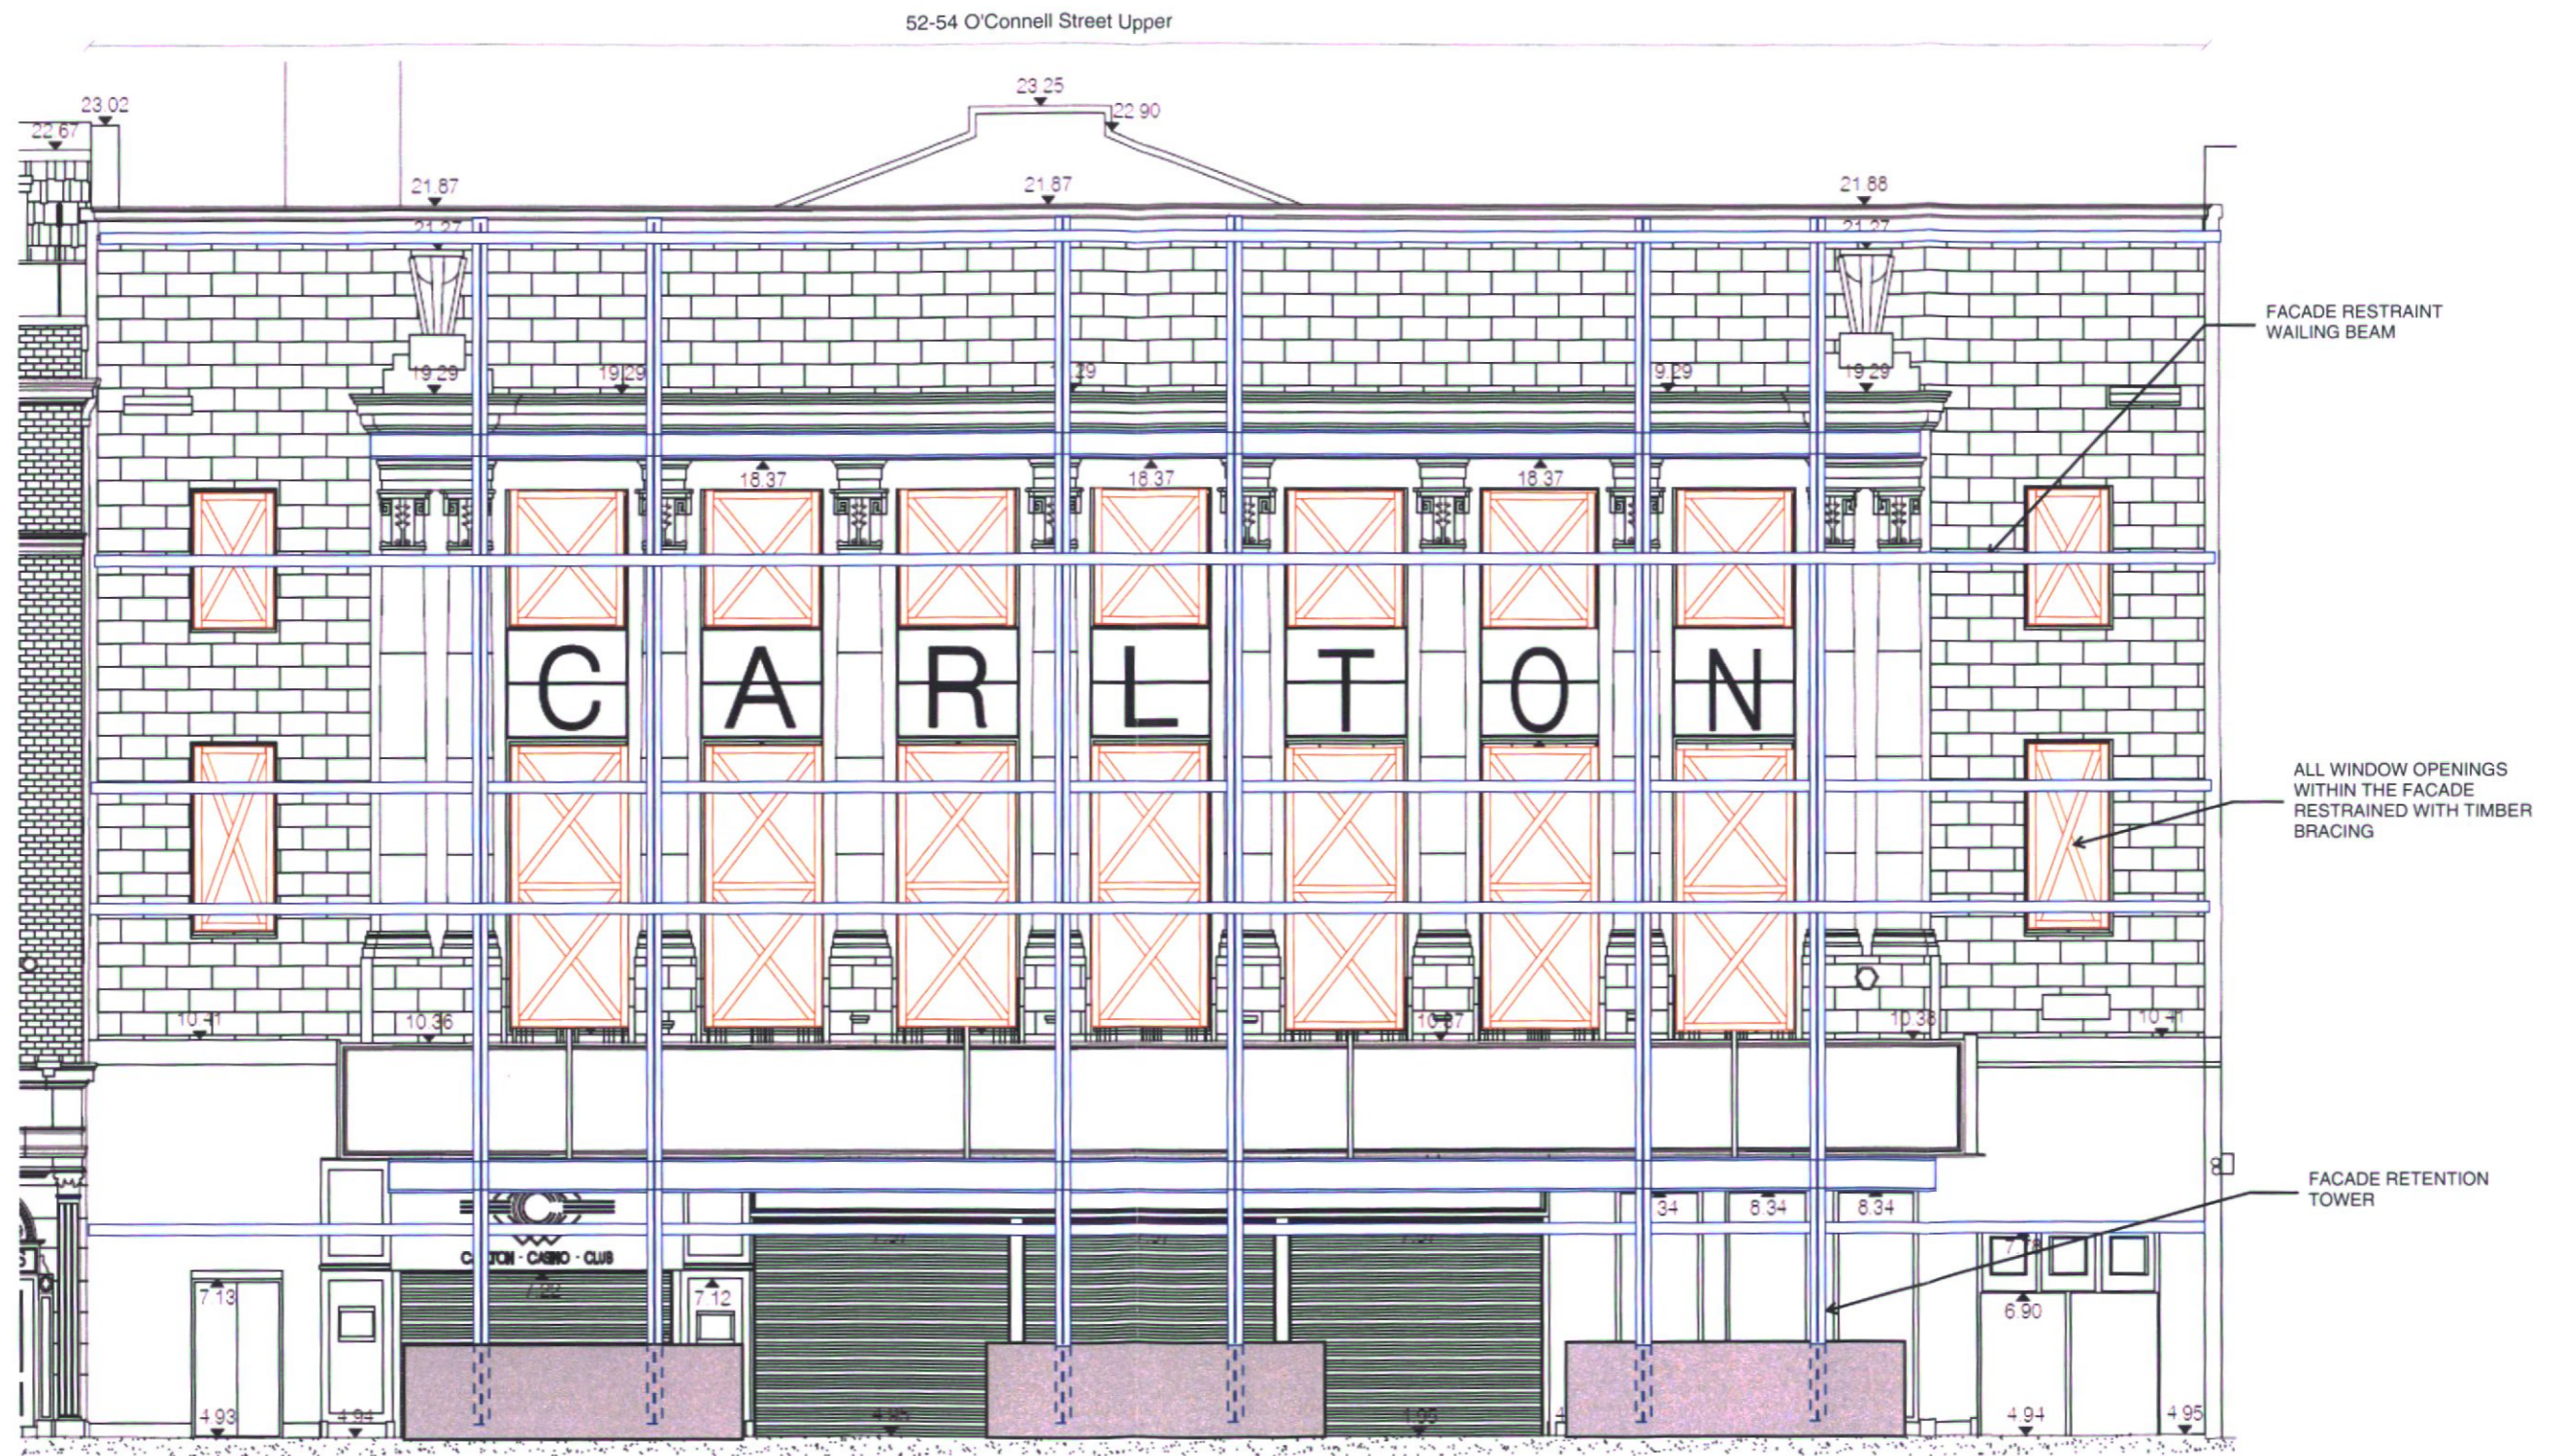
52-54 O'Connell Street Upper - Elevation
SCALE 1:100

SUITABLE WEATHER PROTECTION
FELT & BATTENS APPLIED TO
REAR FACADE AS DEMOLITION
PROCEEDS TO PREVENT FACADE
BEING EXPOSED TO WEATHER

TEMPORARY BEAM TO
SUPPORT CORNICE

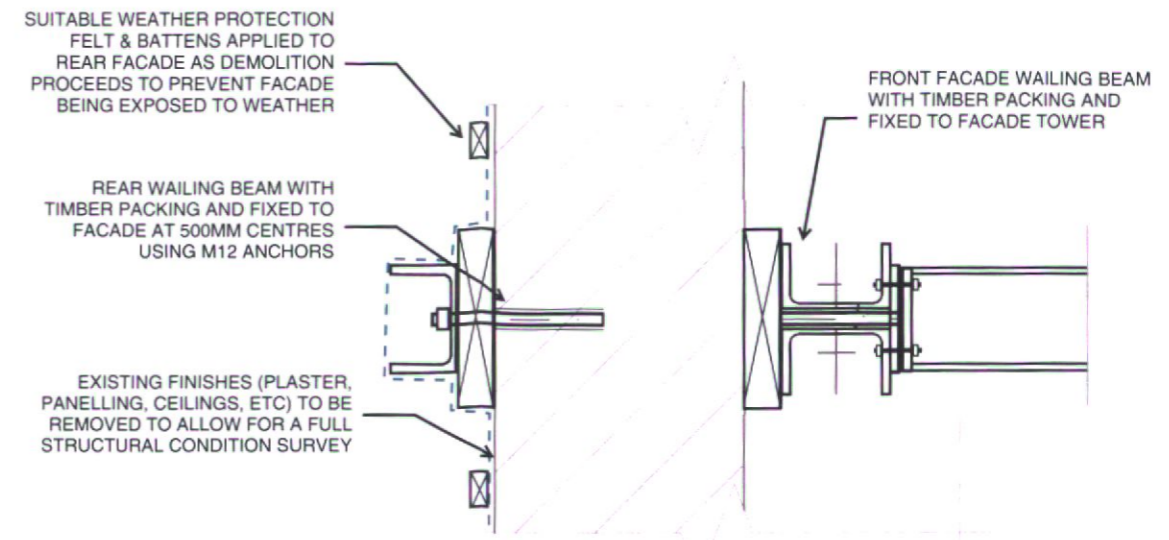
PFC TO FACADE FIXING DETAIL - SECTION
SCALE - NTS

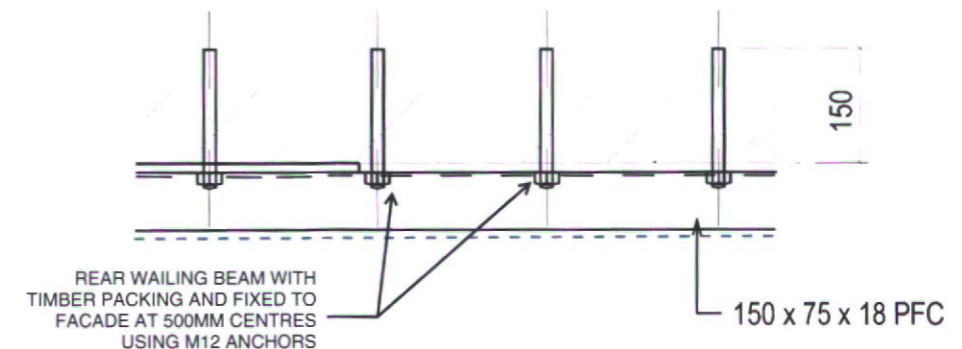
REAR FACADE FIXING DETAIL - PLAN
SCALE - NTS

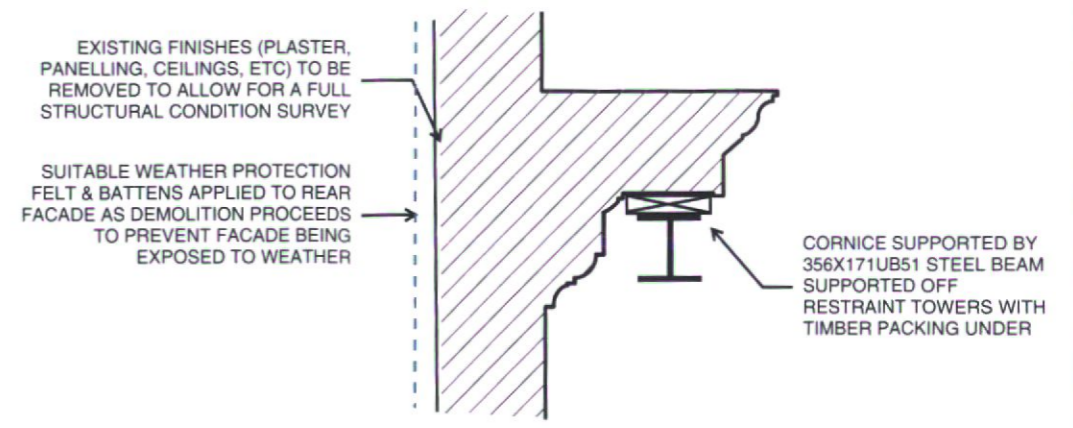
CORNICE SUPPORT DETAIL - SECTION
SCALE - NTS
