TEST REPORT

Determination of Particle Size Distribution

Contract No.	24083	Report No.	R135336
Contract Name:	Tesco, Cavan		
BH/TP*:	BH01	Lab. Sample No.	A22/3553
Sample No.*	AA172991	Customer:	Tesco Irl./ Pinnacle
Sample Type:	B	Date Testing started	20/06/2022
Depth* (m)	1.00	Description:	Grey/brown slightly sandy, gravelly, CLAY

Client:	Tesco, Cavan
Project Code:	OR0301 - EIAR
Project Description:	Development of the site for Tesco
Scenario Description:	Foundations, Receptor at 30m

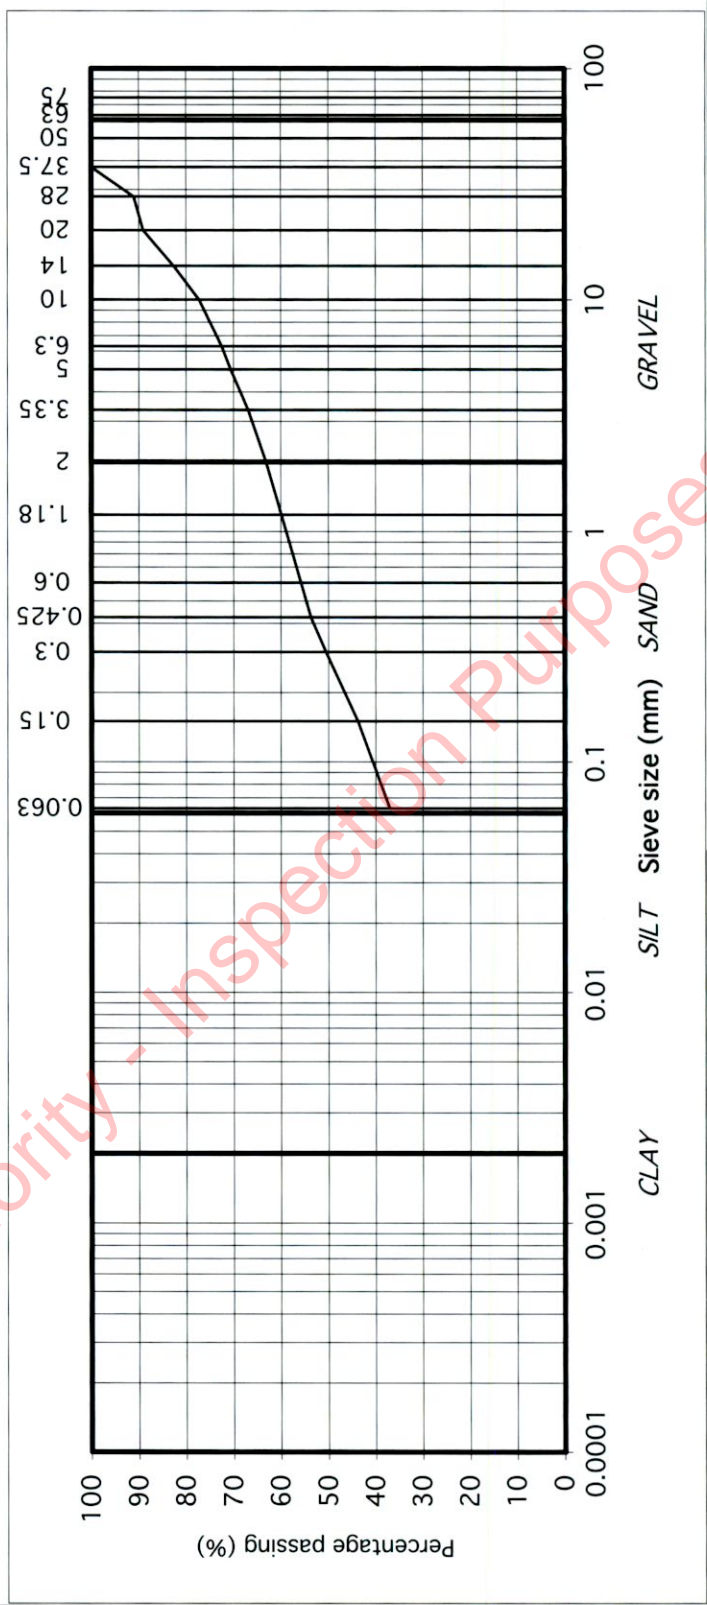
particle size	% passing
75	100
63	100
50	100
37.5	100
28	91
20	89
14	83
10	77
6.3	72
5	71
3.35	67
2	63
1.18	60
0.6	56
0.425	54
0.3	50
0.15	44
0.063	37

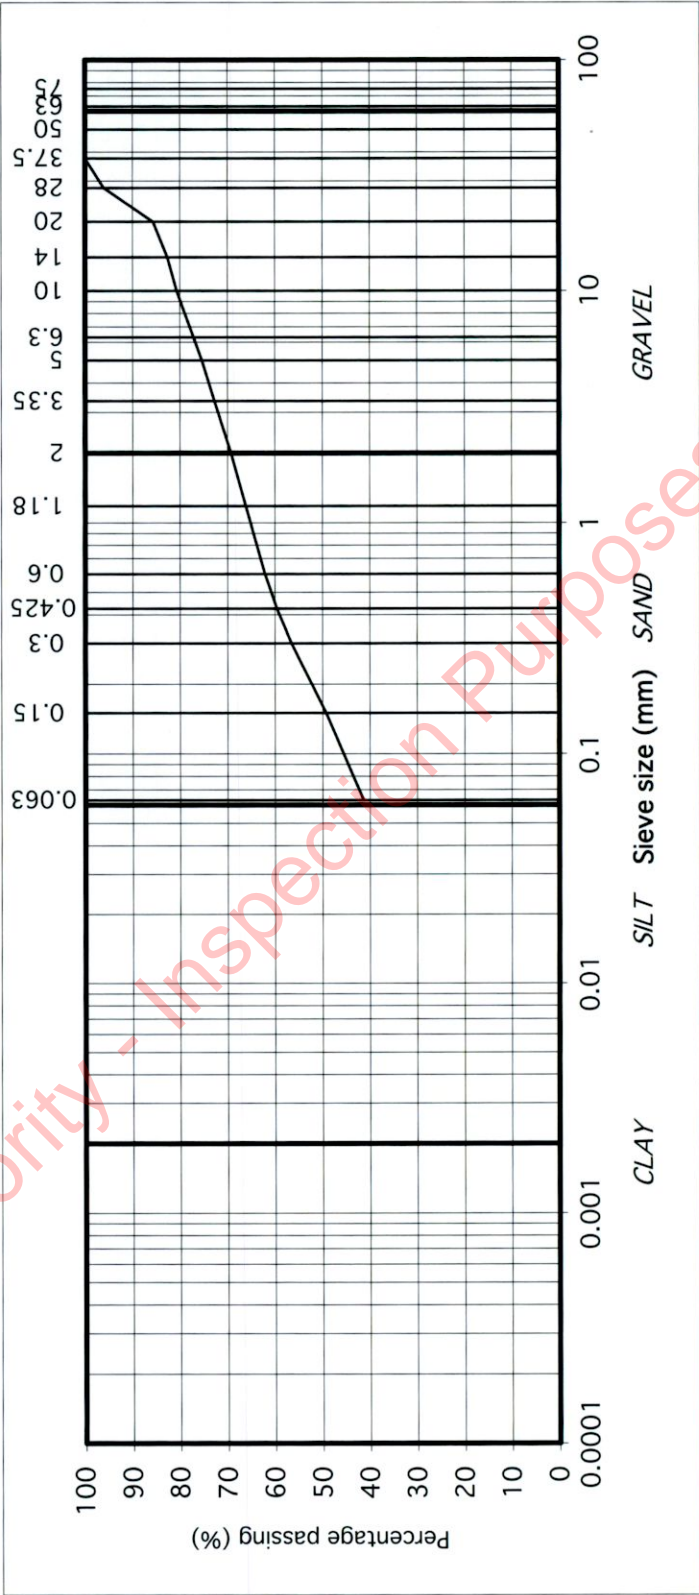
Contract No.	24083	Report No.	R135337
Contract Name :	Tesco, Cavan		
BH/TP* :	BH03		
Sample No.*	AA172982	Lab. Sample No.	A22/3555
Sample Type:	B		
Depth* (m)	2.00	Customer:	Tesco Irl./ Pinnacle
Date Received	20/06/2022	Date Testing started	20/06/2022
Description:	Brown slightly sandy, slightly gravelly, CLAY

particle size	% passing
75	100
63	100
50	100
37.5	100
28	96
20	86
14	83
10	81
6.3	77
5	75
3.35	73
2	69
1.18	66
0.6	62
0.425	60
0.3	57
0.15	49
0.063	41

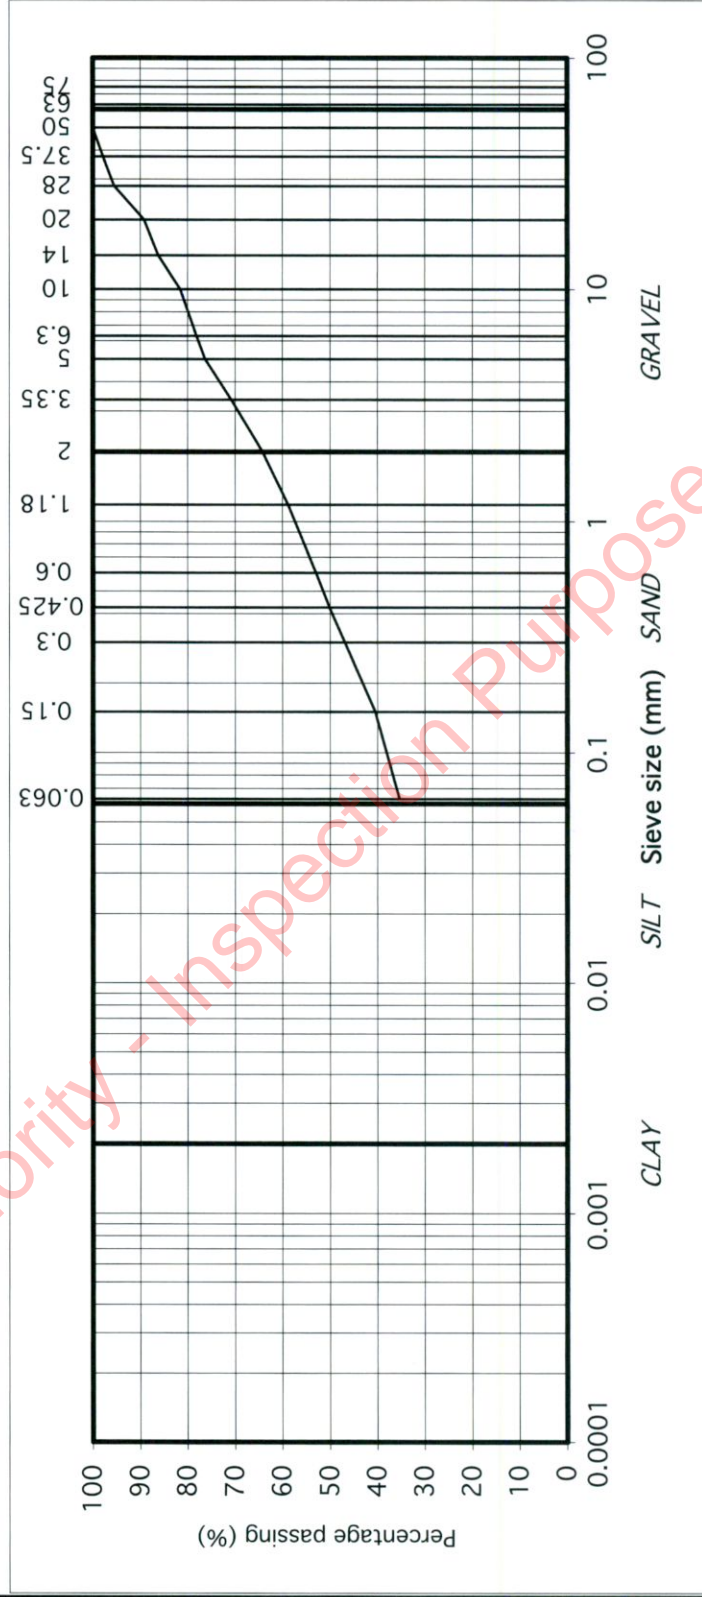
particle size	% passing
75	100
63	100
50	100
37.5	98
28	96
20	89
14	86
10	82
6.3	78
5	76
3.35	71
2	64
1.18	59
0.6	53
0.425	50
0.3	47
0.15	40
0.063	35

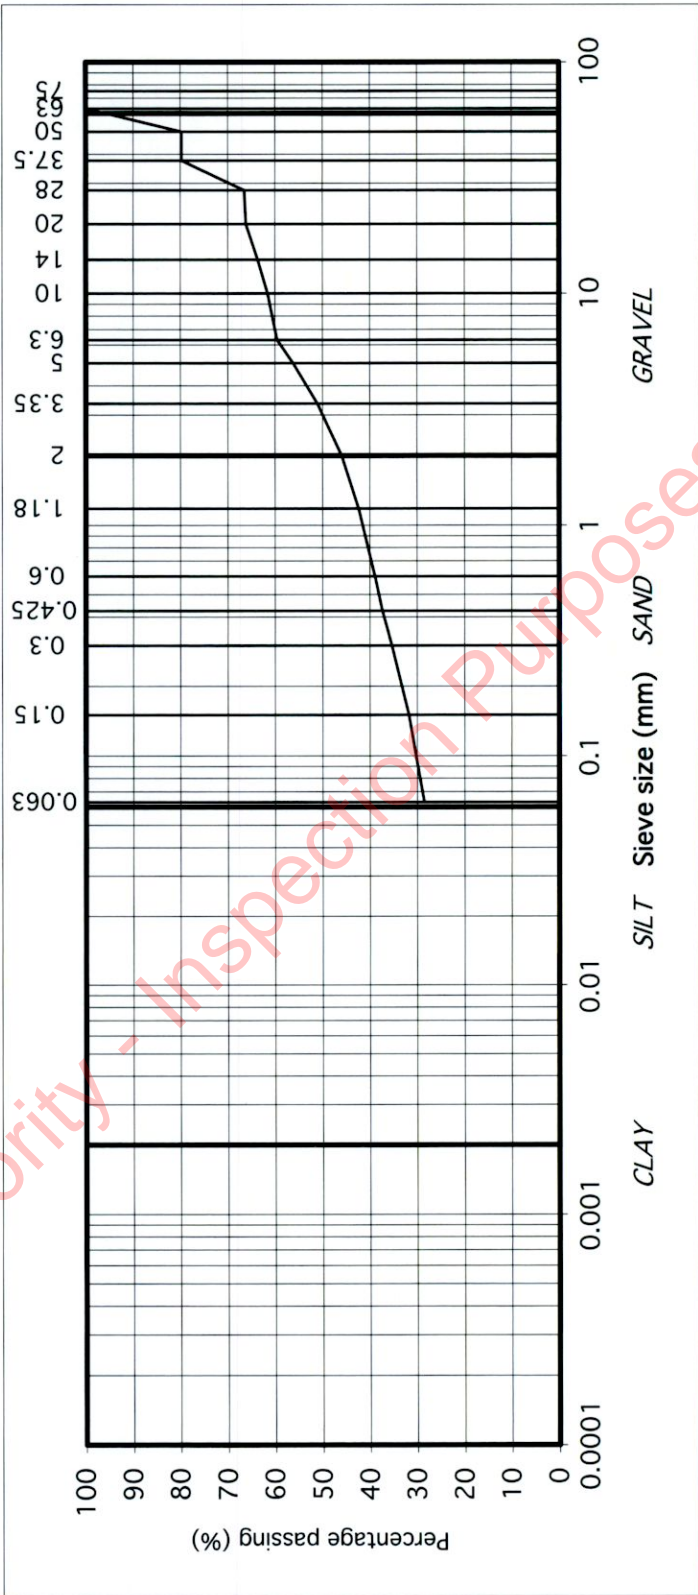
particle size	% passing	
75	100	COBBLES
63	100	
50	80	
37.5	80	
28	66	
20	66	
14	64	GRAVEL
10	62	
6.3	60	
5	56	
3.35	51	
2	46	
1.18	42	
0.6	39	
0.425	37	SAND
0.3	35	
0.15	32	
0.063	29	SILT/CLAY

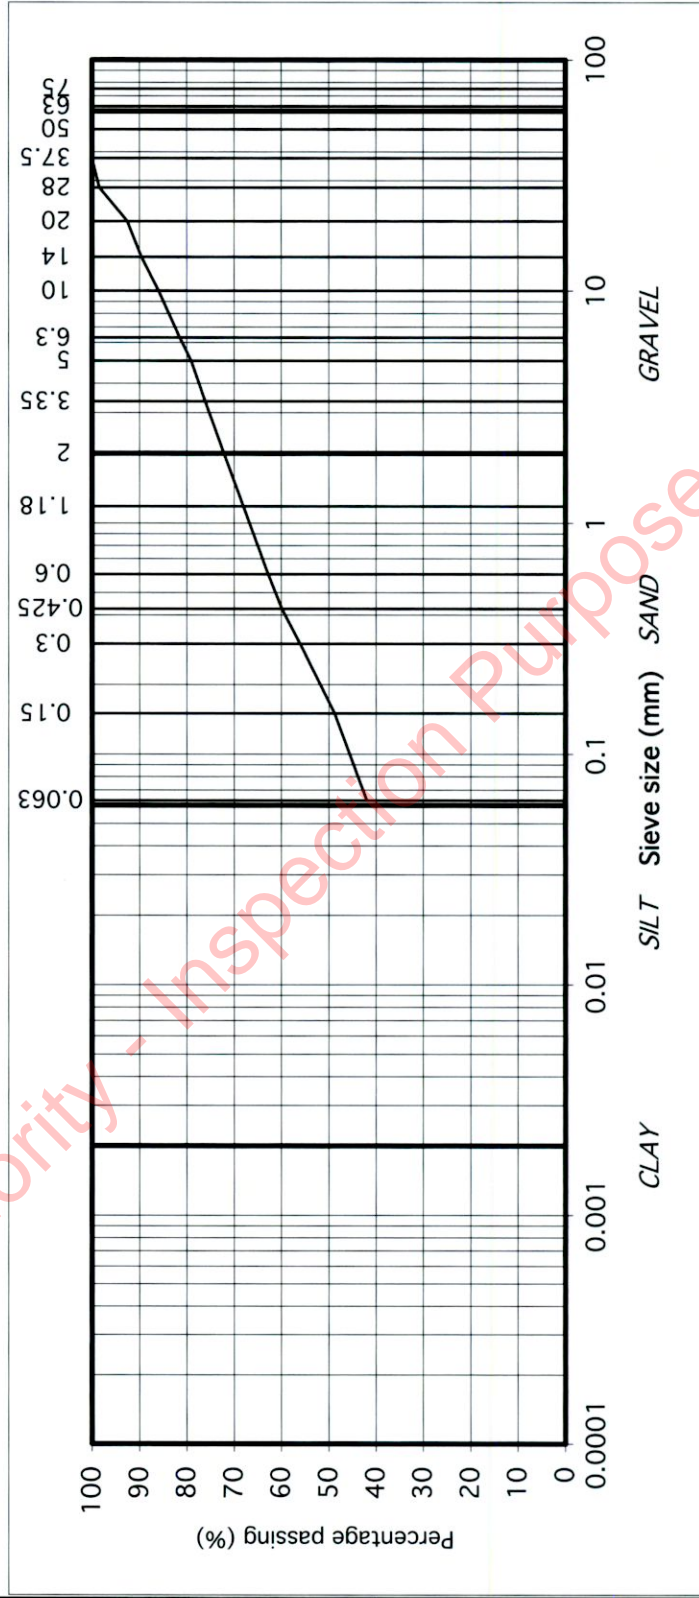
particle size	% passing
75	100
63	100
50	100
37.5	100
28	98
20	93
14	90
10	86
6.3	82
5	79
3.35	76
2	72
1.18	68
0.6	63
0.425	60
0.3	56
0.15	49
0.063	42

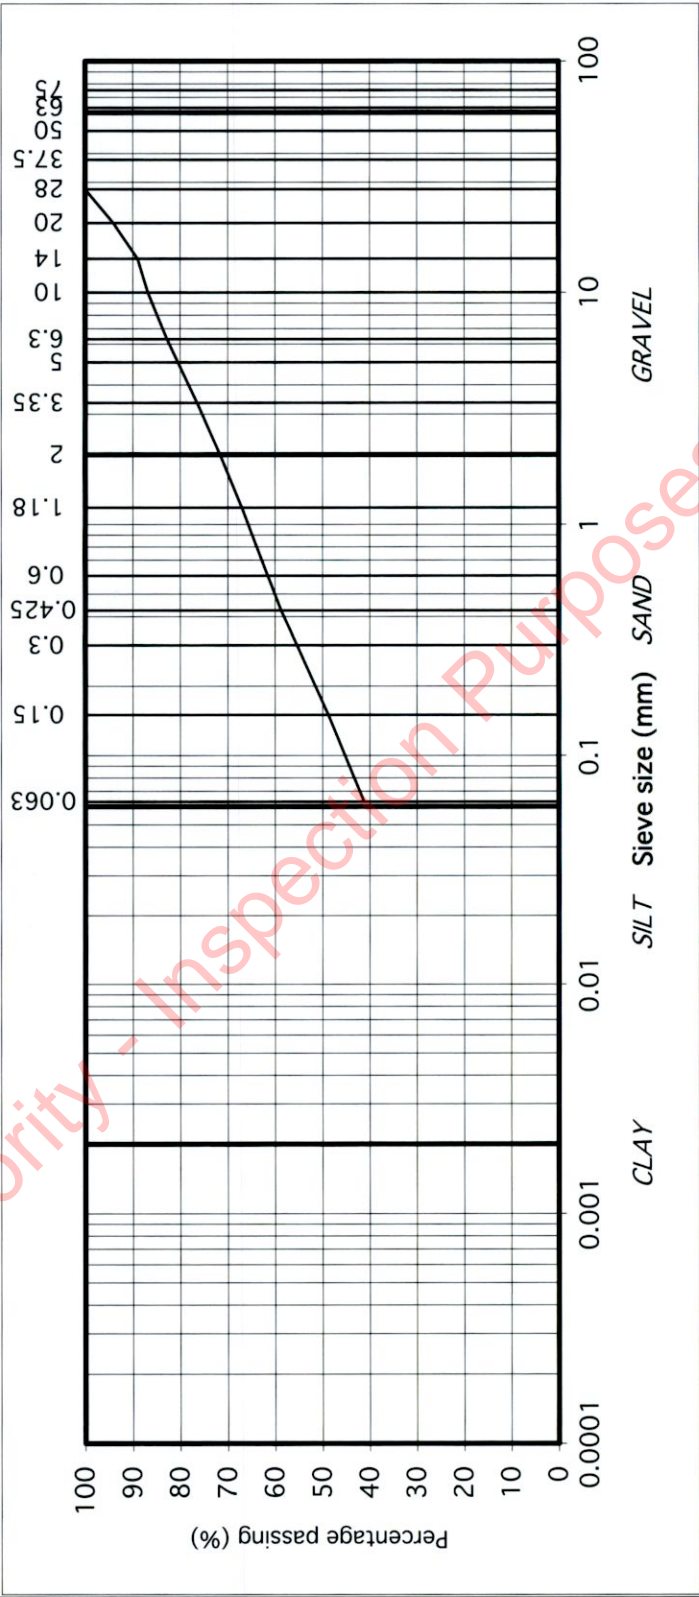
particle size	% passing
75	100
63	100
50	100
37.5	100
28	100
20	94
14	89
10	87
6.3	83
5	81
3.35	76
2	72
1.18	67
0.6	62
0.425	59
0.3	55
0.15	49
0.063	41

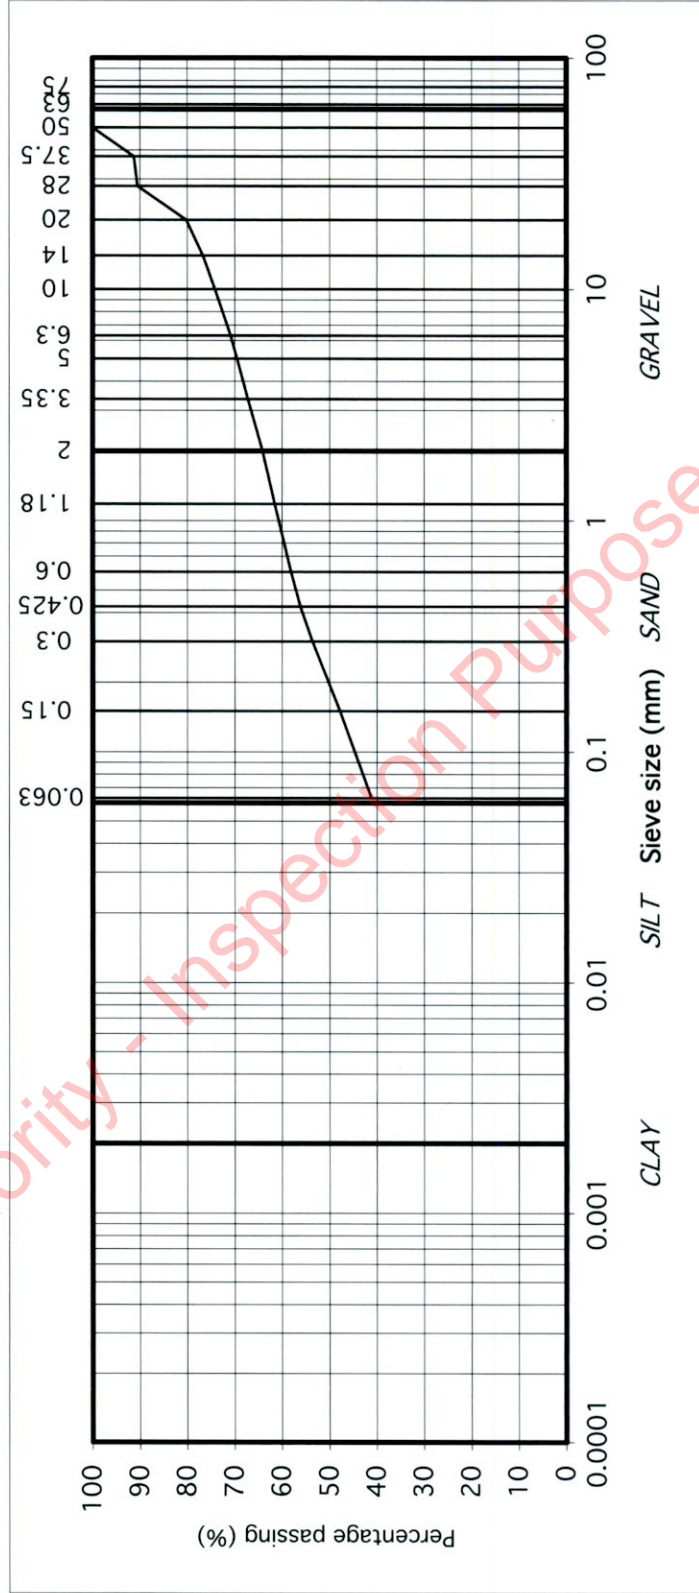
particle size	% passing
75	100
63	100
50	100
37.5	91
28	90
20	80
14	77
10	74
6.3	71
5	69
3.35	67
2	64
1.18	62
0.6	58
0.425	56
0.3	54
0.15	48
0.063	41

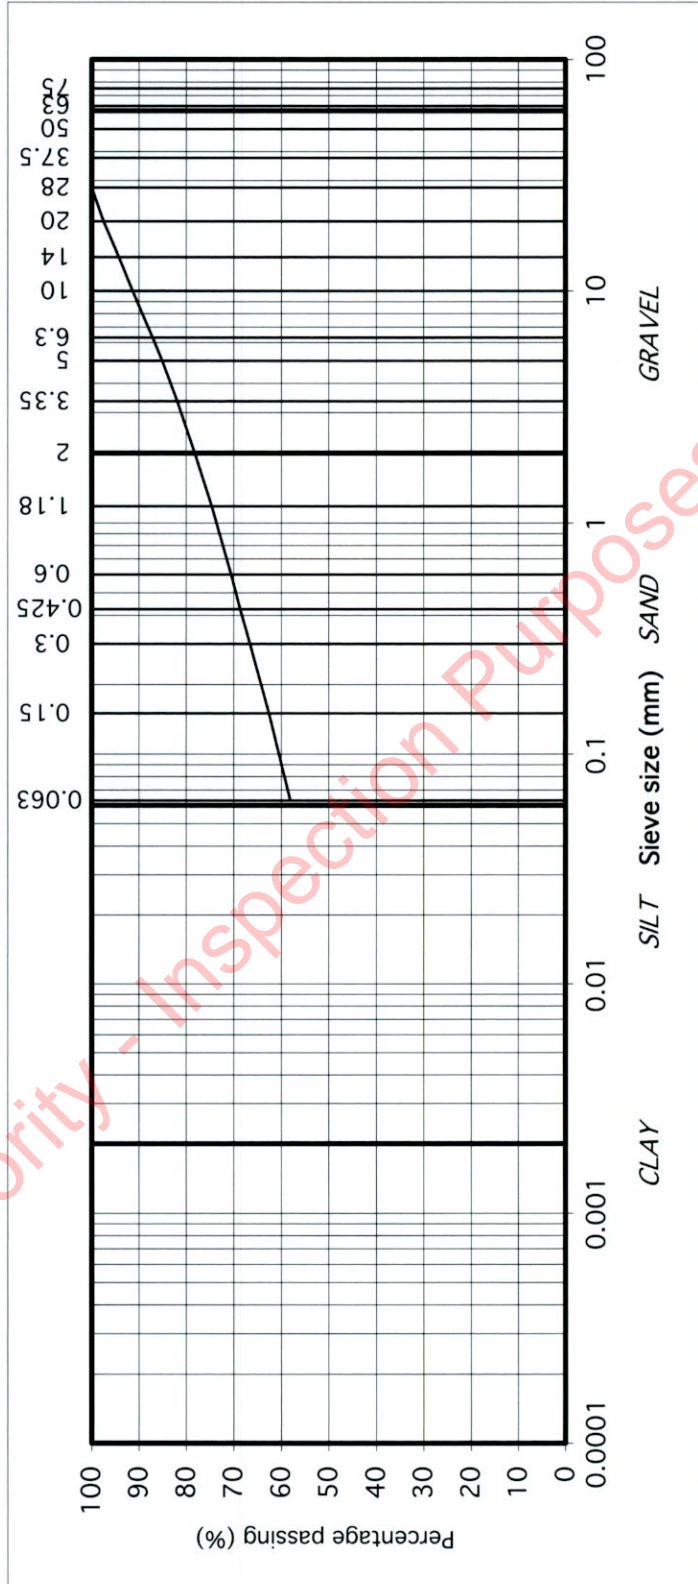
particle size	% passing
75	100
63	100
50	100
37.5	100
28	100
20	97
14	94
10	91
6.3	87
5	85
3.35	82
2	78
1.18	75
0.6	71
0.425	69
0.3	67
0.15	63
0.063	58

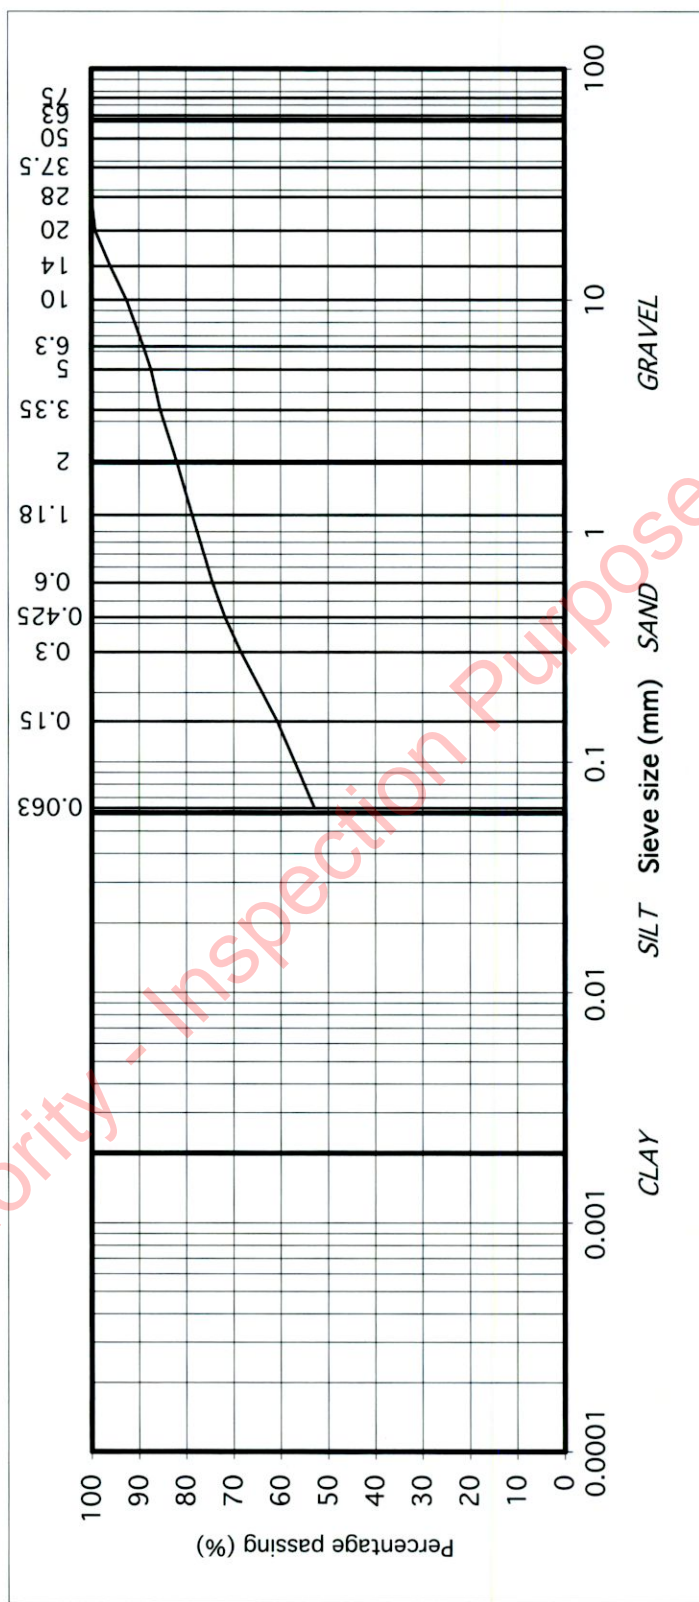
particle size	% passing
75	100
63	100
50	100
37.5	100
28	100
20	99
14	96
10	93
6.3	89
5	87
3.35	85
2	82
1.18	79
0.6	74
0.425	72
0.3	68
0.15	61
0.063	53

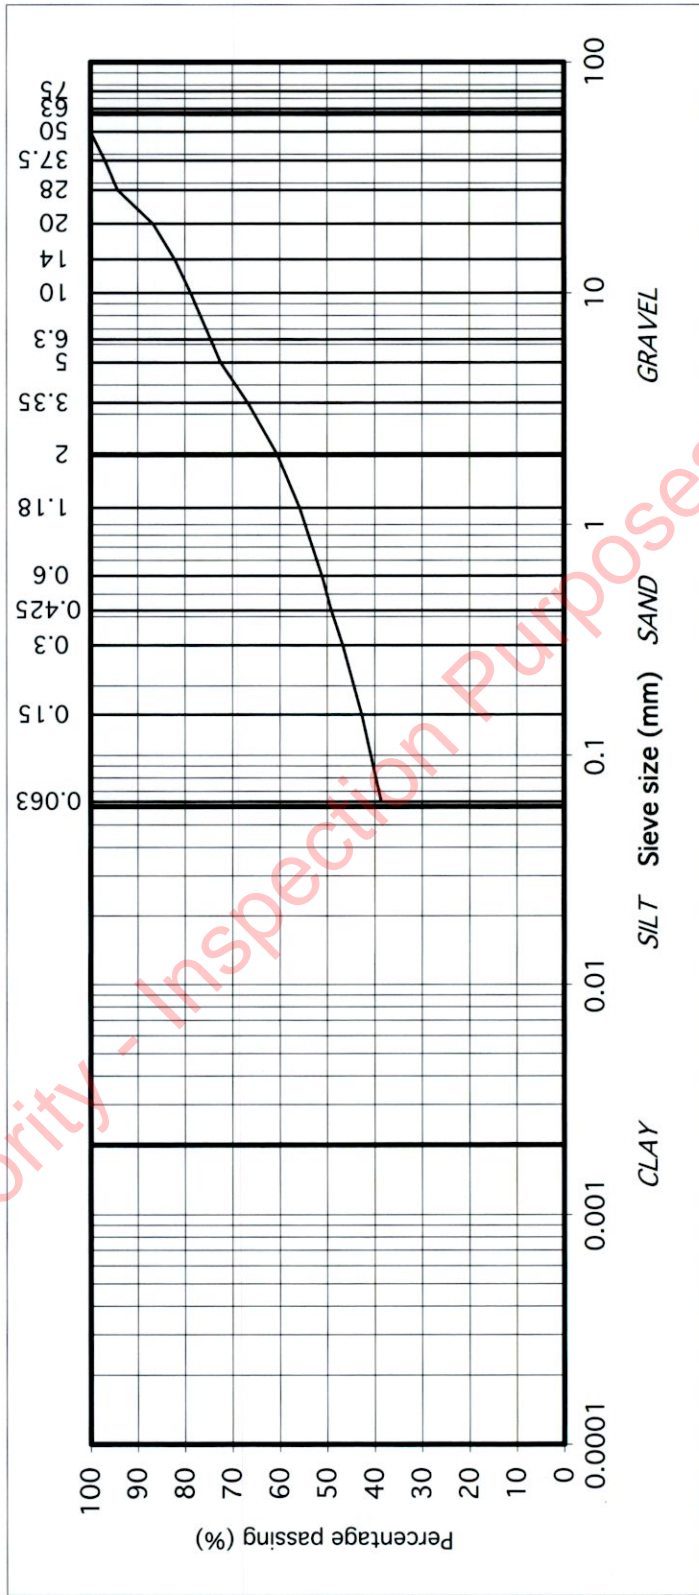
particle size	% passing
75	100
63	100
50	100
37.5	97
28	94
20	87
14	82
10	79
6.3	75
5	72
3.35	67
2	60
1.18	56
0.6	51
0.425	49
0.3	47
0.15	43
0.063	39

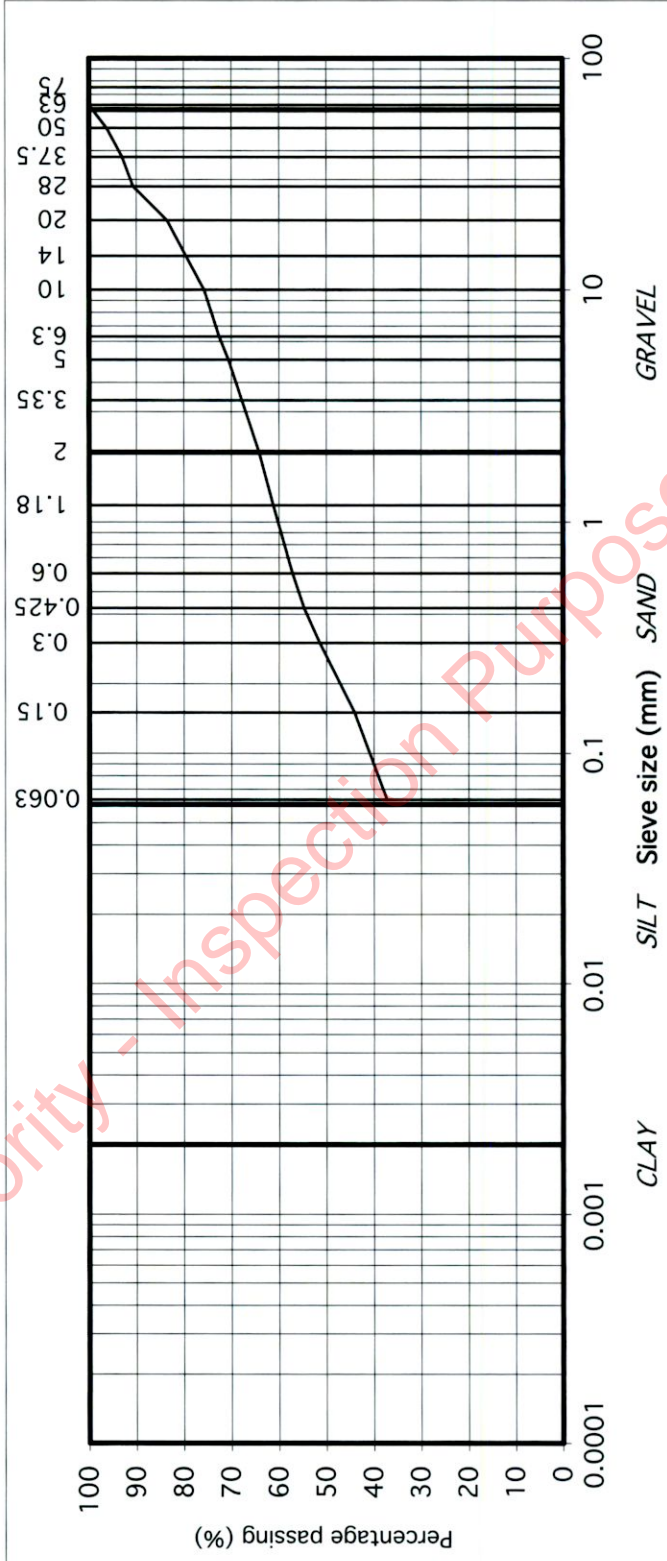
particle size	% passing	Soil Classification
75	100	COBBLES
63	100	
50	96	GRAVEL
37.5	93	
28	91	GRAVEL
20	84	
14	80	GRAVEL
10	76	
6.3	73	GRAVEL
5	71	
3.35	68	GRAVEL
2	64	
1.18	61	GRAVEL
0.6	57	
0.425	55	SAND
0.3	51	
0.15	44	SAND
0.063	37	
		SILT/CLAY

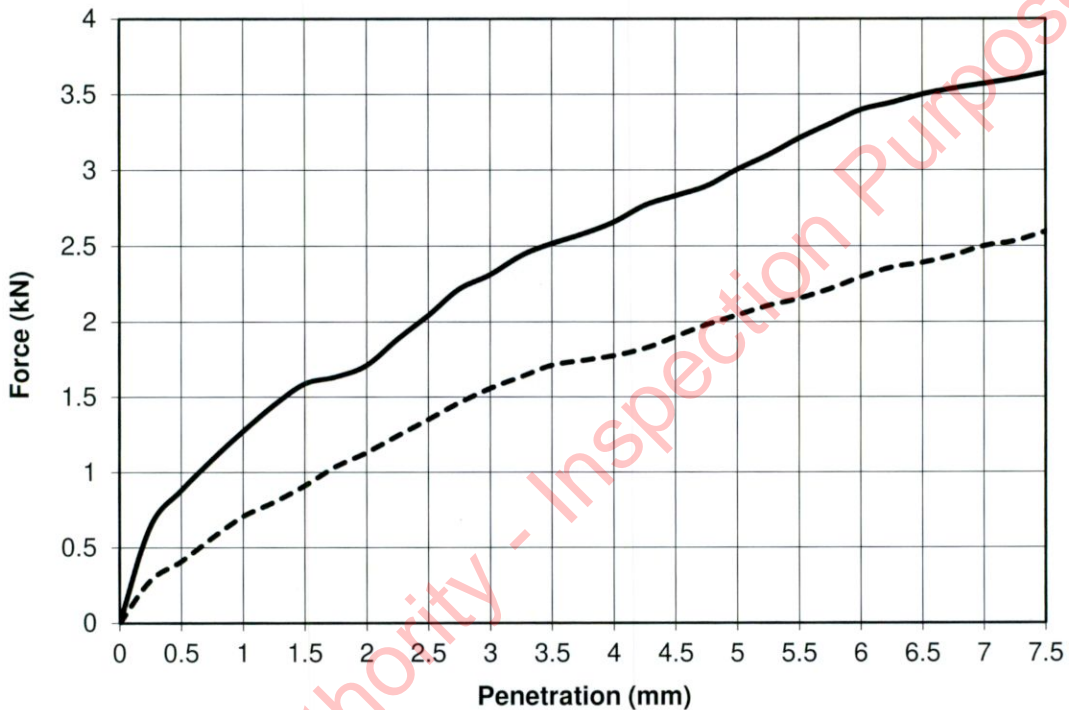
Report No. R135295 Contract Tesco , Cavan  
 Contract No. 24083 Customer Tesco Irl / Pinnacle  
 Date received 20/06/22 Date Tested 21/06/22  
 BH/TP No.\* TP05 Sample No.\* AA178465 Type: B  
 Depth\* (m) 1.80 Lab sample No. A22/3549

Key: ——— Top      - - - - - Base

Description: Brown slightly sandy, slightly gravelly, SILT/CLAY			
Initial Condition:		Unsoaked	
Moisture Content (%):	10	Bulk Density (Mg/m <sup>3</sup> ):	2.30
Surcharge (kg):	4	Dry Density (Mg/m <sup>3</sup> ):	2.09
% Material >20mm:	3.2		
Method of compaction:		Static Compaction Method 2

Test Result	Top	Base
<b>CBR %</b>	<b>15</b>	<b>10</b>
Moisture Content %	10	10

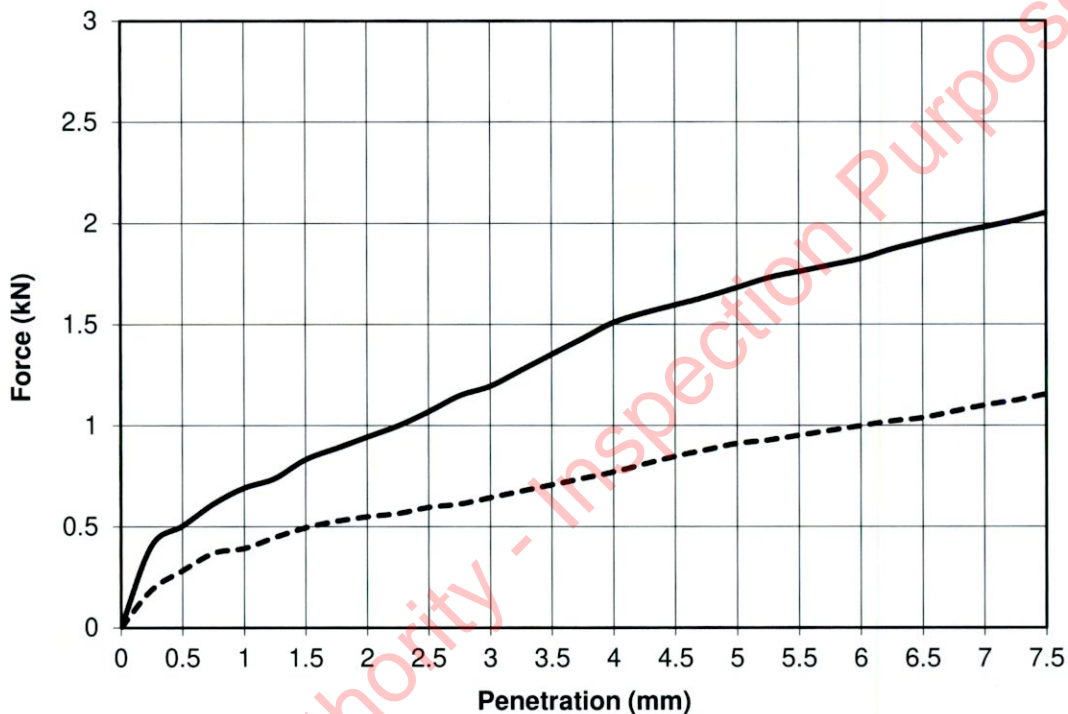
Report No. R135296 Contract Tesco , Cavan  
 Contract No. 24083 Customer Tesco Irl / Pinnacle  
 Date received 20/06/22 Date Tested 21/06/22  
 BH/TP No.\* TP07 Sample No.\* AA178460 Type: B  
 Depth\* (m) 1.30 Lab sample No. A22/3560

Key: ————— Top      - - - - - Base

Description: Brown slightly sandy, gravelly, CLAY			
Initial Condition:		Unsoaked	
Moisture Content (%):	8	Bulk Density (Mg/m <sup>3</sup> ):	4.57
Surcharge (kg):	4	Dry Density (Mg/m <sup>3</sup> ):	2.30
% Material >20mm:	6.3		
Method of compaction:		Static Compaction Method 2

Test Result	Top	Base
CBR %	8.4	4.6
Moisture Content %	11	11

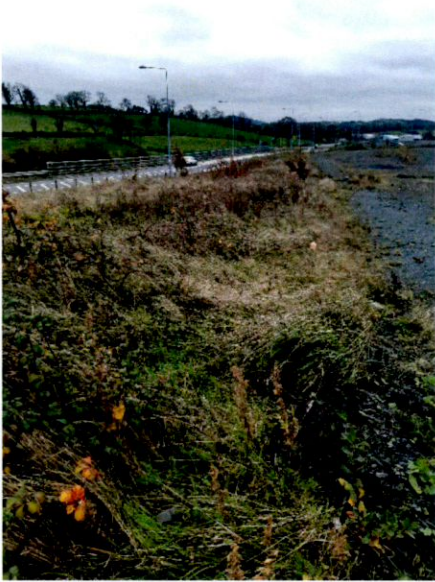
Grassy Verge along Eastern Boundary

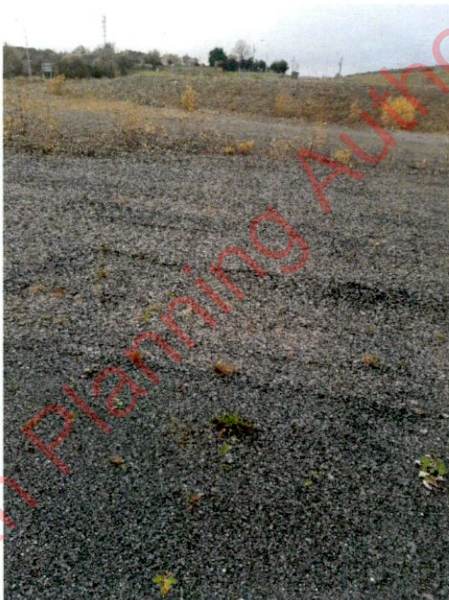
Bare Ground Habitats within the Site

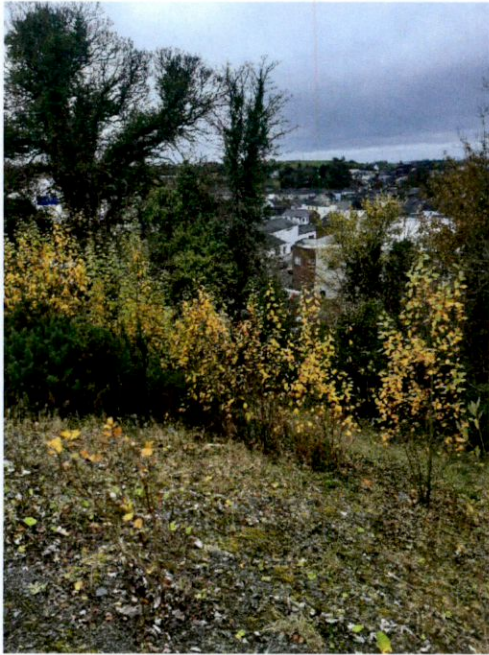
Embankment and Treeline Along Western Boundary

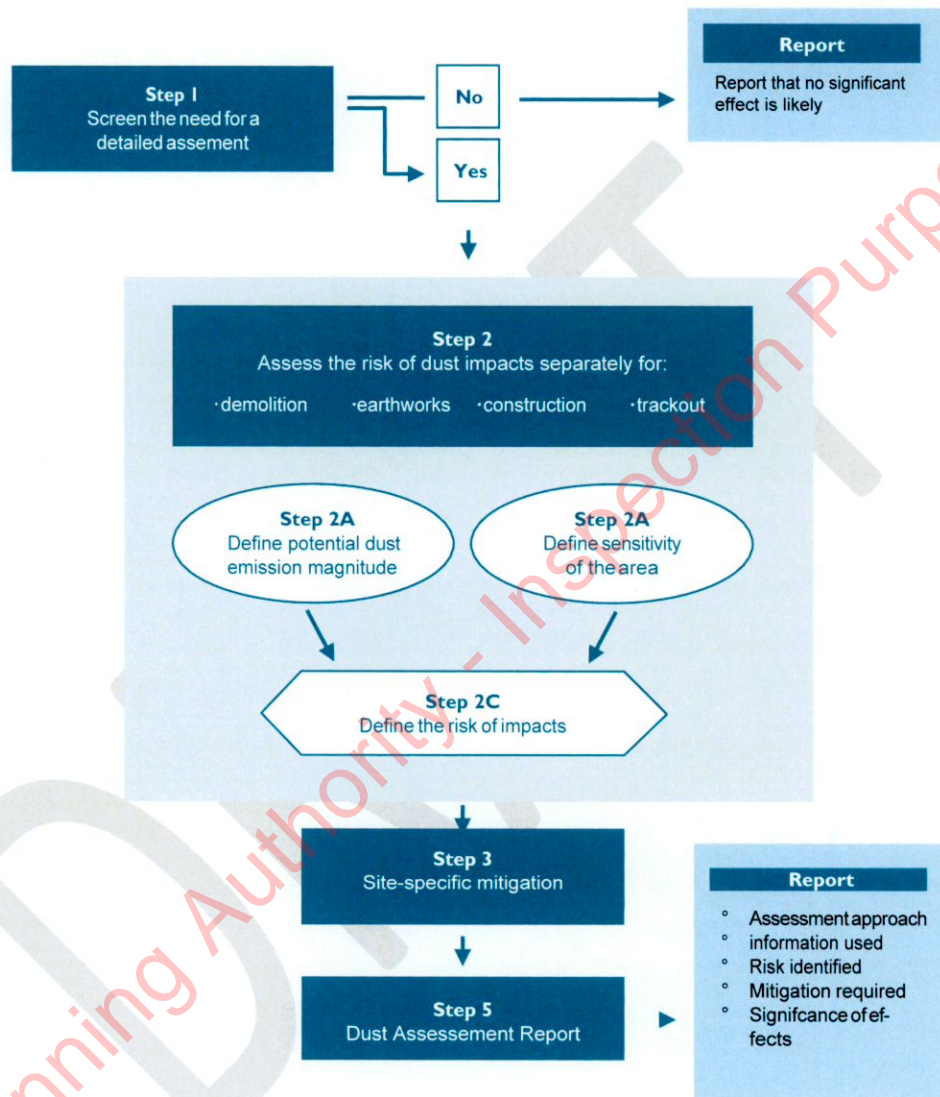
**Appendix Figure 12.1: Steps to Perform a Dust Assessment (IAQM, 2014)**

Step 1 and Step 2 methods from the IAQM construction dust guidance are defined below to assign dust risk categories for each of the different construction actions.

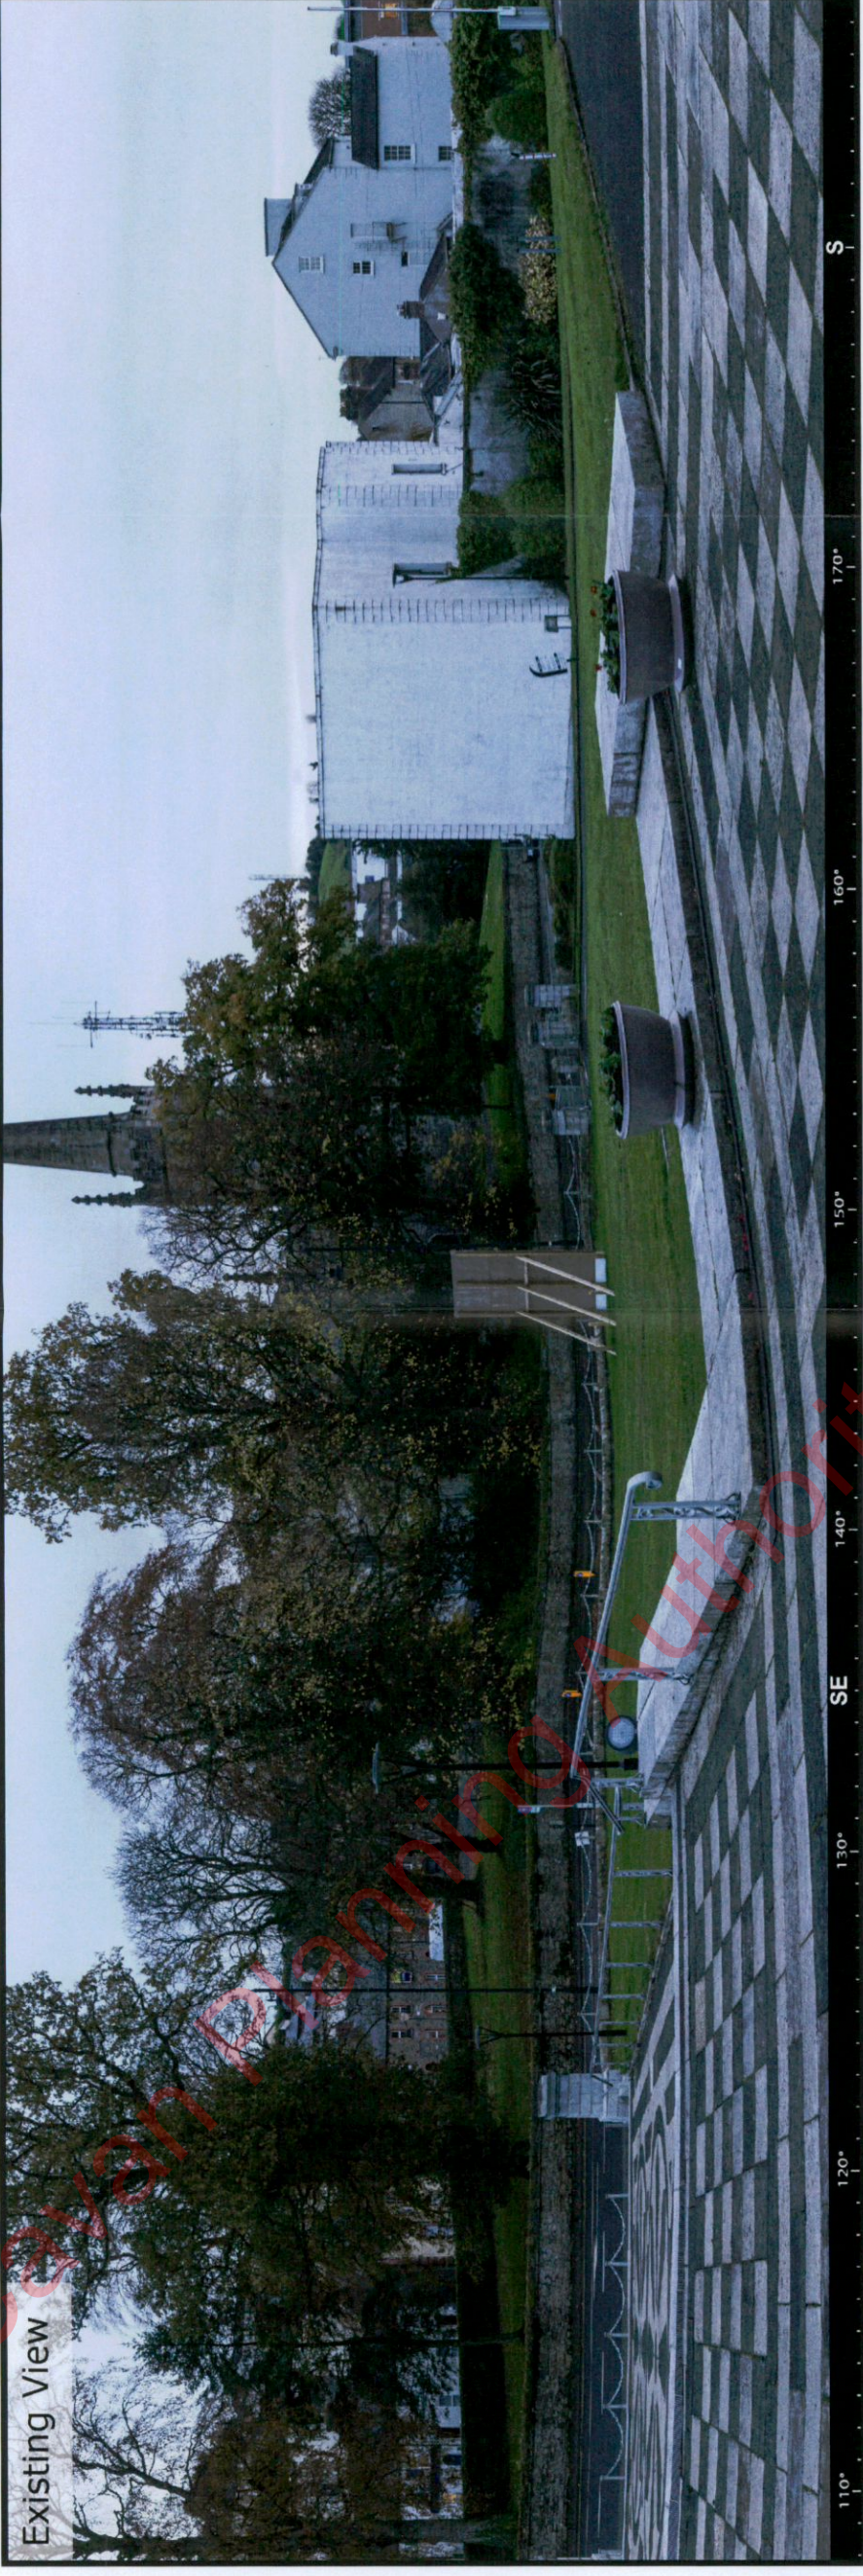
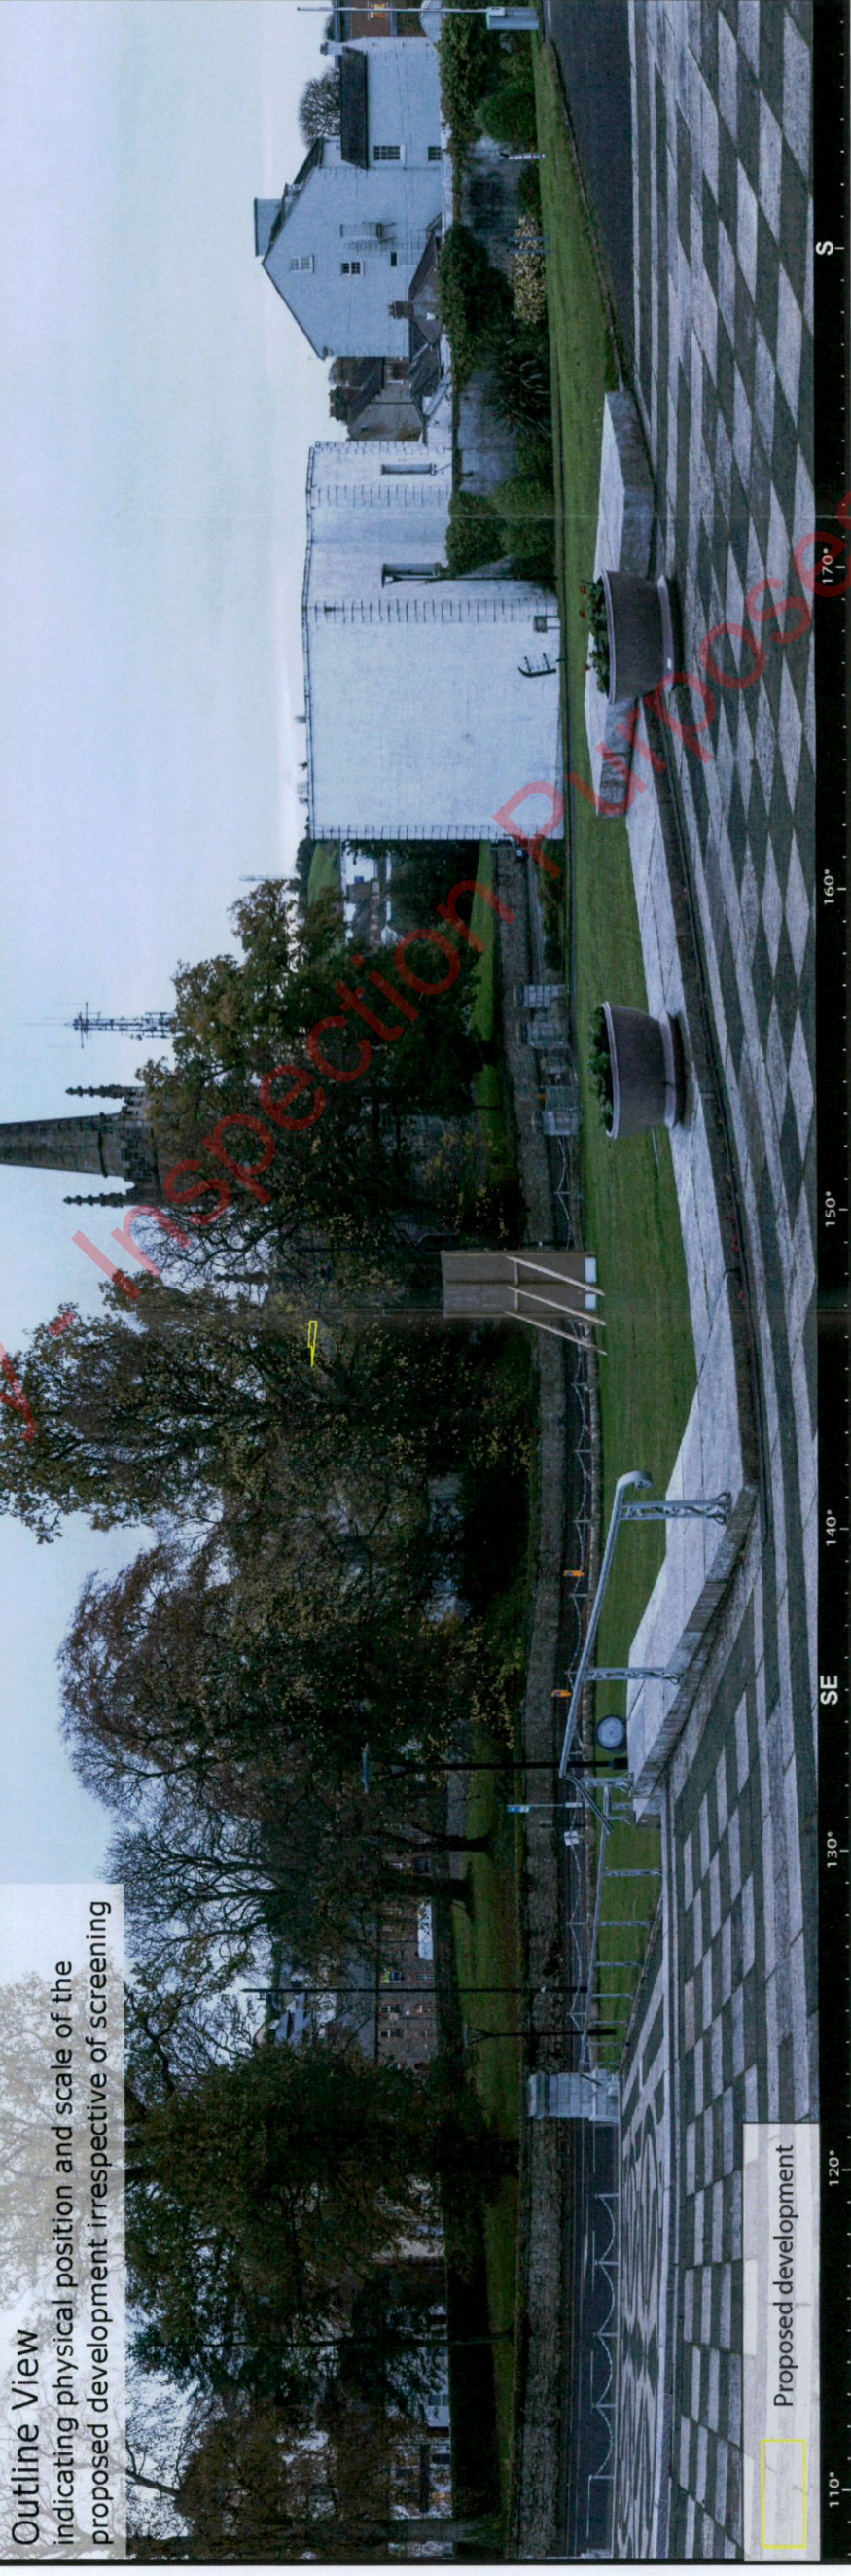
**Outline View**  
 indicating physical position and scale of the proposed development irrespective of screening

Eastings (ITM): 641871	Lens: 50mm / Full Frame Sensor	Date: 09/11/2022
Northing (ITM): 805255	Camera: Canon 1-D Mark II digital SLR	Time: 15:39
Direction of View: SE	Camera Height: 1.7m Above Ground Level	
Angle of View: 80°
