TEST REPORT

Determination of Particle Size Distribution

Contract No.	24083	Report No.	R135336
Contract Name:	Tesco, Cavan		
BH/TP*:	BH01	Lab. Sample No.	A22/3553
Sample No.*	AA172991	Customer:	Tesco Irl./ Pinnacle
Sample Type:	B	Date Testing started	20/06/2022
Depth* (m)	1.00	Description:	Grey/brown slightly sandy, gravelly, CLAY

Client:	Tesco, Cavan
Project Code:	OR0301 - EIAR
Project Description:	Development of the site for Tesco
Scenario Description:	Foundations, Receptor at 30m

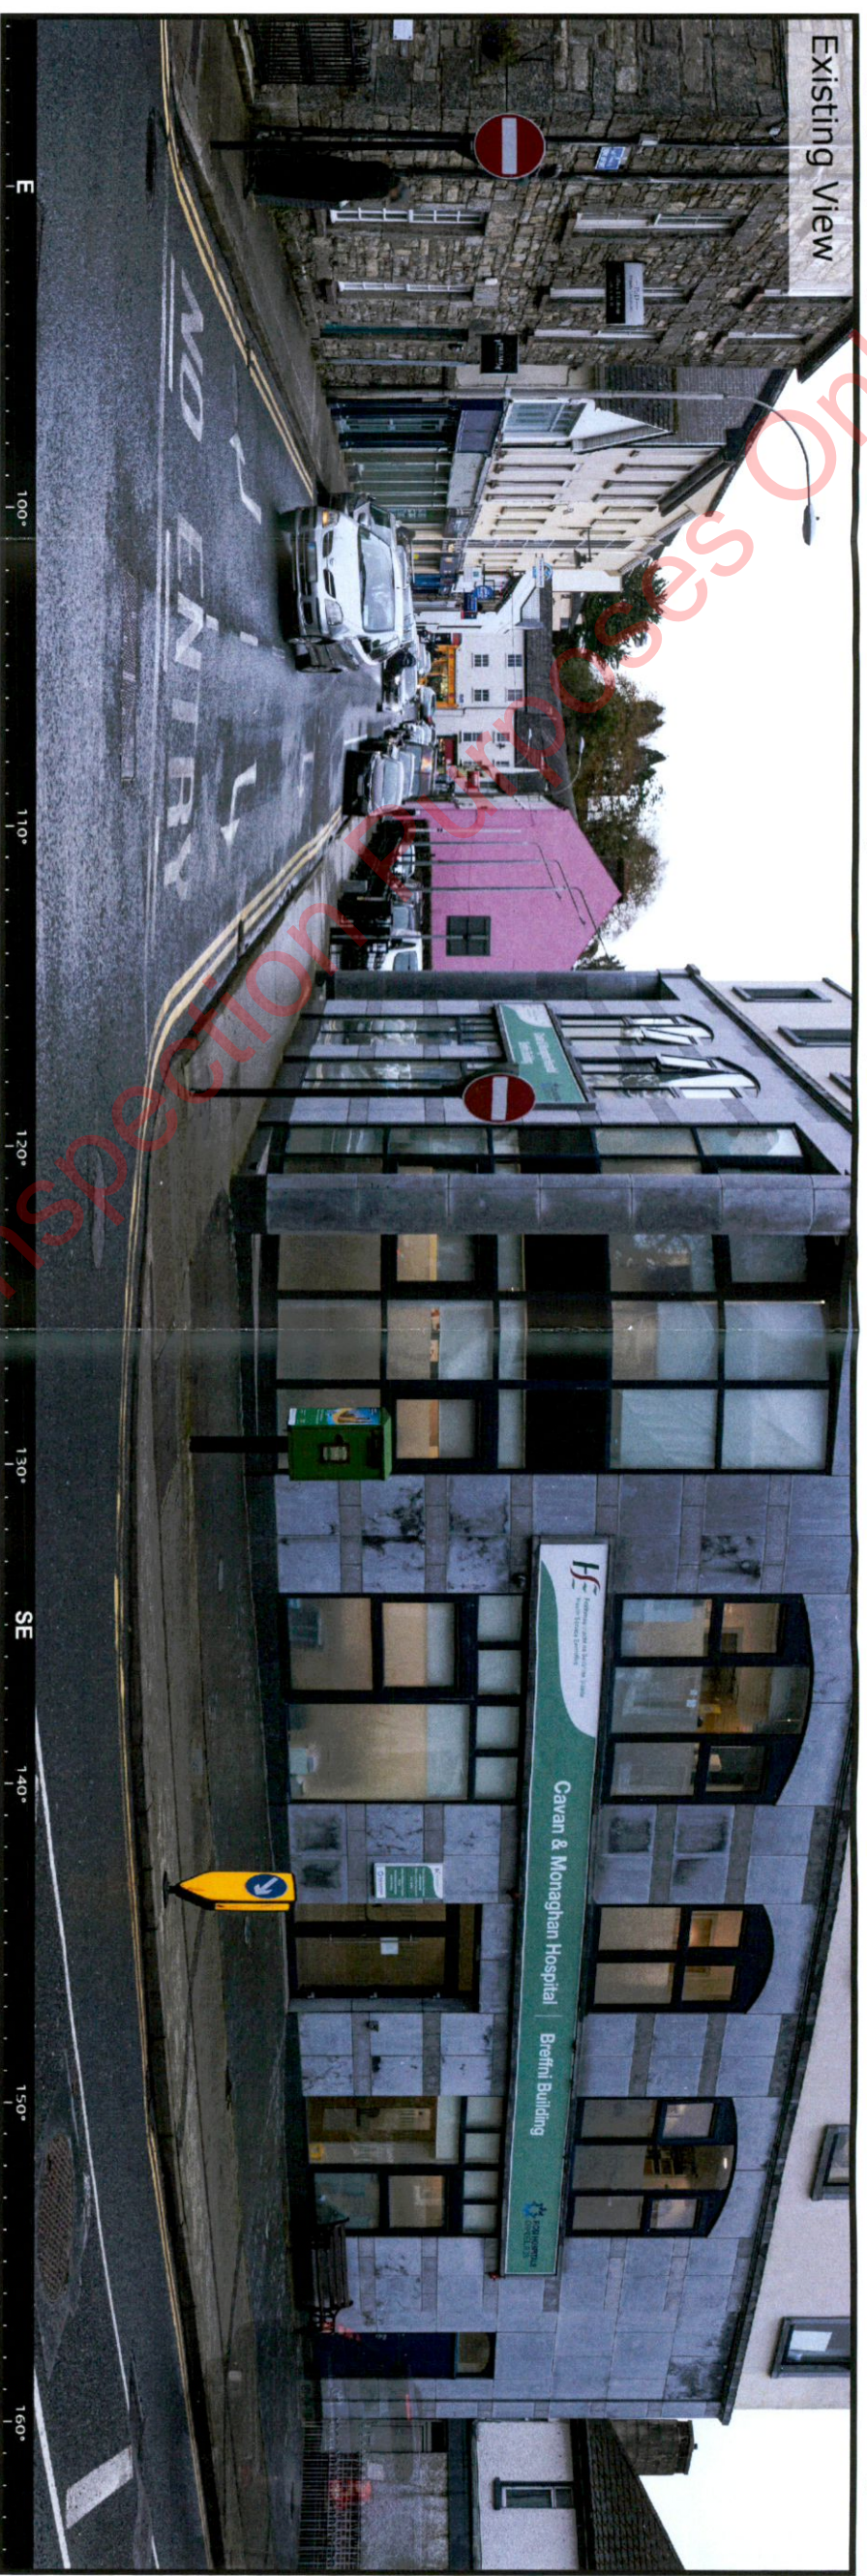
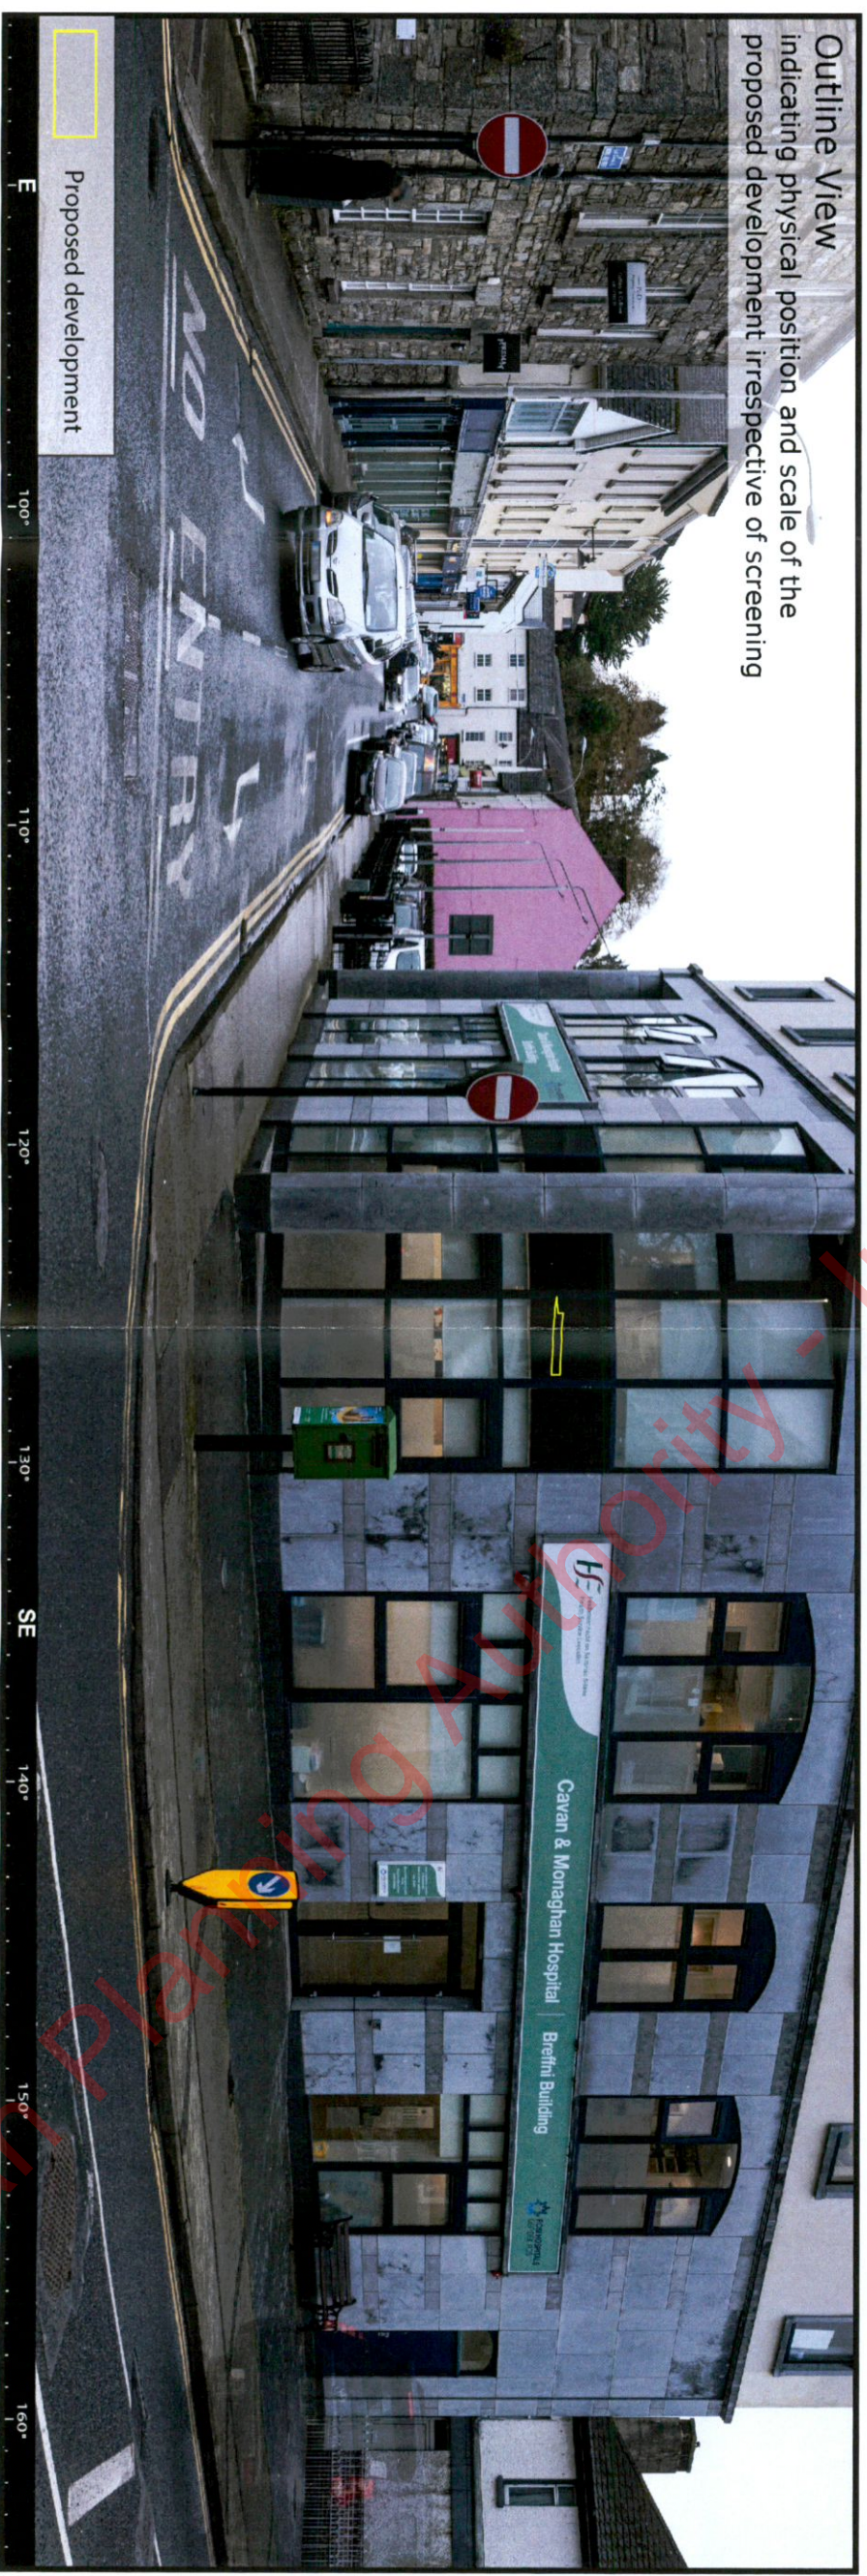
**Outline View**  
 indicating physical position and scale of the  
 proposed development irrespective of screening

Lens: 50mm / Full Frame Sensor  
 Camera: Canon 1-D Mark II digital SLR  
 Camera Height: 1.7m Above Ground Level

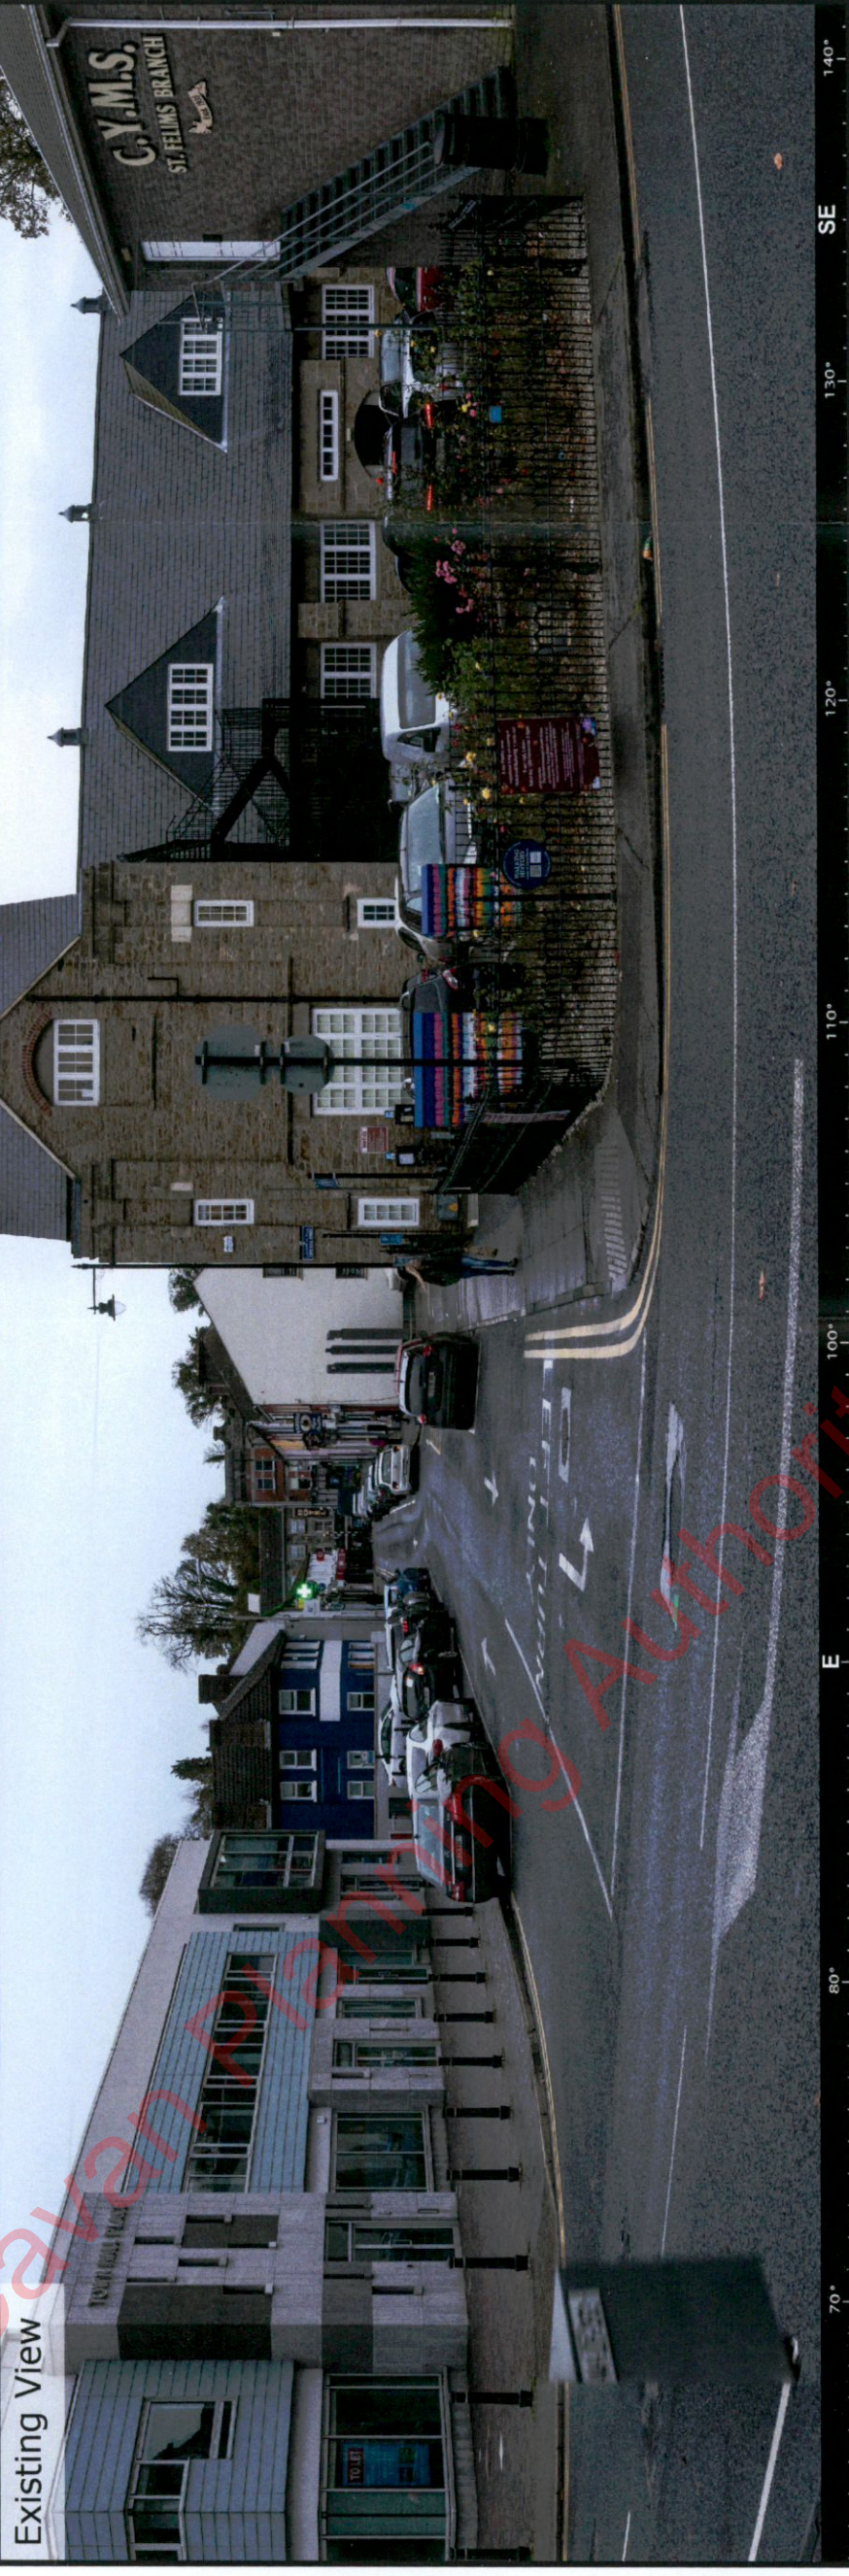
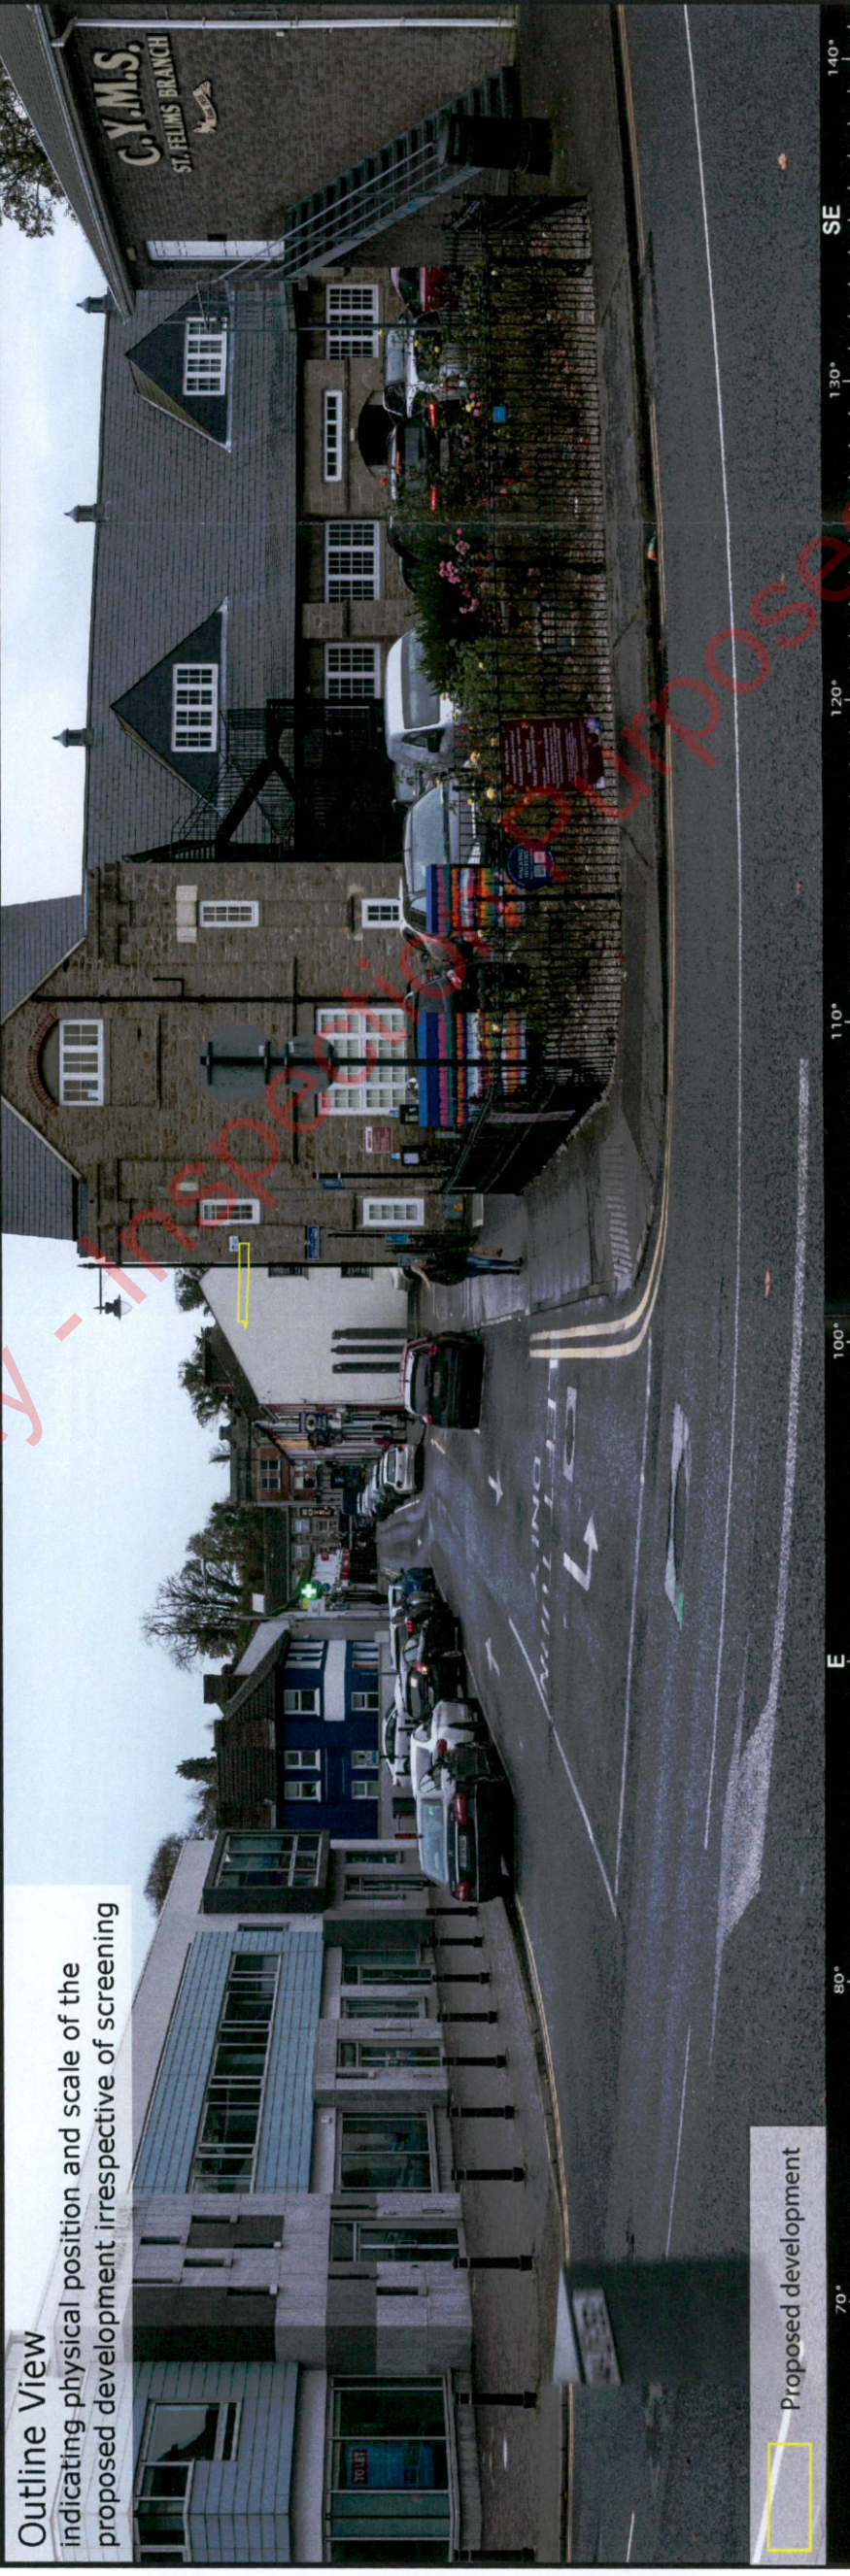
**Outline View**  
 indicating physical position and scale of the proposed development irrespective of screening

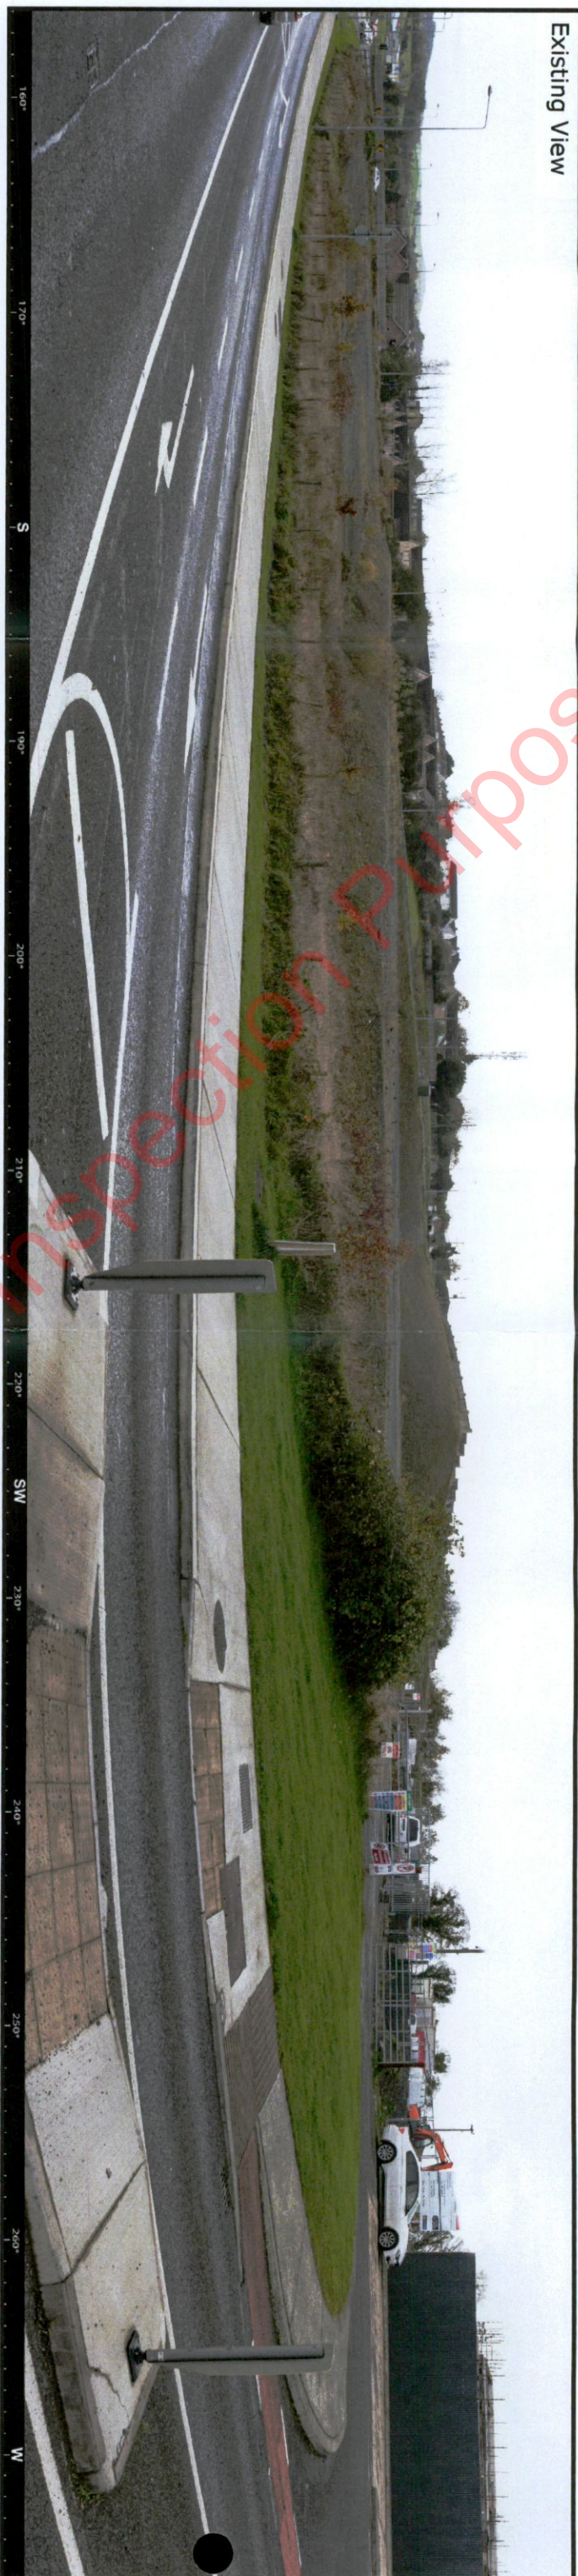
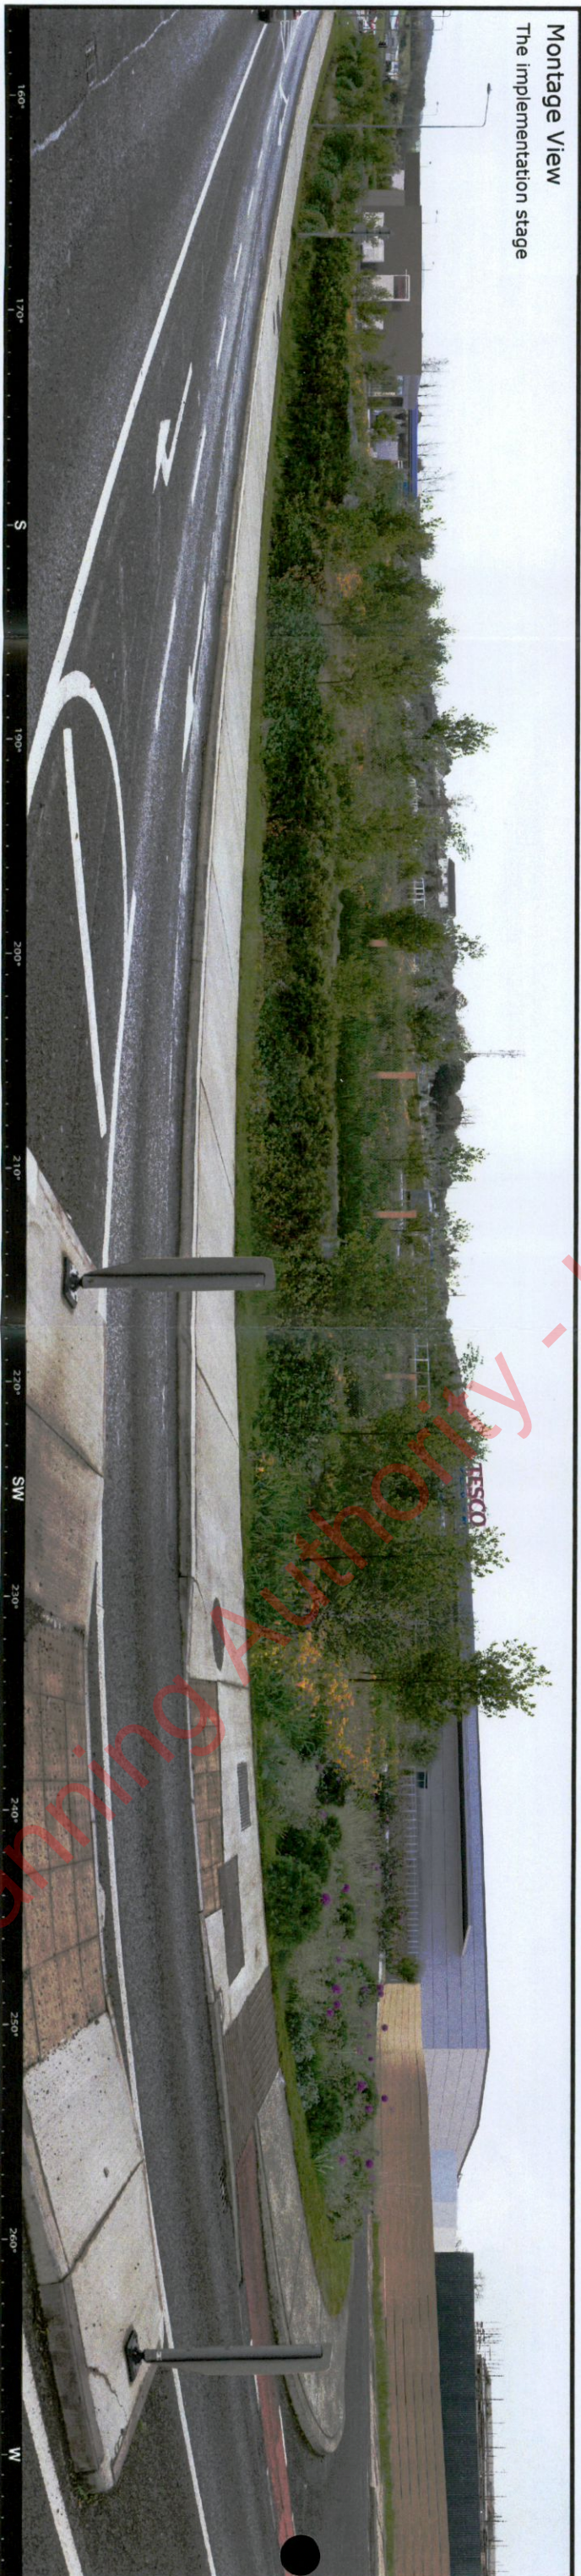
Cock Hill Road at entrance to Gaelscoil Bhreifne VP04 Page 2 of 2

Existing View

Montage View  
The implementation stage

These are 120° panoramic montages captured and presented in accordance with the guidance set by the British Landscape Institute 2011 - Advice Note 01/11.  
To view these panoramas on a flat surface one must move from left to right along its length whilst maintaining a perpendicular viewing direction and the specified correct viewing distance of 30cm. To see this entire panoramic scene in reality would necessitate turning one's head through 80°.

Easting (ITM):	804879	Lens:	50mm / Full Frame Sensor	Date:	09/11/2022
Northing (ITM):	642327	Camera:	Canon 1-D Mark II digital SLR	Time:	14:03
Direction of View:	SW	Camera Height:	1.7m Above Ground Level		
Angle of View:	120°

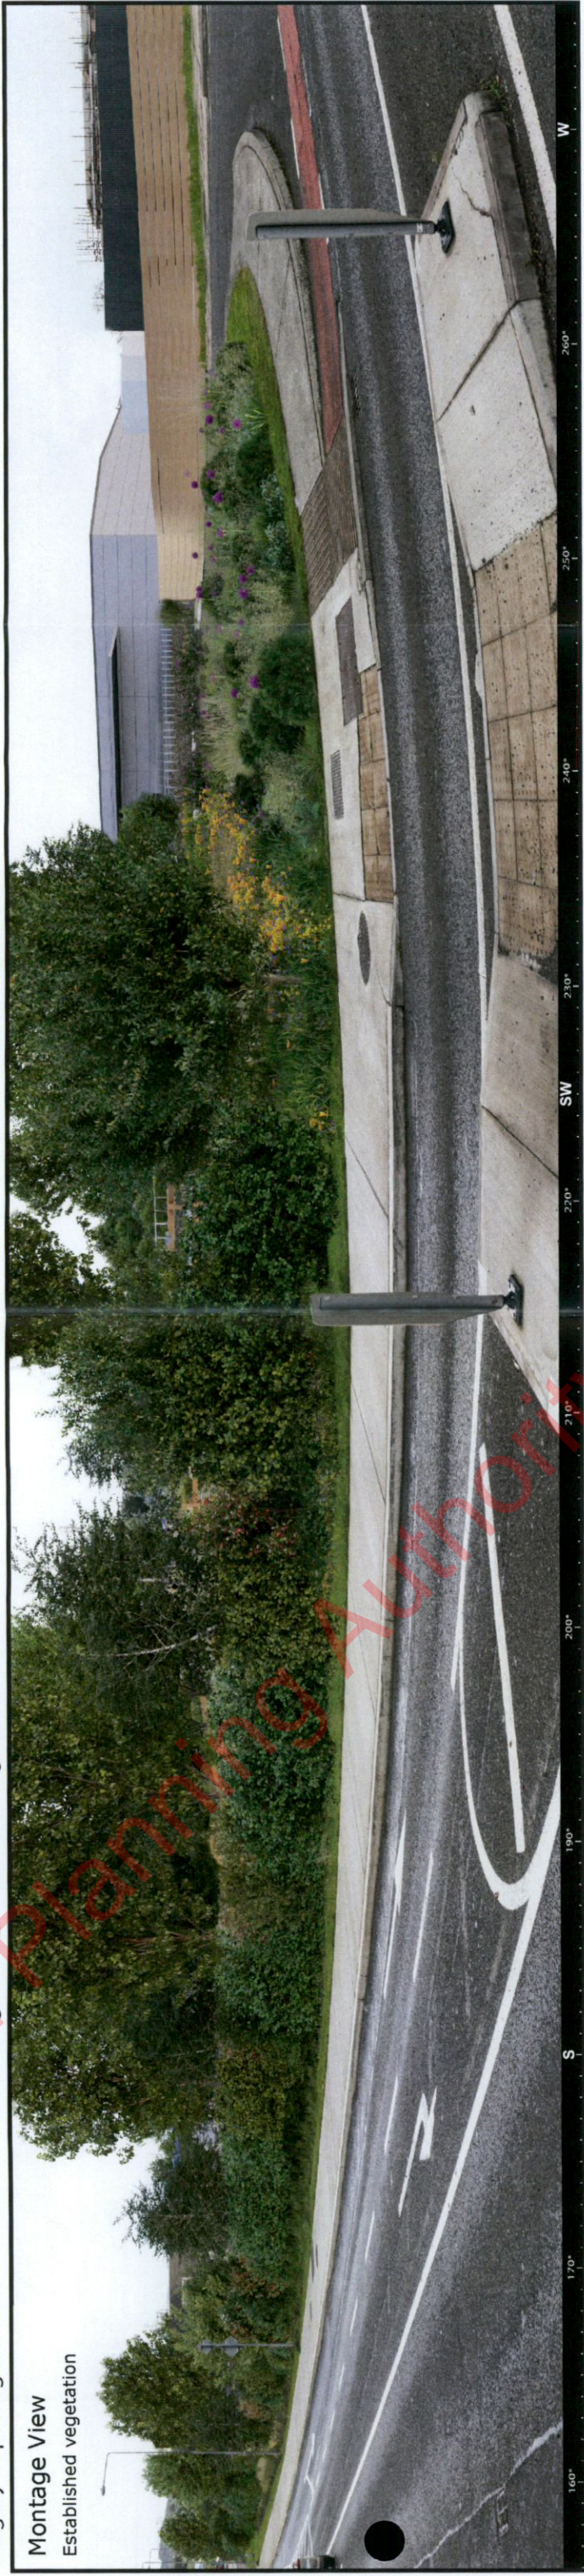
Montage View  
Established vegetation

These are 120° panoramic montages captured and presented in accordance with the guidance set by the British Landscape Institute 2011 - Advice Note 01/11.  
 To view these panoramas on a flat surface one must move from left to right along its length whilst maintaining a perpendicular viewing direction and the specified correct viewing distance of 30cm. To see this entire panoramic scene in reality would necessitate turning one's head through 80°.

Easting (ITM): Northing (ITM): Direction of View Angle of View:	804879 642327 SW 120°	Lens: Camera: Camera Height:	50mm / Full Frame Sensor Canon 1-D Mark II digital SLR 1.7m Above Ground Level	Date: Time:	09/11/2022 14:03
--	--------------------------------	------------------------------------	--	----------------	---------------------

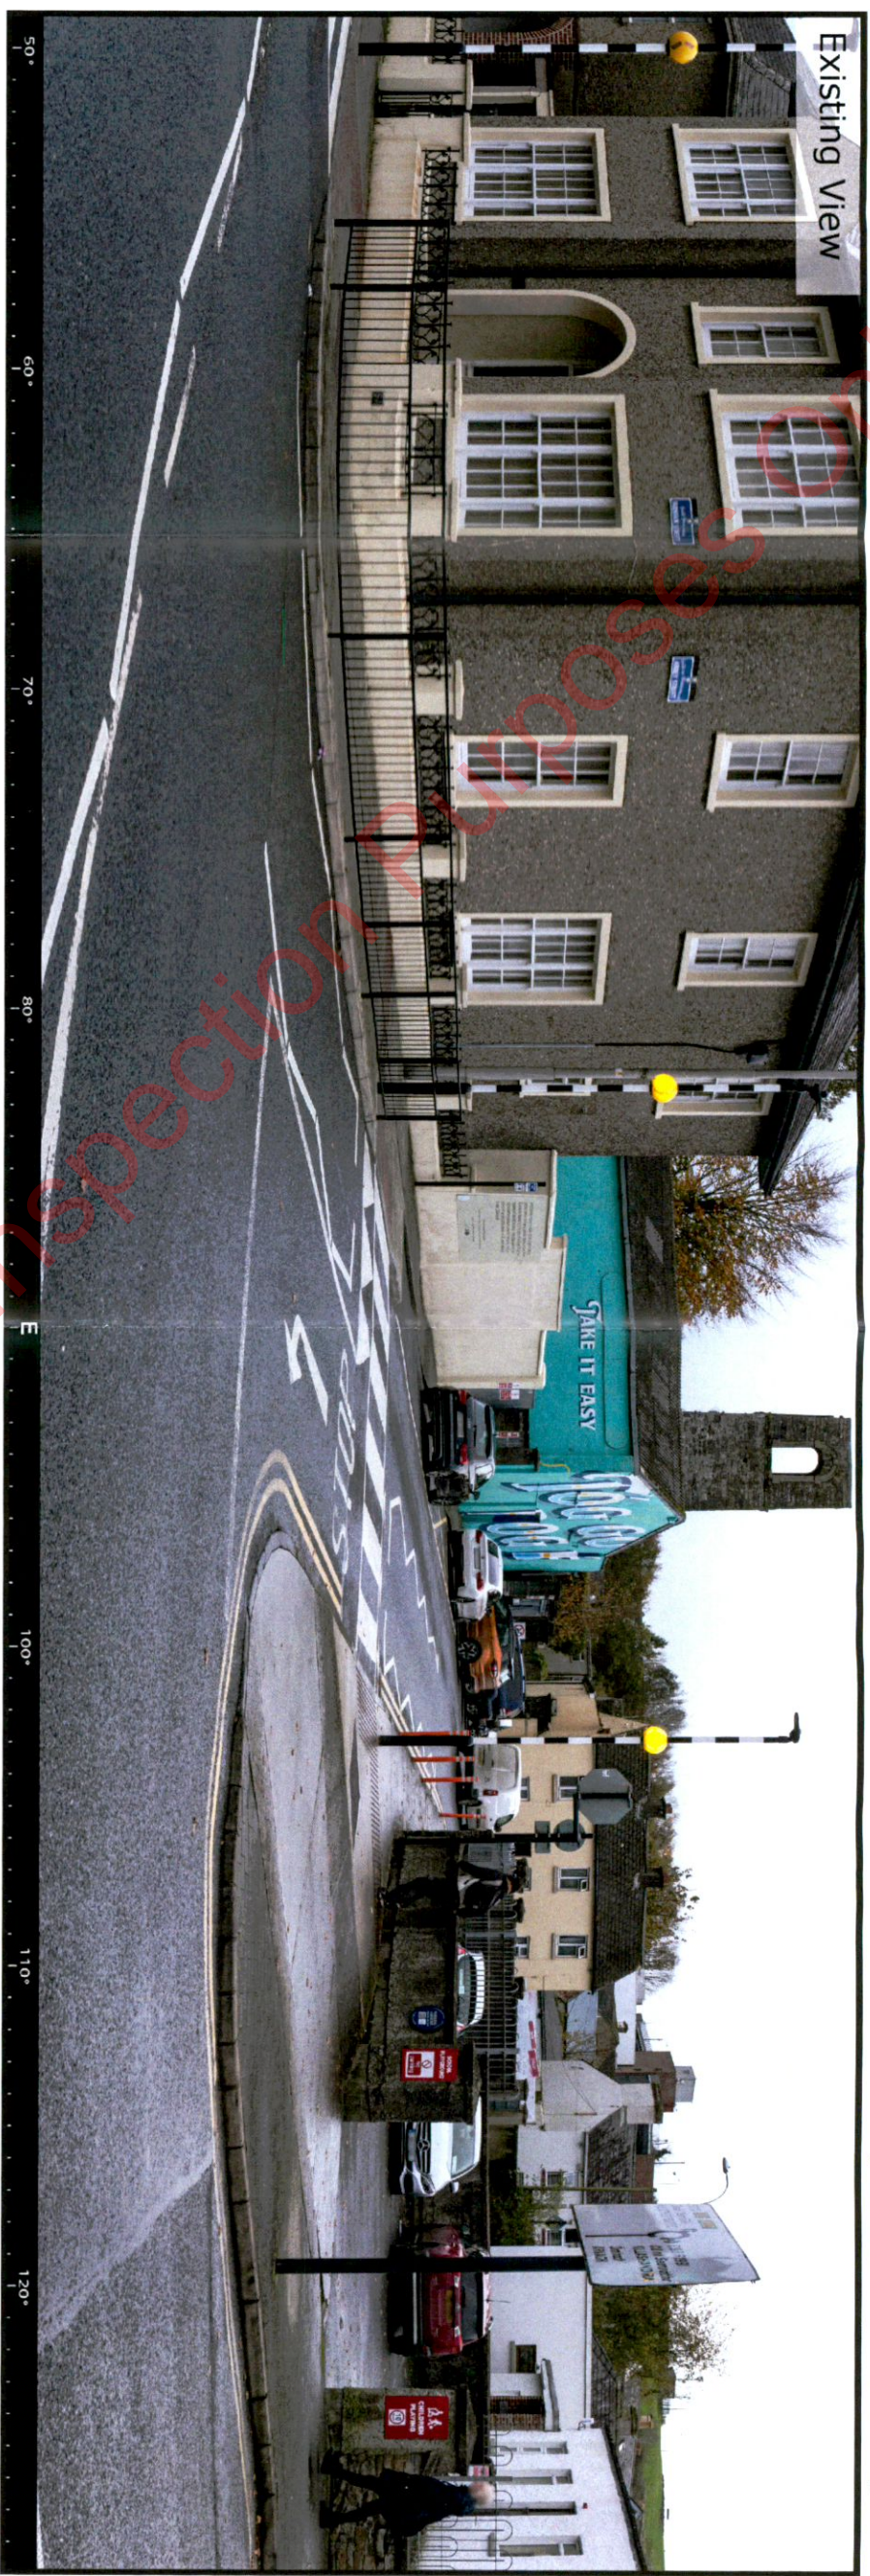
Outline View  
indicating physical position and scale of the proposed development irrespective of screening

Easting (ITM):	641763	Lens:	50mm / Full Frame Sensor
Northing (ITM):	804772	Camera:	Canon 1-D Mark II digital SLR
Direction of View:	E	Camera Height:	1.7m Above Ground Level
Angle of View:	80°	Date:	09/11/2022
		Time:	15:15

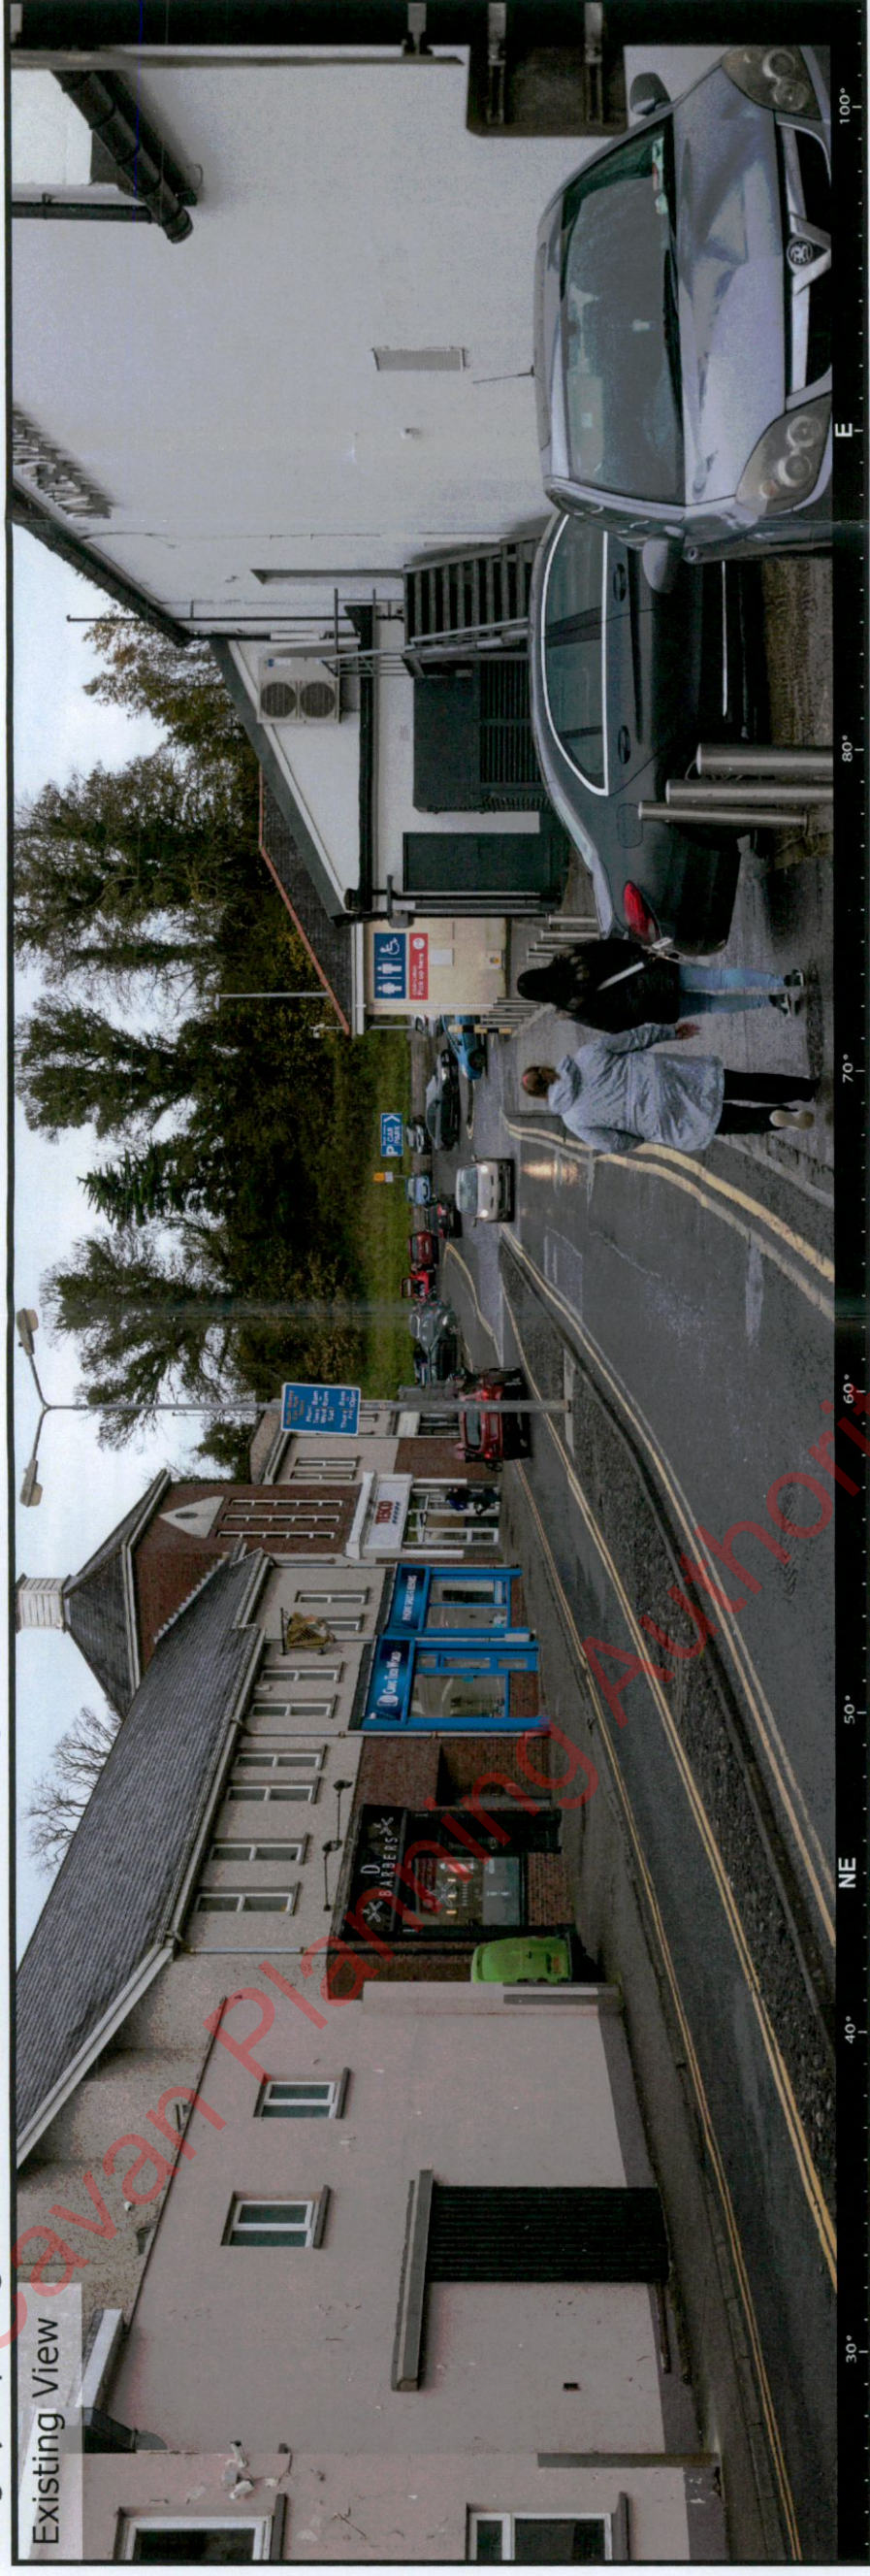
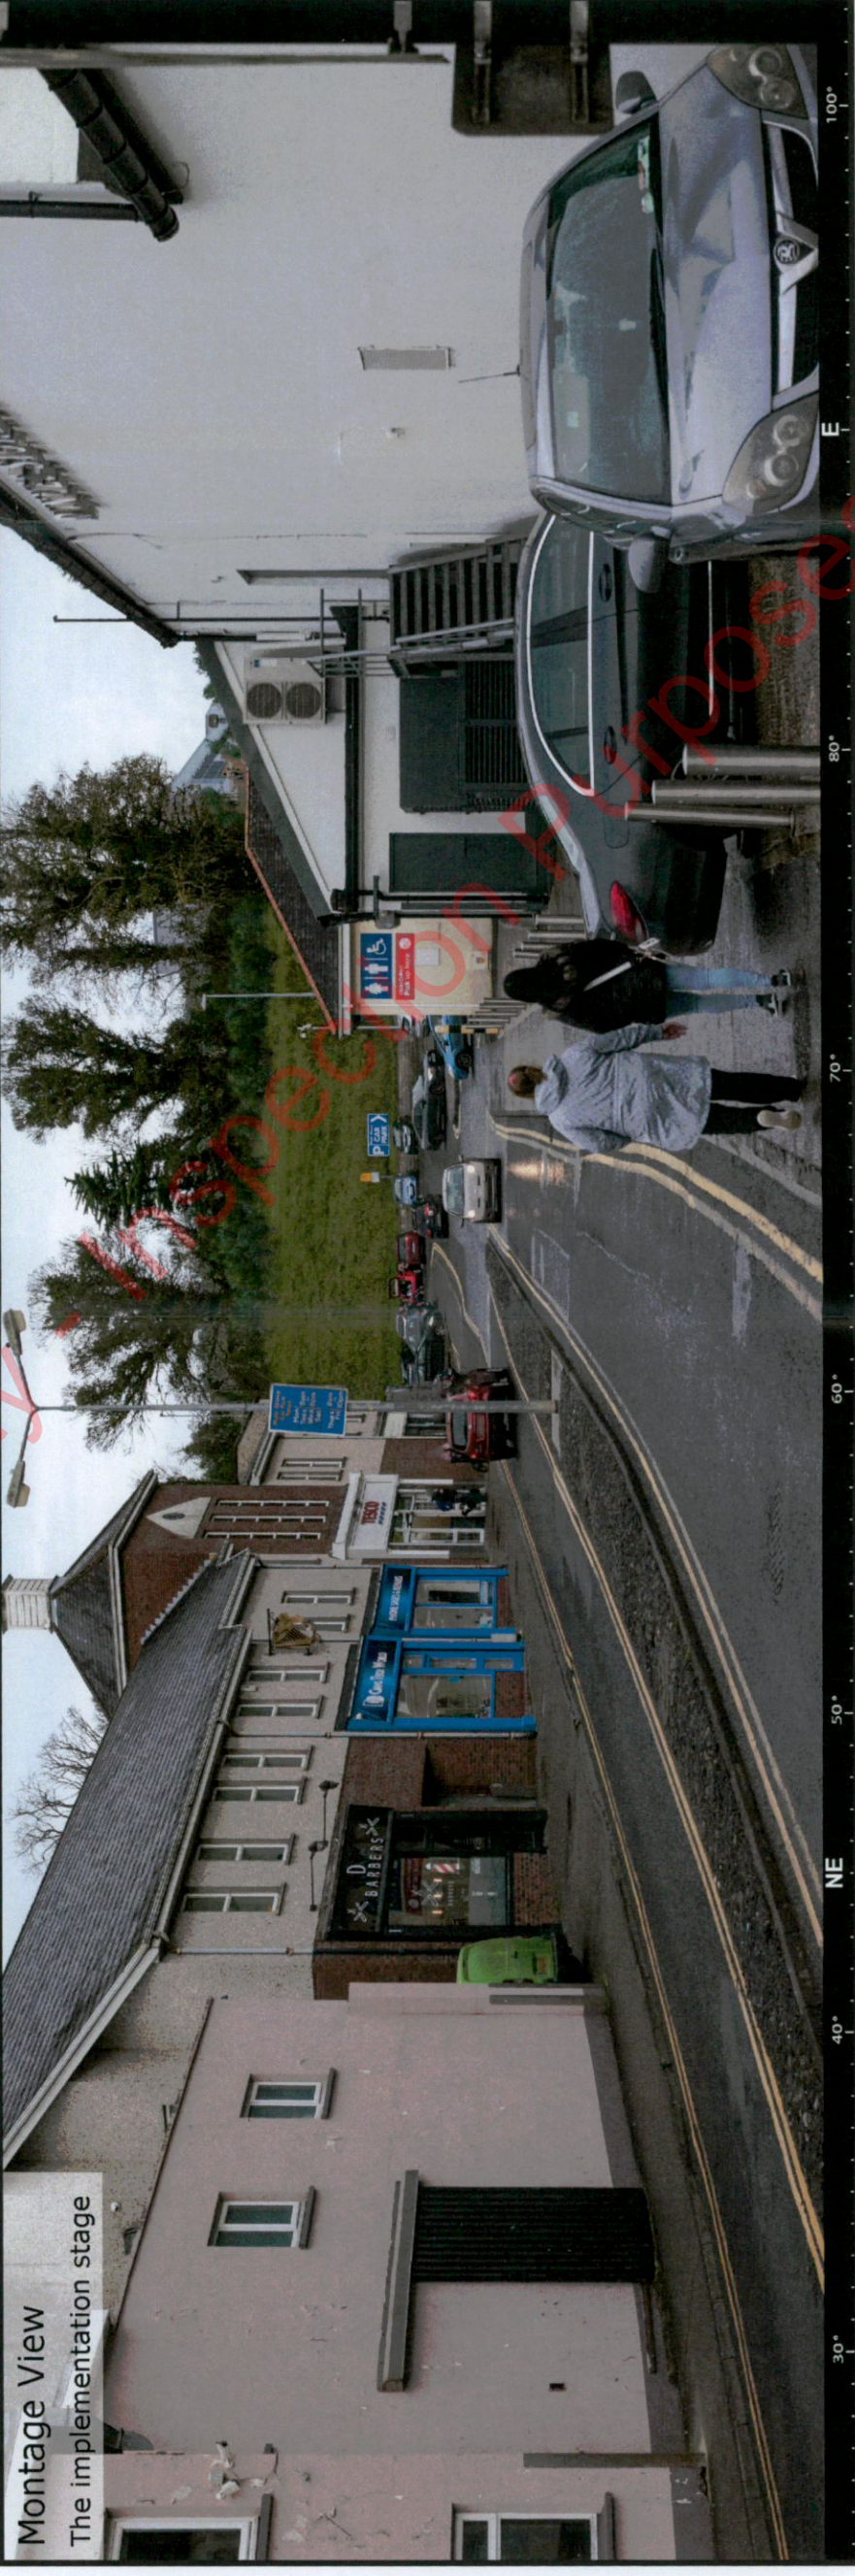
Existing View

Montage View  
The implementation stage

These are 80° panoramic montages captured and presented in accordance with the guidance set by the British Landscape Institute 2011 - Advice Note 01/11.

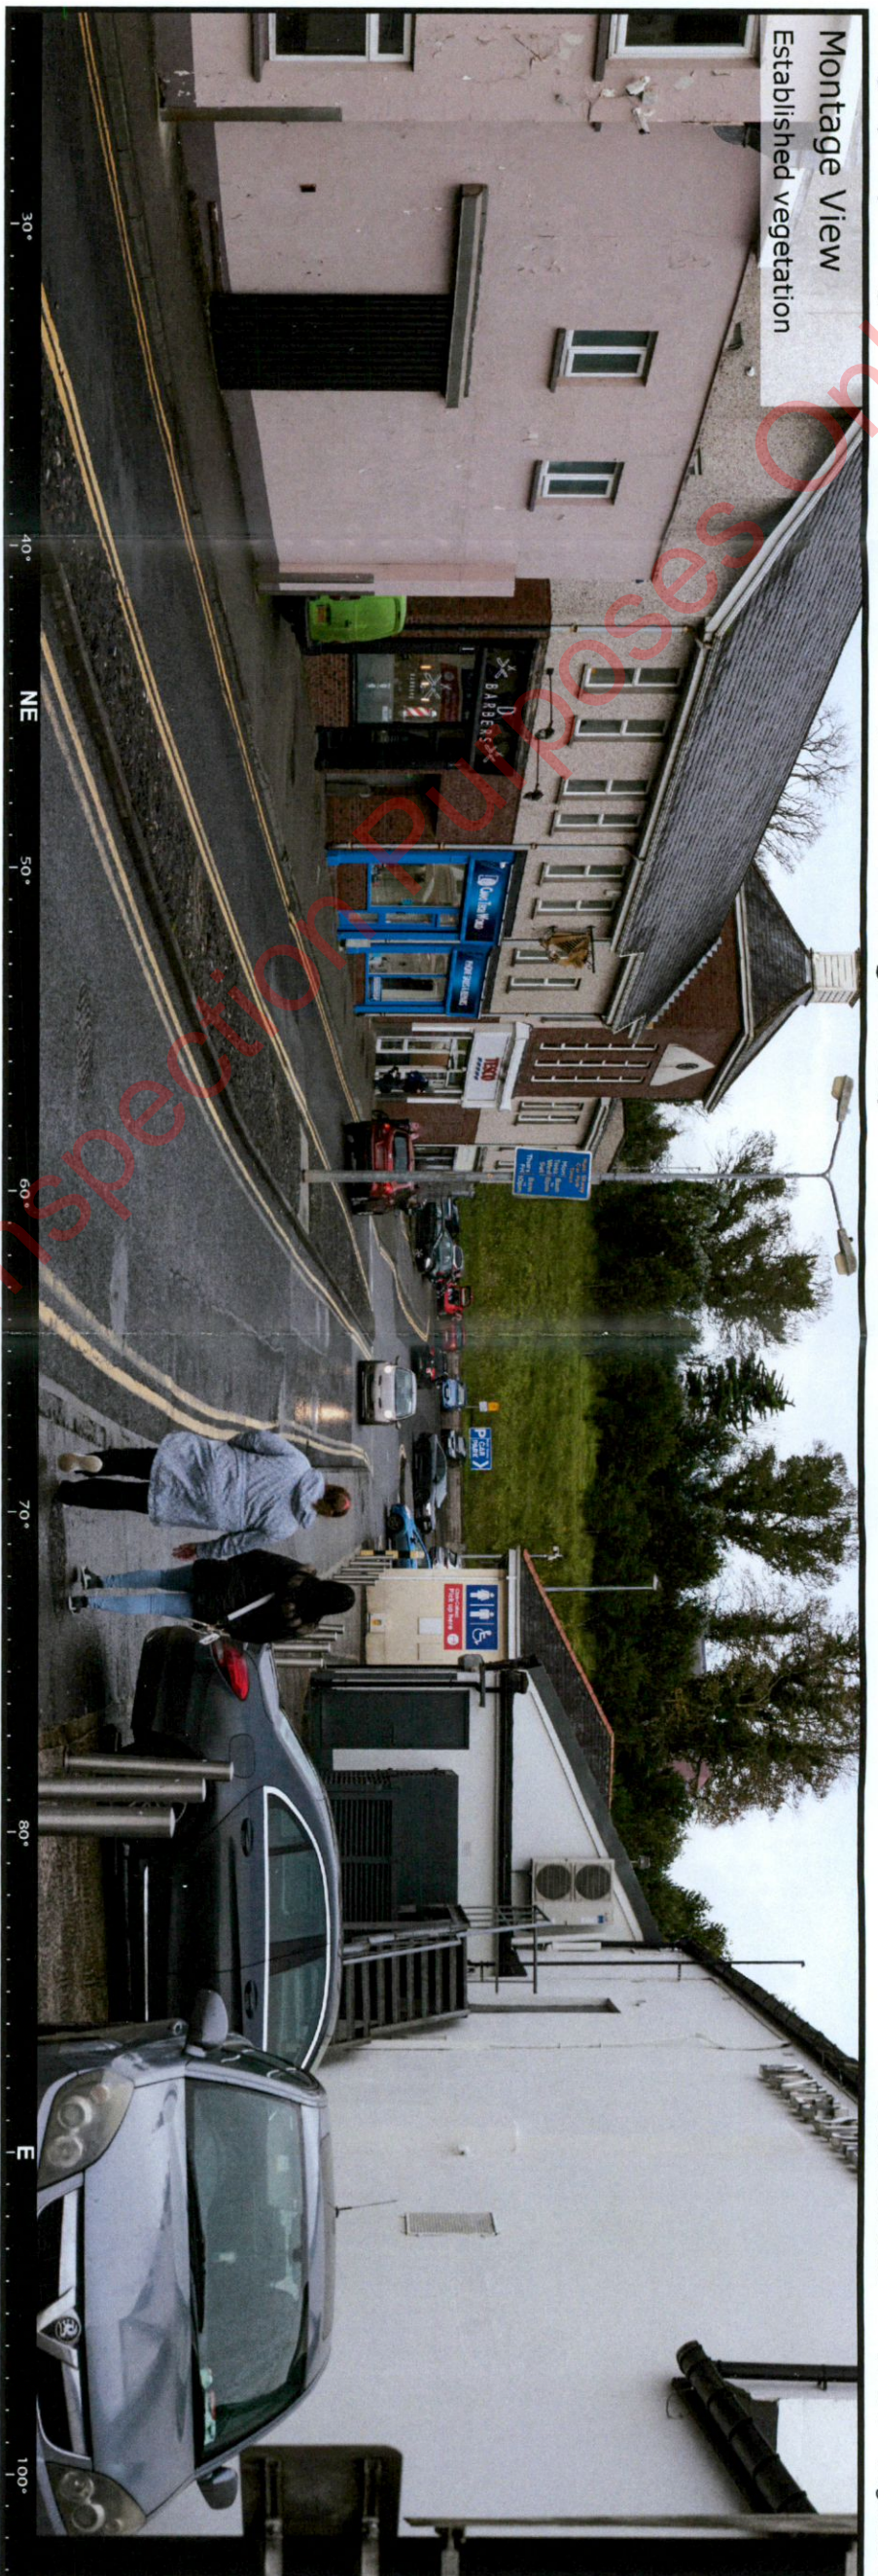
Montage View  
Established vegetation

These are 80° panoramic montages captured and presented in accordance with the guidance set by the British Landscape Institute 2011 - Advice Note 01/11.

Easting (ITM):	641970	Lens:	50mm / Full Frame Sensor	Date:	09/11/2022
Northing (ITM):	804744	Camera:	Canon 1-D Mark II digital SLR	Time:	14:52
Direction of View:	E	Camera Height:	1.7m Above Ground Level		
Angle of View:	80°
