TEST REPORT

Determination of Particle Size Distribution

Contract No.	24083	Report No.	R135336
Contract Name:	Tesco, Cavan		
BH/TP*:	BH01	Lab. Sample No.	A22/3553
Sample No.*	AA172991	Customer:	Tesco Irl./ Pinnacle
Sample Type:	B	Date Testing started	20/06/2022
Depth* (m)	1.00	Description:	Grey/brown slightly sandy, gravelly, CLAY

Client:	Tesco, Cavan
Project Code:	OR0301 - EIAR
Project Description:	Development of the site for Tesco
Scenario Description:	Foundations, Receptor at 30m

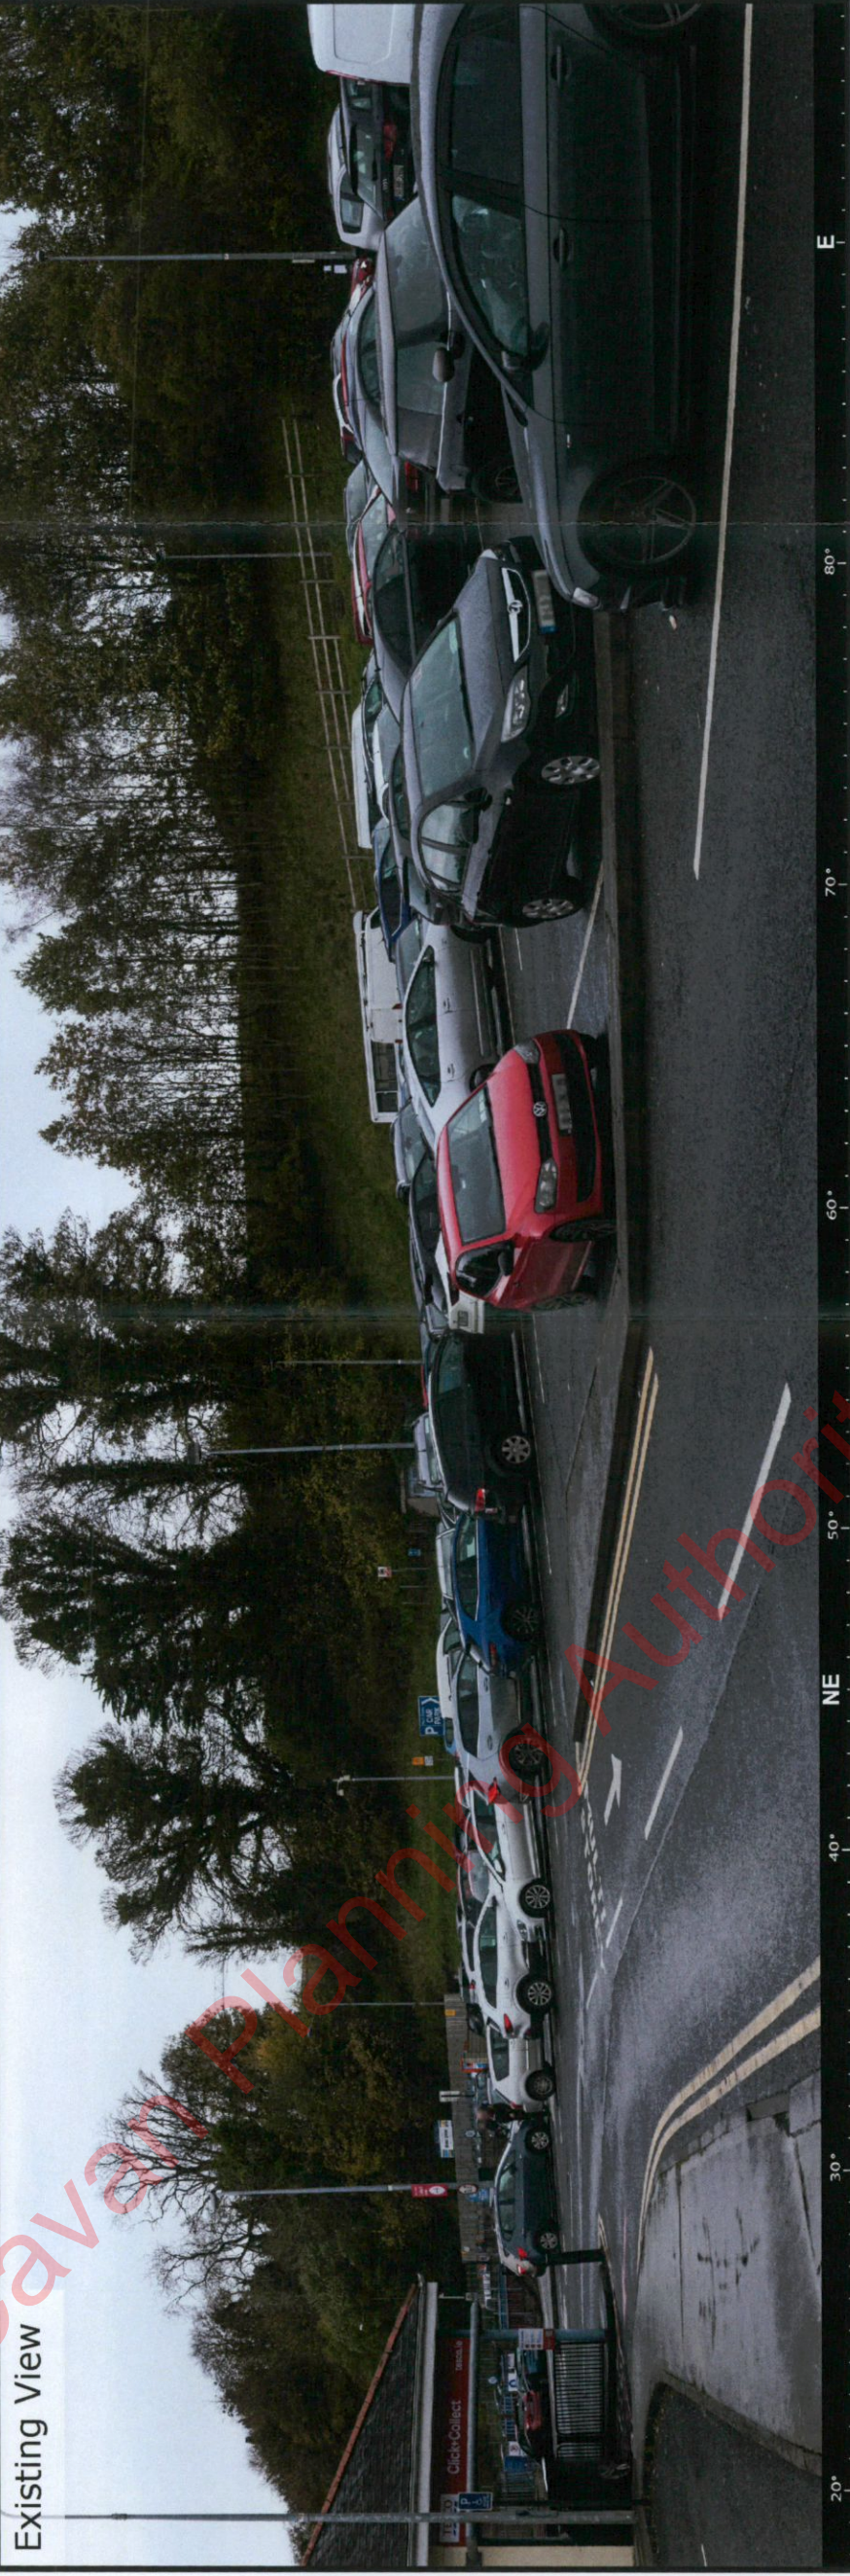
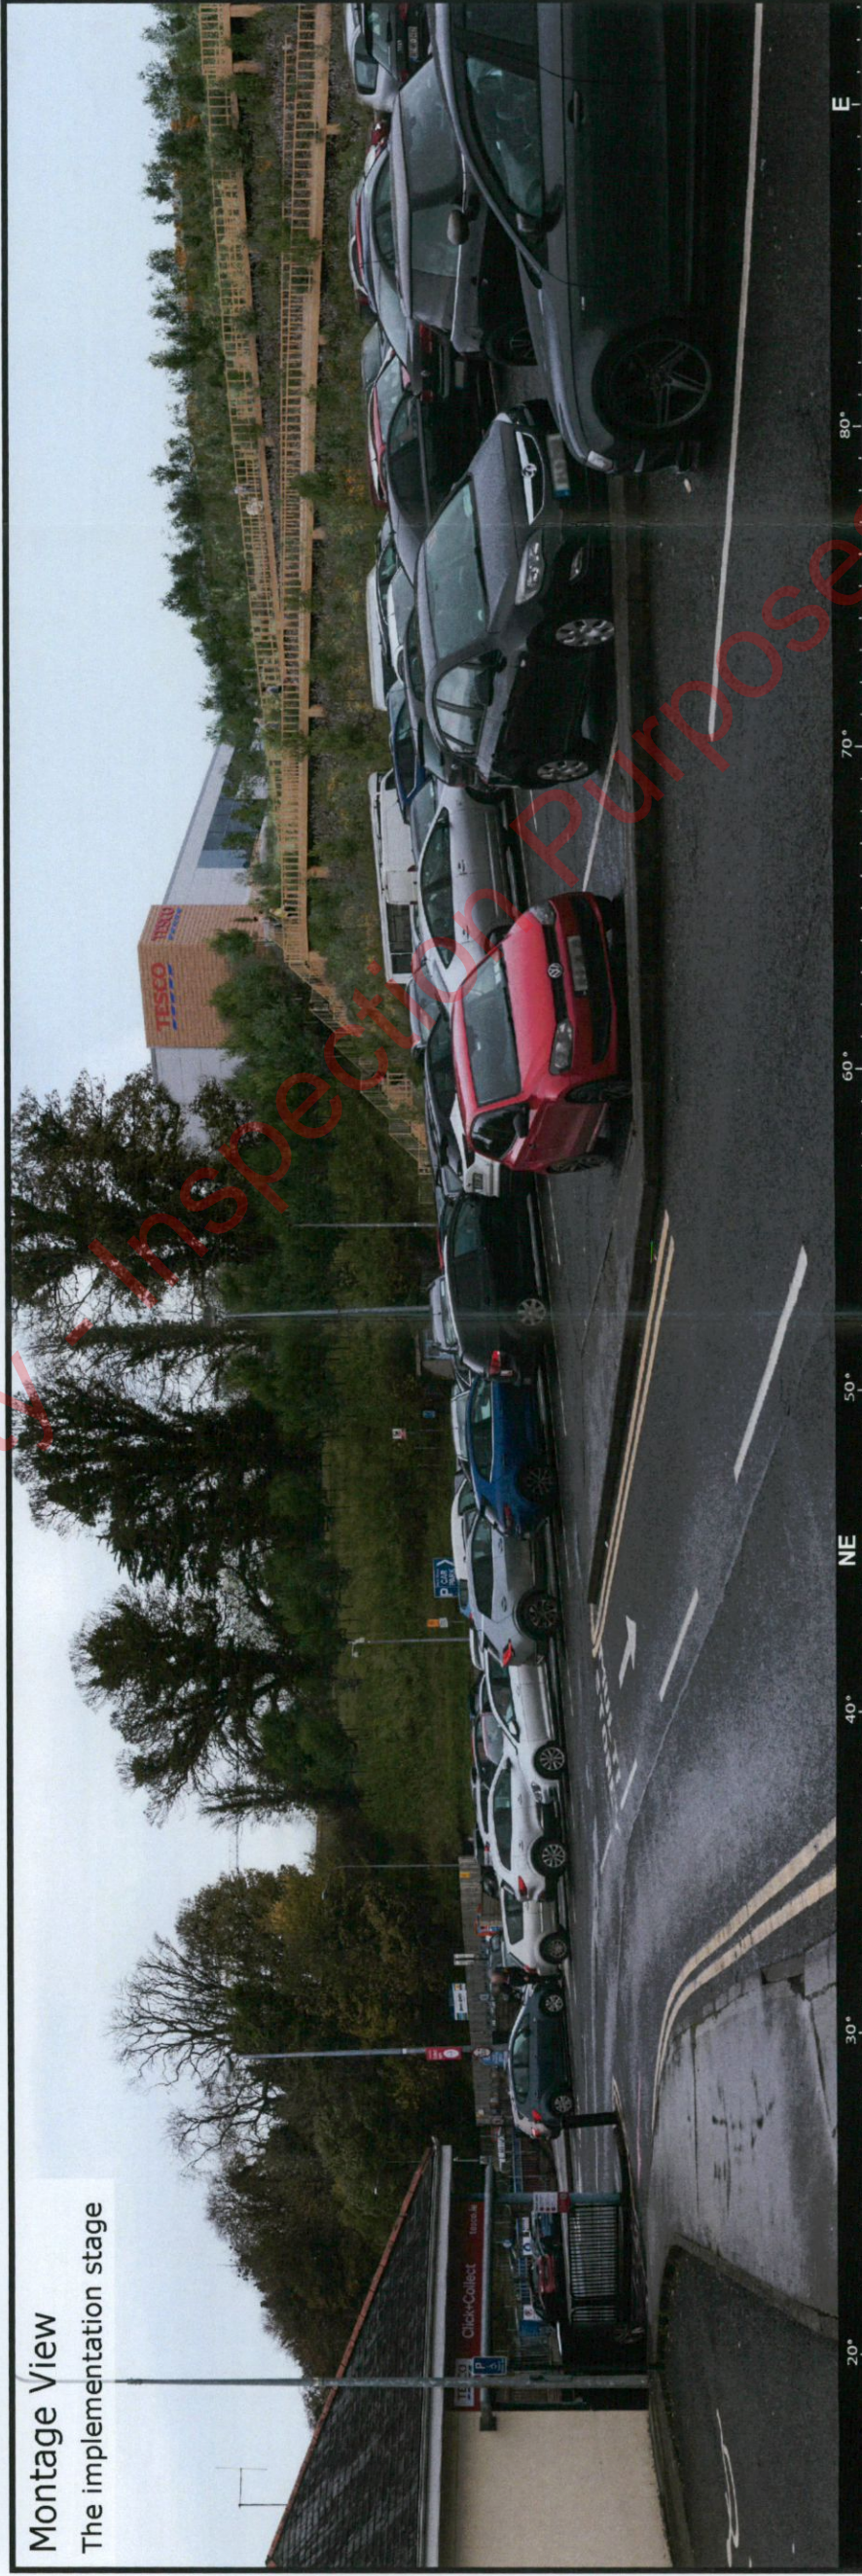
Existing View

Montage View  
The implementation stage

These are 80° panoramic montages captured and presented in accordance with the guidance set by the British Landscape Institute 2011 - Advice Note 01/11.  
To view these panoramas on a flat surface one must move from left to right along its length whilst maintaining a perpendicular viewing direction and the specified correct viewing distance of 30cm. To see this entire panoramic scene in reality would necessitate turning one's head through 40°.

Eastings (ITM):	642404	Lens:	50mm / Full Frame Sensor	Date:	09/11/2022
Northings (ITM):	804706	Camera:	Canon 1-D Mark II digital SLR	Time:	14:30
Direction of View:	E	Camera Height:	1.7m Above Ground Level		
Angle of View:	80°

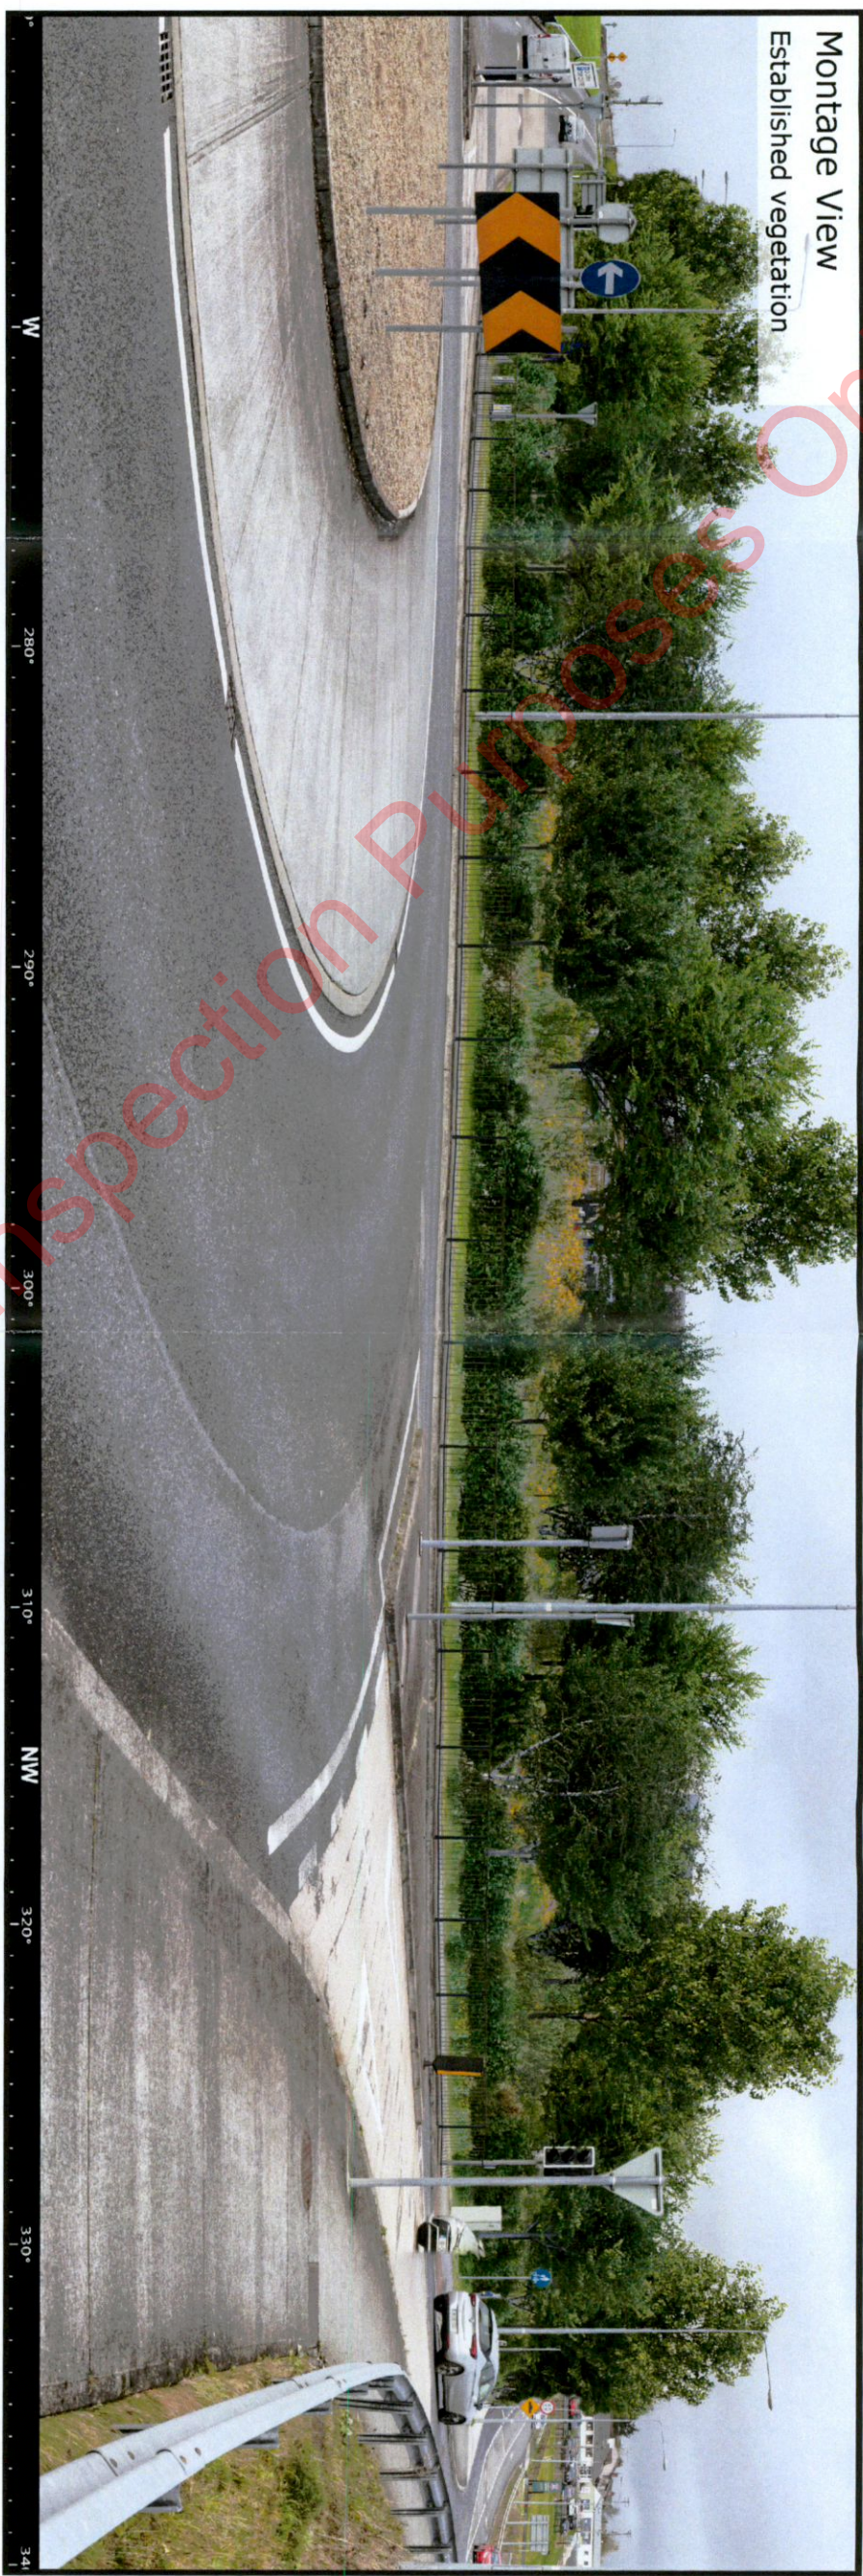
Montage View  
Established vegetation

These are 80° panoramic montages captured and presented in accordance with the guidance set by the British Landscape Institute 2011 - Advice Note 01/11.

Easting (ITM):	642404	Lens:	50mm / Full Frame Sensor	Date:	09/11/2022
Northing (ITM):	804706	Camera:	Canon 1-D Mark II digital SLR	Time:	13:42
Direction of View:	NW	Camera Height:	1.7m Above Ground Level		
Angle of View:	80°

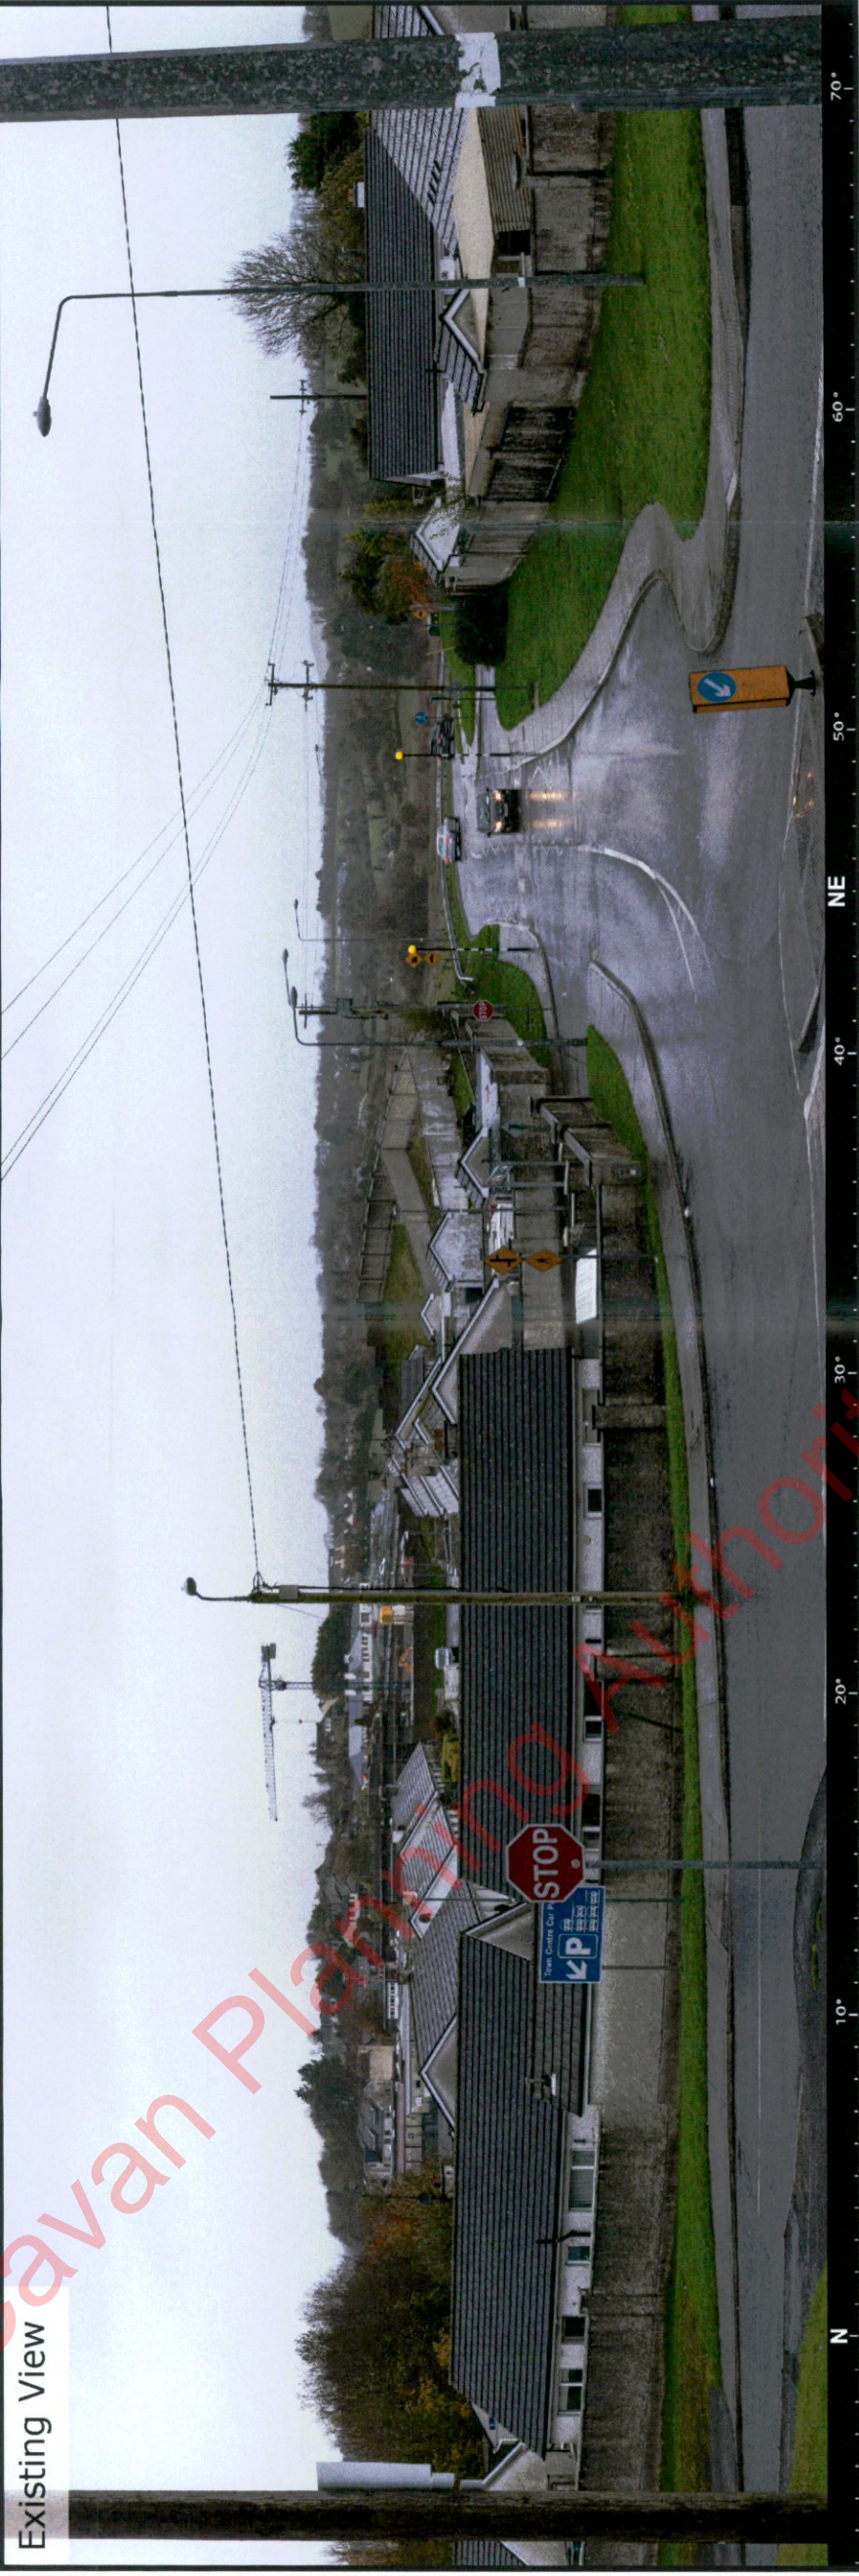
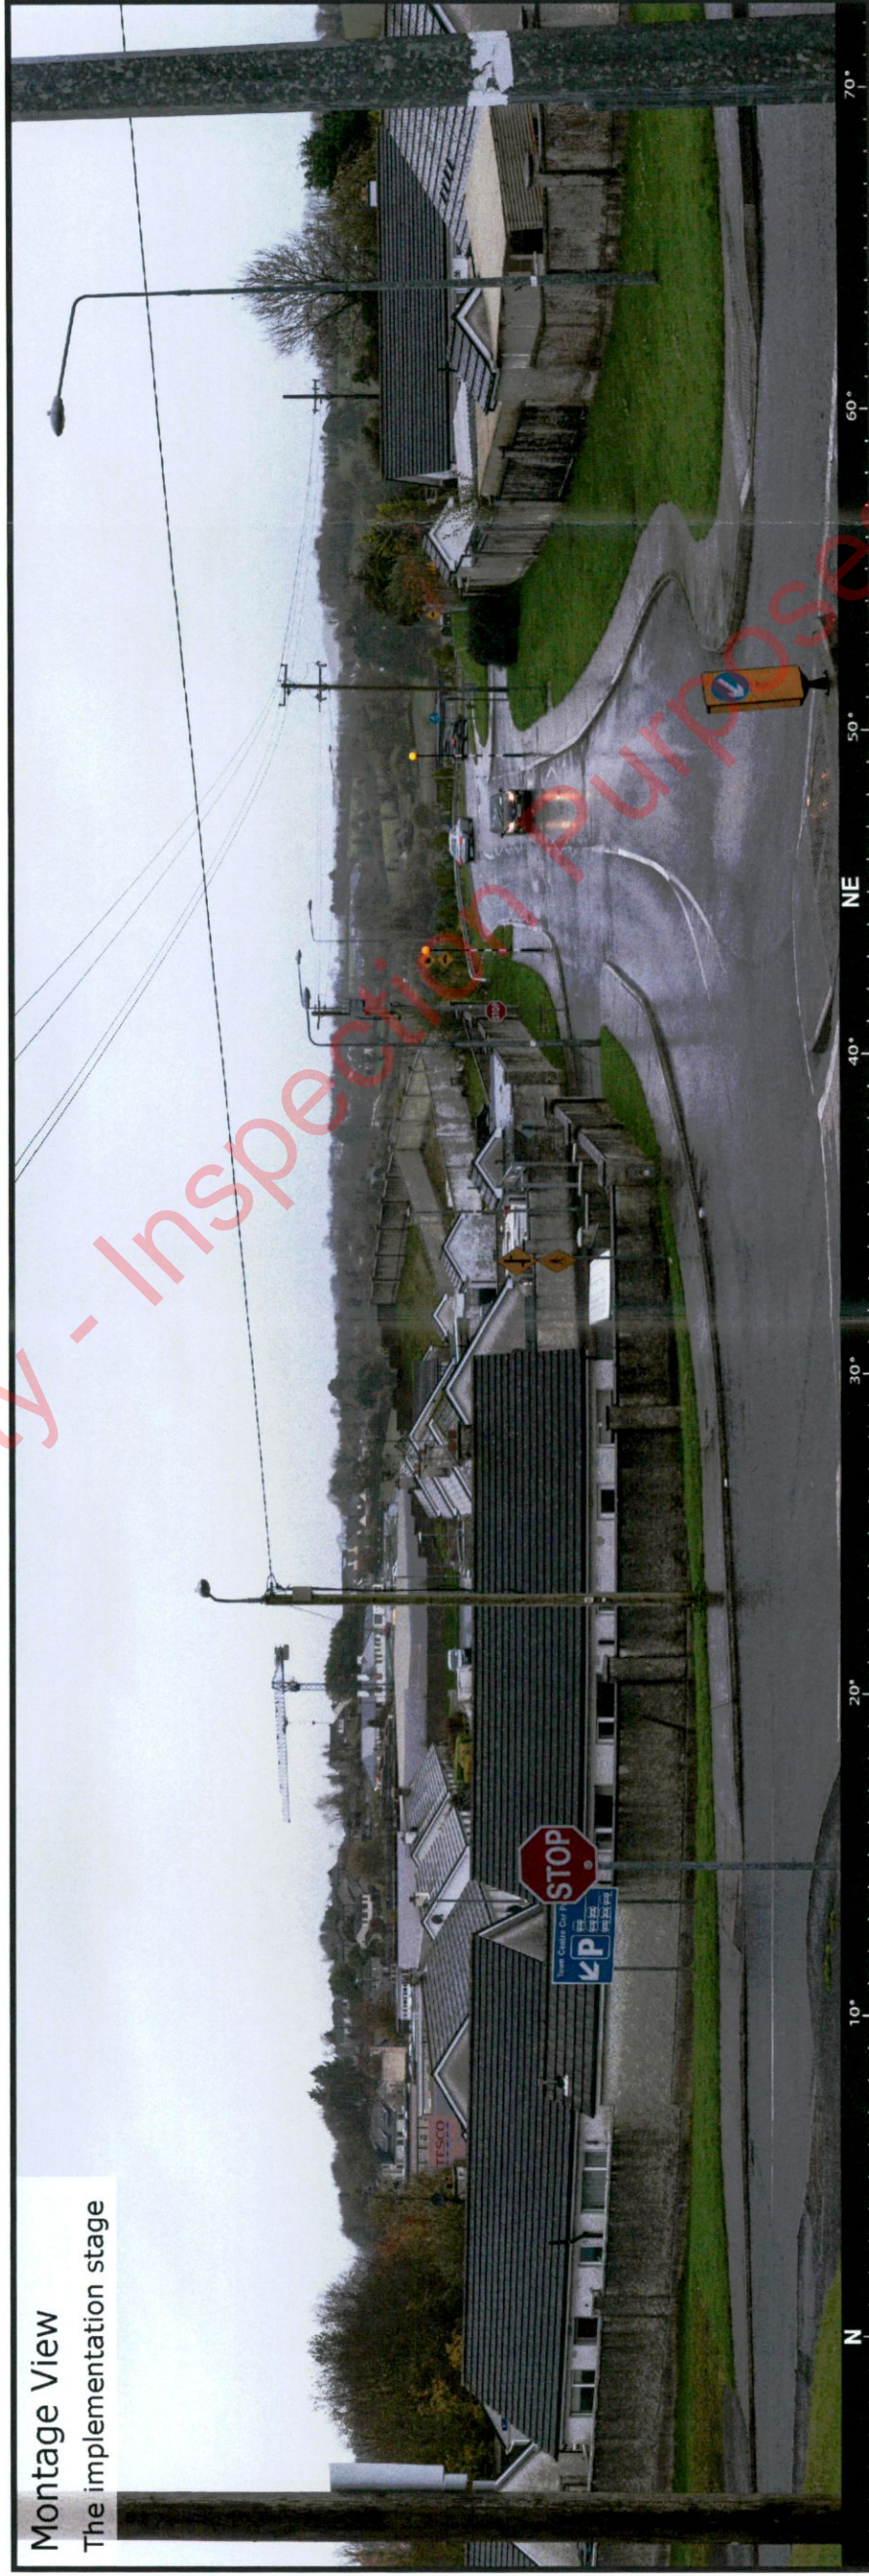
Existing View

Montage View  
The implementation stage

These are 80° panoramic montages captured and presented in accordance with the guidance set by the British Landscape Institute 2011 - Advice Note 01/11.

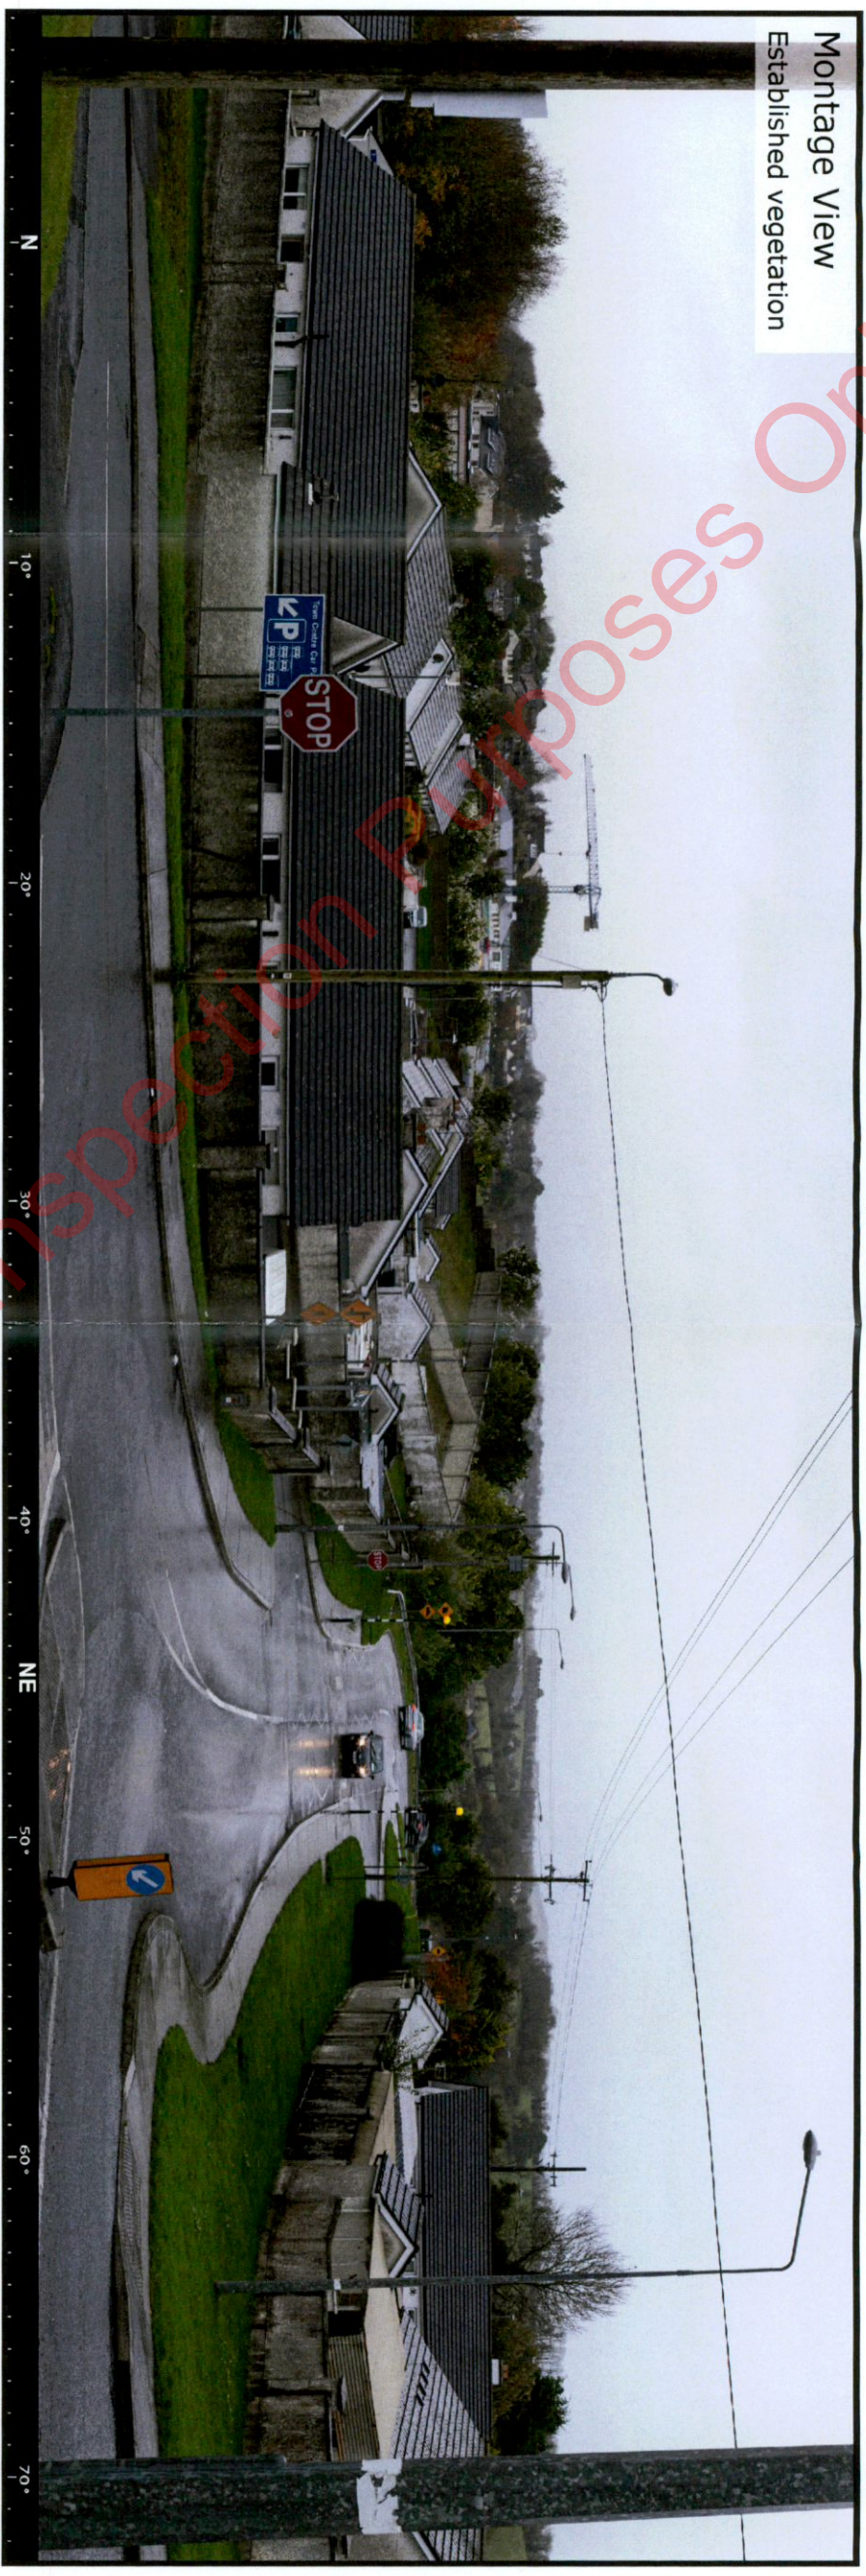
Montage View  
Established vegetation

These are 80° panoramic montages captured and presented in accordance with the guidance set by the British Landscape Institute 2011 - Advice Note 01/11.

Eastings (ITM):	642112	Lens:	50mm / Full Frame Sensor	Date:	09/11/2022
Northings (ITM):	804603	Camera:	Canon 1-D Mark II digital SLR	Time:	16:13
Direction of View:	NE	Camera Height:	1.7m Above Ground Level		
Angle of View:	80°

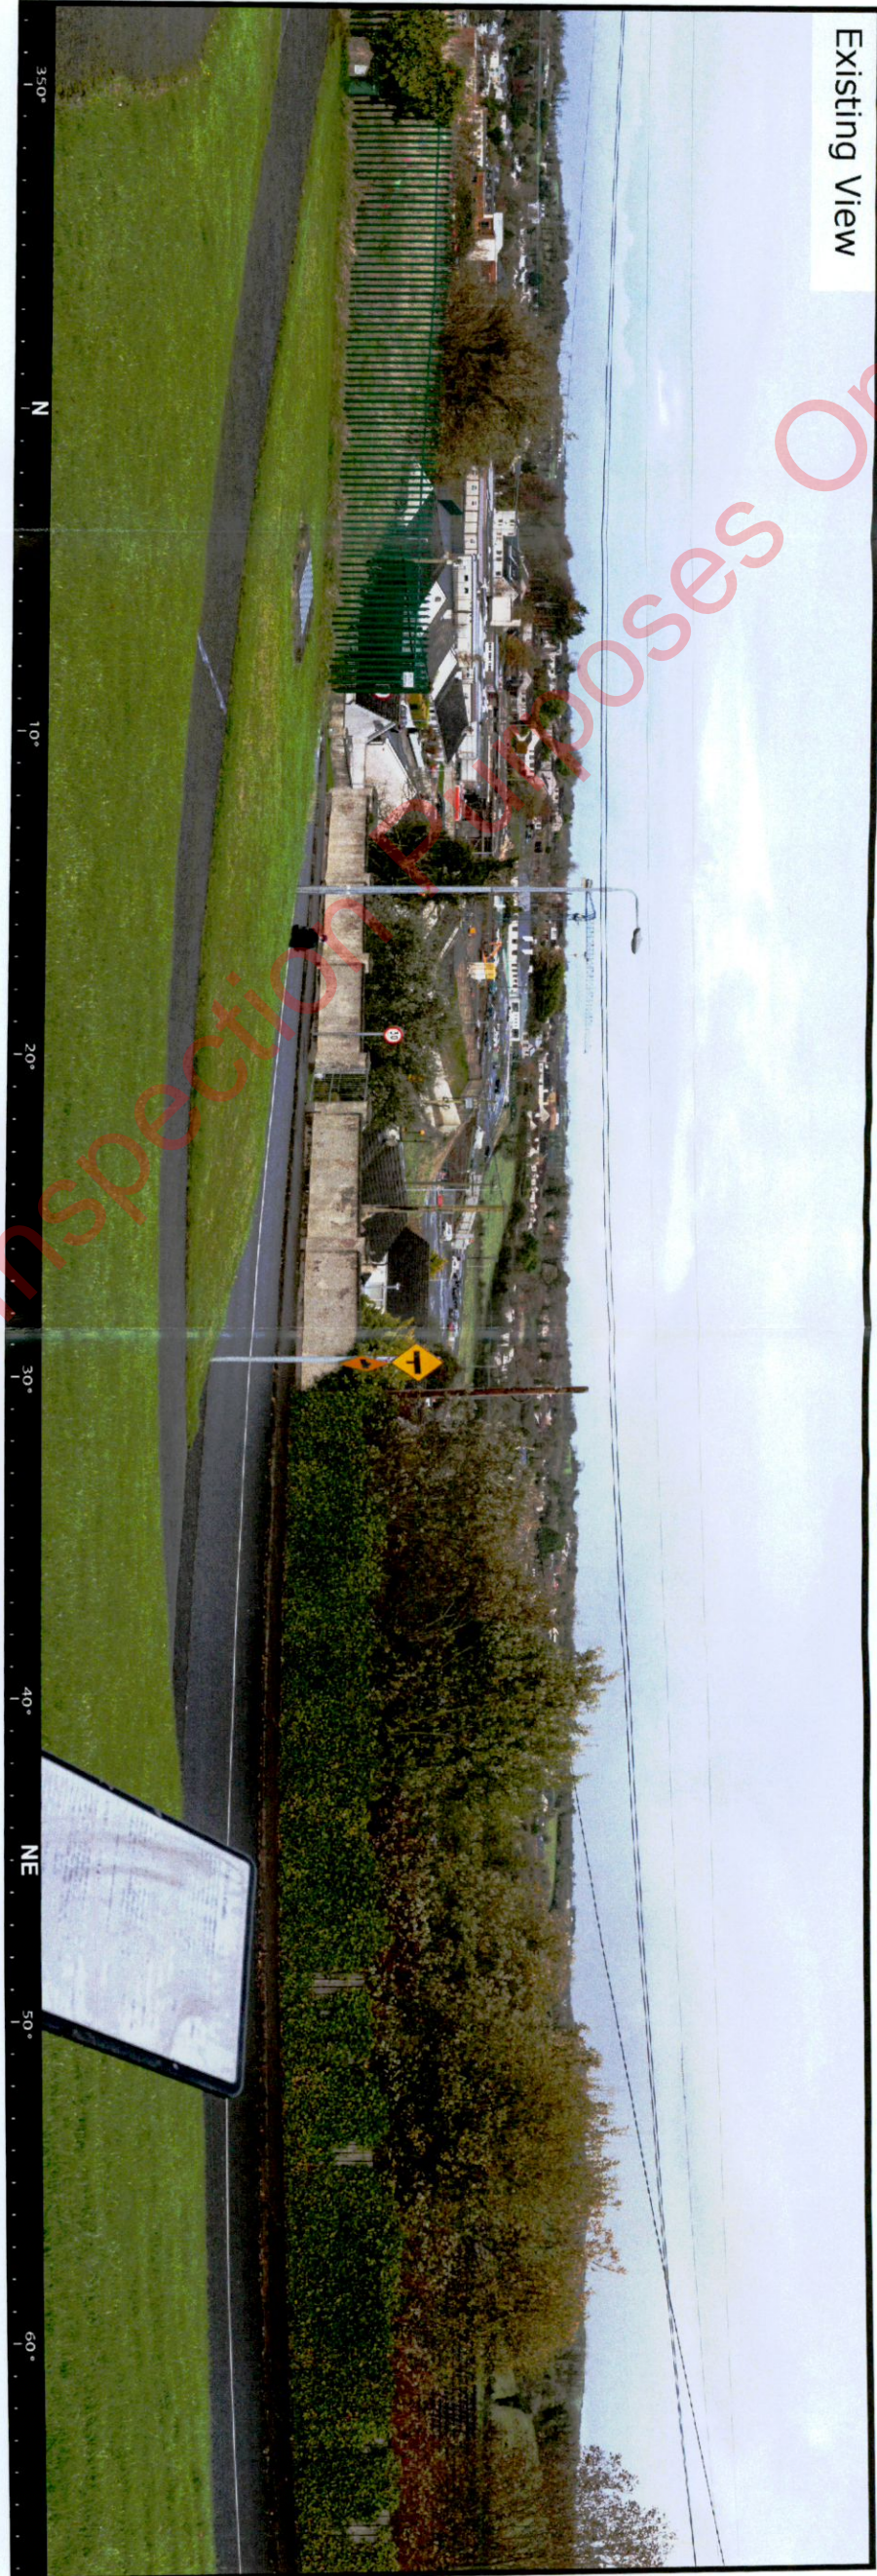
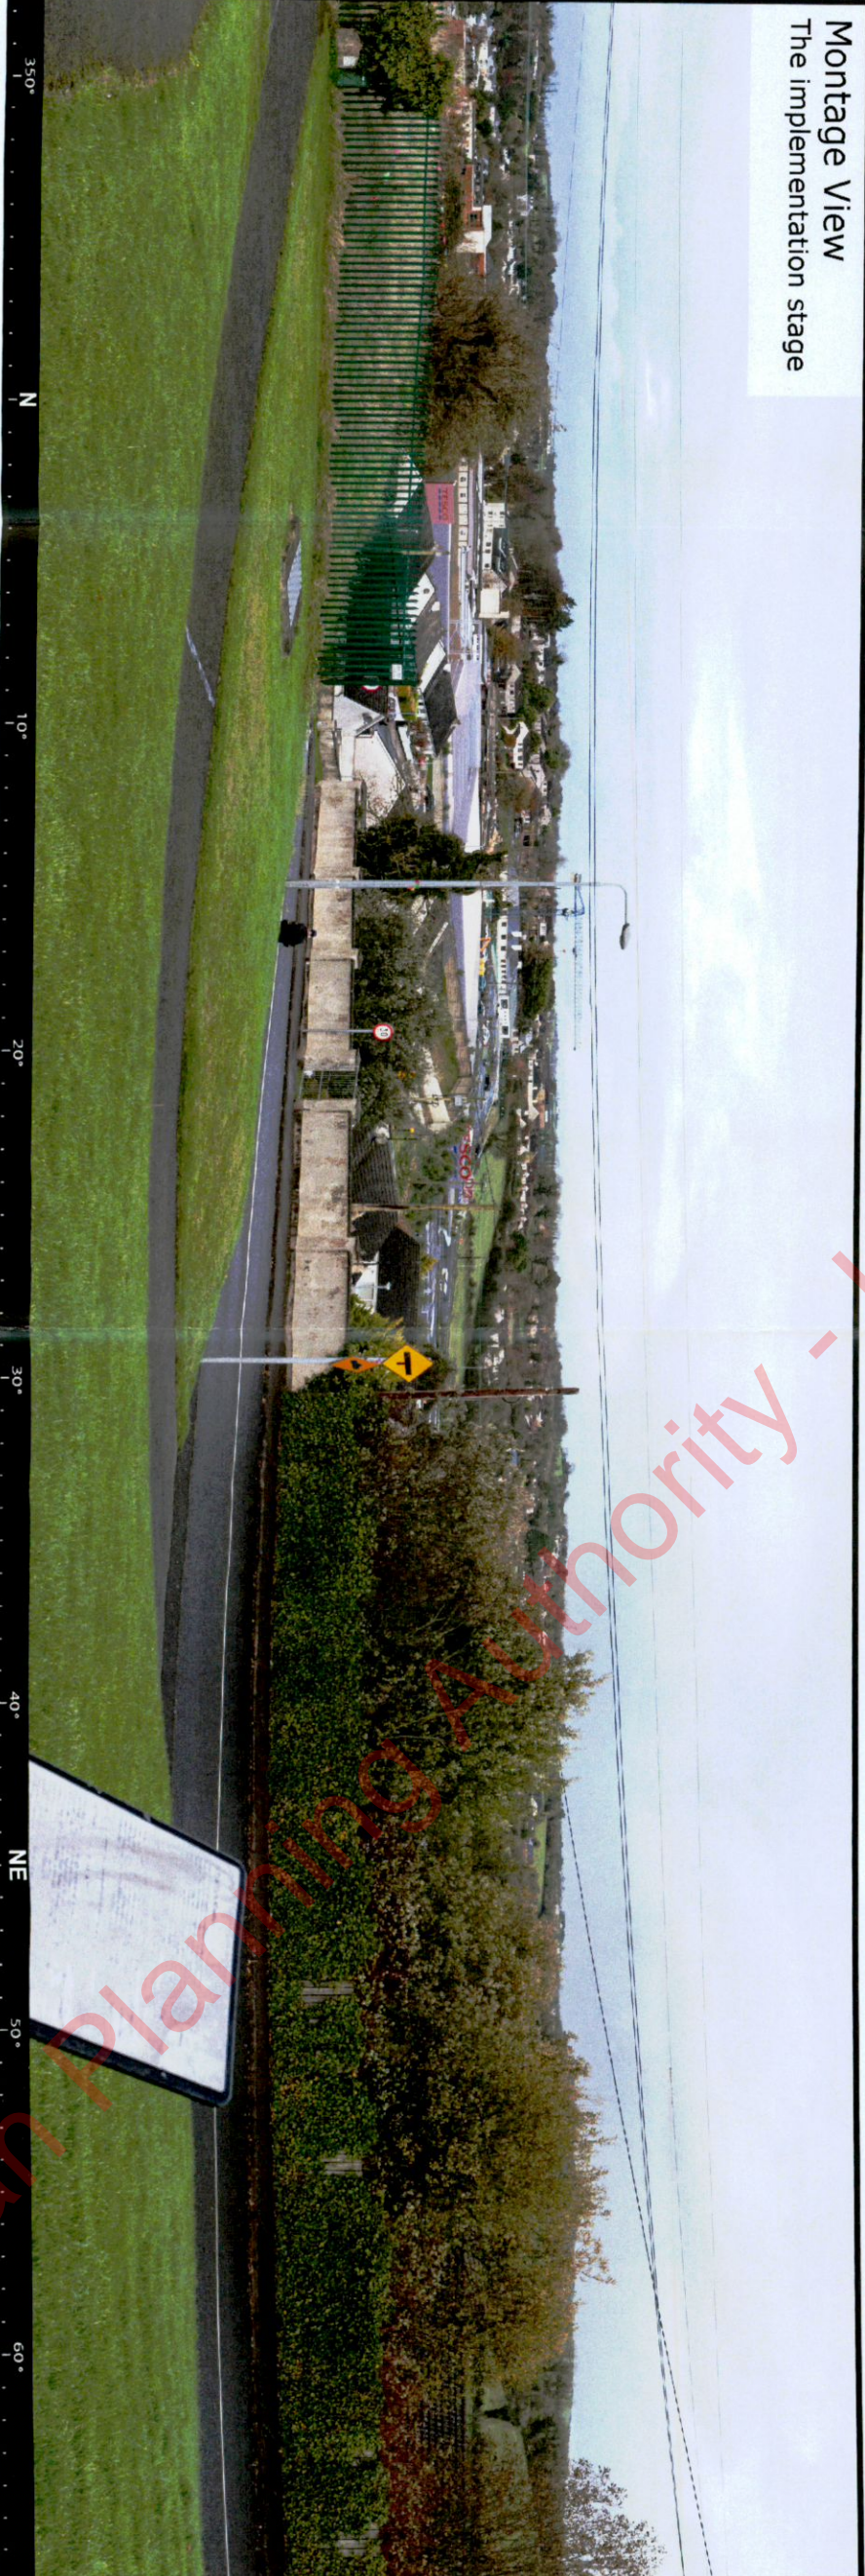
Existing View

Montage View  
The implementation stage

These are 80° panoramic montages captured and presented in accordance with the guidance set by the British Landscape Institute 2011 - Advice Note 01/11.
