# Environmental Impact Assessment Report

Volume 2: Appendices

Proposed Large-scale Residential Development consisting of 716no. residential units and 1no. childcare facility.

In the Townlands of Castlefarm, Rusk, Clonee and Loughsallagh, Dunboyne, County Meath

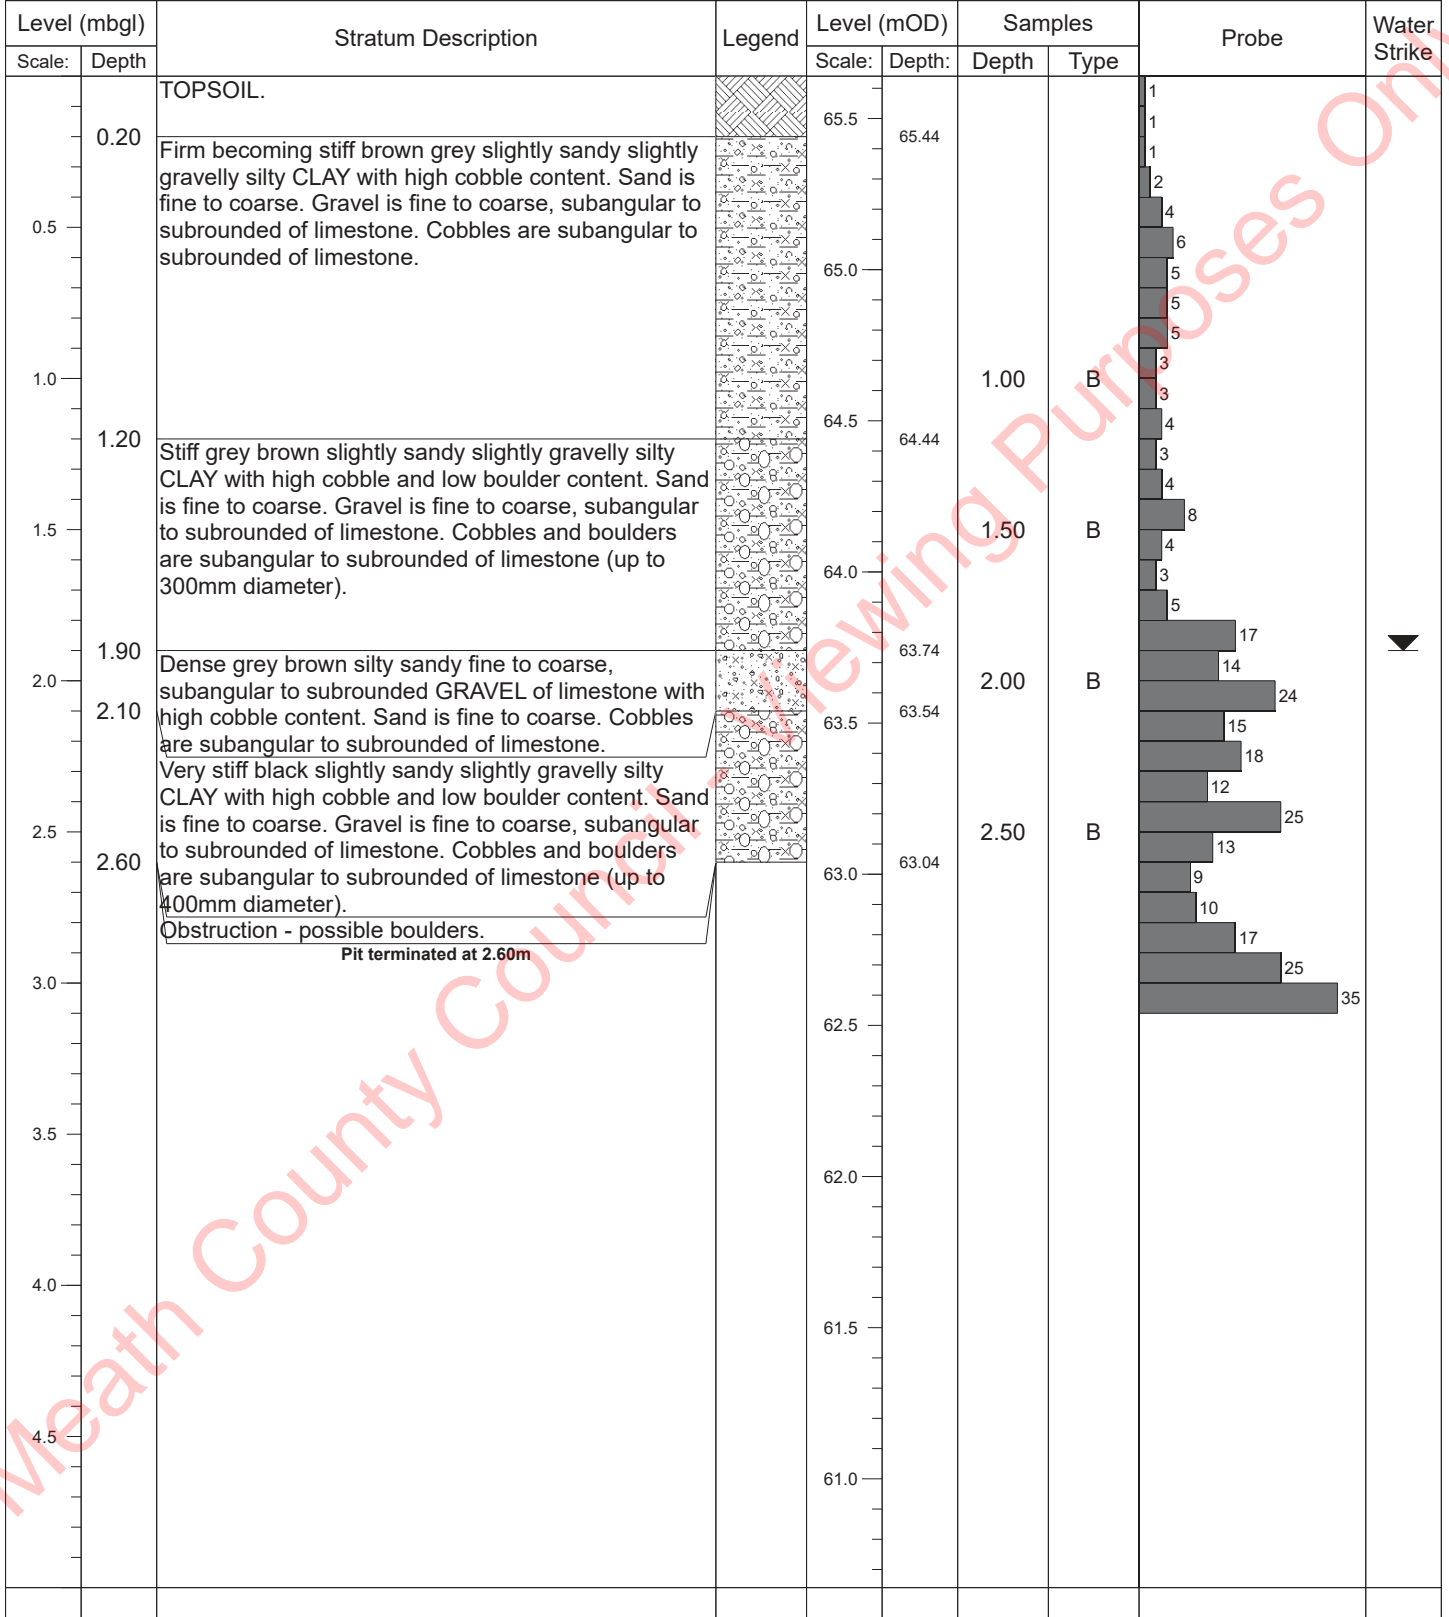
Termination:	Pit Wall Stability:	Groundwater Rate:	Remarks:	Key:
	Obstruction - possible boulders.	Pit walls stable.	1.90 Slow	-	B = Bulk disturbed D = Small disturbed CBR = Undisturbed CBR ES = Environmental

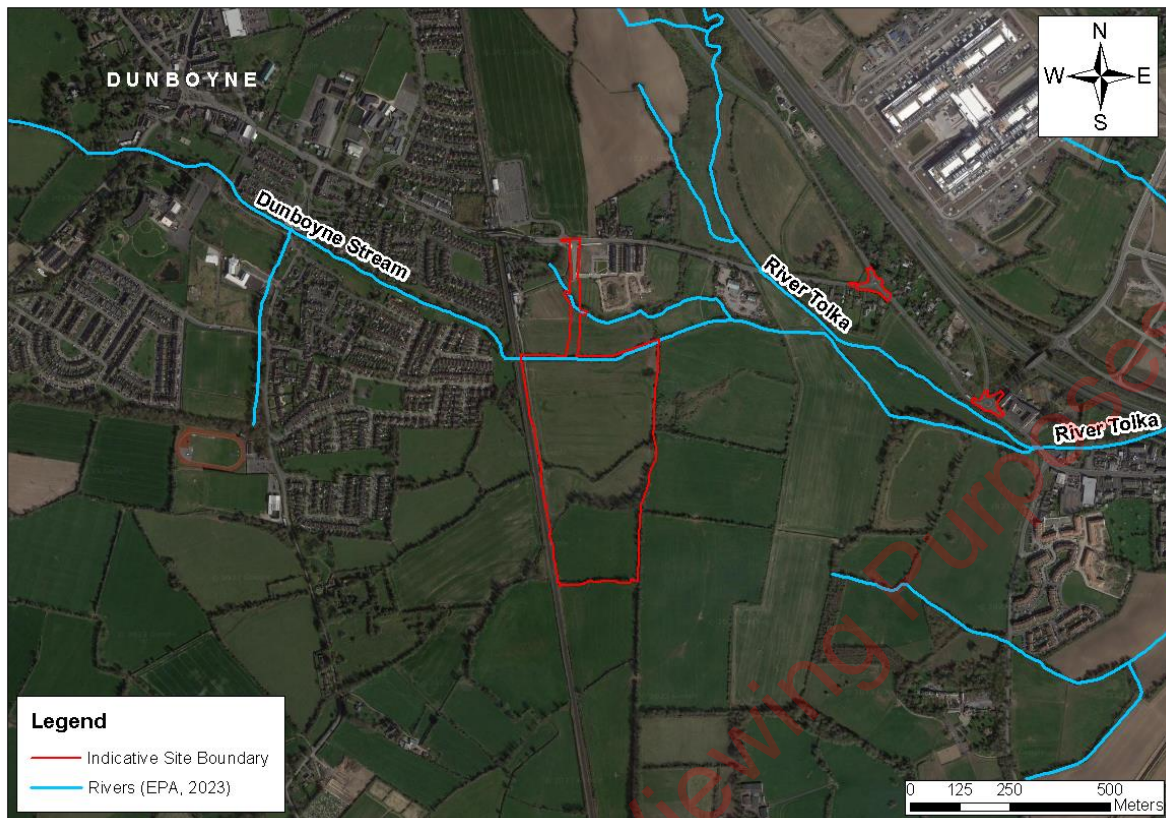
**Figure 1.1 Location and Hydrological Environment**

The EPA (2022) on-line database identifies the watercourse along the northern boundary of the site as the Dunboyne Stream (refer to Figure 1.1 below). The Dunboyne Stream joins the River Tolka c. 900 m to the east of the proposed housing site. The River Tolka immediately adjoins a roundabout on the R147 that requires to be upgraded as part of the development.

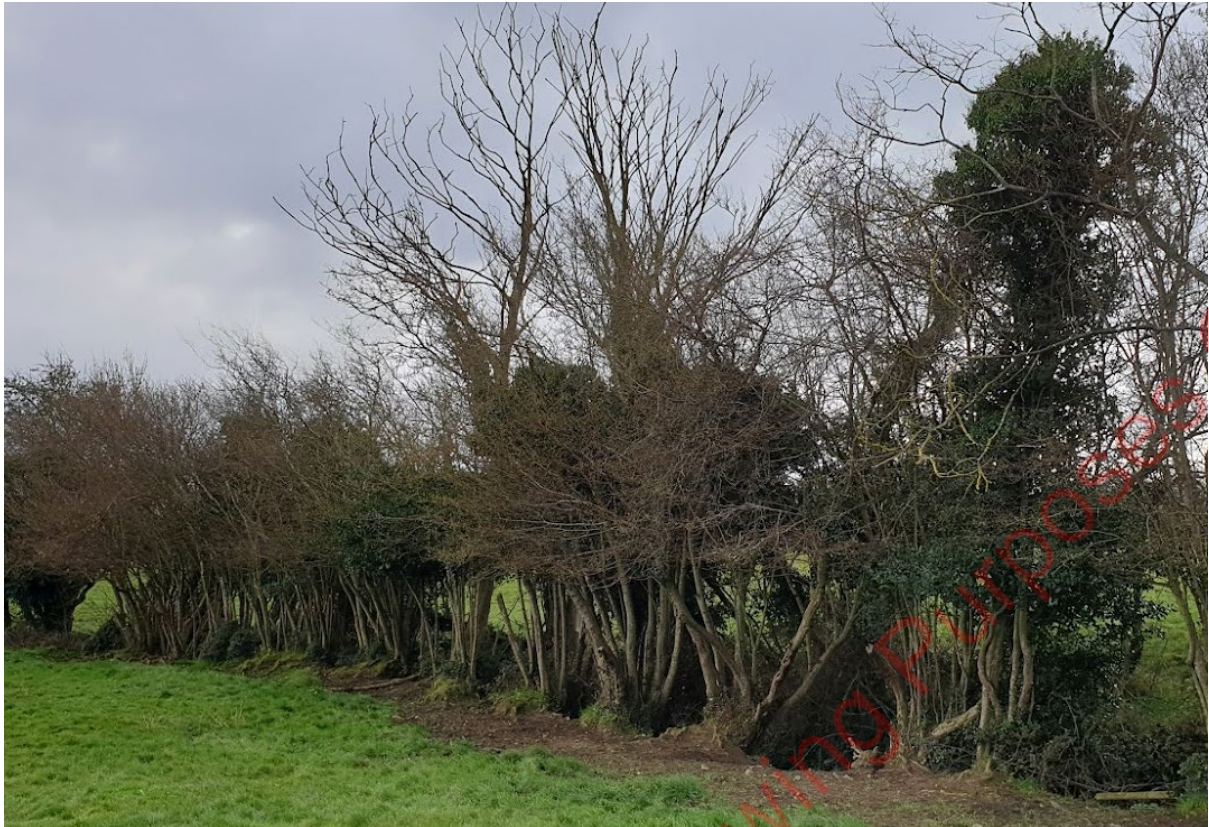
*Photo 3. Low value Hazel and Ash. The Ash throughout the site has some level of Ash dieback.*

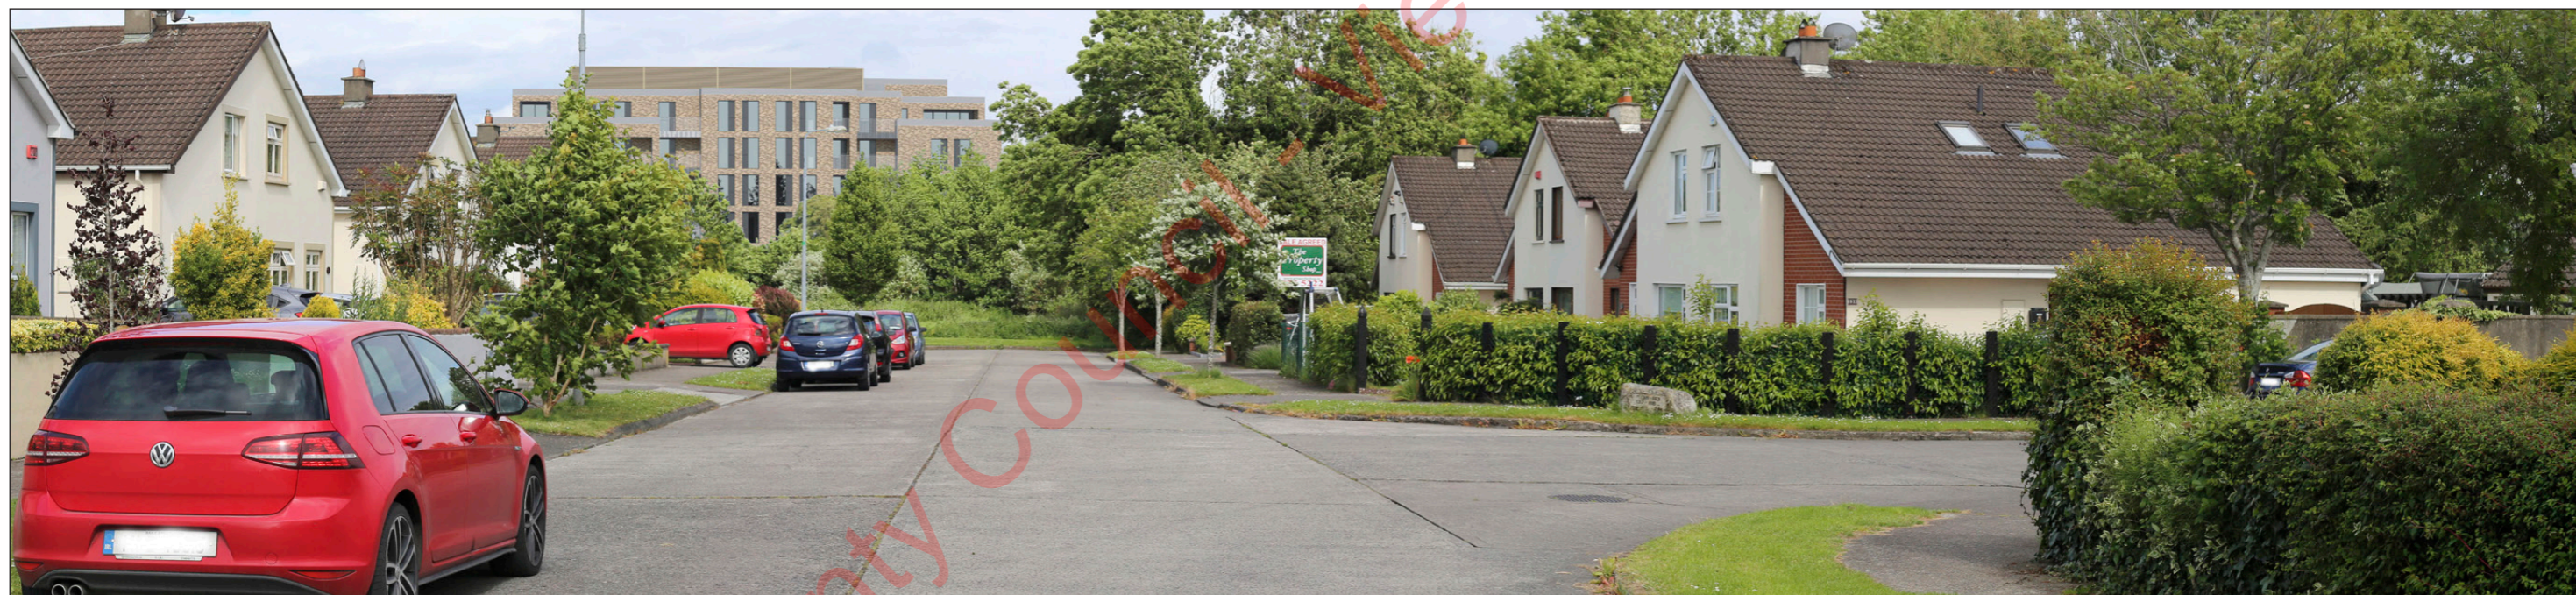
Figure 2.0: Viewpoint 1 | Beechdale

Proposed View - Photomontage

OS reference:	302039E 241372N	Horizontal field of view:	60° (cylindrical projection)	Camera:	Canon EOS 6D
Eye level:	70.13m AOB	Paper size:	420 x 297 mm (A3)	Lens:	50mm (Canon RF 50mm f/1.8)
Direction of view:	E	Correct printed image size:	390 x 110 mm	Camera height:	1.5m AGL
Distance to Application Site:	335m			Date and time:	11/06/2023 17:12

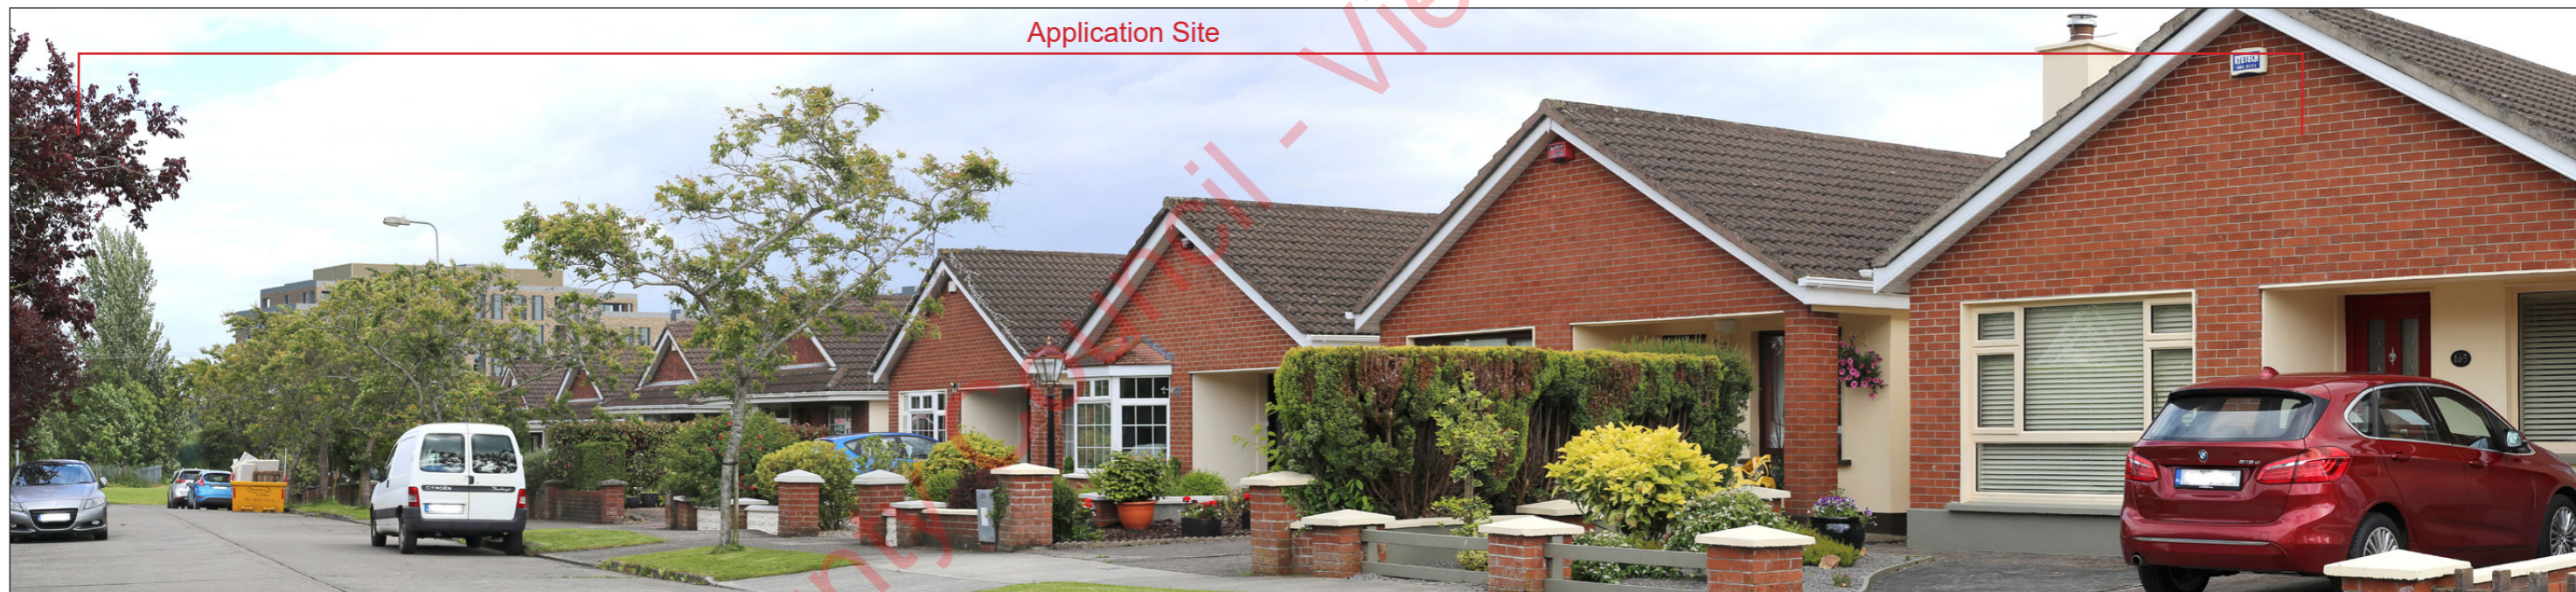
Figure 3.0: Viewpoint 2 | Beechdale

Proposed View - Photomontage

OS reference:	302017E 241451N	Horizontal field of view:	60° (cylindrical projection)	Camera:	Canon EOS 6D
Eye level:	70.27m AOB	Paper size:	420 x 297 mm (A3)	Lens:	50mm (Canon RF 50mm f/1.8)
Direction of view:	E	Correct printed image size:	390 x 110 mm	Camera height:	1.5m AGL
Distance to Application Site:	172m			Date and time:	11/06/2022 17:22

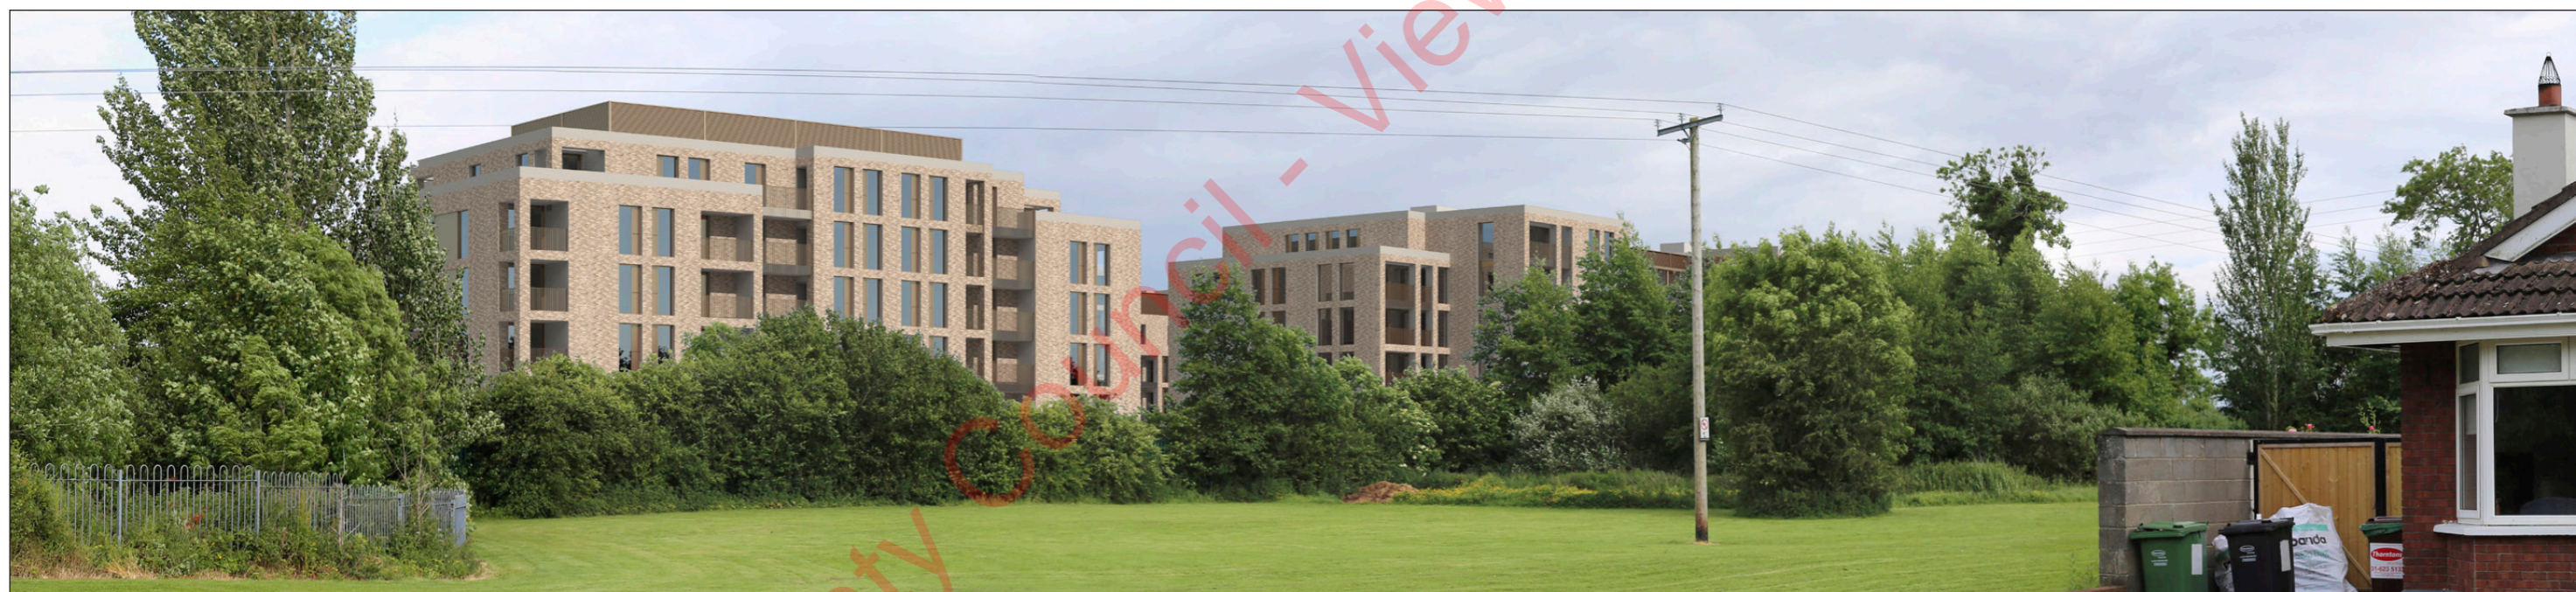
Figure 4.0: Viewpoint 3 | Beechdale

Proposed View - Photomontage

OS reference:	302124E 241446N	Horizontal field of view:	60° (cylindrical projection)	Camera:	Canon EOS 6D
Eye level:	68.57m AOB	Paper size:	420 x 297 mm (A3)	Lens:	50mm (Canon RF 50mm f/1.8)
Direction of view:	E	Correct printed image size:	390 x 110 mm	Camera height:	1.5m AGL
Distance to Application Site:	77m			Date and time:	11/06/2022 17:20

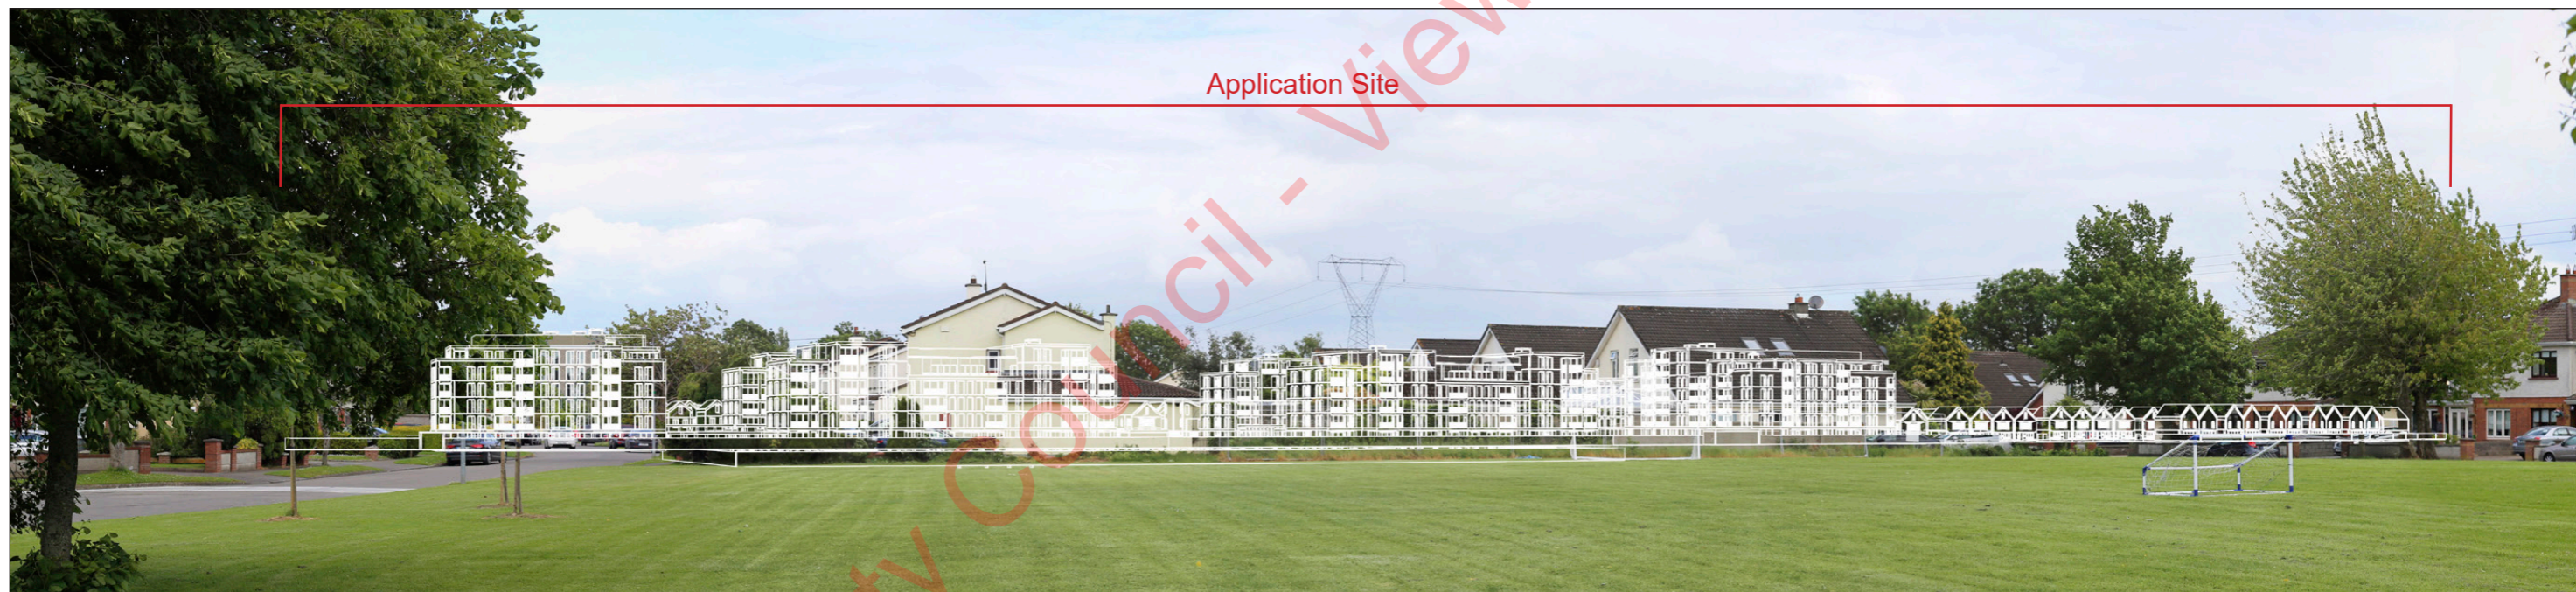
Figure 6.0: Viewpoint 5 | Beechdale

Proposed View - Wireline depicts proposed development, but it is obscured by intervening residential properties

OS reference:	301834E 241358N	Horizontal field of view:	60° (cylindrical projection)	Camera:	Canon EOS 6D
Eye level:	70.35m AOB	Paper size:	420 x 297 mm (A3)	Lens:	50mm (Canon RF 50mm f/1.8)
Direction of view:	E	Correct printed image size:	390 x 110 mm	Camera height:	1.5m AGL
Distance to Application Site:	378m			Date and time:	11/06/2022 17:08

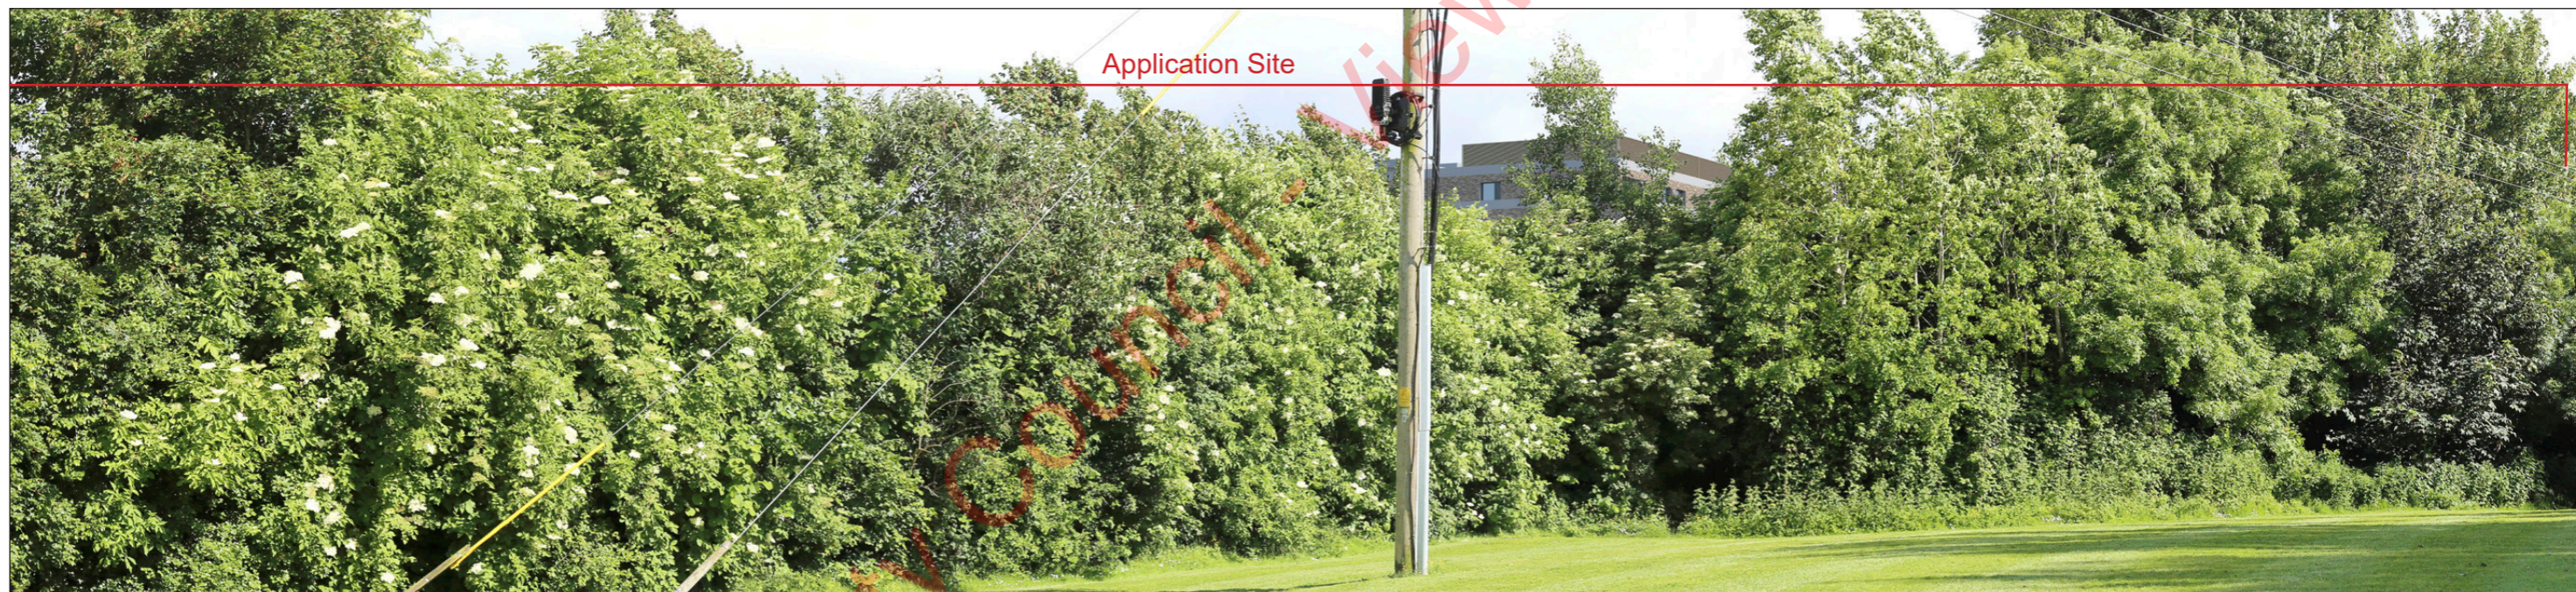
Figure 8.0: Viewpoint 7 | Larchfield

Proposed View - Photomontage

OS reference:	302113E 241527N	Horizontal field of view:	60° (cylindrical projection)	Camera:	Canon EOS 6D
Eye level:	69.05m AOB	Paper size:	420 x 297 mm (A3)	Lens:	50mm (Canon RF 50mm f/1.8)
Direction of view:	SE	Correct printed image size:	390 x 110 mm	Camera height:	1.5m AGL
Distance to Application Site:	120m			Date and time:	11/06/2022 16:57

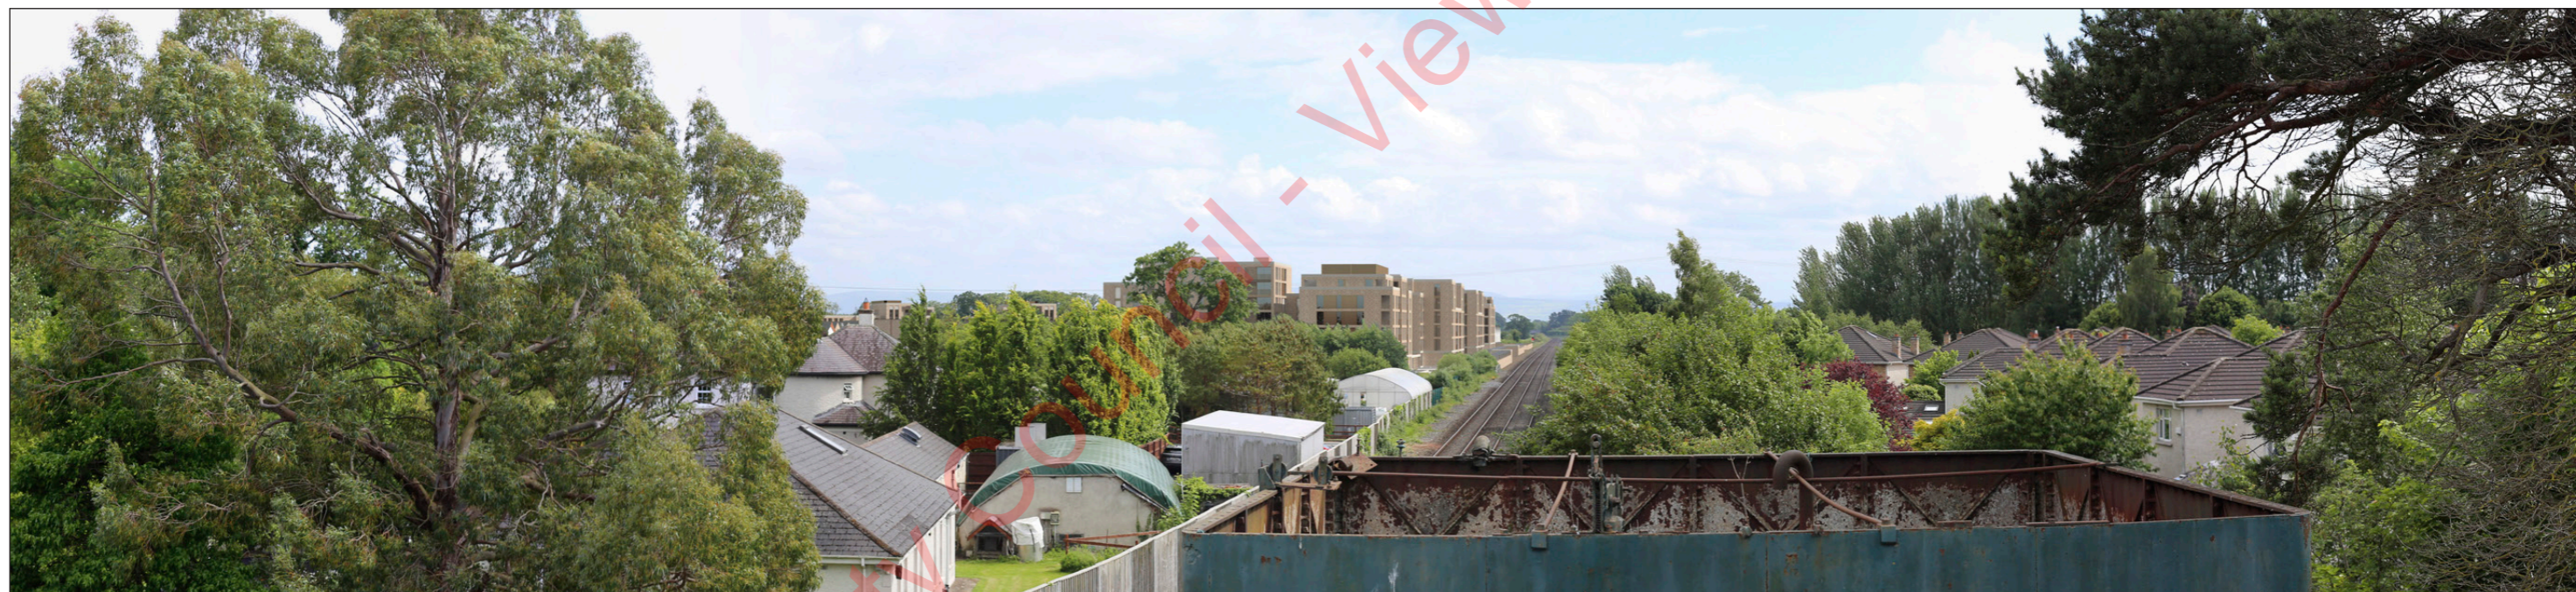
Figure 10.0: Viewpoint 9 | L2228 Station Road, Dunboyne Railway Bridge

Proposed View - Photomontage

OS reference:	302137E 241741N	Horizontal field of view:	60° (cylindrical projection)	Camera:	Canon EOS 6D
Eye level:	70.48m AOB	Paper size:	420 x 297 mm (A3)	Lens:	50mm (Canon RF 50mm f/1.8)
Direction of view:	S	Correct printed image size:	390 x 110 mm	Camera height:	1.5m AGL
Distance to Application Site:	307m			Date and time:	11/06/2022 16:12

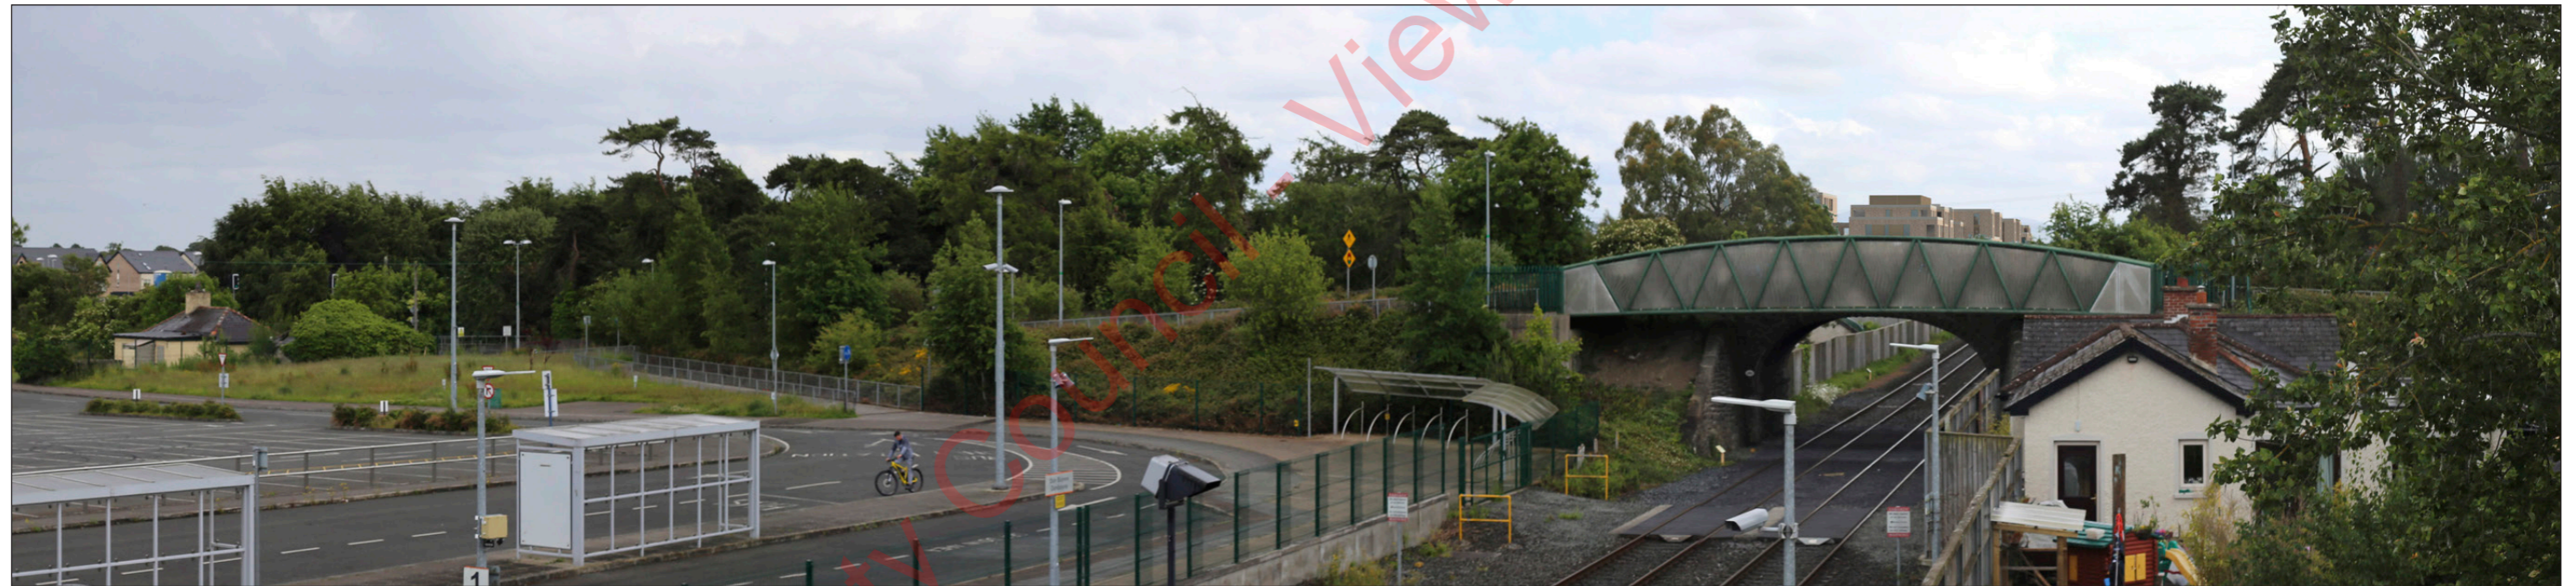
Figure 11.0: Viewpoint 10 | Dunboyne Train Station

Proposed View - Photomontage

OS reference:	302121E 241835N	Horizontal field of view:	60° (cylindrical projection)	Camera:	Canon EOS 6D
Eye level:	68.34m AOB	Paper size:	420 x 297 mm (A3)	Lens:	50mm (Canon RF 50mm f/1.8)
Direction of view:	S	Correct printed image size:	390 x 110 mm	Camera height:	1.5m AGL
Distance to Application Site:	402m			Date and time:	11/06/2022 16:00

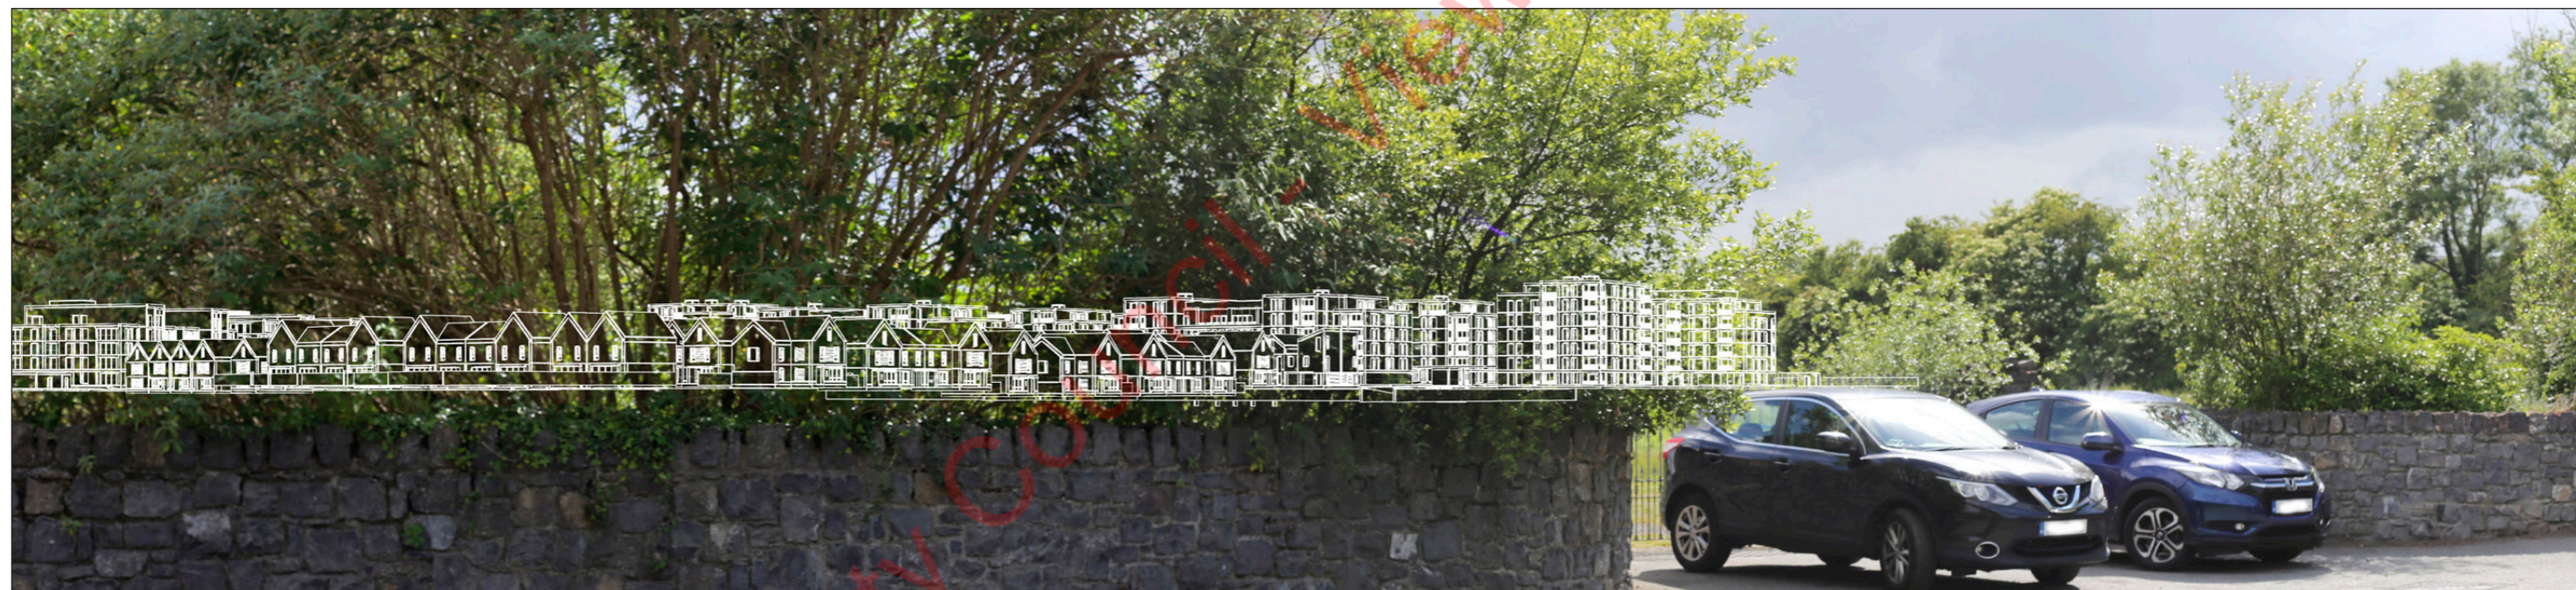
Figure 13.0: Viewpoint 12 | L228 Station Road near Clonee Sawmills

Proposed View - Wireline depicts proposed development, but it is obscured by intervening vegetation

OS reference:	302828E 241655N	Horizontal field of view:	60° (cylindrical projection)	Camera:	Canon EOS 6D
Eye level:	66.5m AOB	Paper size:	420 x 297 mm (A3)	Lens:	50mm (Canon RF 50mm f/1.8)
Direction of view:	SW	Correct printed image size:	390 x 110 mm	Camera height:	1.5m AGL
Distance to Application Site:	377m			Date and time:	11/06/2022 16:36

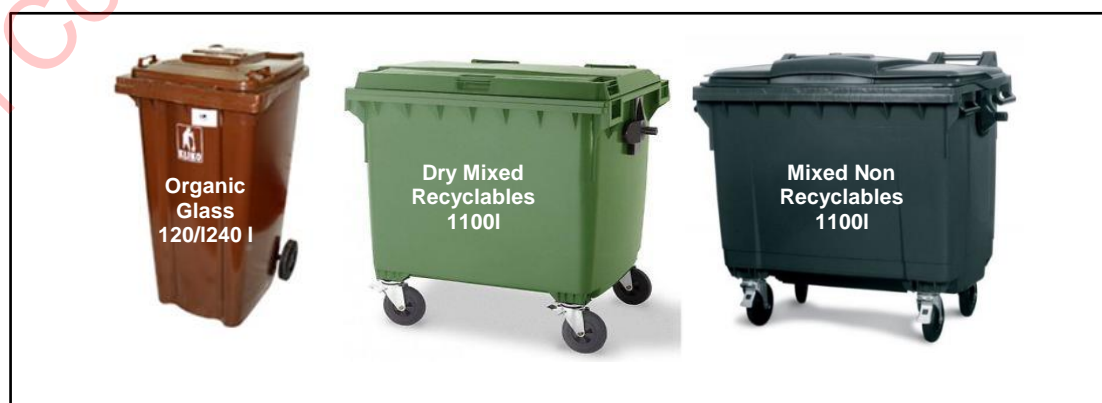
**Figure 5.1** Typical waste receptacles of varying size (240 L and 1100 L)

The types of bins used will vary in size, design and colour dependent on the appointed waste contractor. However, examples of typical receptacles to be provided in the WSAs are shown in Figure 5.1. All waste receptacles used will comply with the SIST EN 840-1:2020 and SIST EN 840-2:2020 standards for performance requirements of mobile waste containers, where appropriate.

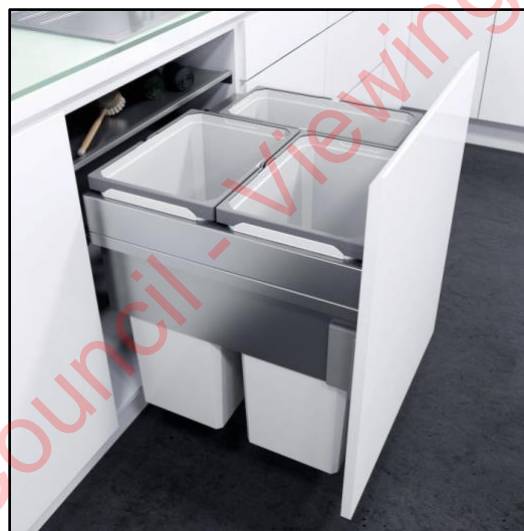
**Figure 5.2** Example three bin storage system to be provided within the unit design

Provision will be made in all residential units to accommodate 3 no. bin types to facilitate waste segregation at source. An example of a potential 3 bin storage system is provided in figure 5.2 below.

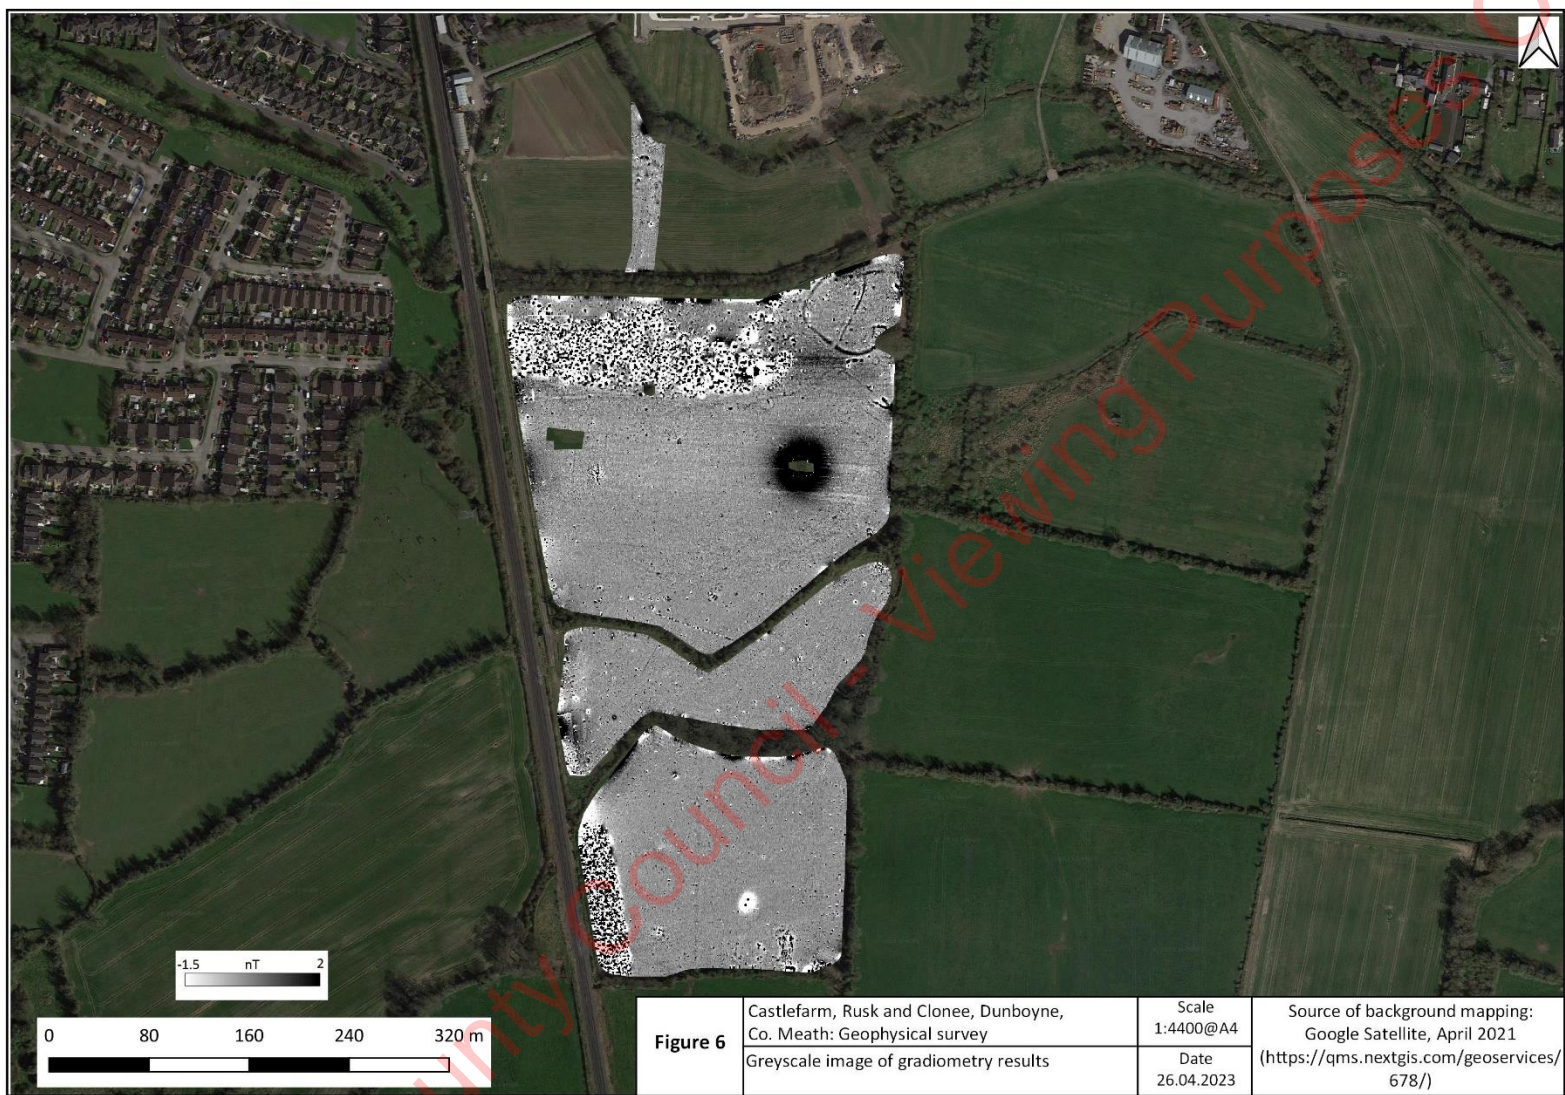
Figure 6. Greyscale image of gradiometry results.

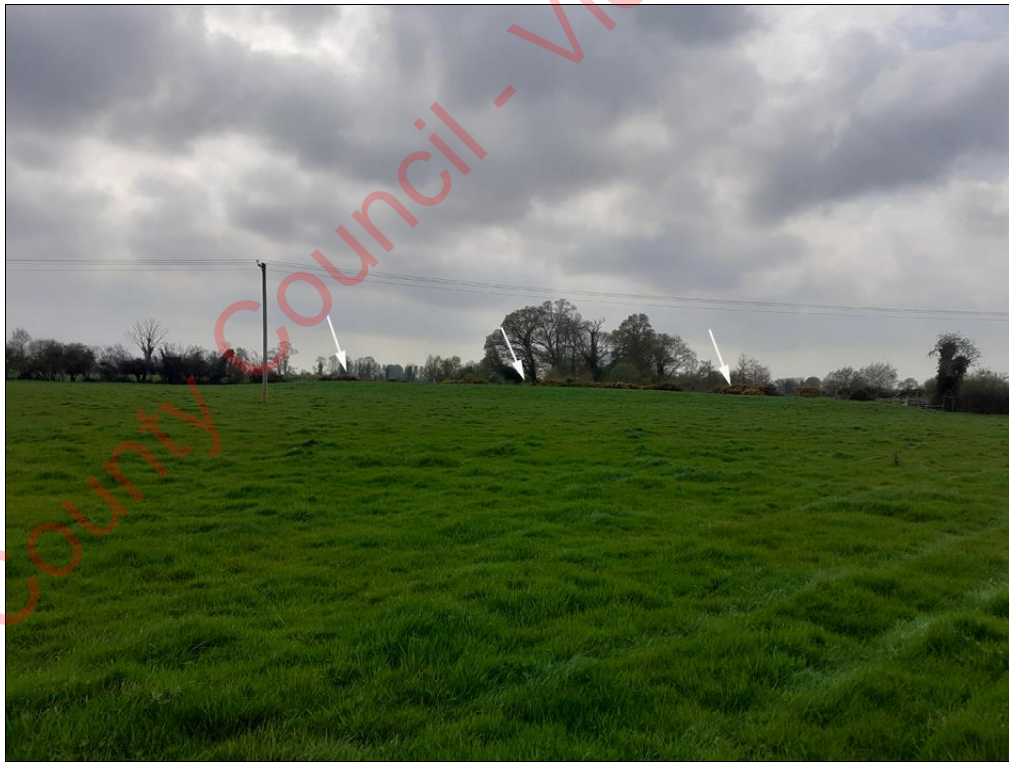
**Plate 4.** Low embankment (arrowed) next to rail line in southern field, looking southwest.

Located on the southeastern edge of the town of Dunboyne, the survey area lies directly east of the Docklands to M3 Parkway Commuter Rail line. The target fields are separated by mature hedgerows supplemented by post-and-wire fences. The terrain is generally flat, though a low, artificial, embankment runs along the western boundary of the southern field, next to the rail line (Plate 4). Overhead electricity wires extend across the southernmost field and the field directly south of the proposed access road (hereafter ‘the northern field’), with the latter high-voltage cable supported by a large electricity pylon located in the eastern sector of the field. A small concrete shed lies next to the field boundary in the southeast corner of the southern field (Plate 5).
