ESB Generating Station Tarbert, Environmental Site Assessment, URS 2009

**Environmental Site  
Assessment**

**ESB Generating Station,  
Tarbert, Co. Kerry**

6 November 2009  
Final

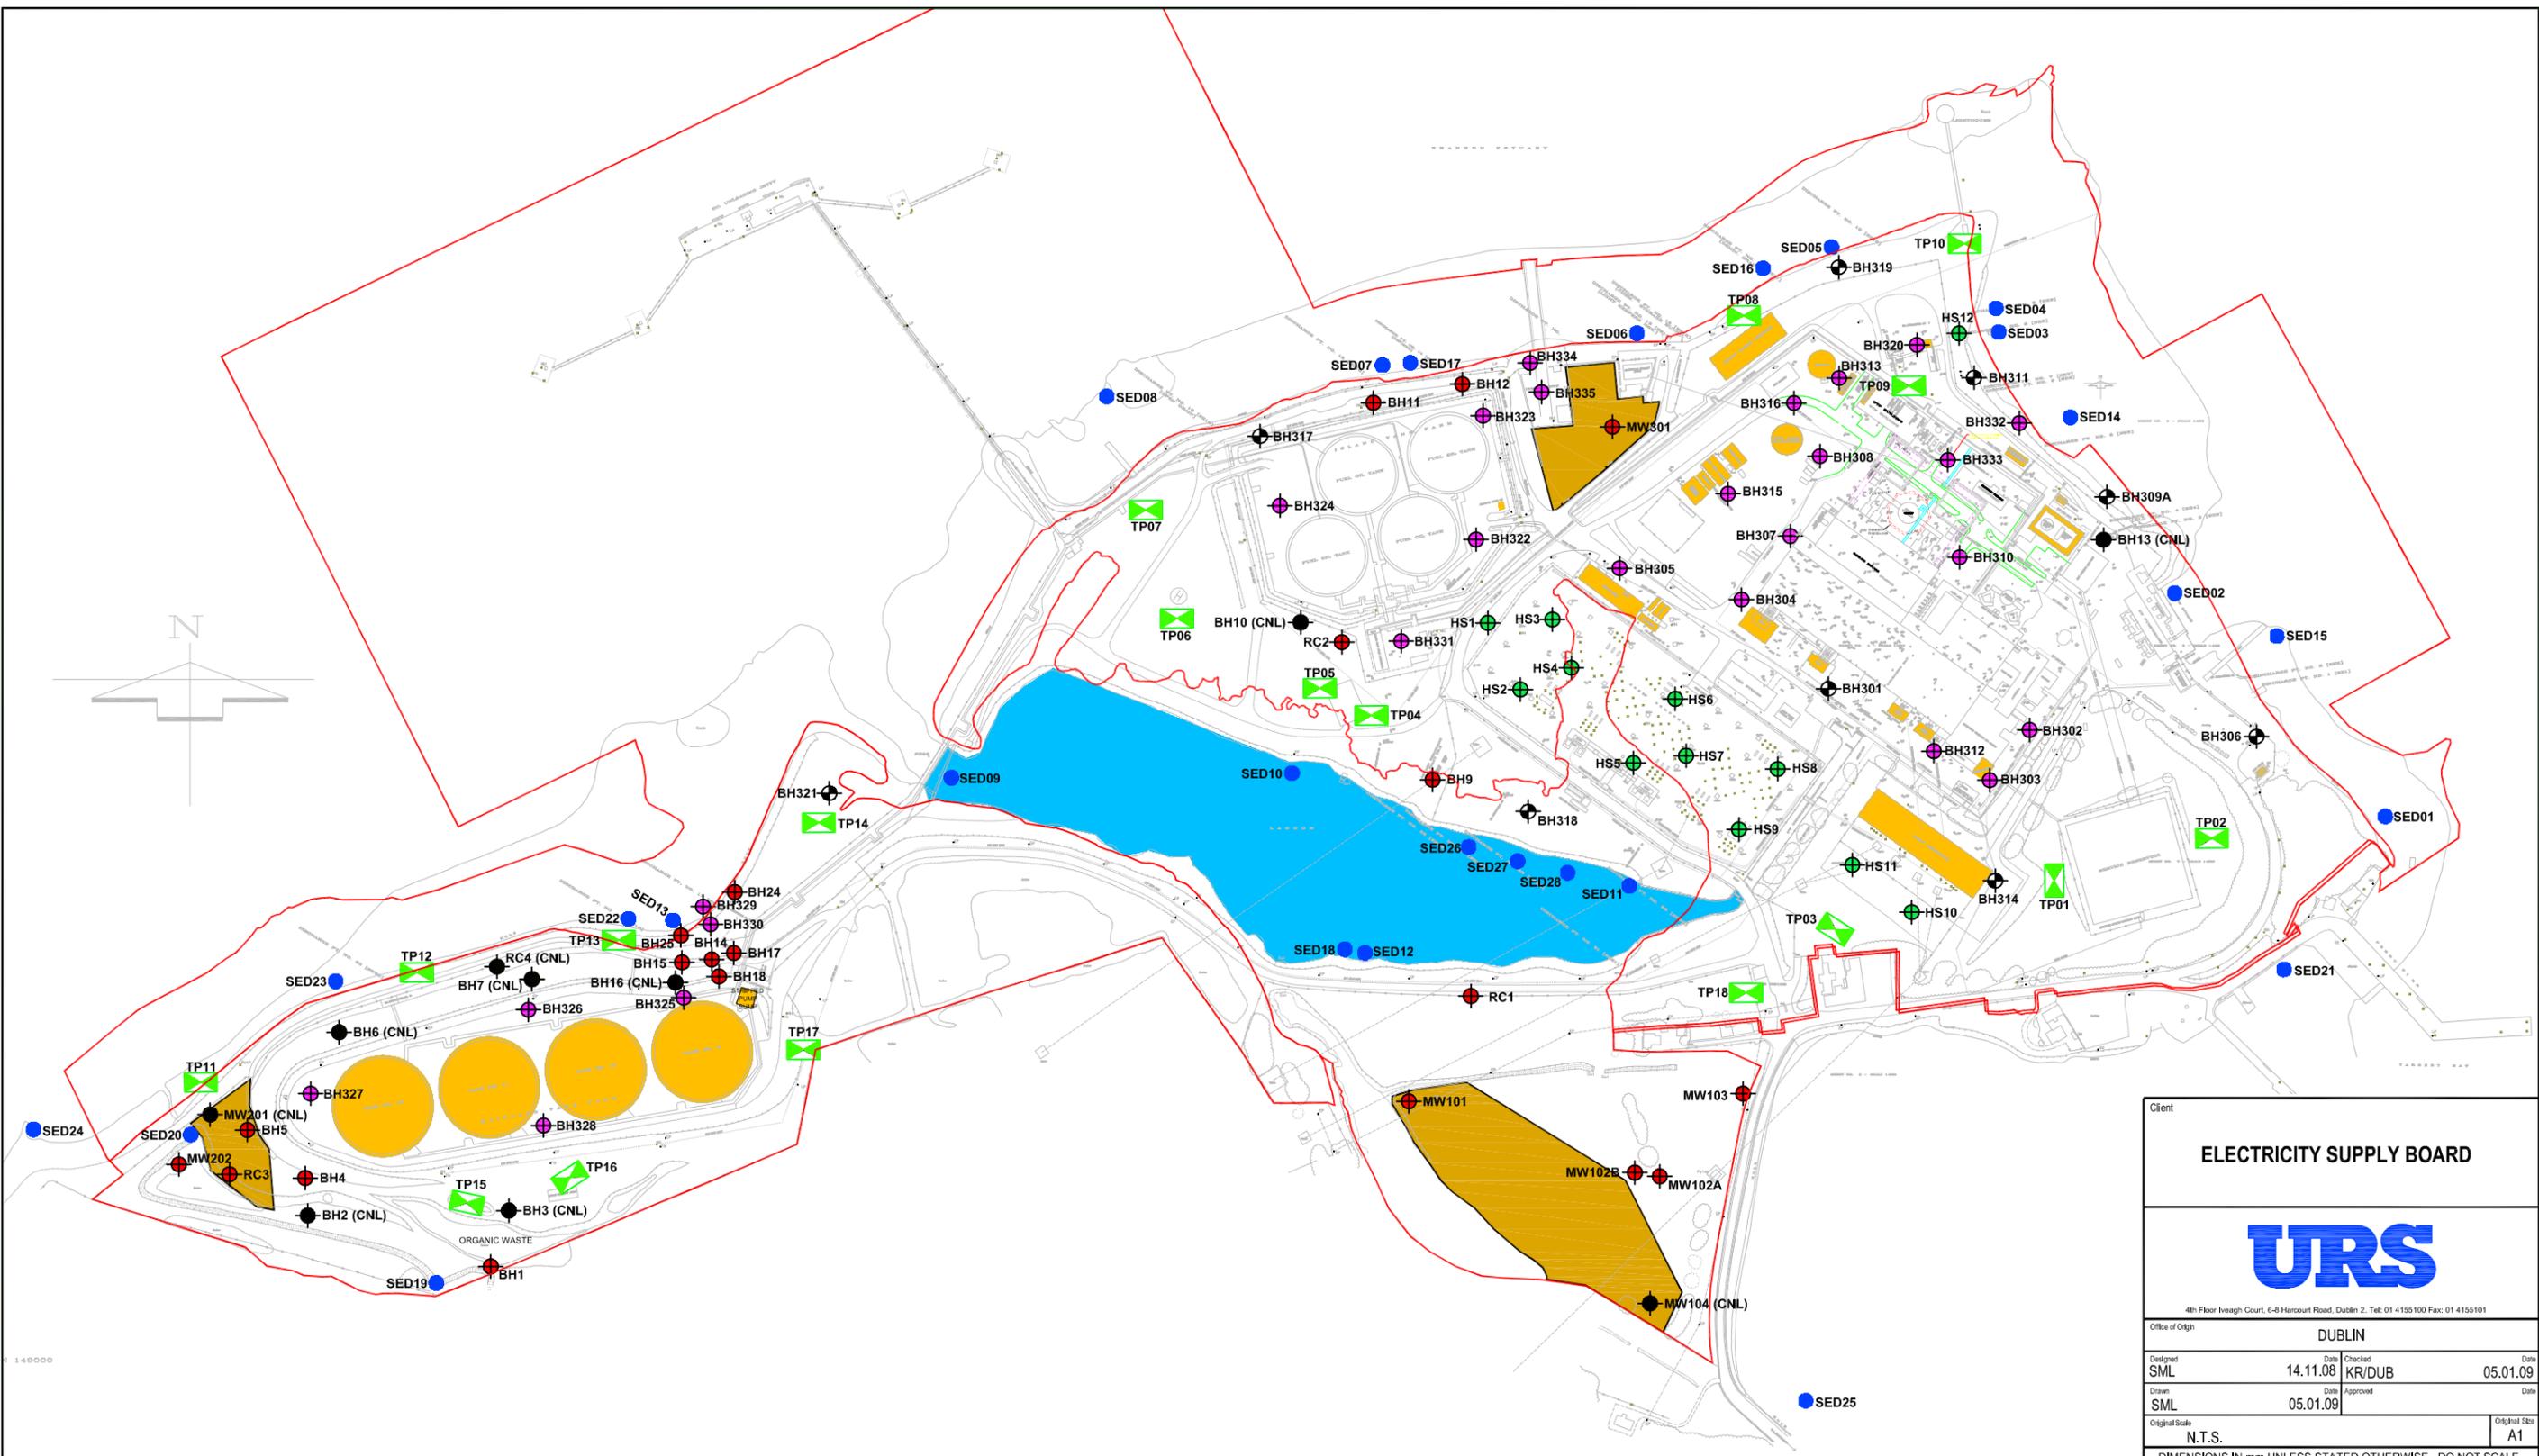
- LEGEND**
- TERRIER RIG
  - BOREHOLE / MONITORING WELL LOCATION
  - EXISTING MONITORING WELL LOCATION
  - HAND EXCAVATION / SAMPLE
  - SEDIMENT SAMPLE LOCATION
  - TRIAL PIT LOCATION
  - CAPPED DISPOSAL AREAS
  - COULD NOT LOCATE WELL - PRESUME DESTROYED

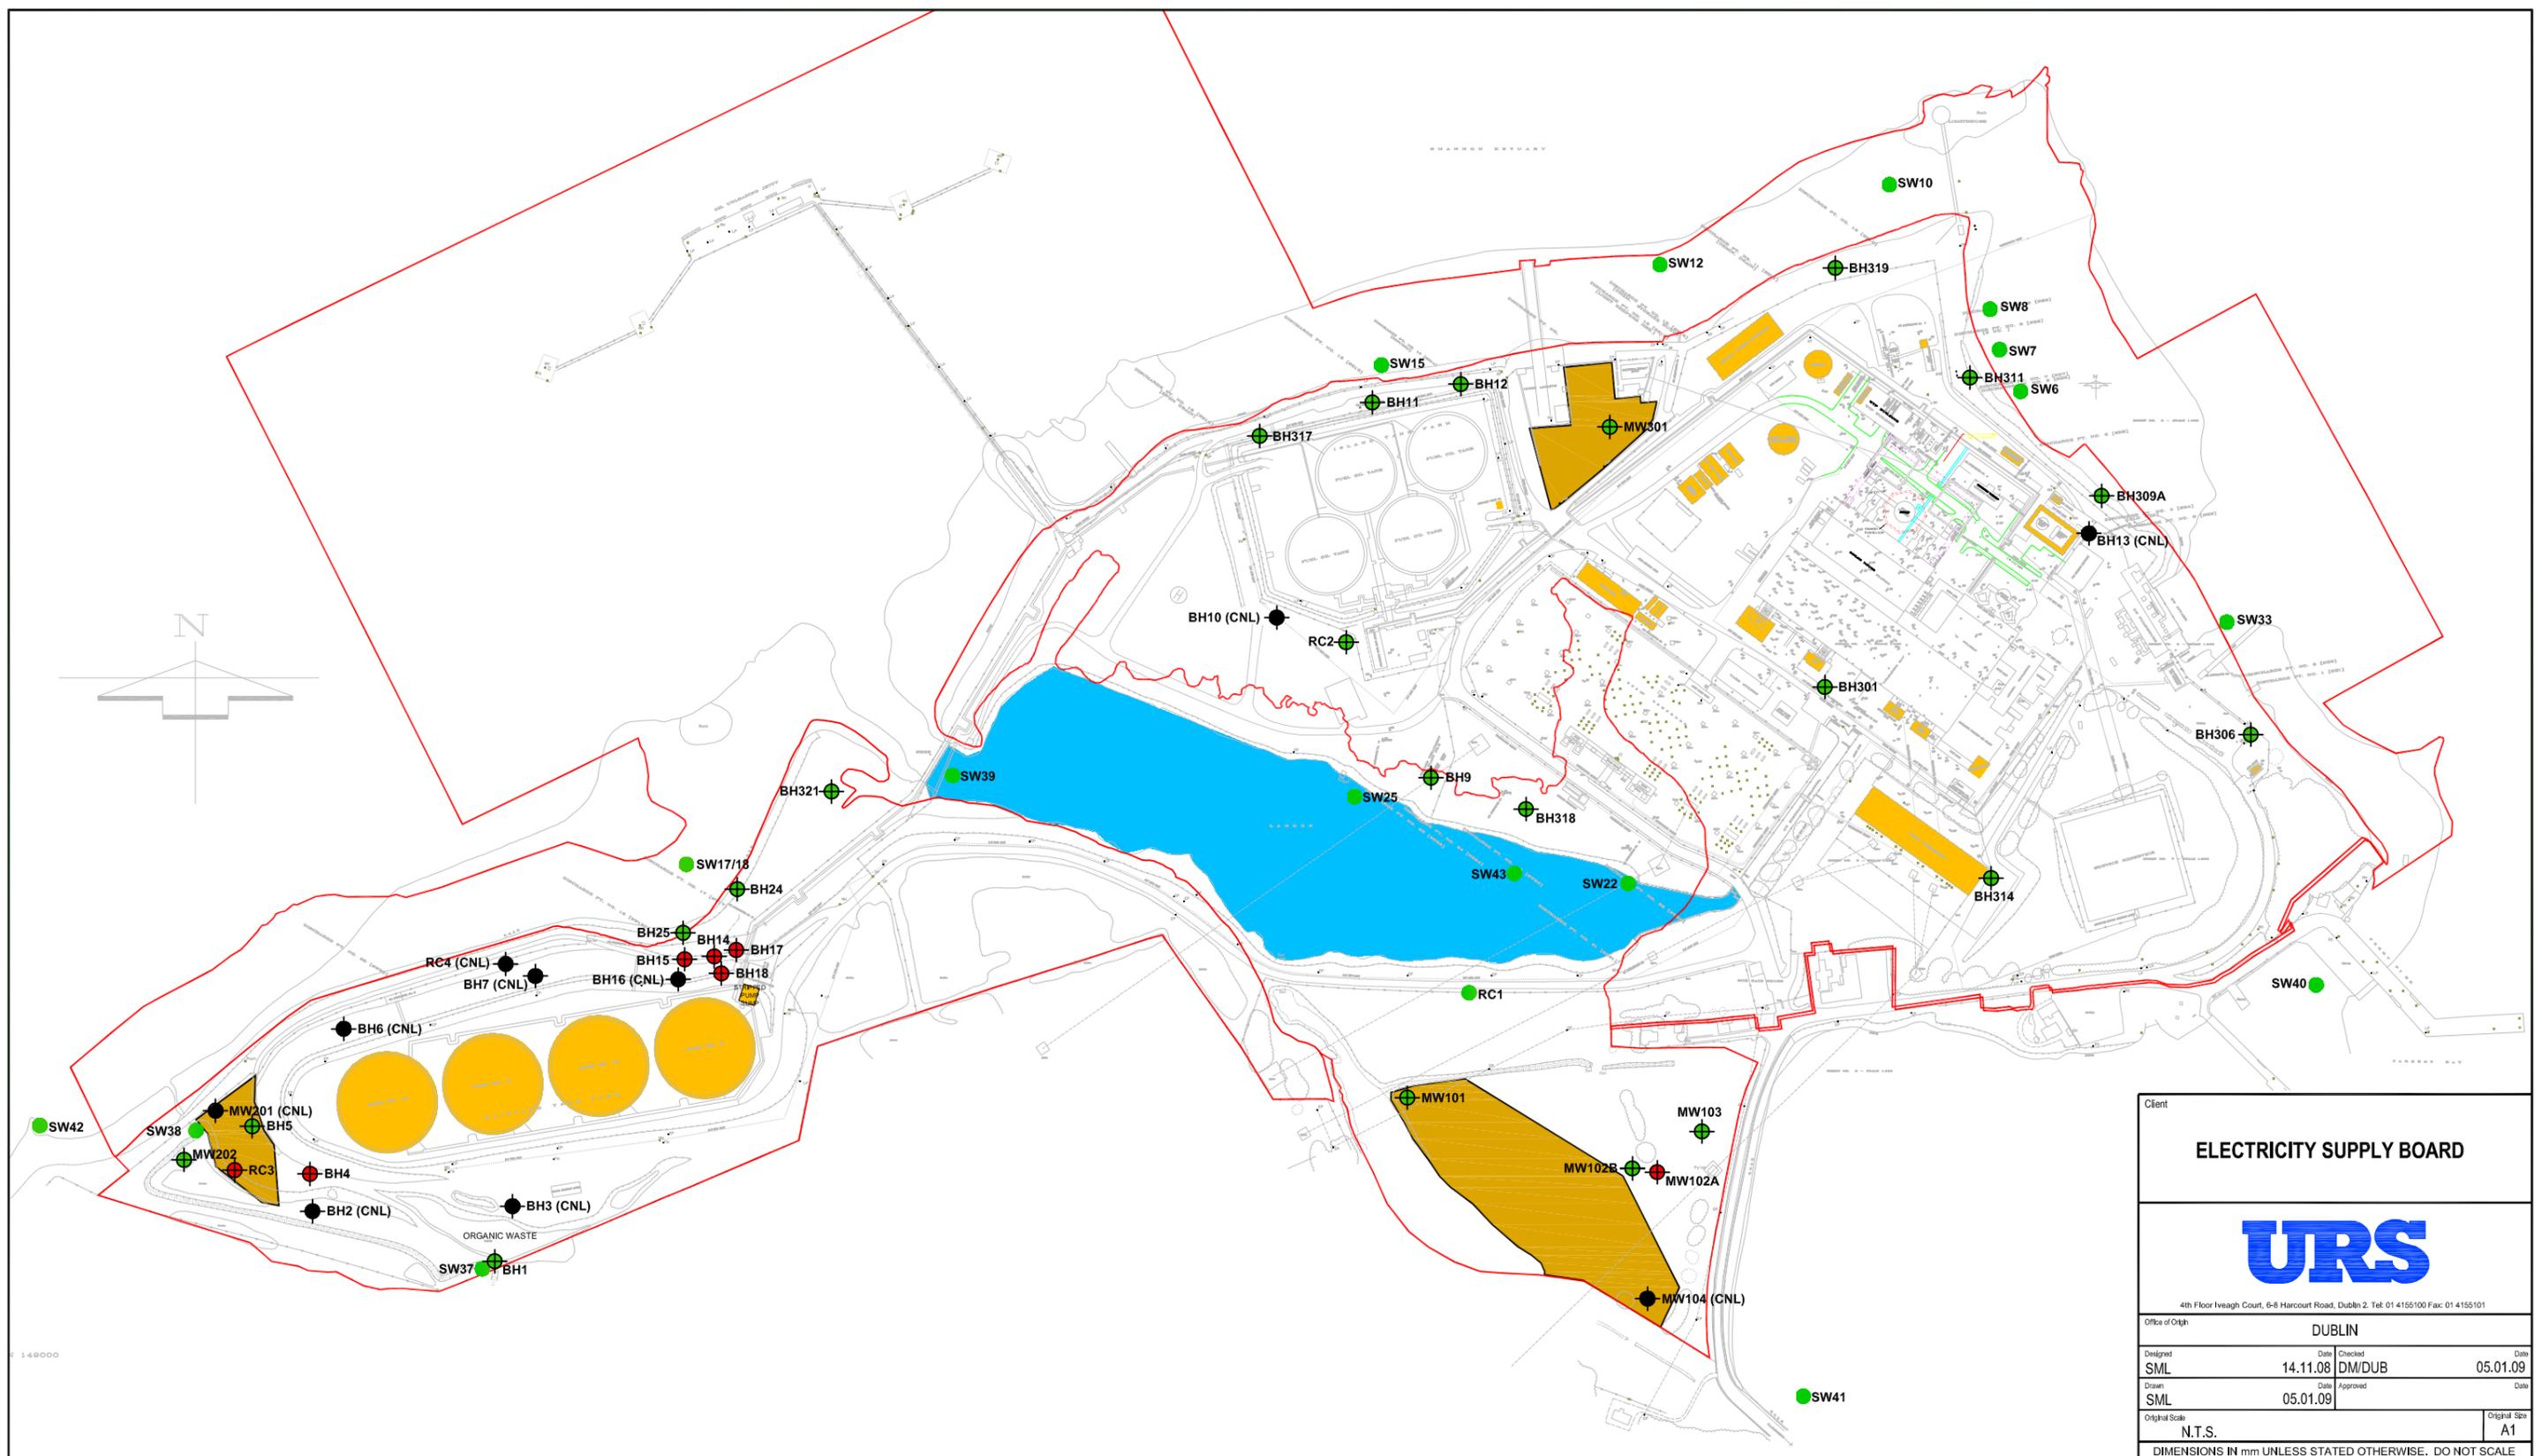
- SURFACE WATER SAMPLE LOCATION
- EXISTING BOREHOLE/MONITORING WELL LOCATION - NO SAMPLE COLLECTED
- COULD NOT LOCATE WELL - PRESUME DESTROYED

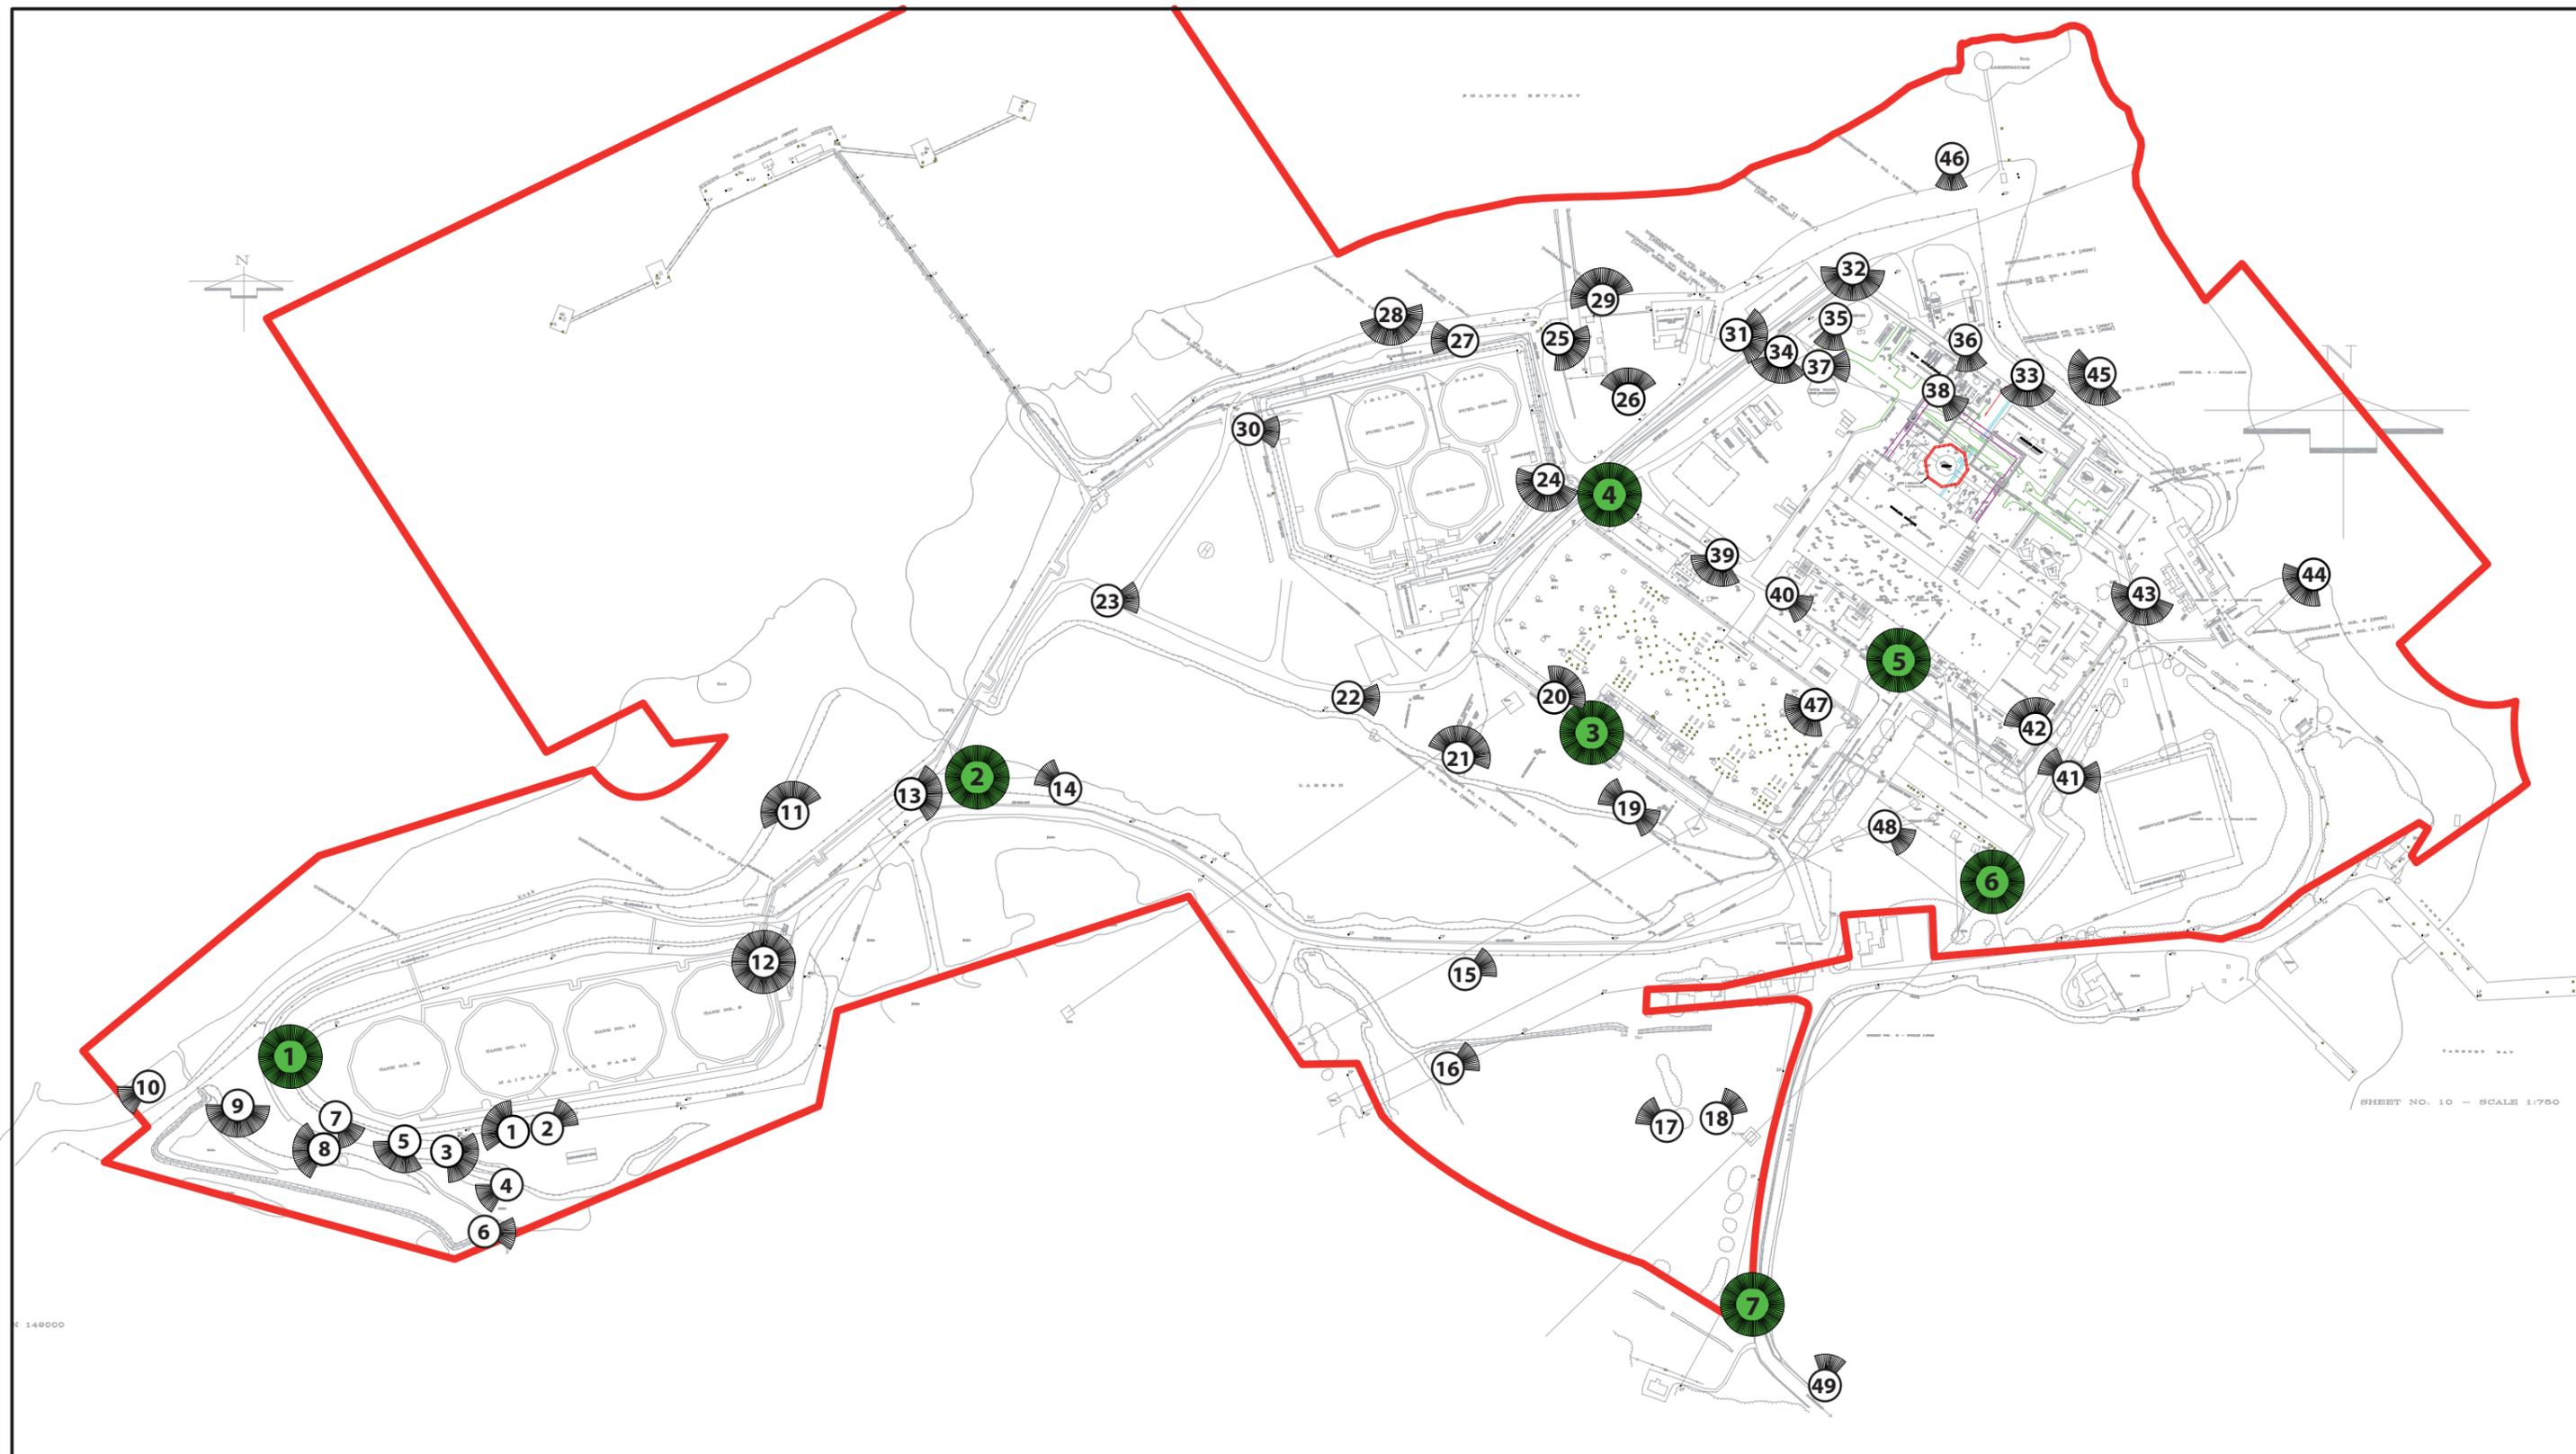
DRAWING TITLE  
**FIGURE 4 - PANORAMIC AND GROUND LEVEL PHOTOGRAPHIC SURVEY LOCATIONS**

In order to record the condition of the site prior to divestment, an elevated photograph survey was undertaken by Murphy Surveys Ltd. The elevated panoramic photographs were taken using a high spec digital camera namely a Canon G7. The camera was mounted on a telescopic mast that is capable of reaching 15m in height, thus allowing an overview of the portion of the site at the survey location. Panoramic photographs were taken at several locations around the site.
