**Road Safety Audit**  
**Stage 2**  
**for**  
**Access Proposals**  
**at**  
**Kilmurray Concrete**  
**R400, Derryarkin, Rhode, Co Offaly**

**Date:** December 2021

**Reference:** RSM/MOB/140921/KILMURRAY RSA 2

The report which follows is the detailed design Stage 2 Road Safety Audit (RSA) for modifications to the access to the Kilmurray Concrete Sand & Gravel Pit off the R400 Regional Road in Derryarkin, Co Offaly, based on the information supplied to the RSA Team as detailed below. The proposals involve reconfiguration of the existing access junction to the quarry site off the R400, and all associated ancillary works.

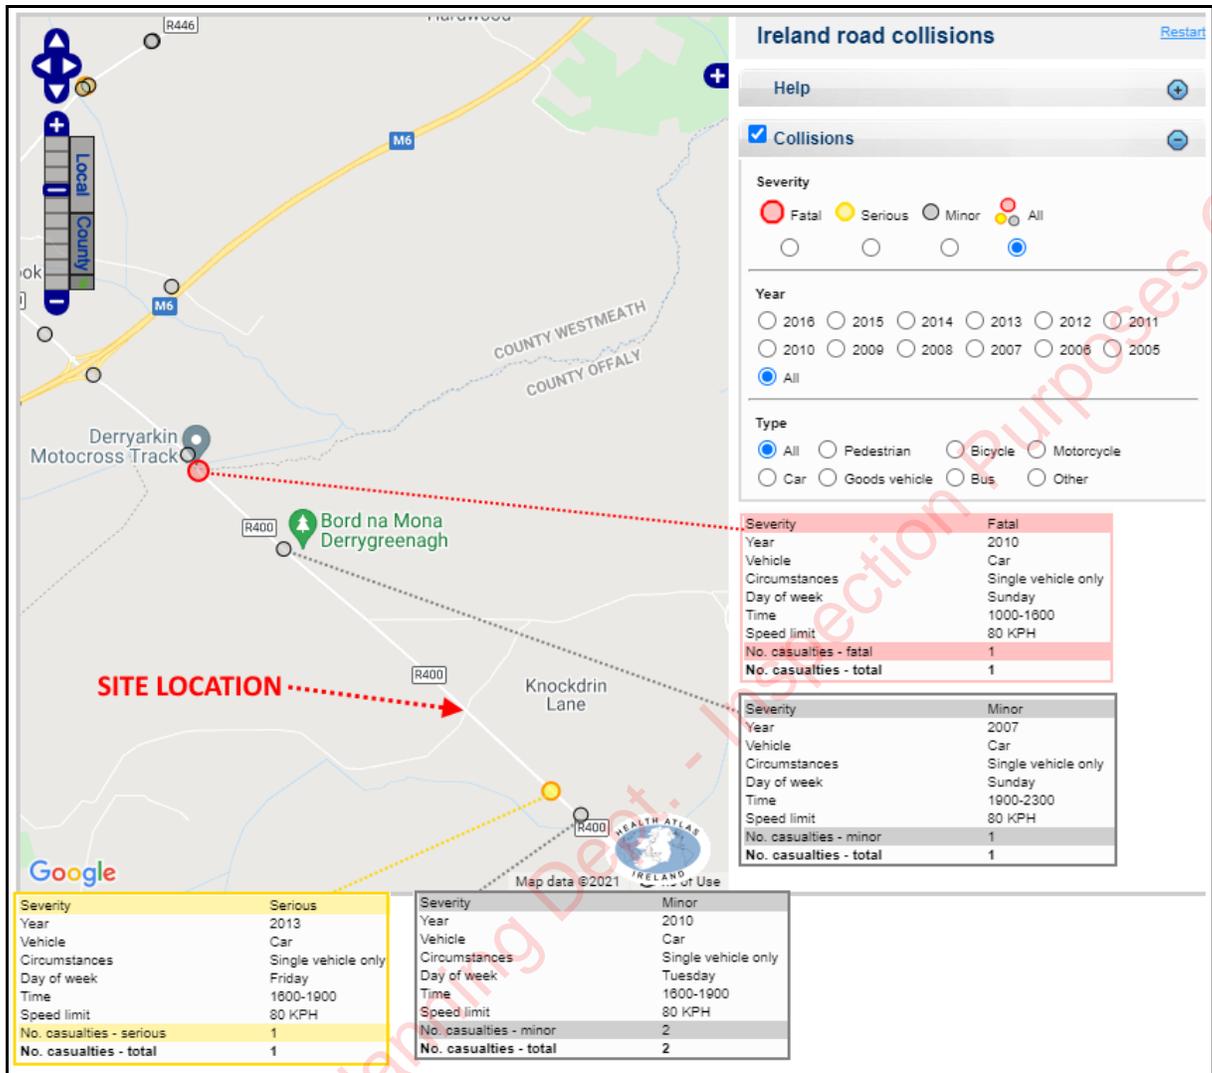
**Figure 3: Collision Plot for Road Network surrounding site**

2.1.2 No information was provided on any existing collision statistics in the vicinity of the site. A review of the Road Safety Authority online collision database indicates that there were no collisions recorded in the immediate vicinity of the access junction to the Kilmurray Quarry on the R400 between 2005 and 2016 inclusive. There were a number of collisions recorded further north and south on the link, including one serious collision and one collision resulting in a fatality, as shown in Figure 3. All of these collisions were single vehicle collisions, which can be indicative of inappropriate speeds and loss of control.

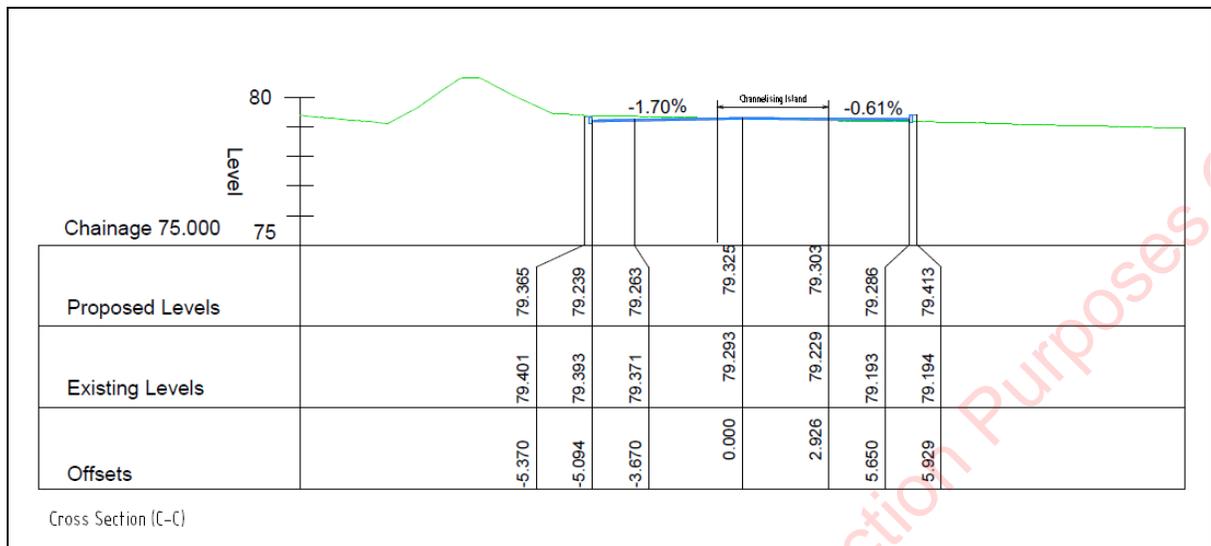
There was no information provided relating to proposed drainage at the reconfigured access junction. The design proposals will involve kerb design and provision of a new channelising island at the access to the Quarry, which will impact on existing drainage on the southern side of the proposed junction. A relatively shallow crossfall is proposed on the entry to the minor arm, as shown in the cross section in figure 4, increasing the risk of ponding and standing water at this location. New kerbs will prevent current runoff into verges, and the provision for new drainage is not clear. Insufficient drainage can lead to an increase in the risk of conflict for all road users, including skidding and loss of control type collisions particularly during wet and icy conditions.

**Figure 4: New kerbs and shallow crossfall on cross section south of channelising Island**

1. The access junction will need to be adequately drained to prevent build-up of surface water, with drainage to be designed to ensure no run-off onto the regional road adjacent, and with the junction to be reprofiled as necessary to achieve suitable crossfall to aid positive drainage adjacent to new kerb line.
2. Drainage proposals should be clarified in advance of construction, with any new gullies and drainage channels to be located outside the desire line for two-wheeled vehicles, and all finished gully levels to be flush with the surrounding carriageway.

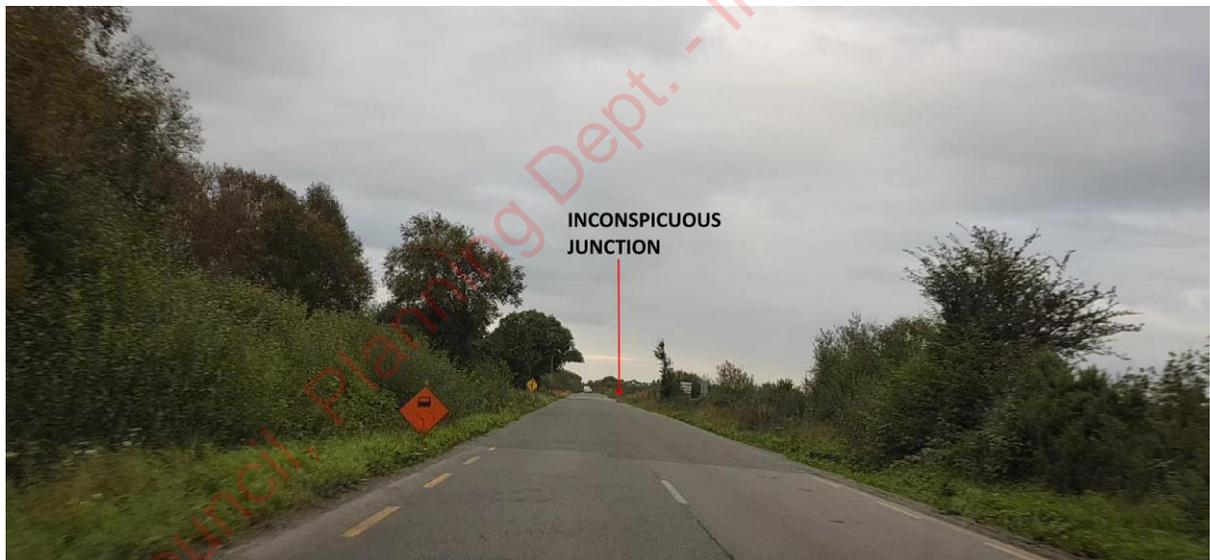
The alignment of the R400 is straight in the vicinity of the site access with good forward visibility and stopping sight distance in both north and southbound directions, however the clear zones along both sides of the R400 are characterised by soft verges and vegetation, which reduces the overall junction conspicuity and clear forward visibility to and from the site access. The levels to the rear of the verges are unknown, and there is no fencing in place at present. There are a number of unprotected hazards in the clear zone of the R400 at present, on both sides of the

**Figure 5: Southbound approach to Junction on R400 showing poor junction conspicuity due to overgrown verges at present**

1. Visibility splays from the proposed site access/egress and minor access road opposite should be clear and unobstructed at all times in accordance with traffic speeds.
2. Vegetation should also be removed from all locations where clear forward visibility of relevant signage could be obstructed.

3. Detailed design should include for site clearance and any necessary earthworks or fencing to address soft verges and level differences to the rear of the verges.
4. Any new hazards should be removed from or located outside the clear zone or subject to a risk assessment to determine the need for VRS in accordance with TII DN-REQ-03034.

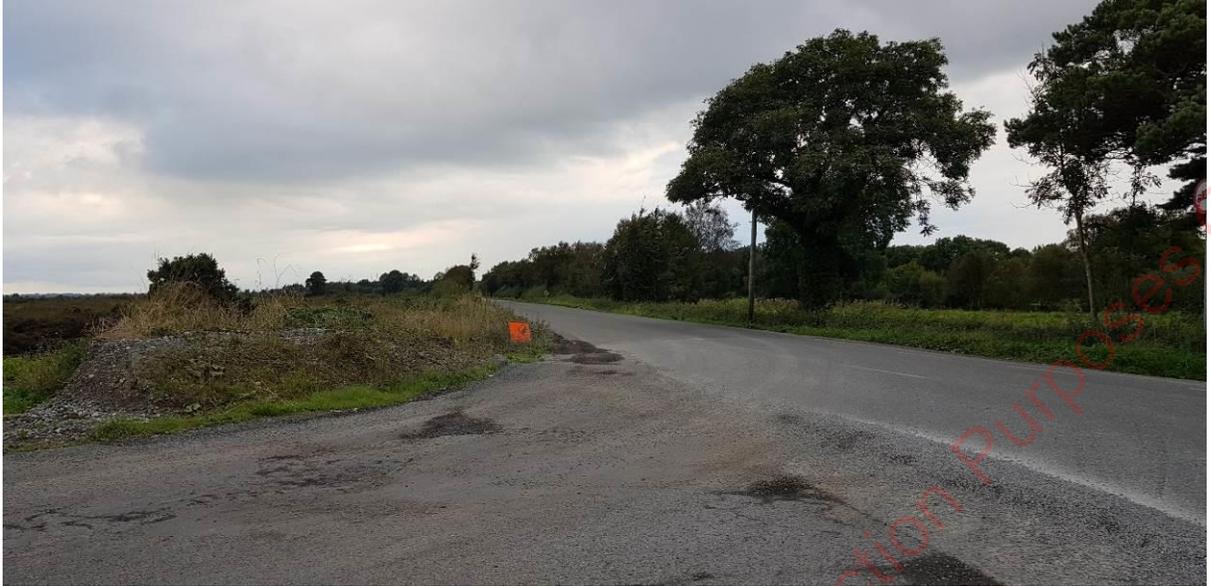
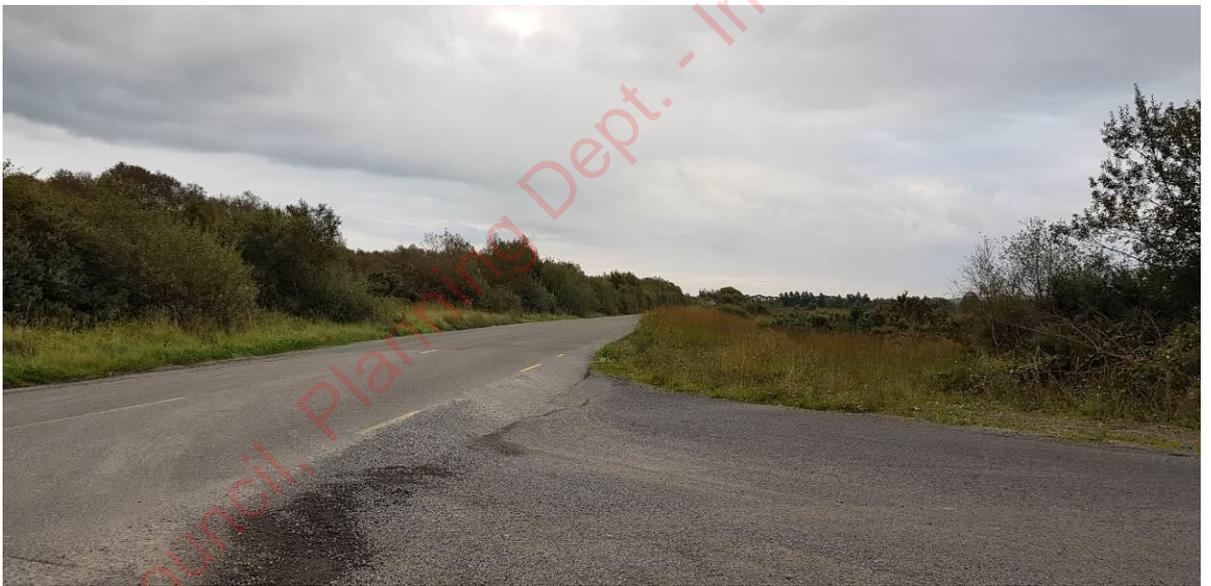
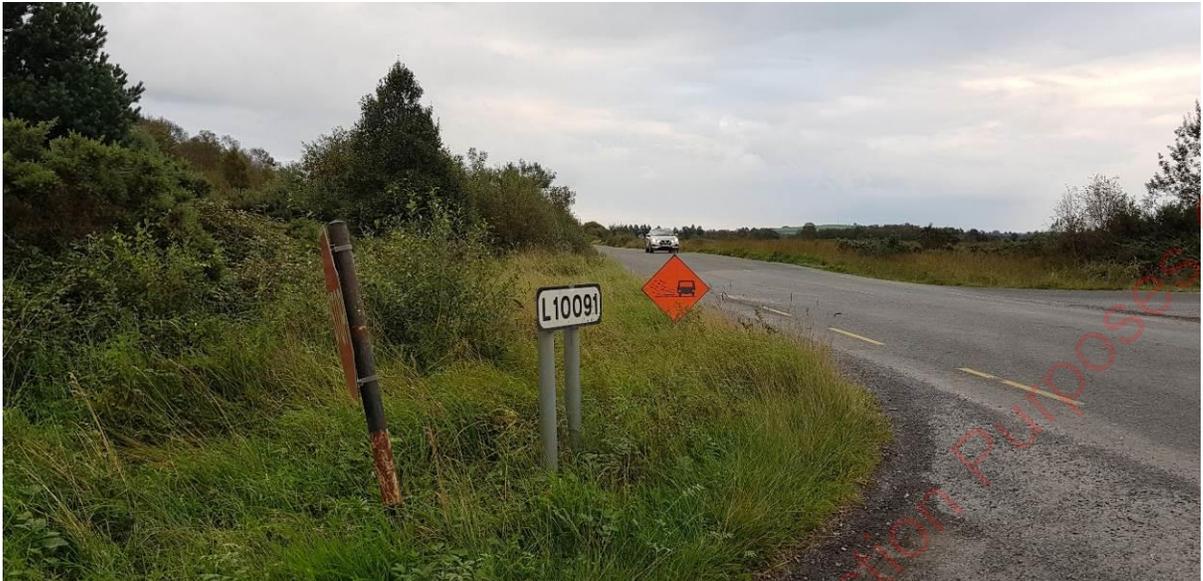
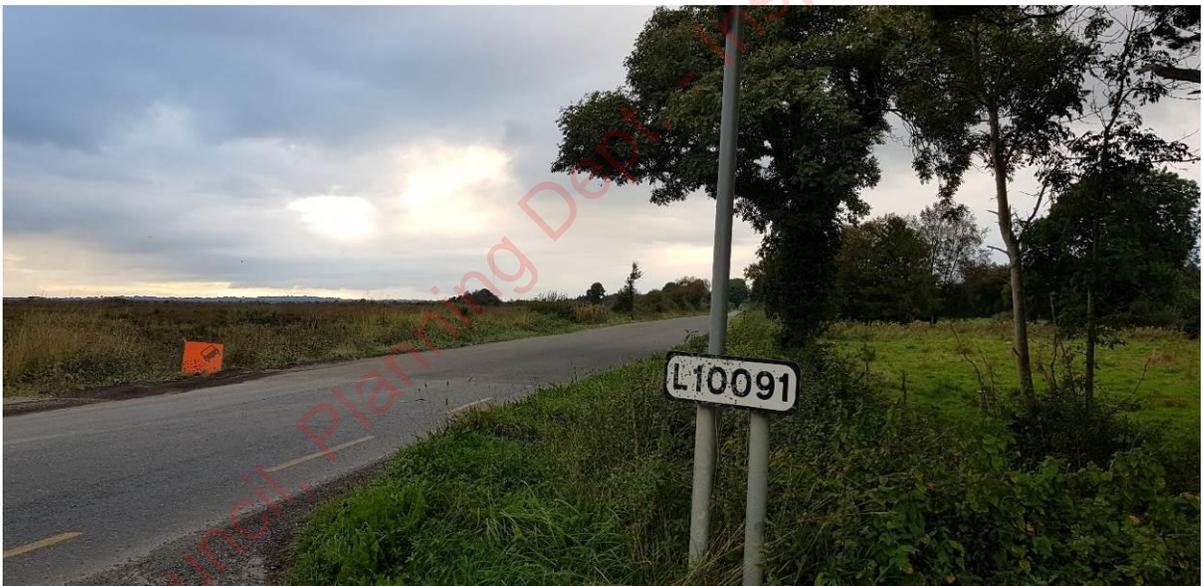
Visibility to the right and left from the existing access is shown in figures 6 and 7, with visibility to the left and right from the L10091 minor road opposite, taken from approximately 2.4m back from the channel line on the major road. Inappropriately located vegetation and overgrown verges can compromise clear intervisibility between motorists, and can lead to an increased risk of pulling out type incidents, right angled collisions and hazardous overtaking manoeuvres. The design proposals include illustration of a 3m x 160m visibility splay to the left and right at the access junction, with a note to say the visibility splay is to be kept clear, however the provision for clearance and maintenance of the verge area and treatment of any level differences to the rear has not been shown. It was noted that there is no provision for junction definition posts on either of the minor arms at the junction at present to highlight the location of the junction during the hours of darkness.

**Figure 6: Visibility to left (north) from existing access**

**Figure 7: Visibility to right (south) from existing access**

**Figure 8: Visibility to left (south) from minor road opposite site (L10091)**

**Figure 9: Visibility to right (north) from minor road opposite site (L10091)**

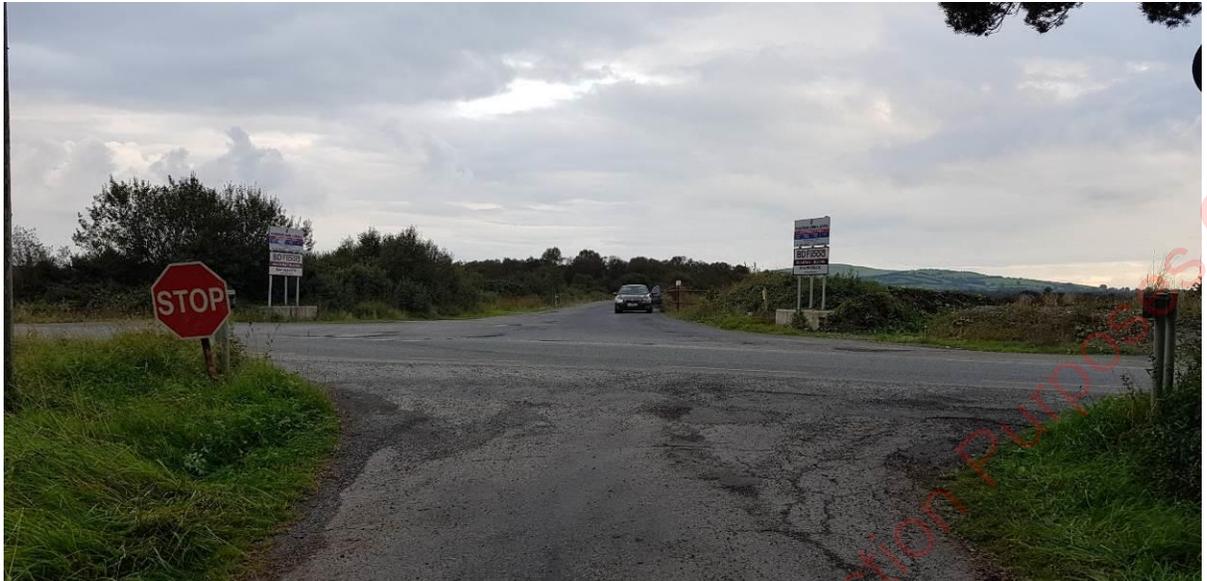
The existing carriageway surface was in a state of disrepair at some locations at the junction, on the minor road approaches, with significant loose debris also noted within the channel lines at the junction which can increase the risk of skidding and loss of control, and present a risk of windscreen shatter. Unravelling joints were also noted along with significant rutting and cracking, which can lead to ingress of water and further carriageway deterioration. Temporary Traffic Management (TTM) works were in place at the site at the time of the site visit, inclusive of Chapter 8 Traffic Signs Manual (TSM) signage regarding loose chippings, soft verges and a slippery surface. The pavement condition may deteriorate further from any construction activities arising from the site expansion, with a risk that mud, debris and gravel may be carried out onto the carriageway of the R400 and contribute towards an increase in the risk of skidding and loss of control for all vehicles. The detailed design for the access junction includes resurfacing on the major road for a distance of 50m back from the centreline of the Quarry access road, as well as resurfacing for a distance of 30m on the southern arm, but does not include provision for resurfacing or remediation on the proposed design layout on the northern arm of the junction.

**Figure 10: Poor carriageway condition on minor road opposite site**

1. The condition of the existing carriageway should be assessed on the northern arm of the junction, with pavement repair and resurfacing to be provided where necessary to ensure loose debris is not carried out onto the major road and the crossroads junction.

2. The existing carriageway skid resistance should also be assessed on approaches to the site, with provision for high friction surfacing as necessary to minimise any skidding or loss of control risks in wet and icy conditions.
3. Provision should also be made for suitable TTM during construction at the site in accordance with the requirements of Chapter 8 of the TSM, with suitable site management post construction to minimise the risk of dirt and debris from the Quarry site being carried out onto the public road.
4. Joints between old and new carriageway surfaces should be kept out of the wheel track for two-wheeled vehicles.

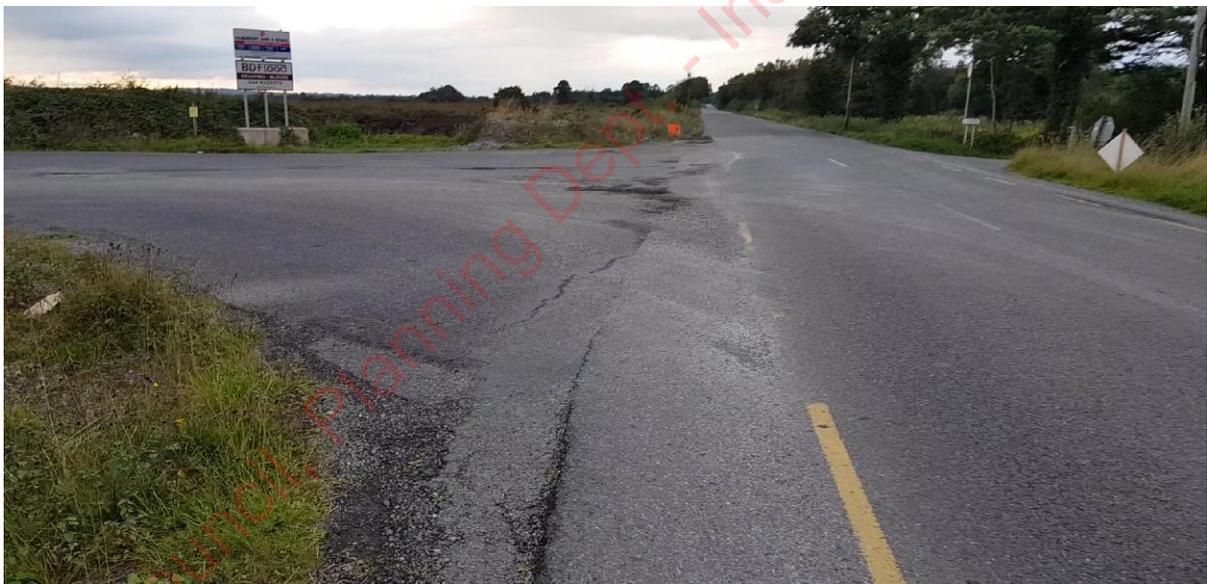
**Figure 11: Poor carriageway condition and loose debris at Site Access**

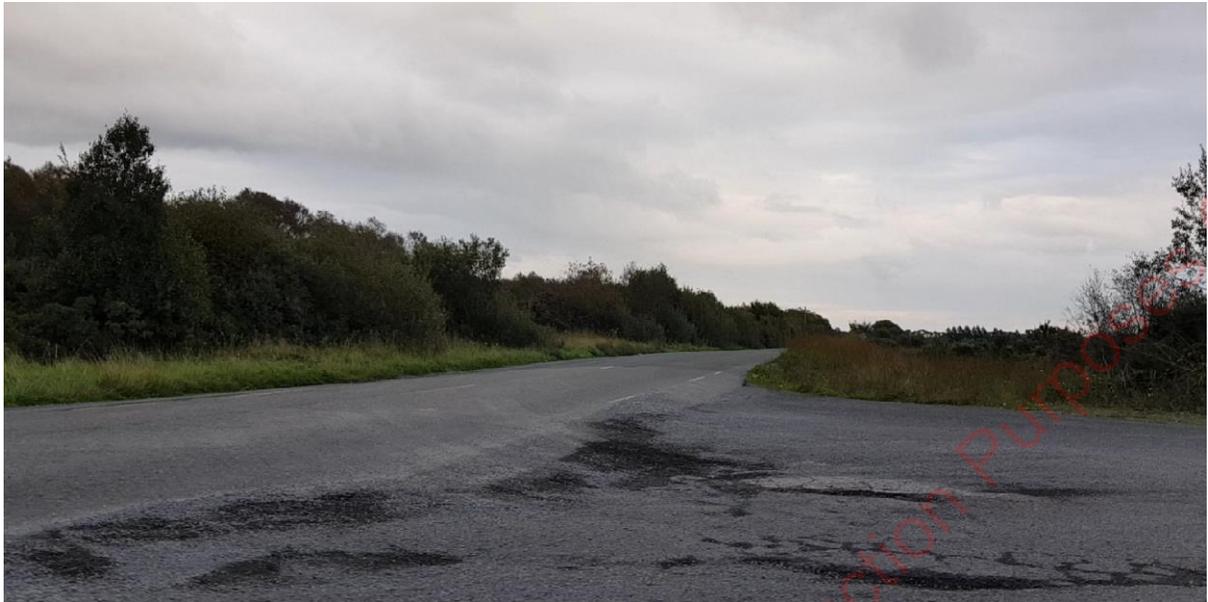
**Figure 12: Poor carriageway condition and loose debris at Site Access**

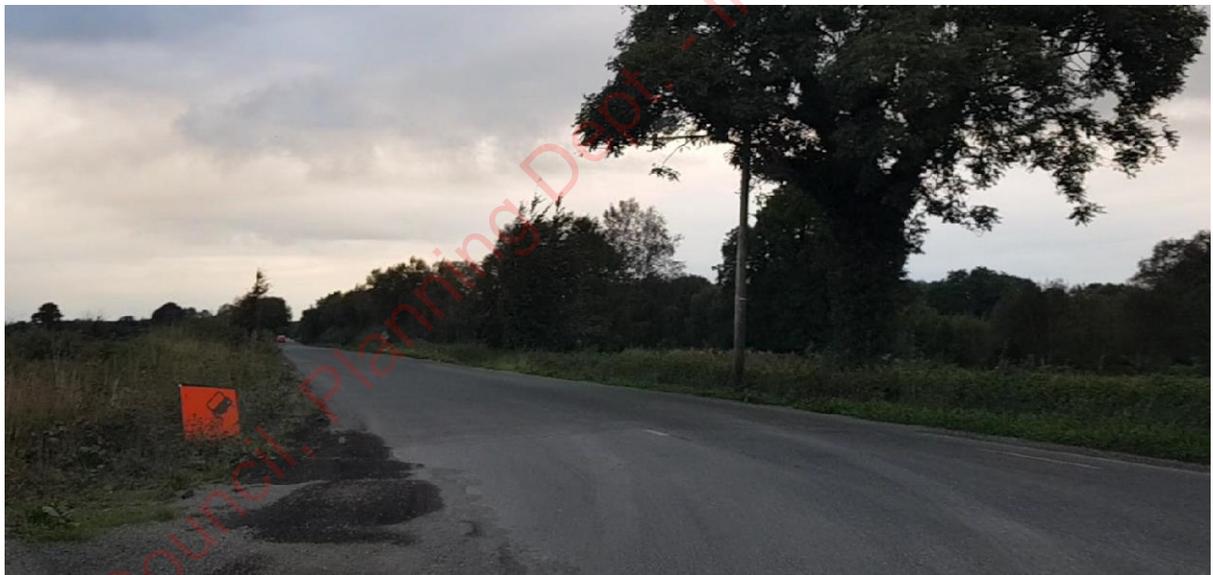
**Figure 13: Poor carriageway condition on minor road  
And TSM Wk 074 Signage for Soft Verge**

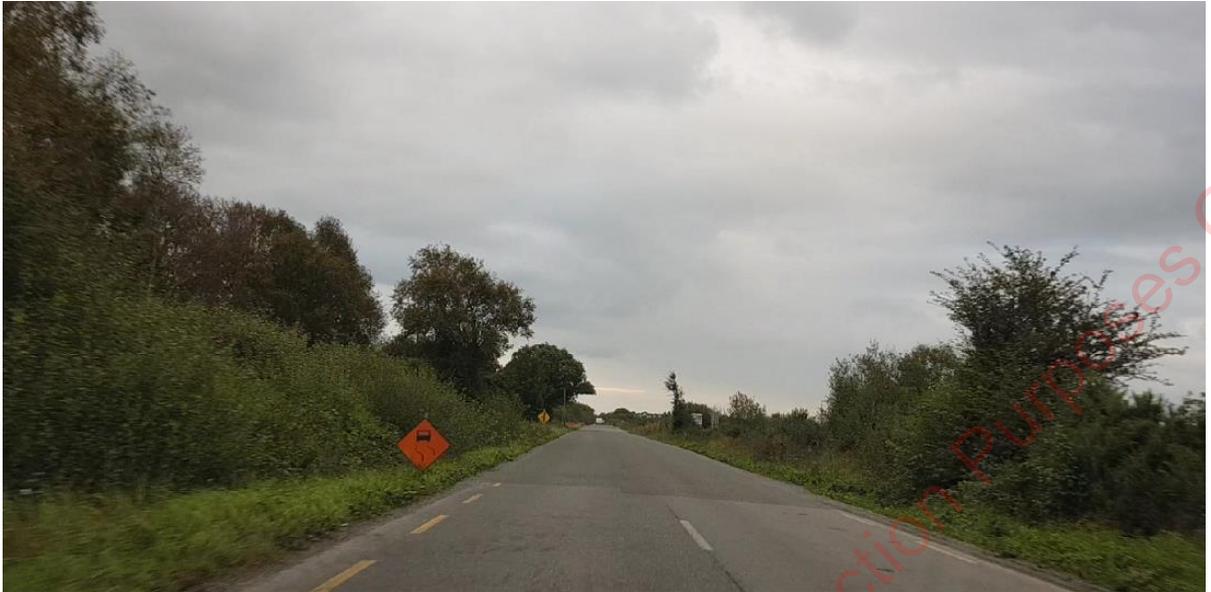
There was no signing and lining schedule produced to accompany the preliminary design, although notes to the relevant sign parameters with reference to the Traffic Signs Manual have been included on the design plan. There were no road markings on the approaches to the site at present, however provision has been made for centreline and edge of carriageway markings on the proposed layout.

**Figure 15: Road markings missing on Approach to Site**

1. A review of all existing and proposed signs and road marking requirements is recommended in advance of construction to take into account issues raised in this Stage 1/2 RSA report, with a signing and lining schedule to be produced to include sign sizes and mounting heights.

7. Detailed design should include for site clearance to include for removal of any redundant signs and road markings, with suitable tie ins to existing markings to the north and south on the R400.

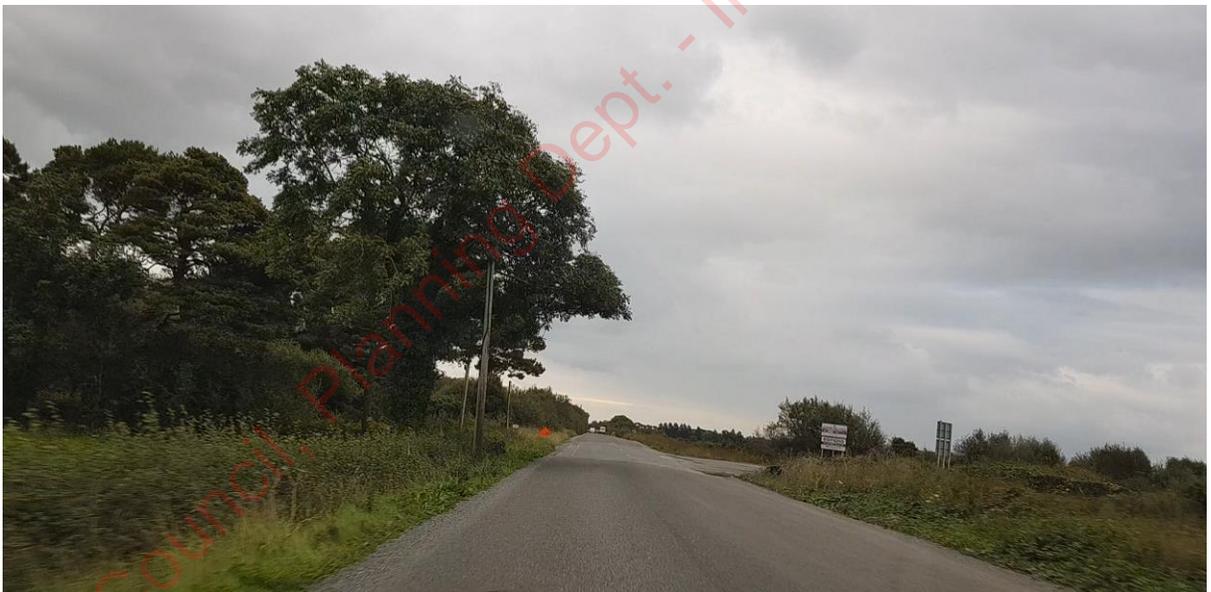
**Figure 16: Road markings missing at Site Access**

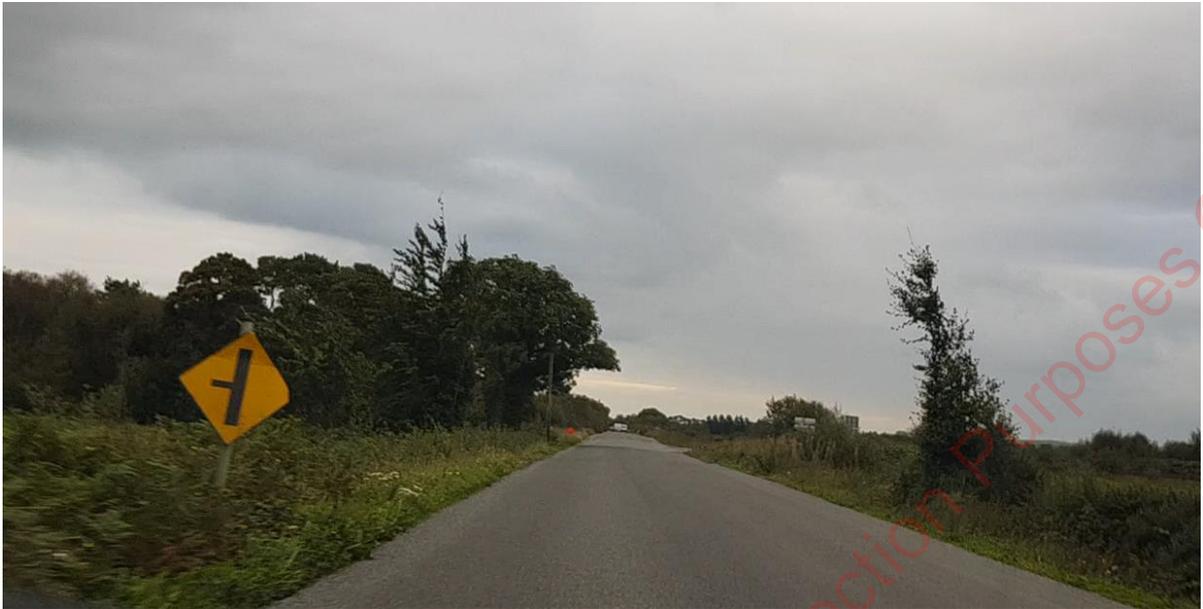
- 2.4.2.1 The proposed design does not include provision for Junction definition posts (JDPs). The proposed kerb buildouts and island will present new hazards which may not be clearly visible during hours of darkness.
- 2.4.2.2 Longitudinal approach markings at the proposed channelisation island appear to be located close to the hazard, increasing the risk that the hazard may be struck by passing and turning vehicles.
- 2.4.2.3 Proposed signs appear to be located too close to the carriageway edges, particularly on the proposed channelisation island, presenting an increased risk of being struck by passing and turning vehicles. There is evidence of existing warning signage at the site being struck, as shown in the photo in figure 17. Mounting heights of some of the existing signage is also low, which can present a hazard to two-wheeled vehicles.

**Figure 17: Low mounting Height and Limited Offset to Existing Signs**

2. All signs should be placed in a location which is clearly visible to motorists and clear of vegetation, with signs to be passively safe, and/or provided with pole diameters less than 89mm.

3. All signs should be sufficiently setback from the carriageway edges to avoid being struck by passing/turning vehicles, typically a minimum 600mm offset is required between the edge of sign face and the edge of carriageway.

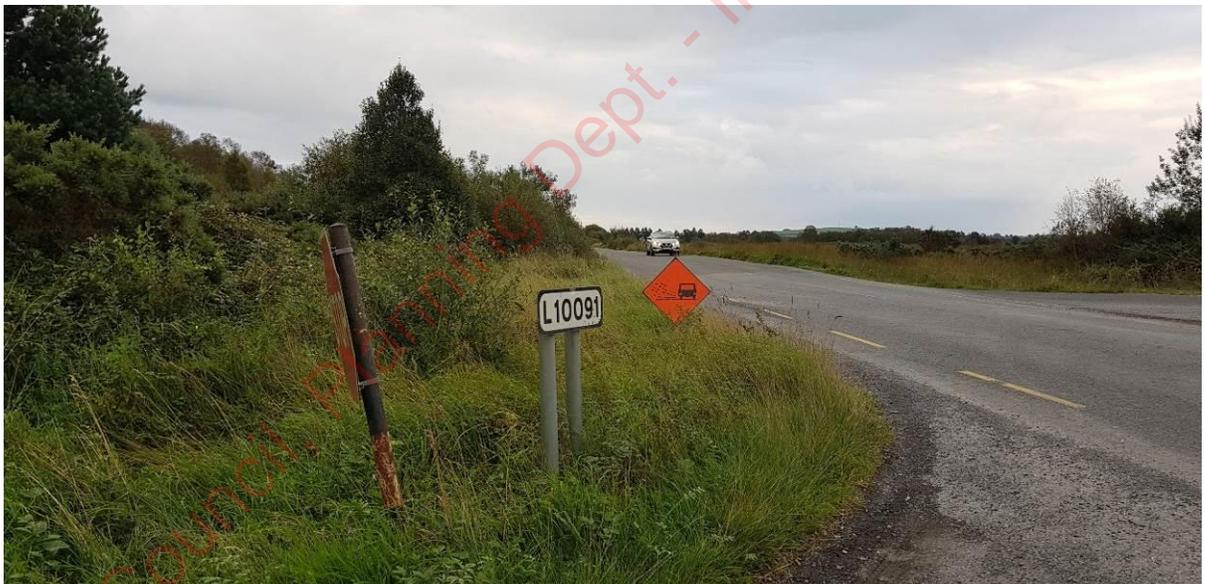
**Figure 18: Low mounting Height to Existing Signs**
