Inchamore Wind Farm Project  
Peregrine flightlines Summer 2017

Section 6: APPENDICES  
 Appendix 1. FIGURES AND MAPS

Figure 3.1 Site Location Map with Hydrology

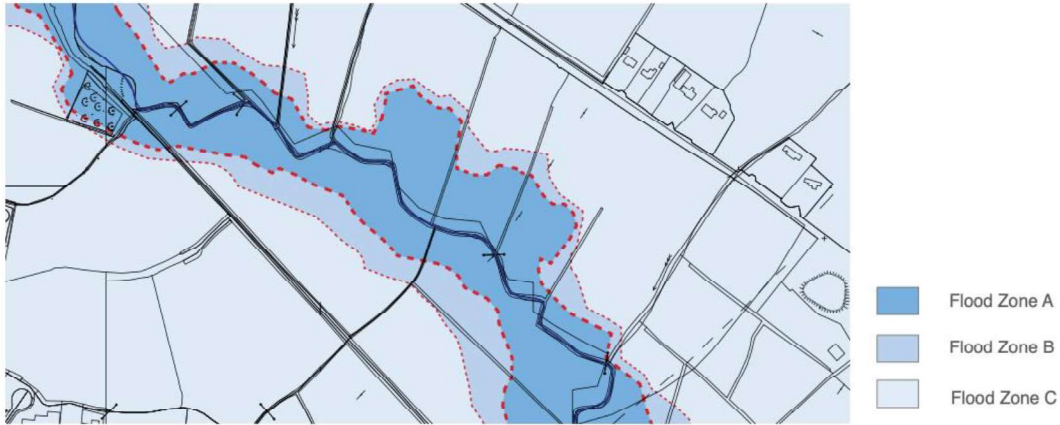
**Figure 4.1: Indicative flood zone map (OPW, 2009)**

In the FRM Guidelines, the likelihood of a flood occurring in an area is identified and separated into Flood Zones **Figure 4.1 - Indicative Flood Zone Map**, which indicate a high, moderate or low risk of flooding from fluvial or tidal sources, defined as follows:

- Flood Zone A - Where the probability of flooding is highest (greater than 1% Annual Exceedance Probability (AEP) or 1 in 100 for river flooding and 0.5% AEP or 1 in 200 for coastal flooding) and where a wide range of receptors would be located and therefore vulnerable.
- Flood Zone B - Where the probability of flooding is moderate (between 0.1% AEP or 1 in 1000 and 1% AEP or 1 in 100 for river flooding and between 0.1% AEP or 1 in 1000 year and 0.5% AEP or 1 in 200 for coastal flooding); and
- Flood Zone C - Where the probability of flooding is low (less than 0.1% AEP or 1 in 1000 for both river and coastal flooding).
