**APPENDIX 9.2:**

**INCHAMORE WIND FARM  
SITE PHOTOGRAPHS**

**Inchamore WF, Co. Cork**

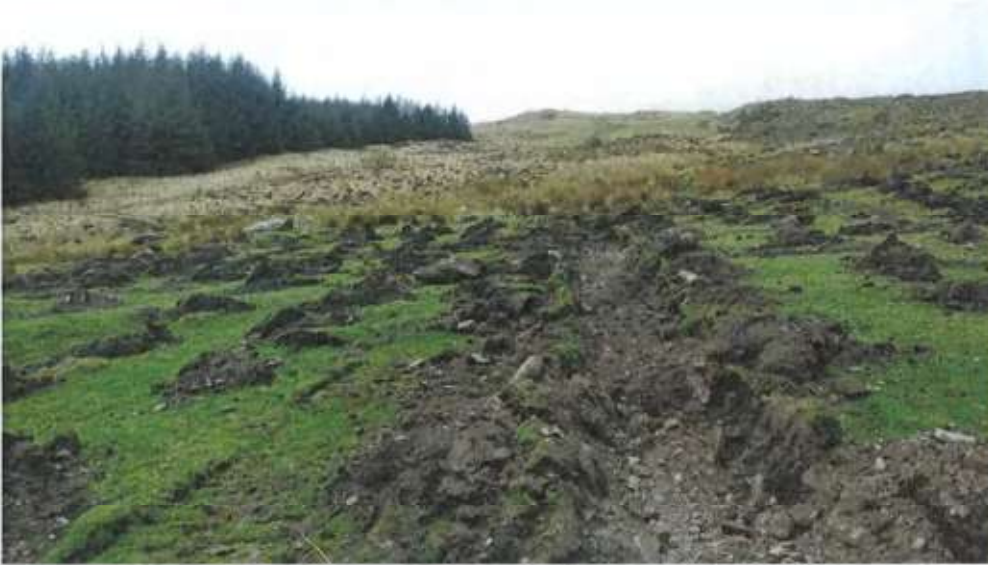
Preparation for forestry plantation observed during Surface Water Sampling R4 16/03/2021, near SW1.

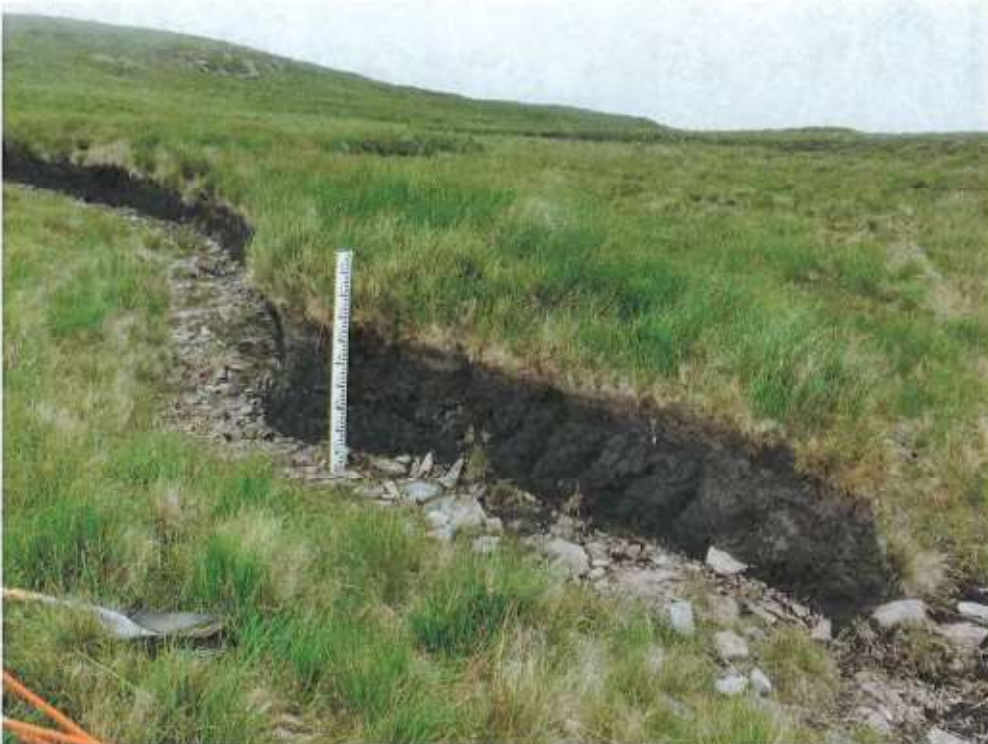
Evidence of peat cutting observed during site surveys 16/06/2020.

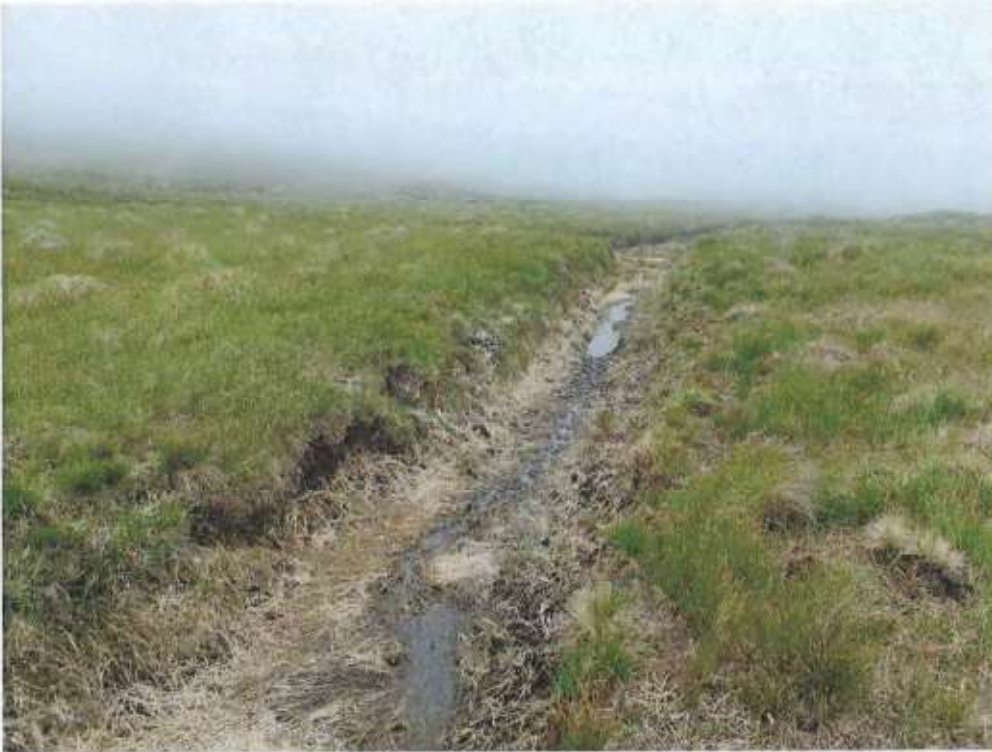
Existing artificial / modified drainage observed during site surveys 16/06/2020.

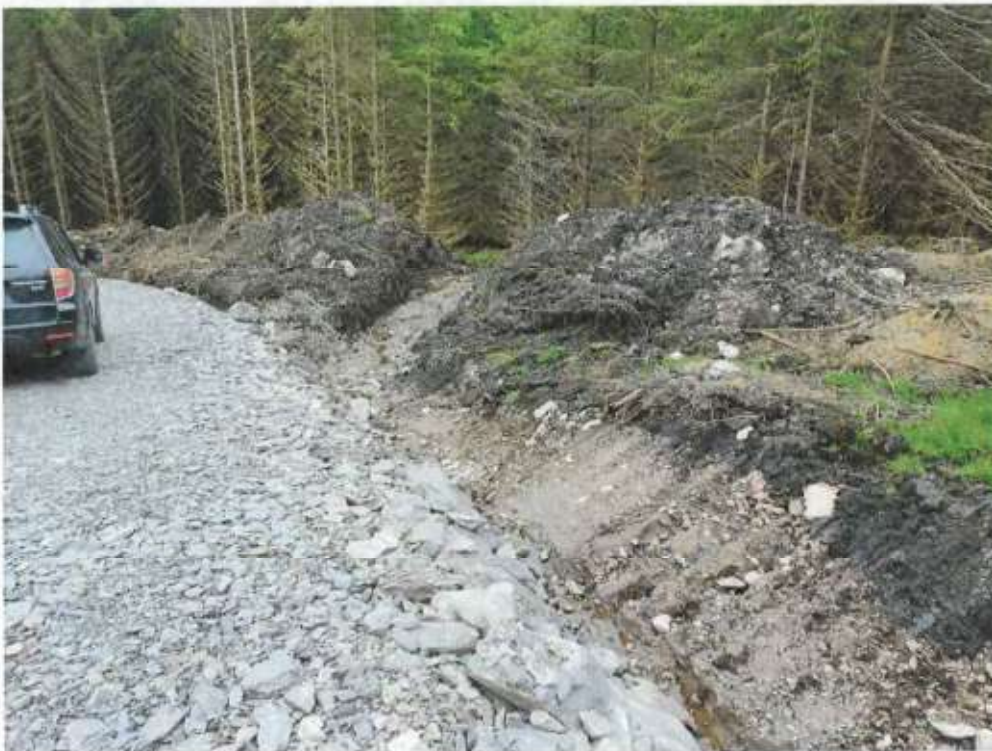
New access track and drainage associated with ongoing forestry activities observed during site surveys 16/06/2020.

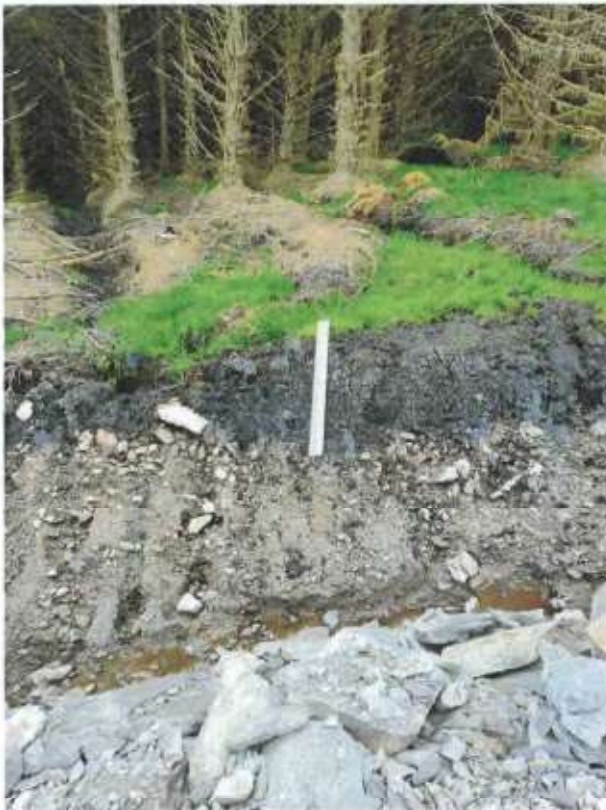
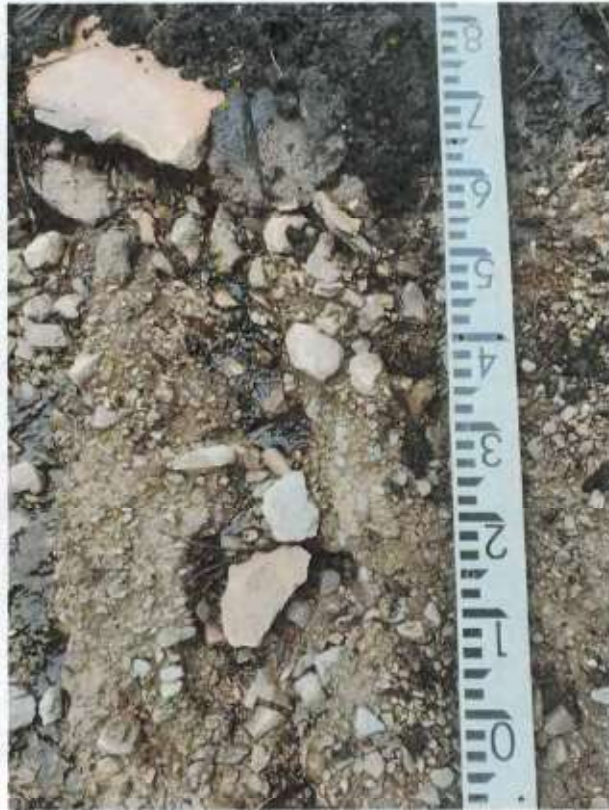
Peat and till exposed at new access track and drainage associated with ongoing forestry activities observed during site surveys 16/06/2020.

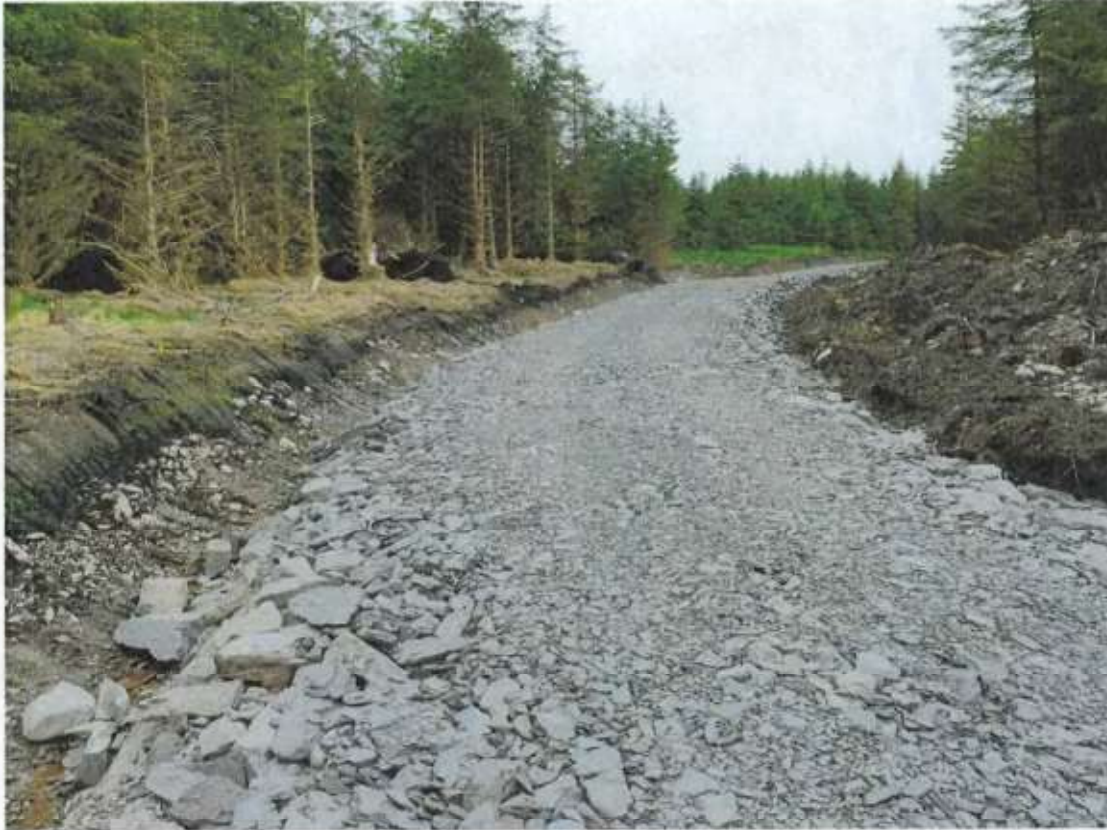
Peat and till exposed at new access track and drainage associated with ongoing forestry activities observed during site surveys.

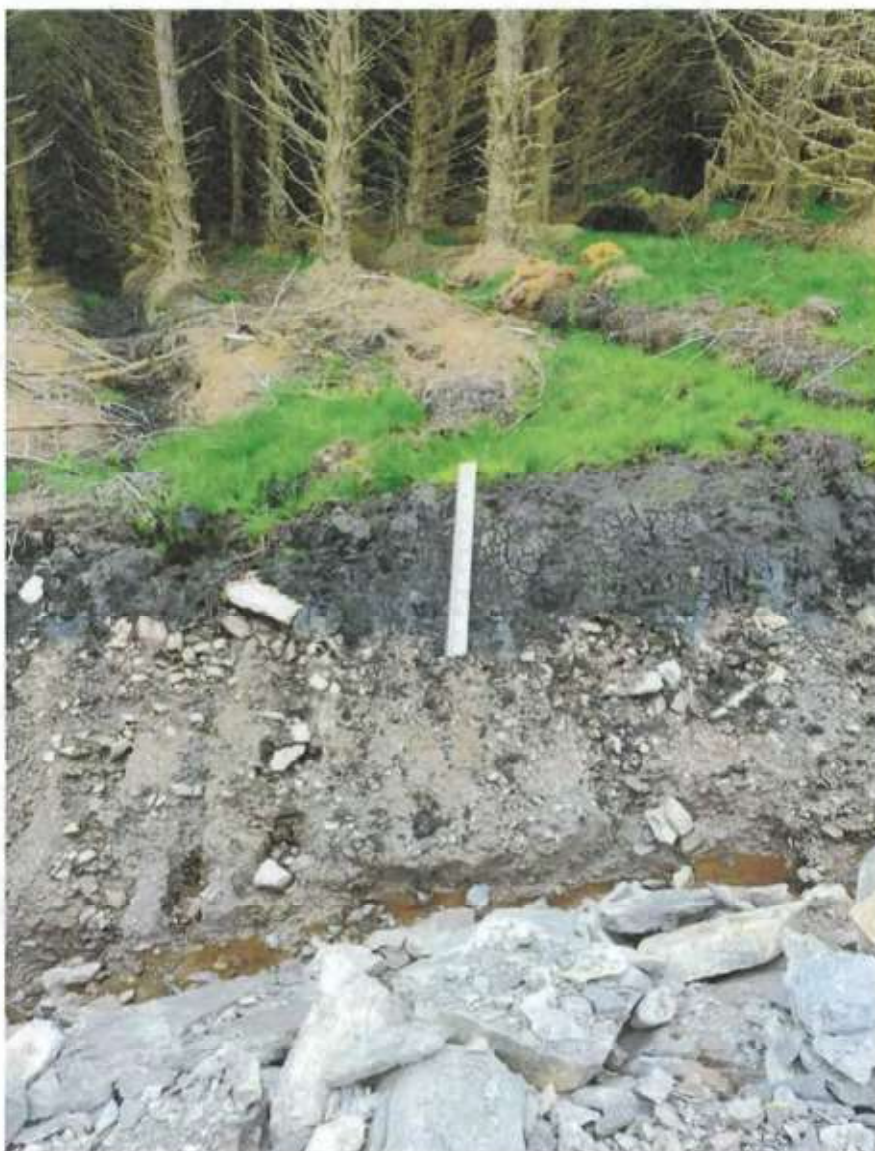
Peat and fill exposed at new access track and drainage associated with ongoing forestry activities observed during site survey.

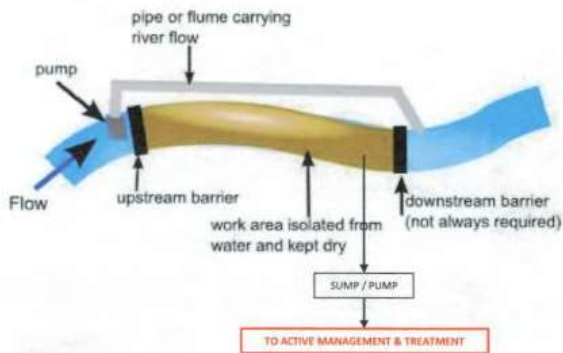
**Full Isolation Over Pumping – Plan**

- Full isolation over pumping / siphon. A whole section of the channel is isolated using barriers that span the full width of the river. This keeps a stretch of the river dry and the water is transferred downstream of the works area by mechanical assistance (pumping or siphon). The pump and associated pipework need not be located in the isolated area.
- This method is the preferred method for channel diversion during instream works, for example, during watercourse crossing / culvert construction. However, the pumping equipment deployed must be capable of the surface water feature discharge rate, including back up equipment and fail safe protocols.

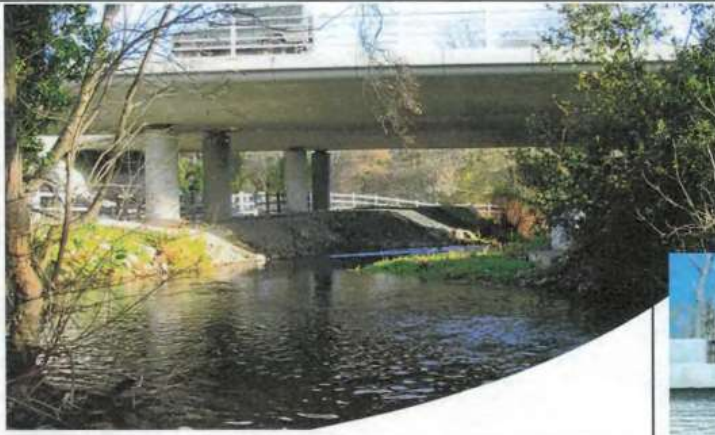
Example of a clear-span bridge which retains the existing river channel, abutments are set back from the river bank (AT&F, 2022)

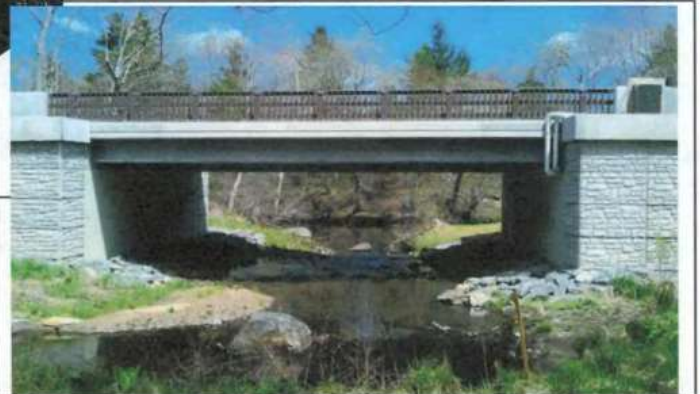
Example of a clear-span bridge, which retains the existing river channel and column set back from the river bank (National Roads Authority, 2008)

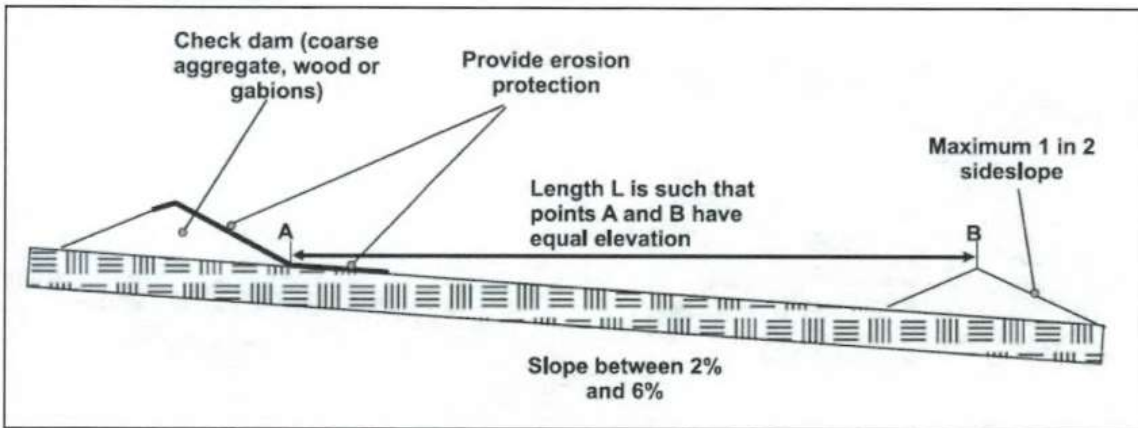
Constructed Drain and Check Dams – Section

Check Dam Design Consideration (CIRIA, 2004)

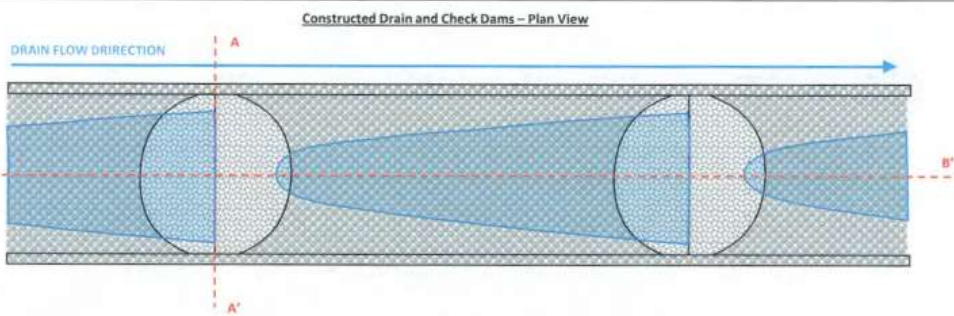
- (\*\*\*) V-notch weirs discussed. Conceptual Design – Drainage Infrastructure Check Dams – With Variable Flow Rate / V – Notch Weirs

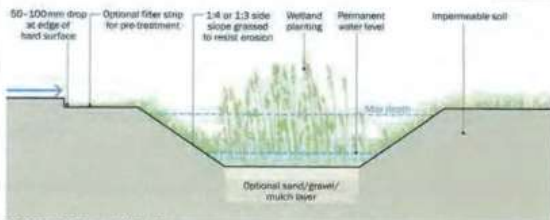
Shallow, vegetated, open channel designed to direct, treat and attenuate surface water runoff with a potential for biodiversity benefits.

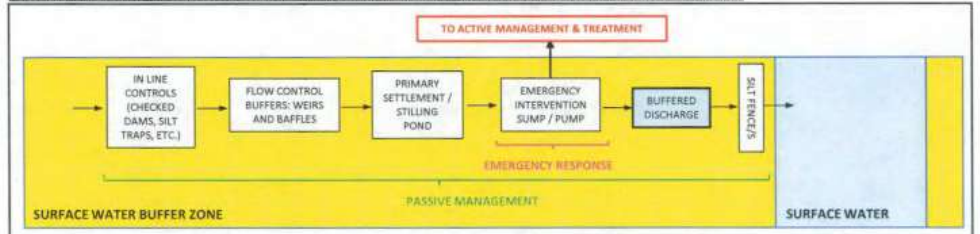
### Conceptual Treatment Train Layout for Construction Areas & Associated Infrastructure within Surface Water Buffer Zones

- NOTES:**
- Whenever possible, outfalls will be positioned outside of Surface Water Buffer Zones.
  - For areas of the development footprint within Surface Water Buffer Zones, in-line measures such as silt screens will be over specified e.g. double / triple silt screens, and access to emergency intervention sump / pumps will be facilitated through design and/or emergency response.
  - Quality of runoff entering buffer zones will be good i.e. suspended solids <25mg/l. Where runoff quality is poor, emergency response will be to use an intervention sump / pump and pump divert runoff to an area of the drainage network where it will be treated before redistribution and discharge.

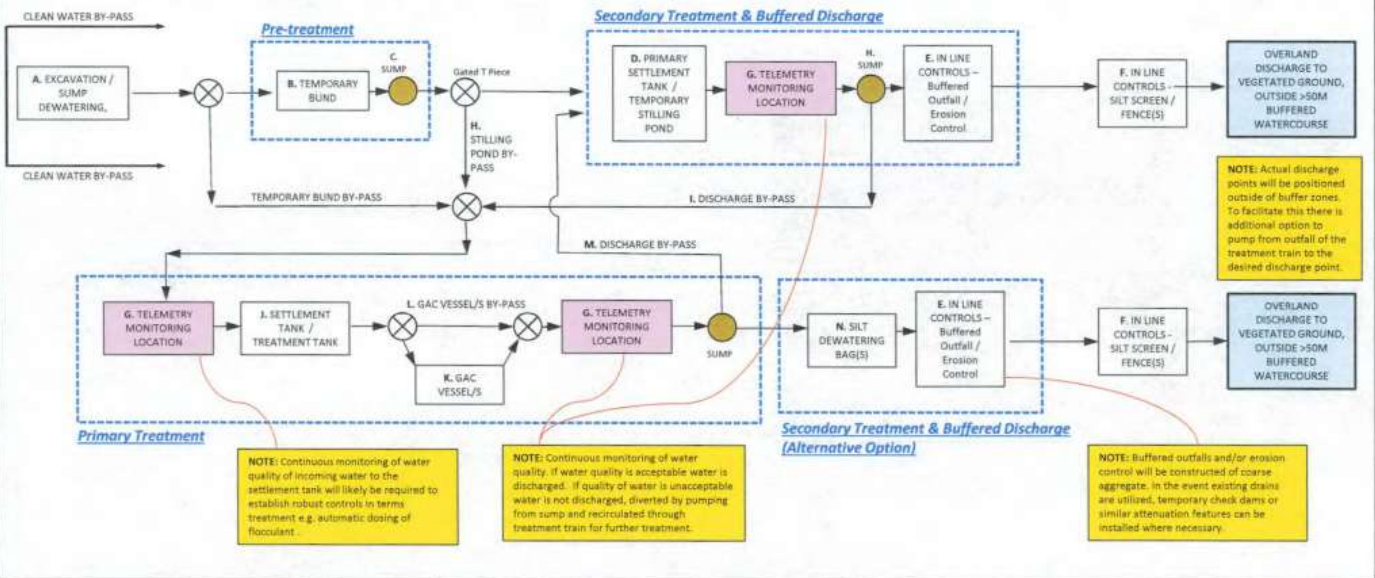
### Conceptual Dewatering and Treatment Train Flow Diagram

Contaminated water arising from construction works, namely, excavations and temporary stockpiling, will be contained and treated prior to release or discharge. The schematic presented here is a conceptual model of measures implemented to manage arisings and runoff.

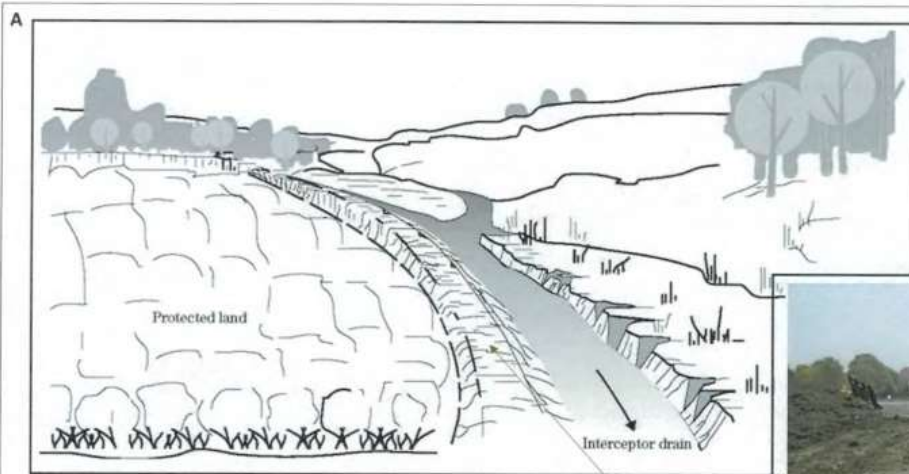
Conceptual graphic of an Interceptor drain  
 (NRCS/USDA.gov, 2007) Available at: [https://www.nrcs.usda.gov/Internet/FSE\\_DOCUMENTS/nrcs141p2\\_017651.pdf](https://www.nrcs.usda.gov/Internet/FSE_DOCUMENTS/nrcs141p2_017651.pdf)

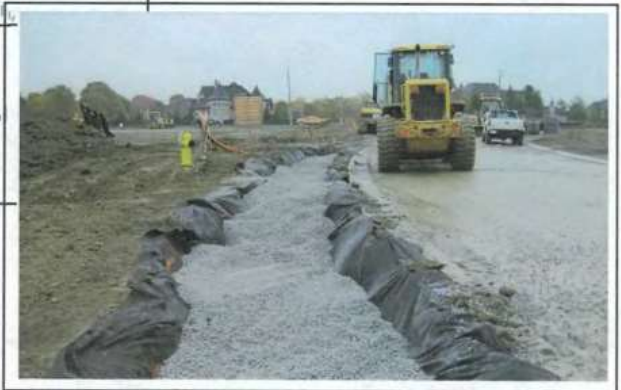
Example of a temporary berm  
 (Green Infrastructure Ontario, 2012) Available at:  
<https://greeninfrastructureontario.org/infiltration-trench-swale-construction/>

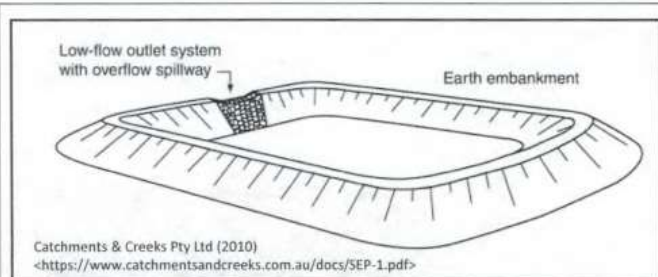
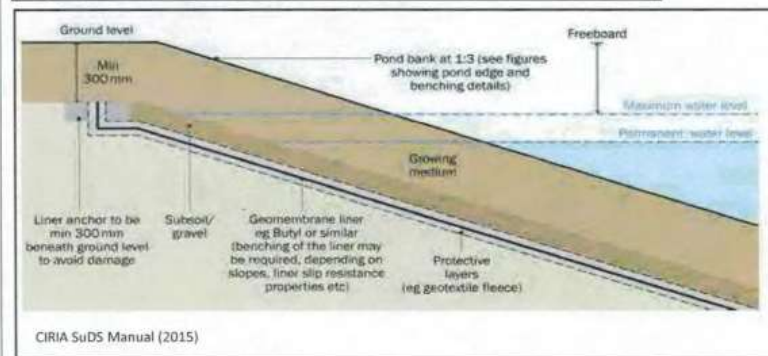
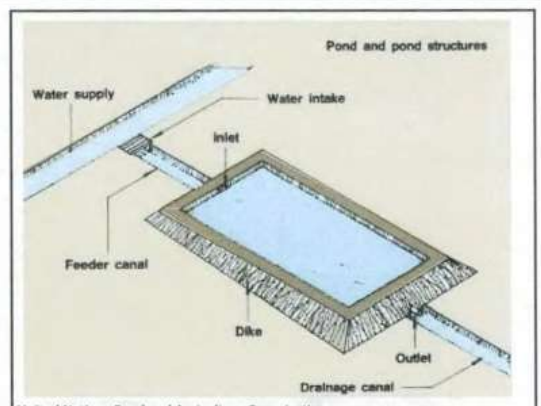
Ponds should be designed to mimic natural forms and have varying depths which can provide a range of different habitats.

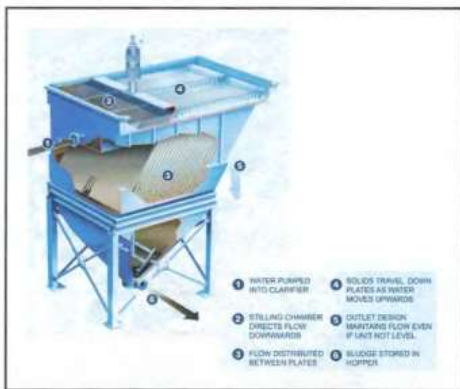
Example of an oil-water separator  
Minerex Environmental Limited, an RSK Group company

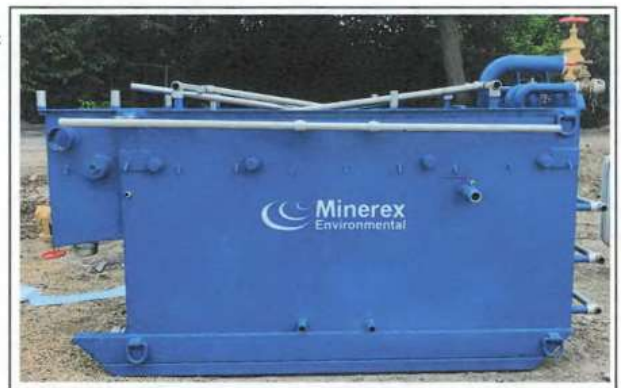
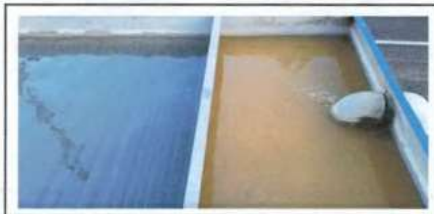
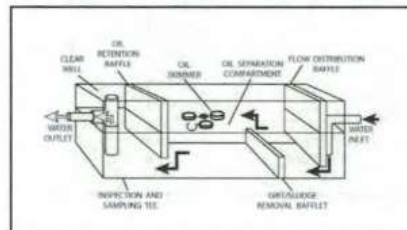
Cross-section of oil-water separator  
Mohr, Kirby S. (2014)

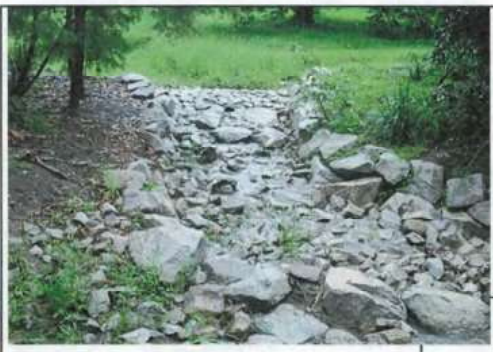
Example of buffered outfall with coarse aggregate  
(Catchments and Creeks Pty Ltd., 2020)

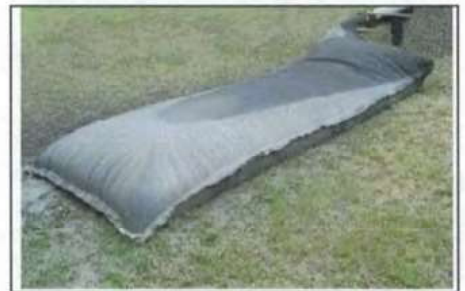
Example of a silt bag  
(Cascade Geotechnical Inc., 2022)

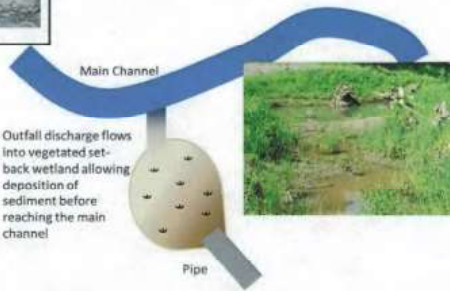
Conceptual graphic of a discharge to vegetated outfall  
(Janes-Bassett et al., 2016)

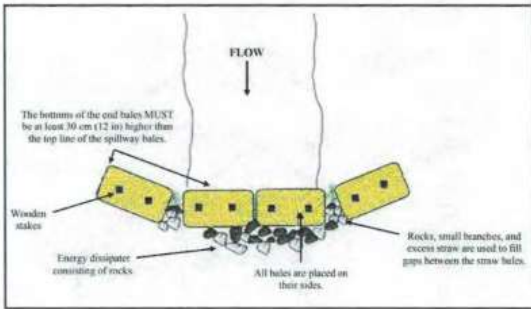
Conceptual graphic of a straw bale checked dam (Storrar, 2013)

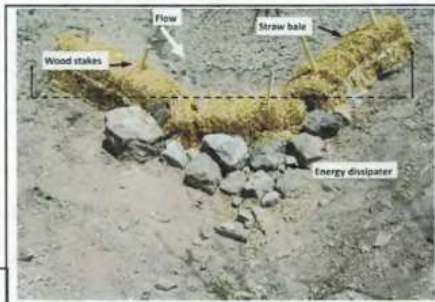
Example of a Strawbale Checked Dam Robichaud, et al. (2019)

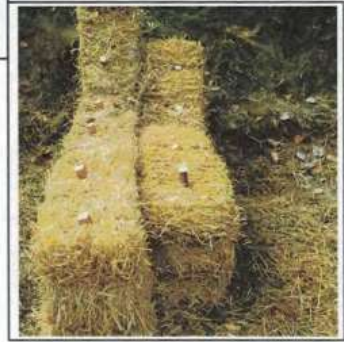
Example of a Strawbale Checked Dam (Kawartha Conservation, 2020)

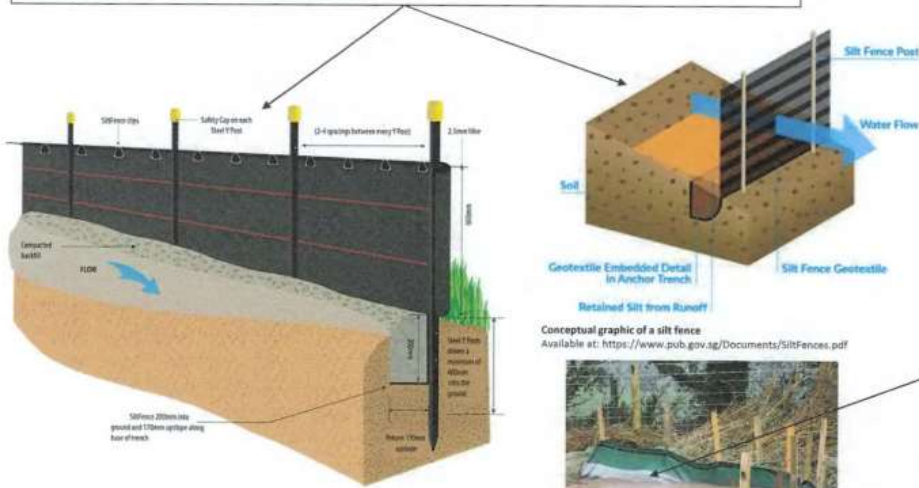
Temporary barrier fabric used to retain erosion of sand, silt, and clay. Geotextile silt fencing acts as a vertical, permeable, interceptor to sediment-laden waters from construction.

Conceptual graphic of a silt fence  
Tech Weave (2020) Available at: <<https://techweave.com/silt-fences/>>

Silt fences control runoff by allowing water to pass through the fabric while collecting leftover sediment.

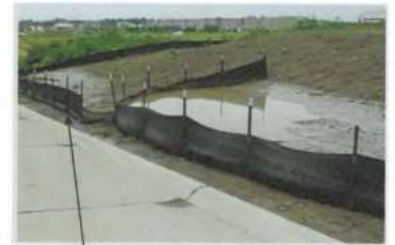
Example of Silt fencing in use  
Bowman Construction Supply (2023) Available at: <<https://www.bowmanconstructionssupply.com/products/silt-fence/>>

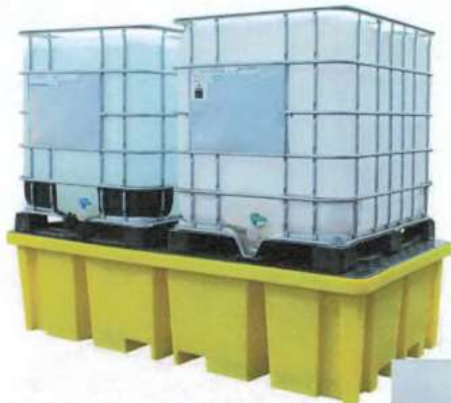
Example of a temporary spill pallet bund (Road Ware, 2023)

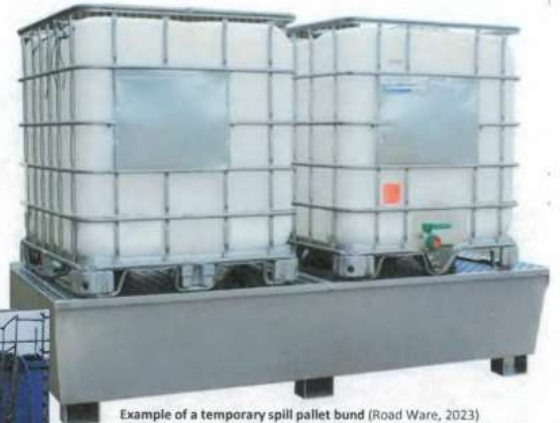
Example of a temporary spill pallet bund (Road Ware, 2023)

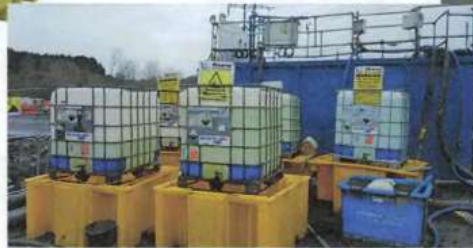
Example of a temporary spill pallet bund (Road Ware, 2023)

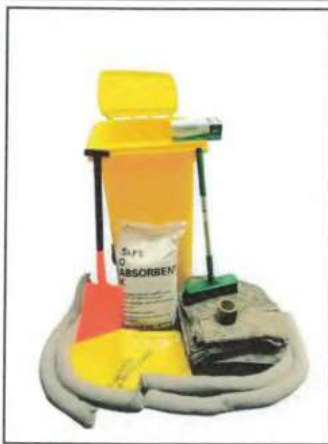
**Polymer Spill Kit**  
 (Yellow Shield Ltd., 2023) Available at:  
<https://www.yellowshield.co.uk/polymer-spill-kit>

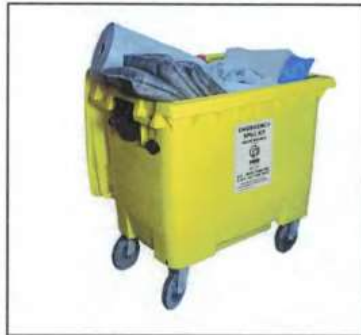
**Maintenance Spill Kit**  
 (Hyde Park Environmental, 2023) Available at: [https://hydepark-environmental.com/1100-litre-maintenance-emergency-spill-kit?utm\\_source=email&utm\\_medium=email&utm\\_campaign=HMK234%2F03.23](https://hydepark-environmental.com/1100-litre-maintenance-emergency-spill-kit?utm_source=email&utm_medium=email&utm_campaign=HMK234%2F03.23)

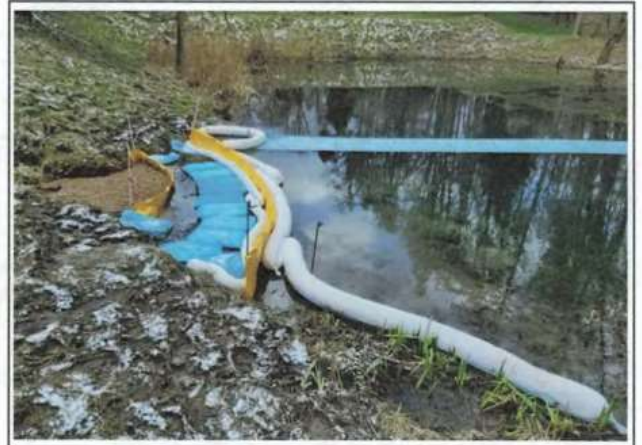
**Example of a spill kit deployed in surface water**  
 (Oracle Environmental Experts Ltd., 2022)  
 Available at: <https://www.oracle-environmental.com/spill-kits>

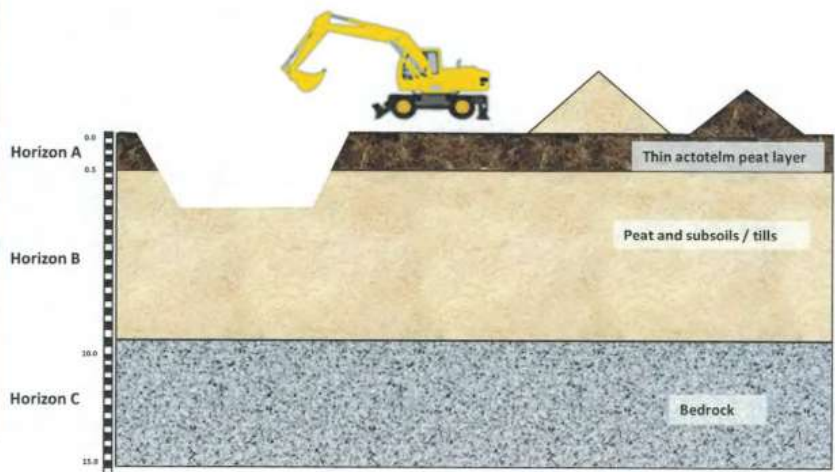
- Infilling with material in identified soil horizons to revert these areas to baseline levels.

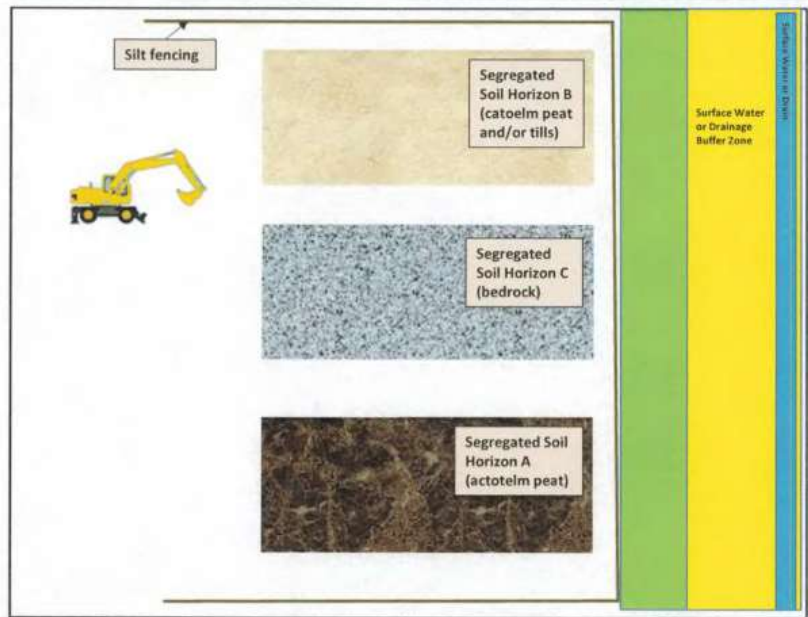
- All stockpiles will be covered with high-grade polythene sheeting to prevent run-off of rainwater and leaching of potential contaminants from the stockpiled material generation and/or the generation of dust.
- Recovered material destined for reuse off site will comply with Article 27 or Article 28 of the EPA to be classified as a by-product or as end-of-life waste, or Certificate of Registration for soils.
- Excess soils which cannot be reused will be tested and classified as a waste and disposed of appropriately.
- Temporary stockpiles will avoid areas on Site near artificial drainage channels (outside designated surface water buffer zones and will adhere to mitigation measures outline in **EIAR Chapter 9 Hydrology and Hydrogeology**, in dealing with entrainment of soils in surface water runoff.
