SOILS, LAND AND GEOLOGY

5 SOILS, LAND AND GEOLOGY

This Chapter of the remedial Environmental Impact Assessment Report (rEIA) considers and assesses any potential impacts resulting from quarrying related activities that have been carried out at Hudson Brothers Ltd Kildare quarry (the 'Site'), on the surrounding land, soils and geology.

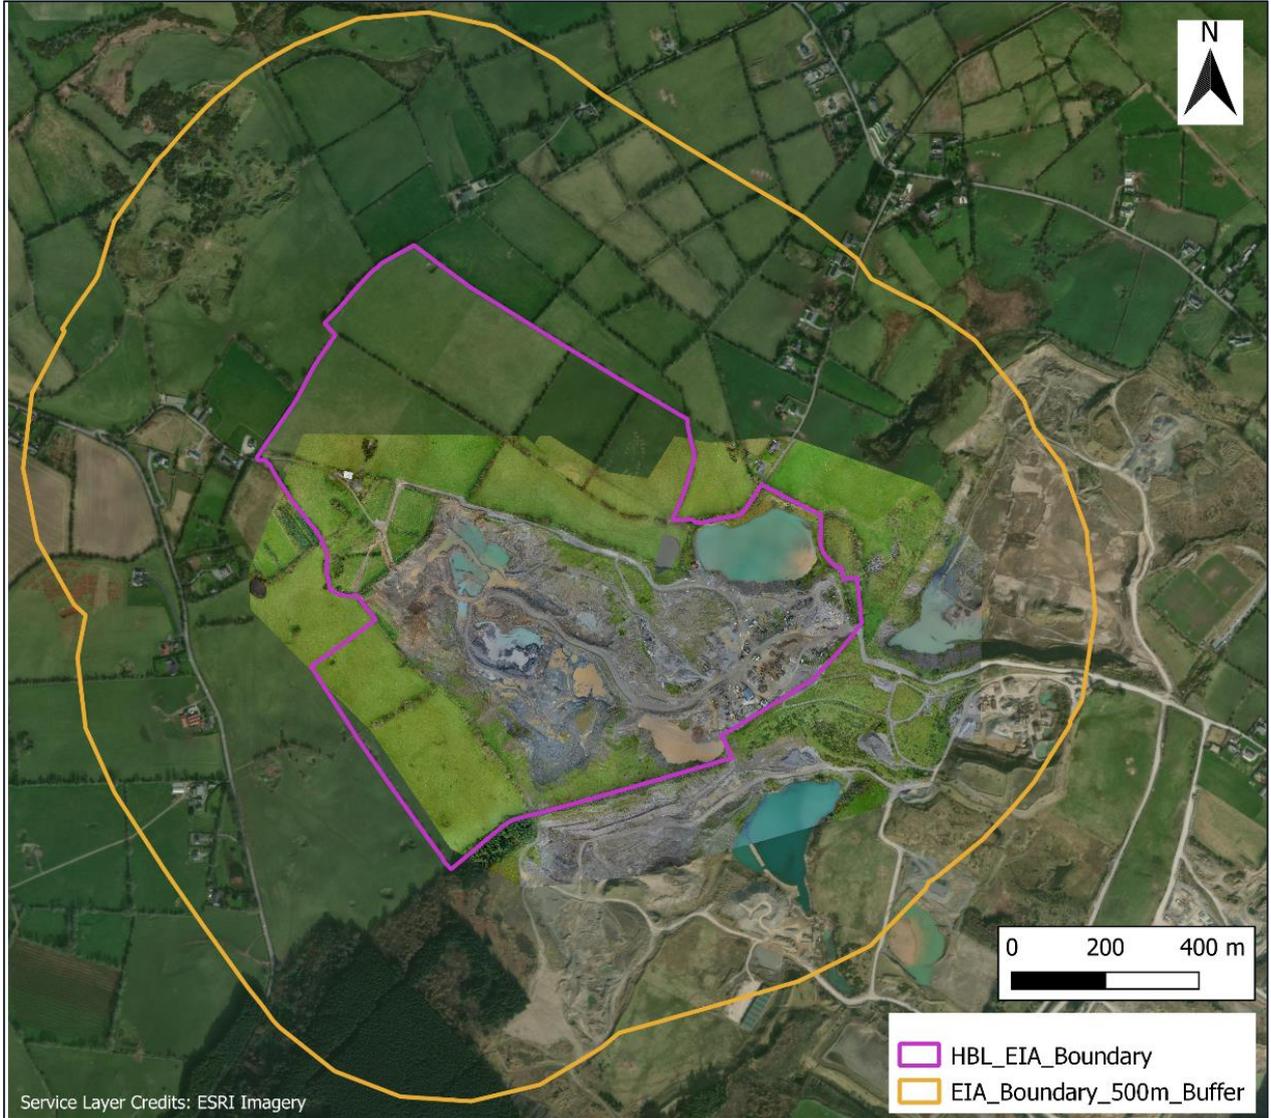
Figure 5-1 - Location of the Site (EIA Boundary) and 500 m Buffer

The geographical study area for the assessment covers the EIA boundary (Site) (identified on Figure 5-1) and a buffer zone of 500 m (forming the study area) from the EIA Site boundary, because most potential effects to geological and soil receptors are anticipated to occur within the Development footprint or immediately adjacent to it. In the context of this rEIA, the Site boundary contains lands which form the existing quarry area and some areas which extend beyond the working areas.

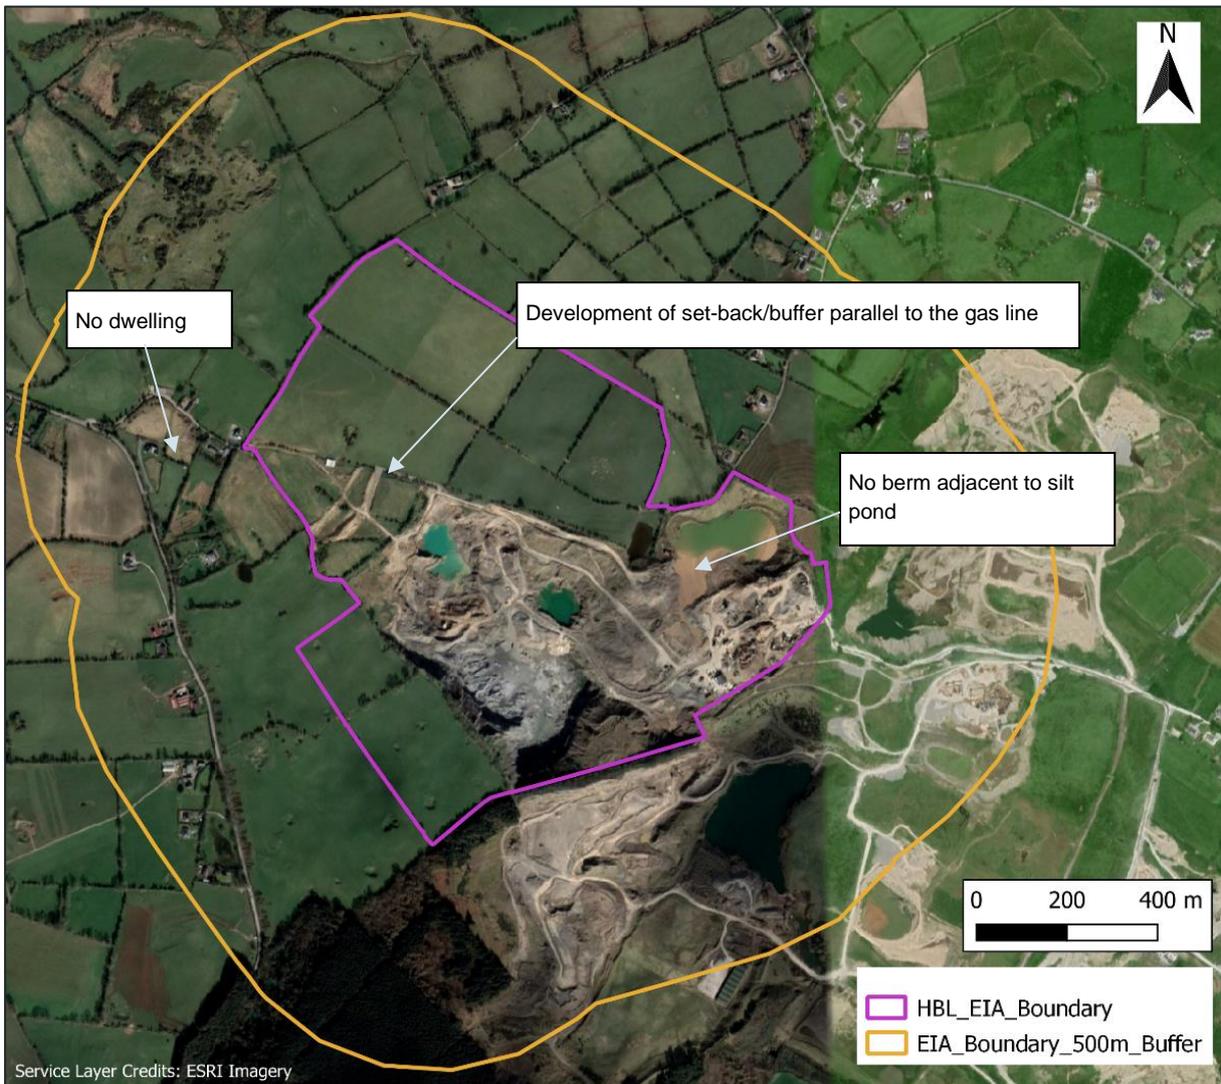
Figure 5-2 - Land Use in March 2020 with 500 m Site Buffer

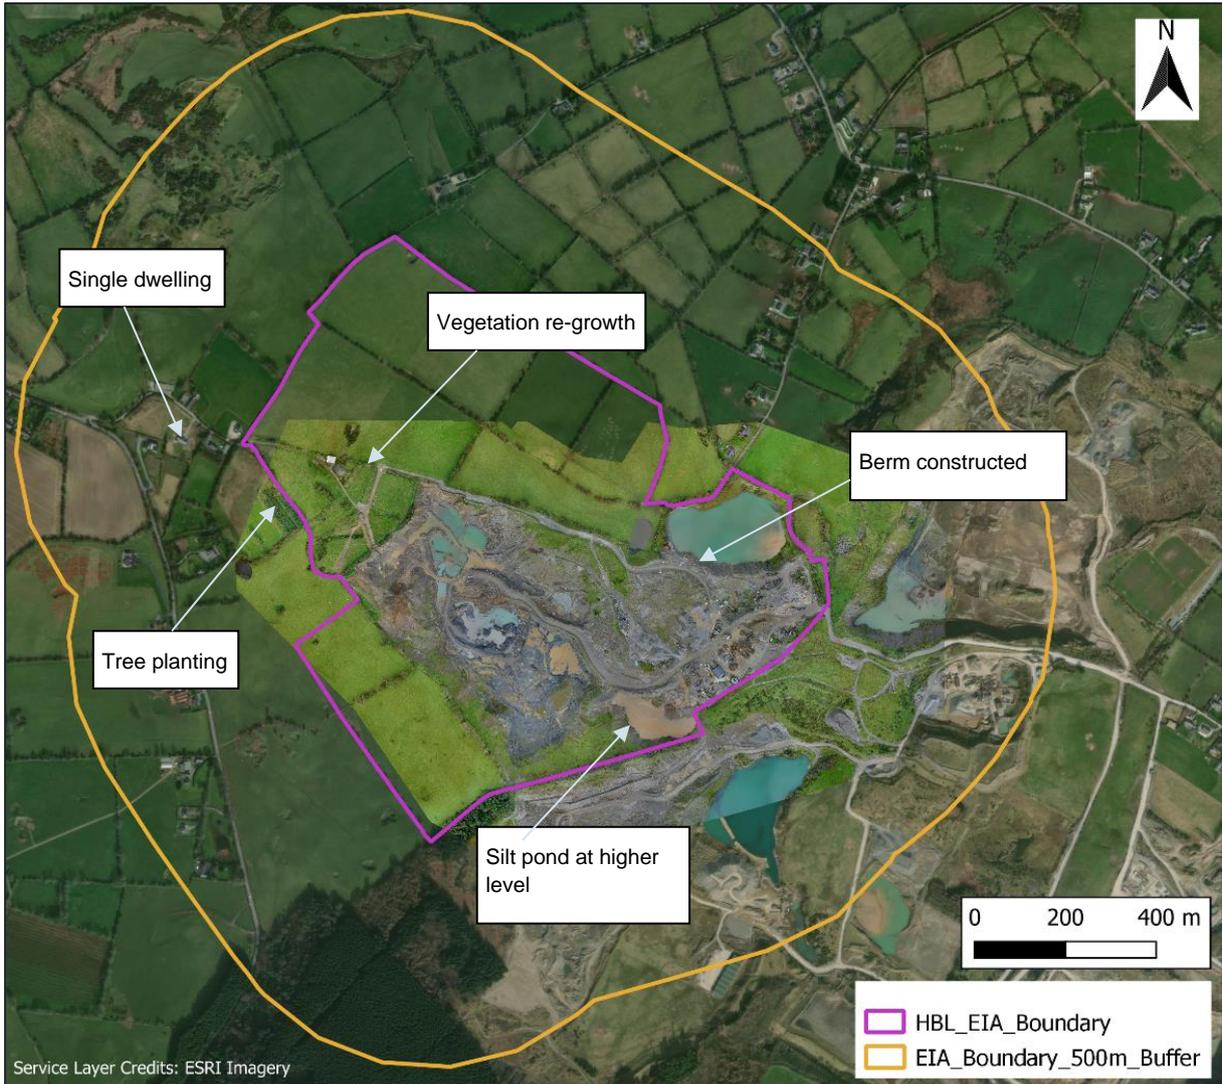
Figure 5-3 - Land Use in October 2023 and March 2022 with 500 m Site Buffer

Between the 2020 and 2023 aerials, the R410 road and surrounding land use has remained unchanged. Between 2020 and 2023 there has been the addition of a single house dwelling and planting of trees, as shown in Figure 5-3. Within the Site boundary, there was re-growth of vegetation over the screening berms, constructed at the western access point to the Site in order to create a buffer to the gas main running through the Site. There has also been changes to the internal site track layout at this access point. A berm and buffer to segregate a silt pond located north of the Site was developed during 2020 and the pond was closed off by the October 2023 aerial. The silt pond to the southeast of the process area can be seen to be filling during the assessment period. This silt pond is in an area where shallow sands and gravels had been extracted down to the competent bedrock.

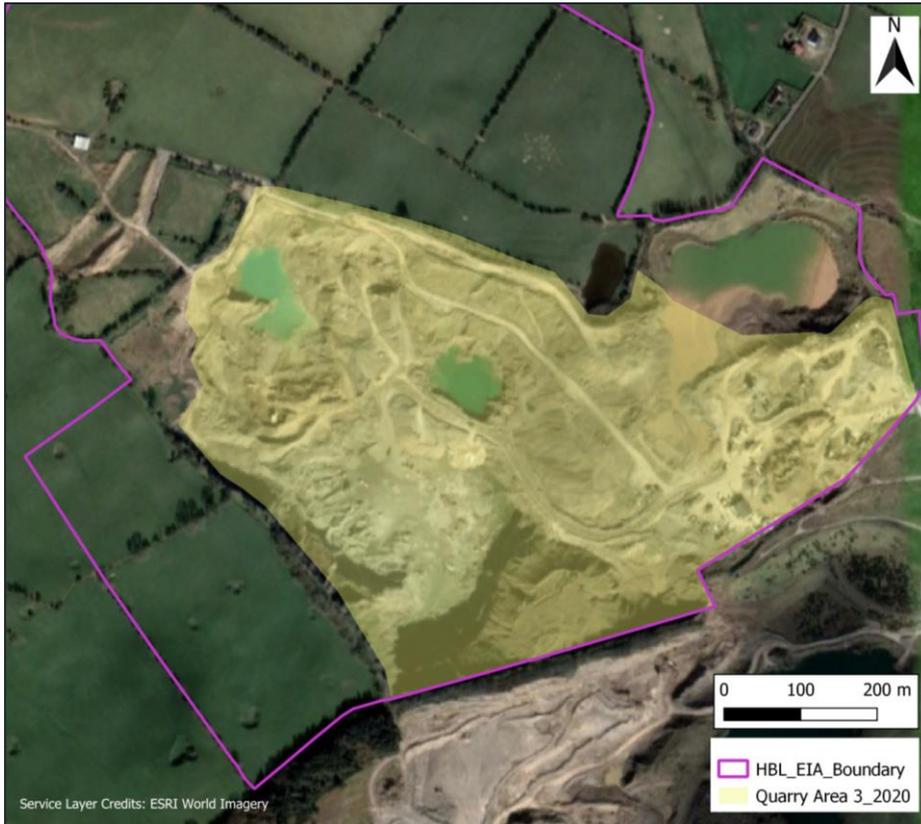
Figure 5-4 – Quarry Area During March 2020 from Google Earth Imagery

The quarry area and surrounding land is presented for available imagery in Figure 5-4, Figure 5-5, Figure 5-6, Figure 5-7 and Figure 5-8 below, with the outline of the quarry depicted. Approximate areas of change have been calculated below for the purposes of the assessment in this chapter. These areas occur within the Substitute Consent application boundary. The quarried area remained consistent between March 2020 and March 2022 at ca. 37.3 ha (0.373 km²). This is due to quarrying focusing on removal of the previously blasted greywacke rock in the centre of the quarry. There is then an increase in quarry area to ca. 37.8 ha (0.378 km²) in January 2023 (Figure 5-7) and a further increase to ca. 38.8 ha (0.388 km²) in October 2023 (Figure 5-8). This increase in area is associated with expansion within the northwest corner of the Site boundary, with digging of the sands and gravels. Digging did not occur outside of the Site boundary over the reporting period.

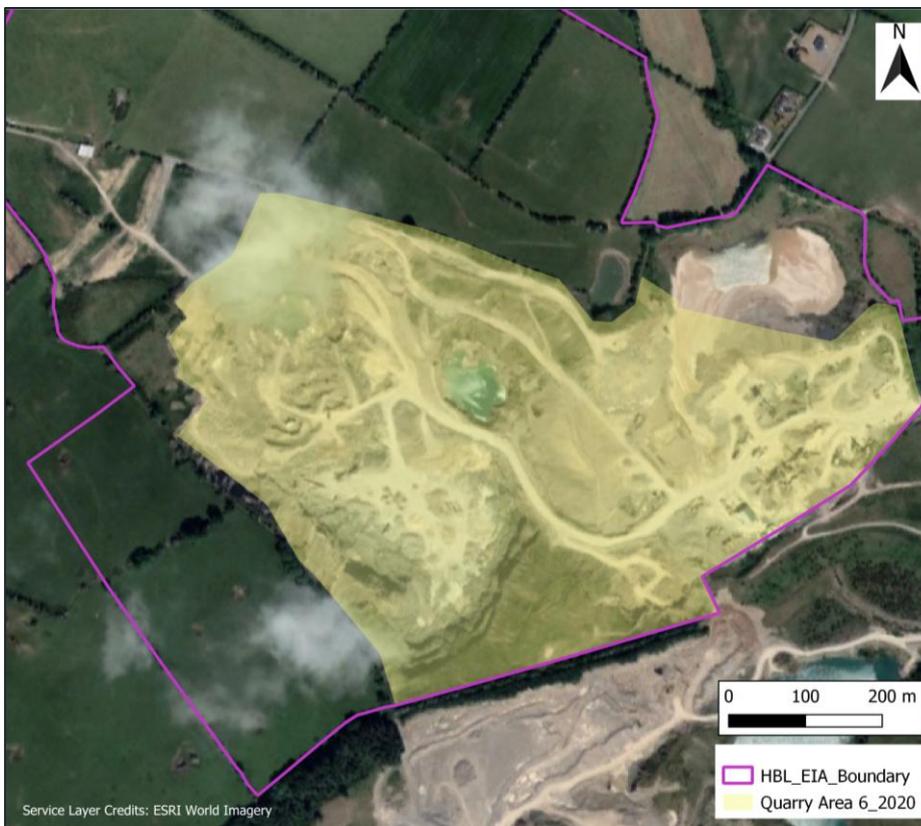
Figure 5-5 – Quarry Area During June 2020 from Google Earth Imagery

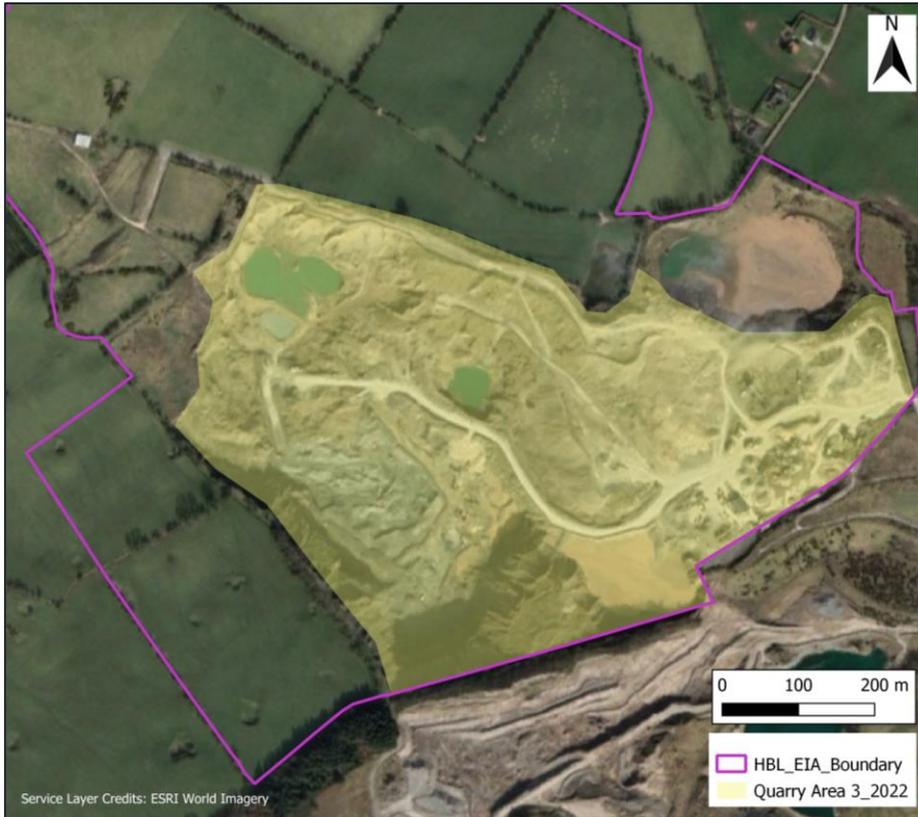
Figure 5-6 - Quarry Area During March 2022 from ESRI World Imagery

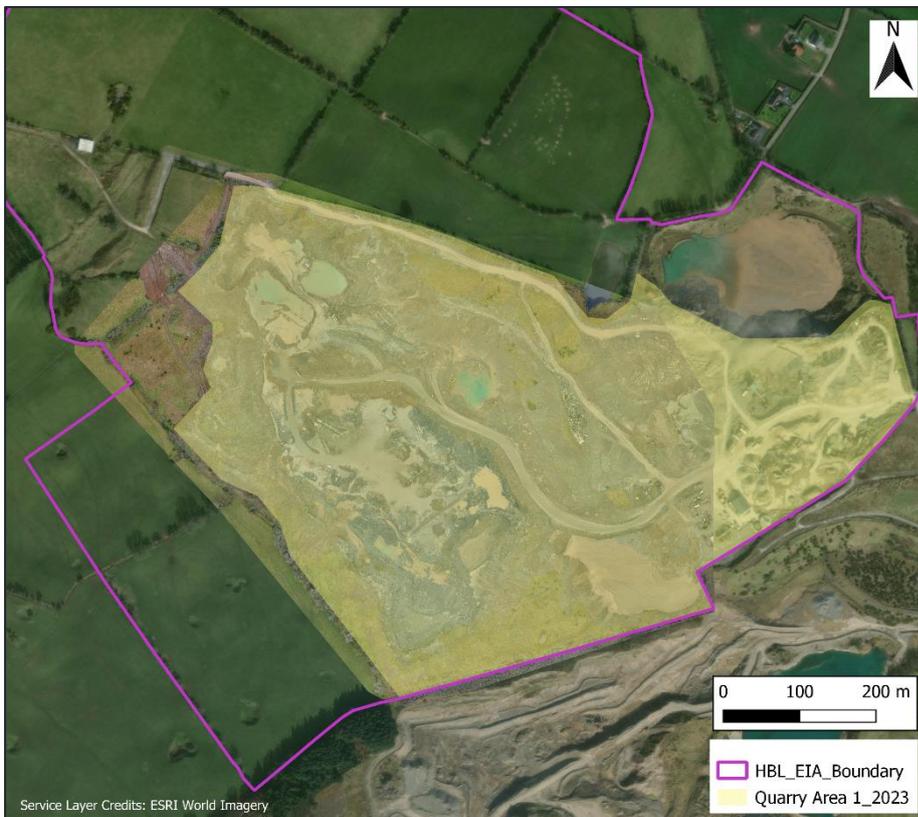
Figure 5-7 - Quarry Area During January 2023 from Drone Survey

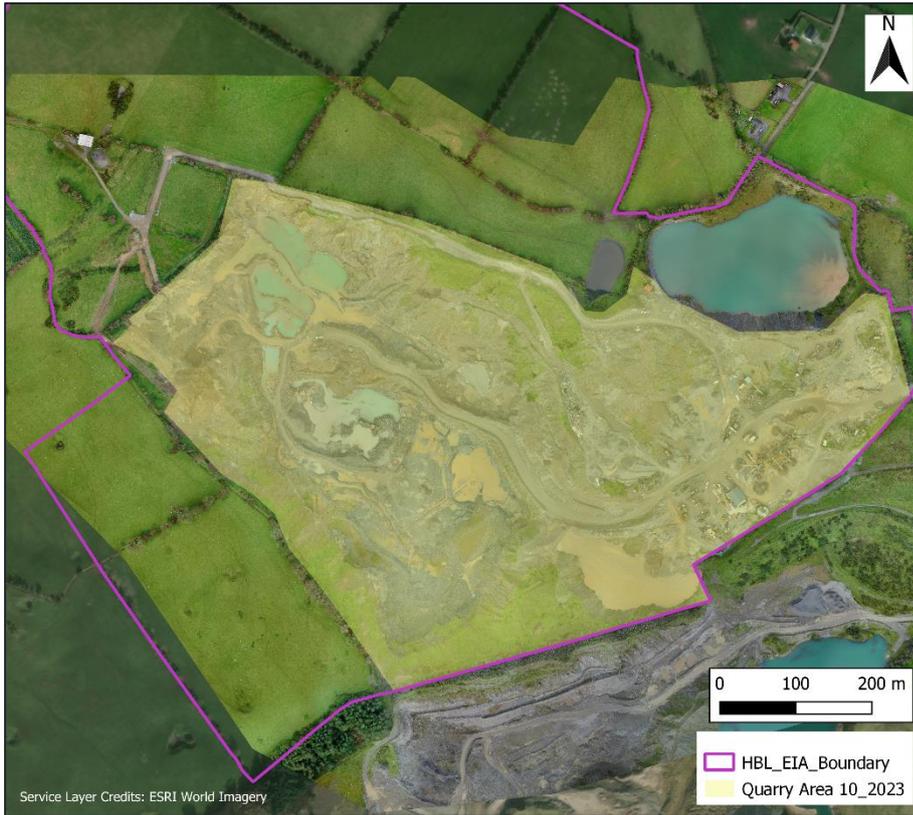
Figure 5-8 - Quarry Area During October 2023 from Drone Survey

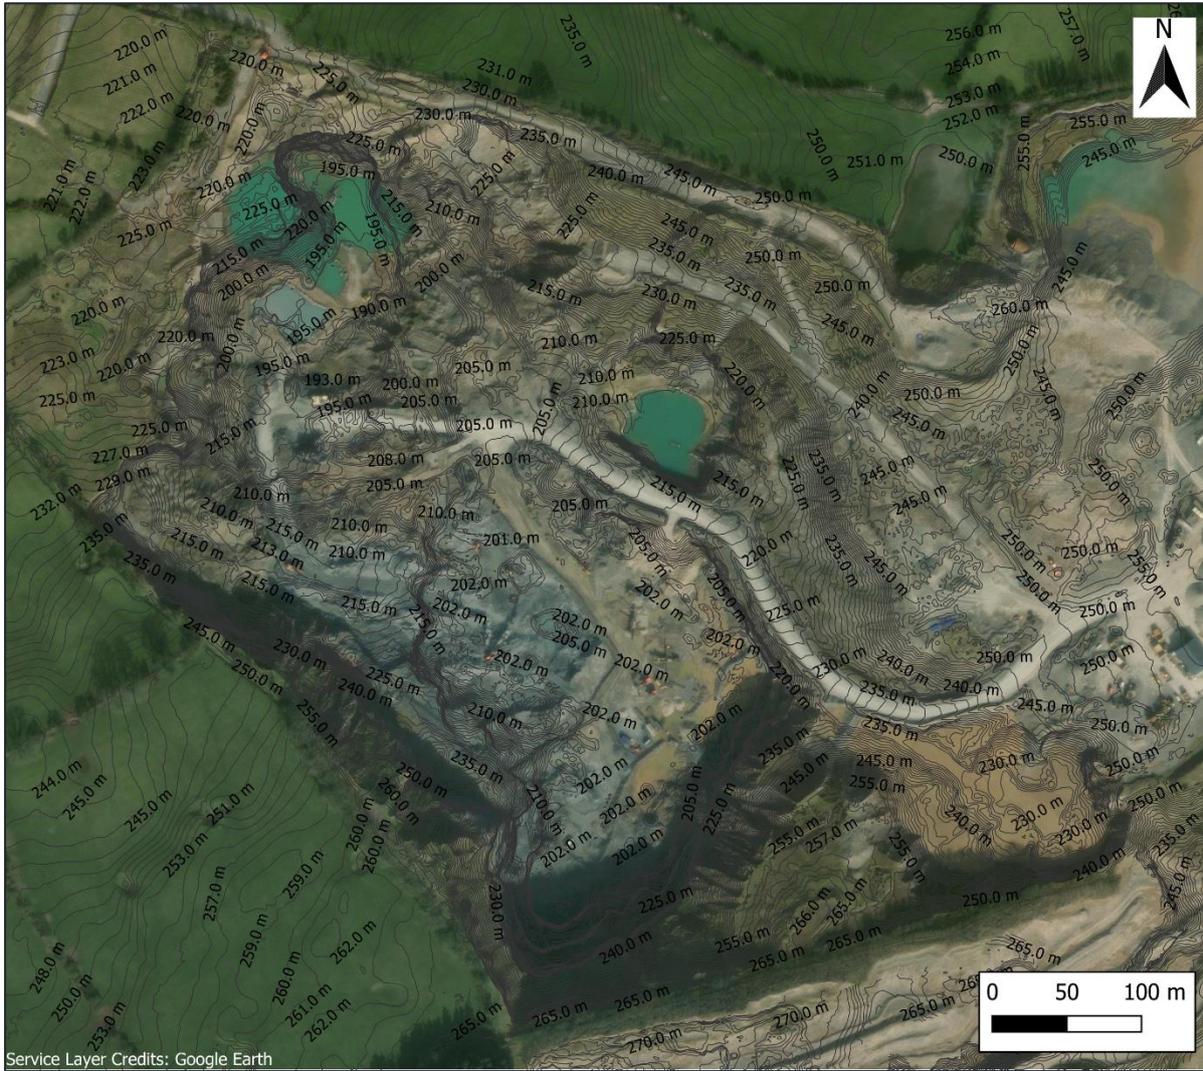
Figure 5-9 - Survey Contours February 2019 and Imagery March 2020

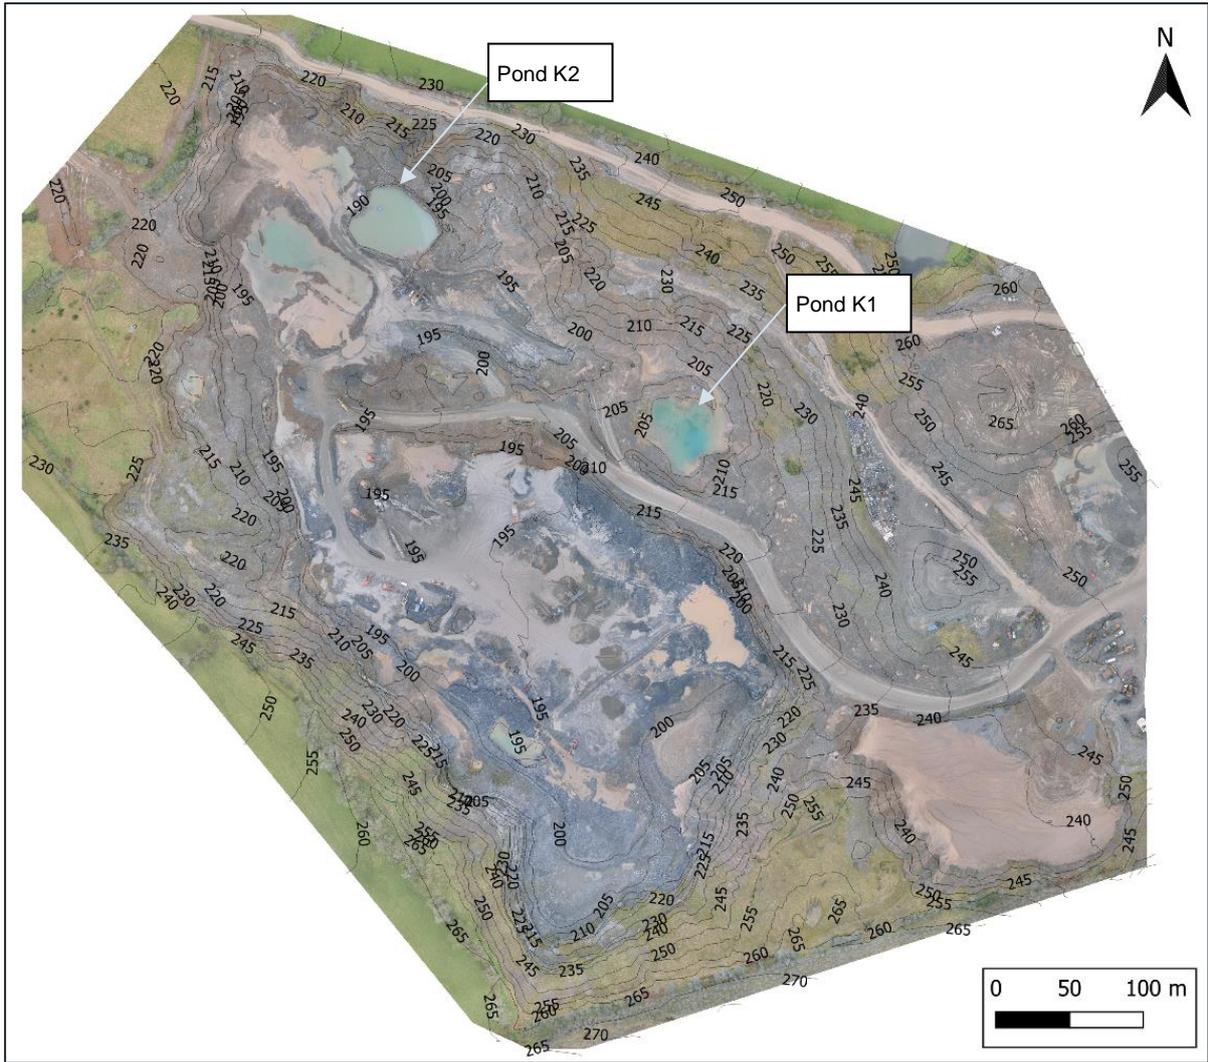
Figure 5-10 - Survey Contours and Imagery January 2023

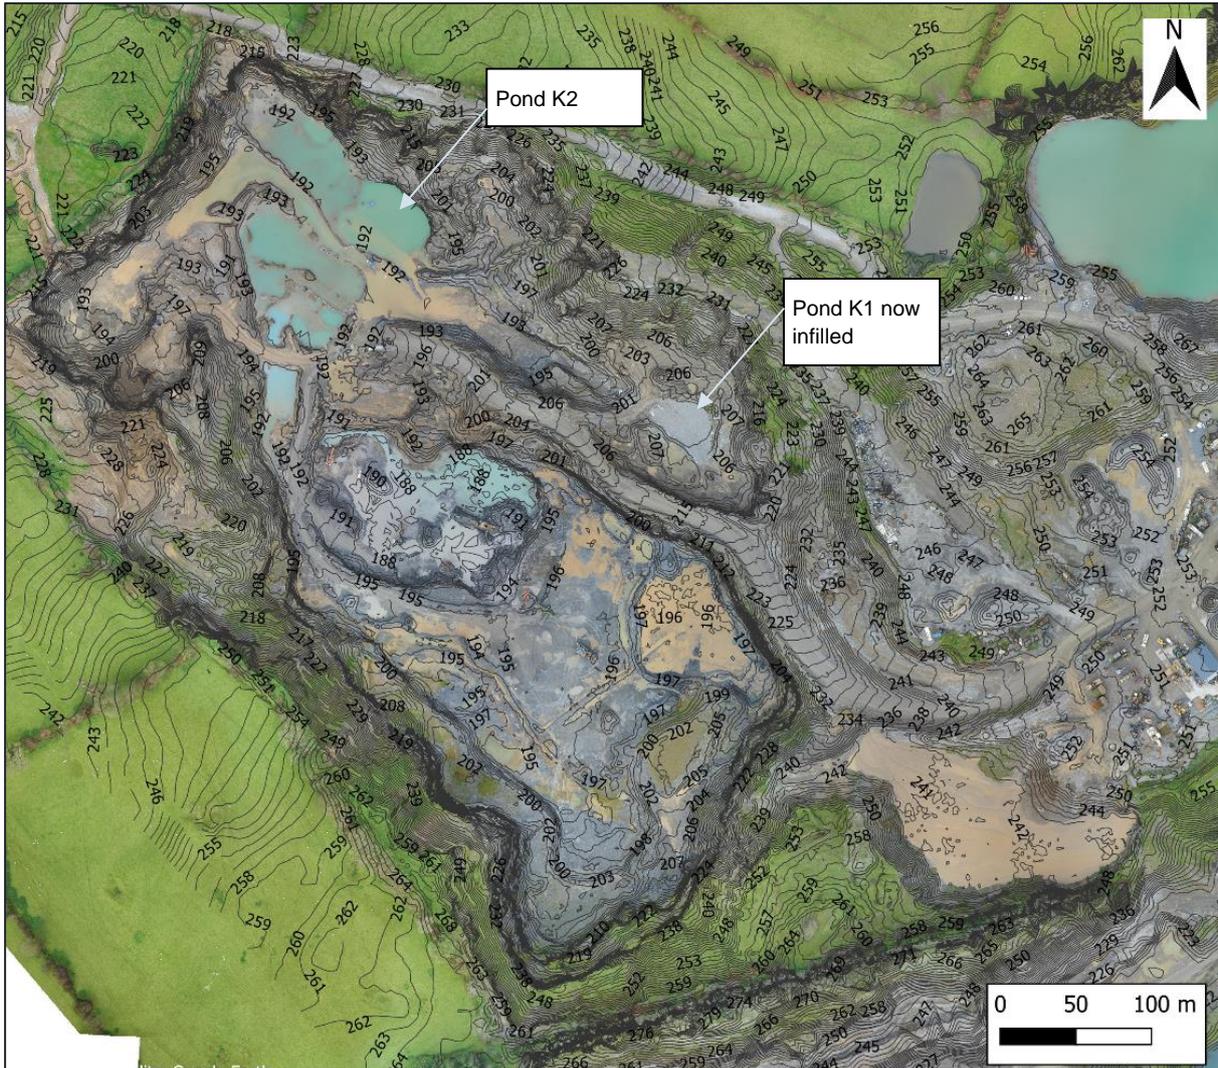
Figure 5-11 - Survey Contours and Imagery October 2023
