7.0 LAND, SOILS AND GEOLOGY

This 'Lands, Soils & Geology' chapter of the Environmental Impact Assessment Report (EIAR) has been prepared for a proposed development area within an existing, operational, limestone quarry at Killaskillen, Kinnegad, Co. Meath.

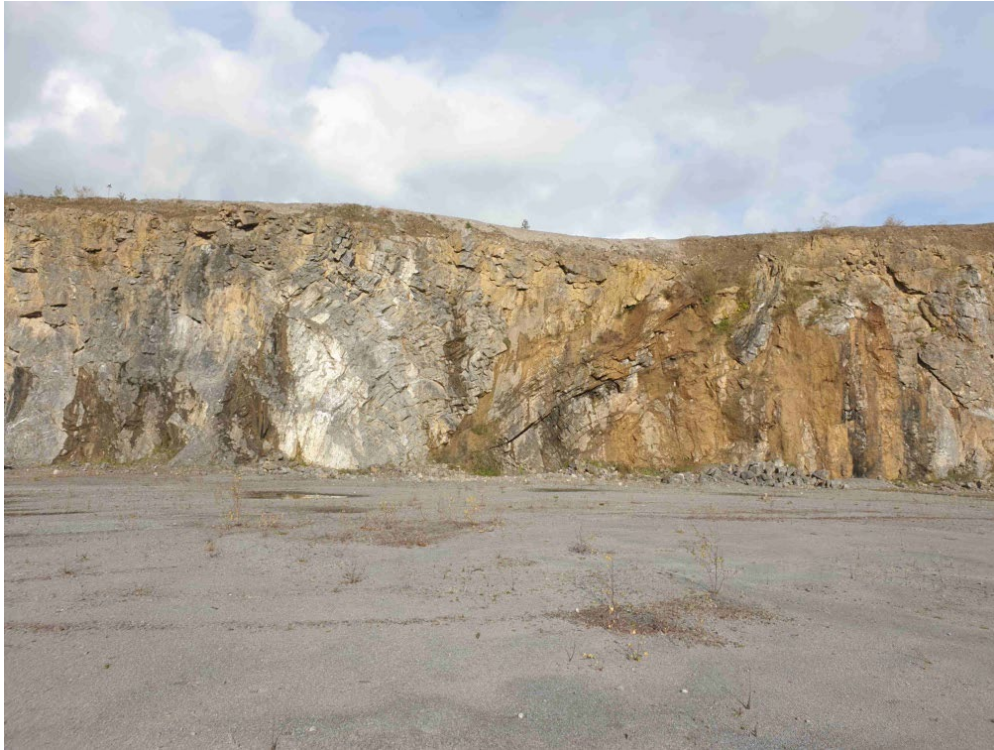
Plate 7.1 Exposure on northeastern face of application area (facing NE towards balancing pond)

The exposed faces revealed relatively clean, competent limestone, generally massive in structure. Bedrock just below undisturbed ground level displays slightly more weathering but no epikarst was observed. No regular bedding or jointing is present. Some deformation is shown in the centre of Plate 7.1. Apex geologists refer to the structure of this wall as evidence of faulting in this area.

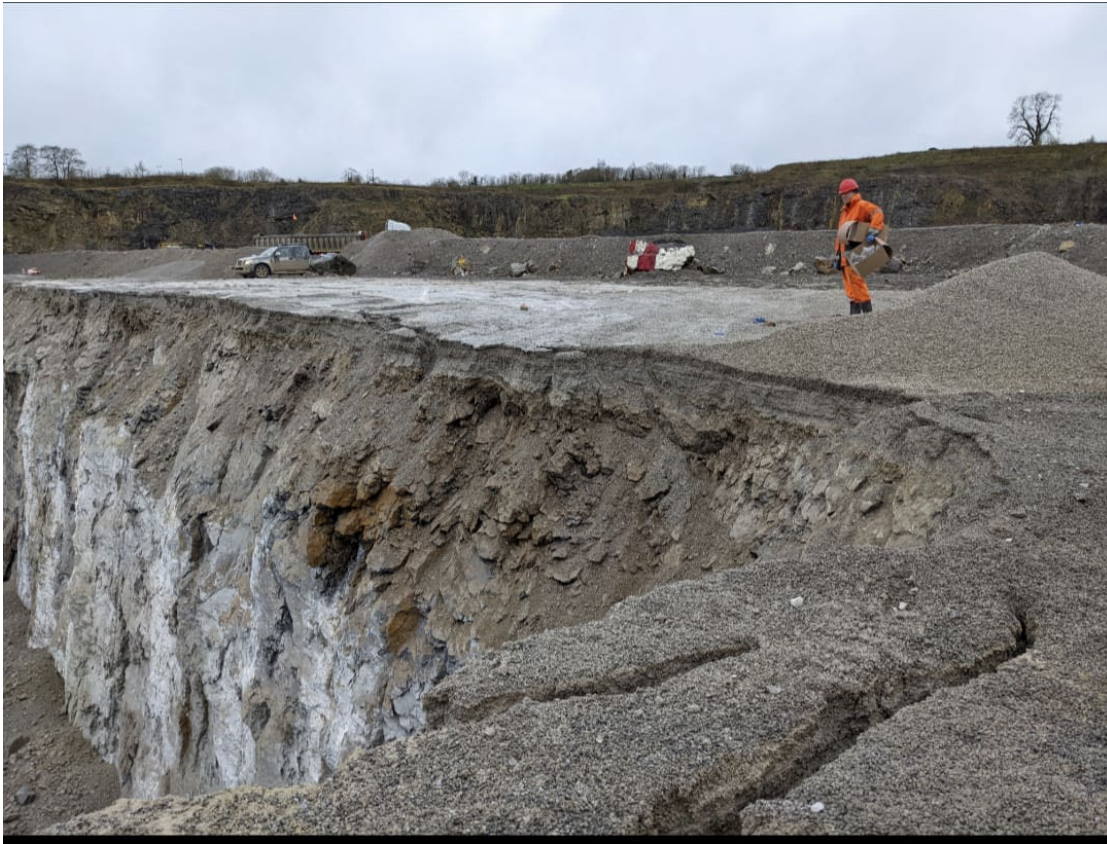
Plate 7.2 Exposure on southern edge of application area (facing west)

With reference to Plate 7-2, the wall of rock, that separates the application area from the main quarry, is completely dry, massive limestone with no clay bands and no evidence of water bearing zones.

The area to the southeast of the application area is the main operational working quarry and therefore, it is possible to observe the bedrock in an additional bench below the application area (Plate 7.2).
