GLARE ANALYSIS RESULTS

Huntstown Circular Economy Hub – Phase One

ARCHAEOLOGICAL IMPACT ASSESSMENT REPORT: PROPOSED RESEARCH AND DEVELOPMENT BUILDING, HUNTSTOWN/COLDWINTERS, COUNTY DUBLIN

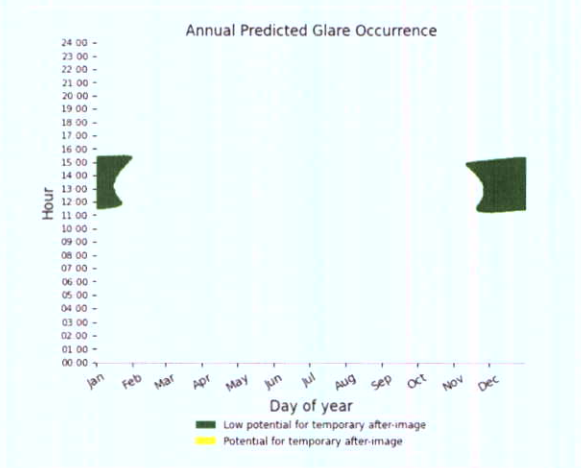
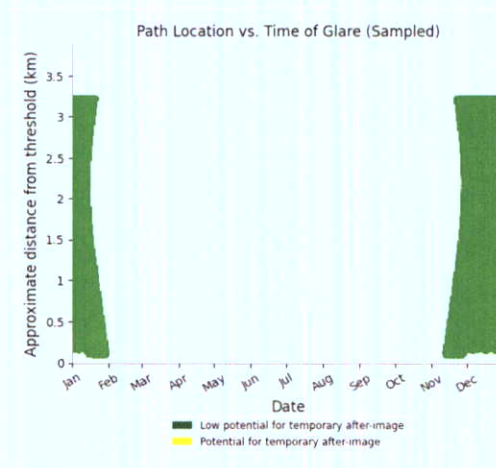
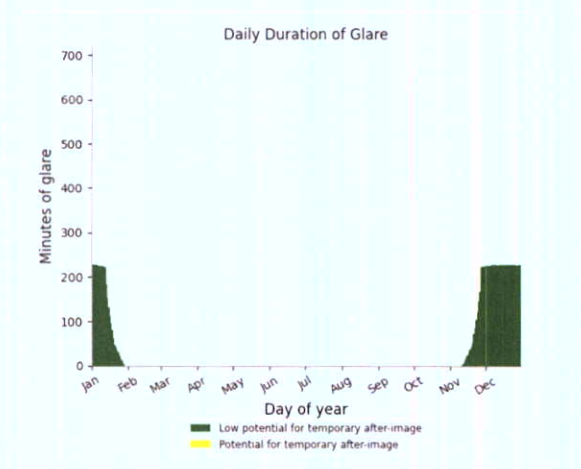
Flight Path: 10L Runway

0 minutes of yellow glare

12868 minutes of green glare

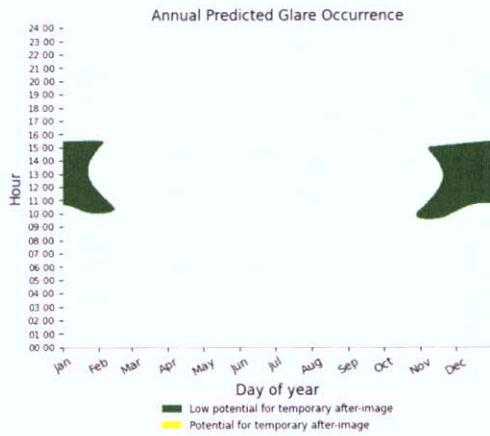
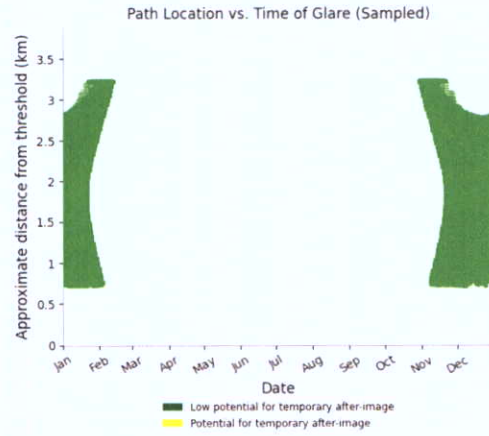
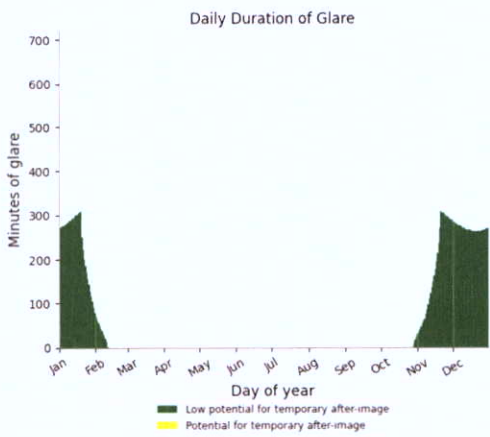
Flight Path: 10 Runway

0 minutes of yellow glare

21805 minutes of green glare

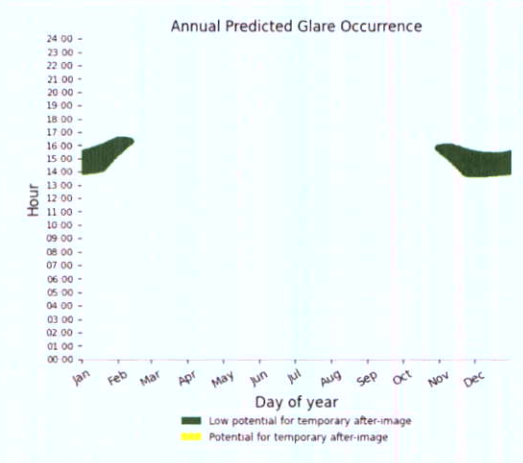
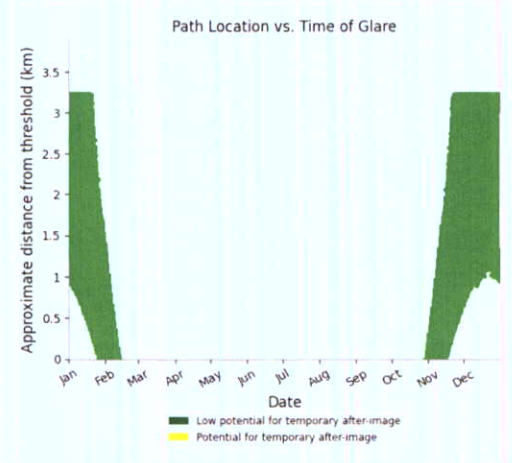
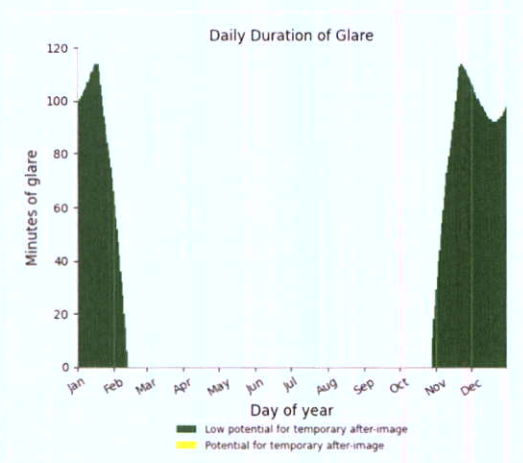
Flight Path: 16 Runway

0 minutes of yellow glare
 9173 minutes of green glare

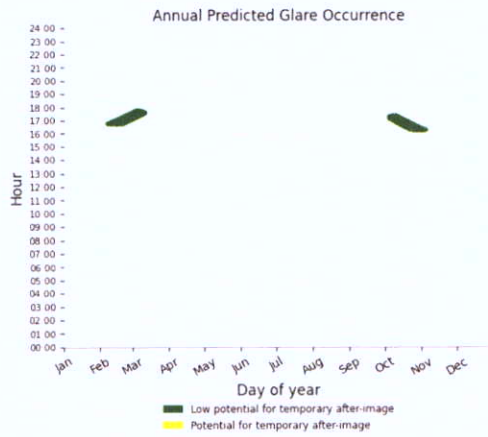
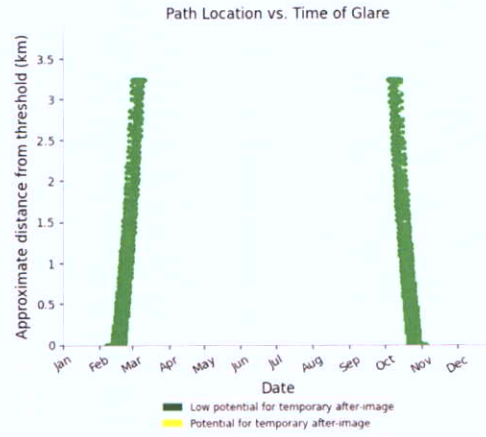
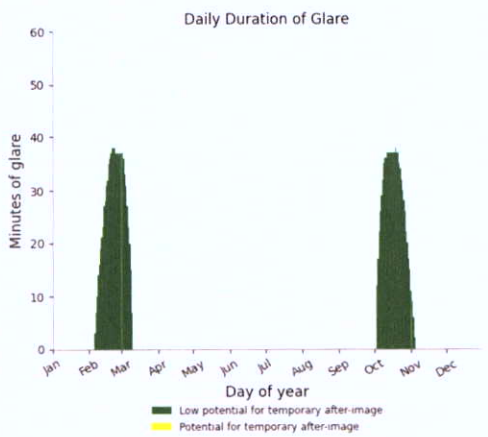
Flight Path: 28R Runway

0 minutes of yellow glare

1807 minutes of green glare

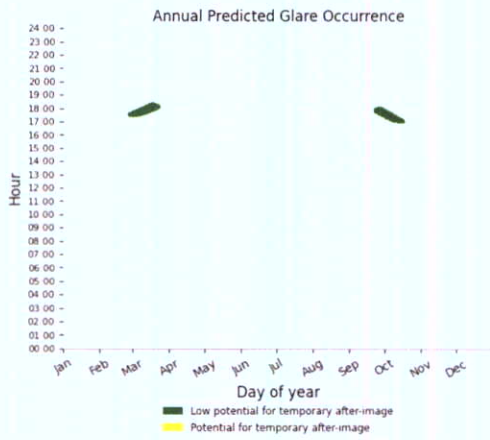
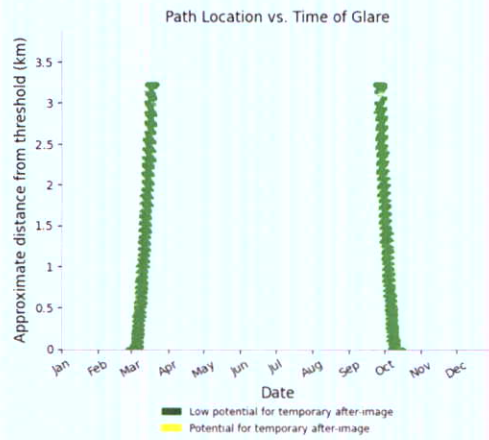
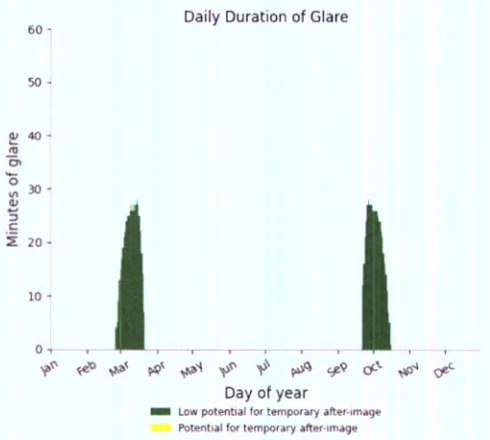
Flight Path: 28 Runway

0 minutes of yellow glare
 1000 minutes of green glare

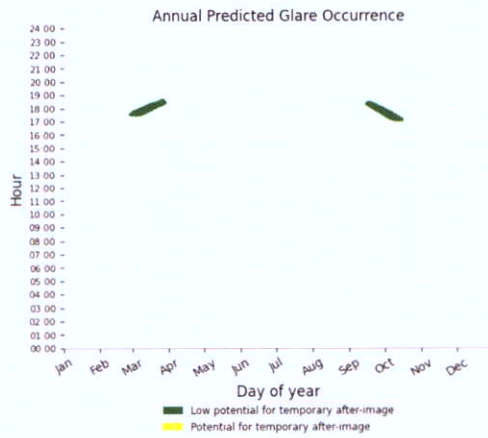
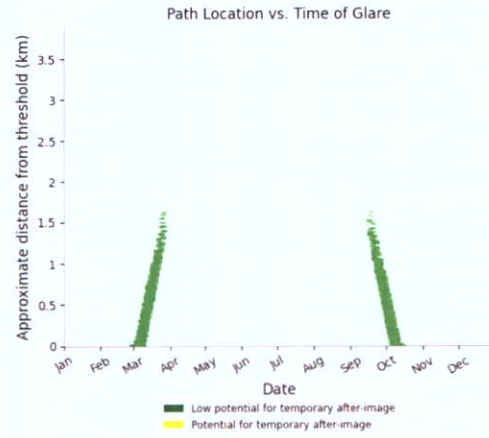
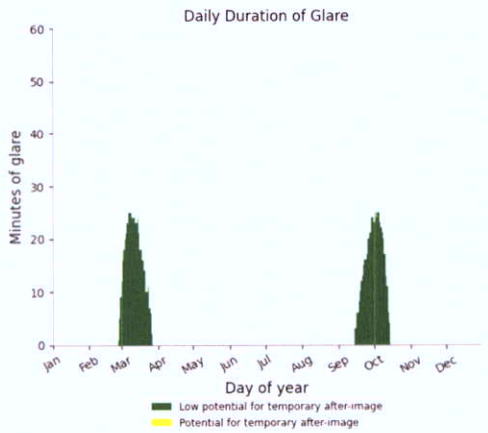
Flight Path: 34 Runway

0 minutes of yellow glare
980 minutes of green glare

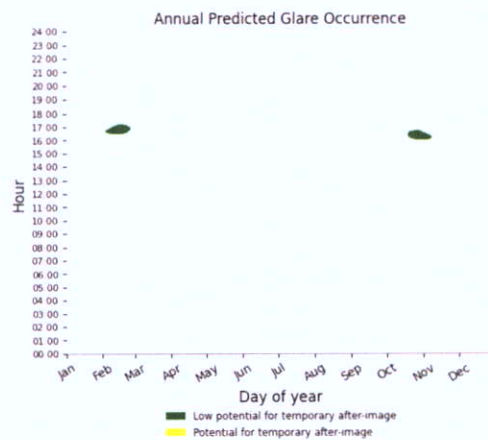
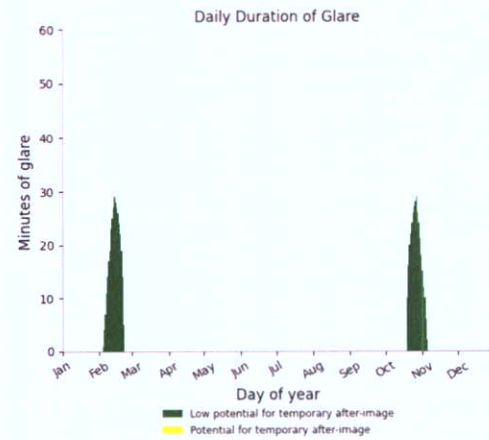
Point Receptor: 1-ATCT

0 minutes of yellow glare
678 minutes of green glare

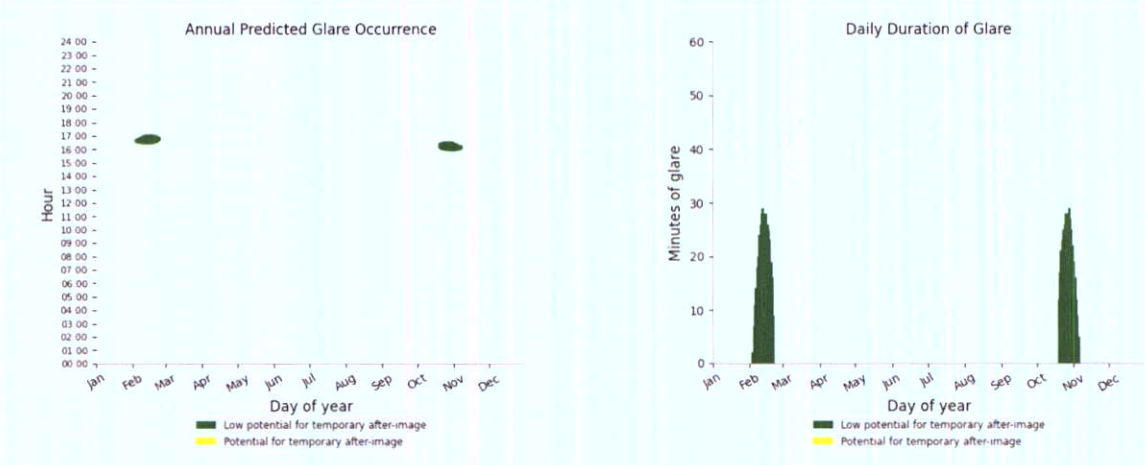
Point Receptor: 2-ATCT

0 minutes of yellow glare
 811 minutes of green glare

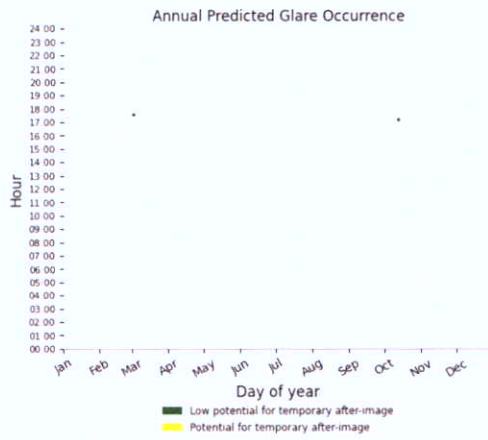
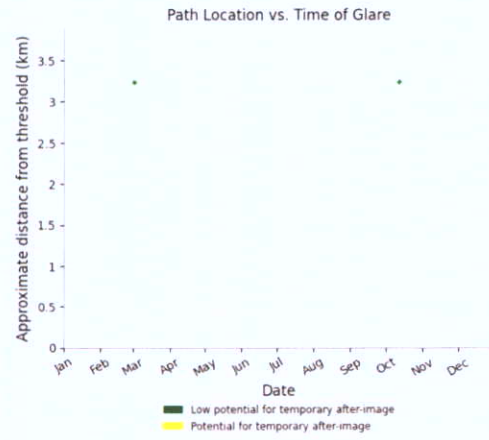
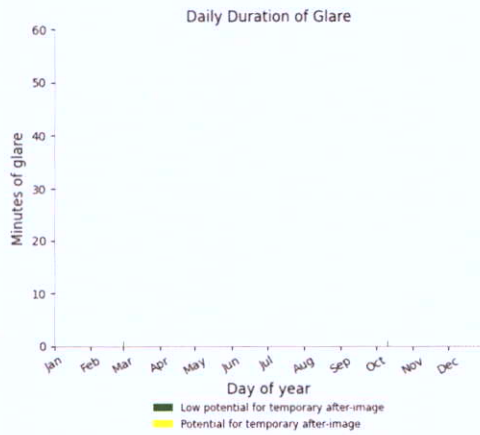
0 minutes of yellow glare

2 minutes of green glare

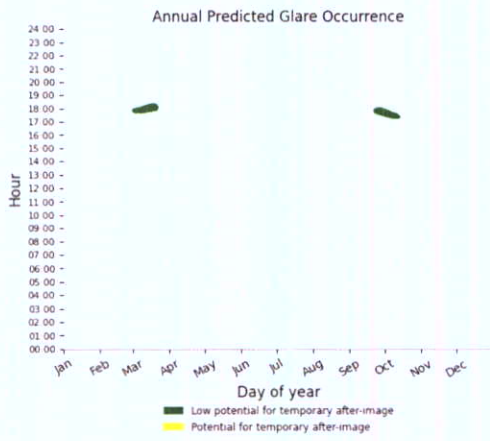
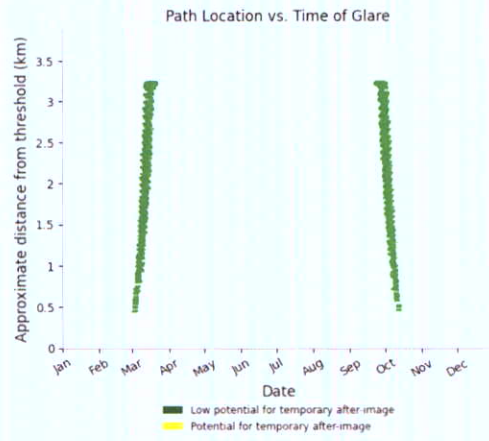
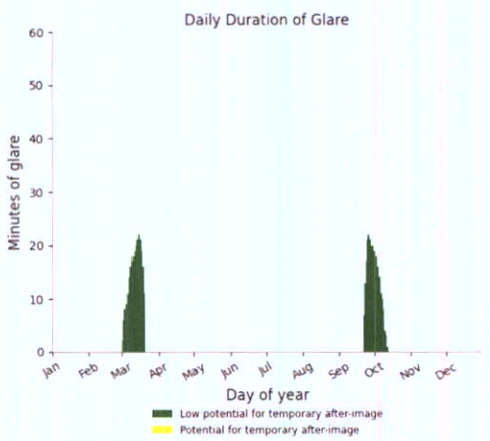
Flight Path: 28 Runway

0 minutes of yellow glare
 597 minutes of green glare

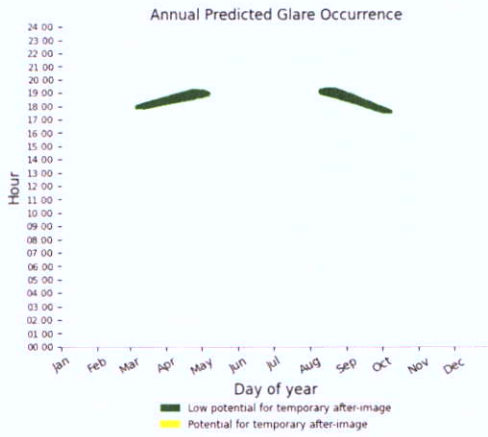
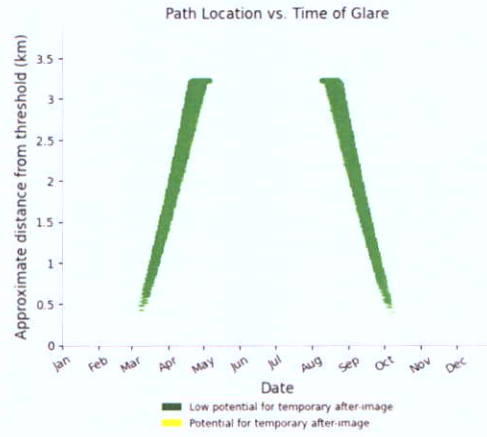
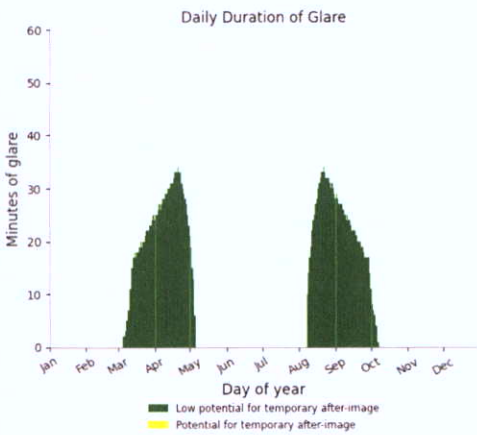
Flight Path: 34 Runway

0 minutes of yellow glare
 2749 minutes of green glare

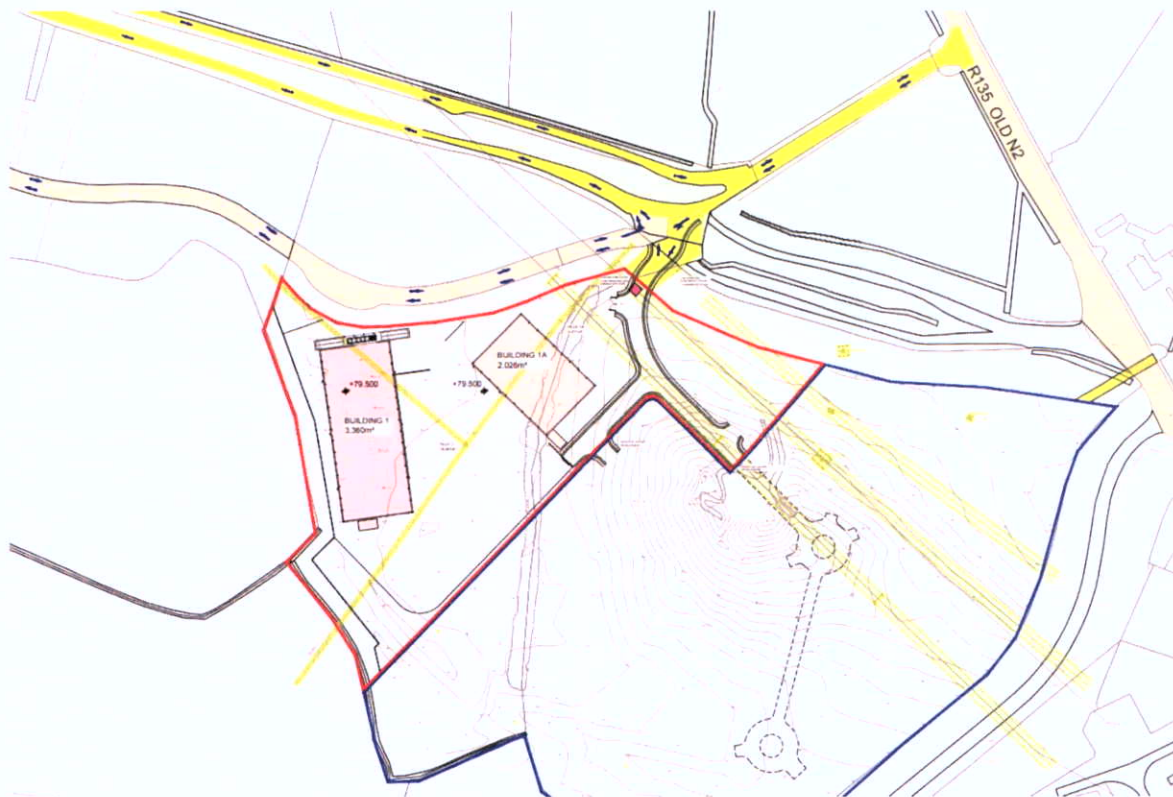
Figure 2: Proposed development layout (Loscher Moran Design Practice)

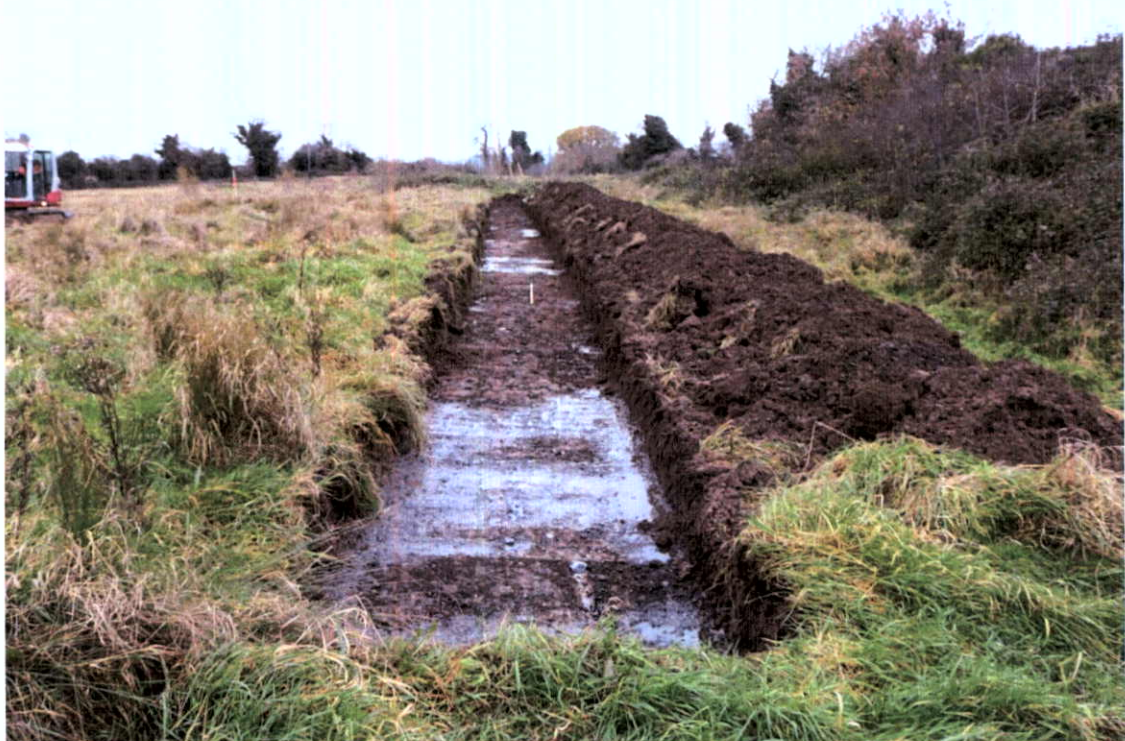
Figure 11: 20E0601 Test-Trench 1 from north.

This trench measured 60m L x 2m W and was excavated to an average depth of 0.4m. The sod and topsoil was 0.3m deep and had been previously disturbed throughout much of the length of the trench. Underlying the topsoil was a hard glacial boulder clay and gravel. Nothing of archaeological interest was noted.

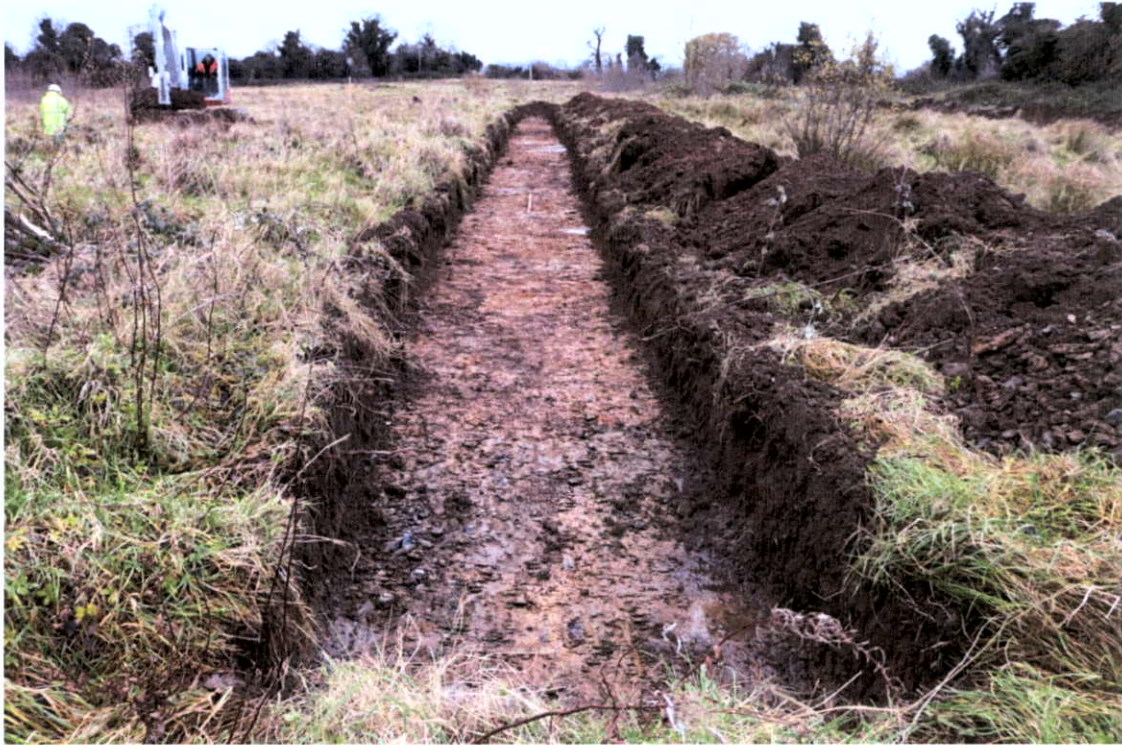
Figure 12: 20E0601 Test-Trench 2 from north.

This trench measured 57m L x 2m W and was excavated to an average depth of 0.4m. The sod and topsoil was 0.3m deep and had been previously disturbed throughout much of the length of the trench. Underlying the topsoil was a hard glacial boulder clay and gravel. Nothing of archaeological interest was noted.

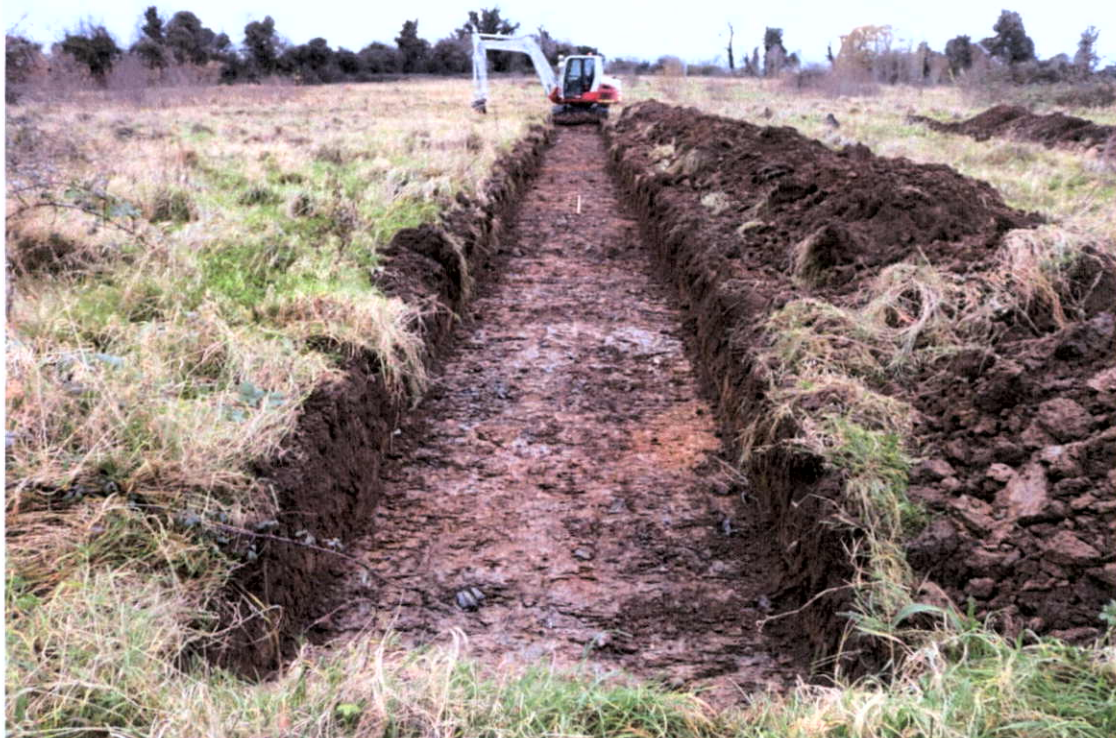
Figure 13: 20E0601 Test-Trench 3 from north.

This trench measured 36m L x 2m W and was excavated to an average depth of 0.4m. The sod and topsoil was 0.3m deep and had been previously disturbed throughout much of the length of the trench. Underlying the topsoil was a hard glacial boulder clay and gravel. Nothing of archaeological interest was noted.

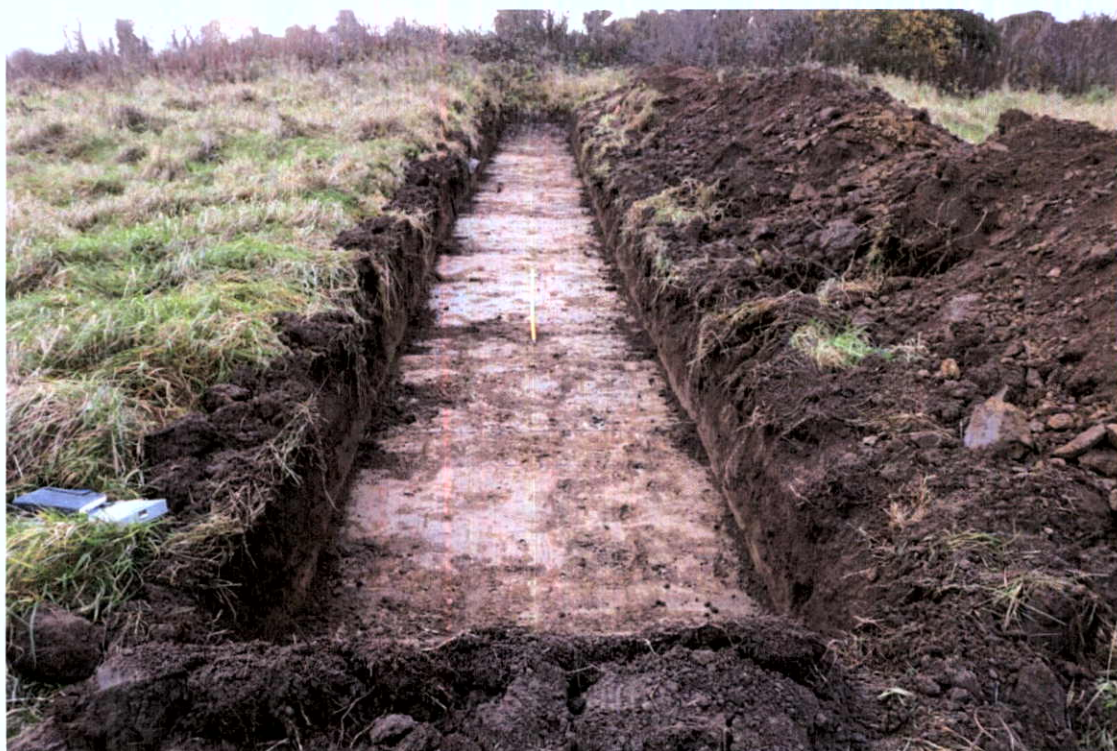
Figure 15: 20E0601 Test-Trench 5 from north.

This trench measured 40m L x 2m W and was excavated to an average depth of 0.4m. The sod and topsoil was 0.3m deep and had been previously disturbed throughout much of the length of the trench. Underlying the topsoil was a hard glacial boulder clay and gravel. Nothing of archaeological interest was noted.

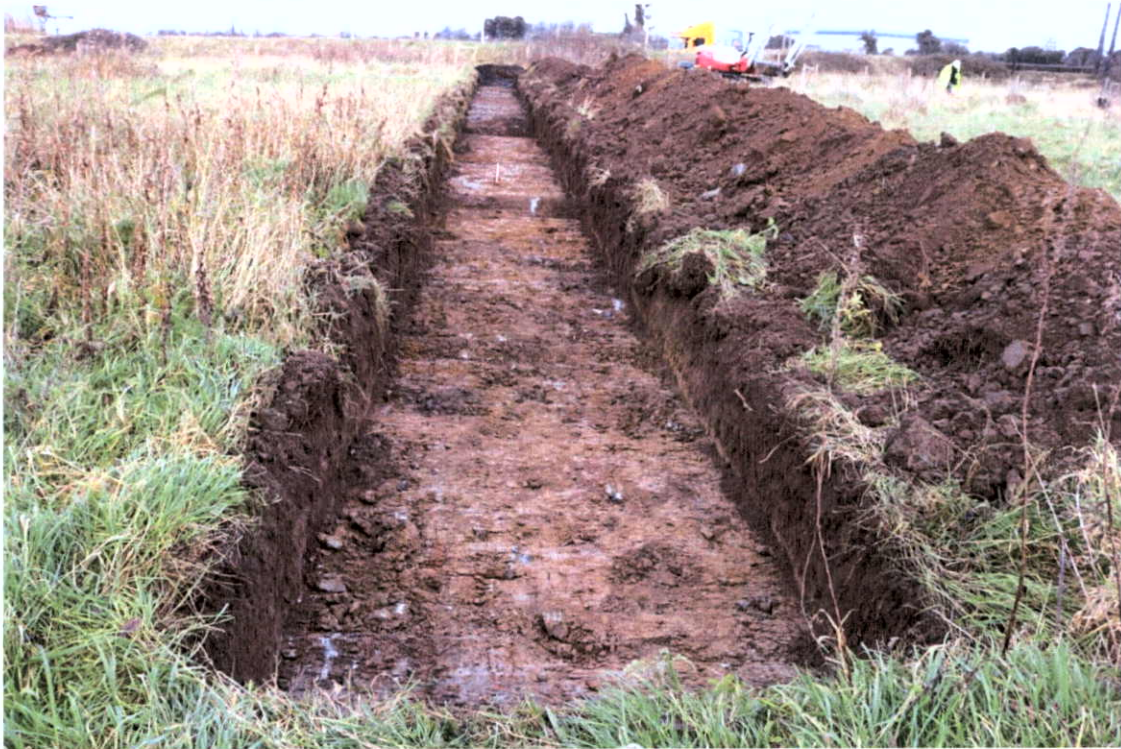
Figure 16: 20E0601 Test-Trench 6 from north.

This trench measured 25m L x 2m W and was excavated to an average depth of 0.4m. The sod and topsoil was 0.3m deep and had been previously disturbed throughout much of the length of the trench. Underlying the topsoil was a hard glacial boulder clay and gravel. Nothing of archaeological interest was noted.

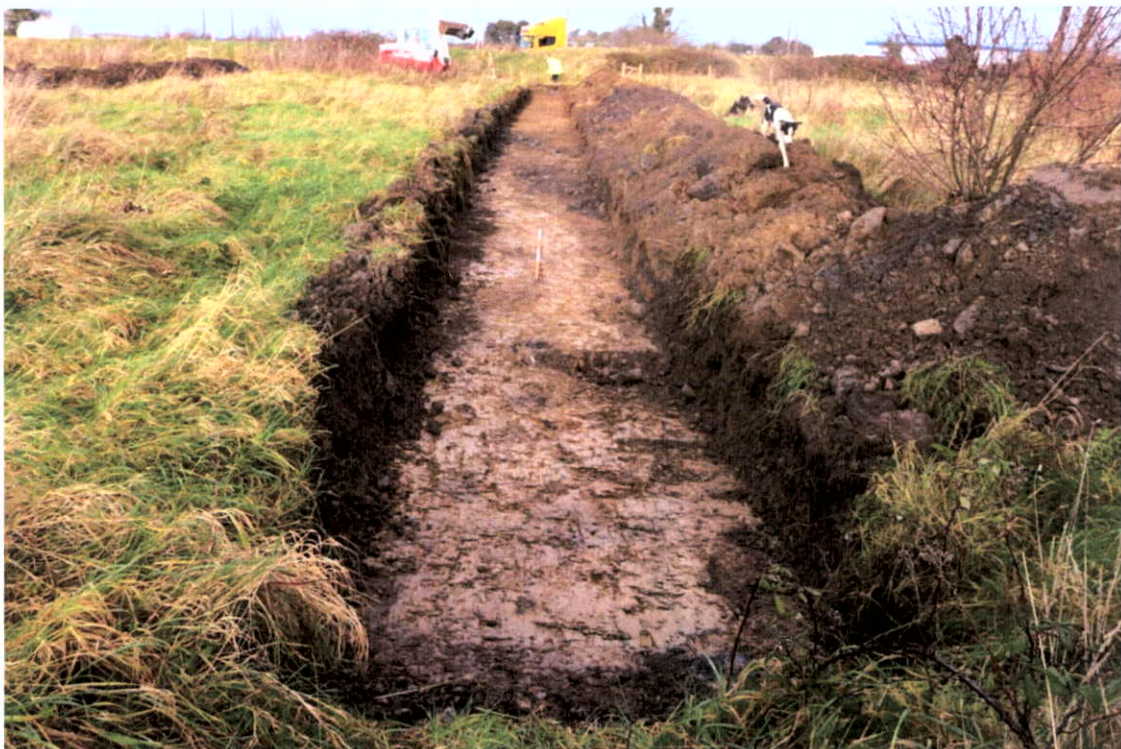
Figure 17: 20E0601 Test-Trench 7 from south.

This trench measured 40m L x 2m W and was excavated to an average depth of 0.4m. The sod and topsoil was 0.3m deep and had been previously disturbed throughout much of the length of the trench. Underlying the topsoil was a hard glacial boulder clay and gravel. Nothing of archaeological interest was noted.
