**APPENDIX 9-4**

**Water Survey Features Report**

**Cavan Regional Sports Campus, Cavan,  
County Cavan**

**Issued: March 2024**

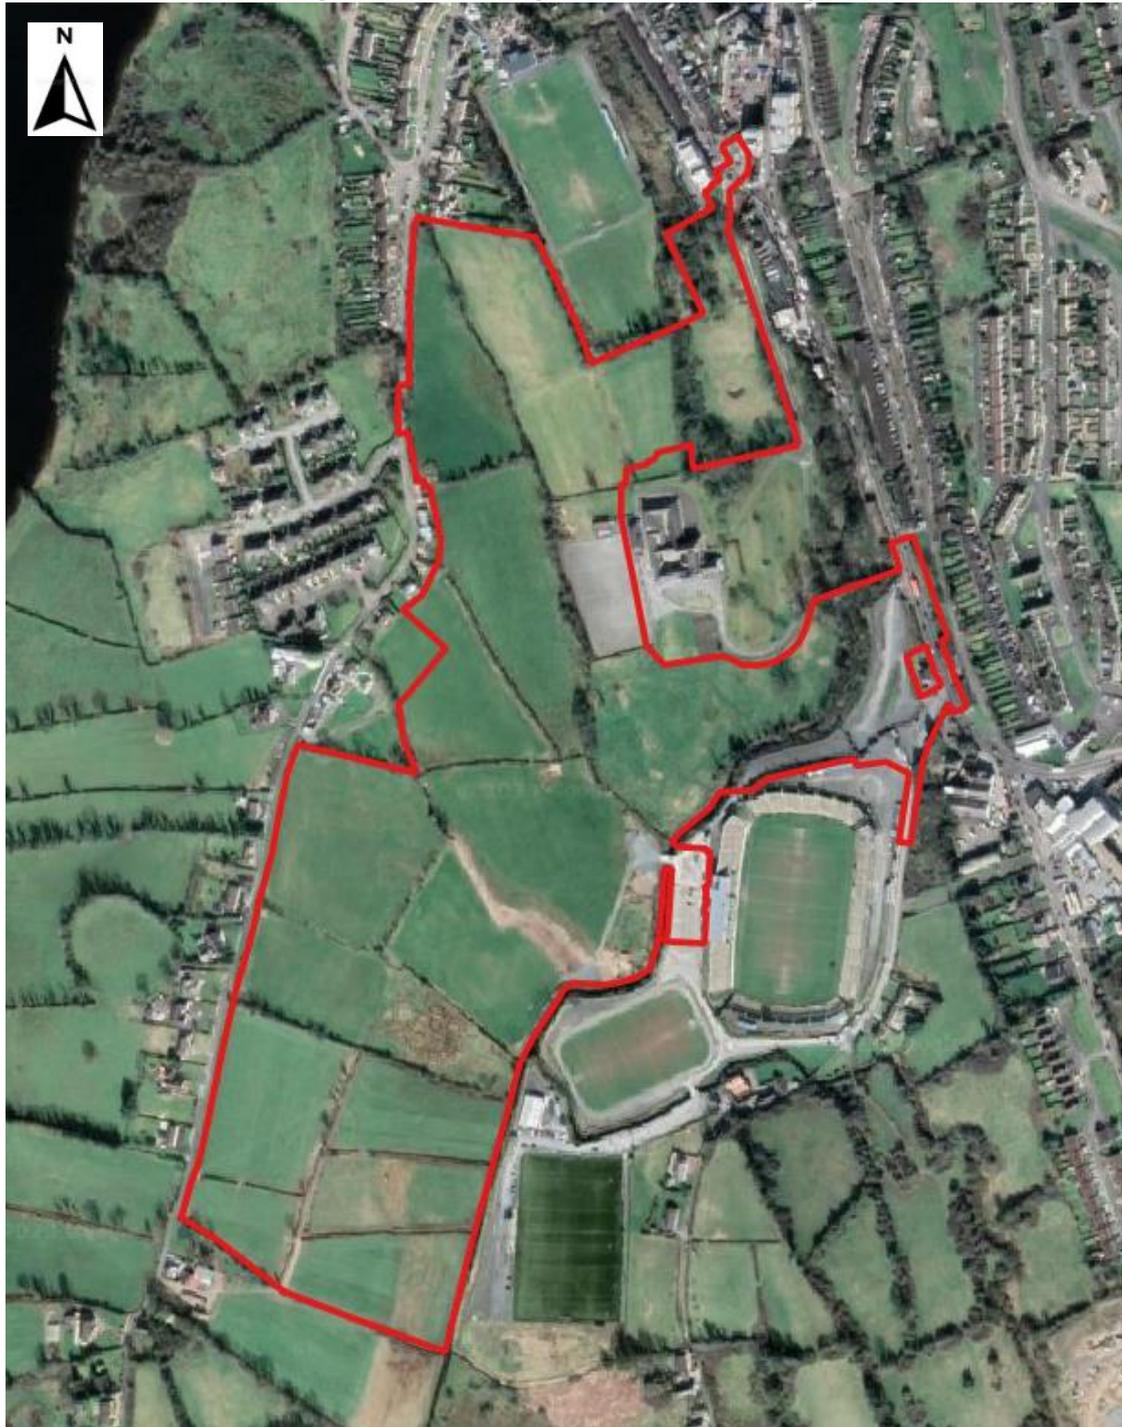
Figure 2: Aerial Image of the Site Boundary

The site, c.27.5ha, is located in central Cavan, County Cavan, on lands surrounding Royal School, College Street and west/northeast of Kingspan Breffni (IGR: 241769, 303932). A site location map is presented as **Figure 1** and the site area is presented as **Figure 2**.

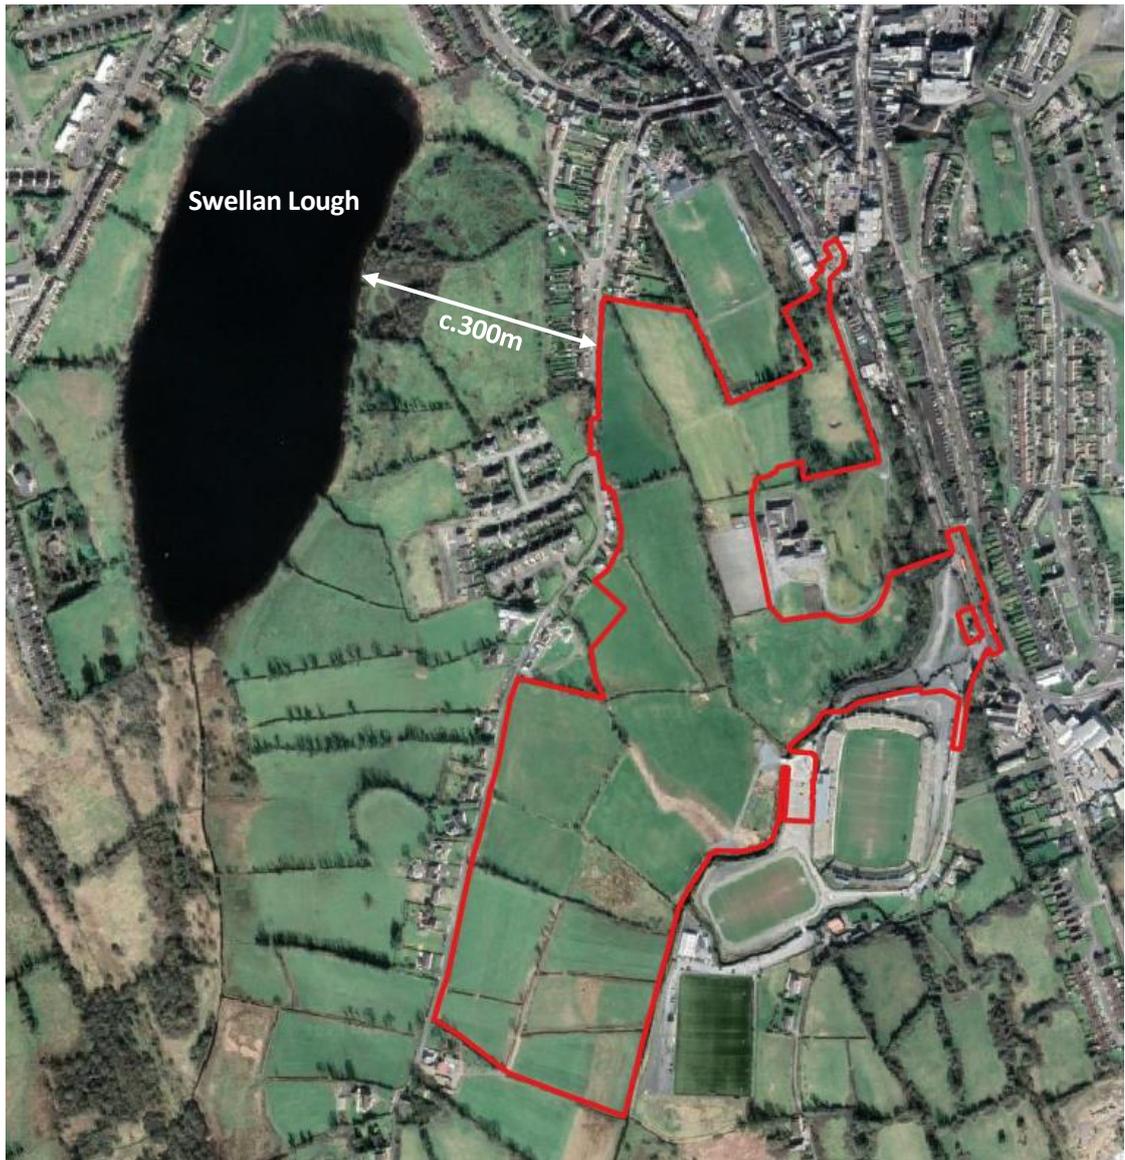
Figure 10: Swellan Lough

Swellan Lough is located on lower ground c.300m to the west of the site, as shown in **Figure 10** below. The site is not hydraulically linked to Swellan Lough, as all groundwater on site flows east/south east towards the Cavan River. A small watercourse c.130m north west of the site was identified flowing west towards and into Swellan Lough. This watercourse is not hydraulically connected the site.

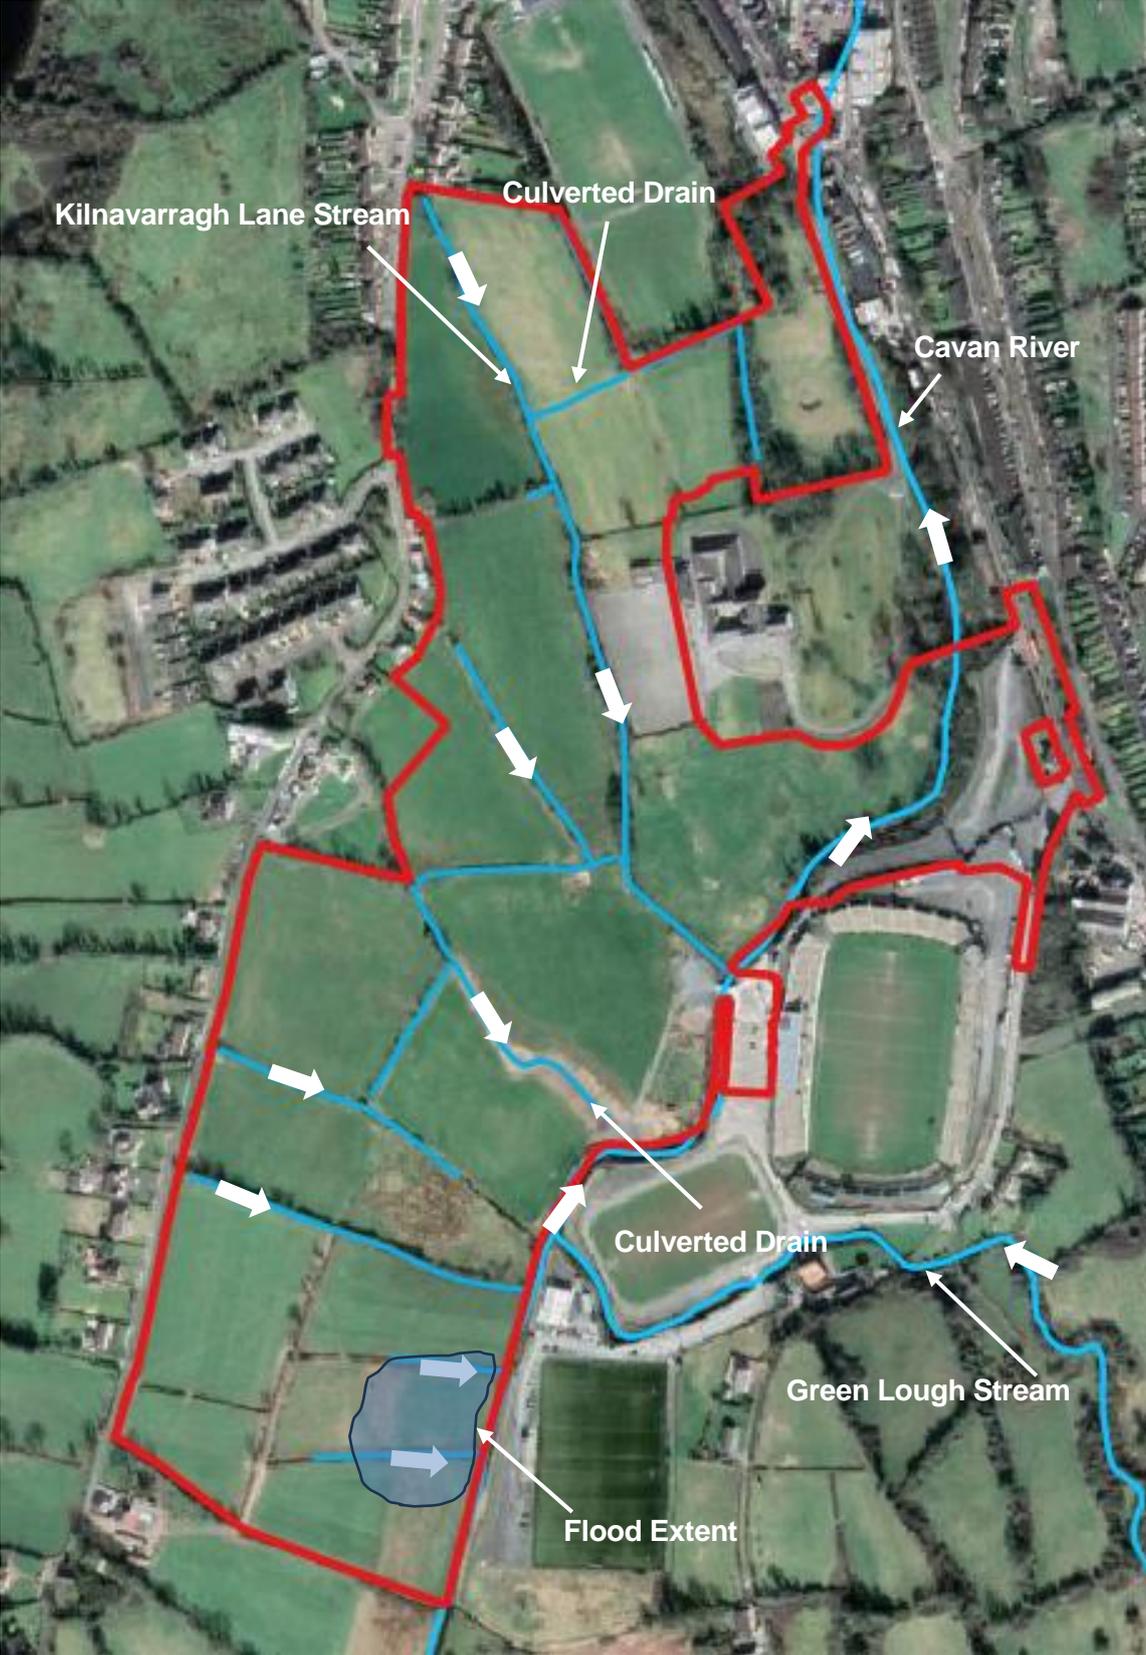
**Figure 13: Watercourses**

Multiple drains are present throughout the site, with a majority in the southern section of the site area. These drains are largely open watercourses, however there are two culverts present on site, as detailed in Section 2.1.2. The drains present on site all flow in a southeasterly direction and discharge

into the Cavan River, however, the drains present in the southeastern most extent of the site experience extensive flooding, likely due to their similarity in elevation to that of the Cavan River.

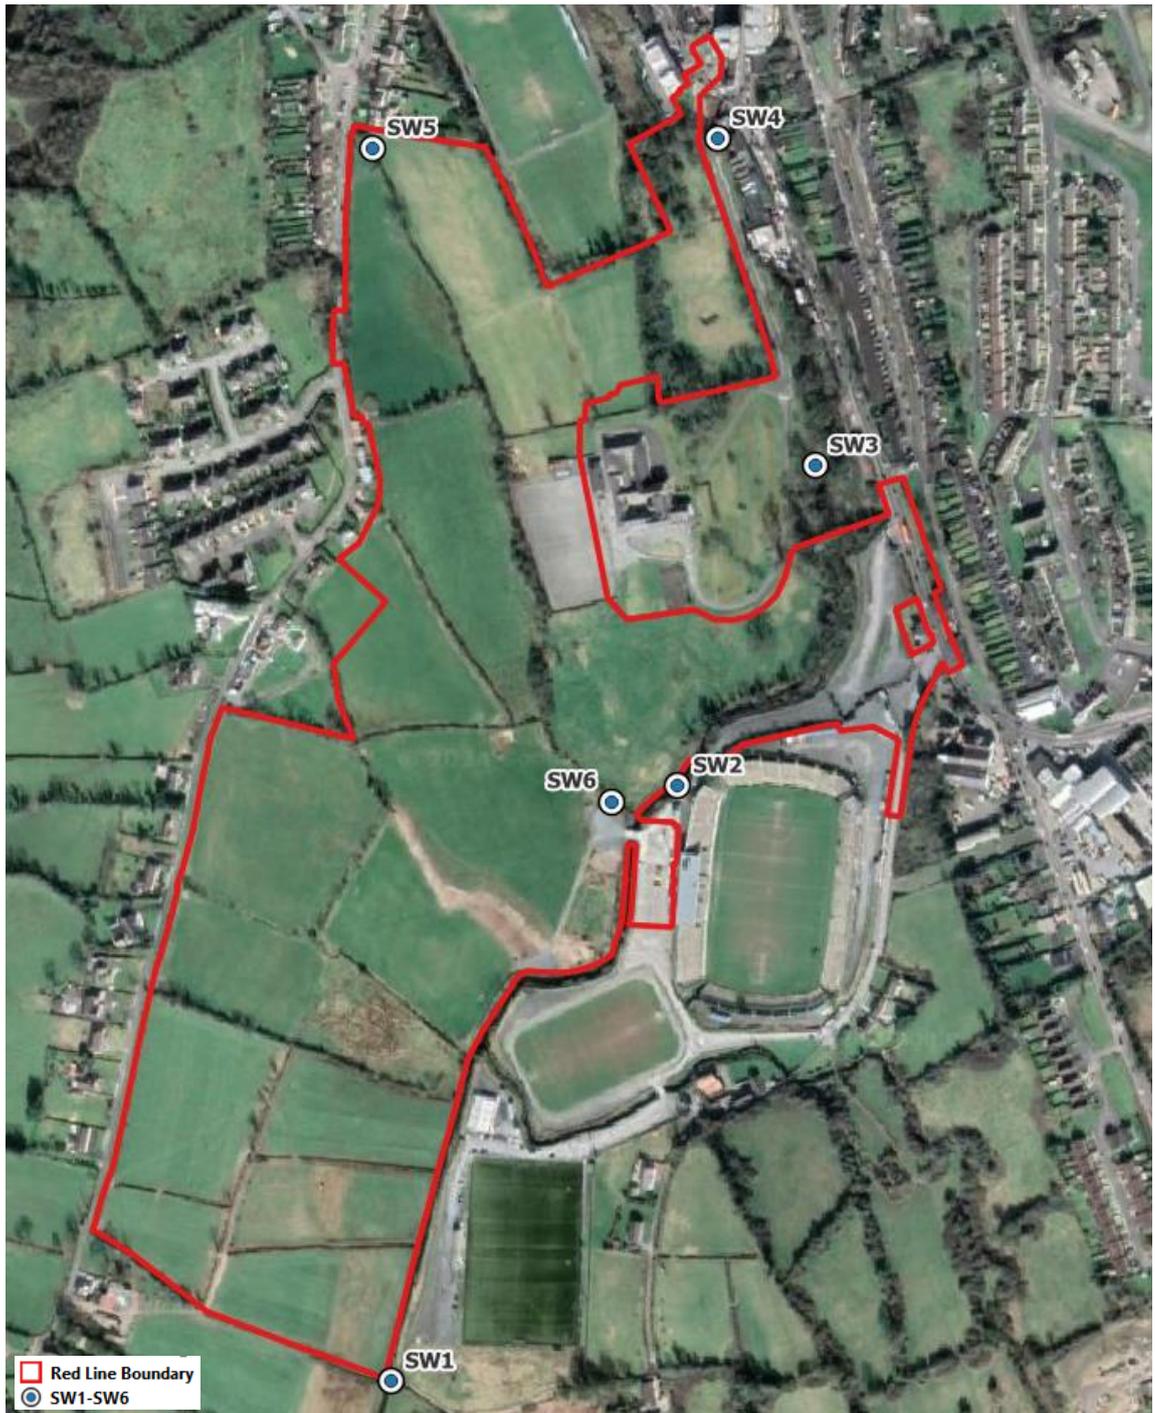
Figure 15: Surface Water Samples

Six surface water samples were obtained on 25<sup>th</sup> January 2024 at sample points (SW1 to SW6), as presented in **Figure 15** and **Table 5**.

These metals are likely to be naturally occurring in the watercourse, given that there are no nearby anthropogenic sources. The exceedances are unlikely to be environmentally significant. There were no detections of, Phenol, Cyanide, Hydrocarbons or VOCs in any of the surface water samples. There are no significant changes in water quality between up flow, midflow and downflow locations. Overall, there is no concern with surface water quality.

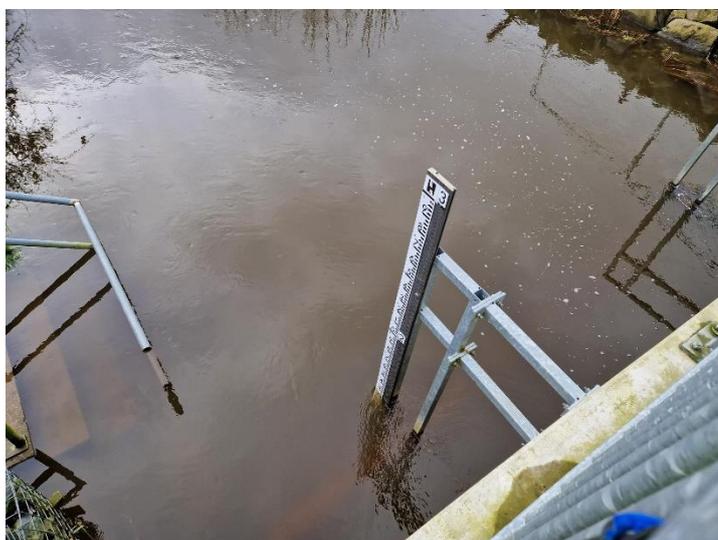
**Plate 1 Stage Monitoring, Cavan River**

A River Stage Monitoring Station was identified in the Cavan River south of the new car park bridge within the site, as shown in **Figure 3** and **Plate 1**, below.

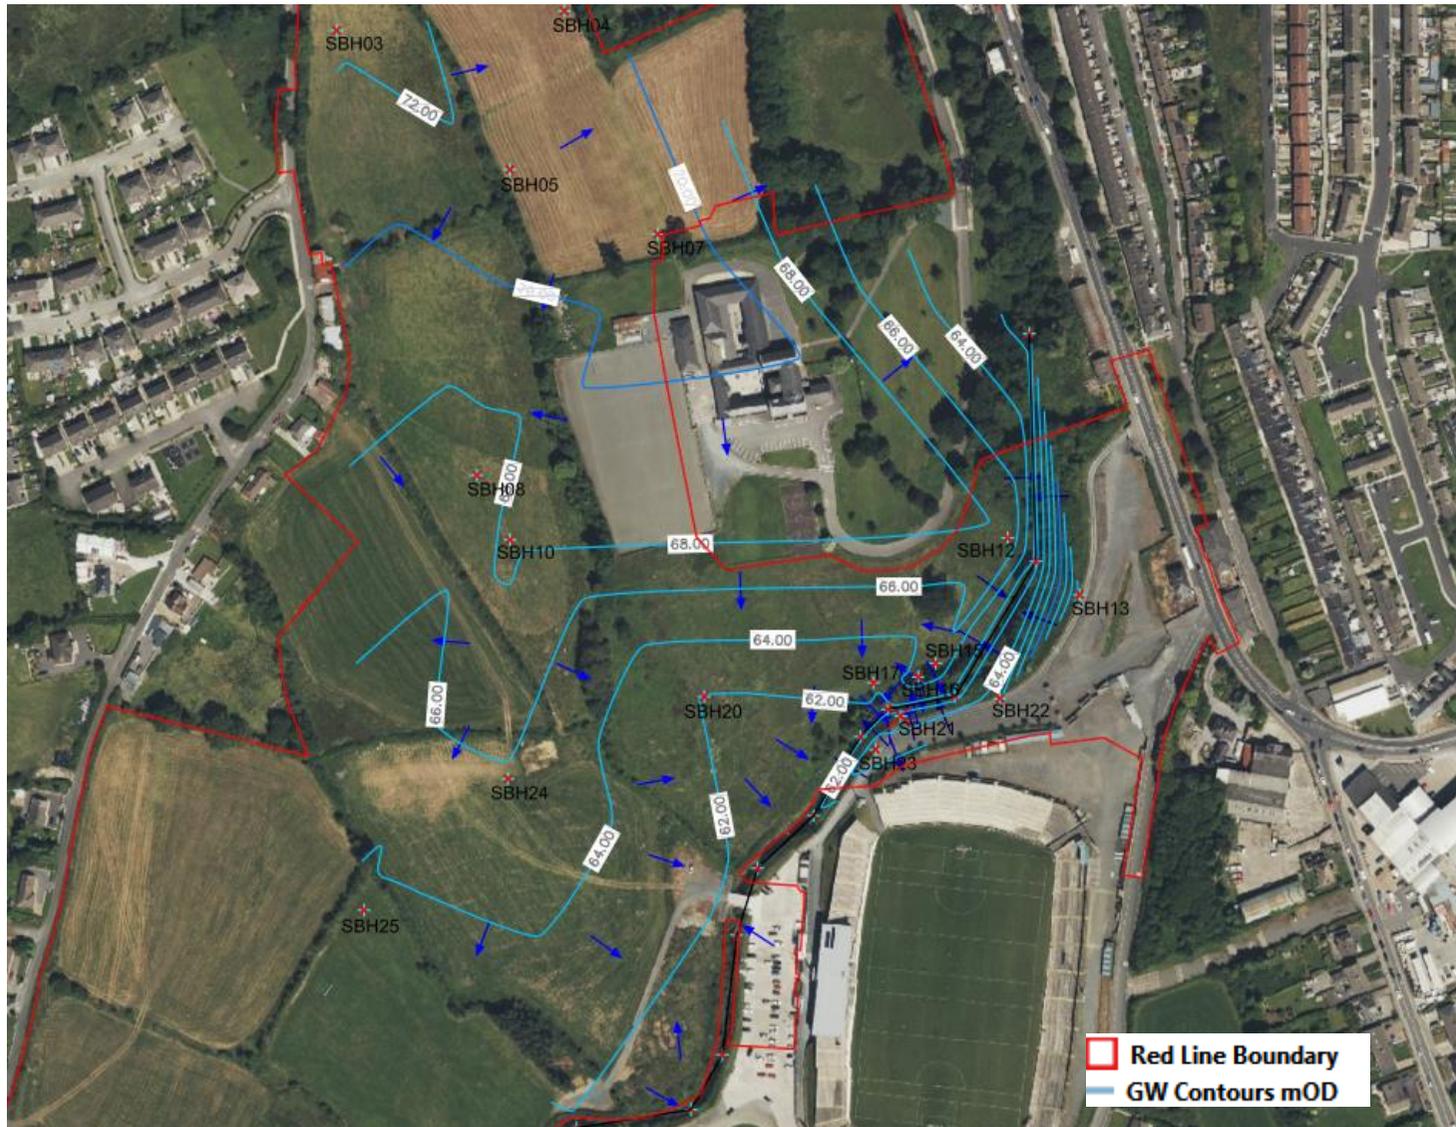
Figure 19: Groundwater Flow Map

A groundwater flow map for the general conditions in the natural gravelly Clay unit has been produced from available site-specific groundwater levels from SBH01-SB25, and is presented in Figure 4. Groundwater levels are presented in Figure 5. It can be seen that groundwater levels remained relatively consistent over the monitoring period.

The groundwater flow map and hydrographs indicate a general west to east groundwater flow direction over lands to the west of the Cavan River, and a general east to west groundwater flow direction over lands to the east of the Cavan River. This confirms, as expected, that all shallow groundwater flow is toward the Cavan River. The Cavan River will therefore receive baseflow from the shallow groundwaters at the site. The shallow groundwater system underlying the site is therefore hydraulically connected to the Cavan River.
