## Technical Appendix 14-1 Turbine Delivery Route Works Report

## EIAR - Volume 3

Knockanarragh Wind Farm

6 March 2024

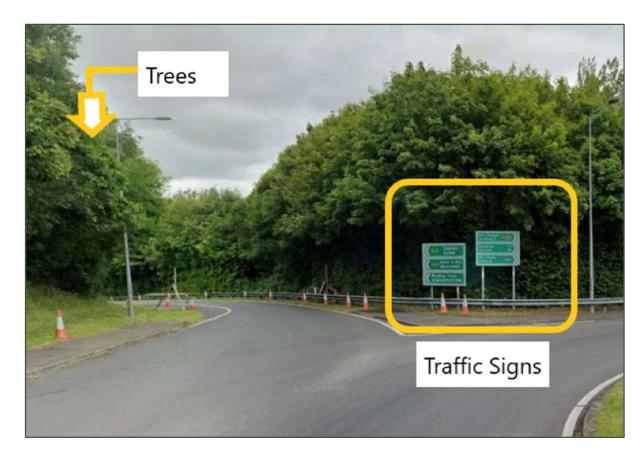
#### Figure 1-3: TDR Works on N4 Westbound On-Slip

- Temporary removal of traffic signs.
- Footway overrun.
- Trimming of trees as necessary.

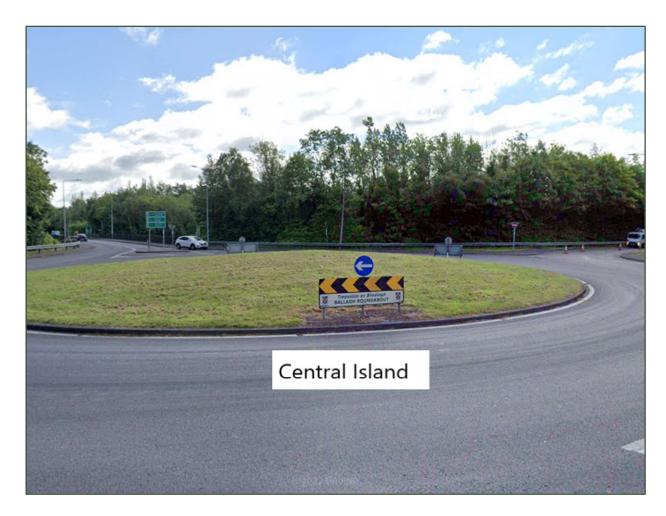
## Figure 1-4: TDR Works on N4/ N52 Delvin Road Roundabout - Central Island

• New roadways across central island.

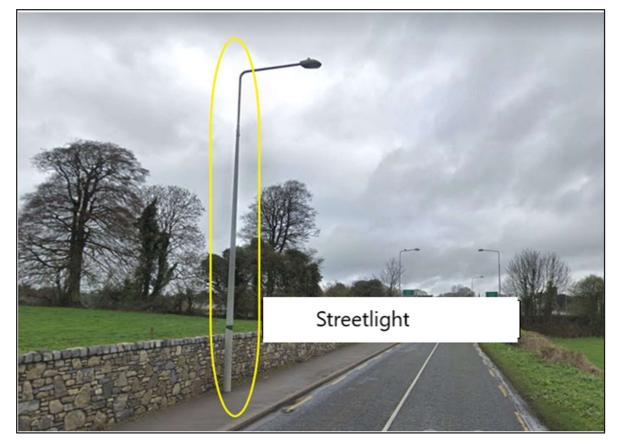
## Figure 2-1: TDR Works along N52 Delvin Road

• Possible temporary removal of street lighting

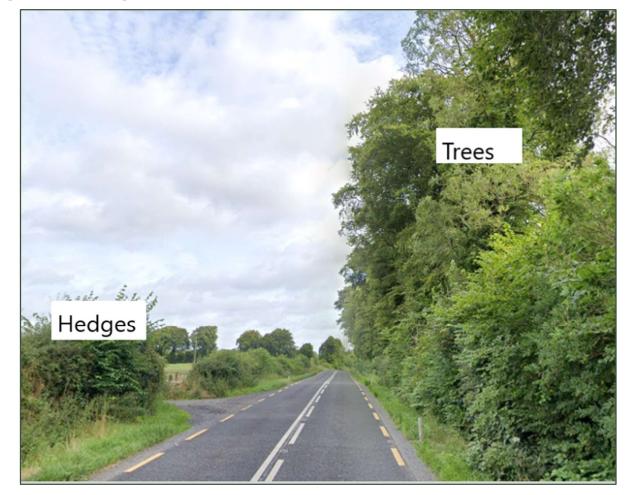
#### Figure 7-1: TDR Works on Existing Access Along N52

- Hedges within visibility splay to be trimmed.
- Trees to be trimmed to allow oversail of verge by the blade tip.

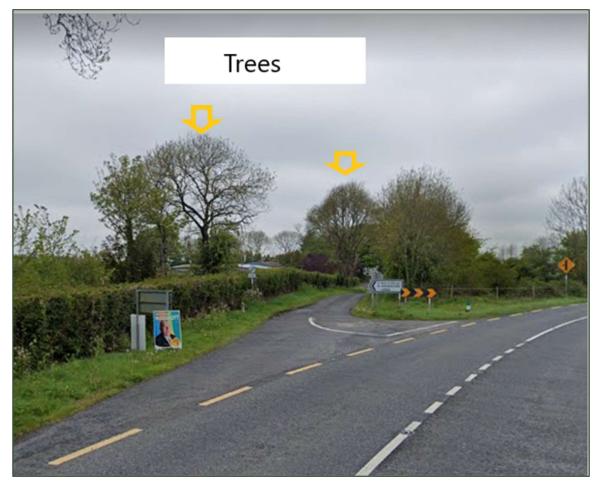
### Figure 10-1: TDR Works on along L5542

- Raising of tree canopy to allow for unhindered passage of delivery vehicle.
- Existing road widened to accord with turbine manufacturer's transport requirement.
- Trees and hedges to be trimmed as necessary.

NODE	NODE LOCATION	TDR WORKS DESCRIPTION	SWEPT PATHS
10	Along L5542 Road	<ul> <li>Raising of tree canopy as seen in Figure 10-1 and Figure 10-2.</li> <li>Trimming of trees as seen in Figure 10 1 and Figure 10 2.</li> <li>Overhead cables along route as seen in Figure 10-3 to be checked for oversail clearance.</li> </ul>	Fond         0.75           0.22         0.24         0.22           0.28         0.24         0.22           0.28         0.47         0.49
Swept pa Volvo FH	th drawings: 16 8X4 + 55m traile	r, 81m blade

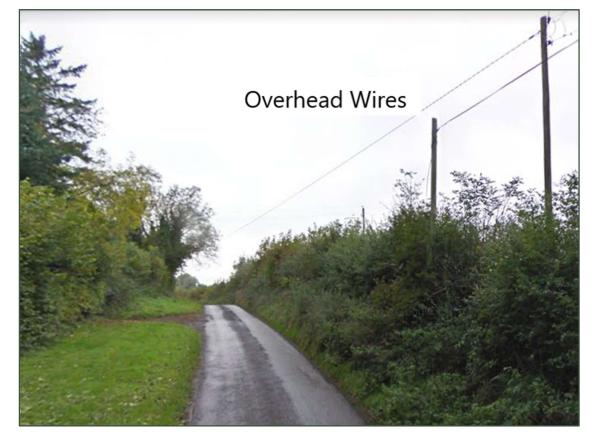
#### Figure 10-3: TDR Works on along L5542

- Overhead wires to be checked for clearance and repositioned or raised as appropriate.
- Existing road widened to accord with turbine manufacturer's transport requirement.
- Raising of tree canopy to allow for unhindered passage of delivery vehicle.

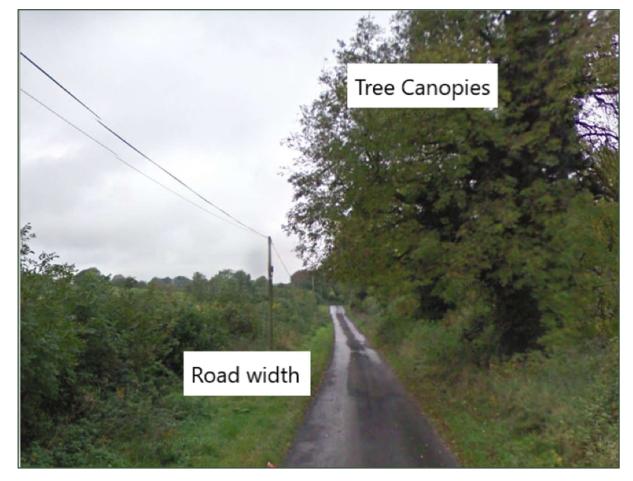
## Figure 11-3: TDR Works along L5542 after South Access

• Blade tip to be raised to oversail hedges on both sides of the road.

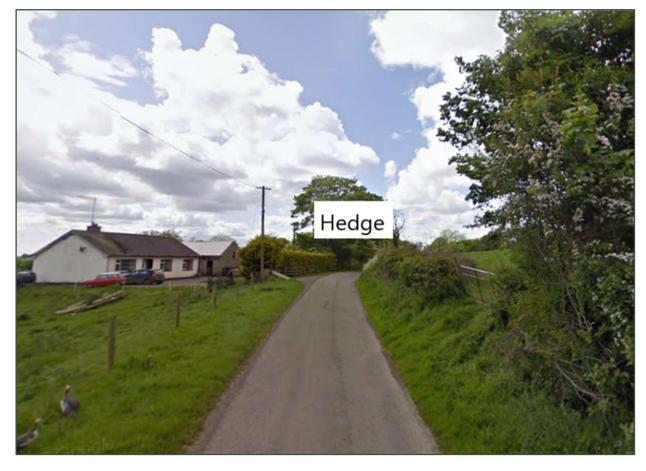
## Figure 13-2: TDR Works along L5542 Site Access North

- New road to be built in field.
- Hedge to remain wherever possible but trimmed to enable blade tip to oversail.

NODE	NODE LOCATION	TDR WORKS DESCRIPTION	SWEPT PATHS
13	L5542 Site Access North	New access road to be constructed for turbine deliveries to avoid bend. Blade tip to oversail existing building as shown in <b>Figure 13-1</b> and oversail hedges and public road as shown in <b>Figure 13-2</b> . Access to be wide enough to accommodate passage of two vehicles.	1.57 Romad School S
	th drawings: 16 8X4 + 55m trailei	r, 81m blade
