**LEAVE APPLICATION
PLANNING REPORT**

Application for Leave to
Apply for Substitute
Consent for Alterations of
the Permitted Meenbog
Wind Farm

Project Title: **Application for Leave to Apply for Substitute Consent for Alterations of the Permitted Meenbog Wind Farm**

Document Title: **Planning Report**

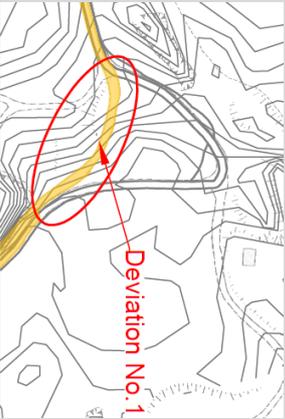
No.	Deviation No. as per SLR Report	Deviation Description	Drawing Extract	SLR Report Deviation Type Description	Nature of Alteration	Reason for Alteration
1	1	Entrance road off N15 (the hairpin bend)

<p><i>“An unconsented element of the development which lies wholly or partially outside the consented footprint.”</i></p>	<p>Alteration to alignment of permitted internal wind farm roads, road junctions, turning heads and or turbine hardstands (at design/construction to account for local topography and ground conditions).</p>	<p>The existing hairpin bend was unsafe as it did not provide adequate line of sight for vehicles using the road. This was a safety concern that only came to light when prior to construction and after it was established that the as-built route was feasible from a geotechnical perspective with the benefit of site investigations.</p> <p>The as-built alignment would have required a reduced construction footprint compared to the permitted.</p>

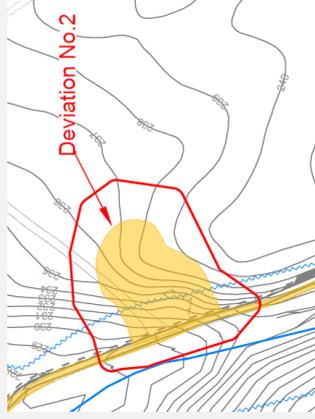
No.	Deviation No. as per SLR Report	Deviation Description	Drawing Extract	SLR Report Deviation Type Description	Nature of Alteration	Reason for Alteration
2	3	Peat cell southeast of substation

<i>“An unconsented element of the development which lies wholly or partially outside the consented footprint.”</i>	Additional peat storage areas.	Peat cells were created as part of the engineering plans for excess peat that was generated during the course of construction and required management, greater than the volumes estimated pre-construction.
3	4	T10 access road:

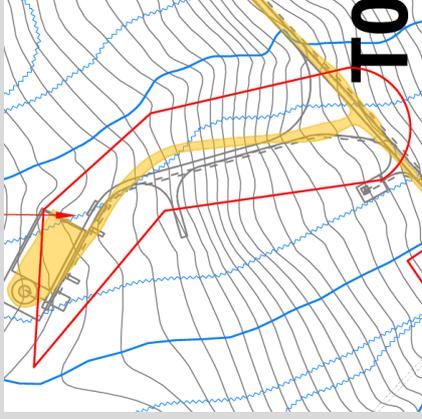
<i>“A consented element which has been constructed wholly or partially outside the consented footprint; a slight relocation or realignment but no greater footprint.”</i>	Alteration to alignment of permitted internal wind farm roads, road junctions, turning heads and or turbine hardstands (at design/construction to account for local topography and ground conditions).	Realigned road was adjusted to follow more favourable ground conditions and topography.

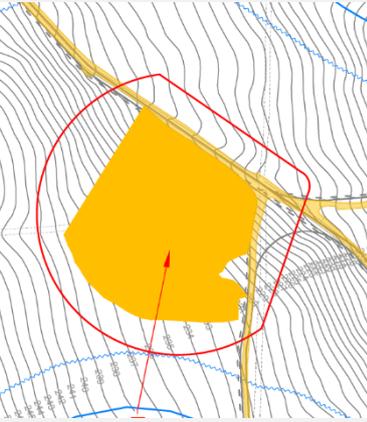
No.	Deviation No. as per SLR Report	Deviation Description	Drawing Extract	SLR Report Deviation Type Description	Nature of Alteration	Reason for Alteration
4	5	Borrow Pit southwest of T12

<p><i>“An unconsented element of the development which lies wholly or partially outside the consented footprint.”</i></p>	<p>Additional borrow pit (expansion of pre-existing borrow pit) in place of previously permitted borrow pit at alternative location. Additional peat storage areas (making use of the void space created after extraction of rock from borrow pit).</p>	<p>Existing forestry borrow pit was expanded to win stone on-site ahead of gaining access to the wind farm borrow pits. Excavation of the existing forestry borrow pit continued in lieu of excavation at the permitted BP1 borrow pit.</p>
5	6	T12 access road

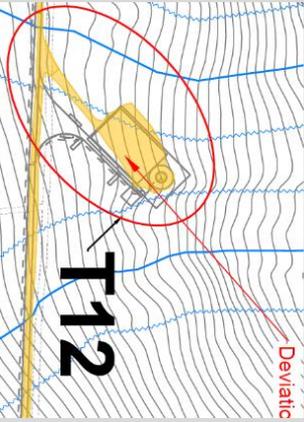
<p><i>“A consented element which has been constructed wholly or partially outside the consented footprint; a slight relocation or realignment but no greater footprint.”</i></p>	<p>Alteration to alignment of permitted internal wind farm roads, road junctions, turning heads and or turbine hardstands (at design/construction to account for local topography and ground conditions).</p>	<p>The natural topography on site required a slight realignment of the approach to T12 due to rising ground to the east of the planned road. Moving the road approximately 30 metres to the west negated the need for excessive cut at this location.</p>

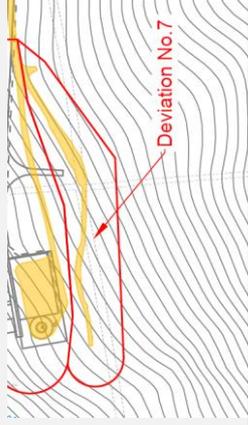
No.	Deviation No. as per SLR Report	Deviation Description	Drawing Extract	SLR Report Deviation Type Description	Nature of Alteration	Reason for Alteration
6	7a	Peat containment berm near T8

<p><i>“An unconsented element of the development which lies wholly or partially outside the consented footprint.”</i></p>	Peat containment berm.	A berm was constructed to the south of T8 as a peat containment safety measure prior to constructing T8.
7	7b	T8 access road (see 7a further above for peat containment berm)

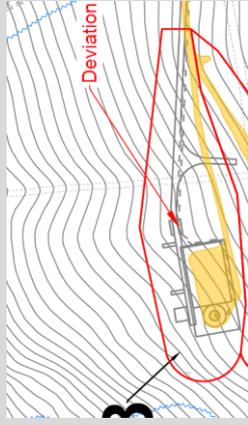
<p><i>“A consented element which has been constructed wholly or partially outside the consented footprint; a slight relocation or realignment but no greater footprint.”</i></p>	Alteration to alignment of permitted internal wind farm roads, road junctions, turning heads and or turbine hardstands (at design/construction to account for local topography and ground conditions).	The access road to T8 was amended to approach the southern side of the turbine and align with the berm.

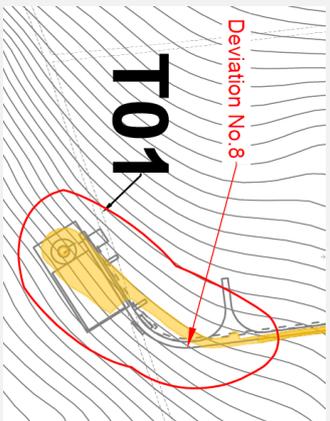
No.	Deviation No. as per SLR Report	Deviation Description	Drawing Extract	SLR Report Deviation Type Description	Nature of Alteration	Reason for Alteration
8	8	T1 access road

<p><i>“A consented element which has been constructed wholly or partially outside the consented footprint; a slight relocation or realignment but no greater footprint.”</i></p>	<p>Alteration to alignment of permitted internal wind farm roads, road junctions, turning heads and or turbine hardstands (at design/construction to account for local topography and ground conditions).</p>	<p>T1 was slightly amended to provide a more effective alignment for delivery vehicles based on detailed design of road alignment pre-construction.</p>
9	9	T2 access road

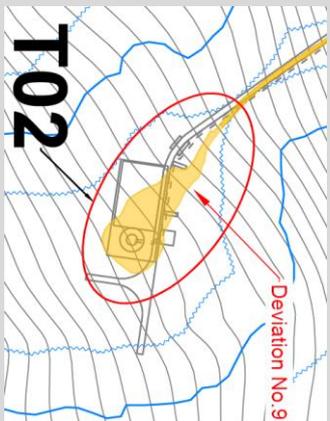
<p><i>“A consented element which has been constructed wholly or partially outside the consented footprint; a slight relocation or realignment but no greater footprint.”</i></p>	<p>Alteration to alignment of permitted internal wind farm roads, road junctions, turning heads and or turbine hardstands (at design/construction to account for local topography and ground conditions).</p>	<p>T2 was slightly amended to provide a more effective alignment for delivery vehicles based on detailed design of road alignment pre-construction.</p>

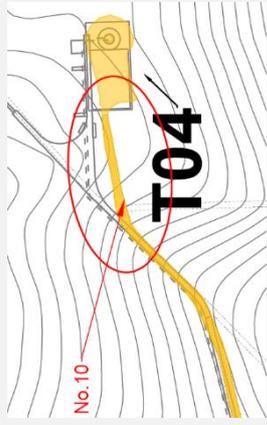
No.	Deviation No. as per SLR Report	Deviation Description	Drawing Extract	SLR Report Deviation Type Description	Nature of Alteration	Reason for Alteration
10	10	T4 access road

<p><i>“A consented element which has been constructed wholly or partially outside the consented footprint; a slight relocation or realignment but no greater footprint.”</i></p>	<p>Alteration to alignment of permitted internal wind farm roads, road junctions, turning heads and or turbine hardstands (at design/construction to account for local topography and ground conditions).</p>	<p>The approach to T4 was slightly amended to provide a more effective alignment for delivery vehicles based on detailed design of road alignment pre-construction.</p>
11	11	Borrow pit (BP2) south of T15

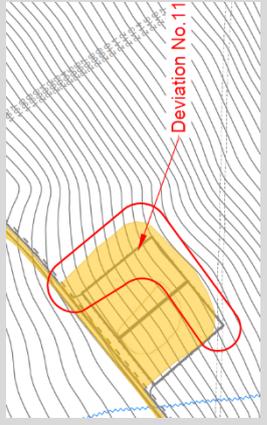
<p><i>“A consented element which has been constructed wholly or partially outside the consented footprint; a slight relocation or realignment with a greater footprint.”</i></p>	<p>Extension to a permitted borrow pit.</p>	<p>Permitted borrow pit was expanded slightly to win more rock on-site.</p>

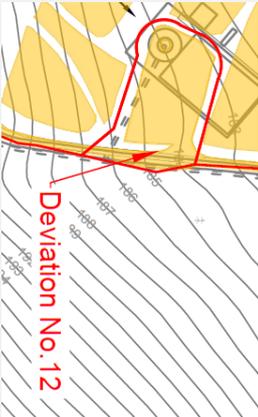
No.	Deviation No. as per SLR Report	Deviation Description	Drawing Extract	SLR Report Deviation Type Description	Nature of Alteration	Reason for Alteration
12	12	T15 hardstand and access road

<p><i>“A consented element which has been constructed wholly or partially outside the consented footprint; a slight relocation or realignment but no greater footprint.”</i></p>	<p>Alteration to alignment of permitted internal wind farm roads, road junctions, turning heads and or turbine hardstands (at design/construction to account for local topography and ground conditions).</p>	<p>The natural topography on site facilitated direct access to T15 off the main spine road at this location which negated the need for the proposed road to T15. This was achieved by rotating the hardstand by 90 degrees.</p>
13	13	T17 access road

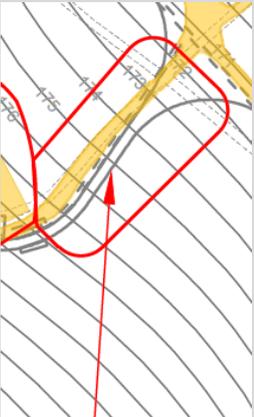
<p><i>“A consented element which has been constructed wholly or partially outside the consented footprint; a slight relocation or realignment but no greater footprint.”</i></p>	<p>Alteration to alignment of permitted internal wind farm roads, road junctions, turning heads and or turbine hardstands (at design/construction to account for local topography and ground conditions).</p>	<p>The permitted road followed the route of a pre-existing forestry firebreak, and the as-built road was constructed as intended, along that firebreak. The intent was clear, but a minor difference in alignment arose between the permitted road and as-built road.</p>

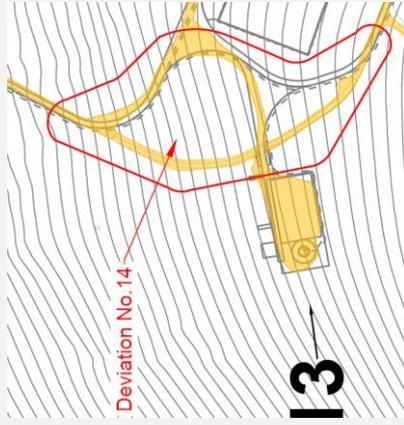
No.	Deviation No. as per SLR Report	Deviation Description	Drawing Extract	SLR Report Deviation Type Description	Nature of Alteration	Reason for Alteration
14	14	T13 road alignment (upgrade of existing forestry track)

<p><i>“An unconsented element of the development which lies wholly or partially outside the consented footprint.”</i></p>	<p>Alteration to alignment of permitted internal wind farm roads, road junctions, turning heads and or turbine hardstands (at design/construction to account for local topography and ground conditions).</p>	<p>An existing road alignment was upgraded and used, thus preventing the need for the construction of the section of new permitted road based on detailed design of road alignment pre-construction.</p>
15	15	Peat cells NW of T18

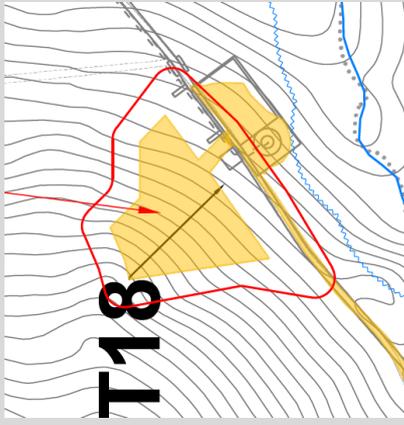
<p><i>“An unconsented element of the development which lies wholly or partially outside the consented footprint.”</i></p>	<p>Additional peat storage areas (created through the excavation of rock to create peat storage cell)</p>	<p>Peat cells were created as part of the engineering plans for excess peat that was generated during the course of construction and required management, greater than the volumes estimated pre-construction.</p>

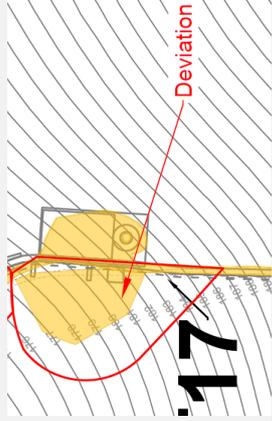
No.	Deviation No. as per SLR Report	Deviation Description	Drawing Extract	SLR Report Deviation Type Description	Nature of Alteration	Reason for Alteration
18	19	Peat cells near T17

<i>“An unconsented element of the development which lies wholly inside the consented footprint.”</i>	Additional peat storage areas.	Peat cell was created as part of the engineering plans for excess peat that was generated during the course of construction and required management, greater than the volumes estimated pre-construction..
19	25	Layby south of T10 with welfare facilities

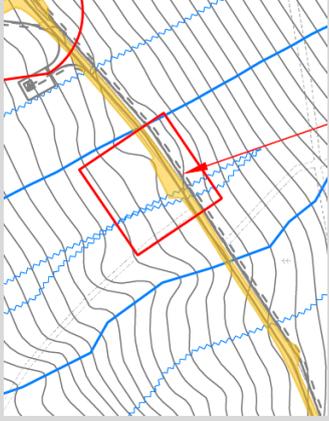
<i>“An unconsented element of the development which lies wholly or partially outside the consented footprint.”</i>	Alteration to alignment of permitted internal wind farm roads, road junctions, turning heads and or turbine hardstands (at design/construction to account for local topography and ground conditions).	This was an existing forestry access for harvesting, which was repurposed for locating site office and welfare facilities, which will be removed upon completion of construction.

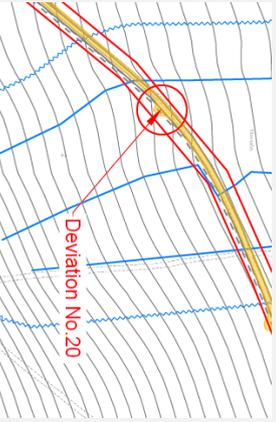
No.	Deviation No. as per SLR Report	Deviation Description	Drawing Extract	SLR Report Deviation Type Description	Nature of Alteration	Reason for Alteration
20	26	Layby northeast of T15

<p><i>“A consented element which has been constructed wholly or partially outside the consented footprint, a slight relocation or realignment with a greater footprint.”</i></p>	<p>Alteration to alignment of permitted internal wind farm roads, road junctions, turning heads and or turbine hardstands (at design/construction to account for local topography and ground conditions).</p>	<p>Layby in this area installed as a safety measure to allow construction traffic to pass. It is along the original permitted road alignment to T15. Passing bays were included in the planning drawings though actual location on the ground may have varied as conditions dictated.</p>
21	28	T19 access road

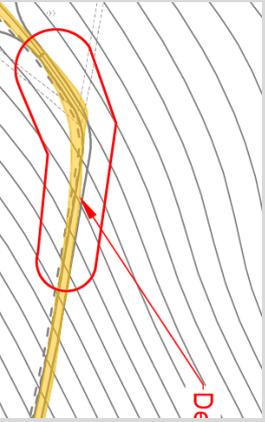
<p><i>“A consented element which has been constructed wholly or partially outside the consented footprint, a slight relocation or realignment with a greater footprint.”</i></p>	<p>Alteration to alignment of permitted internal wind farm roads, road junctions, turning heads and or turbine hardstands (at design/construction to account for local topography and ground conditions).</p>	<p>Slight widening and curve realignment to increase horizontal bend radius for turbine blade delivery.</p>

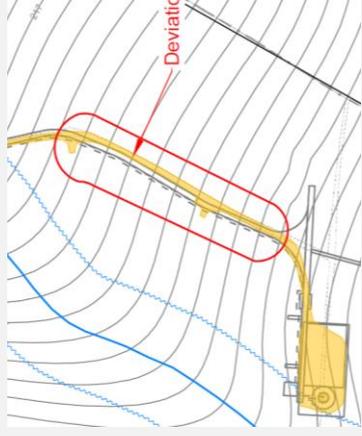
No.	Deviation No. as per SLR Report	Deviation Description	Drawing Extract	SLR Report Deviation Type Description	Nature of Alteration	Reason for Alteration
22	29	T9 access road

<i>“A consented element which has been constructed wholly or partially outside the consented footprint; a slight relocation or realignment but no greater footprint.”</i>	Alteration to alignment of permitted internal wind farm roads, road junctions, turning heads and or turbine hardstands (at design/construction to account for local topography and ground conditions).	The permitted road followed the route of a pre-existing forestry track, and the as-built road was constructed as intended, along that forestry track. The intent was clear, but a minor difference in alignment arose between the permitted road and as-built road.
23	32	Additional storage area and access road to T7

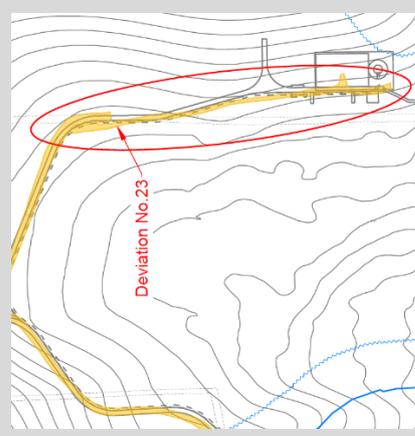
<i>“Not a deviation”</i>	Alteration to alignment of permitted internal wind farm roads, road junctions, turning heads and or turbine hardstands (at design/construction to account for local topography and ground conditions).	The realigned road served the dual purpose of acting as a peat containment berm following the November 2020 peat failure.

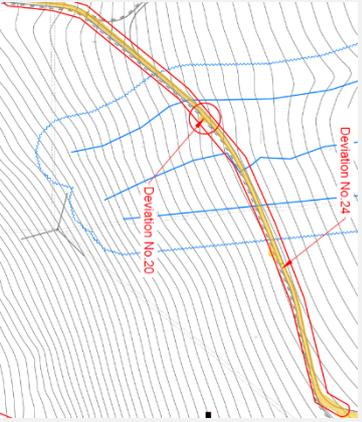
No.	Deviation No. as per SLR Report	Deviation Description	Drawing Extract	SLR Report Deviation Type Description	Nature of Alteration	Reason for Alteration
24	37	Roadside berms and settlement ponds

<p><i>“An unconsented element of the development which lies wholly or partially <u>outside the consented footprint.</u>”</i></p>	<p>Ancillary works consisting of environmental mitigations measures and water quality (drainage design) protection measures.</p>	<p>Small, low-level roadside berms were used to contain mud within the road corridor surface and prevent run-off into the wind farm drainage system or settlement ponds, check dams and silt fences.</p> <p>Settlement ponds are entirely consistent with the permitted wind farm’s drainage design, but wouldn’t have been shown on planning drawings and therefore may appear to have been outside the permitted footprint.</p>

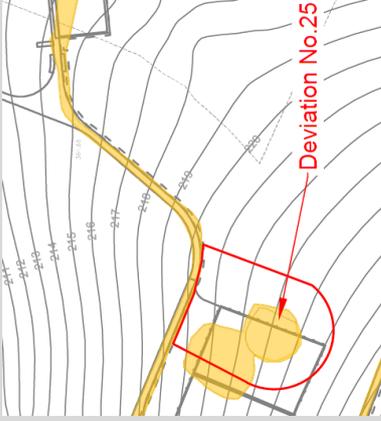
No.	Deviation No. as per SLR Report	Deviation Description	Drawing Extract	SLR Report Deviation Type Description	Nature of Alteration	Reason for Alteration
25	40	Assessment of additional excavated borrow pit and peat storage cell at T-13

"Not a deviation"	Repositioning of permitted borrow pit. Additional peat storage areas.	Position of permitted borrow pit was repositioned to suit local topography.

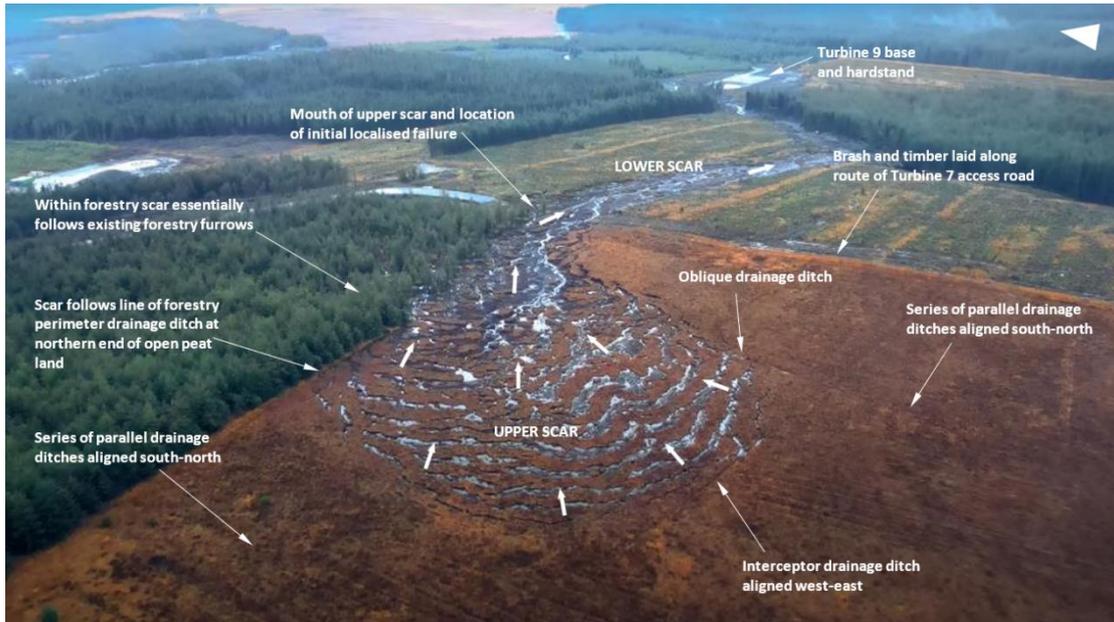
Figure 7.1 Peat failure location

A floating road was under construction towards T7. Construction works for the floating road had progressed to what was to prove to be the failure location, and preparatory works had started on the remainder of the access track and T7 hardstand with the laying of timbers and brash along the line of the access track to T7. The failure occurred at about 13:25pm whilst the floating road was being constructed, when a localised section of floating road about 20m in length failed.

The loading from the construction of the floating road would have increased the applied stress through the full depth of the underlying peat over the full width of the road. The failure, initially localised beneath the recently loaded area, resulted in the development of a rupture surface and hence a decrease to the residual strength of the peat. This localised area of peat would have continued to fail along the rupture surface.

Once the initial localised failure had occurred below the floating road and the failed peat started to move downslope this removed lateral support to the peat upslope within the flat plateau area. The slope immediately upslope of the initial localised bearing failure would have then subsequently failed. This successive localised failure and movement of peat downslope retrogressed upslope until a critical mass of peat had failed that sufficient lateral stress was applied to cause failure of the intact peat on the downslope side of the floating road. Once a critical mass of peat had failed upslope then the lateral applied stress would have exceeded the shear strength of the intact peat on the downslope side of the floating road. At this point, the peat downslope would have failed progressively.

As the downslope peat progressively failed and moved this caused subsequently more peat to fail within the upper scar. The peat in the margins of the upper scar were significantly weak that they were not self-supporting. As such, the upper scar enlarged as material locally and retrogressively failed by localised sliding then flowing from the side and the upslope margins of the scar into the centre of the scar to form a saucer shape.

In a Peat Stability Assessment report prepared by FTC and submitted to the Environmental Protection Agency, the volume of peat that moved in the peat slide was quantified to be 86,240m³, of which 65,740m³ is estimated to have left the scar areas.

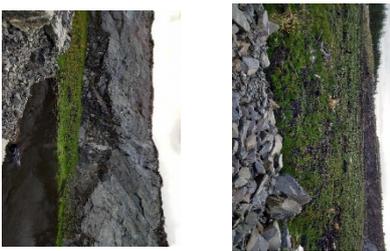
Ref	Brief Description (from MKO)	Location/Habitat	Description and notes	Ecological Risks of Deviation	Map Extract	Photo
5	Borrow Pit south of T12 Existing Forestry Borrow Pit was expanded to win stone on site ahead of gaining access to the designated borrow pits. Area already partially reinstated with peat storage. It is intended to place further peat here to further reinstate this area.	Existing small borrow pit, young plantation, and semi-mature plantation, according to imagery, but simply mapped as conifer plantation in EIAR. The young plantation would have been dominated by <i>Molinia</i> etc on peat c.0.5m deep (assessed from exposed peat at cliff tops) so essentially wet heath or blanket bog with small conifer trees. Aerial imagery indicates that this is at least the second crop of trees in this location. The borrow pit is > 50m from watercourse, but still connected	Unconsented use of an existing forestry borrow pit, involving blasting out of rock and expanding the borrow pit to 10 times its original size (was < 0.2ha and is now c.2ha). The resultant pit was then filled with peat to a depth of 20m (with more material than expected due to clearing up after the 'event') held in on the downslope side with a ~2m high retaining wall constructed from rock and finer material. Peat and other soil has been stripped back above the 'quarry face' however vertical peat 'cliffs' are present above. Water discharged from the peat cells via two pipes into the forestry drains which ultimately discharges to	Disturbance of wildlife due to blasting of rock. Loss of 2ha of habitat, comprising the existing borrow pit, a small pond within the borrow pit, some semi-mature conifer plantation and some young conifer plantation/degraded wet heath. The pond in the borrow pit is described as a small artificial pond, see p6-30 of EIAR, with only two plant species recorded however this may reflect a lack of survey effort rather than an impoverished flora.

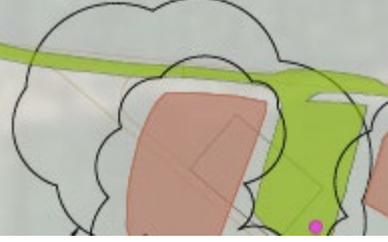
Ref	Brief Description (from MKO)	Location/Habitat	Description and notes	Ecological Risks of Deviation	Map Extract	Photo
12	T15: The natural topography on site facilitated direct access to T15 off the main spine road at this location which negated the need for the proposed road to T15. This was achieved by rotating the hardstand by 90 degrees.	Forestry plantation, mid-aged conifers which have now been cleared for bat mitigation. Bunadaowen catchment.	Approximately 140m of access road not constructed leading to a potential reduction of the development footprint, however much of this area has now been developed as peat cells see Ref 18.	Reduced risk as slightly less vegetation clearance required.
