3. DESCRIPTION OF THE SUBJECT DEVELOPMENT

Drawing Title
Subject Development Layout

Project Title
Substitute Consent for Deviations at Meenbog Wind Farm, Co. Donegal

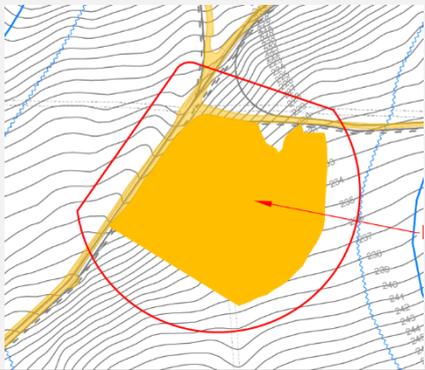
<p>Existing forestry borrow pit was expanded to win stone on-site ahead of gaining access to the wind farm borrow pits. Excavation of the existing forestry borrow pit continued in lieu of excavation at the permitted BP1 borrow pit.</p>
5	T12 access road

Deviation No. 4 concerns the borrow pit southwest of T12. The ITM Coordinates are 607214.436E, 885893.880N. An existing forestry borrow pit was expanded to win stone on-site ahead of gaining access to the wind farm borrow pits. Excavation of the existing forestry borrow pit continued in lieu of excavation at the permitted BP1 borrow pit which was not used due to peat stability concerns.

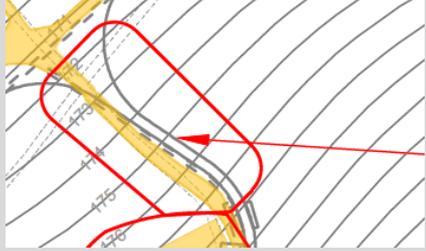
<p>The permitted road followed the route of a pre-existing forestry firebreak, and the as-built road was constructed as intended, along that firebreak. The intent was clear, but a minor difference in alignment arose between the permitted road and as-built road.</p>
14	T13 road alignment (upgrade of existing forestry track)

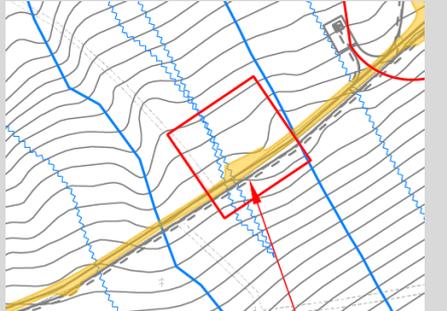
This was an existing forestry access for harvesting, which was repurposed for locating site office and welfare facilities, which will be removed upon completion of construction.
20	Layby northeast of T15

Deviation No. 19 consists of an existing forestry access for harvesting, which was repurposed for locating site office and welfare facilities. These facilities will be removed upon completion of construction. The location of Deviation 19 is shown in Figure 3-1.

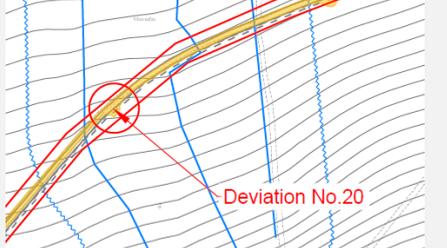
Layby in this area installed as a safety measure to allow construction traffic to pass. It is along the original permitted road alignment to T15. Passing bays were included in the planning drawings though actual location on the ground may have varied as conditions dictated.

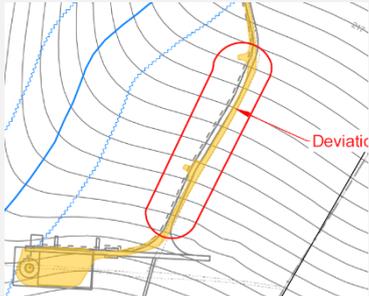
<p>The permitted road followed the route of a pre-existing forestry track, and the as-built road was constructed as intended, along that forestry track. The intent was clear, but a minor difference in alignment arose between the permitted road and as-built road.</p>
23	Additional storage area and access road to T7

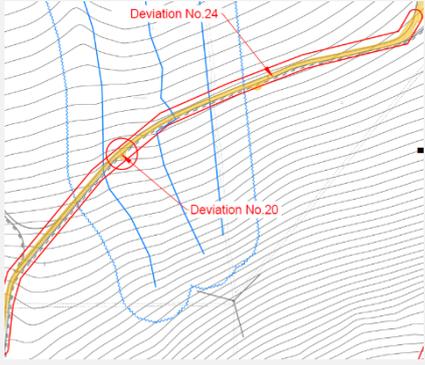
<p>Small, low-level roadside berms were used to contain mud within the road corridor surface and prevent run-off into the wind farm drainage system or settlement ponds, check dams and silt fences.</p> <p>Settlement ponds are entirely consistent with the permitted wind farm's drainage design, but wouldn't have been shown on planning drawings and therefore may appear to have been outside the Permitted Development footprint.</p>

Deviation No. 24 consists of roadside berms and settlement ponds that were constructed as part of the Meenbog Windfarm's drainage design for the purpose of protecting water quality. The use of such measures is best practice for sediment and erosion control on construction projects.
