Shannon Technology and Energy Park (STEP) Power Plant

Appendix A12.4: Catalogue of Cultural Heritage Sites Identified During Field Inspection

CATALOGUE OF CULTURAL HERITAGE SITES IDENTIFIED DURING FIELD
INSPECTION

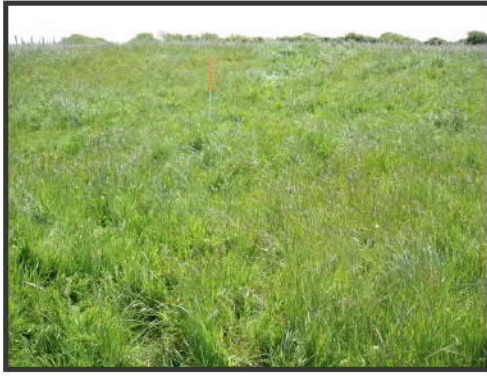
Semi-circular shaped mound (c. 1.5m high) with a central depression (c. 6m E-W) in a field of medium pasture that slopes down to the north towards the estuary. It was impossible to determine from the field inspection if the site was of any archaeological significance without further archaeological investigation.

Plate 1: CHS 1; Possible archaeological site looking SE

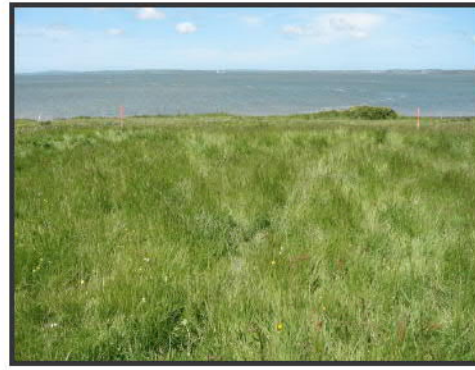
Plate 2: CHS 1; Possible archaeological site looking NW

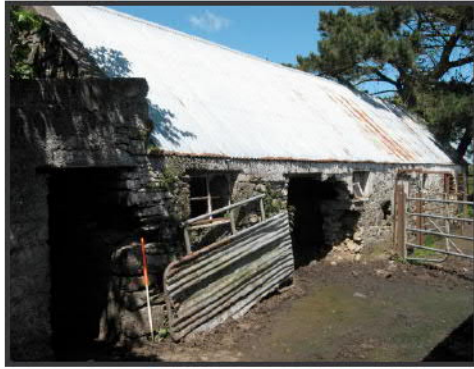
Building 1 is a 7-bay, single storey, gable-ended structure with a corrugated iron roof. It is in use for storage, however, it may have originally been a dwelling house (Plate 3). It is oriented northeast-southwest and is of random rubble construction, except for the northwest wall which is of concrete. A small random rubble outhouse with lean-to roof adjoins the southwest gable.

Plate 3: CHS 2; Building 1, southeast elevation looking north

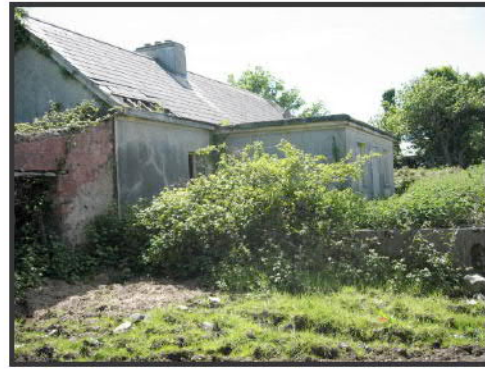
Building 2 is a dwelling house to the southeast of Buildings 1 and 5 (Plate 4). It is a single storey gable-ended building with a slate roof and is oriented northeast-southwest. The front (northwest) elevation has a window ope at the north and south and the centre of the elevation is obscured by a 3-bay, flat-roofed addition. The rear (southeast) elevation is obscured by dense overgrowth. A roofless lean-to addition adjoins the northeast gable. The interior was not accessed at the time of inspection.

Plate 4: CHS 2; Building 2, northwest elevation, looking south

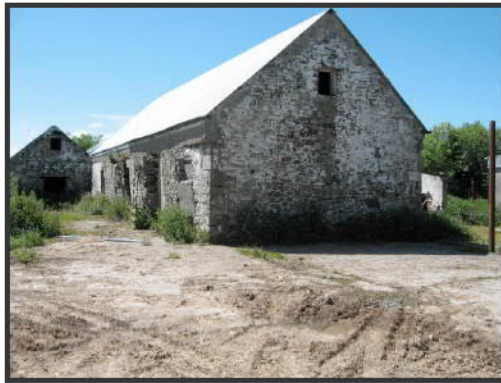
Building 3 stands to the southwest of Building 1. It is a single storey with loft, gable-ended building with a modern corrugated roof and is in a ruinous condition (Plate 5). The roof may have originally been thatched. The walls are of random rubble construction with a white lime wash. The front (southeast) elevation is 4-bay comprising a door ope and three window opes. The rear (northwest) elevation is 2-bay comprising a window and a door ope at the east end. A roofless addition adjoins the centre of this elevation. The interior comprises three rooms at ground floor level. The main, central, room has a large fireplace in the west wall, although the chimney is not now visible on the outside (Plate 6). The ceiling is a tray ceiling and is timber panelled. This building is similar in style to Building 4 (CHS 9)

Plate 5: CHS 2; Building 3, SE elevation and NE gable, looking W

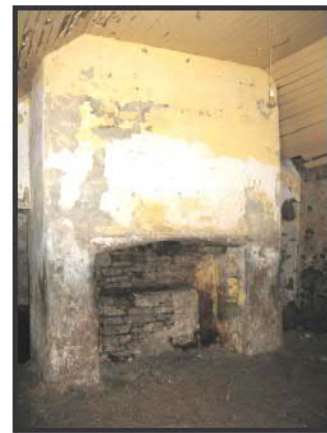
Plate 6: CHS 2; Building 3, fireplace and ceiling

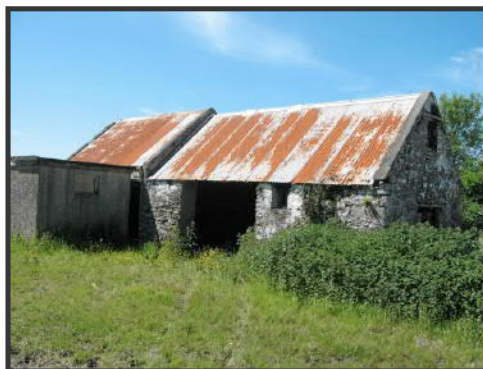
Building 4 stands to the immediate west of Building 3 (Plate 7). It is a single storey with loft, gable-ended building with a corrugated iron roof. The front (southeast) elevation is 3-bay comprising an enlarged entrance ope with a window ope on either side. The northeast gable is 1-bay comprising a door ope at ground floor level and a window ope above. A modern gable-ended building with corrugated iron roof adjoins the southwest gable.

Plate 7: CHS 2; Building 4, southeast elevation, looking northwest

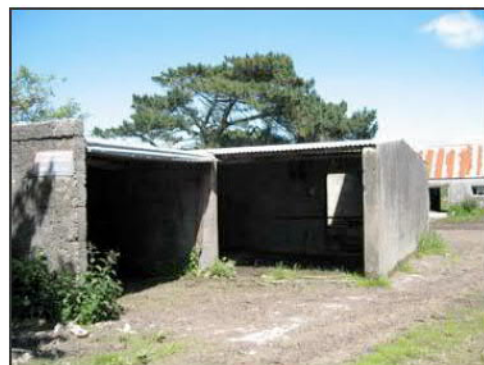
Building 5 is of concrete block. A building is shown in this location on all editions of the OS maps.

Plate 8: CHS 2; Building 5, north elevation, looking northeast

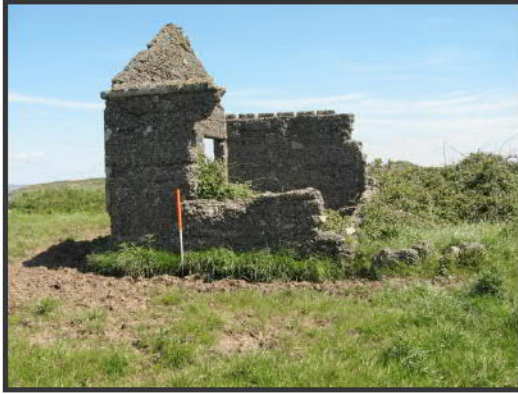
A structure is depicted in this location only on the OS 25-inch map of 1896 to the immediate west of a Trigonometrical Station. It is situated on high ground with extensive views to the west and north over the Shannon estuary. The structure is of concrete and is in a ruinous condition, the south gable and most of the west wall having collapsed (Plate 8). There is a door ope in the north gable and the remains of a

window ope in the west wall. According to local information, this structure was used to store nets and fishing gear and would also provide shelter to the fishermen who would have fished the weir on the estuary. This structure was known locally as ‘the concrete’ (*pers.comm.* Donal O’Connor).

Plate 8: CHS 3; Structure from the west

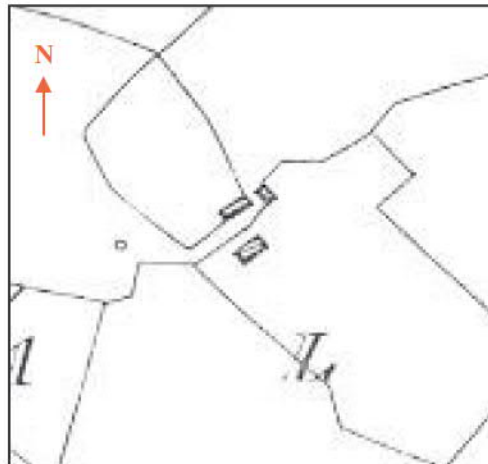
Fig. 8a: OS 6-inch map of 1841/2, enlarged, showing CHS 4 complex

Depicted on all three OS map editions (Figs. 8a and 8b). It comprises two buildings in a ruinous condition and two modern buildings (Fig. 8b).

Building 1 is a dwelling house oriented northeast-southwest (Plate 9). It is a 2-bay, single storey gable-ended building with a slate roof and a chimney at the northeast gable. The entrance door is in the northeast gable. There are two window ope in the southeast elevation and one in the northwest. The walls are rendered. A structure is shown in this location on the OS maps of 1841/2 (Fig. 8a) and 1986 (Fig. 8b) but the present building appears to be smaller and of a later date.

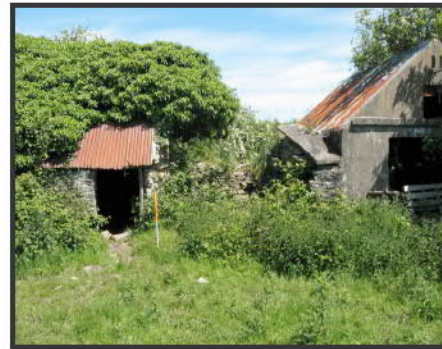
Building 2 is a small single storey gable-ended outhouse with a corrugated iron roof (Plate 10). It is oriented roughly north-south and is of random rubble construction. There is a door ope in the west wall. The remains of a gable-ended structure adjoin the south gable of this outhouse and a modern northeast-southwest outhouse adjoins the south gable of this.

Plate 9: CHS 4; Building 1, southeast elevation **Plate 10:** CHS 4; Building 2, west elevation

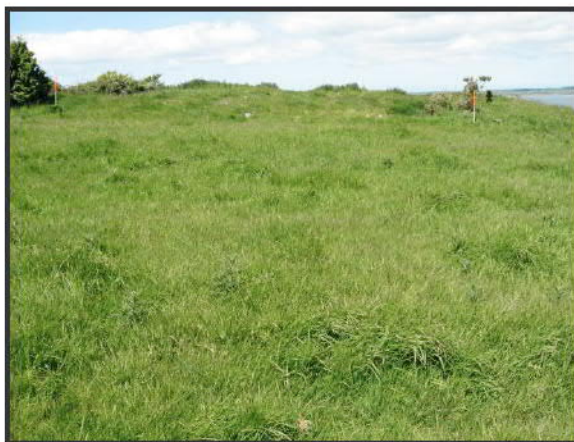
Raised rock outcrop on a height up against the western boundary of a large undulating field under pasture. The potential site, roughly covering an area 38m N-S and 15m E-W, occupies a commanding position with good views over the estuary to the north.

Plate 11: CHS 5; Possible archaeological feature looking NW

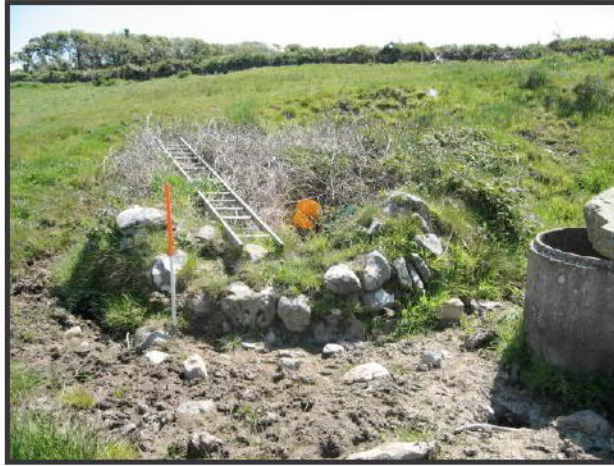
This well is depicted on the OS 25-inch map of 1896 and labelled '*Pump*' and is depicted but not named OS 6-inch map of 1914. It is of random rubble construction, roughly circular in shape, with an internal diameter of c.1.7m.

Plate 12: CHS 6; Well, looking south

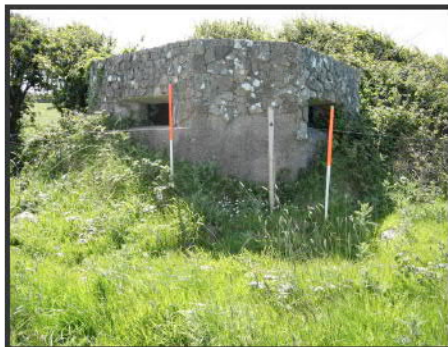
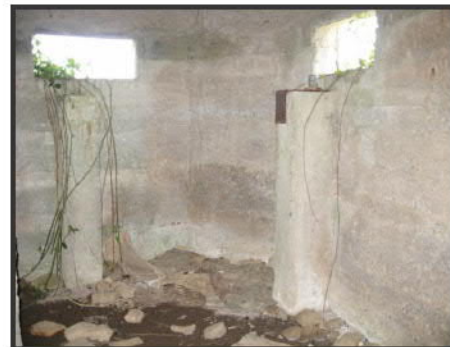
There is a gun emplacement (Plate 13) in the boundary between Fields 45 and 46 (Refer to Figure 14B.1 of Appendix 14B) on high ground with extensive views to the north and west over the Shannon estuary. The structure is not depicted on any OS map editions. It is irregular in plan, of concrete construction with a flat concrete roof. There are two viewing apes measuring 0.66m wide and 0.28m high in the north elevation. A similar ope in the south elevation is obscured with overgrowth. The door ope (measuring 1.24m high and 0.7m wide) is located at the south end of the east wall. The interior of the bunker is c. 1.8m high. Beneath each viewing ope there is a concrete pillar with metal socket on top, which would have held a gun (Plate 14). This structure appears to be an outlying part of Fort Shannon, situated in the adjacent townland, Carhoonakineely, just bordering the proposed development site to the east. Fort Shannon was constructed by the 9th Company, Irish Army Engineers in 1941/42 during Ireland's 'state of emergency'. Remnants of Fort Shannon include this gun emplacement within the proposed development site and further gun emplacements, machine gun posts, an ordnance store, a well for fresh water and one building in the adjacent townland a short distance to the east (Holly, 1981, 76).

Plate 13: CHS 7; Bunker from the north**Plate 14:** CHS 7; Interior of bunker, looking north

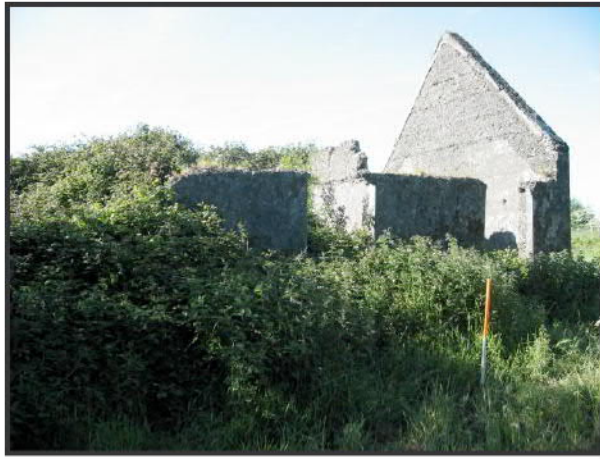
There is a structure depicted in this location on all editions of the OS maps, however, the outline of the building changes on each edition and it is not certain if the present building is part of these earlier structures. This building is of mass concrete construction and is in ruins (Plate 15). The northeast gable stands and the southwest gable has collapsed and is obscured with dense overgrowth.

**Plate 15:** CHS 8 from the south, looking north

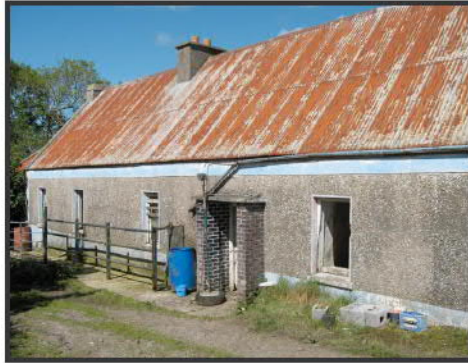
Building 1 is a 5-bay, single storey with attic, gable-ended dwelling house with a corrugated iron roof (Plate 16). The house was originally thatched. There is a chimney to the north of centre and one at each gable. The walls are rendered with rough pebbledash. A small red brick porch with a flat roof has been added to the door ope. A gable-ended outhouse with a corrugated iron roof adjoins the north gable and a further outhouse, with a lean-to roof, adjoins the north gable of this outhouse. A modern, flat-roofed extension adjoins the south end of the east elevation. Mr. Tim O'Mahony's family bought one of the farms about 1936 and this building, the main residence, was lived in until the 1980's (*pers. comm.* Tim O' Mahony).

Plate 16 CHS 9; Building 1, front elevation

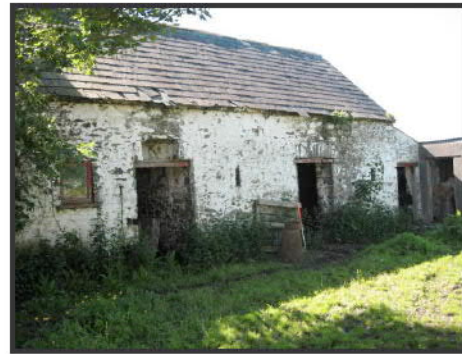
Building 2 is to the northwest of Building 1 (Plate 17). It is a 3-bay, one-storey with attic, gable-ended building with a slate roof. A random rubble outhouse with lean-to corrugated iron roof adjoins the north gable and a modern shed with a lean-to roof adjoins the east wall of this outhouse (Plate 18).

Plate 17: CHS 9; Building 2, east elevation

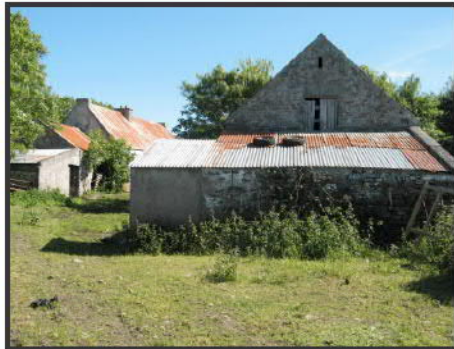
Plate 18: CHS 9; Building 2, north gable

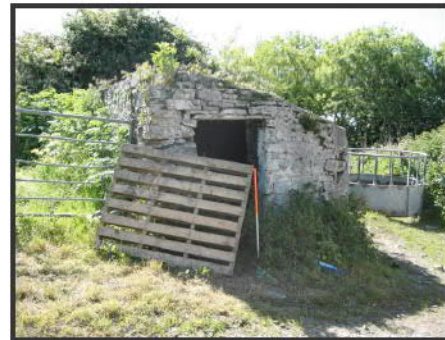
Building 3 stands to the southwest of Building 1. It is oriented east-west and is a small outhouse of random rubble construction with a lean-to roof (Plate 19). The overgrown ruins of another building lie to the south of this and may be the remains of the north-south building depicted on the OS maps.

Plate 19: CHS 9; Building 3, east elevation

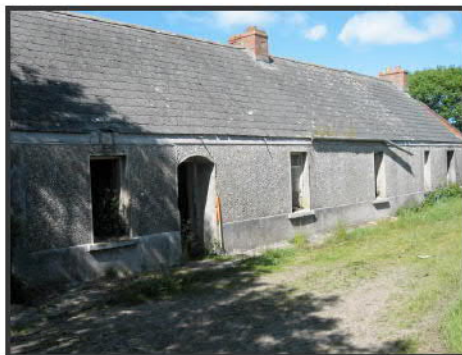
Building 4 is a dwelling house at the north side of a farmyard on the east side of a laneway leading to Buildings 1-3. It is single-storey with a slate roof and red brick chimneys and is 4-bay with a 2-bay extension at the east gable (Plate 20). A gable-ended addition with corrugated iron roof adjoins the east gable of the extension. A modern flat-roofed extension adjoins the west end of the north elevation. The main

Plate 20: CHS 9; Building 4, south elevation

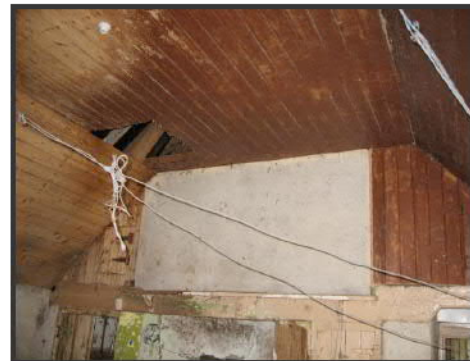
room was inspected and has a large fireplace in the east wall. The ceiling is a tray ceiling and is timber panelled (Plate 21).

Plate 21: CHS 9, ceiling of Building 4

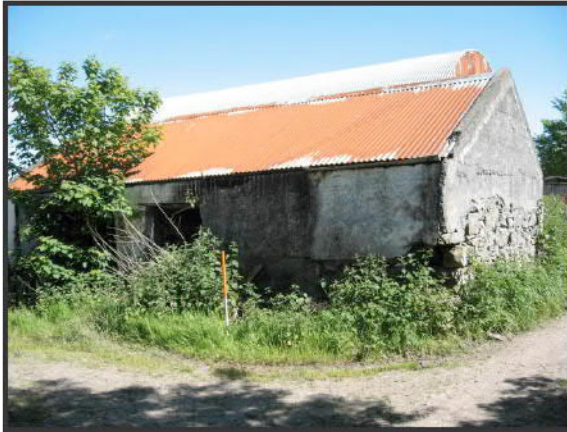
Building 5 is an outhouse on the south side of the later farmyard. It is a single storey, gable-ended structure with a corrugated iron roof (Plate 22). The walls are of random rubble construction with a rough concrete render in places. It comprises two areas each accessed by means of a door ope in the north elevation. A small shed with a corrugated iron roof adjoins its east gable and a large modern barn adjoins its south side.

Plate 22: CHS 9; Building 5, from northwest

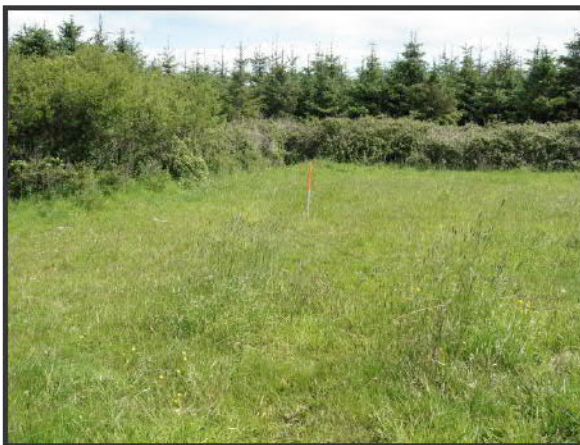
There is no above ground evidence for this recorded site rath/ringfort (KE003-004). It is depicted as a circular area enclosed by a bank on the OS map of 1841/2. On later maps (1986 and 1914), only the western half of the bank is depicted, the eastern half is no longer represented. The site was surveyed by Toal in 1989. At that time, the remains of the site consisted of a semi-circular earthen bank, c. 22m in length that was cut by the townland boundary between Ralappane and Carhoonakineely. According to Toal, the bank had an external height of 0.4m, an internal height of 0.4m and the width of the bank at the base measured c 5m (Appendix 14C; Section B). Although there is no above ground evidence for the site at present, it is highly likely that remains exist intact below the ground surface.

Plate 23: CHS 10; Site of recorded rath, no above ground evidence looking NE

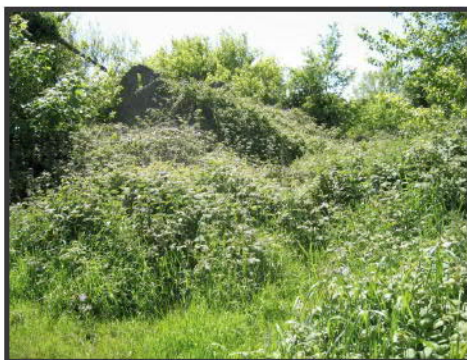
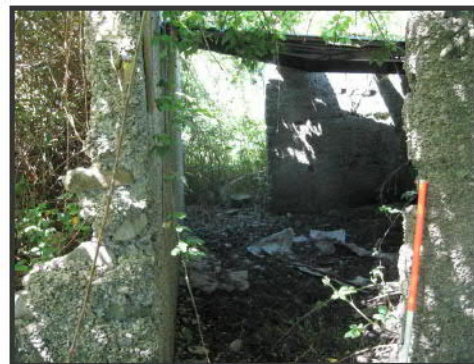
A structure is depicted towards the centre of a small, square field on the OS map of 1841/2 (Fig. 10a). On later maps (1896 (Fig. 10b) and 1914) the field layout has been changed and there are two small structures depicted in the vicinity of this earlier building. However, as both of these buildings adjoin the eastern field boundaries in is likely that these are different structures to the one shown on the 1841/2 map (Fig. 10a). The present structure is gable-ended and of rough concrete construction. It is in a

ruinous condition and is mostly obscured with dense overgrowth. A small shed with a lean-to, corrugated iron roof, adjoins the east gable.

Plate 24: CHS 11; structure from E structure

Plate 25: CHS 11; concrete walls of looking W

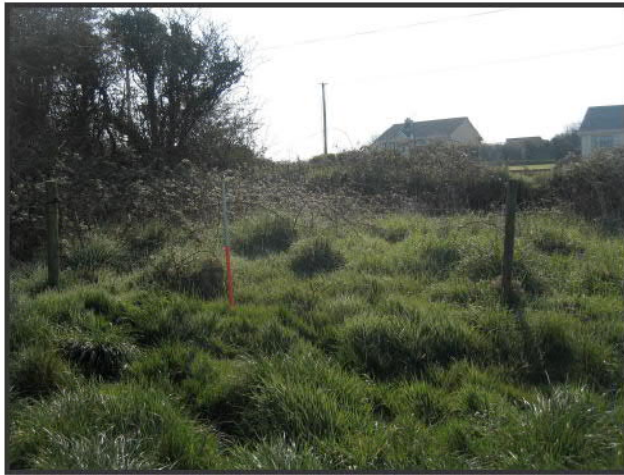
There appears to be no above ground evidence for the forge in Field 29, though the area is completely overgrown with vegetation that may obscure some low structural

Plate 26: Overgrown site of forge

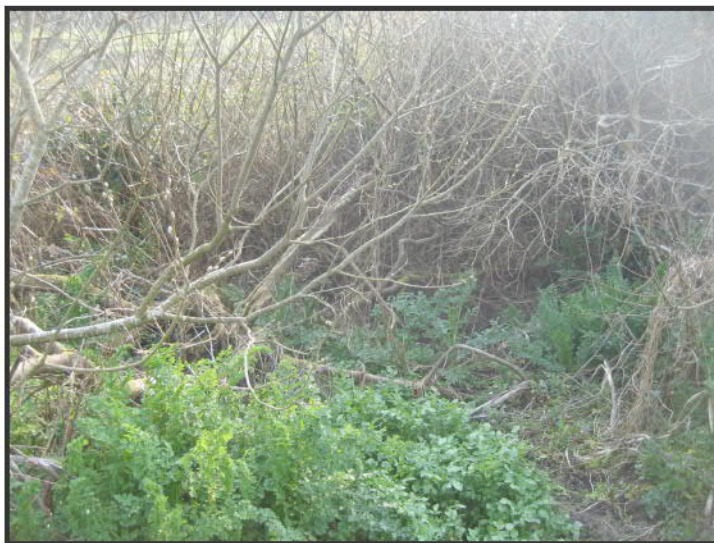
In Field 33, in an area known locally as the Glen, there is a well (CHS 13) called *Tubberagleanna* - well of the Glen. The site of the well is an open spring that is now engulfed with vegetation. A story attached to the well goes as follows; This well was originally situated on the opposite side of the stream in the field known as O'Connell's Hill. Seven girls went to the well to wash some clothes in it. The next morning the well dried up and appeared on the opposite side of the stream in its present location in the Glen (*pers. comm.* Michael Finnucane and Tim O'Mahony).

Plate 27: Overgrown site of Tubberagleanna

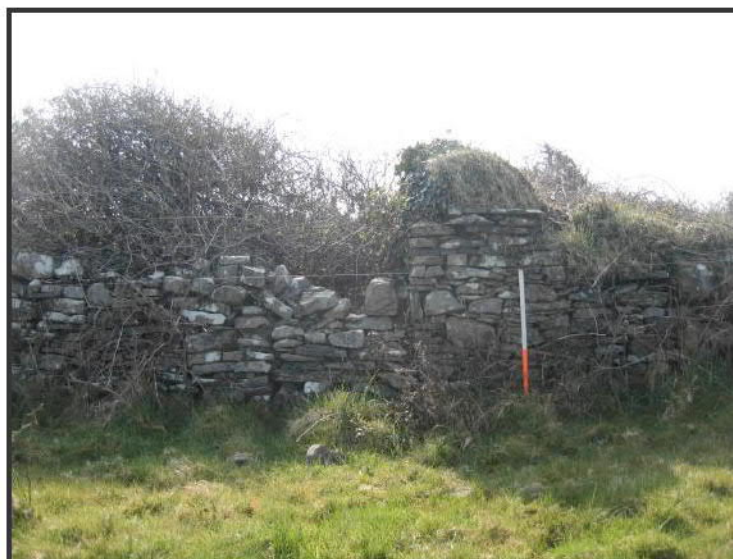
The possible remains of a structure are located in Field 46, at the east end of the southern boundary (Plate 28) (Refer to Figure 14B.1 of Appendix 14B). An east-west rectangular building is depicted in roughly this location on the OS 25-inch map of 1896 (Fig. 10). Two small, square structures are shown to the south of this, one at the southeast and one at the southwest. The OS 6-inch map of 1914 (Figure 14.5 of EIS) shows the rectangular structure but the two small structures are no longer present. The remains comprise a random rubble wall (c. 13m long x c. 1m high) with blocked openings visible in places. There is a buttress on the north side of the wall (Plate 28). The south side is obscured by dense overgrowth.

Plate 28: Possible remains of structure in southern boundary, looking south
