Shannon Technology and Energy Park (STEP) Power Plant

Appendix A12.6: Archaeological Test Trenching Report

Report on Archaeological Test Trenching carried out on the proposed Shannon LNG Site in the Townlands of Ralappane and Kilcolgan Lower, Kilnoughtin Parish, Co. Kerry, Vol. 1

Licence number: 08E587

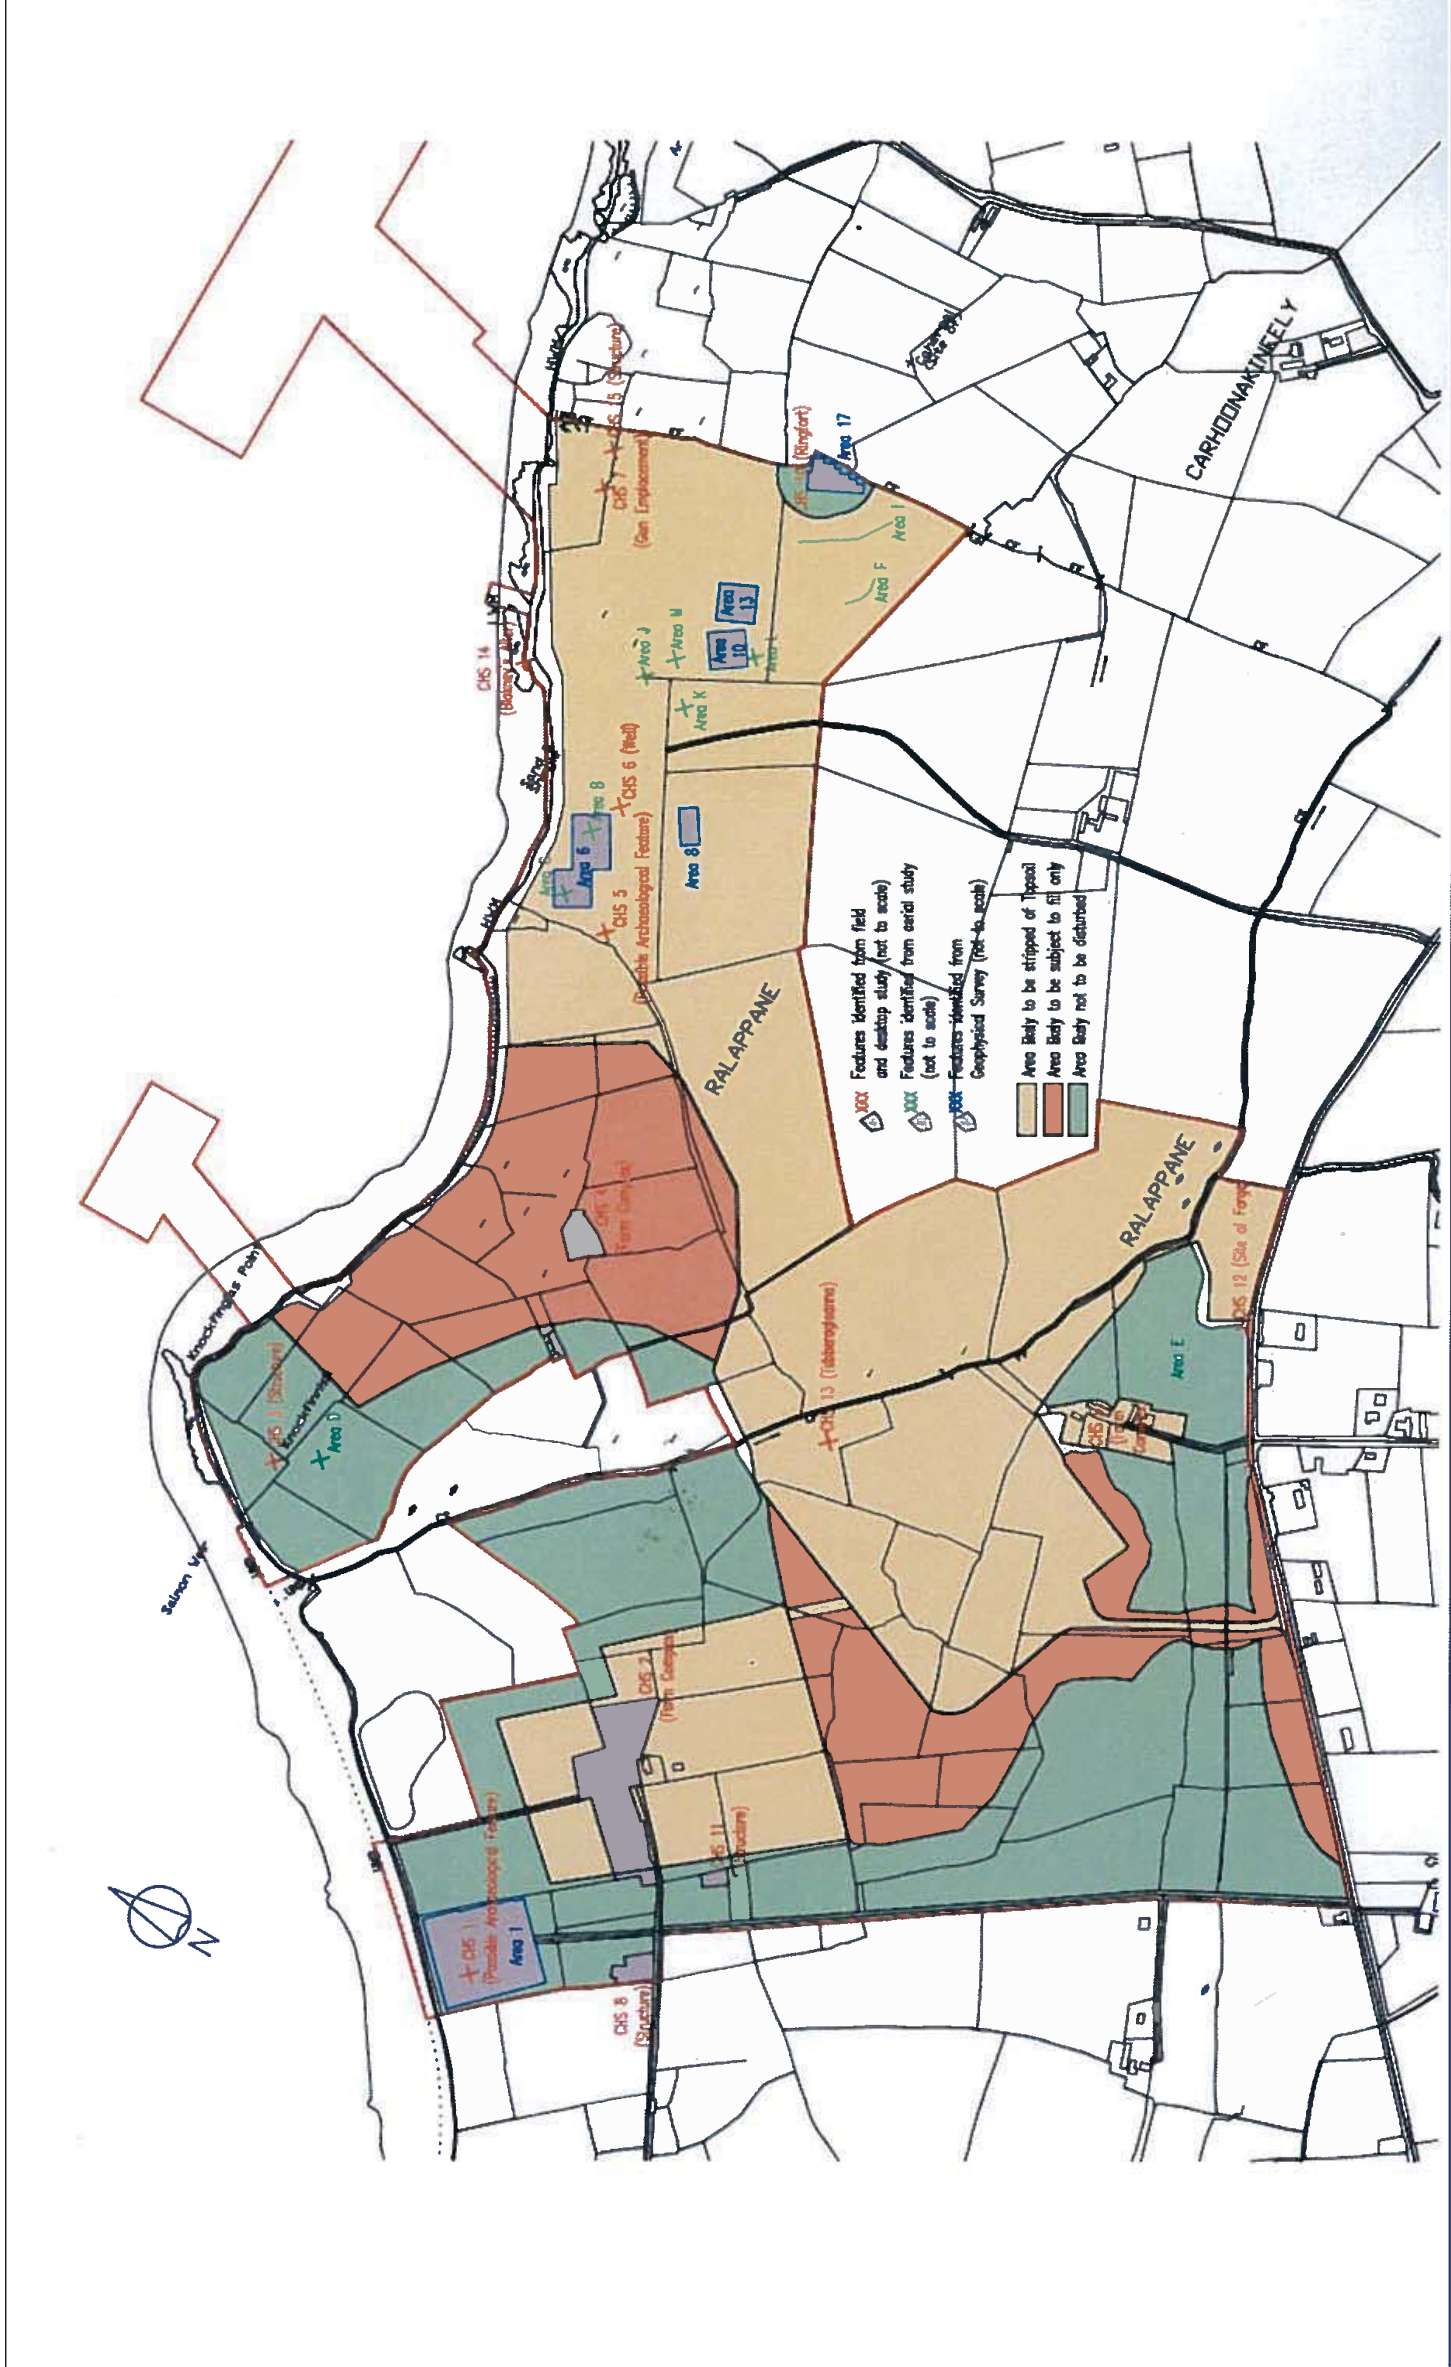
Figure 4 - Archaeological sites identified in EIS (after Lane).

Another structure within the proposed development site (CHS 3, Figure 4) was known locally as 'the concrete' (pers. comm. Donal O' Connor). This structure is not depicted on any OS map editions. It is situated on high ground with extensive views to the north and west over the Shannon estuary. The structure is in a ruinous condition, the south gable and most of the west wall having collapsed. According to Mr. O'Connor, this structure was used to store nets and fishing gear and would also

There appears to be no above ground evidence for the forge (CHS 12, Figure 4), though the area is completely overgrown with vegetation that may obscure some low structural remains. According to local information (pers. comm. Michael Finucane and Tim O' Mahony), this building was in use up until the late 1920's. The forge would have been a very important place within the community where the tools of farming were made and repaired. It would also have been the hub of the community, functioning as a social outlet and meeting place for people of the locality. The forge is evident on all three editions of the OS map and so dates to at least 1841. It is identified on the 1894 map edition as 'smithy'. The building fell into disrepair when it ceased to function as a forge in the 1920's.

A Geophysical survey carried out between 3 and 10 October 2006 determined the location and extent of buried archaeological remains, where present, within eight areas of archaeological potential highlighted from the aerial photographic survey, field inspections and cartographic research. The areas of archaeological potential included one possible archaeological feature noted during the preliminary geological survey; five potential sites identified during aerial photographic survey; the western zone of archaeological potential for rath site KE003-004; and one potential site identified during the field inspection (Figure 4).

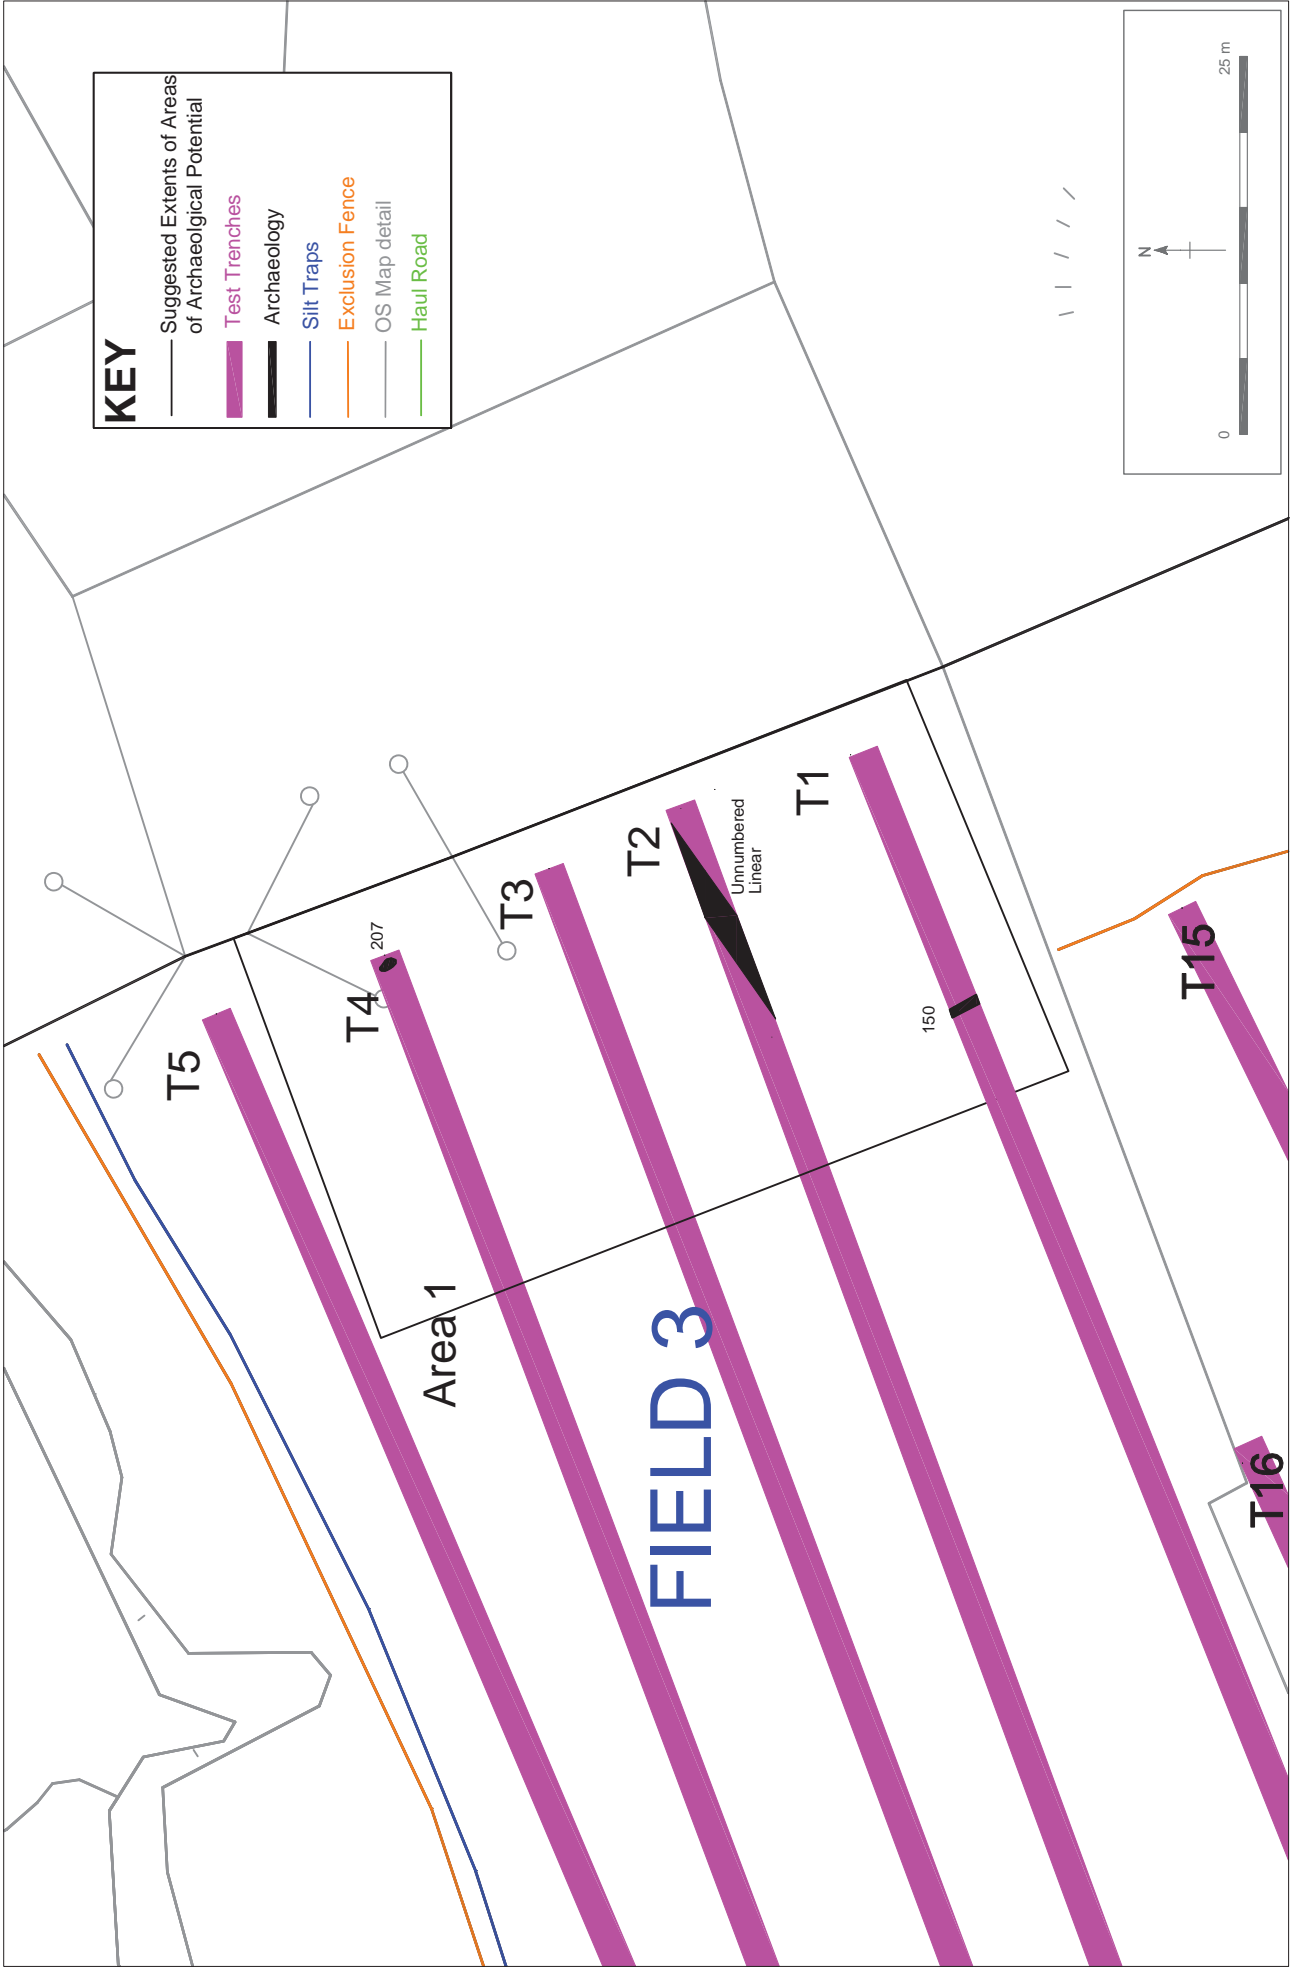
Figure 5 - Shannon LNG Site: Area 1

Area 1 Field 3 (Figure 5); consisted of a moderate number of furrows, a linear feature, a charcoal-rich pit (207) and a shallow deposit of shell midden material (150). These features were confined to the east of the field, on the east side of a pronounced rocky knoll. Natural bedrock was exposed in the west side of the trenches. The furrows were noted but not surveyed or recorded as they are of little archaeological significance.

The deposit of midden material (150) was identified in the east side of Trench 1. It was dark-brown, loosely compacted, sandy-silt with frequent seashells. The deposit was not fully exposed during testing but measured 2 m long by 0.5 m wide and 0.12 m deep within the trench.

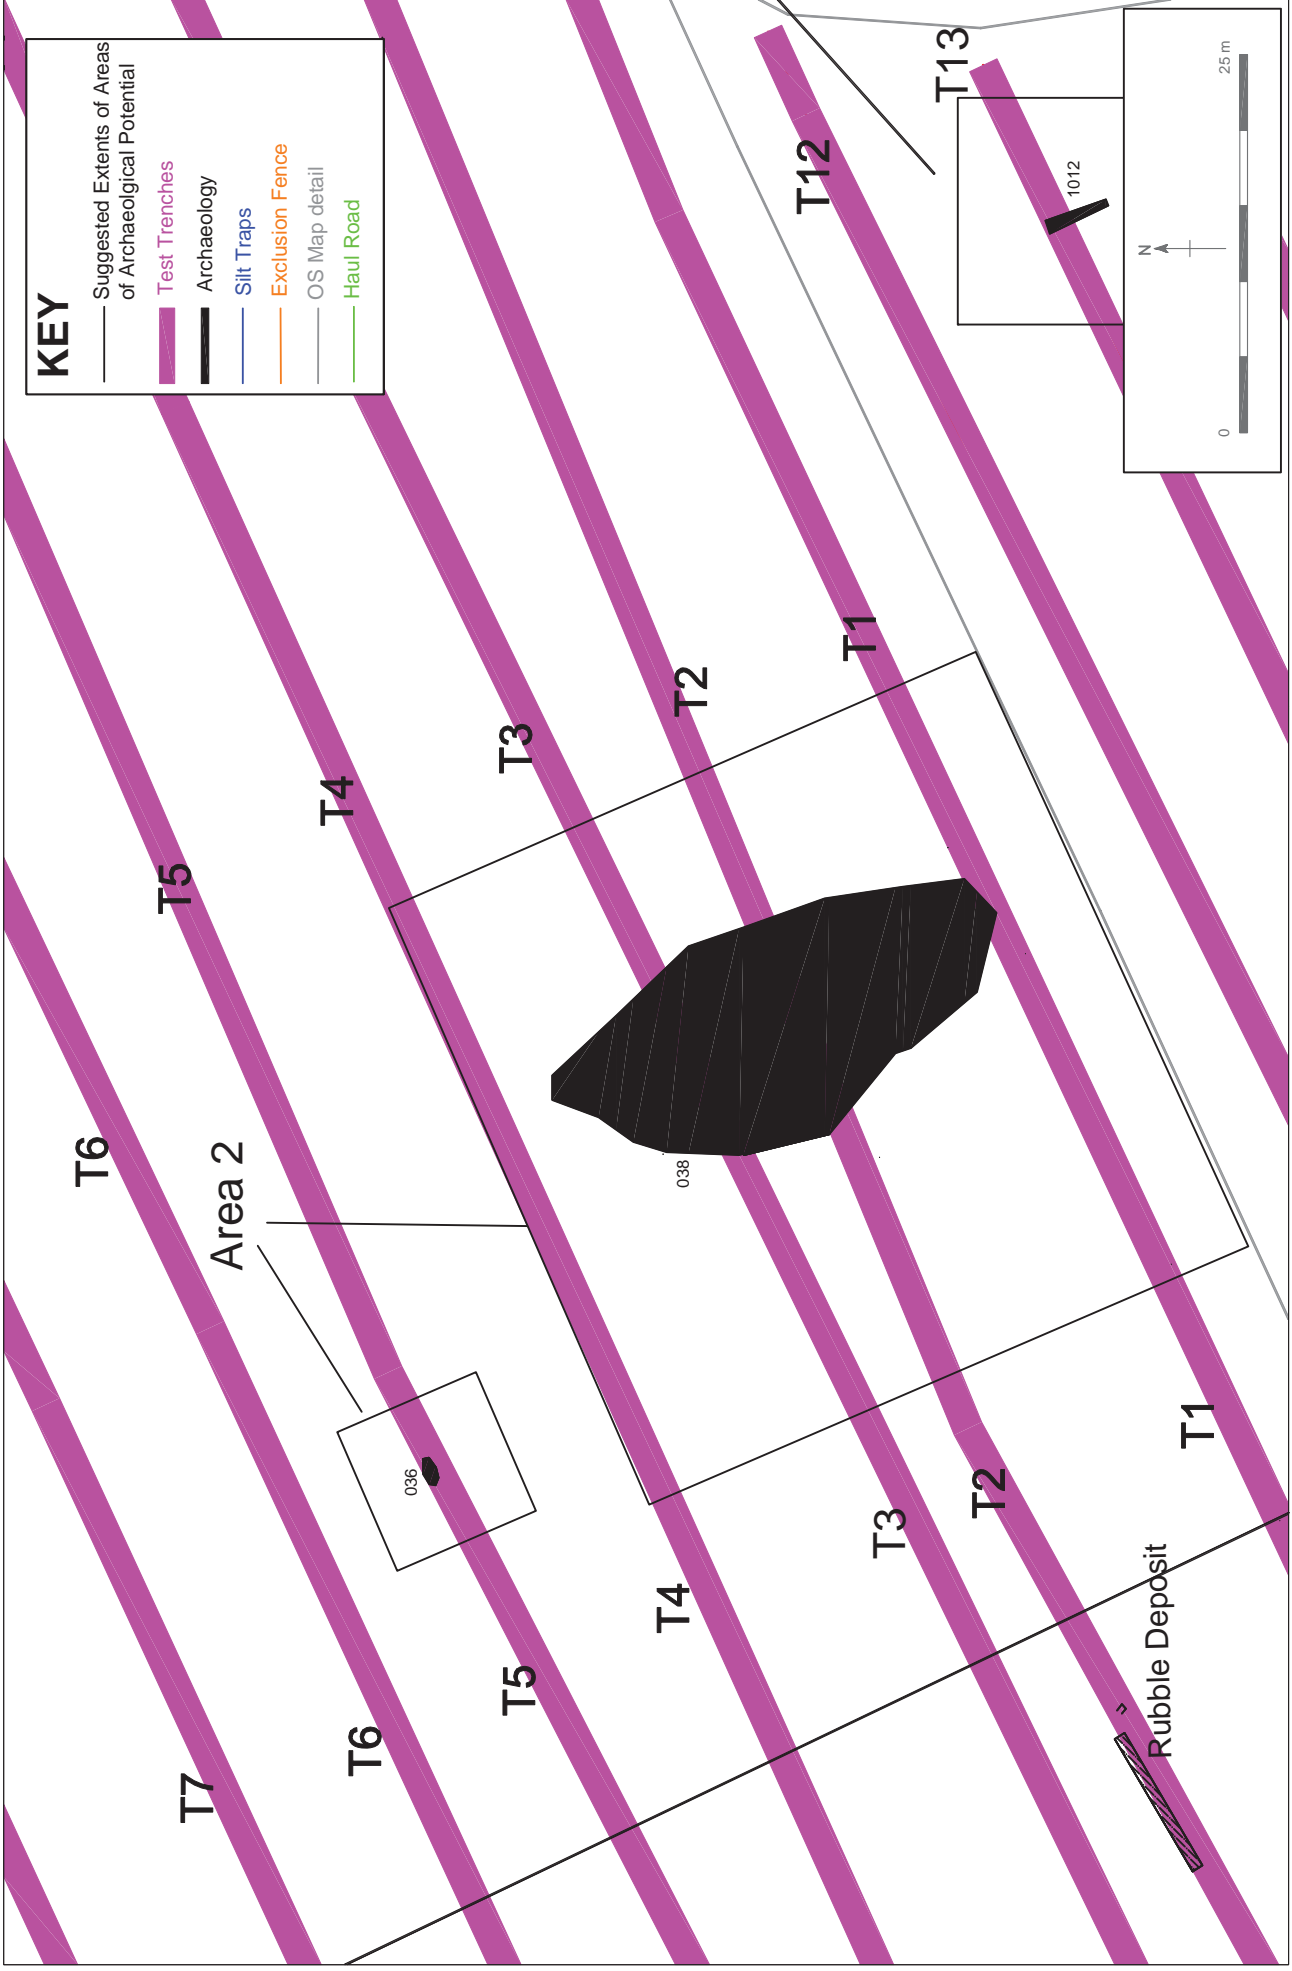
Figure 6 - Shannon LNG Site: Area 2

Area 2 Field 6A (Figure 6); consisted of a mound of burnt material recorded in Trenches 1, 2 and 3. An additional area of investigation (364.75m²) was opened to establish the extent of this mound (Plate 3).

The burnt mound (038) consisted of dark-greyish-black, heat shattered stone and charcoal in a sandy-silt matrix. The deposit measured 32 m northwest/ southeast by 15.4 m northeast/ southwest. Two thin parallel stones of equal size could be seen protruding slightly through the surface of the deposit on the north side, possibly representing a stone lined trough measuring approximately 1.7 m by 0.7 m.

A charcoal-rich pit (036) was identified to the northwest of the burnt mound deposit. The feature extended beyond the limits of the trench and appeared to be sub-circular or sub-rectangular in plan (Plate 4). It was not excavated during testing but the upper fill (037) was recorded as dark-brownish-black, moderately compacted, sandy-silt with frequent charcoal inclusions measuring 1.9 m long within the trench.
