Ground Investigations Ireland

ATU Letterkenny

Tobins

Ground Investigation Report

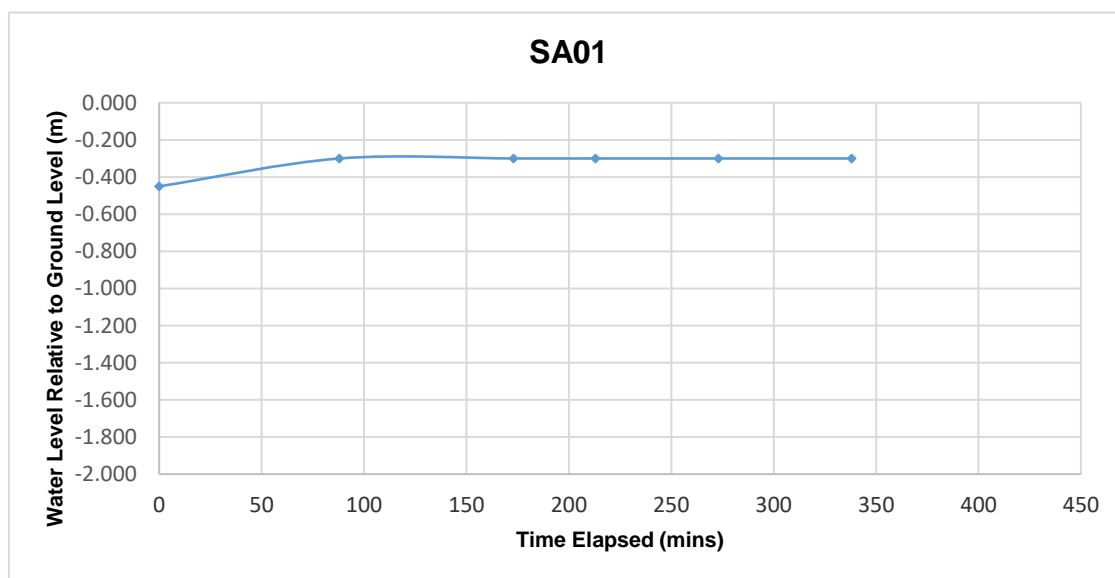
***Soakaway failed - Pit backfilled**

Start depth	Depth of Pit	Diff	75% full	25%full
0.45	1.600	1.150	0.7375	1.3125

The soakaway testing was carried out in selected trial pits at the locations shown in the exploratory hole location plan in Appendix 1. These pits were carefully excavated and filled with water to assess the infiltration characteristics of the proposed site. The pits were allowed to drain and the drop in water level was recorded over time as required by BRE Digest 365. The pits were logged prior to completing the soakaway test and were backfilled with arising's upon completion. The soakaway test results are provided in Appendix 3 of this Report.

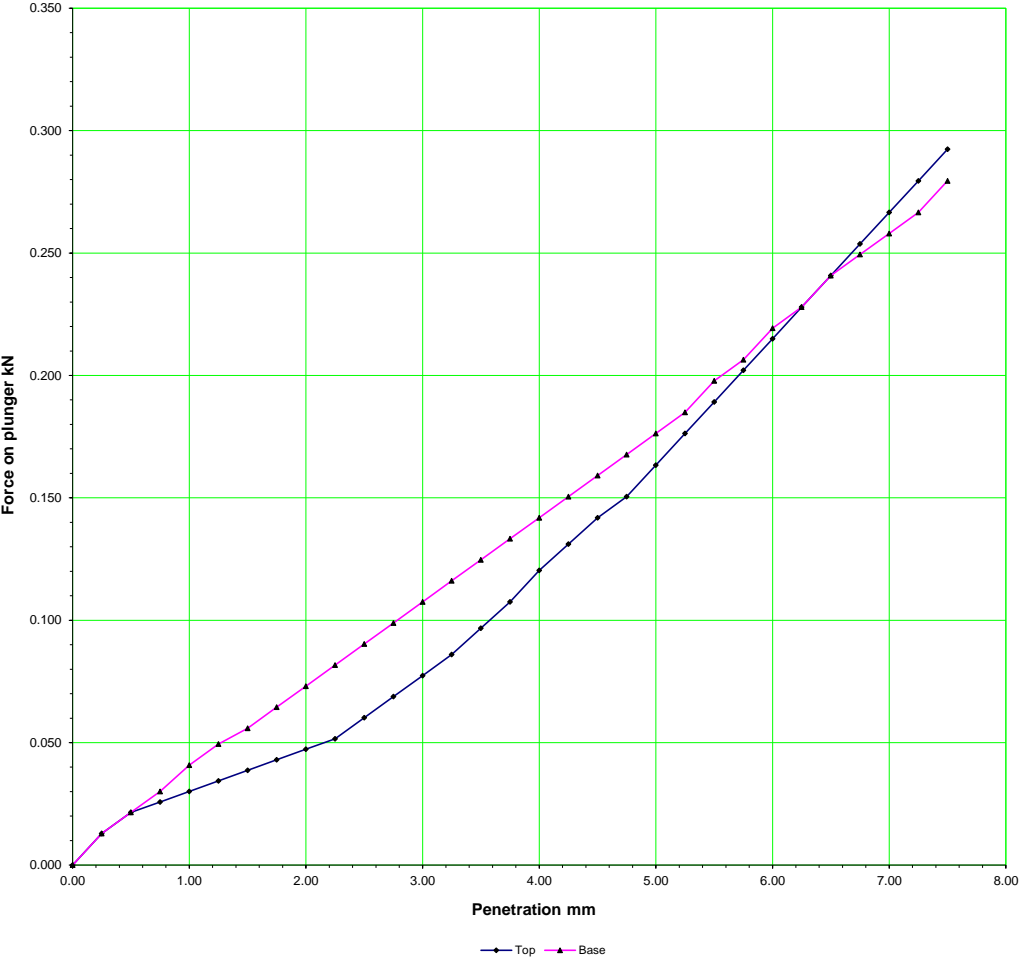
NM TL Ltd	Project: ATU Regional Sports Hubb		Date	Project No.	NMTL3607
		Operator	Tch 22-Feb-23	Trial Pit No.	TP01
		Checked	Nc	Sample No.	B
		Approved	Bc	Depth	1.30m

DETERMINATION OF THE CALIFORNIA BEARING RATIO TEST
BS 1377 : PART 4 : CLAUSE 7 : 1990

The proposed pavements are recommended to be designed in accordance with the CBR test results included in the Appendices of this Report. The low CBR test results indicate that a capping layer or a sufficient depth of crushed stone fill may be required. Plate bearing tests are recommended at the time of

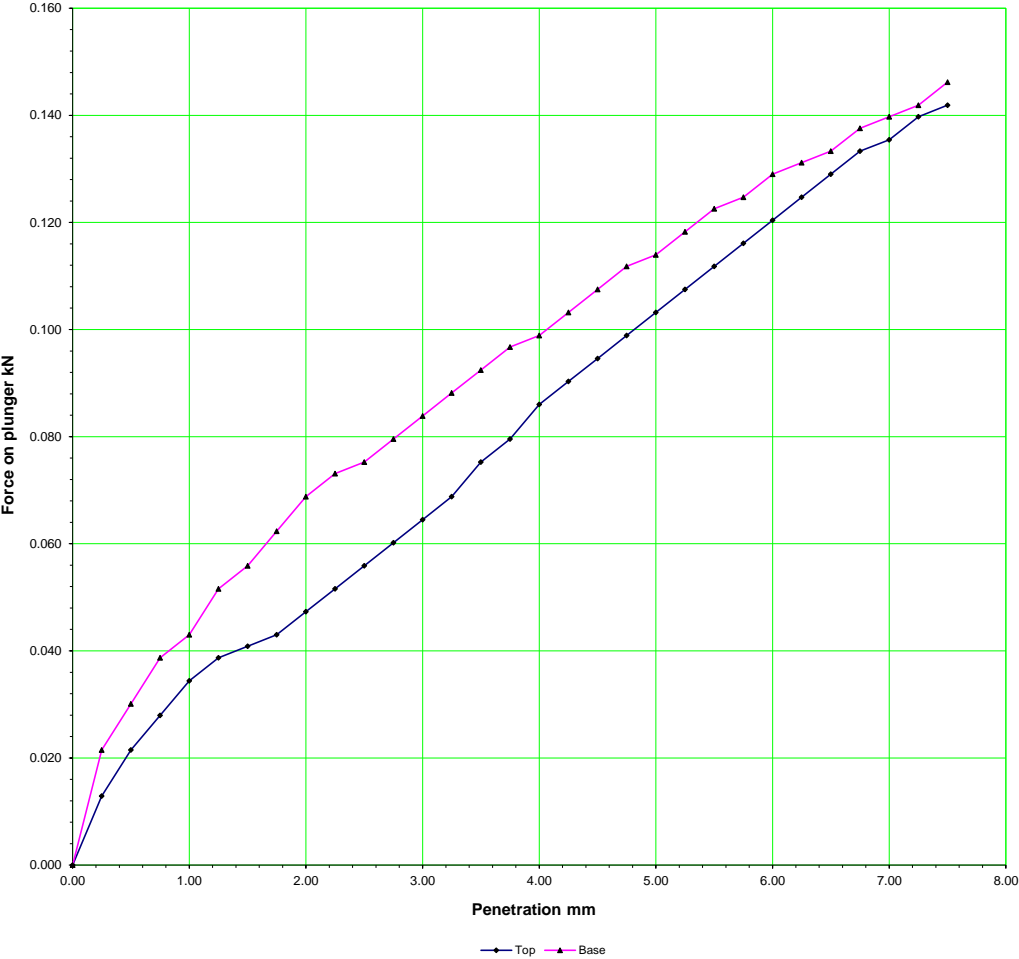
NM TL Ltd	Project: ATU Regional Sports Hubb		Date	Project No.	NMTL3607
		Operator	Tch 22-Feb-23	Trial Pit No.	TP02
		Checked	Nc	Sample No.	B
		Approved	Bc	Depth	0.50m

DETERMINATION OF THE CALIFORNIA BEARING RATIO TEST
BS 1377 : PART 4 : CLAUSE 7 : 1990

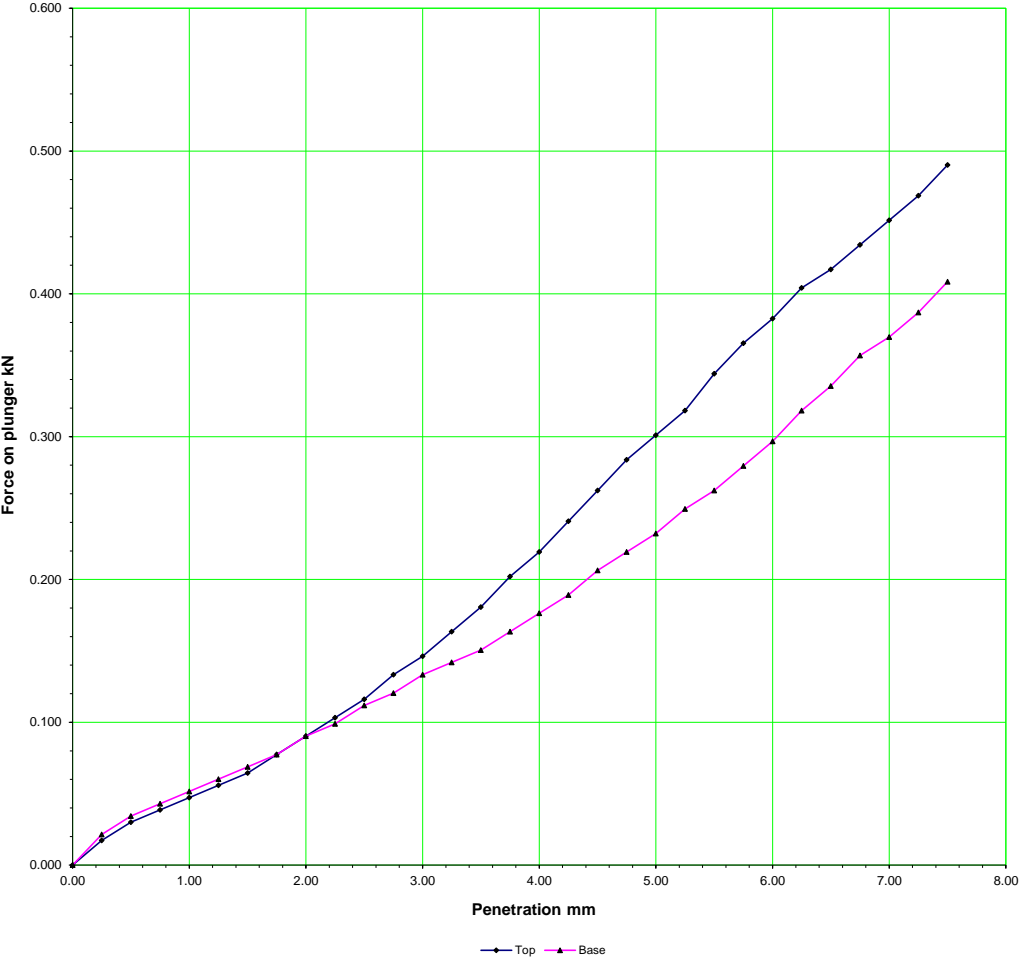
NM TL Ltd	Project: ATU Regional Sports Hubb		Date	Project No.	NMTL3607
		Operator	Tch 22-Feb-23	Trial Pit No.	TP03
		Checked	Nc	Sample No.	B
		Approved	Bc	Depth	0.50m

DETERMINATION OF THE CALIFORNIA BEARING RATIO TEST
BS 1377 : PART 4 : CLAUSE 7 : 1990
