BLANKET BOG REHABILITATION AND MANAGEMENT PLAN AT KILGARVAN WIND FARM, CO. KERRY

Dr. John Conaghan,

Consultant botanist,

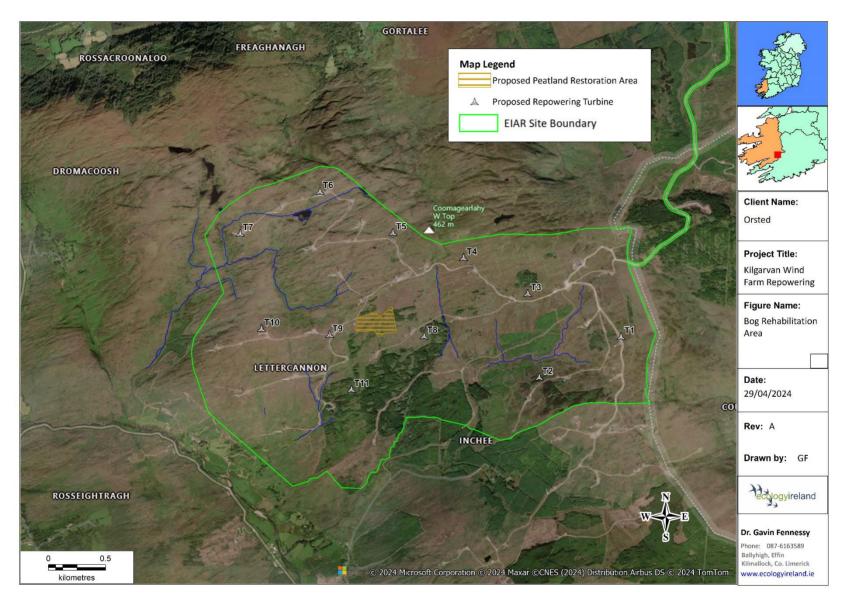
Figure A6.8.1. Location of peatland restoration area at the Proposed Development site.

The rehabilitation area is located in the western-central part of the EIAR Site Boundary (see Figure A6.8.1). The area is surrounded by a mixture of open blanket bog (to the north) and afforested wet heath/blanket bog. The plot measures approximately 5.5 hectares in area.
