## **APPENDIX 7-6**

### ***ELECTROFISHING SITE CHARACTERISTICS***

## Appendix 7-6 Kilgarvan Electrofishing Site Characteristics

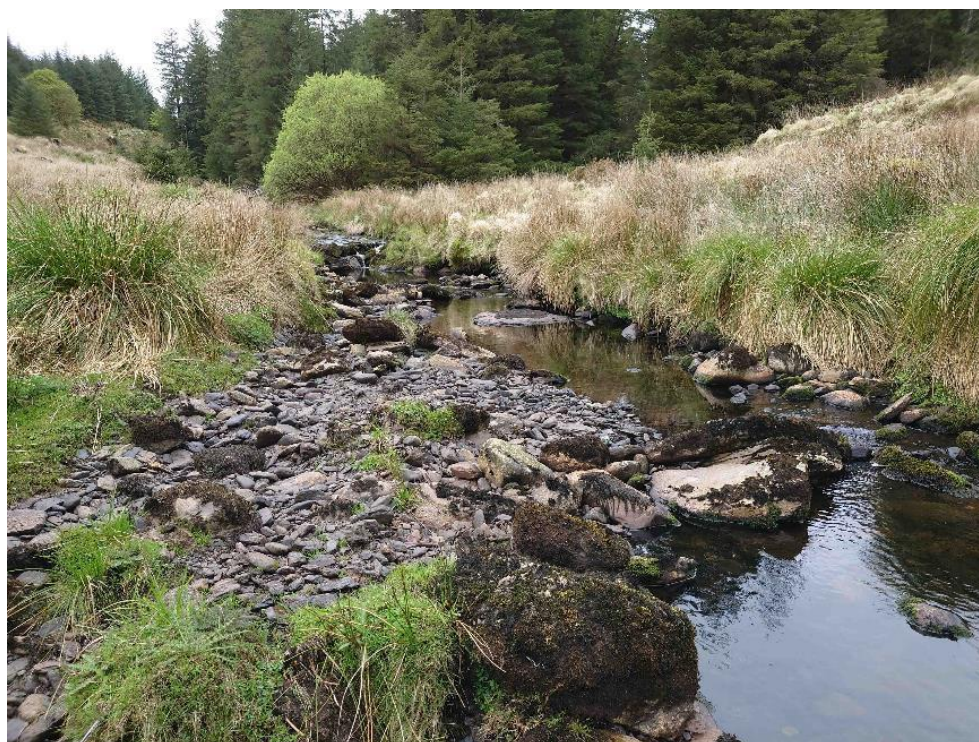
**Plate 1** Site K16 – Glanlee tributary, view upstream over lower reach of fished area (29/09/2022)

| Site Code | Site K16 |
|---|--|
| Habitat Type | Habitats include long pool/glides and short runs over cobble and vertical drops, which may form barriers to fish passage upstream. Moderately high gradient, mountain-type stream with leafy liverworts, <i>Fontinalis antipyretica</i> , <i>Rhynchostegium</i> and trace amounts of FGA ( <i>Microspora</i> and <i>Mougeotia</i> ) on the coarse substrate. |
| Other Observations | Generally open and unshaded in the sampled reach, but conifer meets the channel upstream. Habitat largely suitable for fish, but none present. |

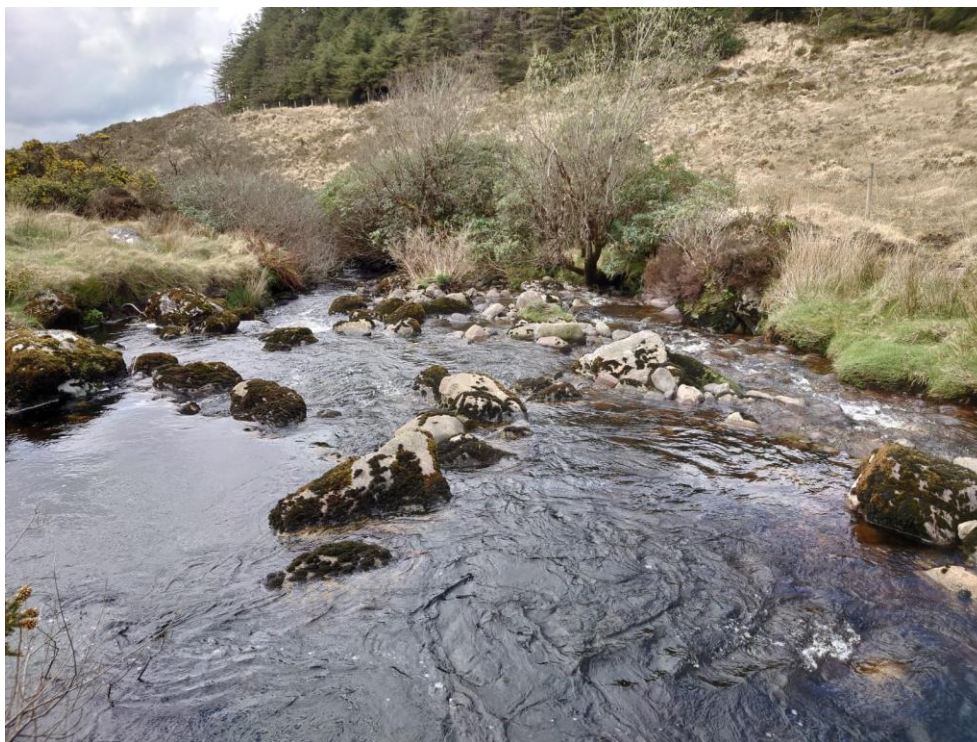
**Plate 2** Site K18, main channel of Inchee branch of Glanlee tributary – view downstream (29/09/2022)

| Habitat Type | Step-pool, cascade, glide/run and riffle/run. Moderately high gradient, mountain-type stream with leafy liverworts, <i>Fontinalis antipyretica</i> , <i>Rhynchostegium</i> . |
| Other Observations | Trout density was very low for a small upland river despite oligotrophic nature, siliceous rocks and high energy. Density should be 5-fold higher for a channel of its type. Possibly related to afforestation and/or absence of upstream / broadleaved riparian buffers. |

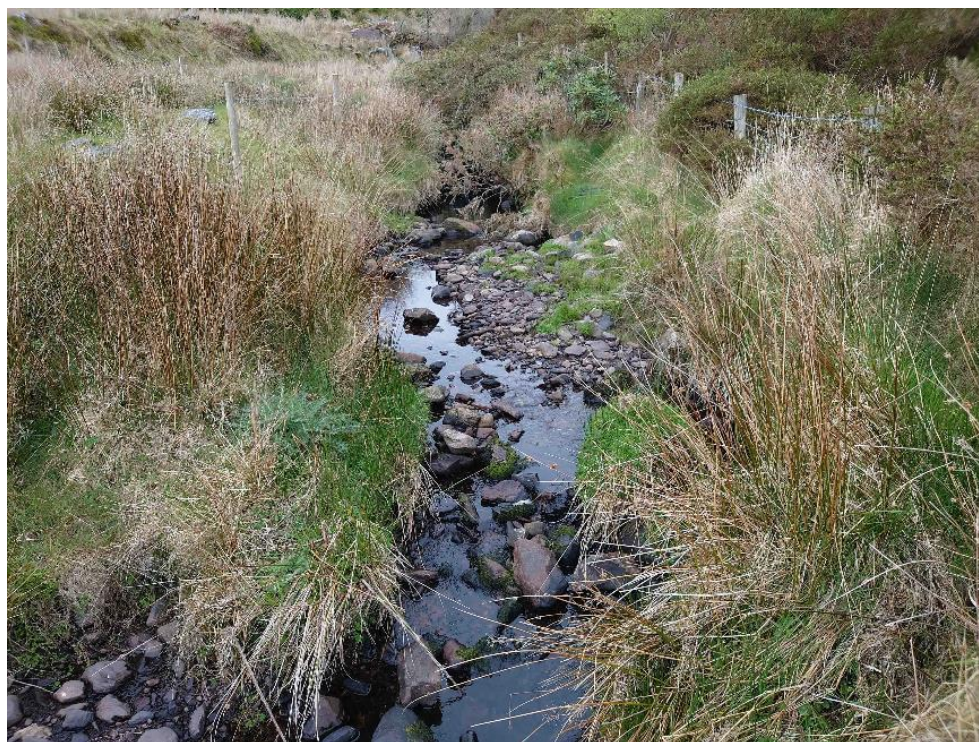
**Plate 3** Site K18B - view upstream (29/09/2022)

| Substrate Type | Cobble and pebble with a good cover of leafy liverwort, <i>Fontinalis antipyretica</i> and <i>Batrachospermum</i> on the larger substrate elements. Small amounts of interstitial peaty organic detritus present. |
| Habitat Type | Pool-glide 70%; riffle-run 30%<br>Small pool/glides and short riffle/run stretches, the latter in moderate to swift flow. |

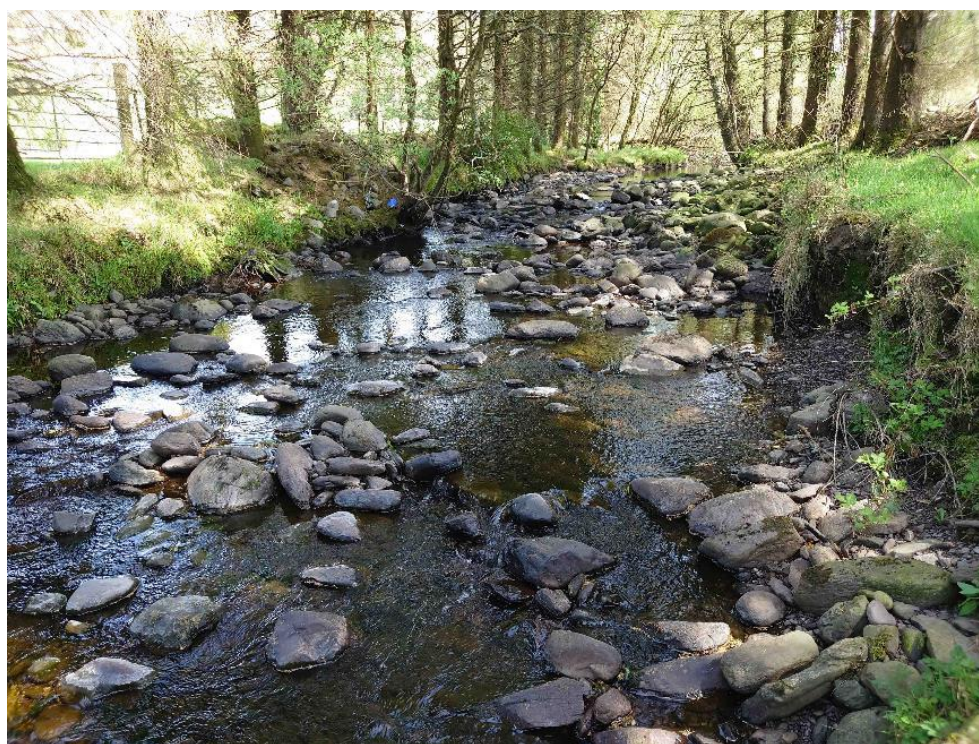
**Plate 4** Site K19, lower end of Glanlee tributary (just upstream Roughy River confluence) (19/08/2022)

| Habitat Type | Riffle-run 100%<br>Moderate to swift flow riffle/run with short step-cascades. In unshaded areas the channel had 30-50% cover of the filamentous green algae <i>Ulothrix zonata</i> . |
| Other Observations | Highly shaded in the lower reaches before the Roughy confluence. Heavy cattle access immediately downstream of survey reach. |

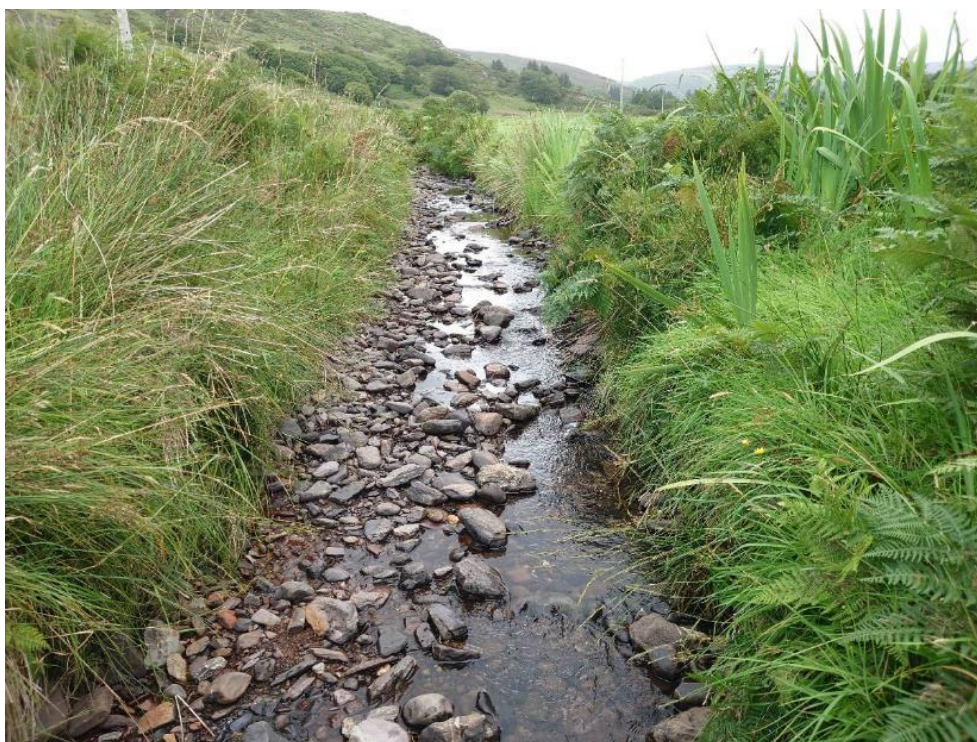
**Plate 5** Site K23 survey stretch – view upstream (19/08/2022)

| <b>Habitat Type</b> | Glide/run 70%, riffle/run 30%<br>Moderate to moderate/swift flow over a largely plant free substrate. Good salmonid nursery habitat. |
| <b>Other Observations</b> | Small tributary of the Roughty just above the confluence. Open, unfenced channel with improved pasture on both banks. Difficult to catch fish due to combination of coarse substrate and very shallow flows – density underestimated. |

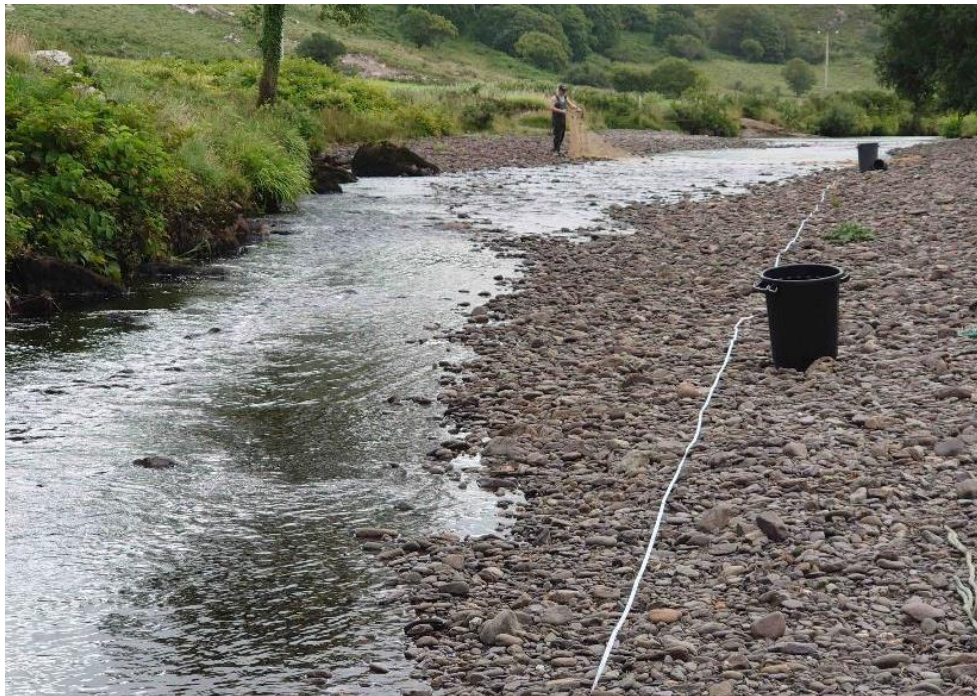
**Plate 6** Site K23 DS - Roughy River main channel, view downstream (20/08/2022)

| Habitat Type | Riffle 90% glide/pool 10%<br>Clear, Moderate to swift flow. Linear pool/glide all along the right-hand side (RHS) of the channel for ~ 40m with slight bank overhang and tree roots & branches extending into the channel concentrating the larger fish in the associated pools. <i>Lemanea</i> sp. was present on large boulders with <i>Fontinalis antipyretica</i> near the water line on the RHS. The RHS bank had some armouring below and grass and herbs above in a moderate to swift flow. Ideal for salmonid nursery. |
| Other Observations | Generally open in this reach with improved grassland up to the unfenced RHS bank. |

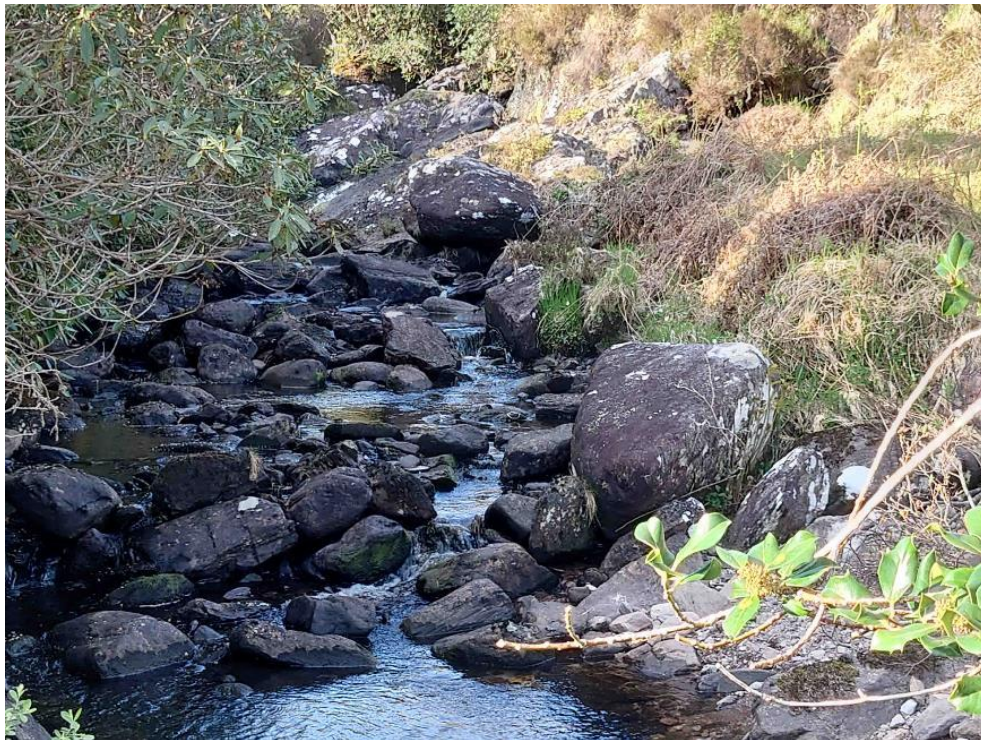
**Plate 7** Site K27 - Lower Thurechouma tributary, just upstream Roughty confluence (19/08/2022)

| <b>Habitat Type</b> | Riffle-run 50%; Glide 50%<br>Steep channel, comprising step-pools and short cascades of moderate to swift and swift flow. Substrates were covered with a light algal/peaty biofilm but were generally scoured. |
| <b>Other Observations</b> | Intermittently high-energy, spate stream. Good salmonid nursery, but limited spawning habitat owing to lack of finer gravels. Open, difficult to fish due to large boulders, fish density underestimated. |

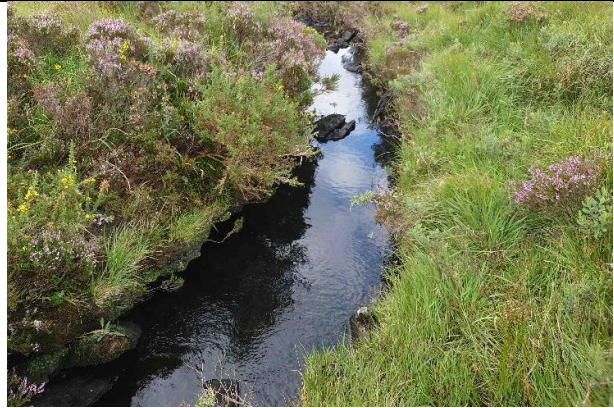
**Site K5 (X, Y ITM: 506599, 577082) Thurechouma tributary (2<sup>nd</sup> order)**

Small channel on the same tributary as K27 (see above) but further upstream near the windfarm.  
10-minute timed pass - suitable salmonid habitat but **no fish present**, possibly owing to natural fish passage barrier(s) downstream.

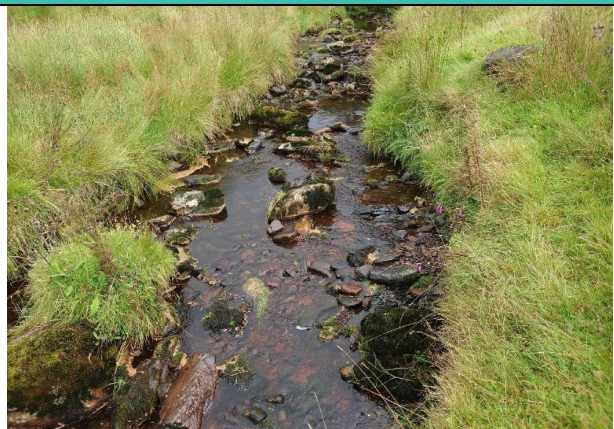
**Site K17A (X, Y ITM: 508868, 575239) Glanlee tributary (2<sup>nd</sup> order)**

Small channel on the same tributary as K19 and K18 (see above) but further upstream.  
10-minute timed pass - suitable salmonid habitat but **no fish present**, possibly owing to natural fish passage barrier(s) downstream.  
A steep waterfall was noted downstream of the survey site which explains absence of salmon.

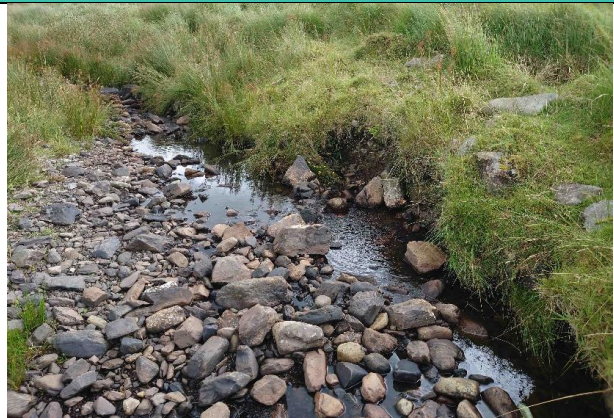
**Site K25 (X, Y ITM: 507473, 575651) Lettercannon tributary (2<sup>nd</sup> order)**

Small channel on the same tributary as K23 (see above) but further upstream near the windfarm.  
10-minute timed pass - suitable salmonid habitat but **no fish present**, possibly owing to natural fish passage barrier(s) downstream.
