Arklow Bank Wind Park 2

Environmental Impact Assessment Report

Volume III, Appendix 18.1: Marine Archaeology Technical Report

Marine Archaeology Technical Report

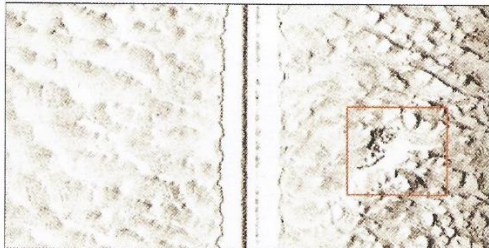
Reference	UTM E	UTM N	Latitude	Longitude	Survey Line/s	Exclusion Zone	
W02788	302221	5859559	52 50 57.84N	05 56 13.92W	LA_W_021.001; LA_W_022.001; L1313 LA W A 021 1 MAG	None	
Description and comment					Length	Width	Height
Unknown, Possible wreck, backscatter linears, acoustic shadow, scour mark and magnetic signature.					23.0	8.5	
No anomaly is indicated at the charted location in the 2019 data set. Magnetometer trackline directly overhead did not register it. The location is 70 m SE of 2019-identified Wreck sites LA_1602 and LA_1605, and 63 m WSW of magnetometer target MAG_LA_0049. Allowing for chart correction due to GIS projection, W02788 is considered to be more correctly located at LA_1605.

<i>Pl. 138 A 500 kHz side-scan sonar image of a possible wreck (W02788) discovered during a geophysical survey of the Arklow Bank in advance of the construction of a wind farm in 2001. (Courtesy of Donal Boland)</i>

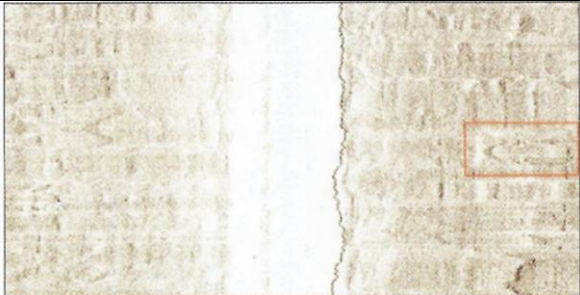
Reference	UTM E	UTM N	Latitude	Longitude	Survey Line/s		Exclusion Zone	
W02800	303111	5864357	52 53 34.08N	05 55 36.84W	LA_N_001_ext		50 m radius from centrepoint	
Description and comment						Length	Width	Height
Unknown, Possible wreck, SSS target, vessel shaped.						22.6	3.8	
No anomaly is indicated at the charted location in the 2019 data set.

<p><i>Pl. 140 A 500 kHz side-scan sonar image of a possible wreck (W02800) discovered during a geophysical survey of the Arklow Bank in advance of the construction of a wind farm in 2001. (Courtesy of Donal Boland)</i></p>								
<p><i>Previous marine geophysical survey records of W02783. Source: K Brady Shipwreck Inventory of Ireland, p. 495</i></p>						<p><i>2019 sonar trace at charted location</i></p>

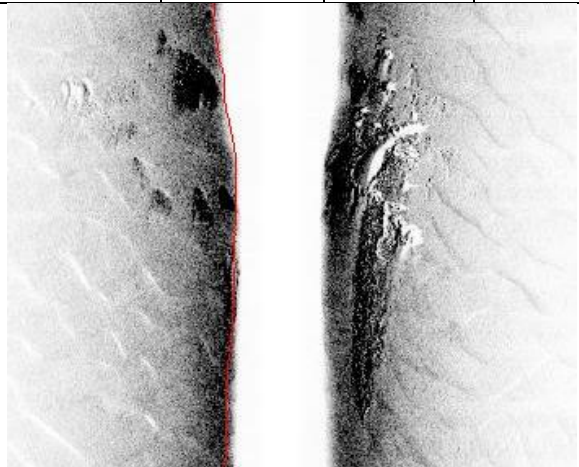
Reference	UTM E	UTM N	Latitude	Longitude	Survey Line/s	Exclusion Zone
UHC19004_SSS_ LA_0738	300789.0	5853374.6	52.793342	-5.954673	LA_W_018A_i4	50 m radius from centrepoint
Description and comment				Length	Width	Height
<p>Wreck.</p> <p>Clearly defined on seabed, orientated NNE/SSW with elements that stand proud in the northern half. Closely grouped set of debris and magnetometer targets extend 20 m N and 20 m S of the wreck's centrepoint. 21 m SW of Wreck/Wreckage LA_1061. 36 m NW of boulder cluster.</p> <p>The 2022 survey did not record any target at the location of LA_0738, but did record a boulder feature (GR_contact_0001) 30 m ESE, where a boulder cluster was recorded in 2019.</p>				21.3	9.0	1.2

<p>2019 survey summary of seabed at charted location</p>

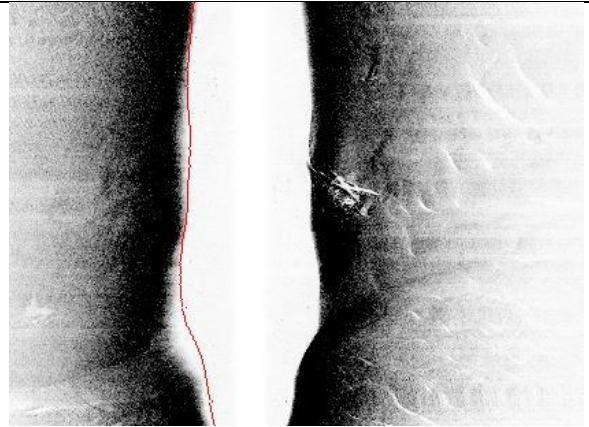
Reference	UTM E	UTM N	Latitude	Longitude	Survey Line/s	Exclusion Zone
UHC19004_SSS_ LA_0761 ; UHC19004_SSS_ R2_0991	300425.8	5853474.3	52.794103	-5.960113	LA_W_010c.004; R2B101	50 m radius from centrepoint
Description and comment				Length	Width	Height
Wreck.				19.3	4.0	2.5
Exposed on sand, suggested orientation NW/SE but bow and stern appear to be buried. Debris recorded 10 m to W and 20 m to E.						
The location was surveyed again in 2022 but it was not detected in any of the devices deployed above it, which comprised multibeam, SSS and magnetometer.

2019 survey summary of seabed at charted location				2019 sonar trace on line R2B101

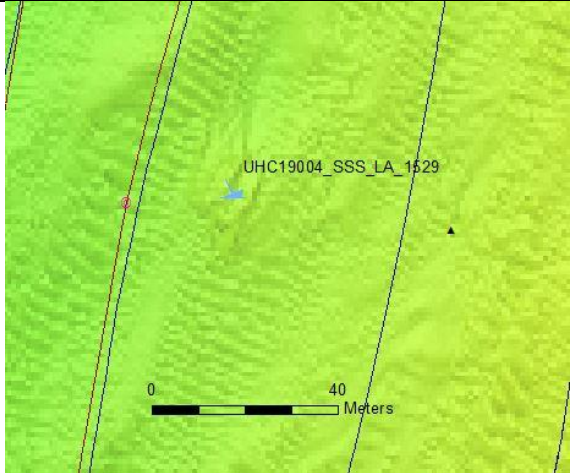
Reference	UTM E	UTM N	Latitude	Longitude	Survey Line/s	Exclusion Zone
UHC19004_SSS_ LA_1529	301879.8	5858841.5	52.842724	-5.941741	LA_W_018.001	50 m radius from centrepnt
Description and comment				Length	Width	Height
Potential wreck.				27.3	14.5	1.0
Poorly defined, seabed scoured around it, orientated NE/SW, magnetometer target MAG_0054 recorded on trackline 22 m to W.

2019 survey summary of seabed at charted location				2019 sonar trace

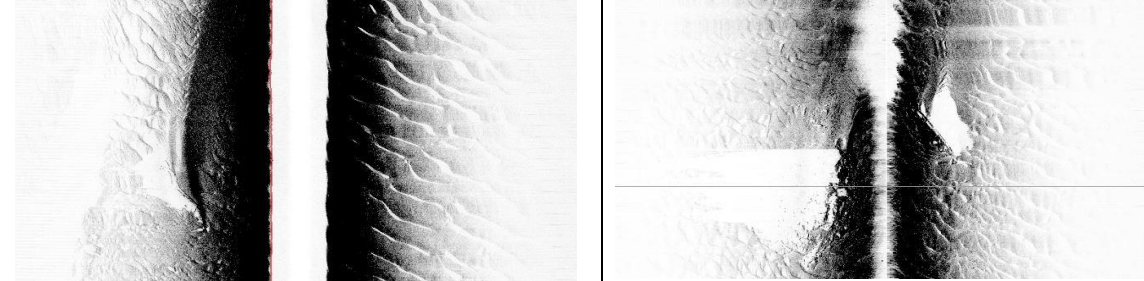
Reference	UTM E	UTM N	Latitude	Longitude	Survey Line/s	Exclusion Zone
UHC19004_SSS_ LA_1605	302183.5	5859618.1	52.849909	-5.937801	LA_W_021.001	100 m radius from centrepont
Description and comment				Length	Width	Height
Wreck. Well defined hull and probable bow, lying on its side, orientated N/S with bow to S. Magnetometer target 0048 directly associated with it. Scour hollow extends c. 100 m NE. 30 m ENE of Wreck LA_1602. 66 m NE of W02788. Considered to be the same site.				24.2	7.3	2.0

2019 sonar trace line LA_W_021.001				2019 sonar trace LA_W_020_001, Slant Range corrected

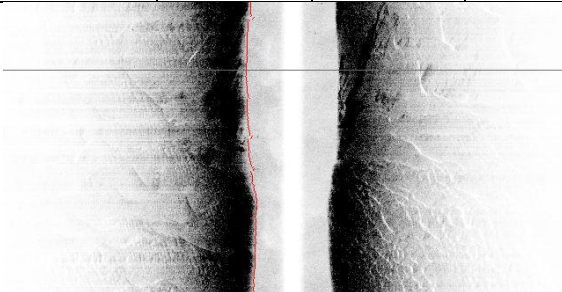
Reference	UTM E	UTM N	Latitude	Longitude	Survey Line/s	Exclusion Zone
UHC19004_SSS_R2_1035	300650.4	5853694.1	52.796034	-5.956860	R2B105	50 m radius from centrepont
Description and comment				Length	Width	Height
<p>Potential wreck.</p> <p>Debris and associated linear scour feature, and debris recorded extending 20 W in a linear fashion, with boulders recorded to E.</p> <p>The 2022 survey did not record any features at this location.</p>				8.7	4.8	1.2

<p><i>2019 survey summary of seabed at charted location</i></p>

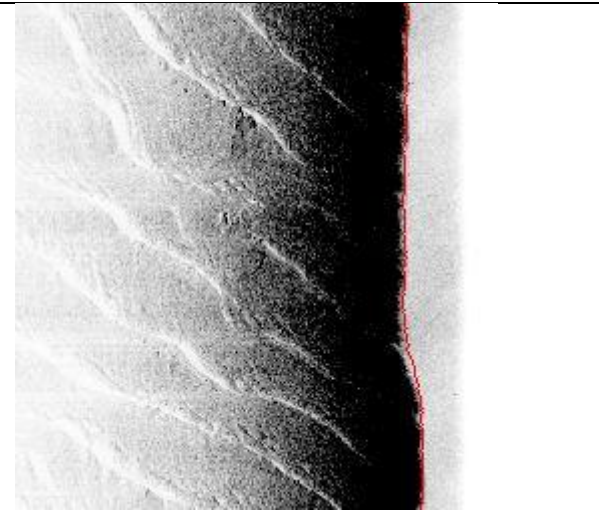
Reference	UTM E	UTM N	Latitude	Longitude	Survey Line/s	Exclusion Zone
ADCO_7	299894.0	5849084.0	52.757778	-5.963333	LA_W_017.005	100 m radius from centrepont
Description and comment				Length	Width	Height
The SSS trace of 2019 shows a defined boat-shaped feature aligned N-S, that is mostly buried. A magnetometer contact was recorded within 10 m of the site, target MAG_0023.				12 m

2019 sonar trace				2019 sonar trace, enlarged
