7 LAND AND SOILD

This chapter has been prepared by John Considine, BE, MStructE, MIEI, CEng, FConsEIM, Chartered Engineer of Barrett Mahony Consulting Engineers and Mr. Paul Stephenson, BE, MIEI, CEng, Chartered Engineer of Barrett Mahony Consulting Engineers.

This section of the EIAR assesses the impacts that the proposed development at Leopardstown Road, Dublin 18, may have on the Land and Soils (including land take) on the surrounding area during the construction and operational phases. This report also addresses earthworks proposed on site including any cut and fill works required.

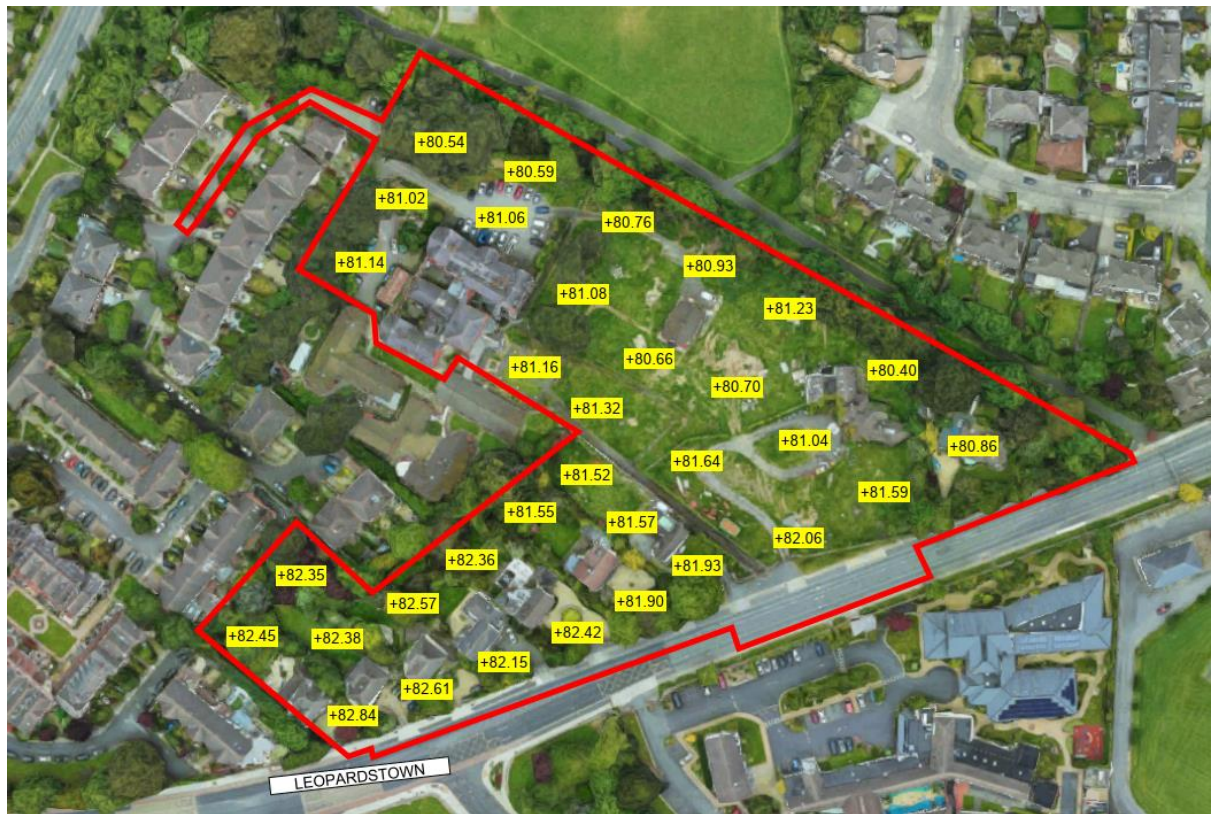
Figure 0:1 – Topographical Survey Extract

There is little variation in ground levels across the site. In broad terms the site generally slopes down from the higher western side of the site to the lower eastern boundary. The difference in ground levels is minimal, with the highest point of the site recorded at approximately +82.84, and the lowest point recorded at +80.66, a difference of 2.18m over a distance of 150m.

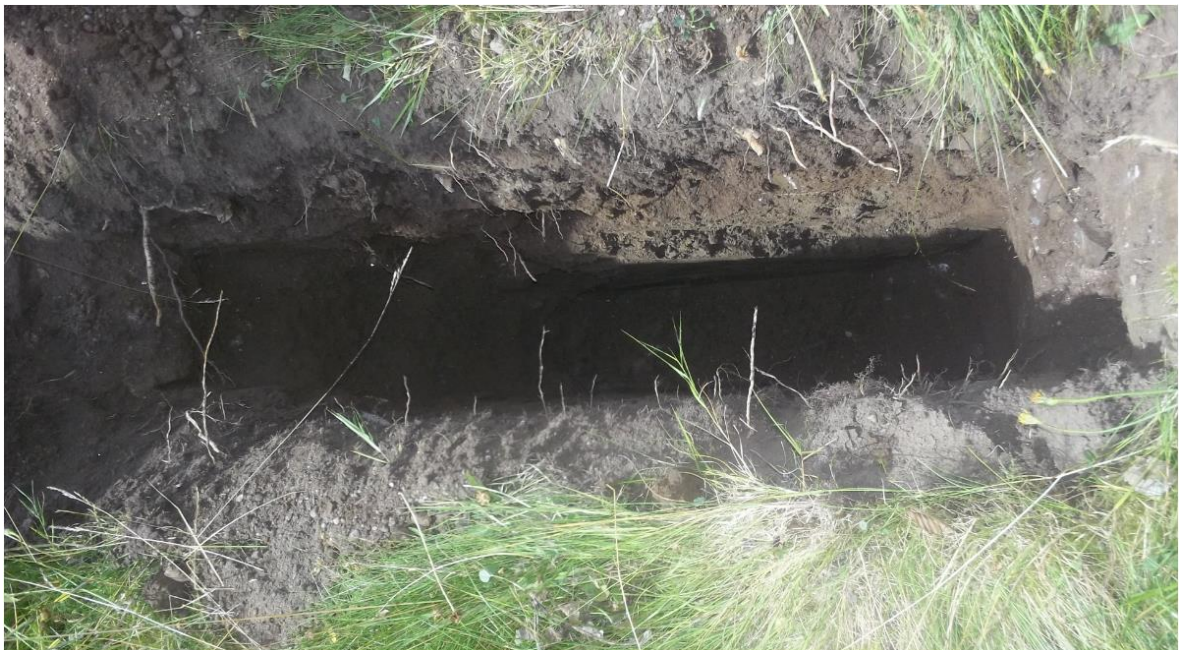
Test Pit before water added – Depth 1.2m

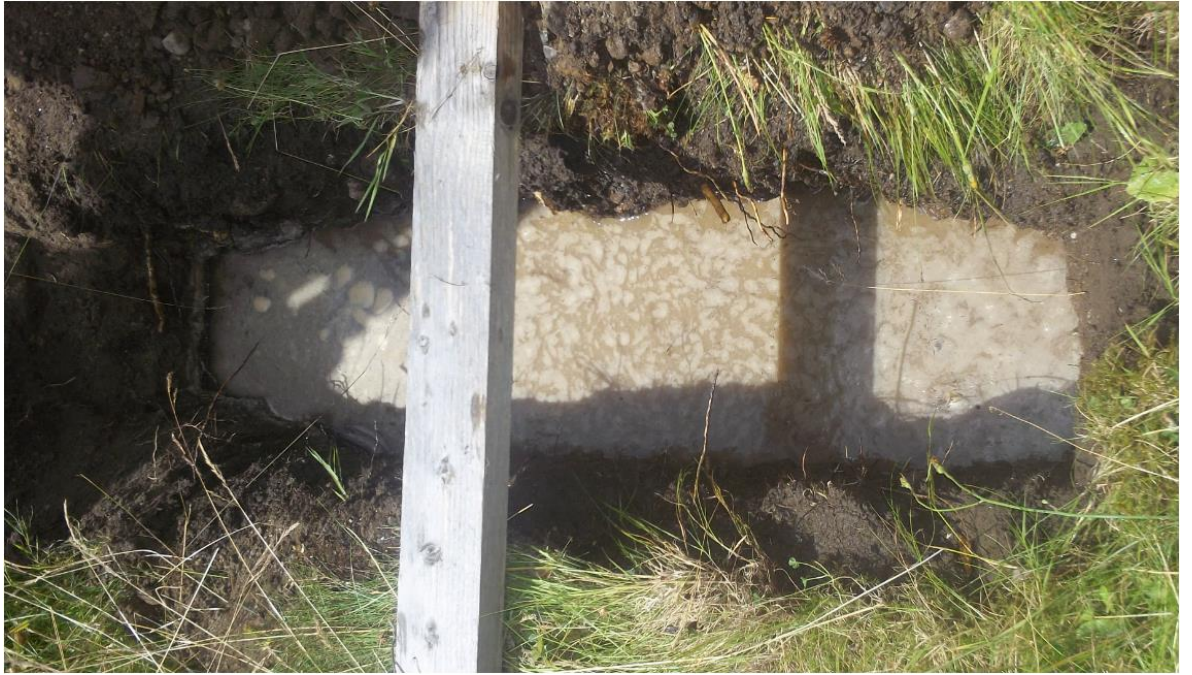
Pit during test

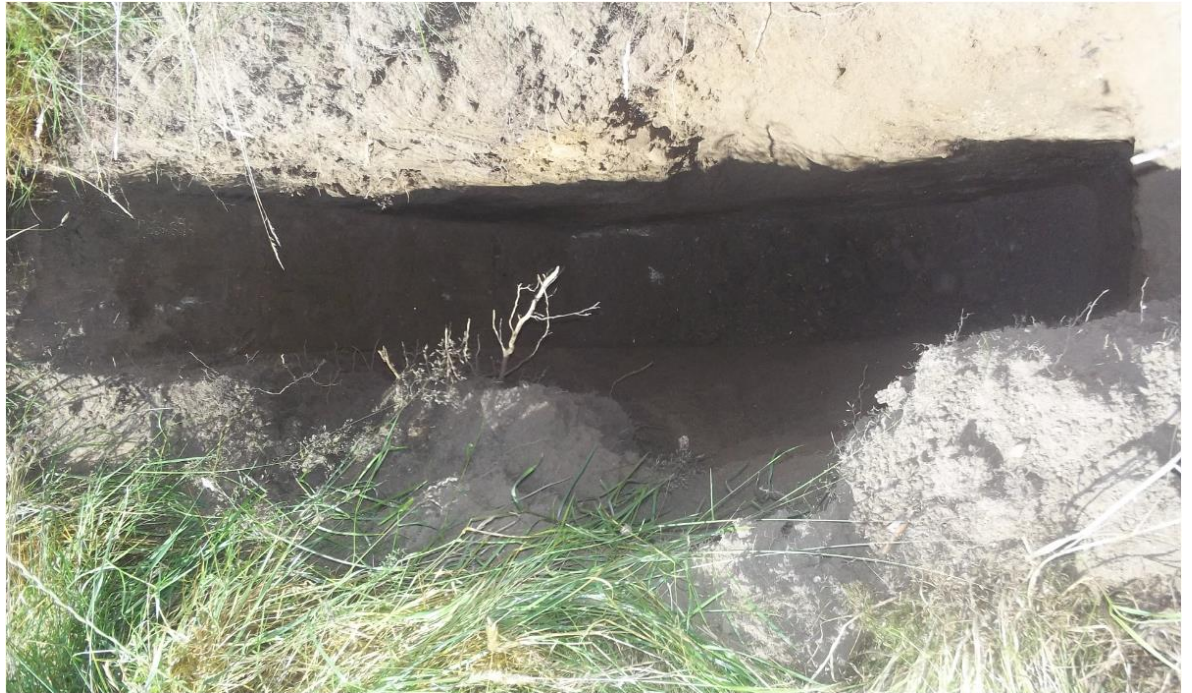
Test Pit before addition of water – depth 1.2m
