# Clonberne Wind Farm Peat Stability Risk Assessment (PSRA)

Client	<b>MKO</b>
Document Ref.	20021-R-01-03
Project Title	Clonberne Wind Farm
Date	09/04/2024

Project Title:	Clonberne Wind Farm
Report Title:	Clonberne Wind Farm Peat Stability Risk Assessment (PSRA)
Document Reference:	20021-R-01-03

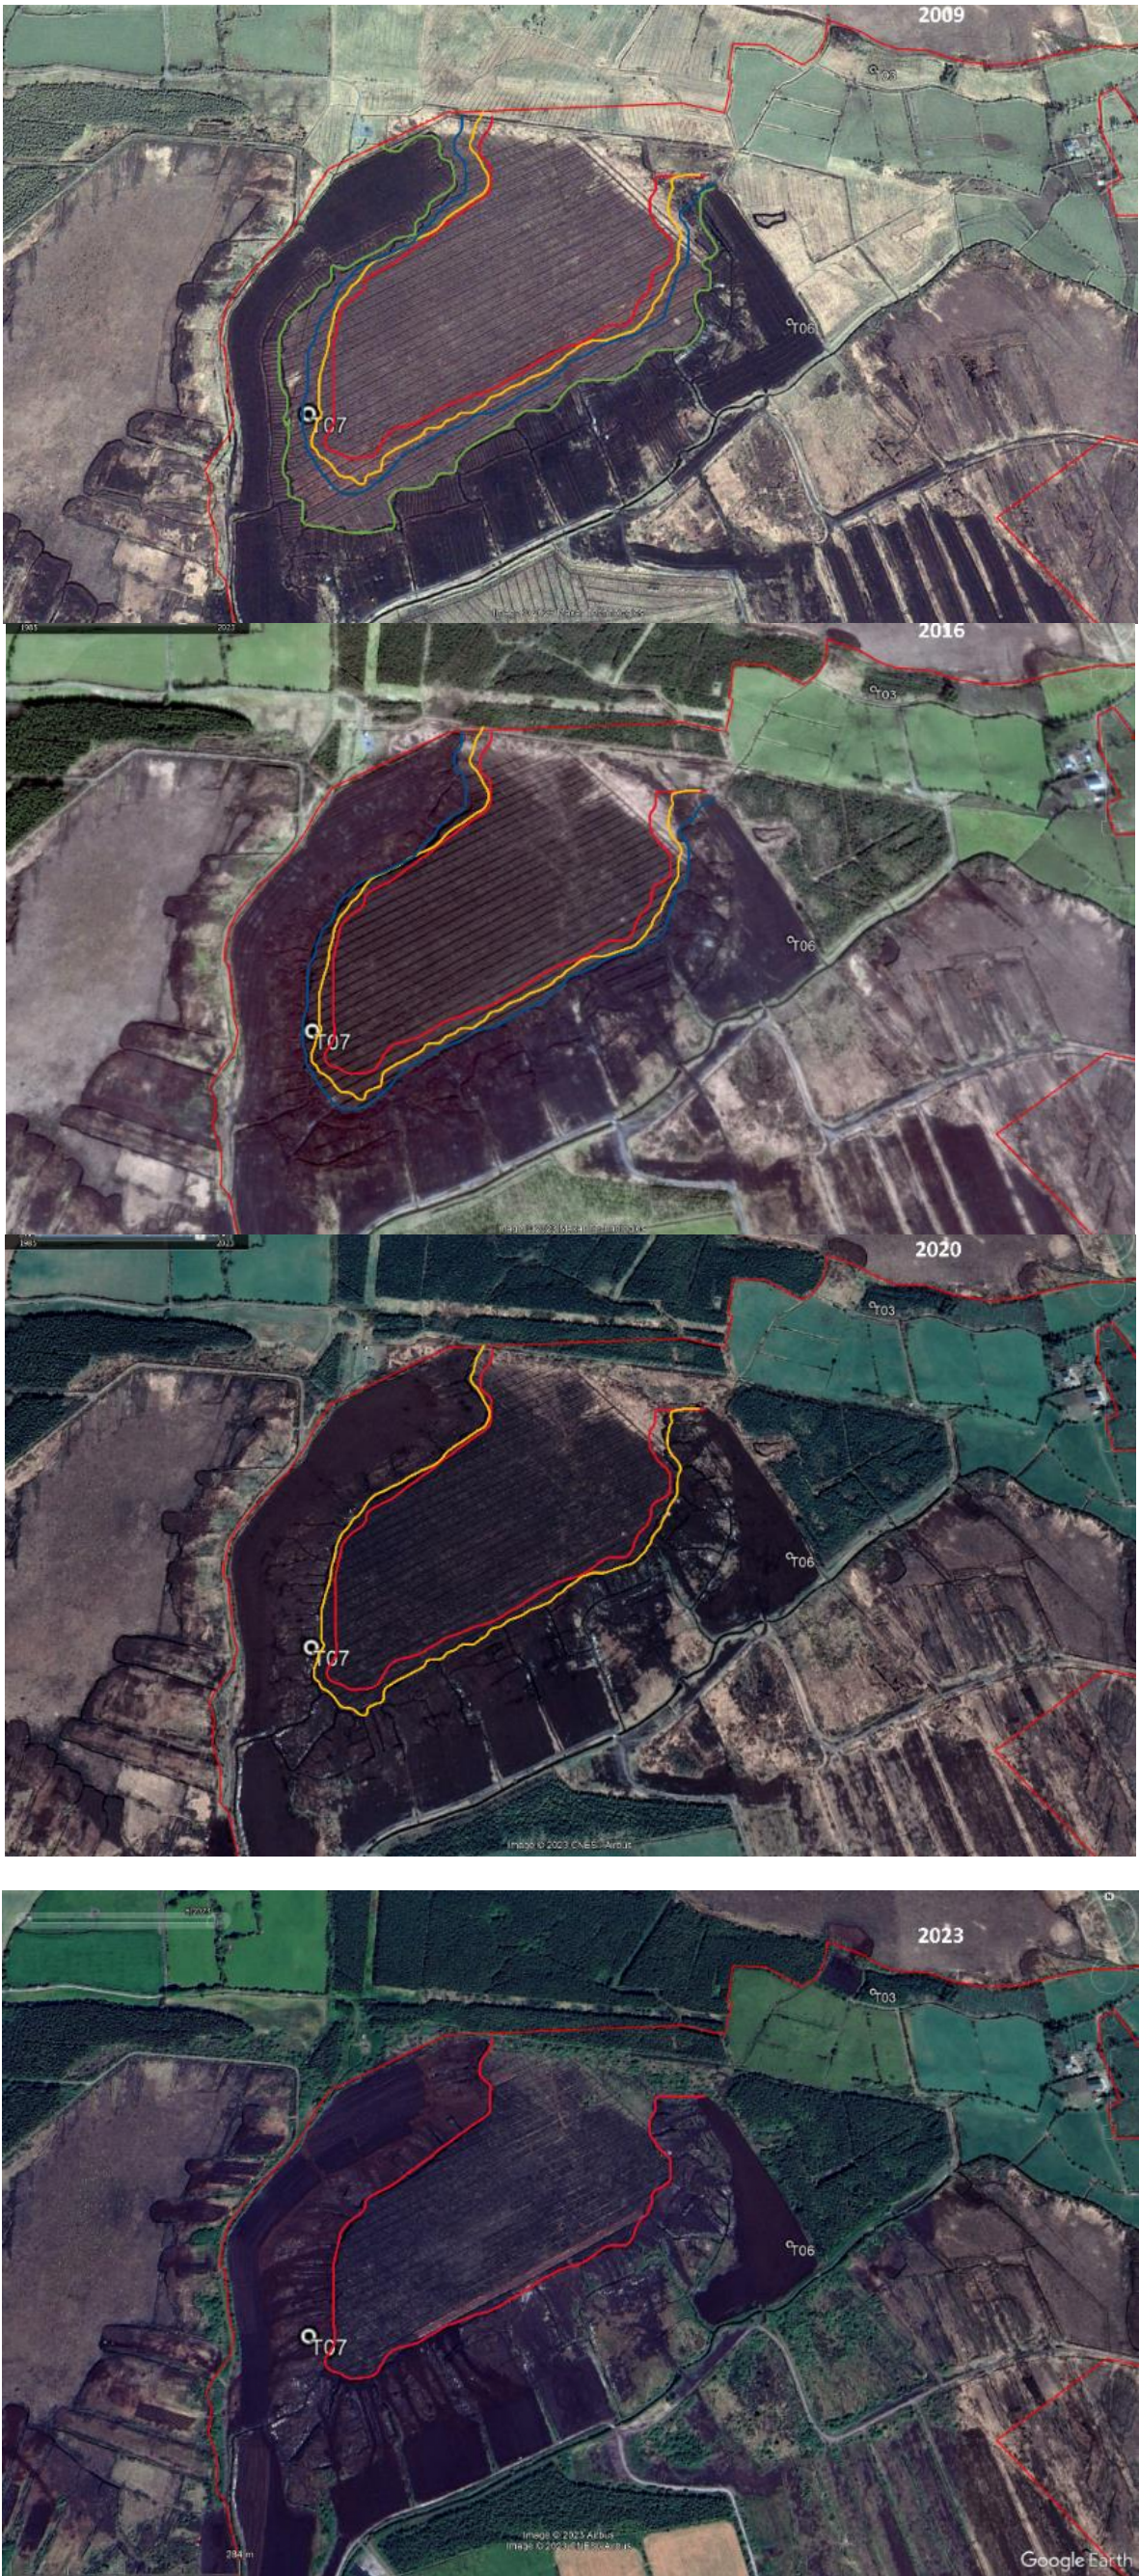
Figure 2-1: Peat cuts and harvesting at T07, showing the retreat of peat cuts from the turbine location (Google Earth, 2009-2023).

- Identify evidence for land management practices that can influence ground conditions (e.g., burning, artificial drainage, peat cutting, forestry). Figure 2-1 and Figure 2-2 illustrate examples of peat cutting and the evolution of the peat extent from 2009 to 2023 due to peat harvesting in the sector of T7 and T10-T11, respectively (2009 shown in green, 2016 shown in blue, 2018 shown in yellow, and 2023 shown in red). In particular, it must be noted that peat harvesting in proximity to T07 has moved areas of deep peat away from the T07 turbine location since the date of the topo capture used in the peat stability calculations (2017).

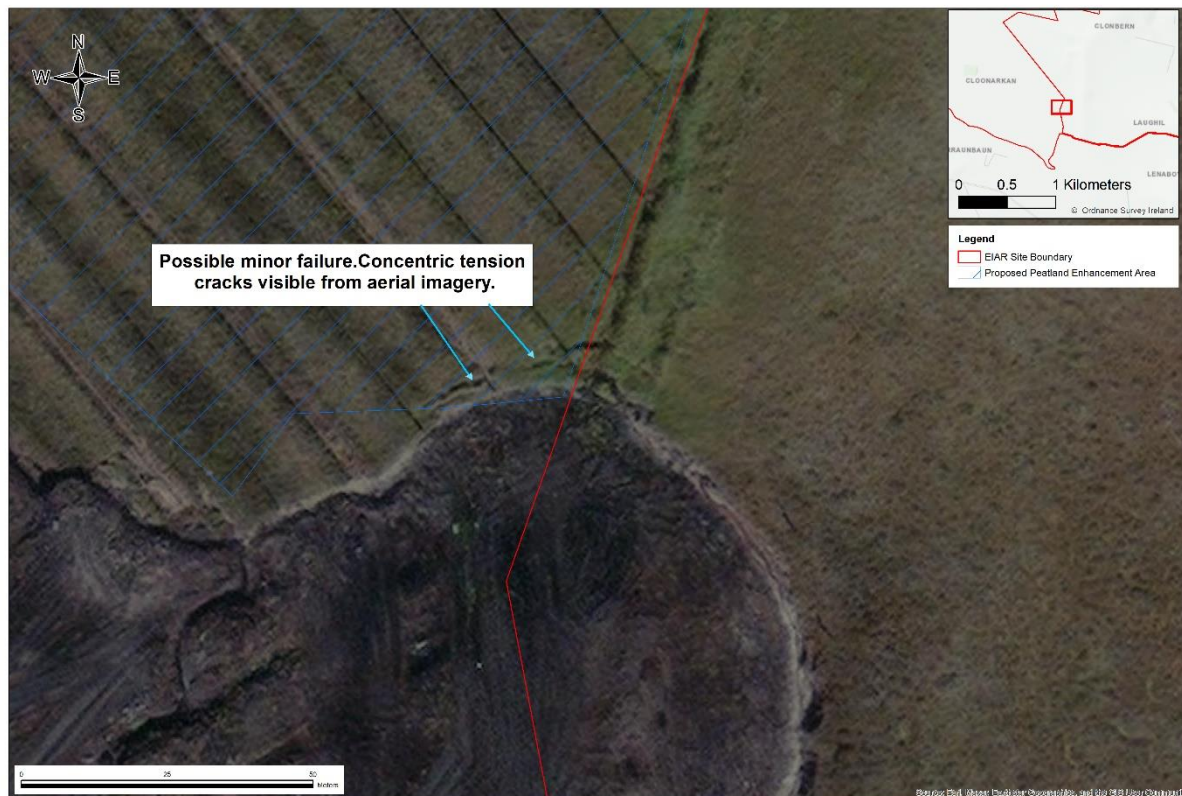
**Figure 2-3: Possible minor failure at the southern edge of the area proposed for peatland enhancement as part of the Proposed Peatland Enhancement Area (ESRI World Imagery, 2020).**

A potential existing failure has been identified at the southeast corner of the area proposed for peatland enhancement, as seen in Figure 2-3. Minor tension cracks suggesting a potential partial failure of the peat cut margin are identified in this location. The aerial imagery analysis suggests that these features are associated with desiccation and drying out of the peat in this location.

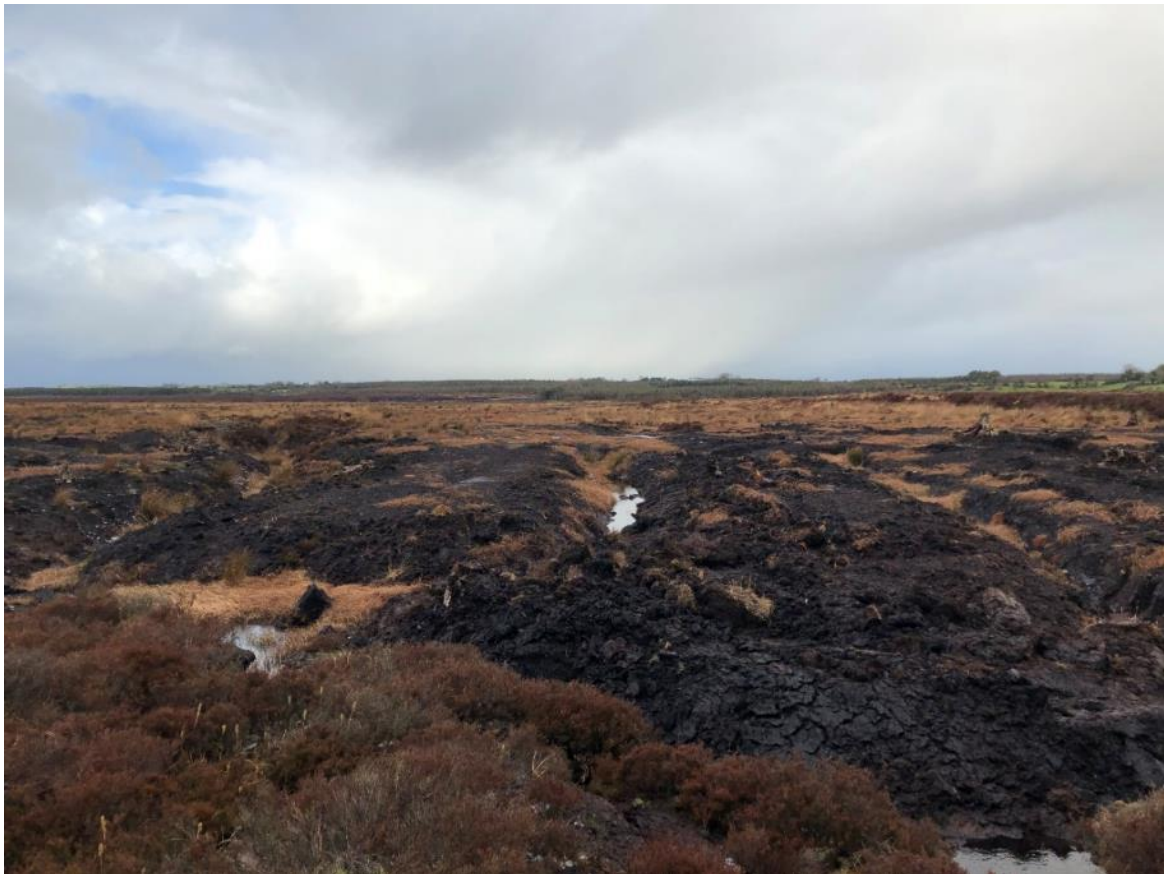
**Figure 3-1: Harvested peat close to T11.**

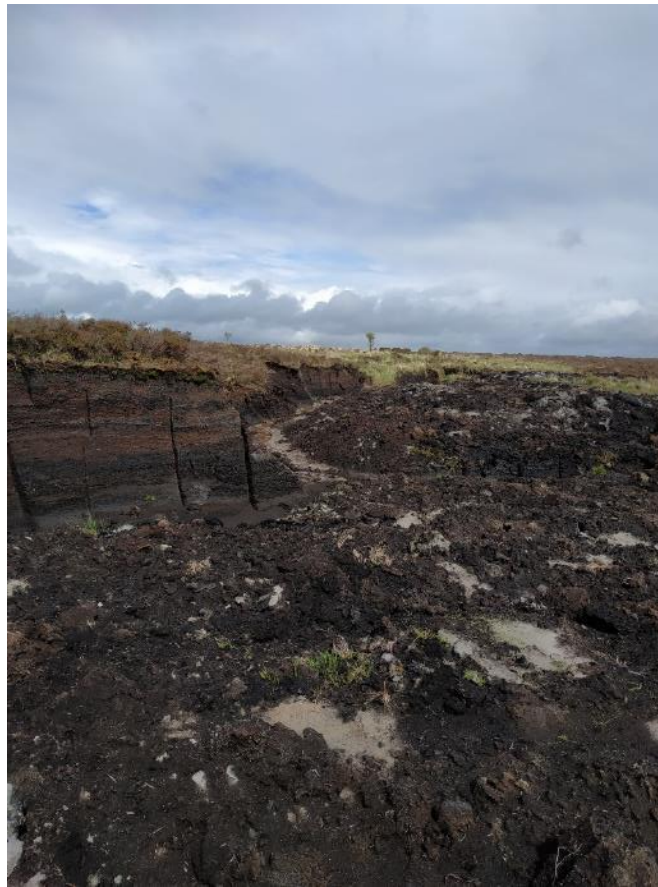
**Figure 3-2: Peat cuts 100m east of T10.**

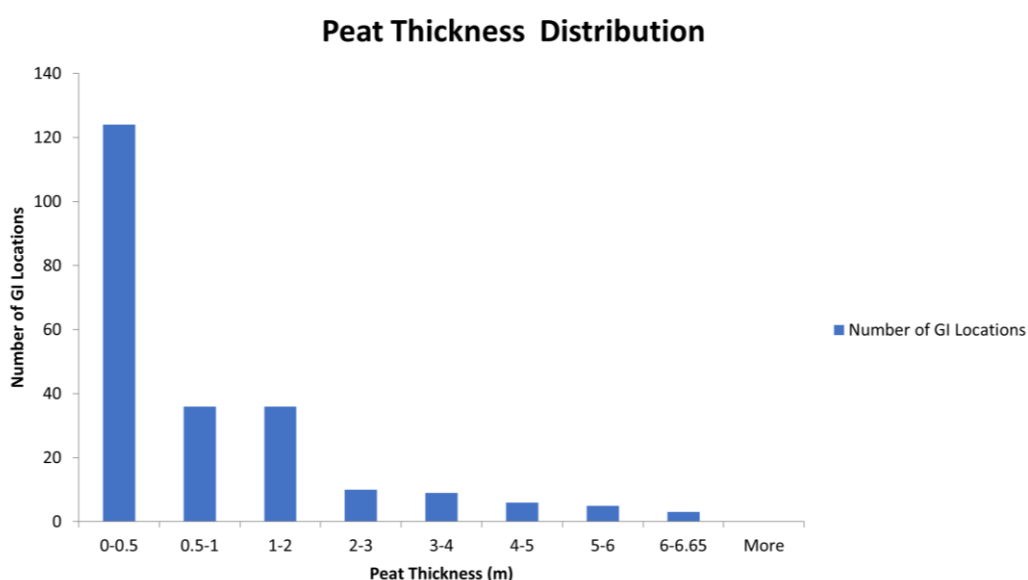
**Figure 3-3: Histogram of peat thickness results across the site.**

The frequency of different peat thicknesses is shown in Figure 3-3. In total, 69.9% of recorded peat thicknesses were under 1m, and 85.6% were under 2m.

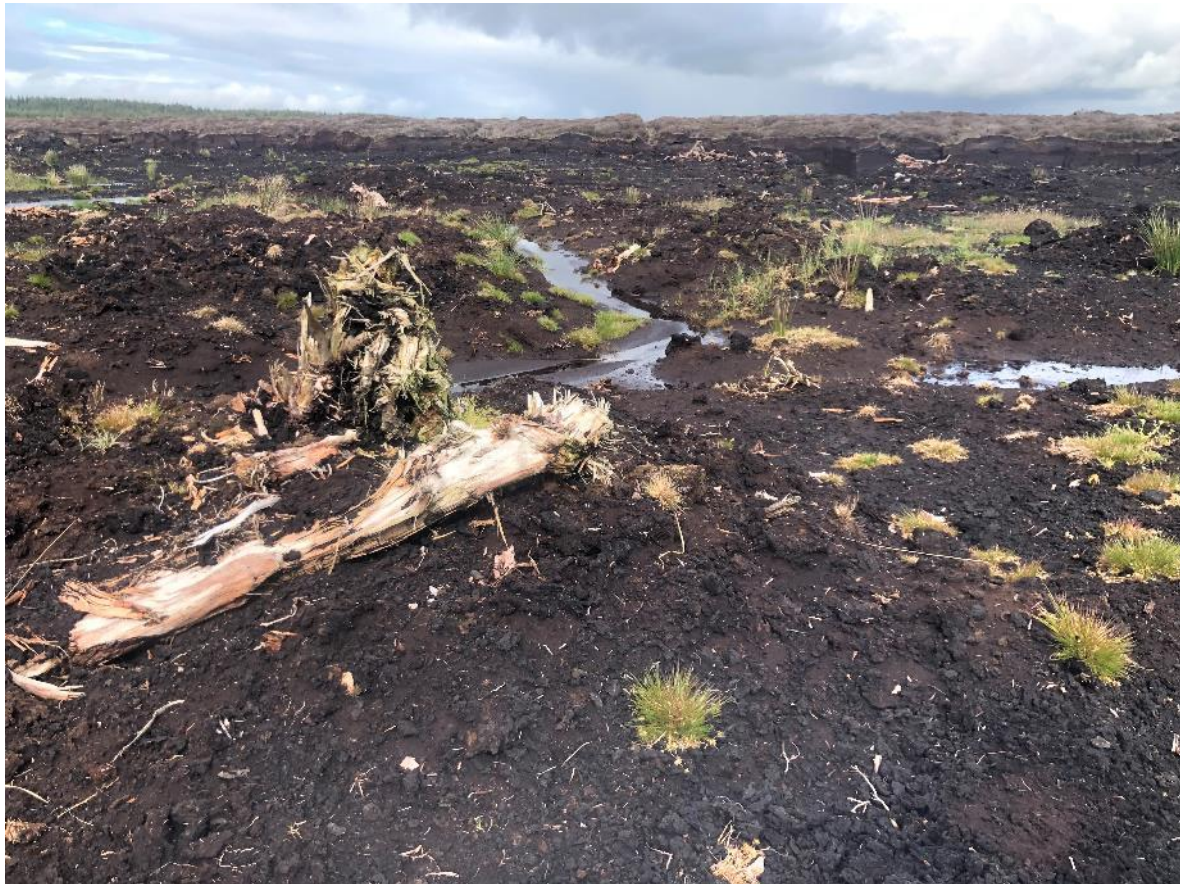
**Figure 4-2: View looking east across the proposed T7 location showing the high peat cut face in the background.**

Much of the Proposed Project Site contains flat-lying, deep peat with active peat cutting. Steep peat cuttings of <1m generate low factors of safety but are considered to be generally of low landslide risk. Raised bog environments like this site may be susceptible to bog burst type failures, which can occur at very low slope angles and may not be fully quantified by the FoS calculation, as they are driven by hydrological factors rather than slope-driven. For this reason, the locations need to be assessed on-site and 'ground-truthed' to identify true hazards. GDG site walkovers identified no evidence of significant bog burst features; however, as described in Section 2.6, a small area of possible past failure at the peat margin was identified.

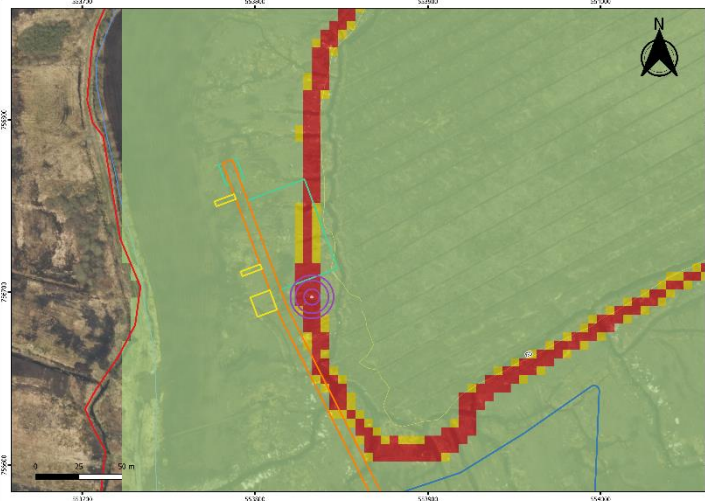
Risk and mitigation	Undrained surcharged FoS analysis
<p>A small section of road interacts with an area of FoS &lt;1.3 in the undrained scenario with 10kPa surcharge. This low factor of safety is assessed to arise from locally deep peat and high slope angles calculated at relict existing peat banks. It is determined that these do not present a global risk of peat failure, <b>but that the ground should be levelled and stabilised locally prior to construction, and that peat should not be placed in this area.</b></p>

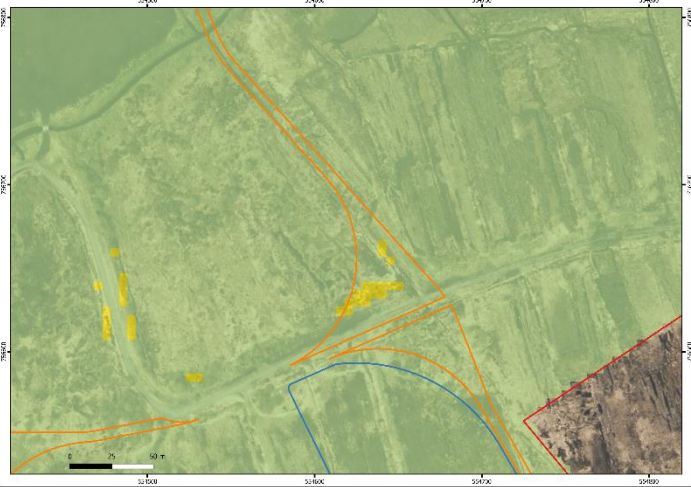
<p>A small section of access road and the cable route with an area of FoS &lt;1.3 in the undrained scenario with 10kPa surcharge. This low factor of safety is assessed to arise from locally deep peat and high slope angles calculated at relict existing peat banks. It is determined that these do not present a global landslide risk. <b>The ground should be levelled and stabilised locally prior to construction, and peat should not be placed adjacent to the road in this area.</b></p>

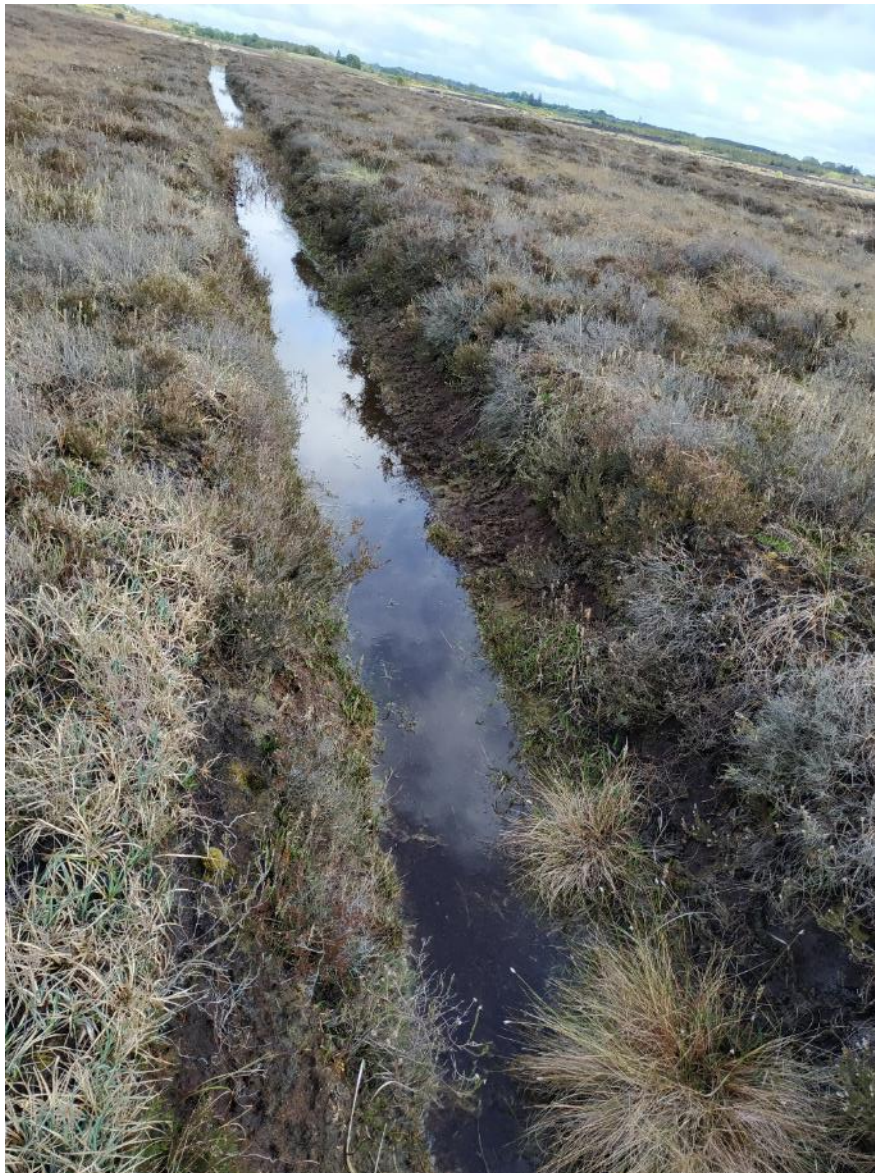
**Figure 5-1: Parallel drainage ditches at the north end of the proposed area of peatland enhancement.**

The location of the proposed peatland enhancement can be seen in Figure A- 1 in Appendix A. The proposed area consists of a section of raised bog (maximum peat thickness from probes recorded at 3.88m), with parallel drains running NW to SE, roughly every 10-15m across the peat surface. The depth of the existing drains is estimated based on limited site walkovers to be between 0.5-1m. The current condition of the drained peat can be seen in Figure 5-1.

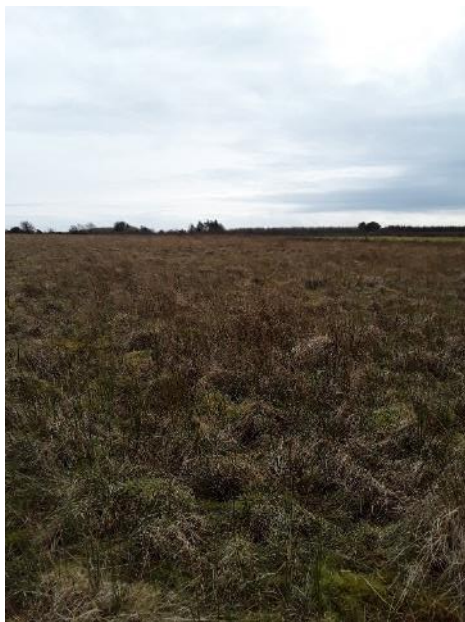
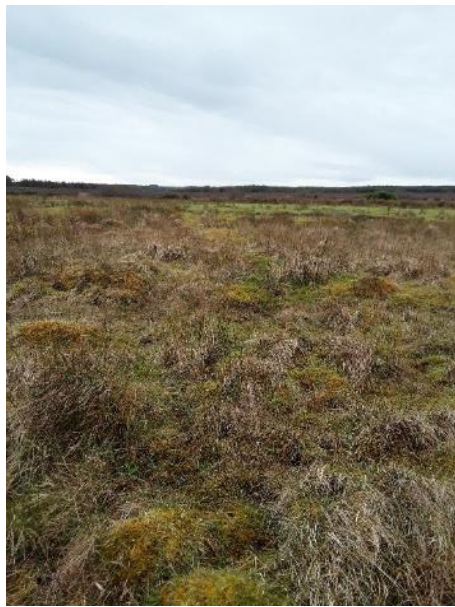
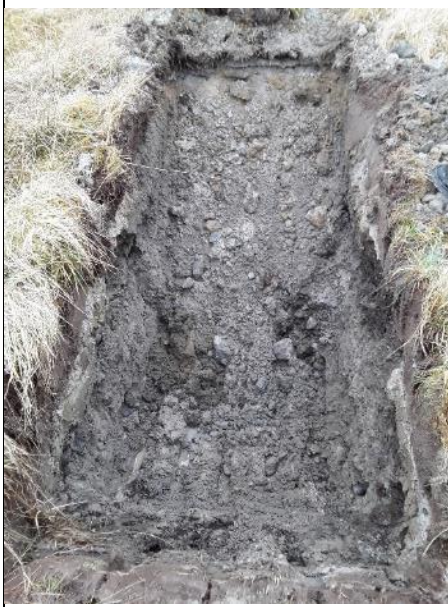
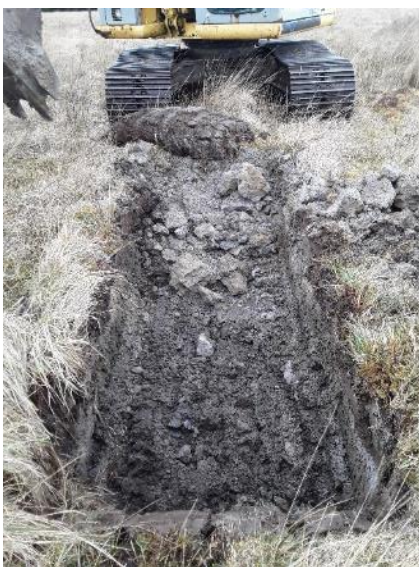
<div>Description</div> <p>Date of the satellite images: March 2022. [Maxar/Esri].</p> <p>Date of the ground-based pictures: 25<sup>th</sup> of February 2020 and , 15<sup>th</sup> of September 2023 [GDG].</p> <p>Geomorphology: T1 is located on a raised peat bog. Topography is flat.</p> <p>Peat: The peat depth at T01 is 0.3 m and slope angle of 1.8 degrees.</p> <p>Instability evidence: No.</p>		<div>20200226_155012.jpg</div>

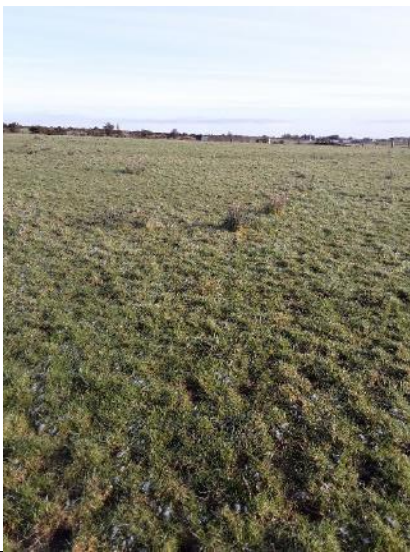
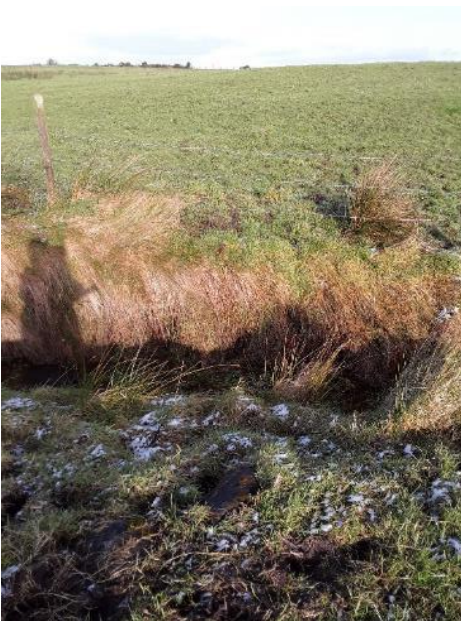
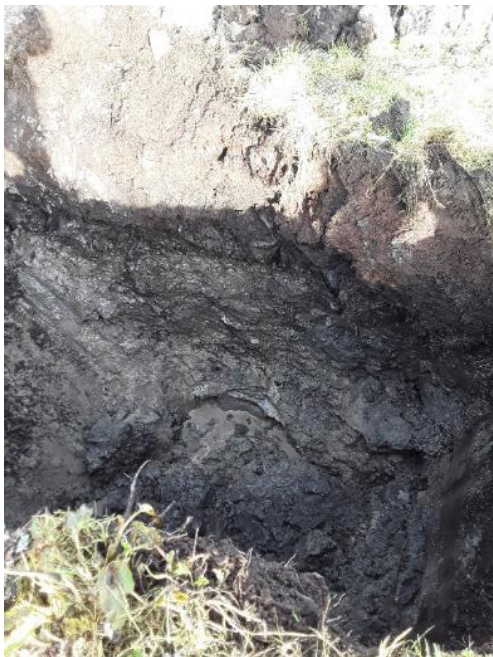
Table J- 2: Site reconnaissance of the Turbine 2 site.

<p>Shared legend</p> <div><p><b>Legend</b></p><p> Photo Locations</p><p> GI Locations</p><p><b>Layout</b></p><p> Turbine Layout</p><p> Borrow Pit</p><p> Cable Route and Cable Access Track</p><p> Cable in the Public Road</p><p> Construction Compound</p><p> Crane Platform Handstanding</p><p> ETAR Site Boundary</p><p> Existing Road To Be Upgraded</p><p> Peat Repository Areas</p><p> Peatland Enhancement Area</p><p> Proposed Roads</p><p> Proposed Spoil Storage Area</p><p> Soft Levelled Areas</p><p> Spoil Repository Access Road</p><p> Turbine Foundations</p><p><b>Interpolated Peat Thickness (m)</b></p><p>Band 1: Band_1 (Gray)</p><p> &lt;= 0.50</p><p>0.50 - 1.00</p><p>1.00 - 2.00</p><p>2.00 - 3.00</p><p>3.00 - 4.00</p><p>4.00 - 5.00</p><p>5.00 - 6.00</p><p>&gt; 6.00</p></div>		
<p>Description</p> <p>Date of the satellite images: March 2022. [Maxar/Esri].</p> <p>Date of the ground-based pictures: 25th<sup>th</sup> of February 2020 and , 15<sup>th</sup> of September 2023 [GDG].</p> <p>Geomorphology: The topography is flat.</p> <p>Peat: The peat depth at T02 is 0.9m with a slope angle of 2.1 degrees</p> <p>Instability evidence: No.</p>	<p>2020-02-26_20200226_093709.jpg</p>

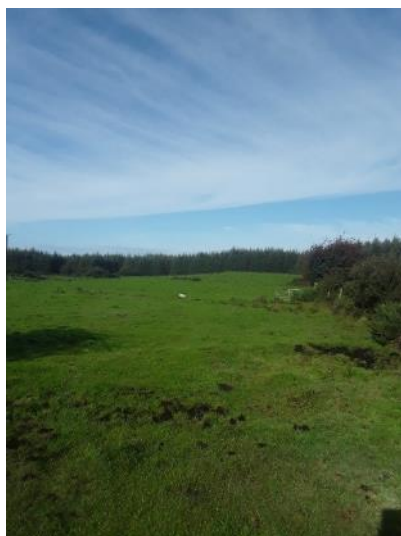
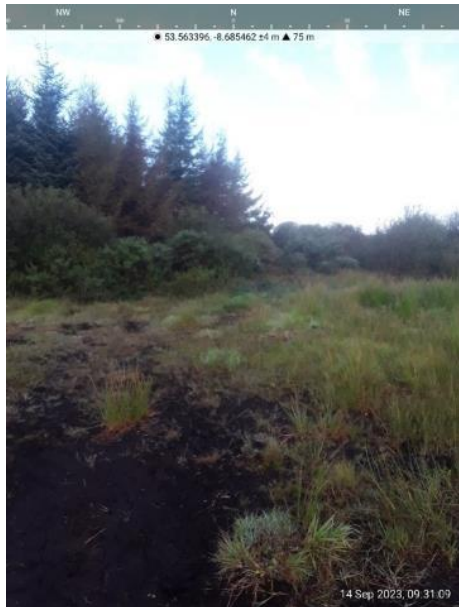
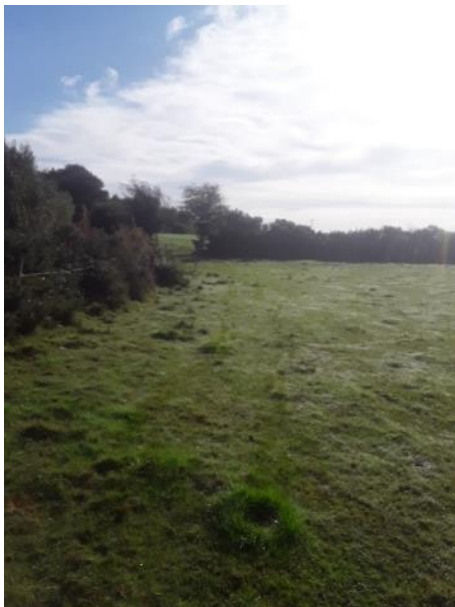
Table J- 3: Site reconnaissance of the Turbine 3 site.

<div>Description</div> <p>Date of the satellite images: March 2022. [Maxar/Esri].</p> <p>Date of the ground-based pictures: 14<sup>th</sup> September 2023 [GDG].</p> <p>Geomorphology: T03 is located on a cut over peat bog. The topography is mostly flat.</p> <p>Peat: The peat depth is ~1.03m at the T03 location. The slope angle is 0.4 degrees.</p> <p>Instability evidence: No.</p>		<div>Solocator-2023-09-14-09-31-09.jpg</div>

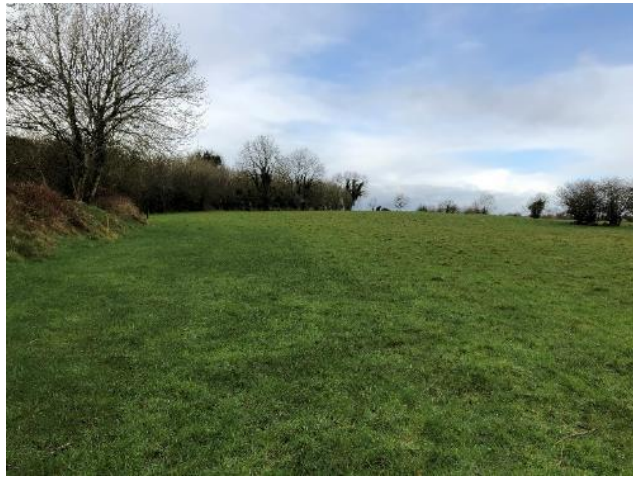
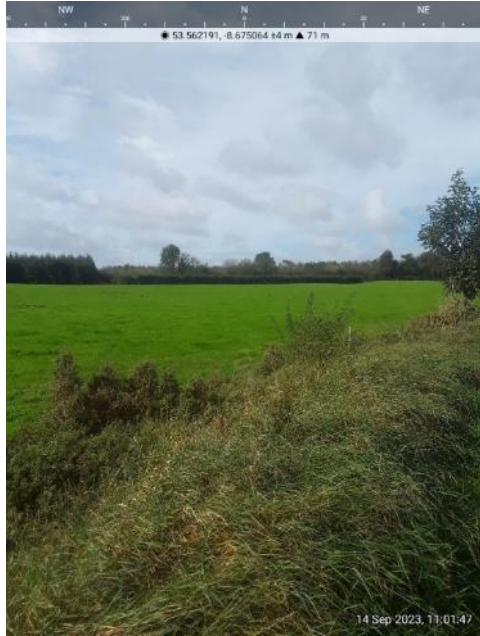
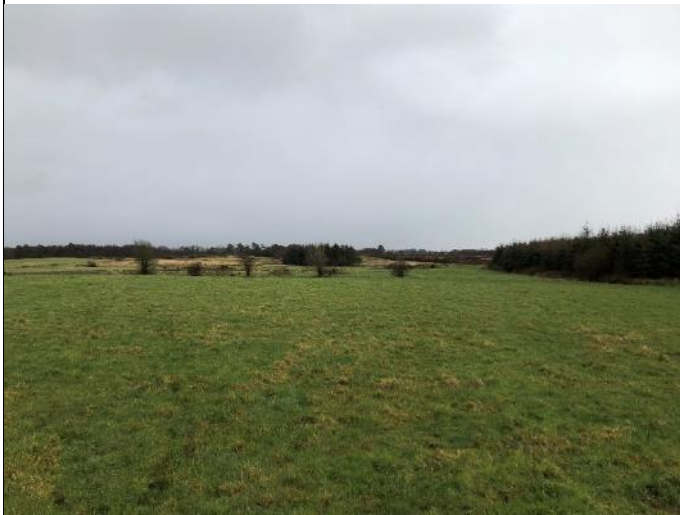
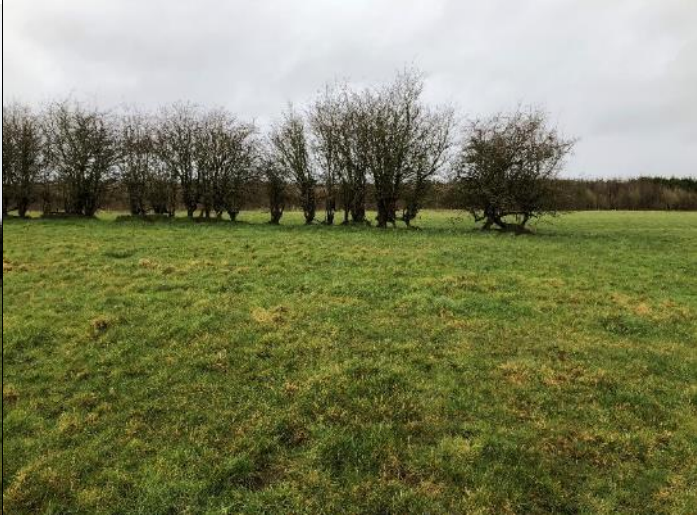
Table J- 4: Site reconnaissance of the Turbine 4 site.

<div>Description</div> <div>Date of the satellite images: March 2022. [Maxar/Esri].</div> <div>Date of the ground-based pictures: 28<sup>th</sup> of March 2020 and 15<sup>th</sup> of September 2023. [GDG].</div> <div>Geomorphology: The topography is generally flat glacial till.</div> <div>Peat: The peat depth in this location is 0.0m. Slope angle is 2.2 degrees.</div> <div>Instability evidence: No.</div>		<div>Solocator-2023-09-14-11-47(1)</div>

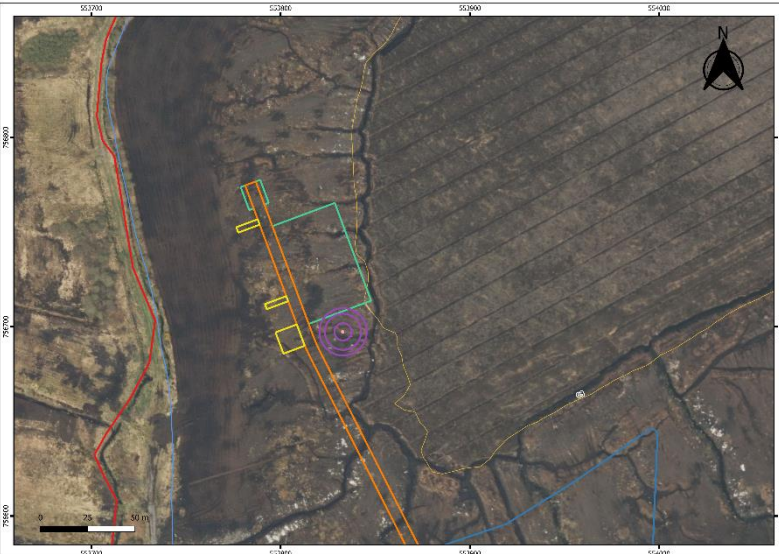
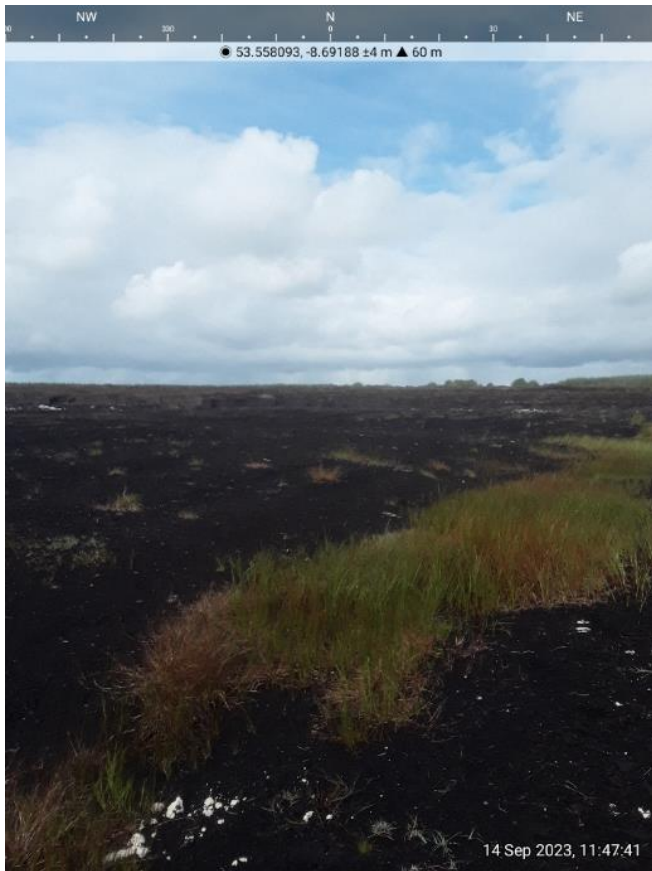
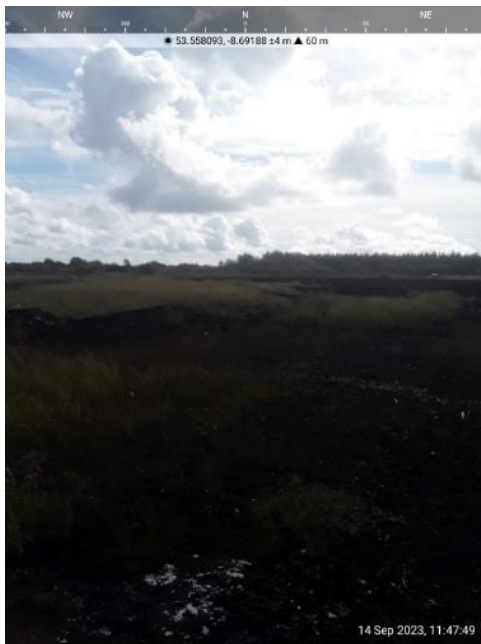
Table J- 7: Site reconnaissance of the Turbine 7 site.

<div>Description</div> <div>Date of the satellite images: March 2022. [Maxar/Esri].</div> <div>Date of the ground-based pictures: 14<sup>th</sup> of September 2023</div> <div>Geomorphology: Topography is mostly flat but there is a large drain &lt;50m from the turbine site</div> <div>Peat: Peat depth at T7 is 4.4m, with a slope angle of 6.3 degrees.</div> <div>Instability evidence: No.</div>		<div>Solocator-2013-09-14-11-47-49(1).jpg</div>

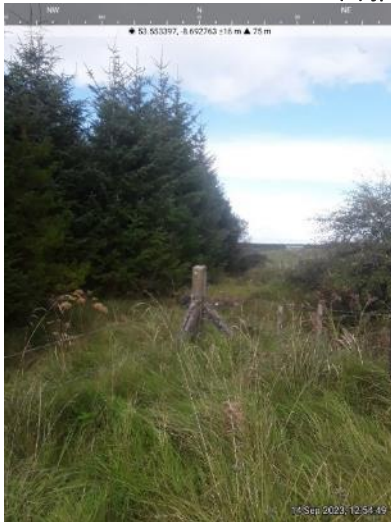
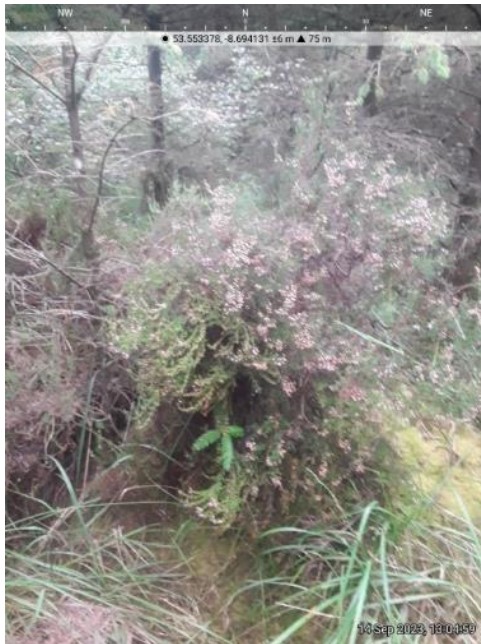
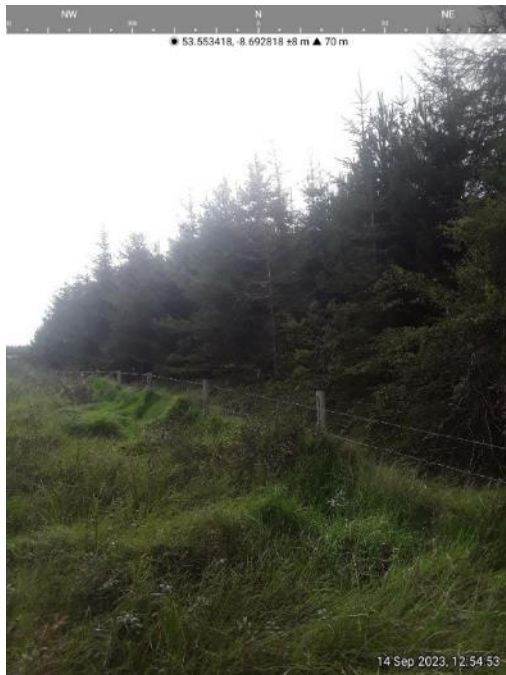
Table J- 8: Site reconnaissance of the Turbine 8 site.

<div>Description</div> <p>Date of the satellite images: March 2022. [Maxar/Esri].</p> <p>Date of the ground-based pictures: 14<sup>th</sup> September 2023 [GDG]</p> <p>Geomorphology: Topography is flat and forested.</p> <p>Peat: Peat depth at T8 is 1.8m, with a slope angle of 2.3 degrees.</p> <p>Instability evidence: No.</p>		<div>Solocator-2023-09-14-13-04-59(1).jpg</div>

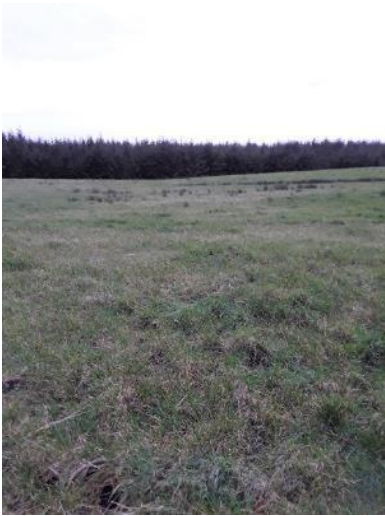
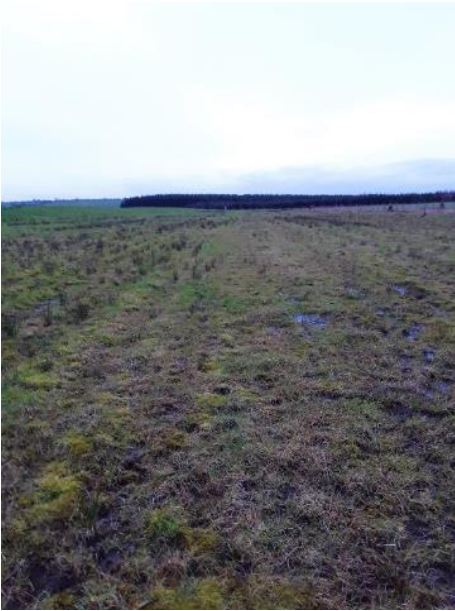
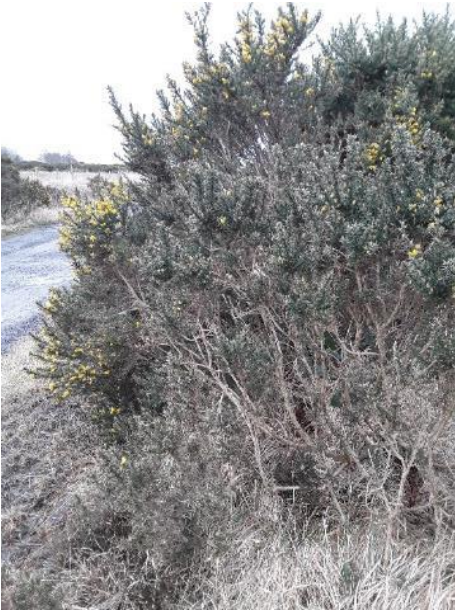
Table J- 9: Site reconnaissance of the Turbine 9 site.

<div>Description</div> <div><div>Date of the satellite images: March 2022. [Maxar/Esri].</div><div>Date of the ground-based pictures: 26<sup>th</sup> February 2020 [GDG]</div><div>Geomorphology: Topography is flat.</div><div>Peat: Peat depth at T9 is 0.09m, with a slope angle of 0.7 degrees.</div><div>Instability evidence: No.</div></div>		<div>P_2020-02-26_17-_20200226_175223.jpg</div>

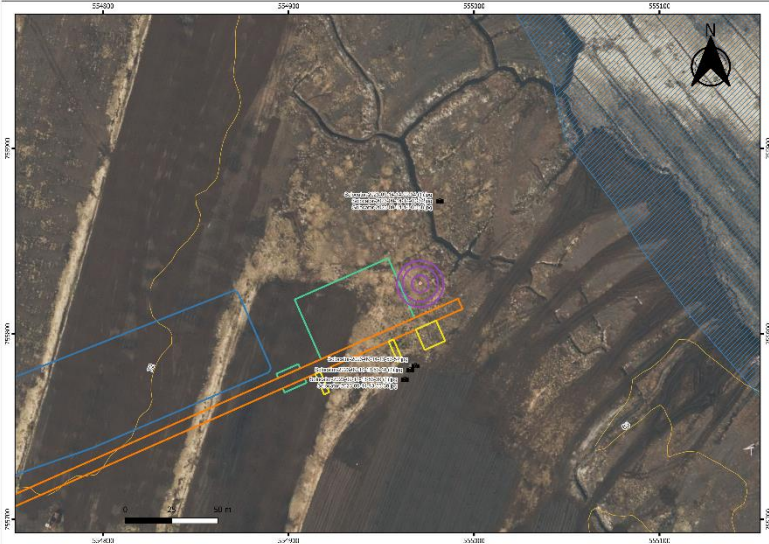
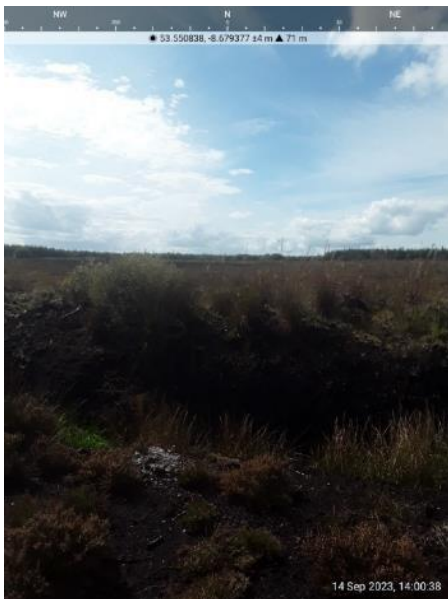
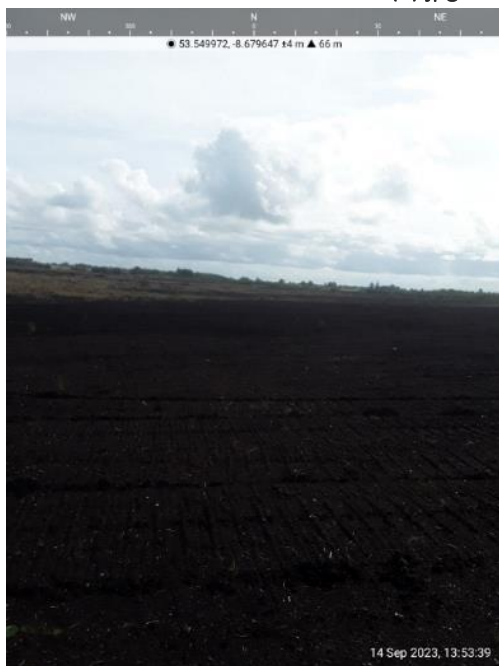
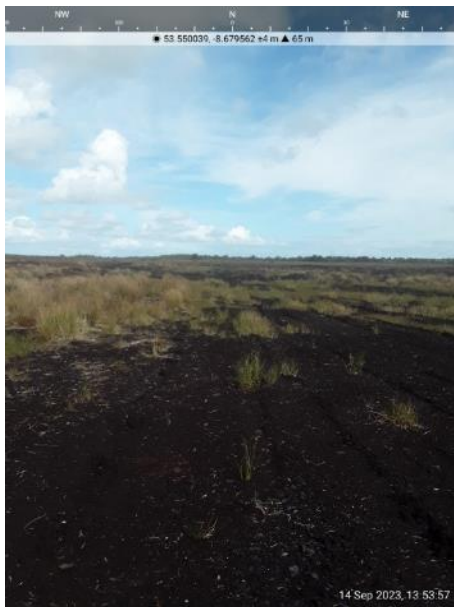
Table J- 10: Site reconnaissance of the Turbine 10 site.

<div>Description</div> <div><div>Date of the satellite images: March 2022. [Maxar/Esri].</div><div>Date of the ground-based pictures: 14<sup>th</sup> of September 2023 [GDG]</div><div>Geomorphology: Topography is flat and forested. Peat is underlain by soft lacustrine silts.</div><div>Peat: Peat depth at T10 is 1.5m, with a slope angle of 0.98 degrees.</div><div>Instability evidence: No.</div></div>		<div>Solocator-2023-09-14-13-53-39(1).jpg</div>

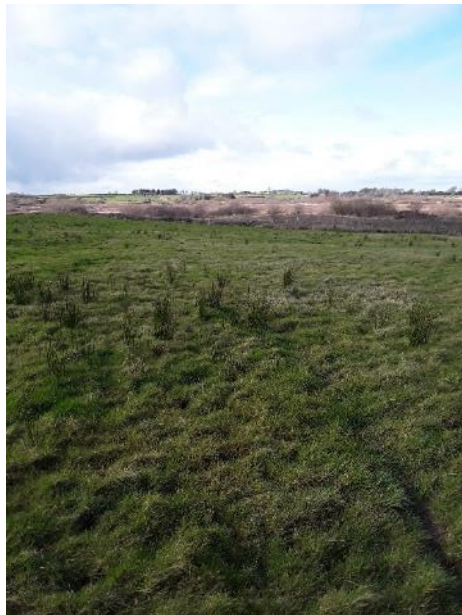
Table J- 12: Site reconnaissance of the north Construction Compound site.

<div>Description</div> <div>Date of the satellite images: March 2022. [Maxar/Esri].</div> <div>Date of the ground-based pictures 24<sup>th</sup> February 2020[GDG].</div> <div>Geomorphology: Topography at site is mostly flat with existing founded roads adjacent to the location.</div> <div>Peat: Peat depth is 0.3m, with a slope angle of 3.3 degrees.</div> <div>Instability evidence: No.</div>		<div>P_2020226_125506.jpg</div>  		<div>P_2020226_125539.jpg</div>

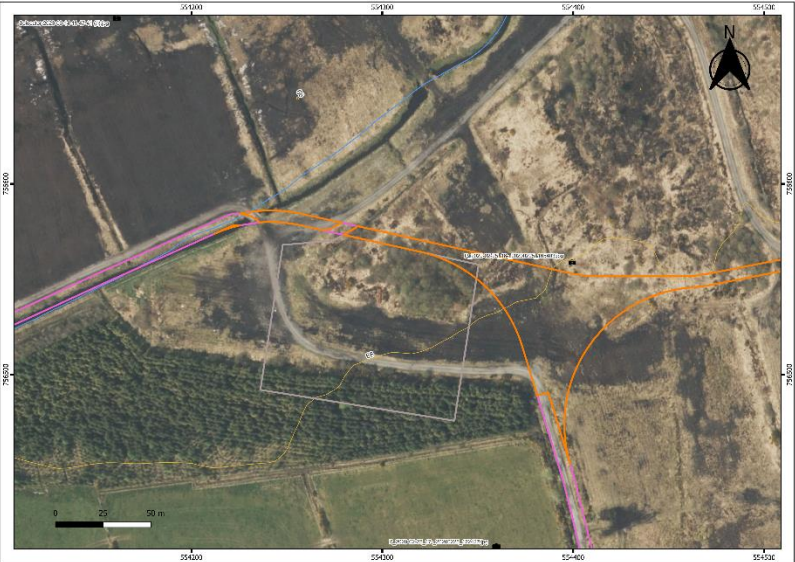
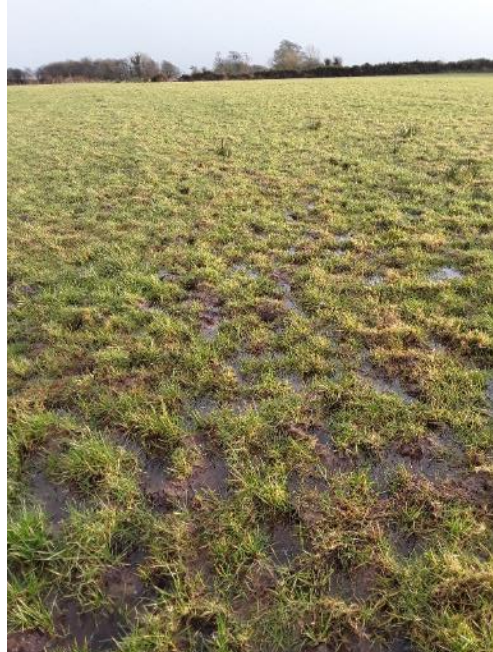
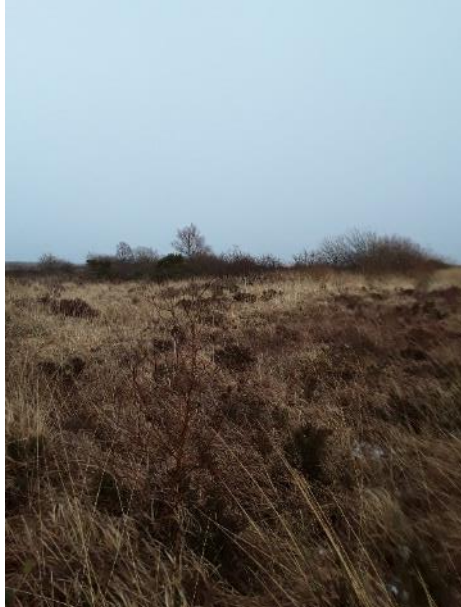
Table J- 13: Site reconnaissance of the south Construction Compound site.

<div>Description</div> <div>Date of the satellite images: March 2022. [Maxar/Esri].</div> <div>Date of the ground-based pictures 25th of February 2020[GDG].</div> <div>Geomorphology: Topography at site is mostly flat cut over peat bog. Peat cuts are set back from the site and there are drains perpendicular to contour lines.</div> <div>Peat: Peat depth is 0.70m, with a slope angle of 1.8 degrees.</div> <div>Instability evidence: No.</div>		<div>P_2020-02-25_17-_20200215_165403.jpg</div>

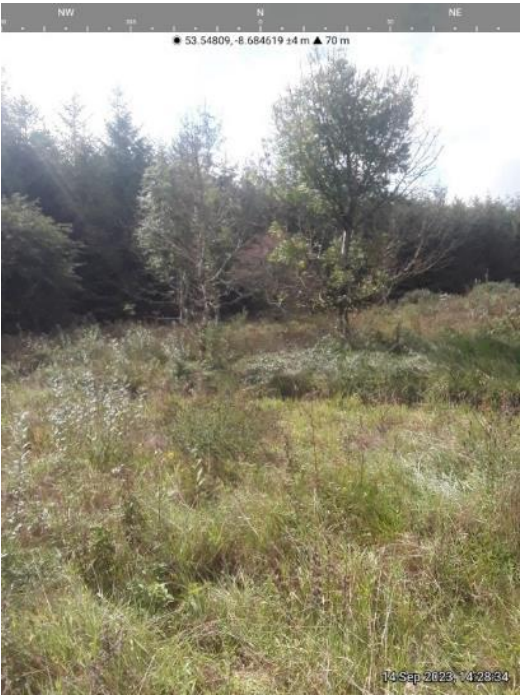
<p>P_2020-02-26_17-_20200226_173450</p>

<p>Description</p> <p>Date of the satellite images: March 2022. [Maxar/Esri].</p> <p>Date of the ground-based pictures: 26<sup>th</sup> of February 2020 and 14<sup>th</sup> of September 2023. [GDG].</p> <p>Geomorphology: Flat forestry.</p> <p>Peat: Peat depth is 0.40m, with a slope angle of 4.4 degrees.</p> <p>Instability evidence: No.</p>	<p>Solocator-2023-09-14-14-28-34 (1)</p>

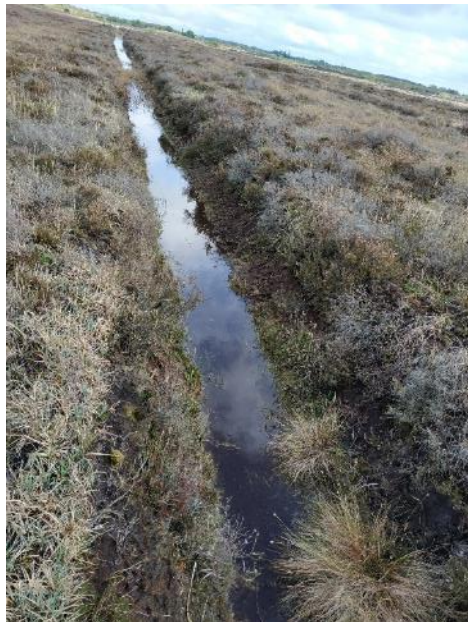
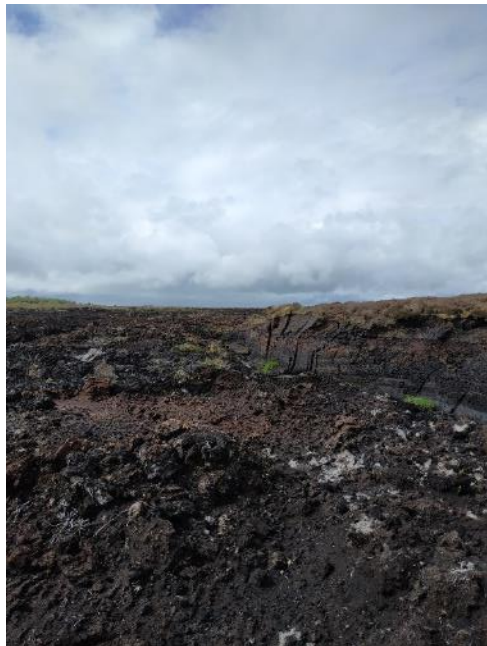
<div>Description</div> <p>Date of the satellite images: March 2022. [Maxar/Esri].</p> <p>Date of the ground-based pictures: May 2023 [GDG].</p> <p>Geomorphology: Flat topography.</p> <p>Peat: Interpolated peat depth 3.88m, slope angle of 0.80 degrees.</p> <p>Instability evidence: No.</p>
