# Clonberne Wind Farm Peat Stability Risk Assessment (PSRA)

Client	<b>MKO</b>
Document Ref.	20021-R-01-03
Project Title	Clonberne Wind Farm
Date	09/04/2024

Project Title:	Clonberne Wind Farm
Report Title:	Clonberne Wind Farm Peat Stability Risk Assessment (PSRA)
Document Reference:	20021-R-01-03

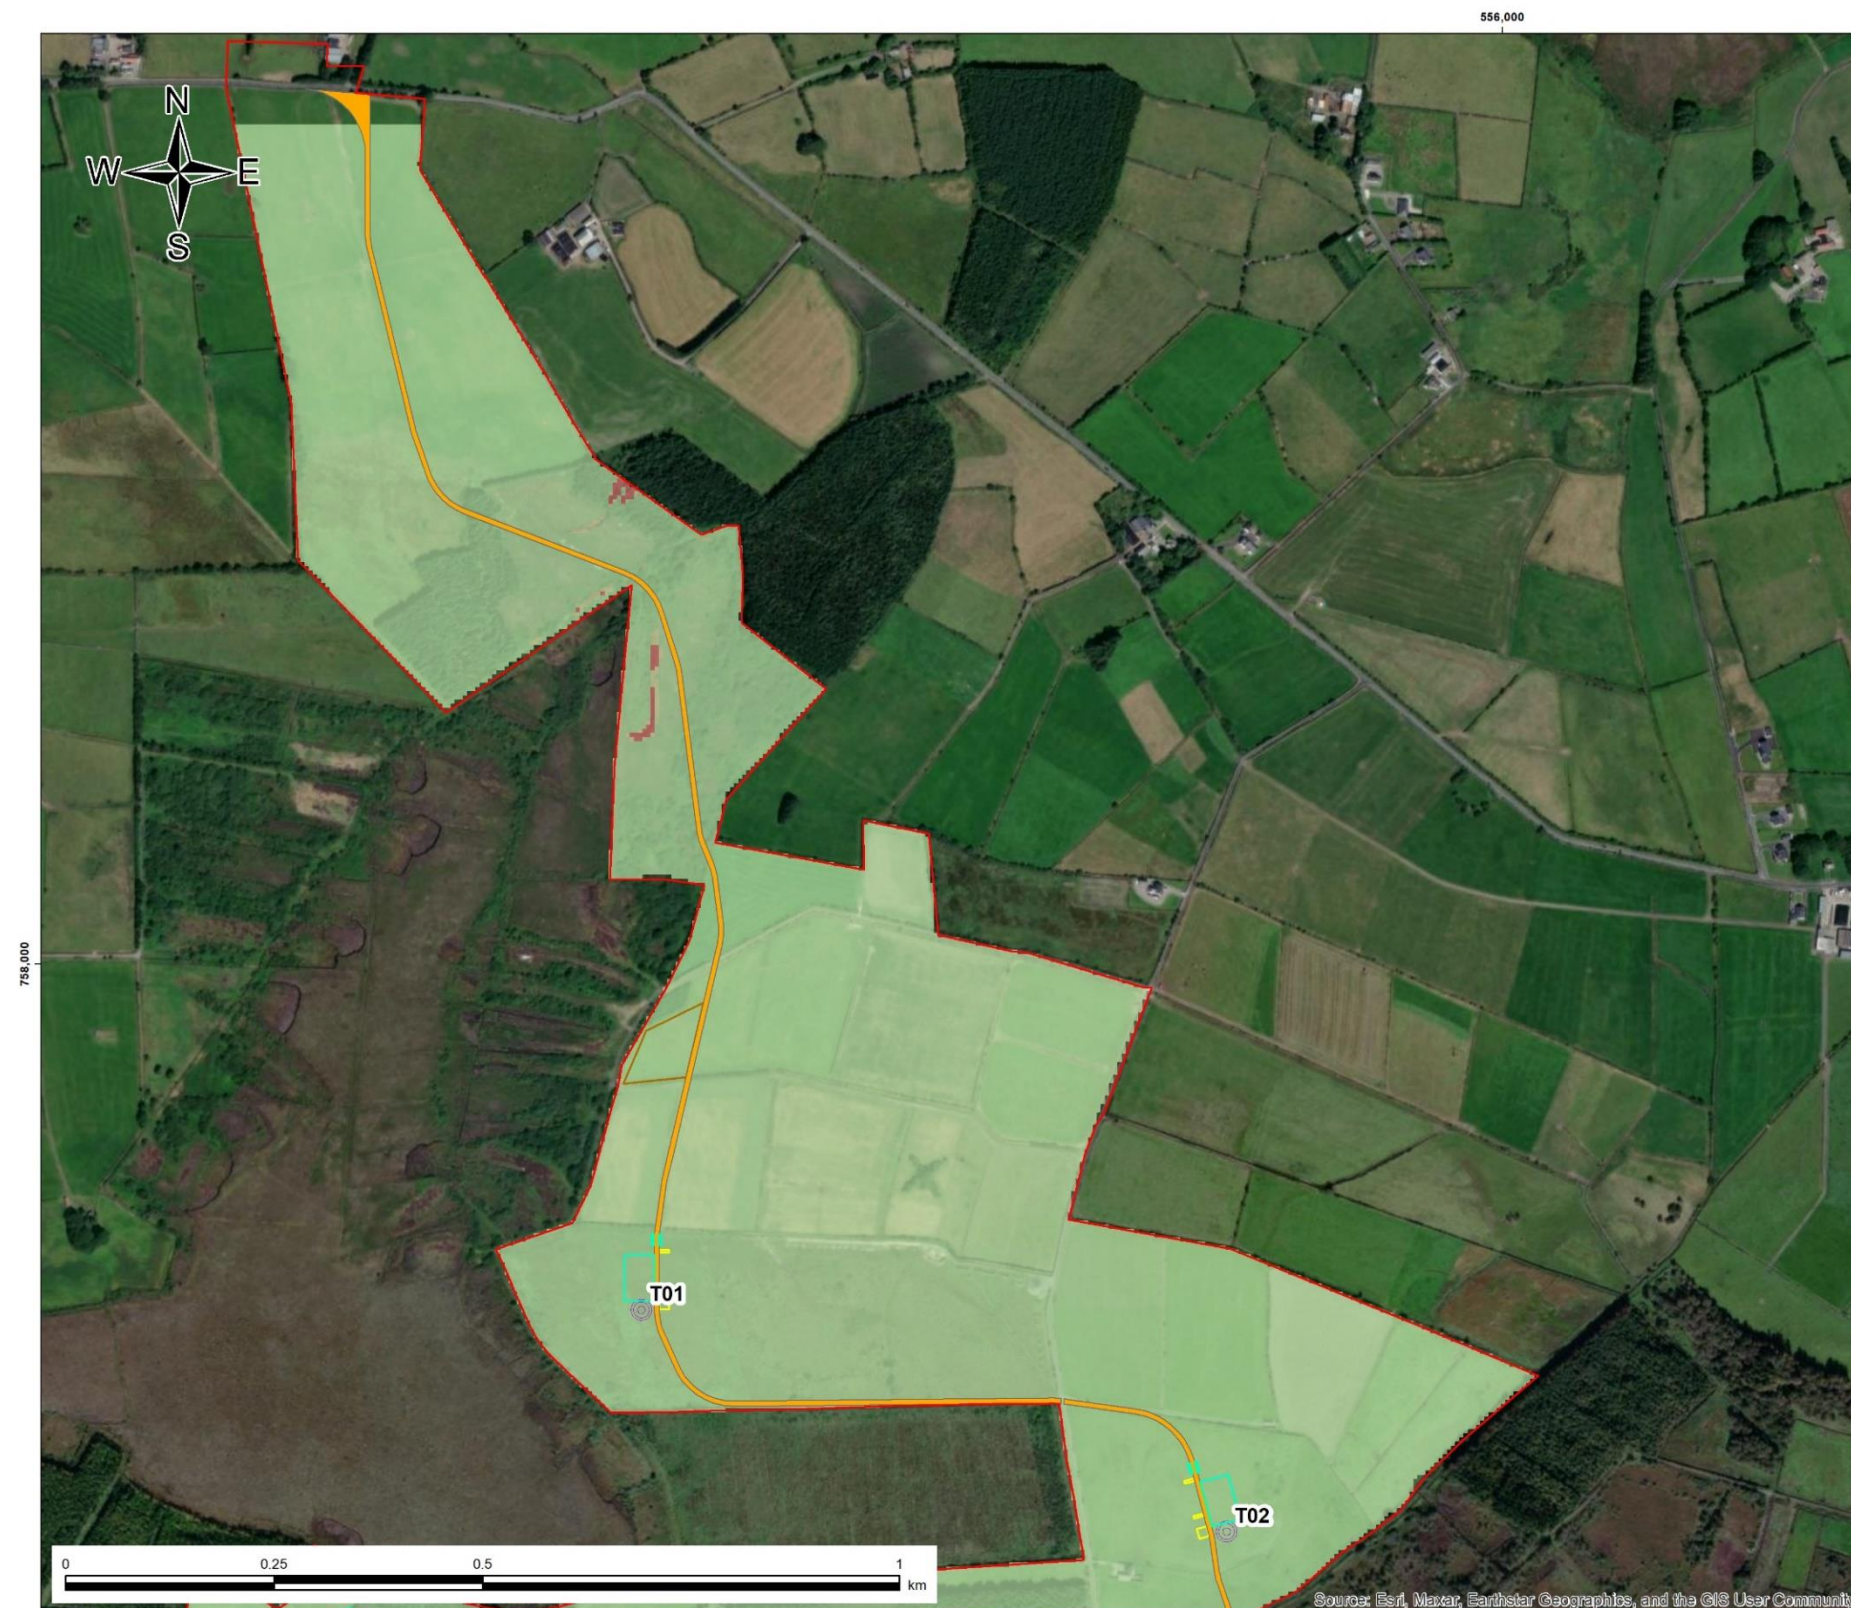
Figure K- 3: Peat Factor of Safety for Undrained Conditions (3 of 3).

Client:		
Project: Clonberne Wind Farm		
Map title: Peat Factor of Safety for Undrained Conditions (3 of 3)		
File: 20021-GDG-02-FS3-MP-C-28		
Sheet size: A3	CRS: 2157	Authored: CE
Date: 09/04/2024	Source: GDG	Checked: JOD

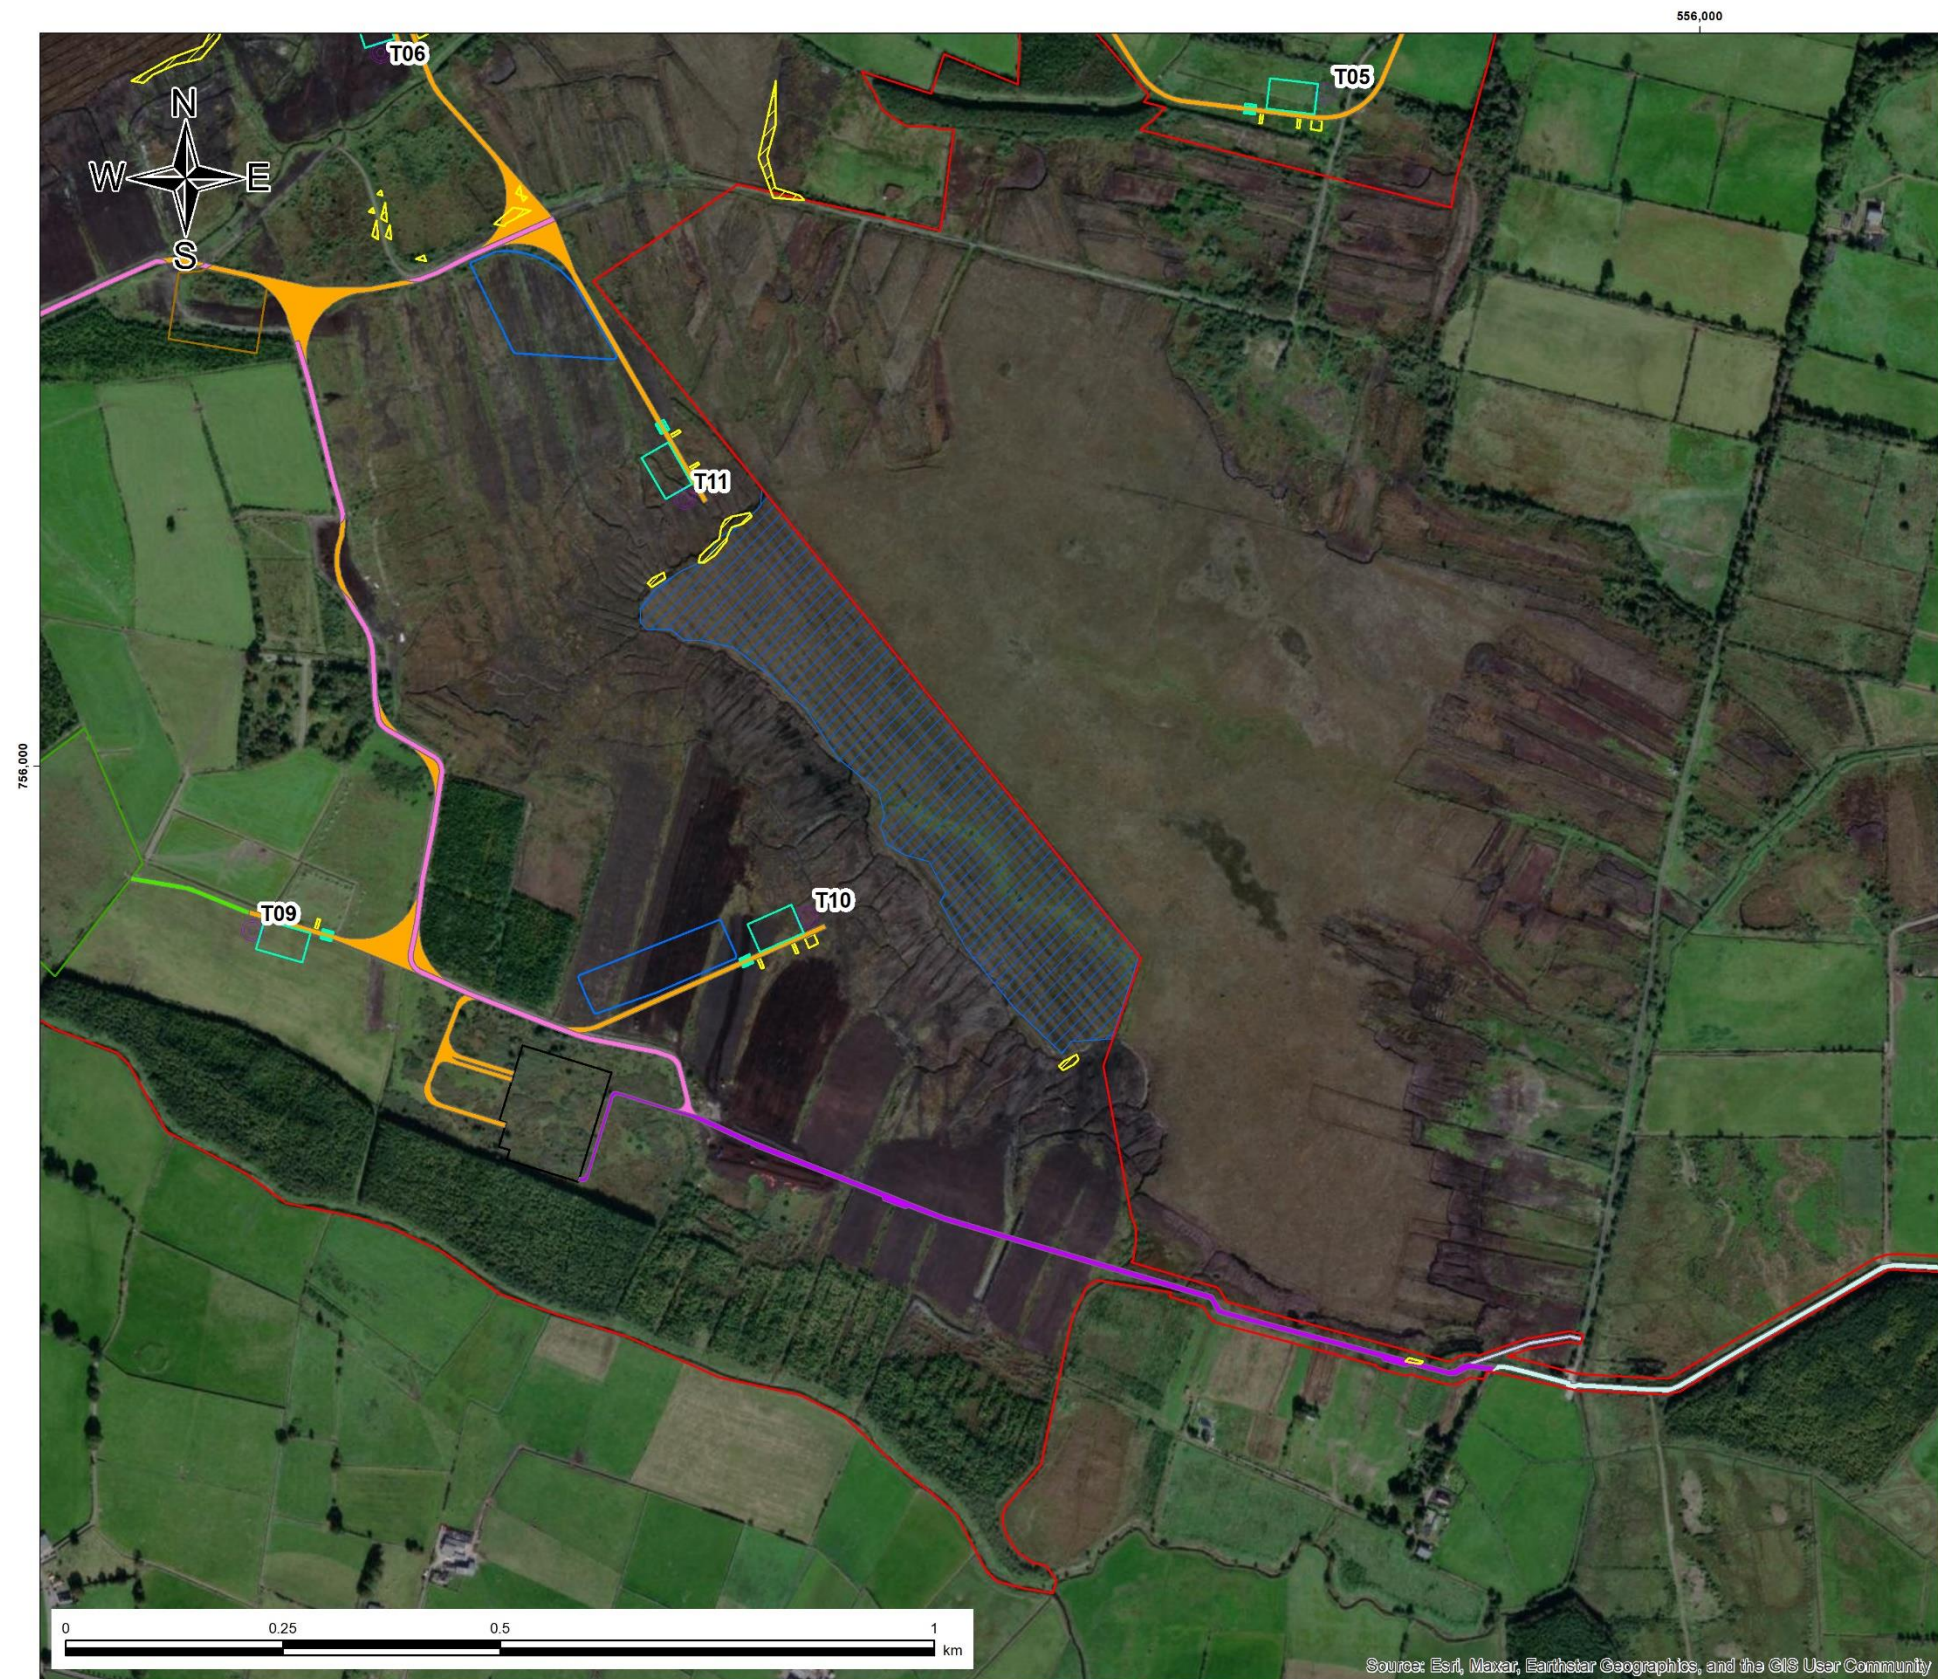
Client:  		  GAVIN & DOWERTY GEOSOLUTIONS	
Project: Clonberne Wind Farm			
Map title: Safety Buffer and Peat Stockpile Restriction Areas (3 of 3)			
File: 20021-GDG-02-SBZ-MP-C-34			
Sheet size: A3	CRS: 2157	Authored: CE	
Date: 09/04/2024	Source: GDG	Checked: JOD
