Appendix 6-2 – Bat Survey Report

Proposed Clonberne Wind
Farm, Co. Galway

Document Title: **Bat Survey Report**

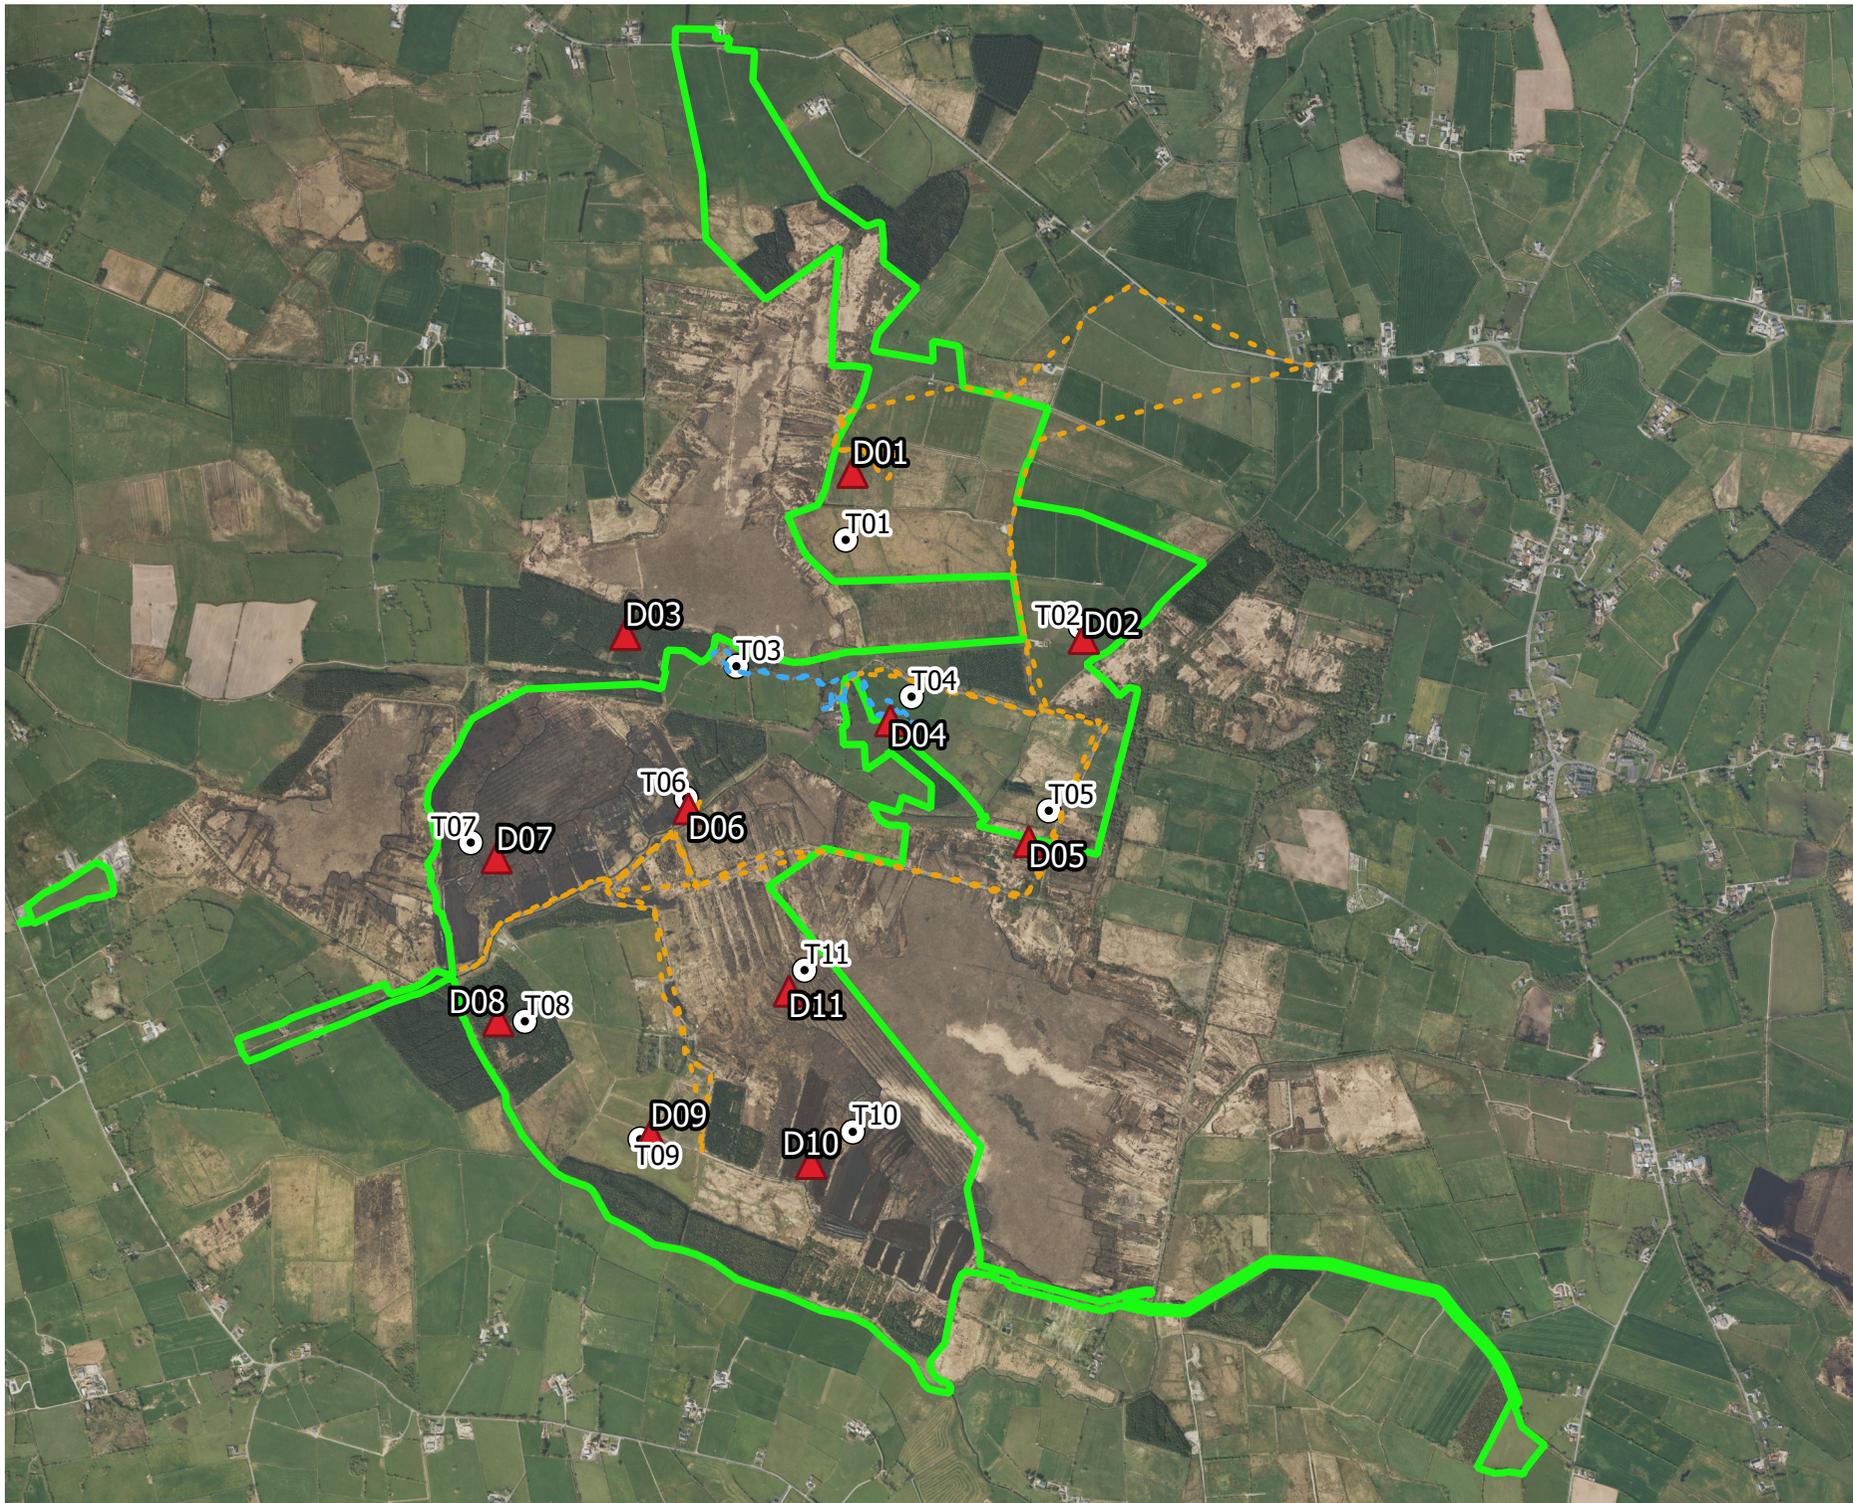
- EIA Site Boundary
- Proposed Turbine Layout
- ▲ 2022 Static Detector Locations
- - - Spring Transect Route
16th May 2022
- - - Summer Transect Route
13th July 2022

Onsite weather monitoring was undertaken concurrently with static detector deployments. One Vantage Pro 2 (Davis Instruments, CA, UCS) was deployed each season and night-time hourly data was tracked remotely to ensure a sufficient number of nights (i.e. minimum 10 in Spring and Autumn and 20 in Summer) with appropriate weather conditions were captured (i.e. dusk temperatures above 8°C, wind speeds less than 5m/s and no or only very light rainfall). Table 3-5 summarises survey effort achieved for each of the detector locations in 2022.

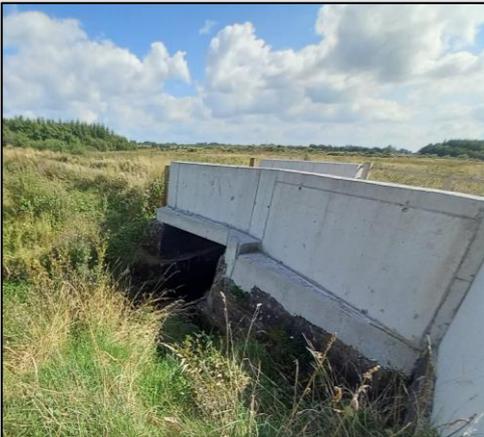
Grid Ref	Culvert type	Photo	Bat Roost Potential	Extent of Works
M 55909 55262	Concrete box culvert

No evidence of bats found. Solid concrete construction with <i>Negligible</i> suitability to support roosting bats.	Horizontal Directional Drilling

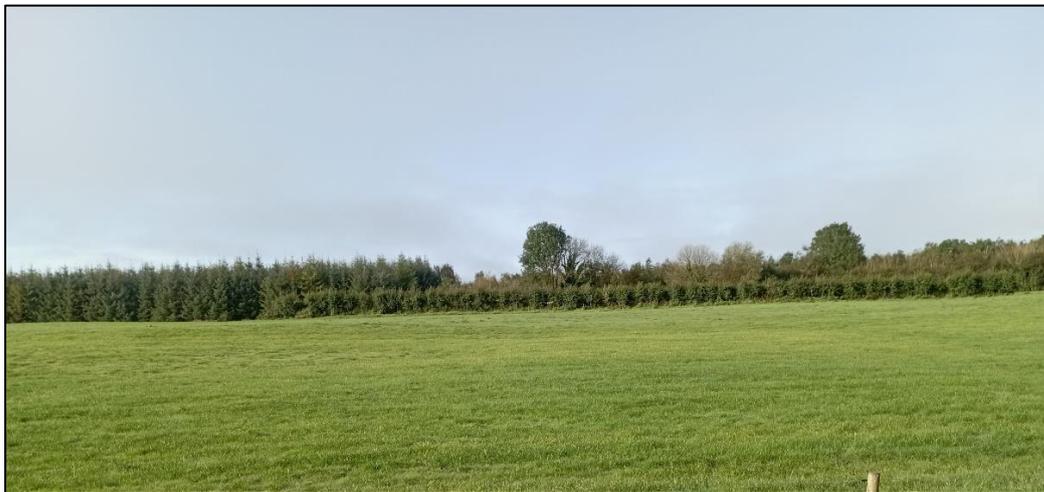
Plate 4-14 Hedgerow to the south of T04 assessed as having Negligible roosting potential.

The hedgerow adjacent to T04 was also evaluated for roosting potential (Plate 4-14). This was assessed as having *Negligible* suitability for roosting bats.

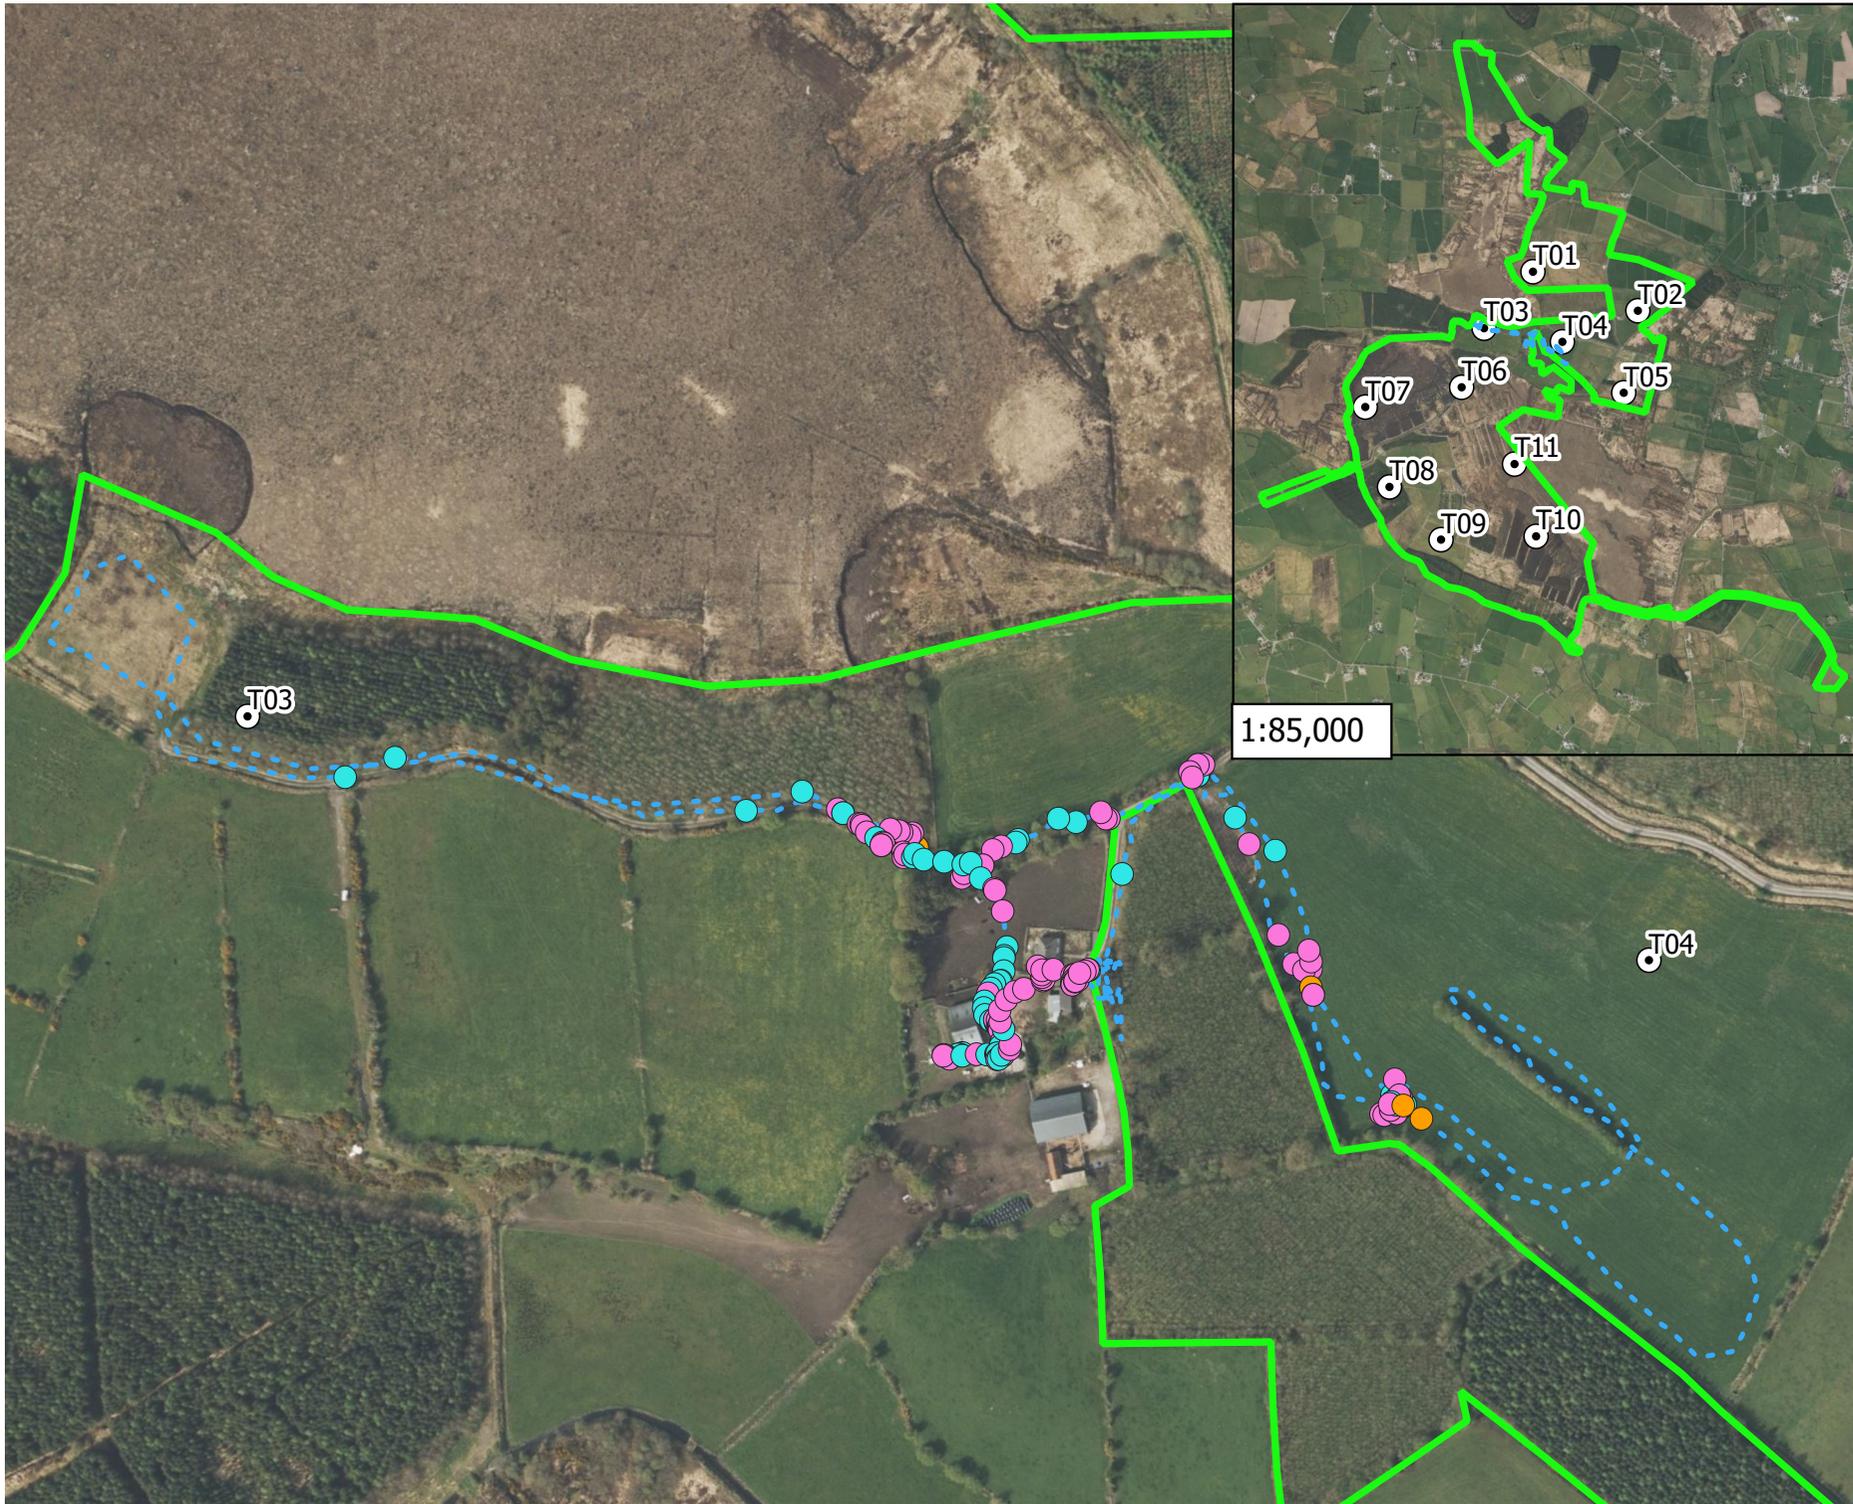
- EIA Site Boundary
- Proposed Turbine Layout
- Spring Transect Route
16th May 2022

Figures 4-1 and 4-2 present the spatial distribution of bat activity across surveys. Bat activity was concentrated along treelines, hedgerows, and linear (road/track) habitats. Common pipistrelle occurred most often in spring, while there was a relatively equal distribution between Common and Soprano pipistrelle in summer. Activity was greatly reduced during the summer manual survey.

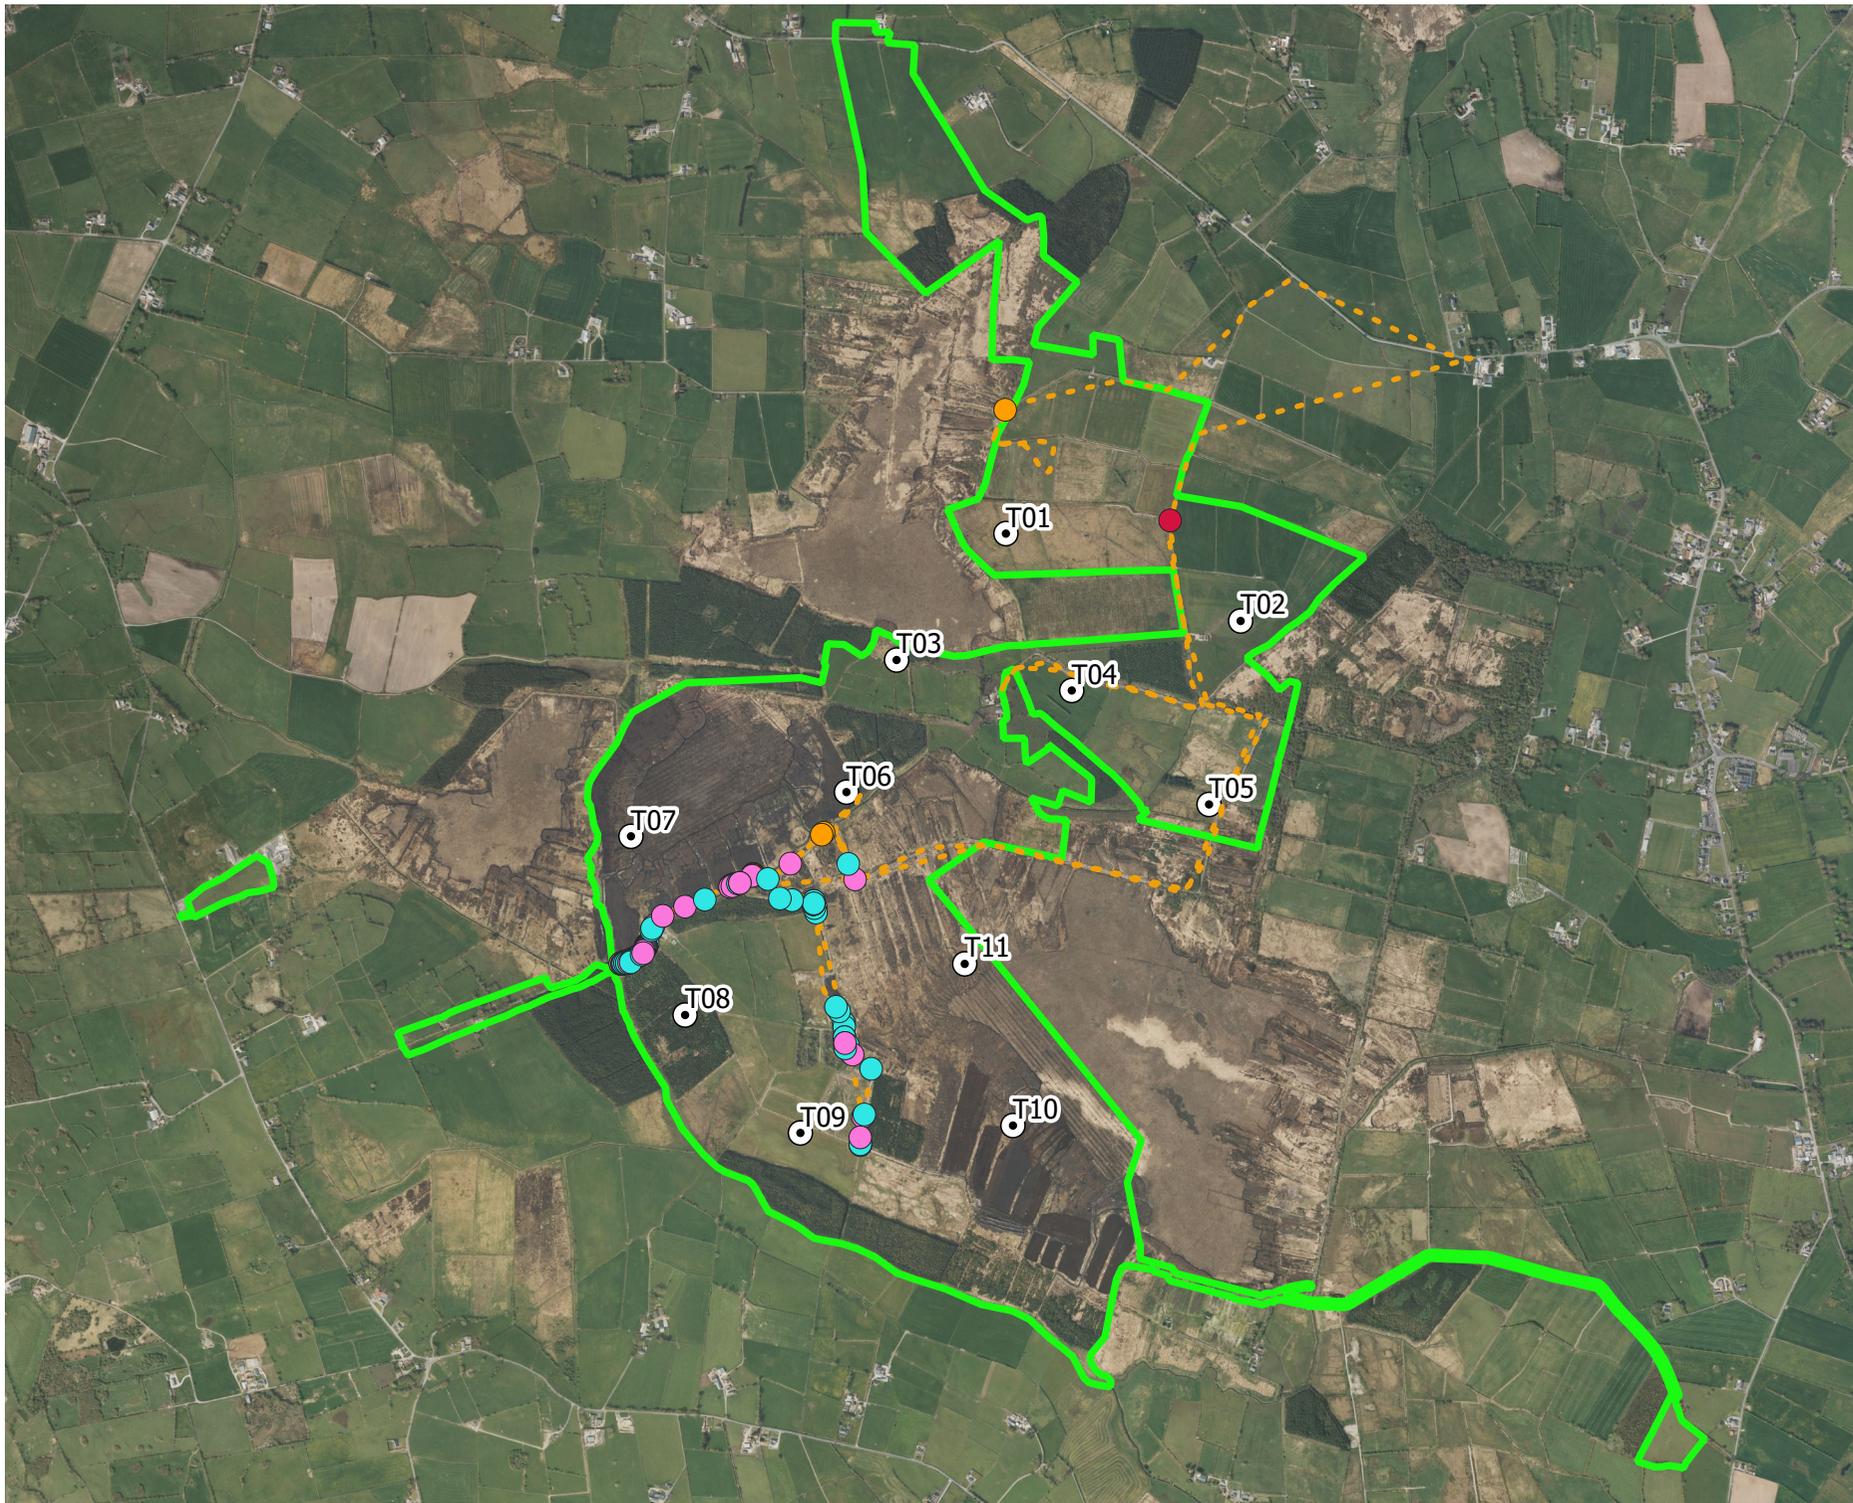
- EIA Site Boundary
- Proposed Turbine Layout
- Summer Transect Route
12th July 2022
- Summer Manual Results**
- Myotis spp.
- Leisler's bat
- Common pipistrelle
- Soprano pipistrelle

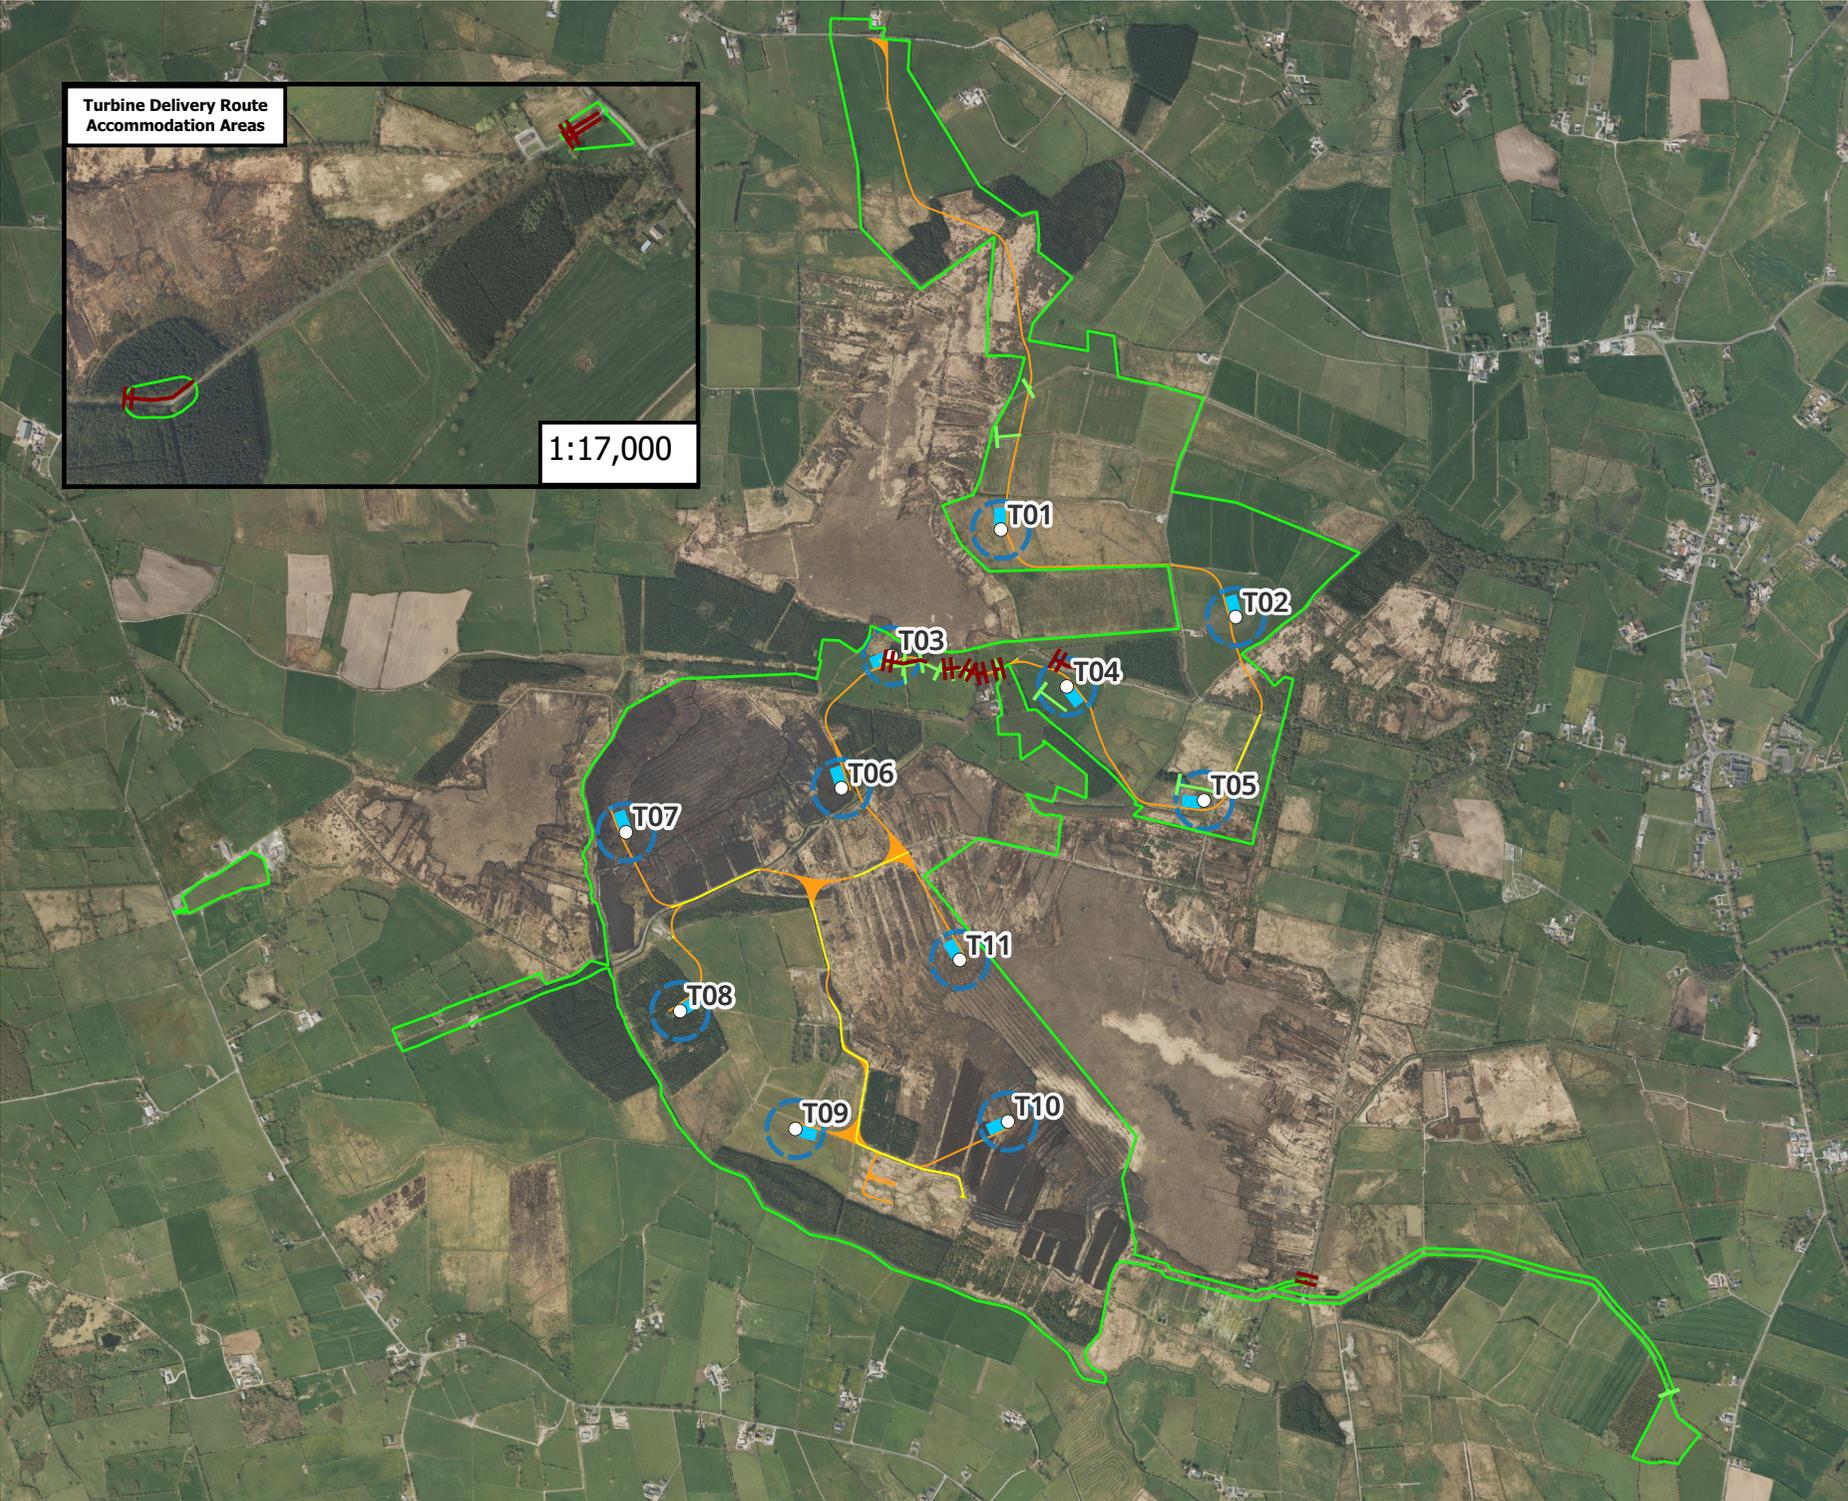
Turbine Delivery Route
Accommodation Areas

1:17,000

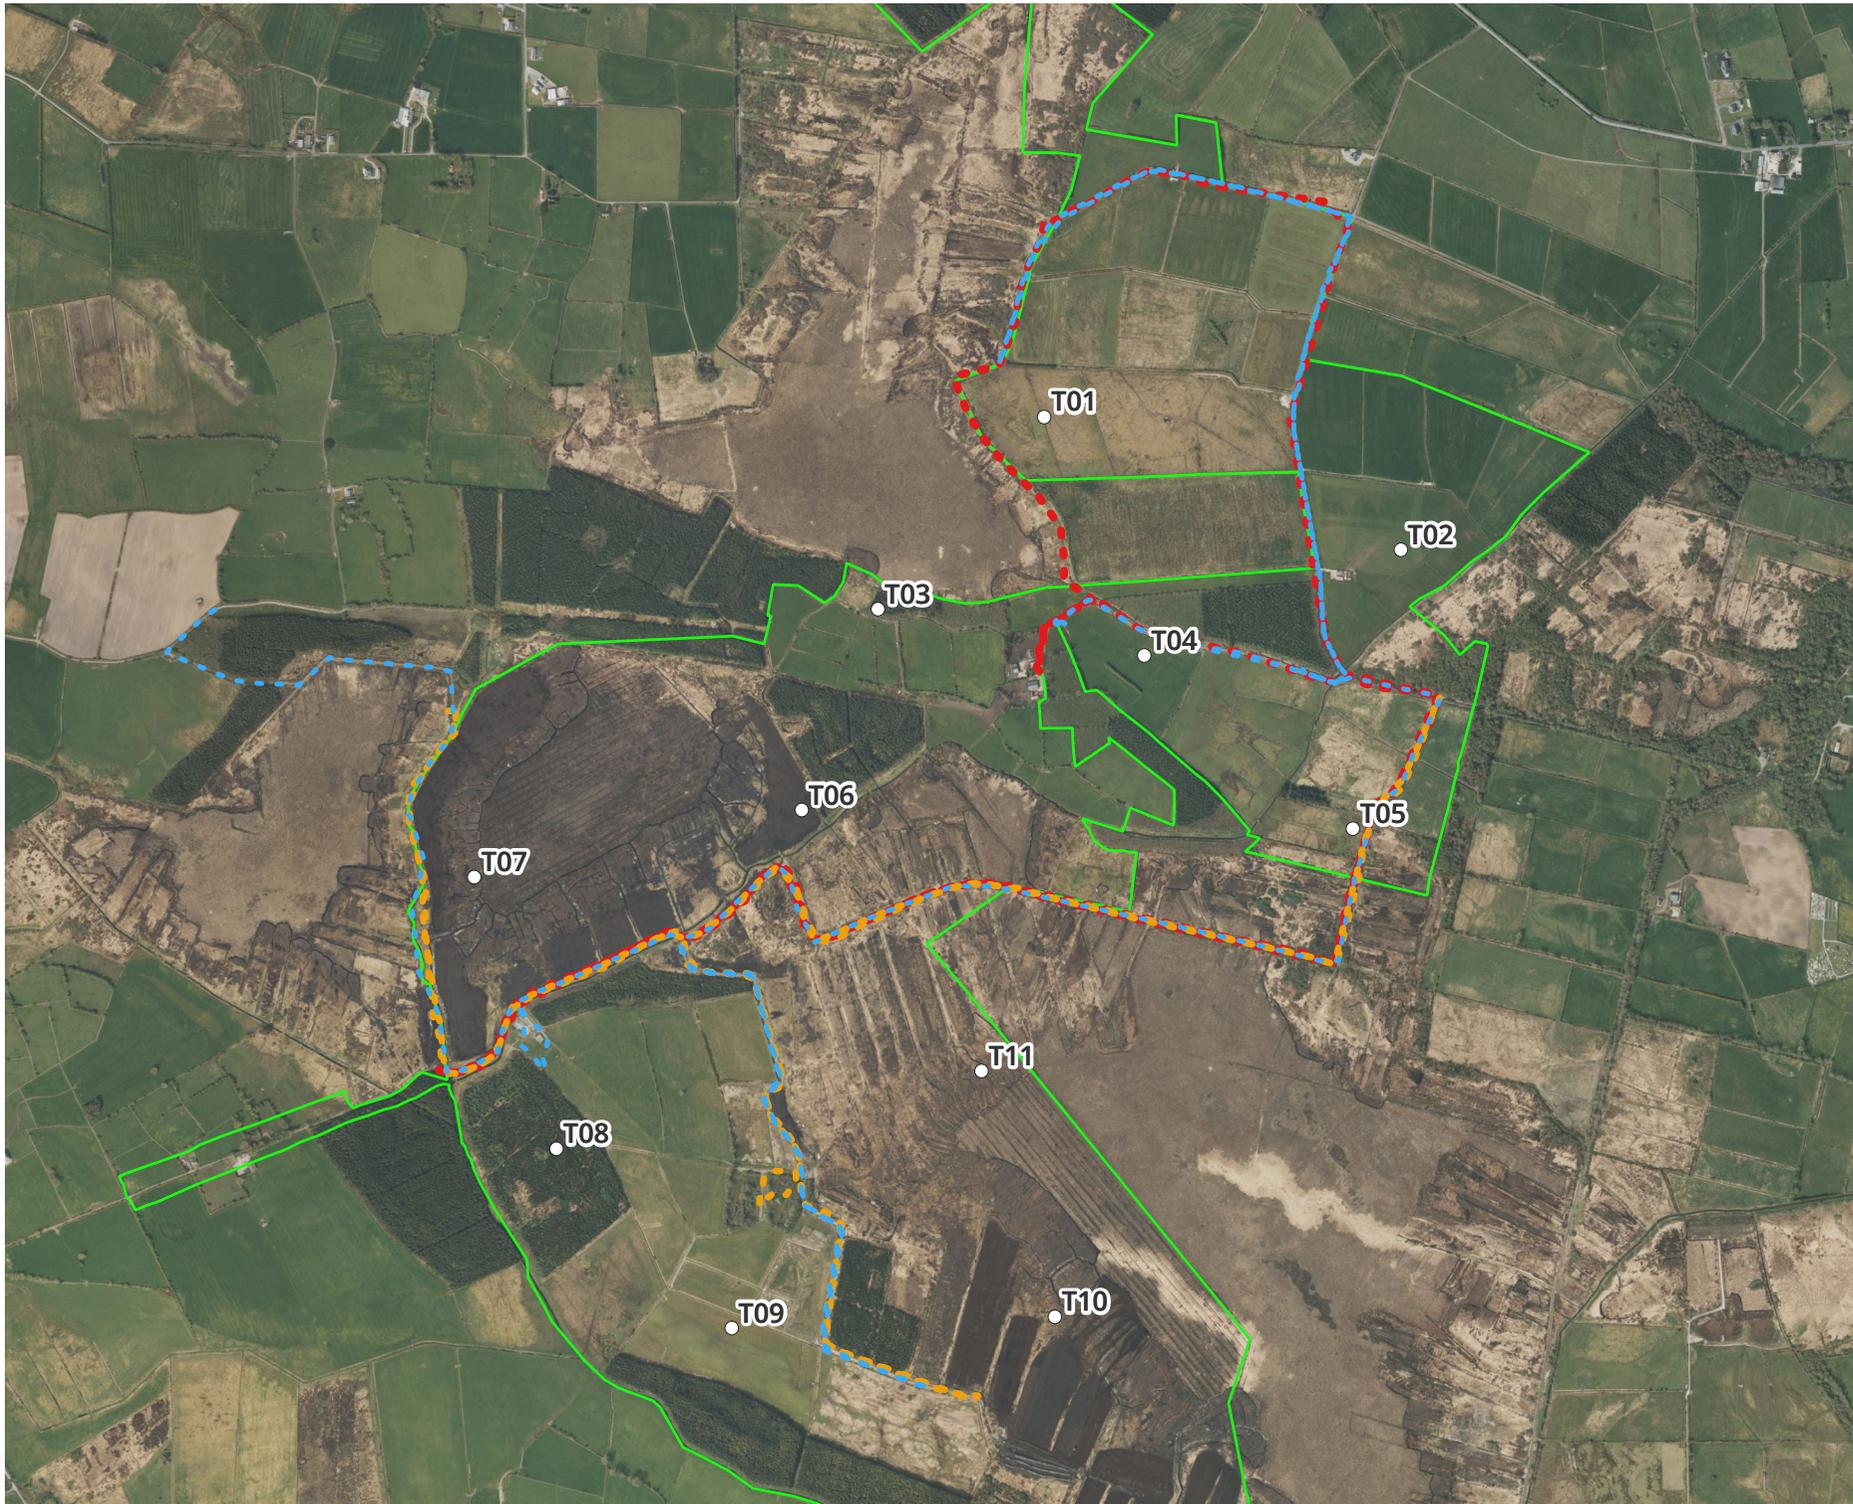
- EIA Site Boundary
- Proposed Turbine Layout
- Spring Transect Route
13th May 2019
- Summer Transect Route
11th July 2019
- Autumn Transect Route
22nd August 2019

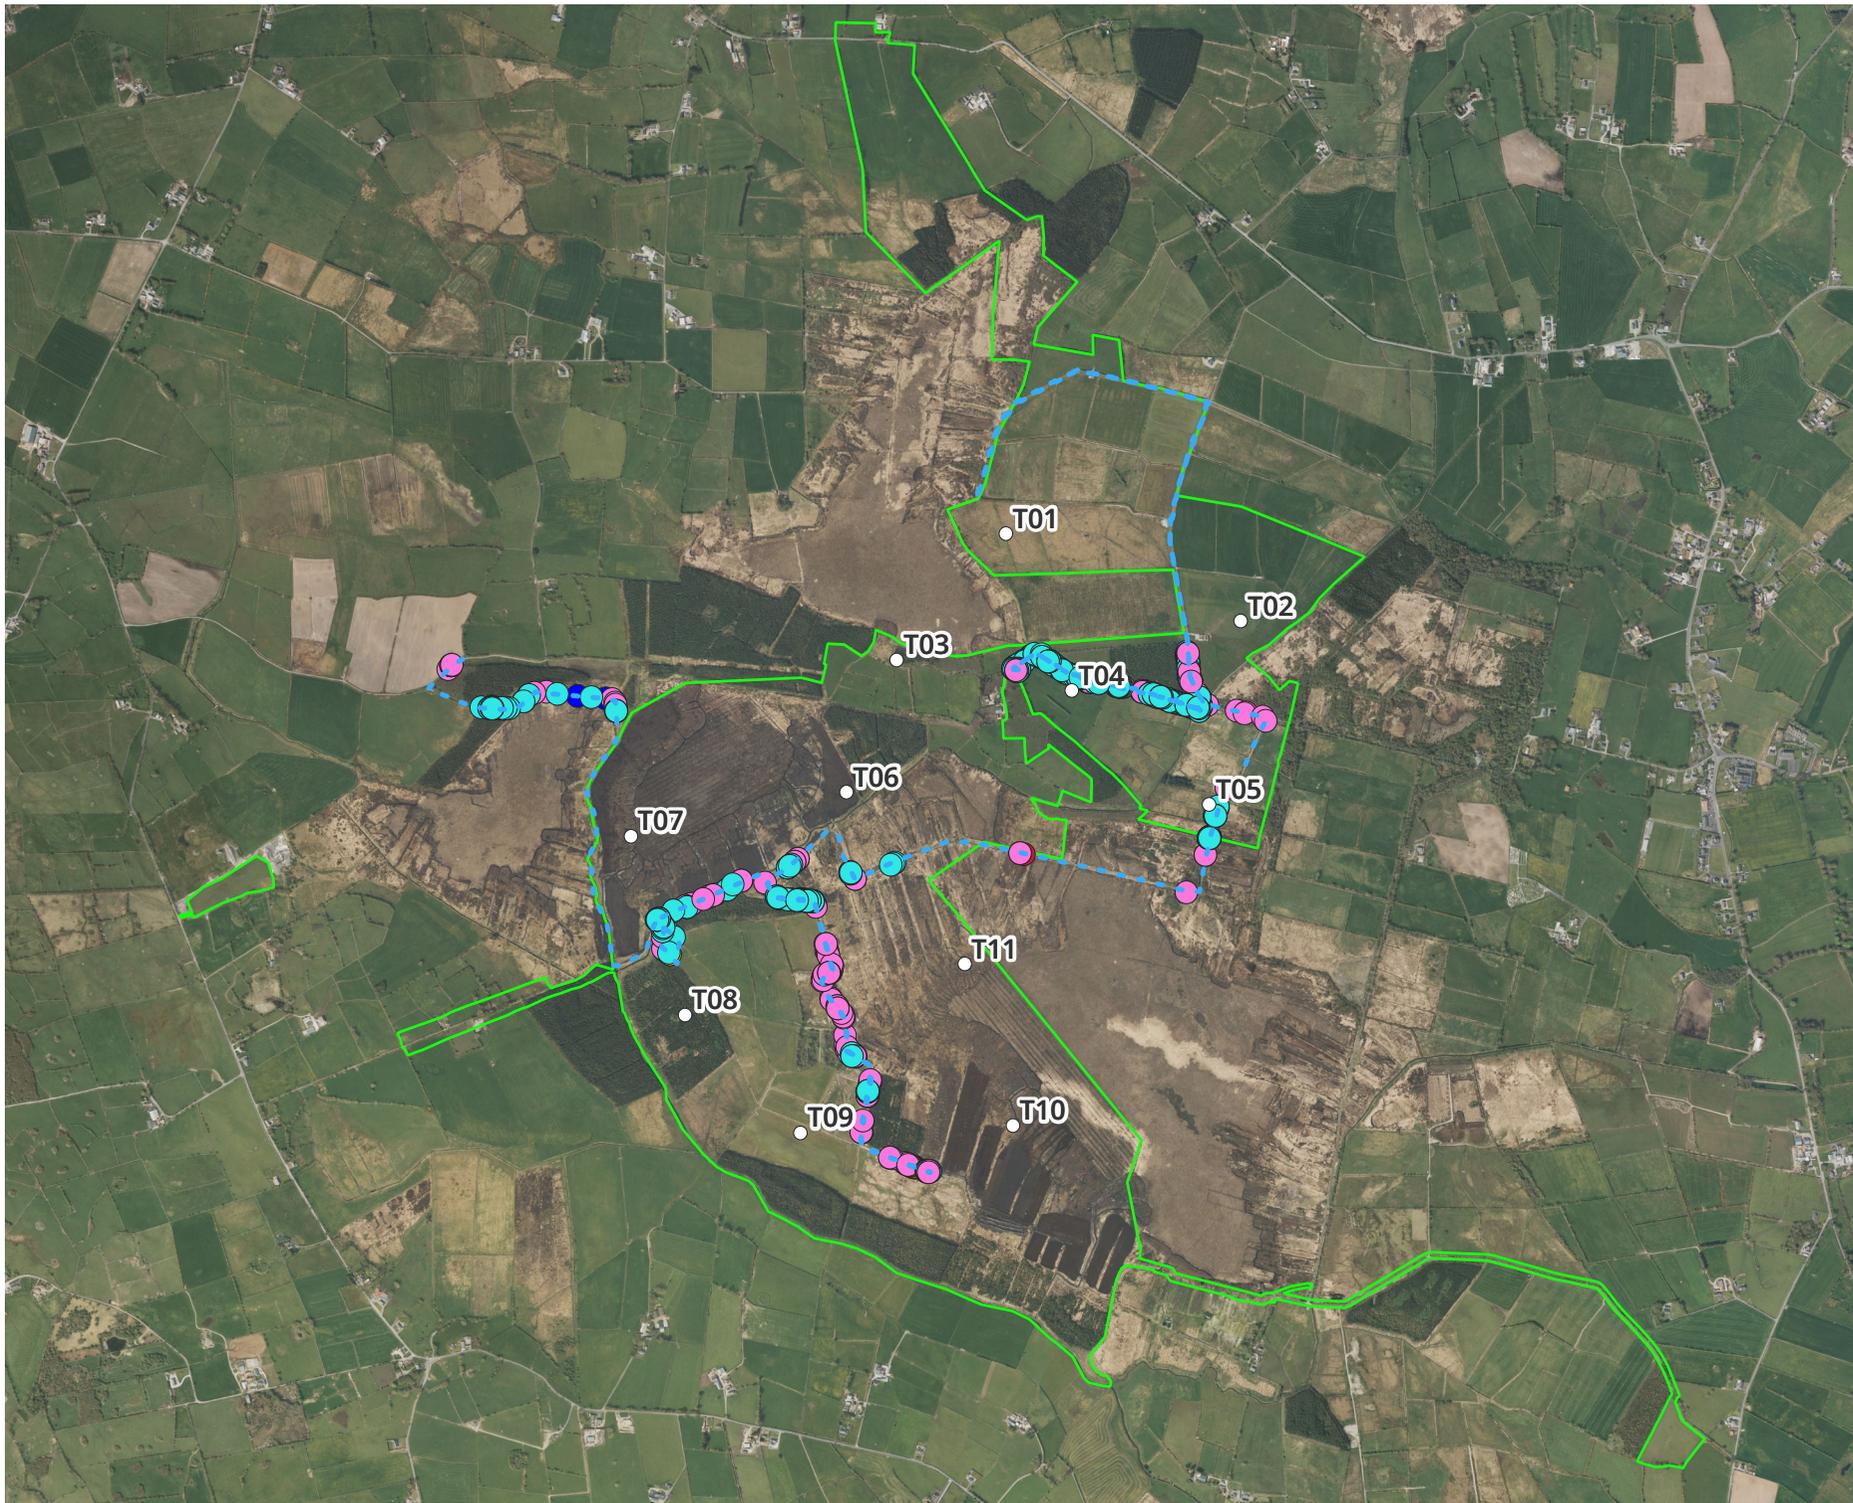
- EIA Site Boundary
- Proposed Turbine Layout
- Spring Transect Route
13th May 2019
- 2019 Spring Manual Results
- Nathusius pipistrelle
- Common pipistrelle
- Soprano pipistrelle

Figure 3-1, Figure 3-2 and Figure 3-3 present the spatial distribution of bat activity across the 2019 surveys. Bat activity was concentrated along hedgerows, scrub and linear (road/track) habitats.

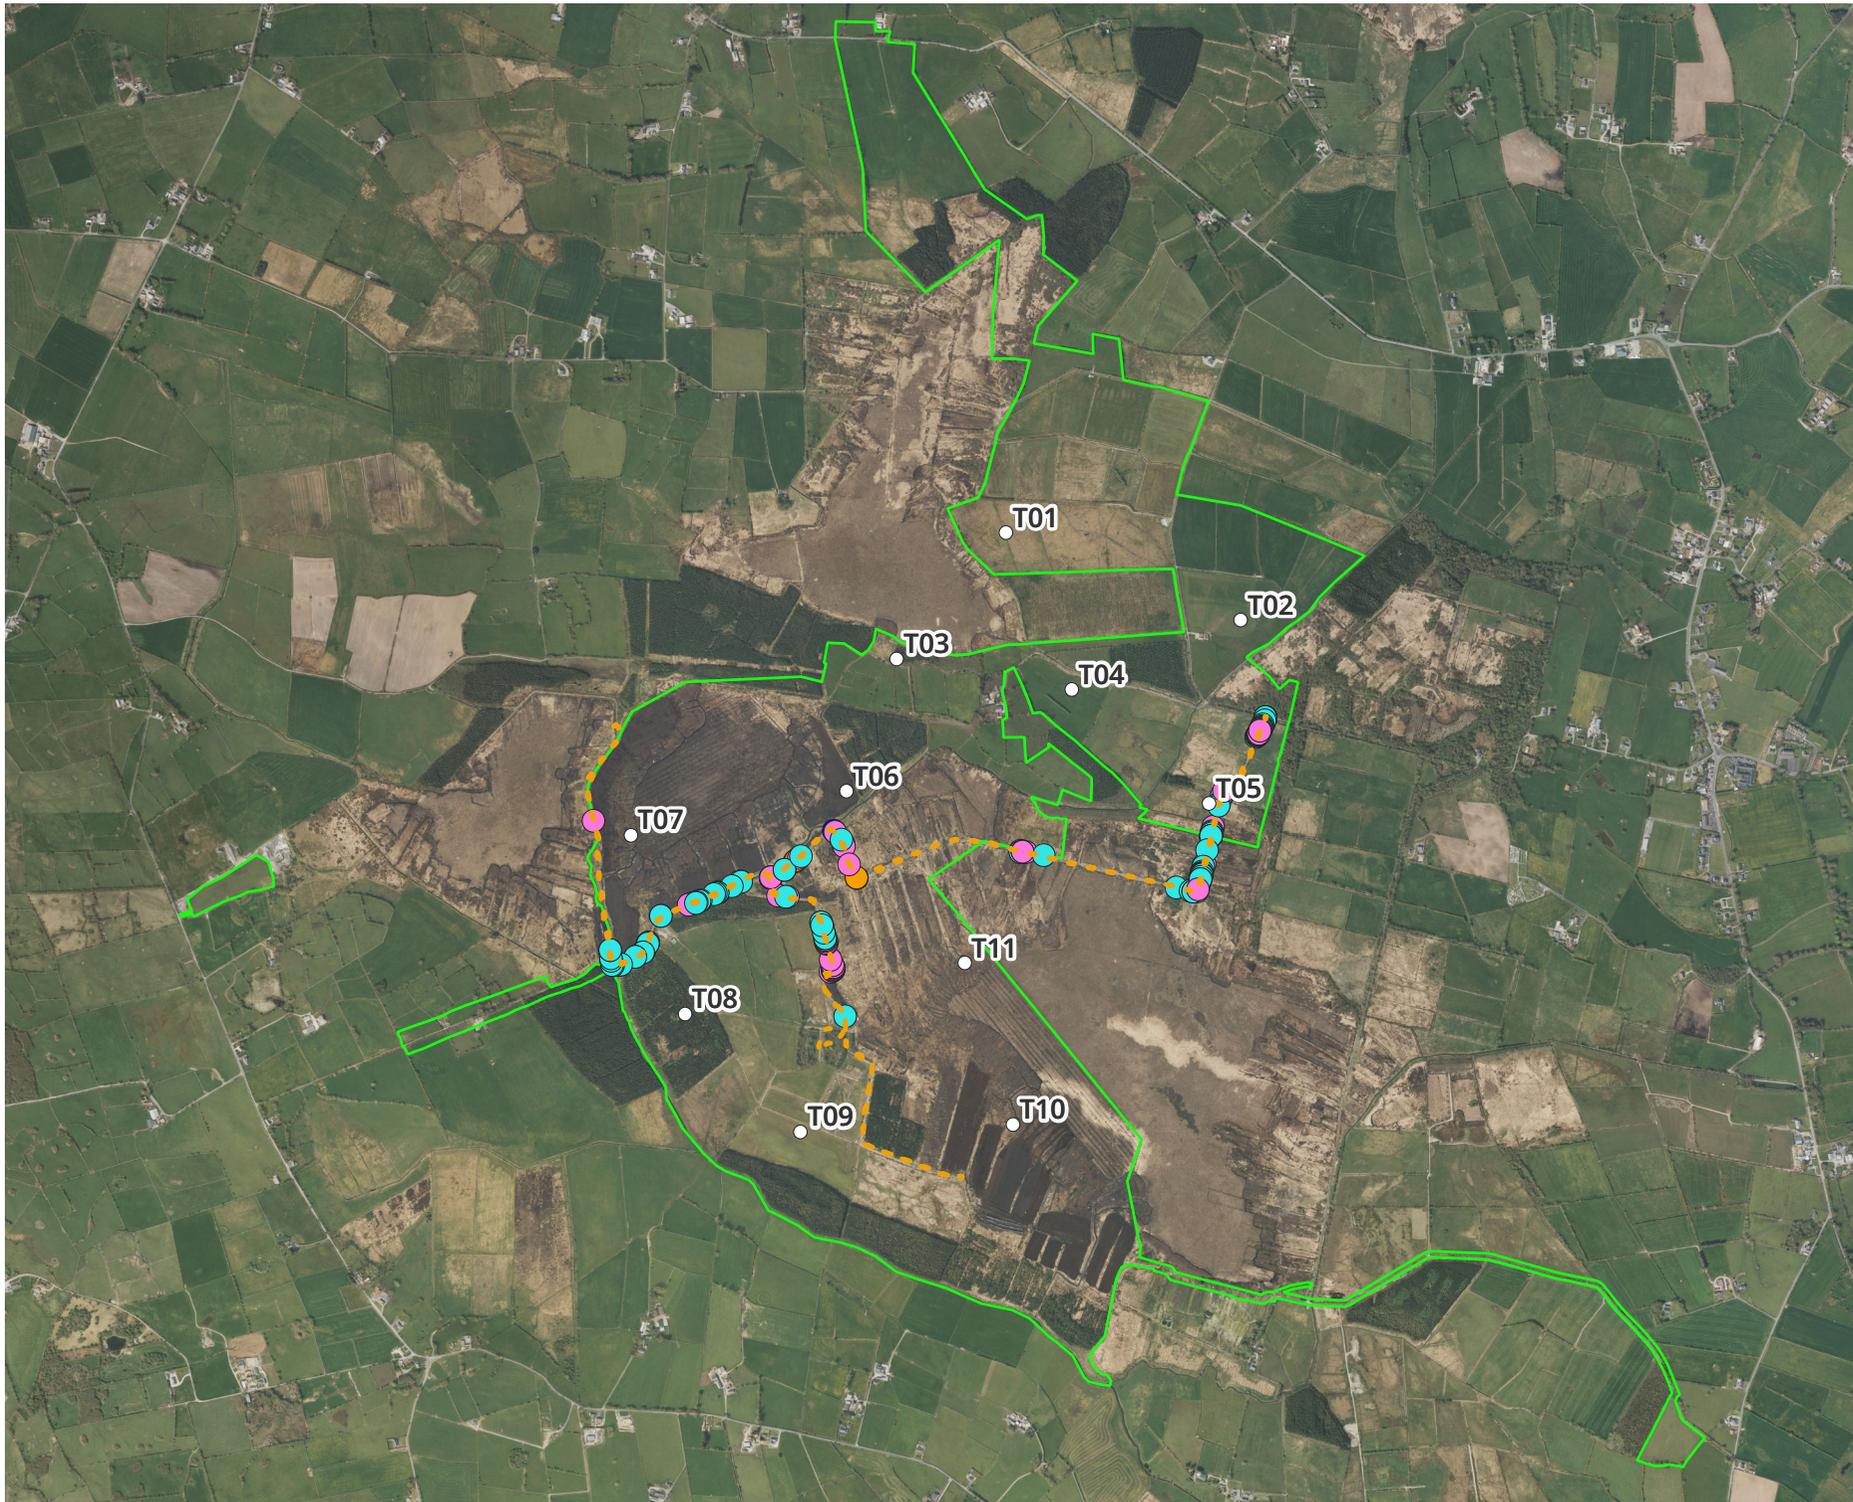
- EIA Site Boundary
- Proposed Turbine Layout
- Summer Transect Route
11th July 2019
- 2019 Summer Manual Results**
- Leisler's bat
- Nathusius pipistrelle
- Common pipistrelle
- Soprano pipistrelle
