Appendix 6-2 – Bat Survey Report

Proposed Clonberne Wind
Farm, Co. Galway

Document Title: **Bat Survey Report**

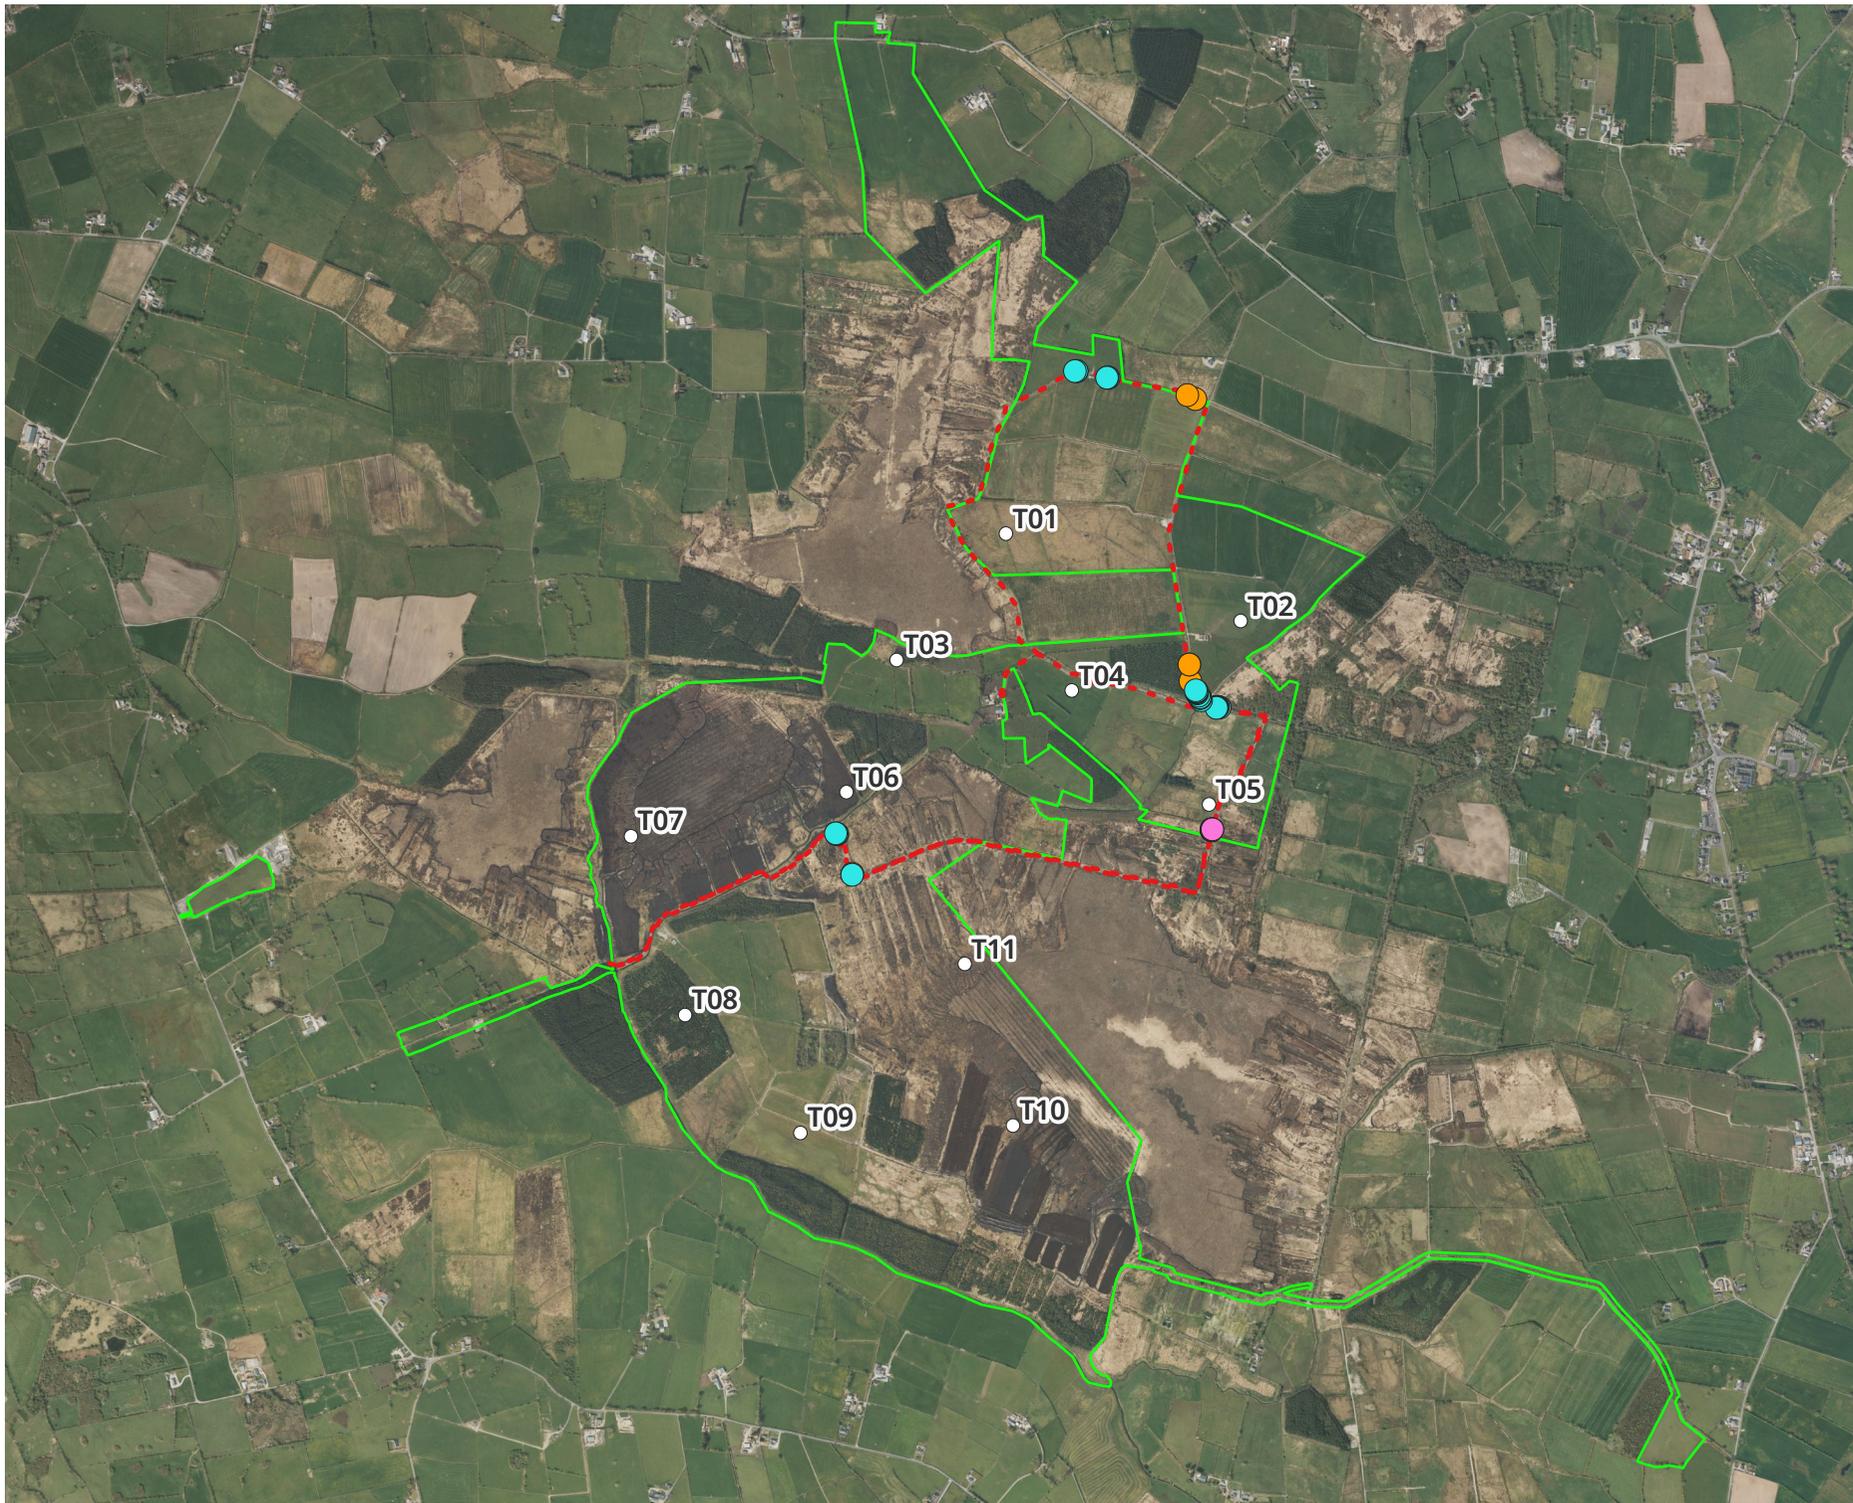
- EIA Site Boundary
- Proposed Turbine Layout
- 2019 Autumn Transect Route
22nd August 2019
- 2019 Summer Manual Results**
- Leisler's bat
- Common pipistrelle
- Soprano pipistrelle

Figure 3-1, Figure 3-2 and Figure 3-3 present the spatial distribution of bat activity across the 2019 surveys. Bat activity was concentrated along hedgerows, scrub and linear (road/track) habitats.
