Clonberne Wind Farm

Stage 1 Road Safety Audit

Alan Lipscombe Traffic & Transport Consultants

June 2024

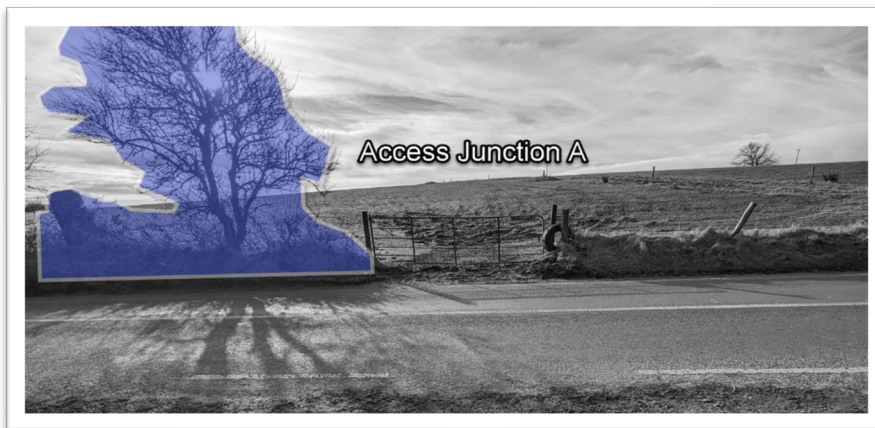
Figure 2.1 – Existing Field Boundary (shaded blue) Obscuring Sight Line to Right

Location: Access Junction A | Emerging Driver's Line of Site Looking to Right

A driver's line of sight to approaching westbound traffic travelling on the R328 appears to be partially obscured by an existing field boundary. This is likely to increase the risk of conflict on the R328 in proximity to the temporary wind farm access during the construction period.

Appropriate sight lines should be provided at the temporary access. This should be supported with practical temporary traffic management interventions to mitigate any residual risks.

Design Team Note 1 – The available visibility splays at the main Access junction A are shown in Figure 15-29 of the EIAR. The figure shows that the area shown hatched in blue in Figure 2.1 of the RSA will be cleared as part of the proposed junction and visibility splays of 3 x 160m will be available to the west, in accordance with the 80 km/h speed limit. To the east the visibility splays are constrained to 3m x 67 metres due to site boundaries. For this reason it is proposed that this junction will be managed by means of signage and Flagmen and the introduction of a temporary reduced speed limit during the construction phase, and then permanently closed once the site Proposed Development is operational. The proposed traffic management measures are discussed in Section 15.1.10 of the EIAR.

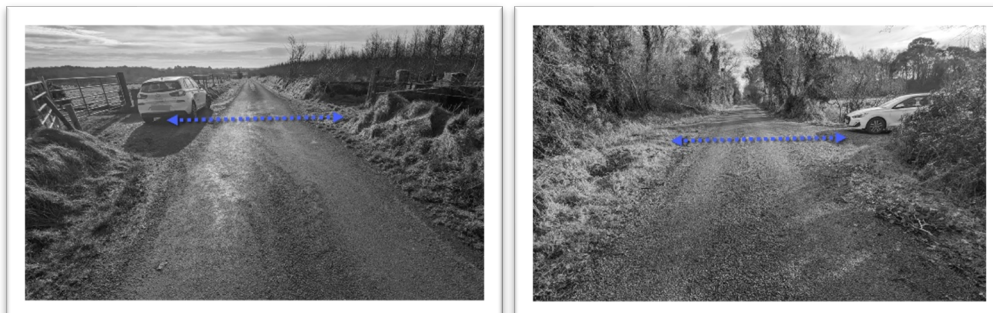
Figure 2.2 – Road Crossings - Access Junction B (Left) & Access Junction C (Right)

Location: Access Junctions B & C | Road Crossings

A number of the site access road approaches are long and straight. This could lead to higher approach speeds and 'failing to stop' type conflicts on the Local Roads.

Appropriate (self-regulating) temporary traffic management measures should be set in place to throttle construction traffic speed and to reduce the risk of collisions on the Local Road crossings.

Design Team Note 2 – It is proposed that signs will be put in place on the access road approaches to the local roads at Junctions B and C and that appropriate traffic management measures, including a Flagman, will be on site at all times during the construction phase. The site accesses will be closed by means of gates during all times that the accesses are not in use during construction. During the operational stage the default will be that the accesses will be closed using gates at all times and opened only during site visits made by maintenance staff. It is noted that visibility splays appropriate for the local speeds on the local road network are available at both junctions, as shown in Figures 15-33 and 15-34 of the EIAR.

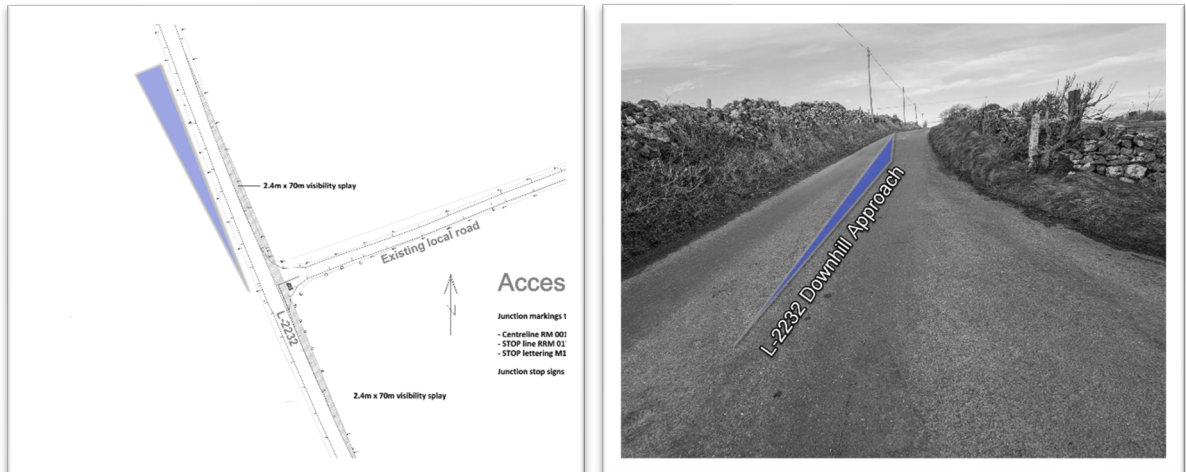
Figure 2.3 – Higher Speeds Observed on Southbound L-2232 Approach to Access Junction F

Location: Access Junction F | Southbound Approach on Local Road L-2232

The downhill approach to Access Junction F is likely to result in higher vehicle speeds. This could increase the likelihood and the severity of a collision at the junction.

Appropriate signage and road markings should be set in place to inform drivers (including drivers of construction related traffic) of the approaching junction and warn them to throttle their approach speeds.

Design Team Note 3 – It is noted that this is an existing junction and during the days that it is used to transport materials from the borrow pit to the site the junction will be controlled by traffic management measures, including temporary signing and a Flagman, which will calm local traffic speeds. Once the construction phase is complete there will be no development generated traffic passing through this junction.
