Environmental Impact Assessment Report

Appendix 16.1

Appendix 16-1

Catalogue of Cultural Heritage Assets

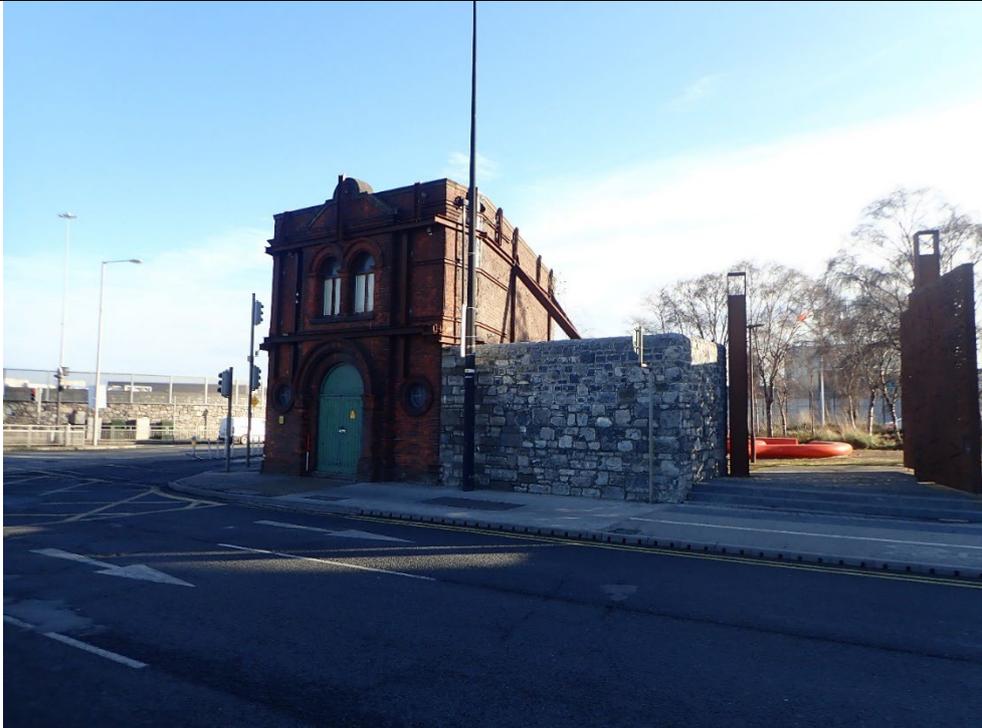
<p>View looking east from East Wall Road towards the Substation</p>

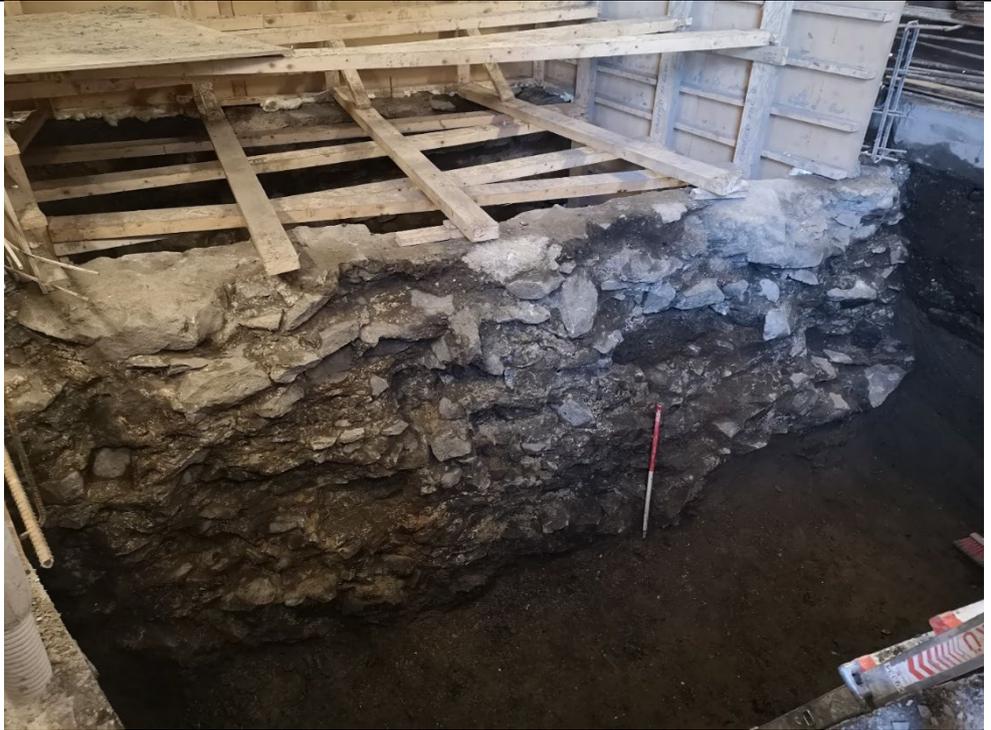
Excavated length of the former sea wall that lies under the Substation

Reference	Site Name	Site Type	ITM Easting	ITM Northing
NIAH 50011170	Substation	Substation	718133	734901
Description	<p>The redbrick building that stands at the junction of East Wall Road and Alexandra Road in Dublin Port is a former electricity substation that was built in 1922, the year of Irish Independence. It has been rehabilitated in 2023 by Dublin Port Company as a small event space known as the Substation. The rehabilitation works were monitored archaeologically by ADCO under licence 21E0737 and in fulfillment of Dublin City Council's grant of planning, reference 2681/20.</p> <p>The Substation was built over the eighteenth-century sea wall that gives its name to East Wall Road and served as a dyke within which the city's growth was able to develop the North Lotts and what became the East Wall. The sea wall is a significant structure whose full width probably extends across much of East Wall Road. The element that has been discovered under the redbrick building is the eastern edge of the sea wall.</p>

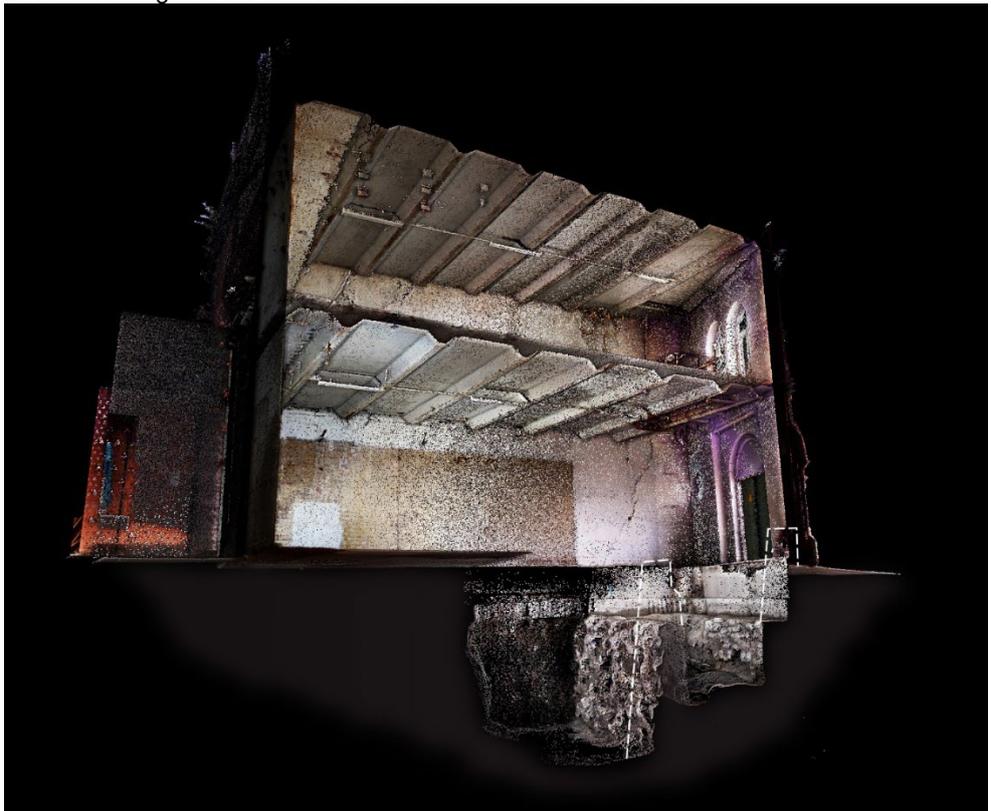
ADCO laser-scan survey showing the exposed extent of the sea wall underneath the Substation

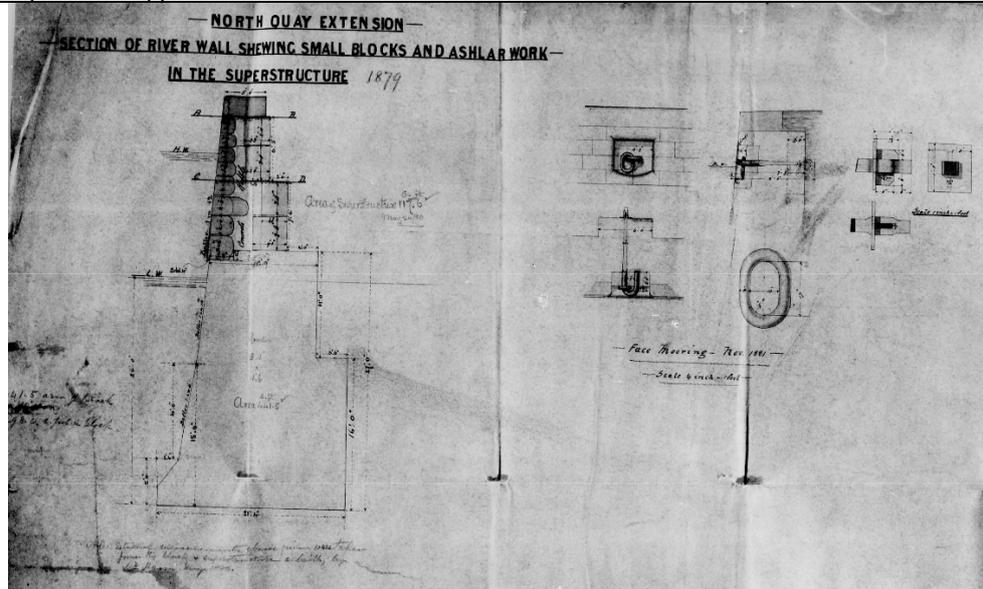
Detail from Dublin Port Archive engineering drawing reference 7929 dated 1879, showing section of quay wall highlighting a foundation block and the ashlar coursing placed above, and detail of a mooring ring.

<ul style="list-style-type: none"> • Capstones and upper courses of granite ashlar to be removed across bridge footprint • Excavation of NWQE surface to working depth of xxm across bridge footprint • Impact with one recessed mooring ring and associated stonework anticipated
Recommended Mitigation	<ul style="list-style-type: none"> • SPAR Bridge designed to minimise impact on NWQE • Supplemental detailed archaeological topographic survey prior to construction • Avoid impact with recessed mooring ring and associated stonework • Archaeological monitoring and resolution • Retention of ashlar granite for sympathetic re-use • Rebuild recessed mooring ring and associated stonework if impacts are unavoidable

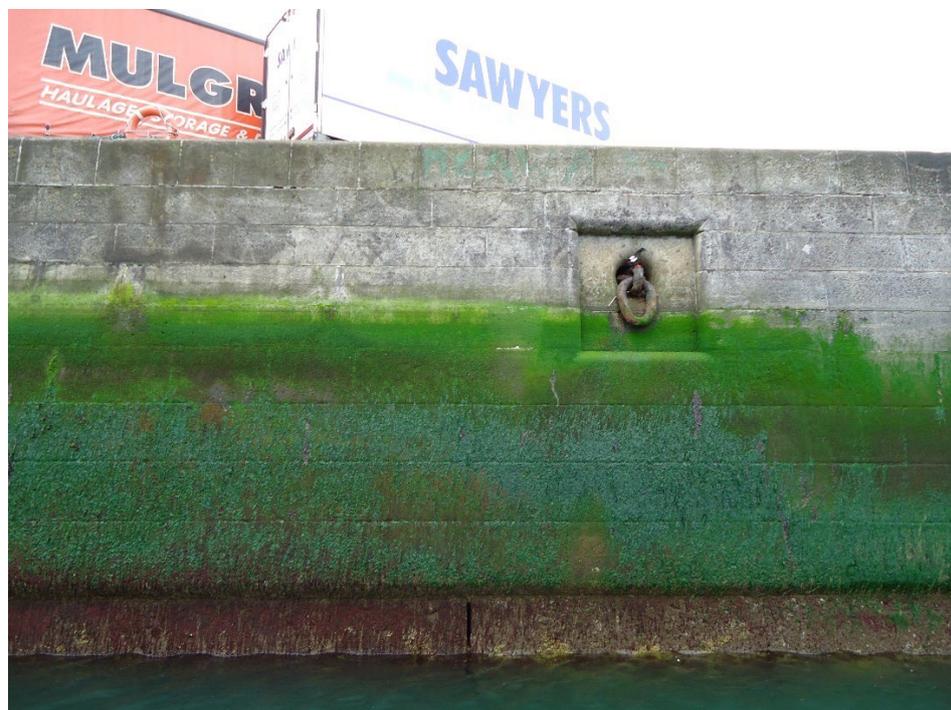
survive in places along the quay edge. The interior surface of the deck is masked by cobble-lock brick that conceals the earlier features on the quay's working surface but lengths of rail line are retained that speak to earlier uses. Underwater inspection (completed under licence 13D0019) also revealed the concrete foundation blocks, the toes of which can be partly buried in silt or exposed.

Photograph shows the top of two mass concrete foundation blocks and the join between both at the base of the image, with the granite ashlar coursing constructed above and a recessed mooring ring

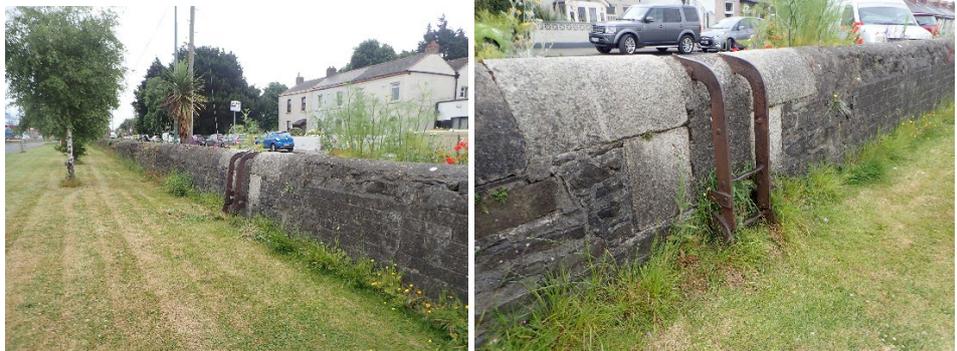
Two views of northern parapet looking south, showing quay wall ladder retained

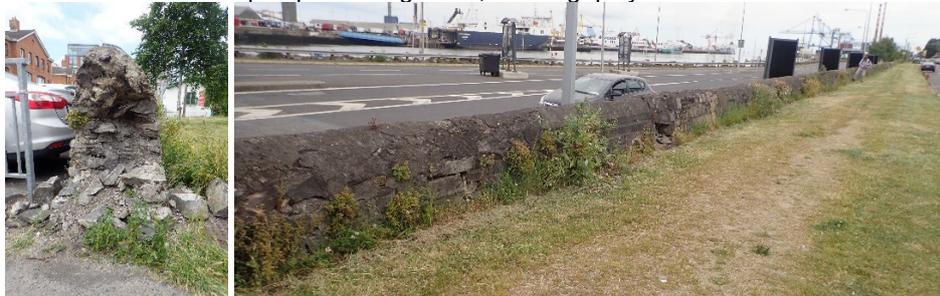
View showing breach in north-facing parapet, and view looking east along north-facing parapet from York Road

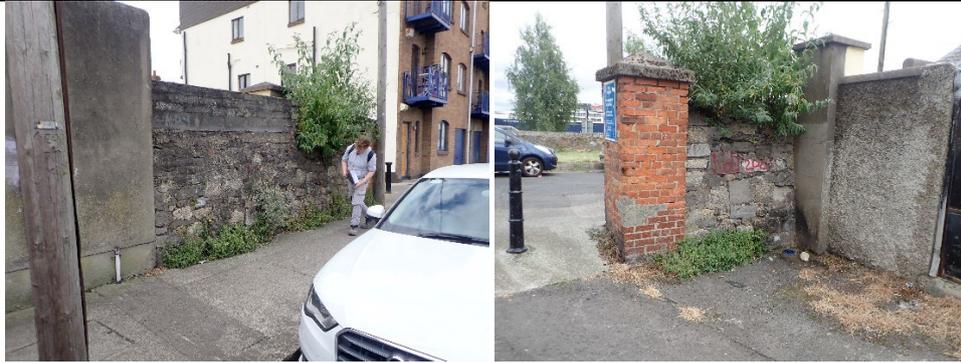
Views of surviving south parapet wall at junction of York Road and Pembroke Cottages

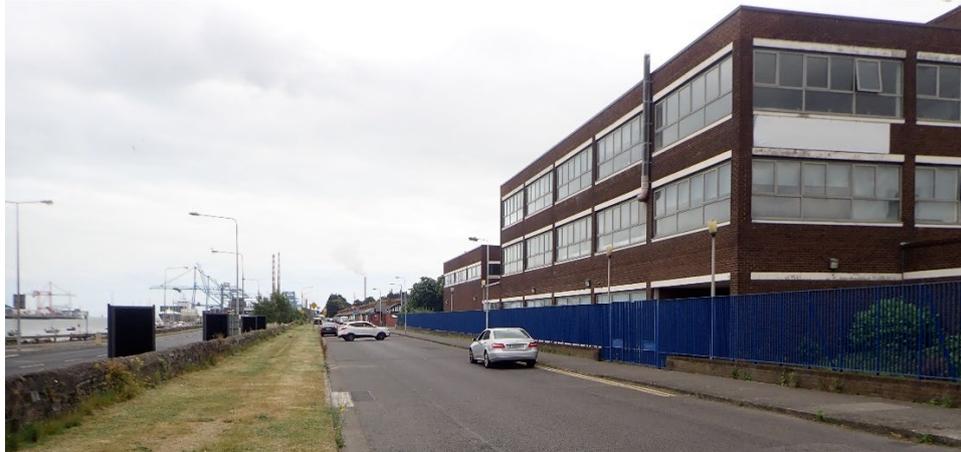
View looking east along York Road where the south-facing parapet does not survive above ground but is replaced with the curtilage fencing of Ringsend College

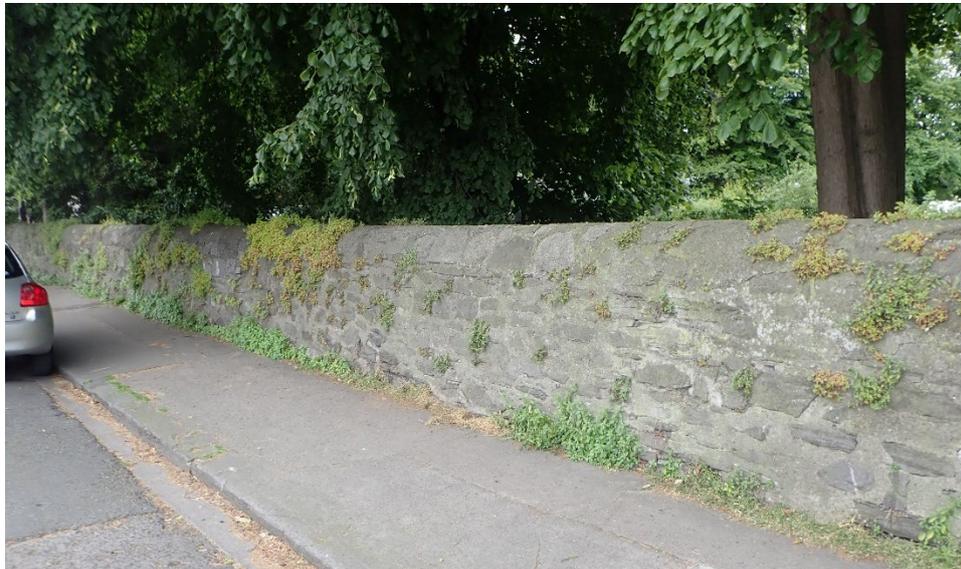
View looking east along Pigeon House Road where the south-facing parapet survives as the standing boundary wall with Ringsend Park

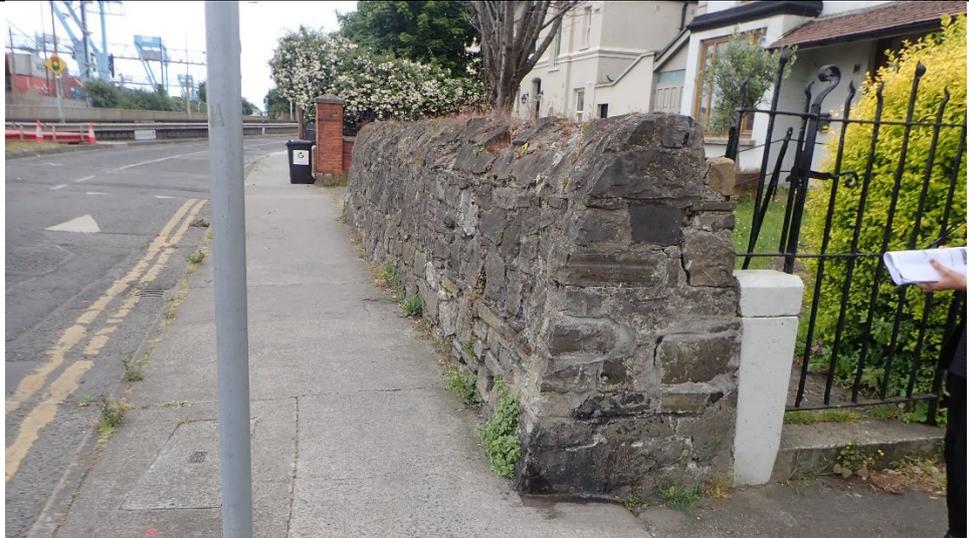
<p>Description</p>	<p>View looking east along Pigeon House Road where the south-facing parapet survives as the front garden boundary wall to residential properties at junction with Cambridge Avenue Poolbeg Yacht and Sail Club to MTL Yard: The R131 has breached the GSW and cuts across the sea wall at an oblique angle.</p> <p>Pigeon House Road continues to the east of the R131 and the front garden walls of the former coastguard cottages (RPS 6782–RPS6792, see below) follow the line of the southern parapet. In contrast, the northern parapet is not upstanding but is most probably underneath a low concrete retaining wall that serves as the boundary with the northern reach of the MTL yard.</p> <p>Within the MTL Yard, a length of the GSW is apparent where a green verge extends for c. 122m. The north-facing wall that retains the grassed area is the southern parapet of the GSW. The northern limit of the GSW does not survive upstanding across the Yard.</p>

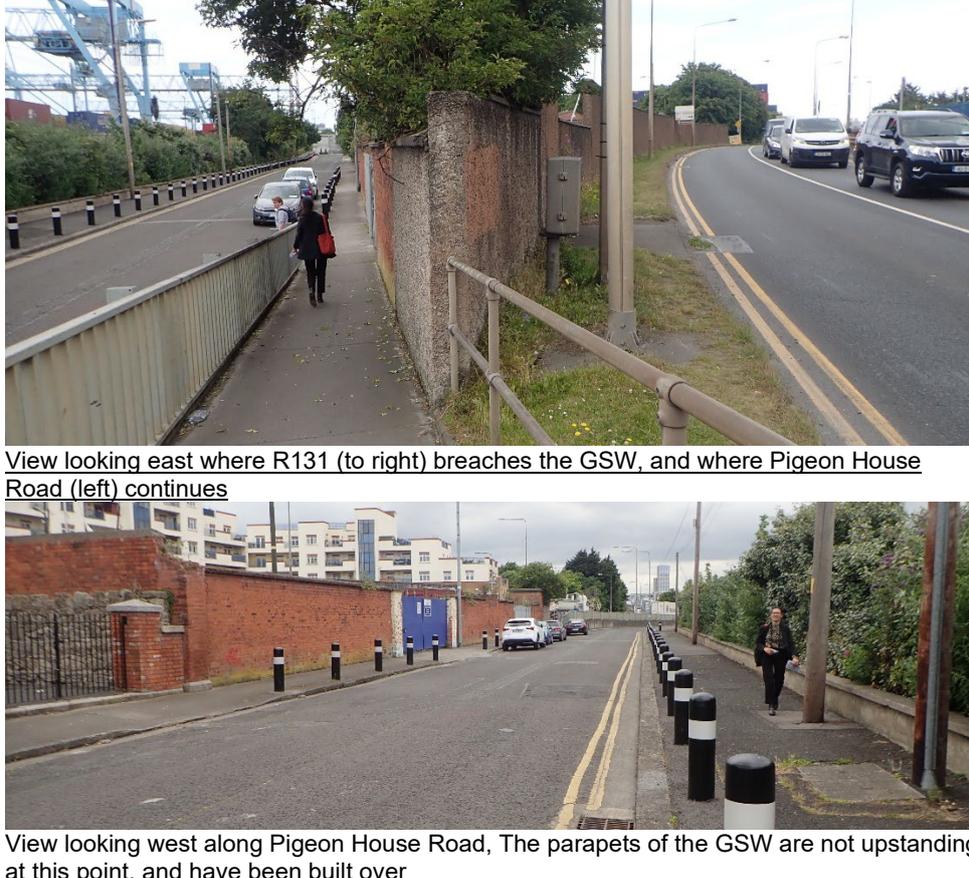
<p>View looking east where R131 (to right) breaches the GSW, and where Pigeon House Road (left) continues</p> <p>View looking west along Pigeon House Road, The parapets of the GSW are not upstanding at this point, and have been built over</p>

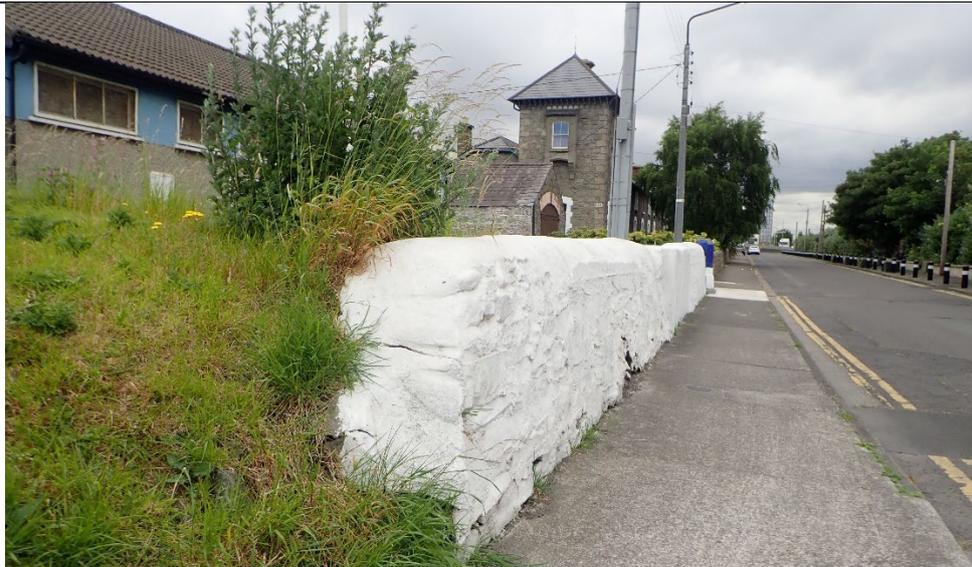
View looking west along Pigeon House Road, showing the southern parapet of the GSW as it survives serving as the boundary wall to the Ringsend Sea Scouts den

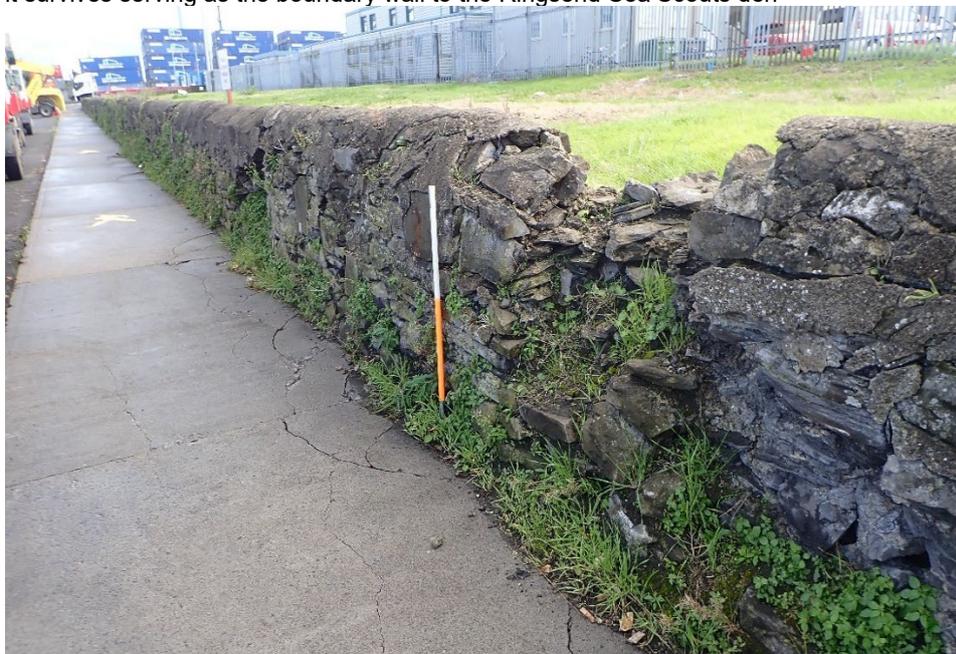
View looking east along upstanding southern parapet of the GSW that retains the north side of the grass verge in the MTL Yard

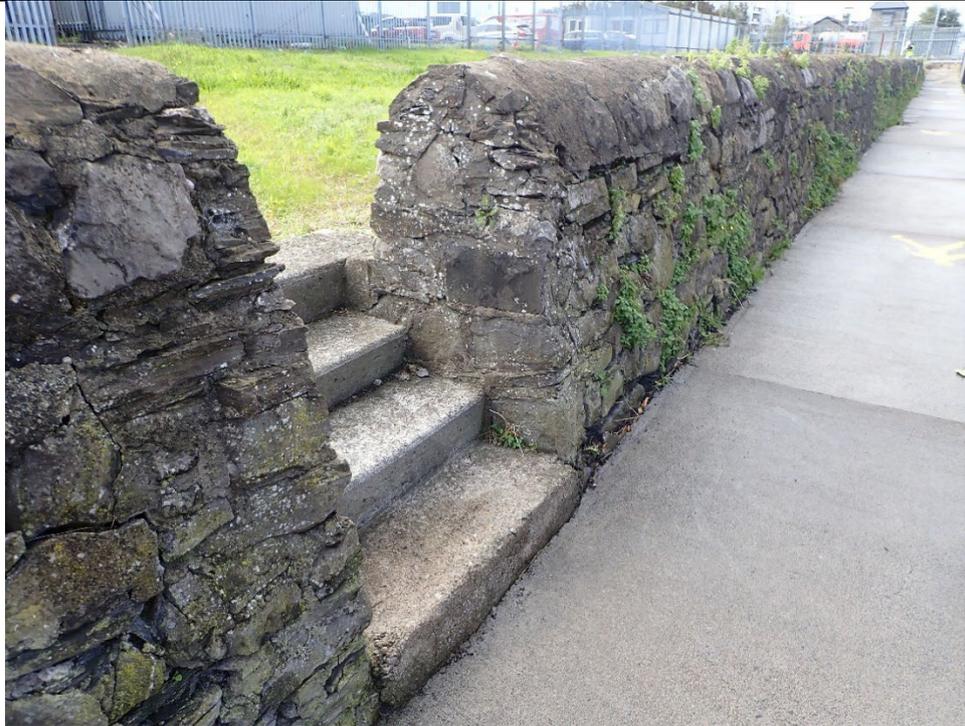
The south parapet of the GSW within the MTL Yard has been breached in several places, in this instance to insert step access

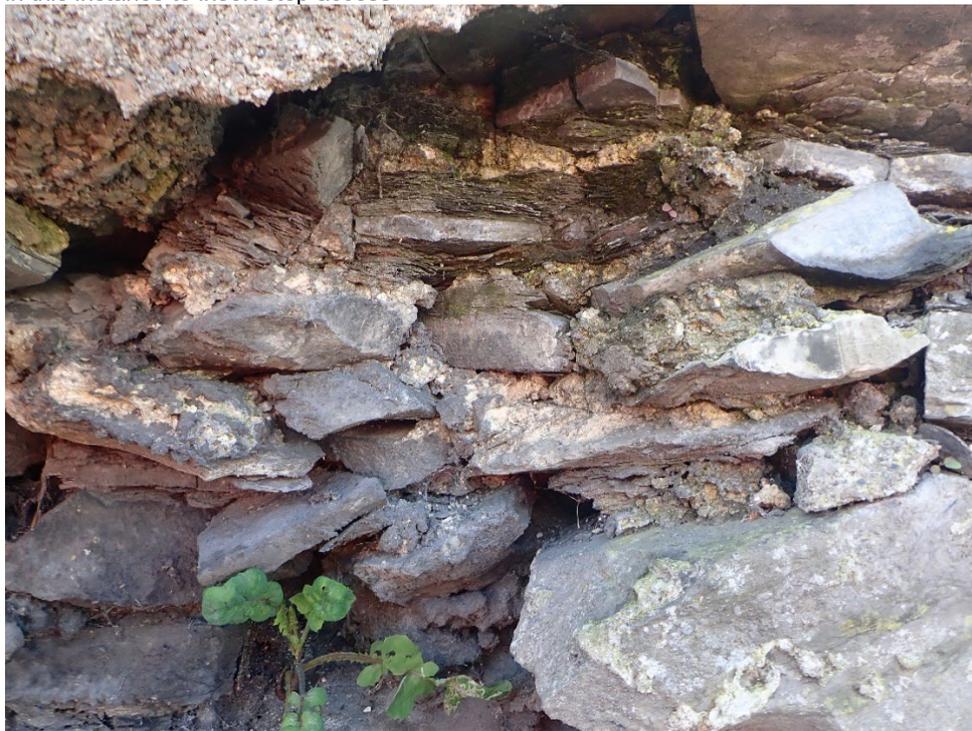
Detail showing fabric of the south parapet of the GSW in the MTL Yard where the wall core is exposed

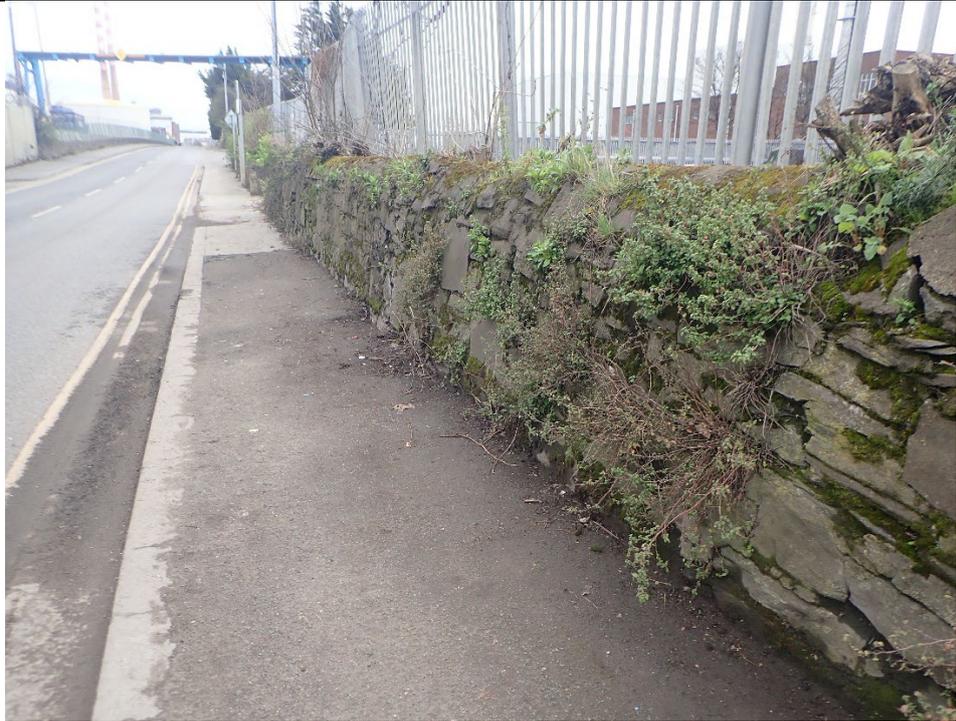
View looking east along upstanding southern parapet at Murphy's Yard

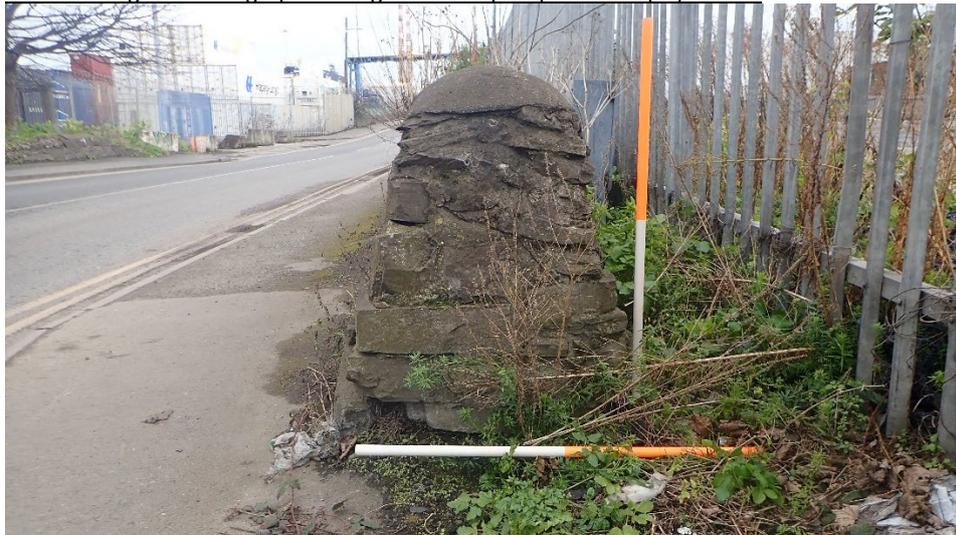
View looking east at section across parapet wall at Murphy's Yard

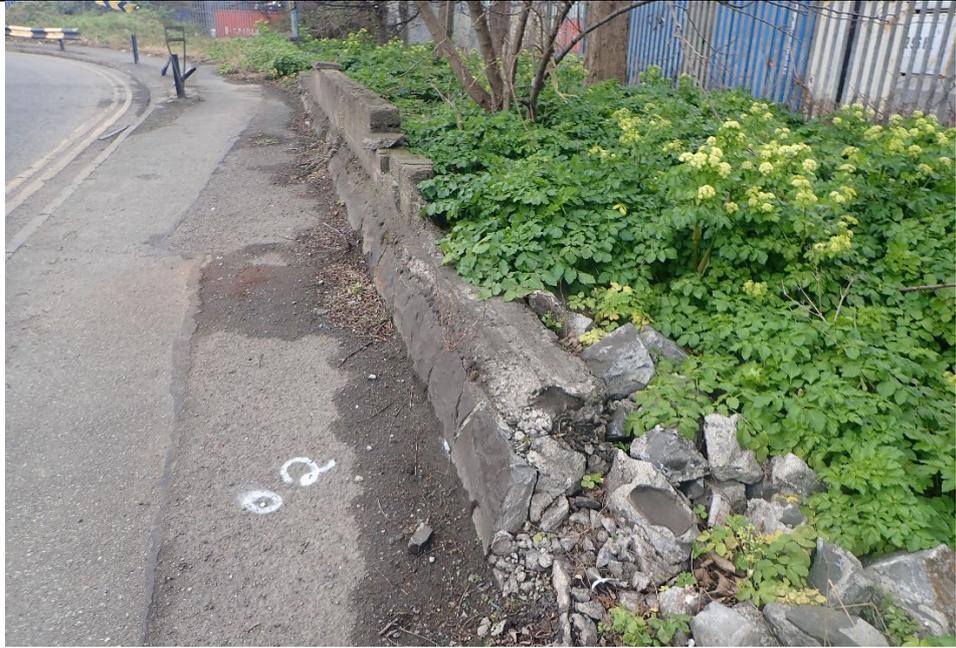
View looking west along ruined wall base over northern parapet opposite Murphy's Yard

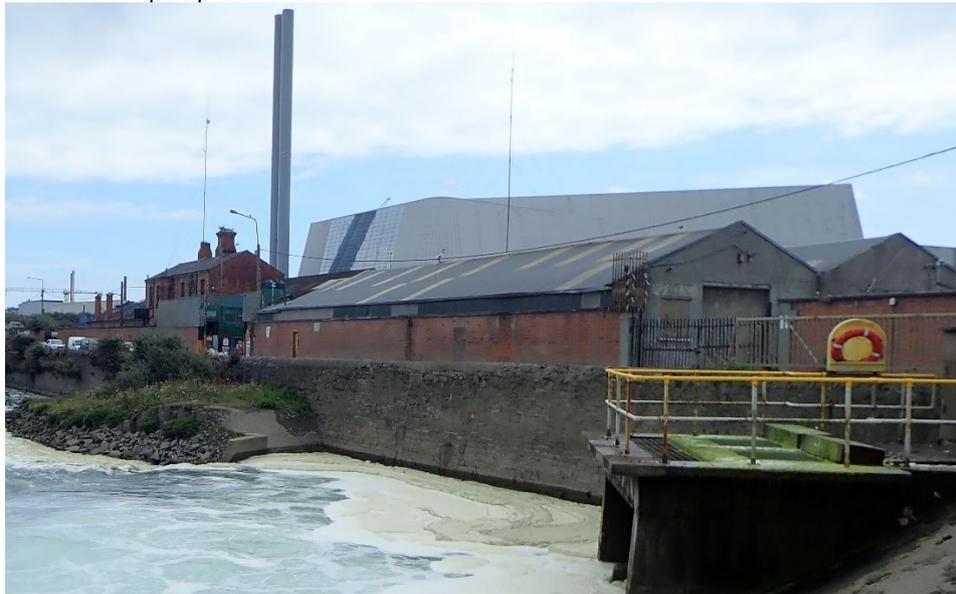
View looking south at sea wall as it drops over 5 m to active seabed opposite the Fever Hospital

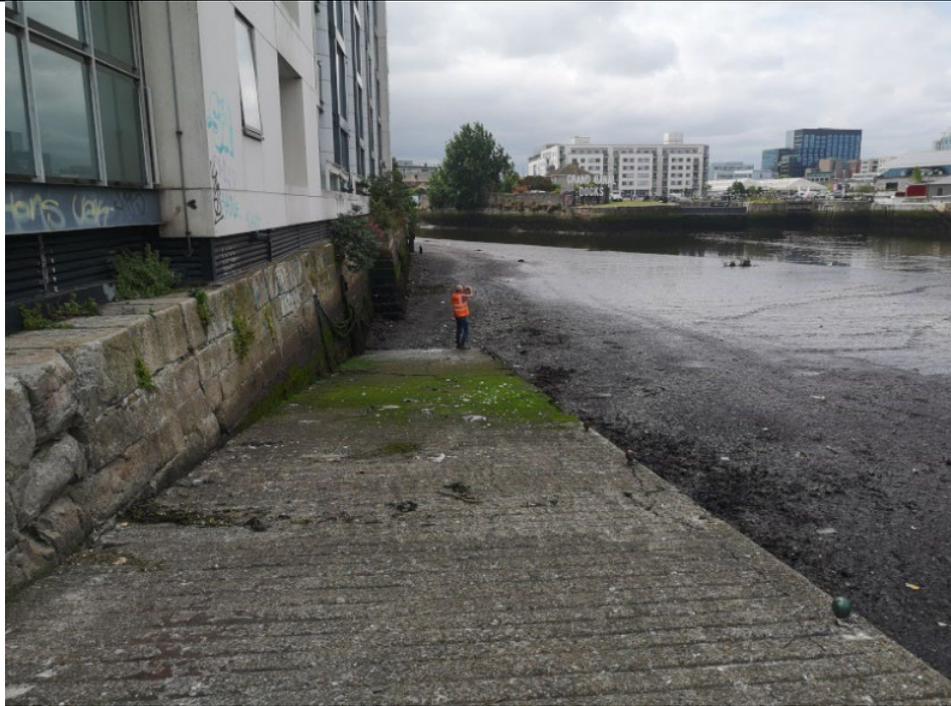
The slip as seen today.

Reference	Site Name	Site Type	ITM Easting	ITM Northing
DCIHR 18-12-118	Boat slip	Boat Slip	717920	734198
Description	Exterior Description: Concrete boat slip c.1920-30, with iron posts and railings and concrete mooring blocks. Cast iron lamppost to northwest corner. Limestone masonry quay wall borders to east. This early twentieth-century boat slip retains original railings, etc. and is an important surviving example of maritime construction within an area that has been largely redeveloped. Slip built on the site of an earlier wooden pier as seen on the OS 3rd edition 6-inch map of 1912.

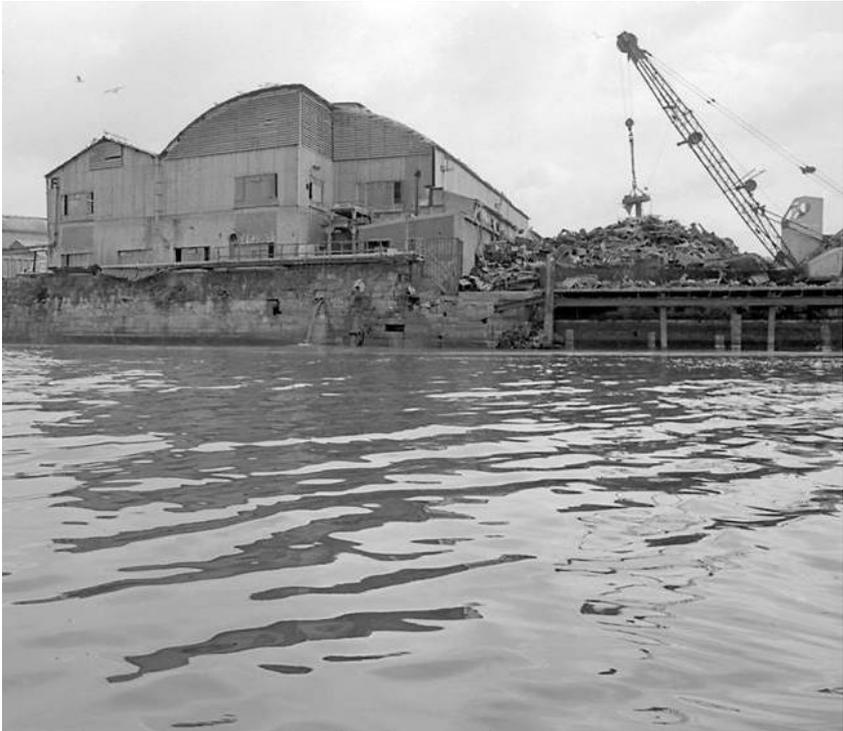
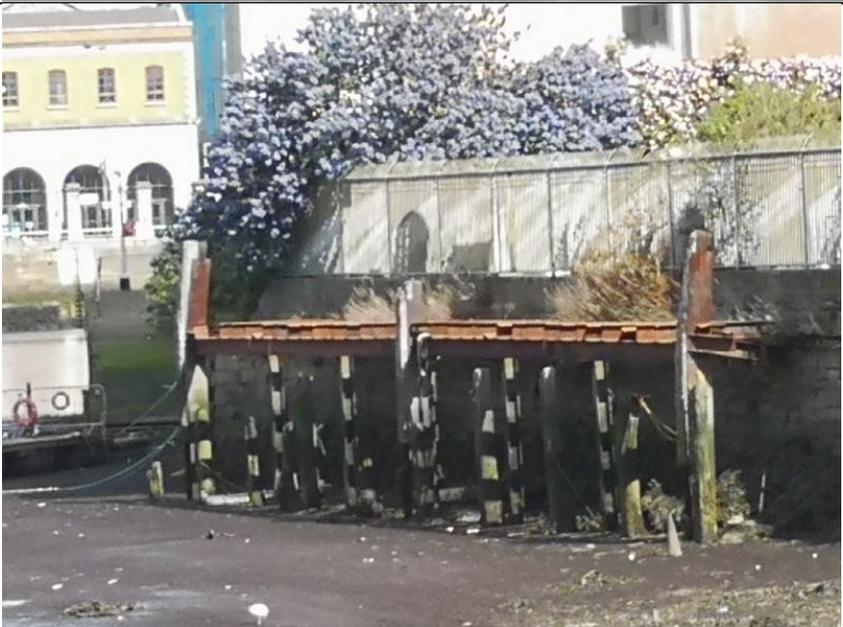
Reference	Site Name	Site Type	ITM Easting	ITM Northing
DCIHR 18-12-121	Landing Stage	Landing Stage	717909	734127
Description	Remains of a landing stage built c.1900, possibly to serve coal yard located to the east. Later served Hammond Metals from 1950s. Timber planks forming deck supported on metal framework, tied into stone revetment wall to eastern bank of river. Though no longer used and having fallen into disrepair, this landing stage provides an important reminder of the industrial heritage of the River Dodder. Located at the mouth of the river as it enters the

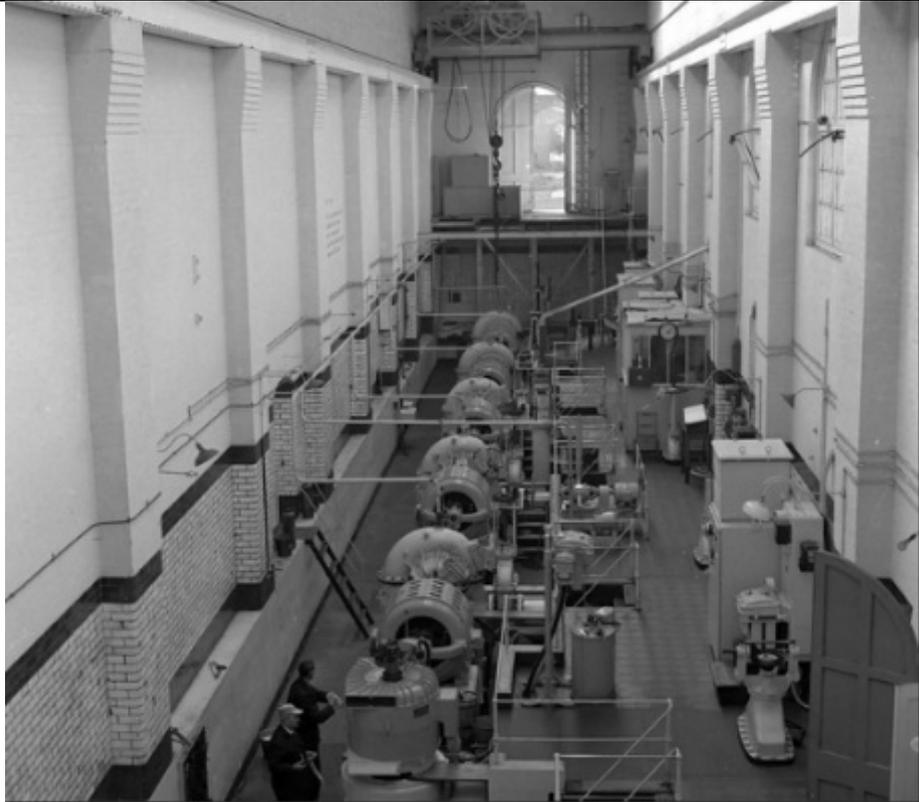
Reference	Site Name	Site Type	ITM Easting	ITM Northing
DCIHR 18-12-152	Dublin Corporation Main Drainage Pumping Station	Pumping Station	718866	733934
Description	<p>Dublin Corporation purchased Pidgeon House Fort, which was then in possession of the War Department. With the fort, the Corporation also purchased 60 acres for the purpose of constructing a pumping station and settlement tanks. Dublin Corporation Pumping Station was built in 1906. A 120-foot-high ventilation chimney was one of the striking features of the building. The building badly damaged in an explosion in 1969.⁷ It was replaced in 1985 with a modern pumping station located to the south of the original site. Though the original pumping station is no longer extant, it is possible that power and plant survive within the newer pumping station.</p>

Main Pumping Station Ringsend - Dublin City Council Photographic Collection

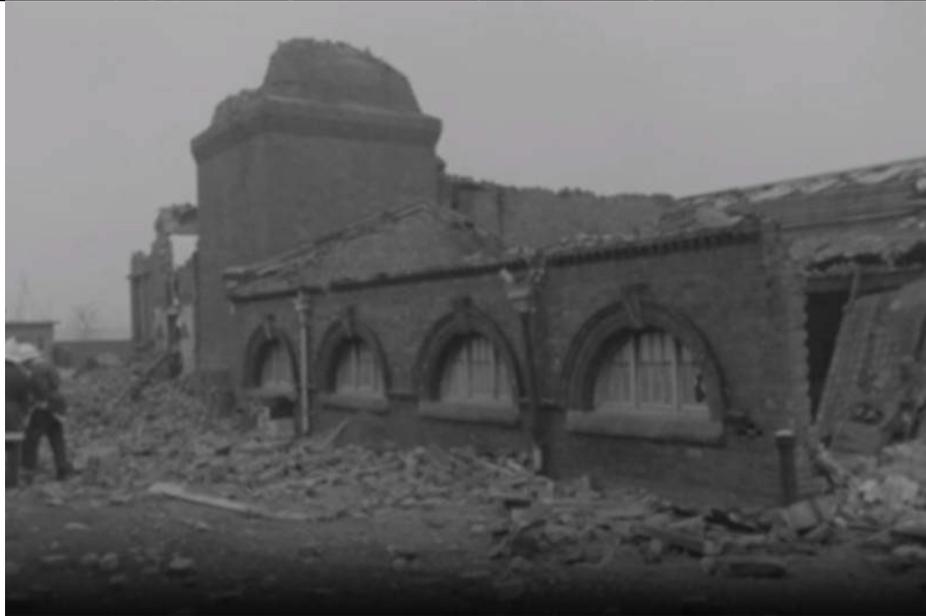
RTE Archive image of the pumping station following explosion in 1969

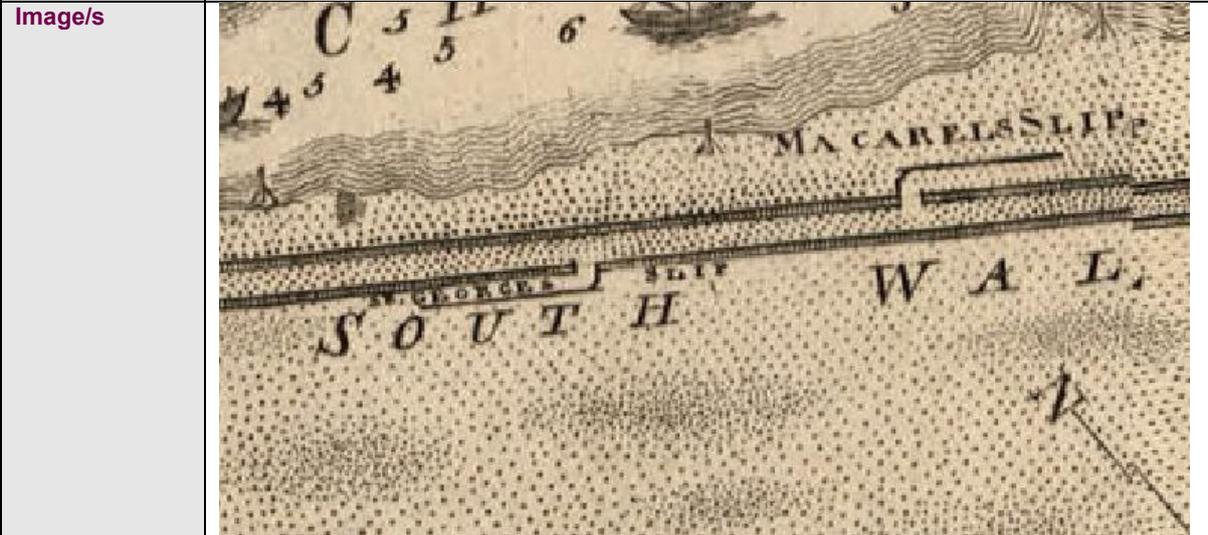
Detail from Rocque 1757 showing Mackarel's Slip. St. George's Slip is also recorded to the west

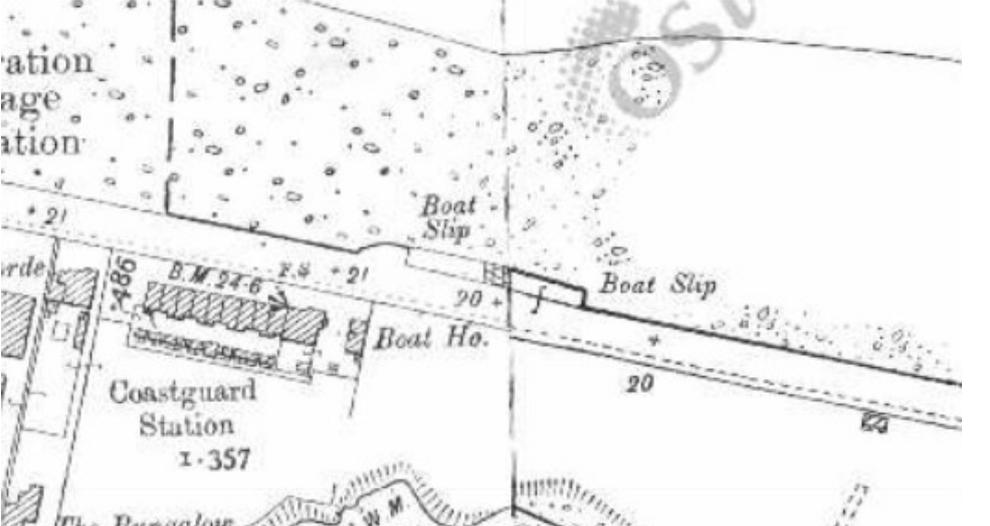
Detail from historic OS 25-inch map showing Boat slip DCIHR 19-009-001, and its relationship to the Coastguard Station on Pigeon House Road

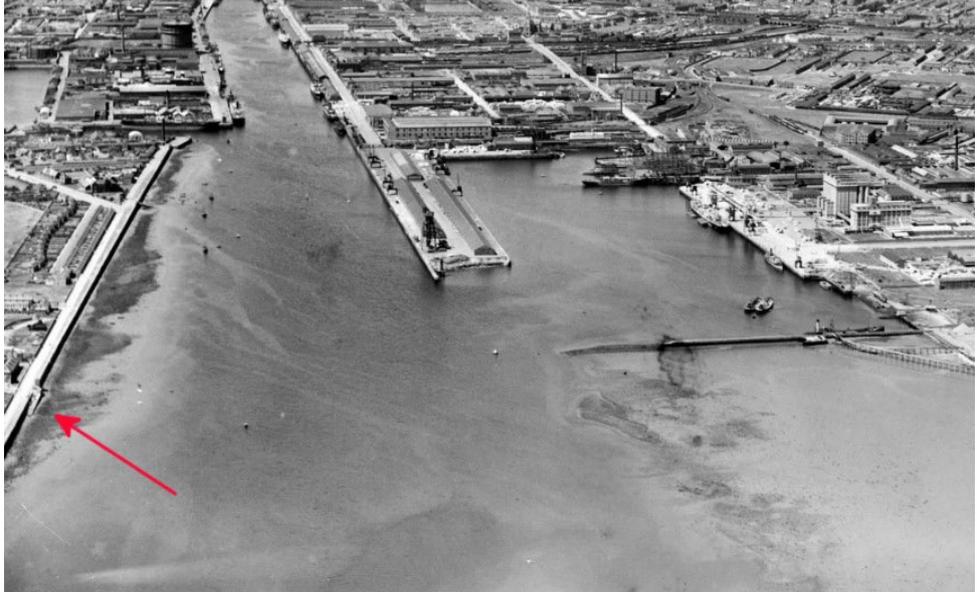
<p>The location of the slip is recorded in this aerial image dated early 1930s. The slip was buried during the construction of the container terminal which became operational in 1974.</p>
<p>Proximity to development</p>	<p>Within development area</p>
<p>Likely Impacts</p>	<p>Adjacent to SPAR in Area K</p>
<p>Recommended Mitigation</p>	<p>Archaeological monitoring of ground disturbance activities, with full archaeological recording and preservation <i>in situ</i> if exposed where possible.</p>

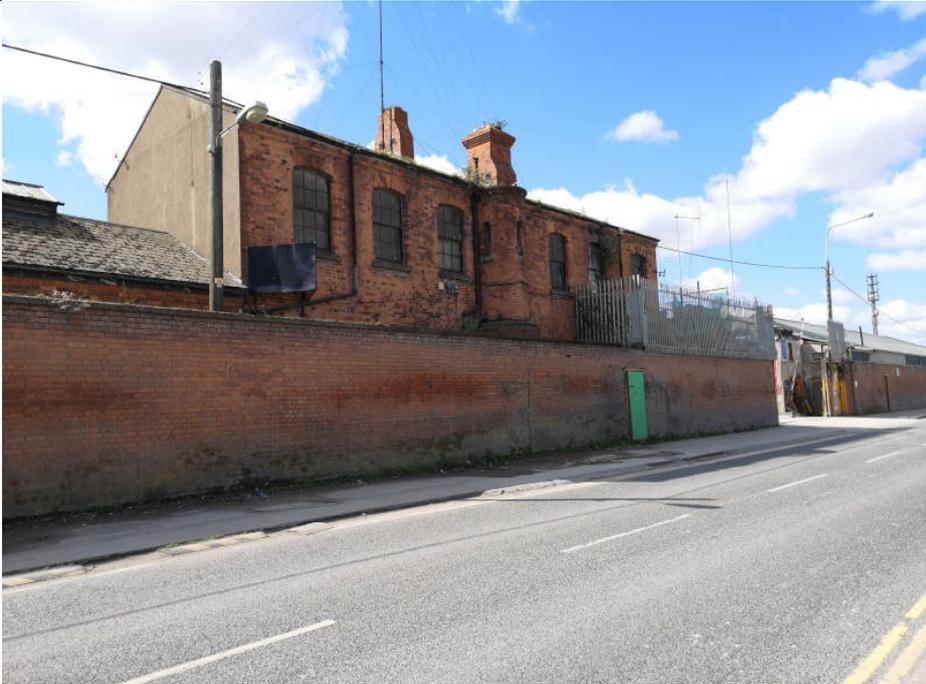
<p>View looking southwest along boundary wall in front of the remains of the Fever Hospital</p>
Proximity to development	Adjacent to development area
Likely Impacts	No physical impact. Anticipated increase in HGV traffic along Pigeon House Road
Recommended Mitigation	None

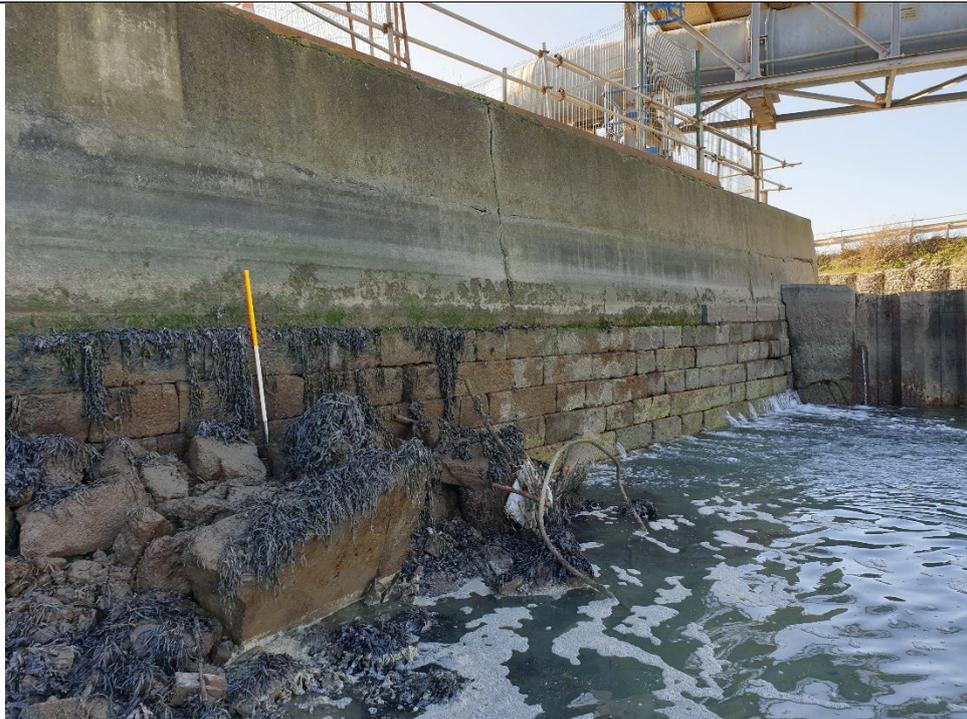
View looking south at northwest corner of Pigeon House Harbour wall, built c. 1791

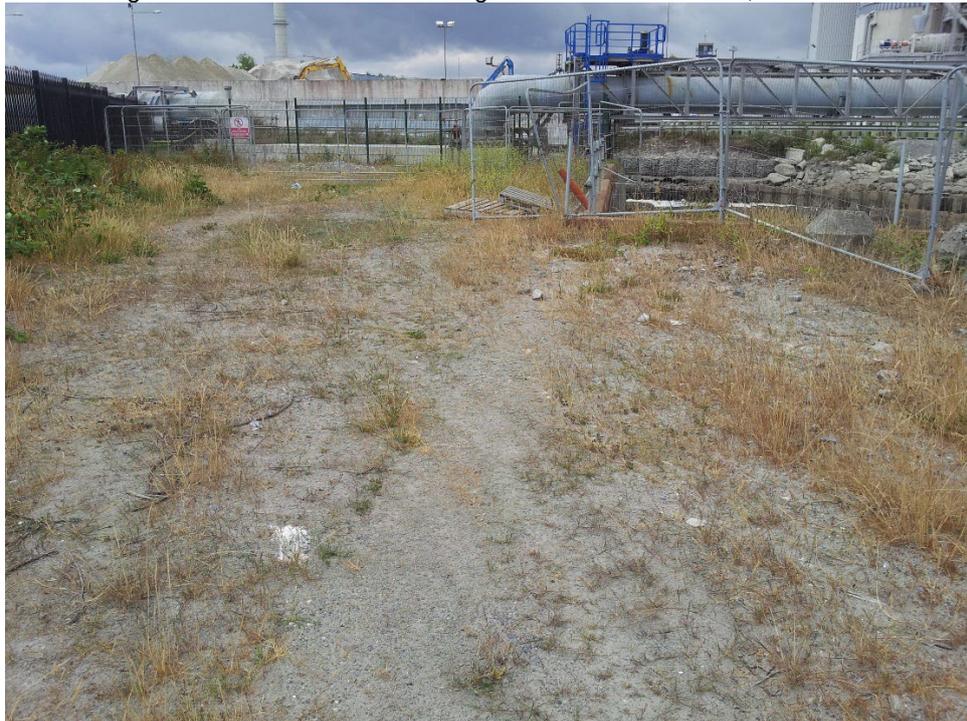
View looking west across reclaimed land, showing the line of the former harbour wall still evident on the ground surface

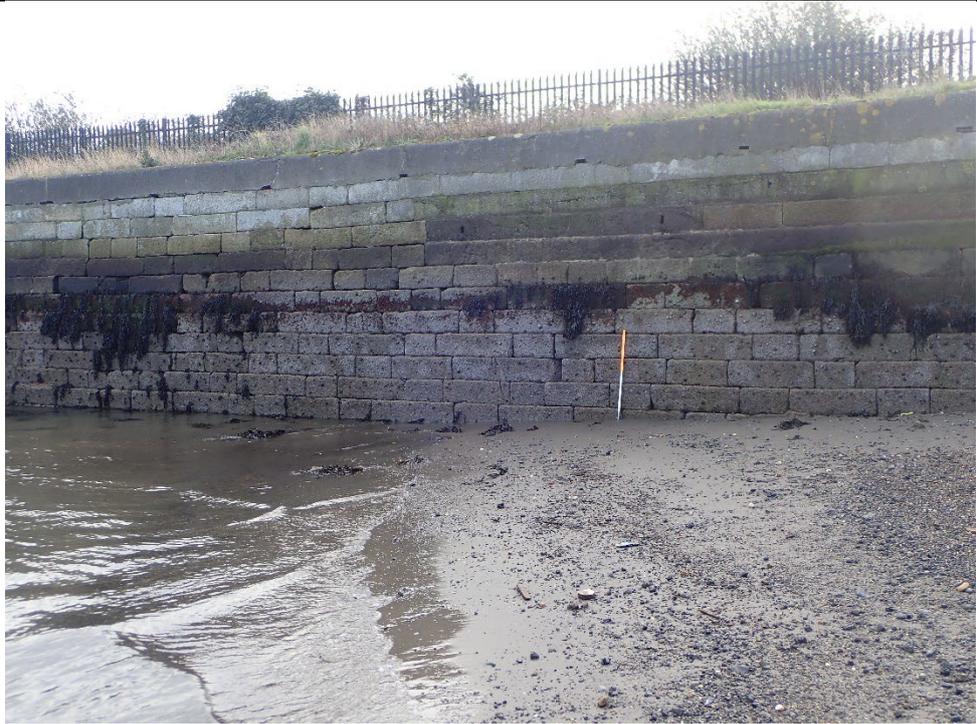
View looking south at north-facing elevation of Pigeon House Harbour wall

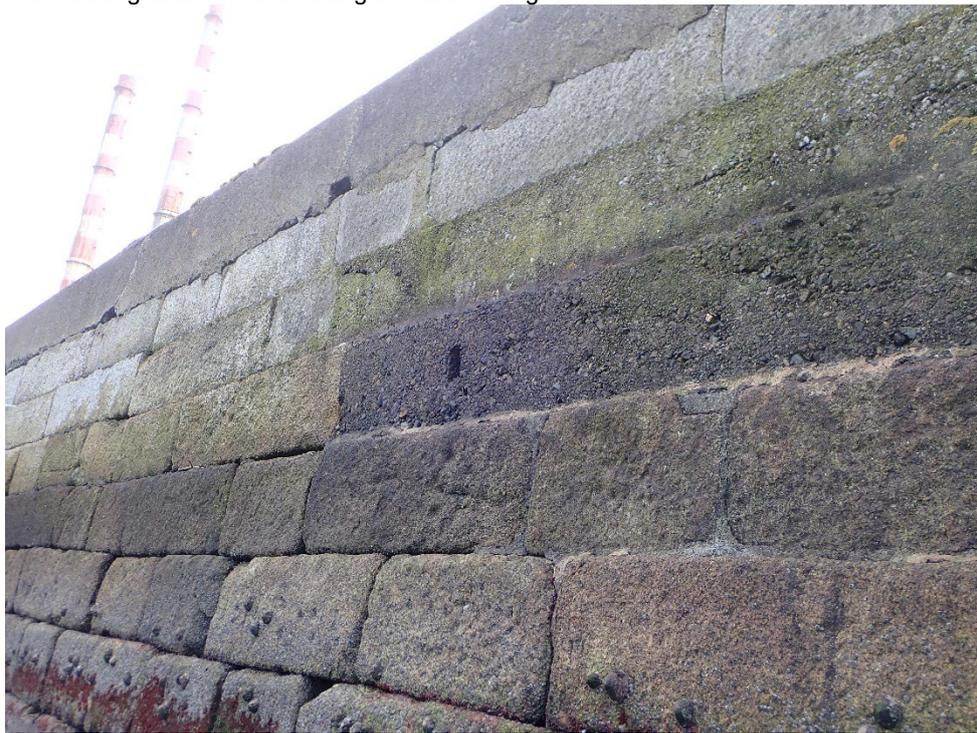
Detail view of north-facing elevation of harbour wall showing the stepped profile that is typical of the construction of the GSW.
