Environmental Impact Assessment Report

Appendix 16.1

Appendix 16-1

Catalogue of Cultural Heritage Assets

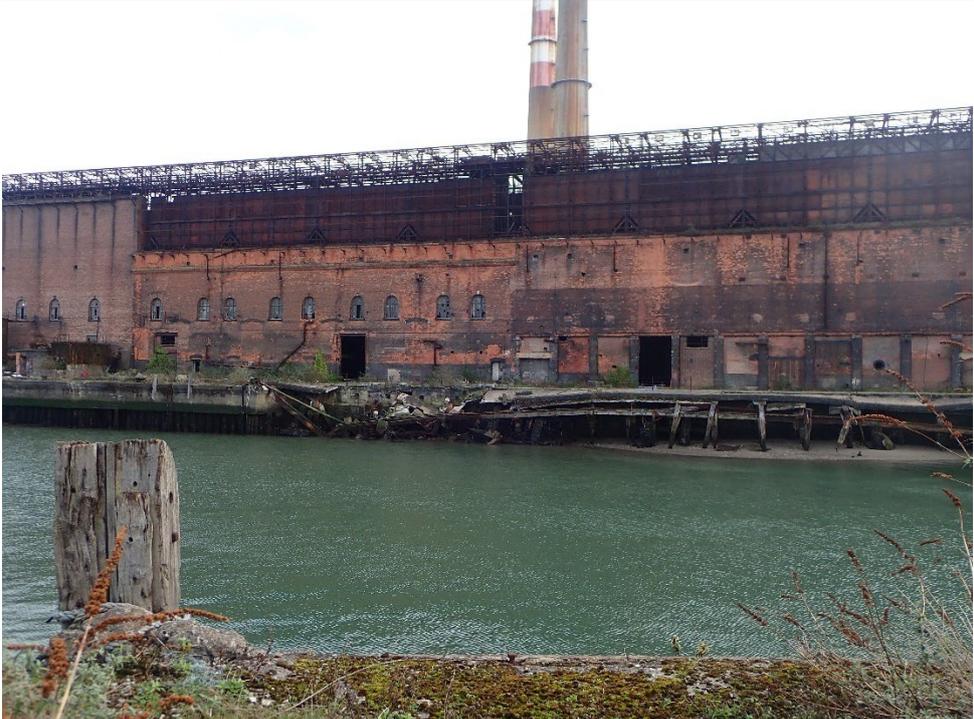
The east side of Pigeon House Harbour has been substantially altered from the original, where a c. 50m-long section of quay wall (oriented north-south) has been removed and replaced with a sheet-piled wall, set back up to 15m from the original. Extensive rock-armour protection has been placed along the base of quay wall. The timber wharf is in a state of dereliction.

<p data-bbox="408 916 1342 972">View looking east across current basin of harbour at ruinous wharf in front of the former Electricity Works (RPS 6796)</p>
Proximity to development	Within development area
Likely Impacts	<ul style="list-style-type: none"> • Demolition of sludge jetty that abuts harbour wall • Constraints imposed by proposed turning circle and Area N on its use as a harbour
Recommended Mitigation	<ul style="list-style-type: none"> • Detailed supplementary archaeological survey prior to undertaking • Rehabilitation of harbour wall stonework where sludge jetty will be removed as advised by conservation architect/engineer

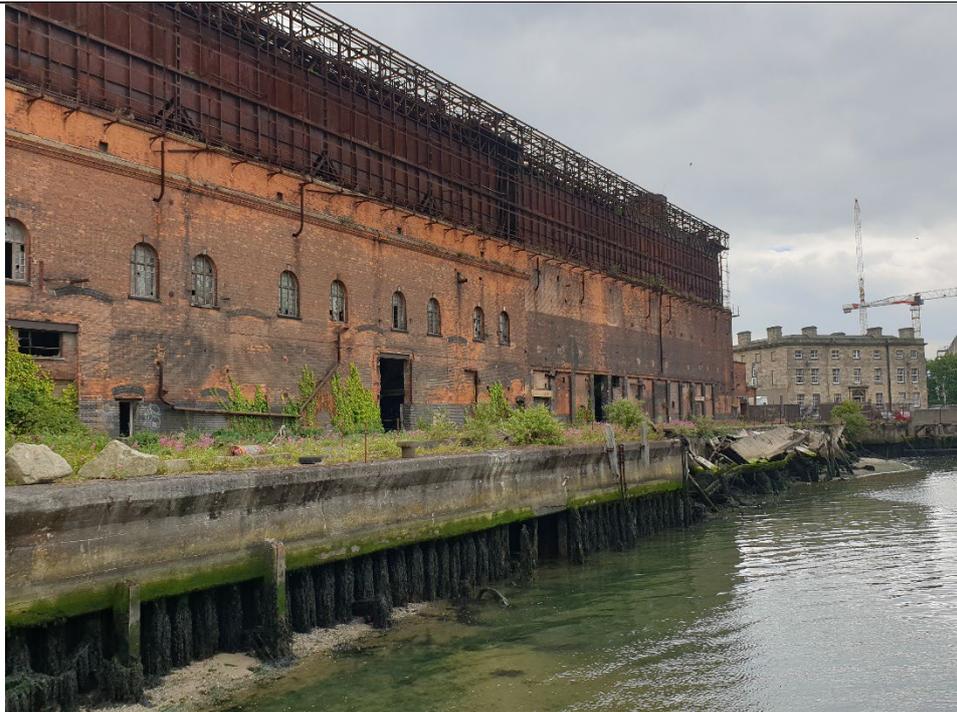
View looking south-southeast along current west-facing wharf of Pigeon House Harbour. The wharf is supported by a mass concrete quayside that was likely added to the original line of the GSW when constructing the generating station.

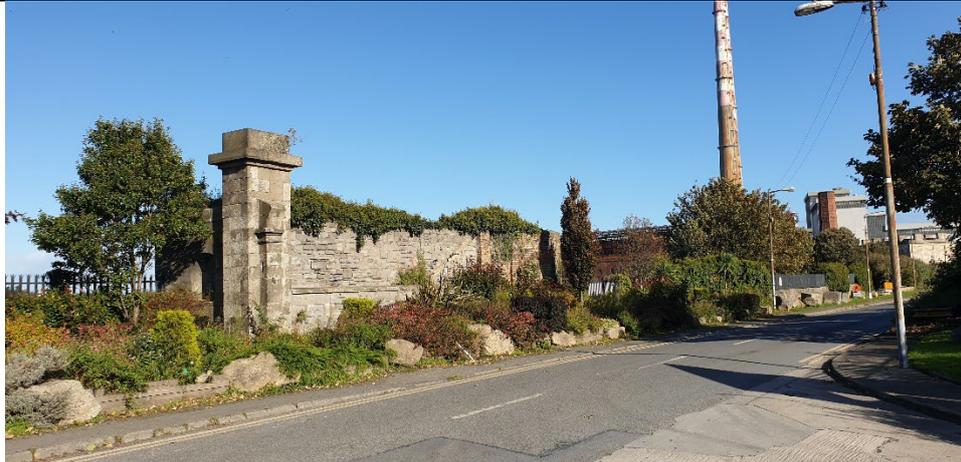
View looking northeast to the remains of the western entrance today, much of which is now. Only the very northern gatepost of the entrance is standing. The area is planted to provide a degree of landscaping

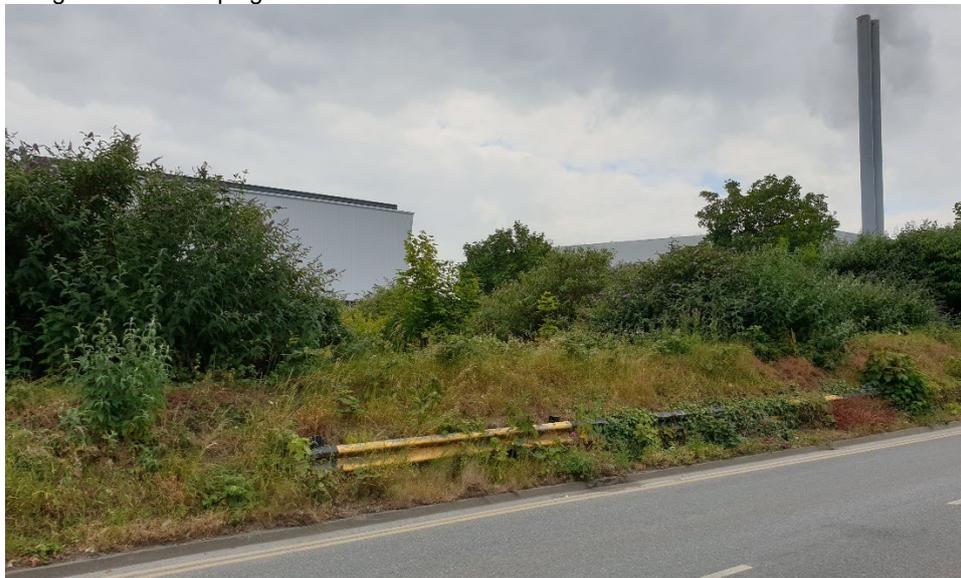
In contrast, the area of the fort that lies south of the Pigeon House Road and would have included the barracks and the southern perimeter wall is effectively abandoned under rough secondary growth that has developed over what appears to be heaps of dumped soil, on lands owned by Uisce Éireann

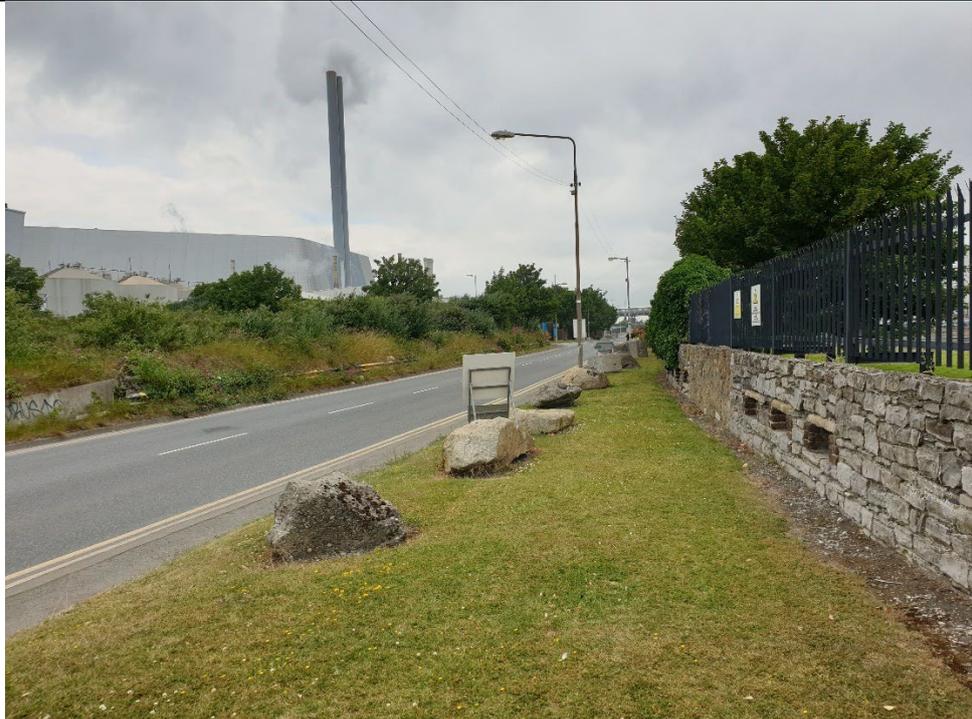
View looking west along Pigeon House Road that is cut through the Fort, across the former Parade Ground. The stone wall on the right is part of the fortified elements of the GSW that would have overlooked the harbour basin and are furnished with a series of gun loops

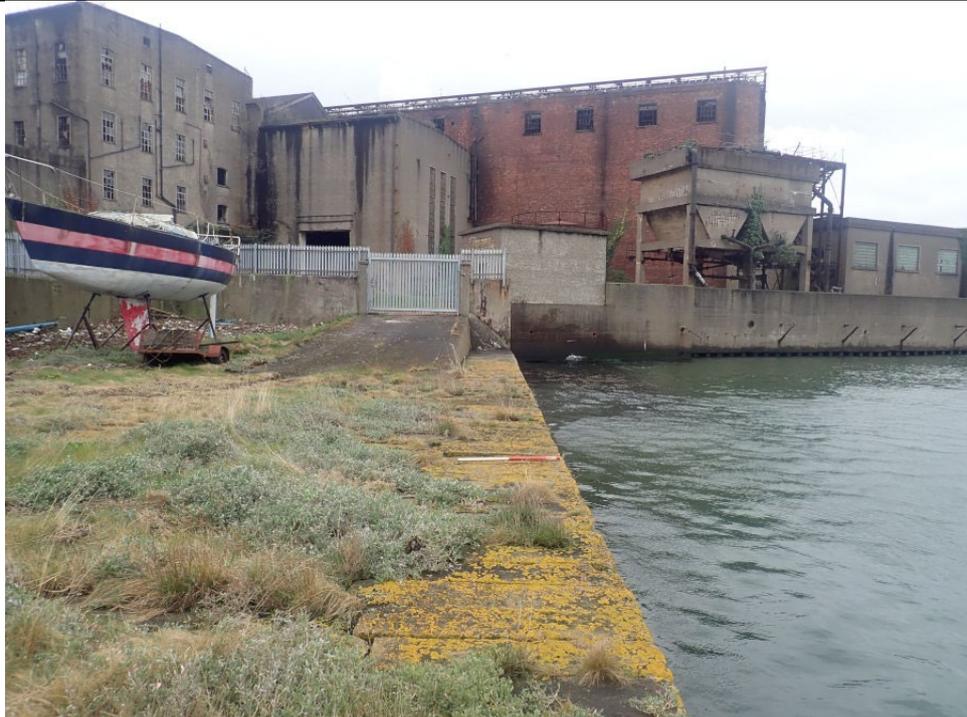
Looking westward towards the eastern entrance to the Pigeon House Fort as seen today

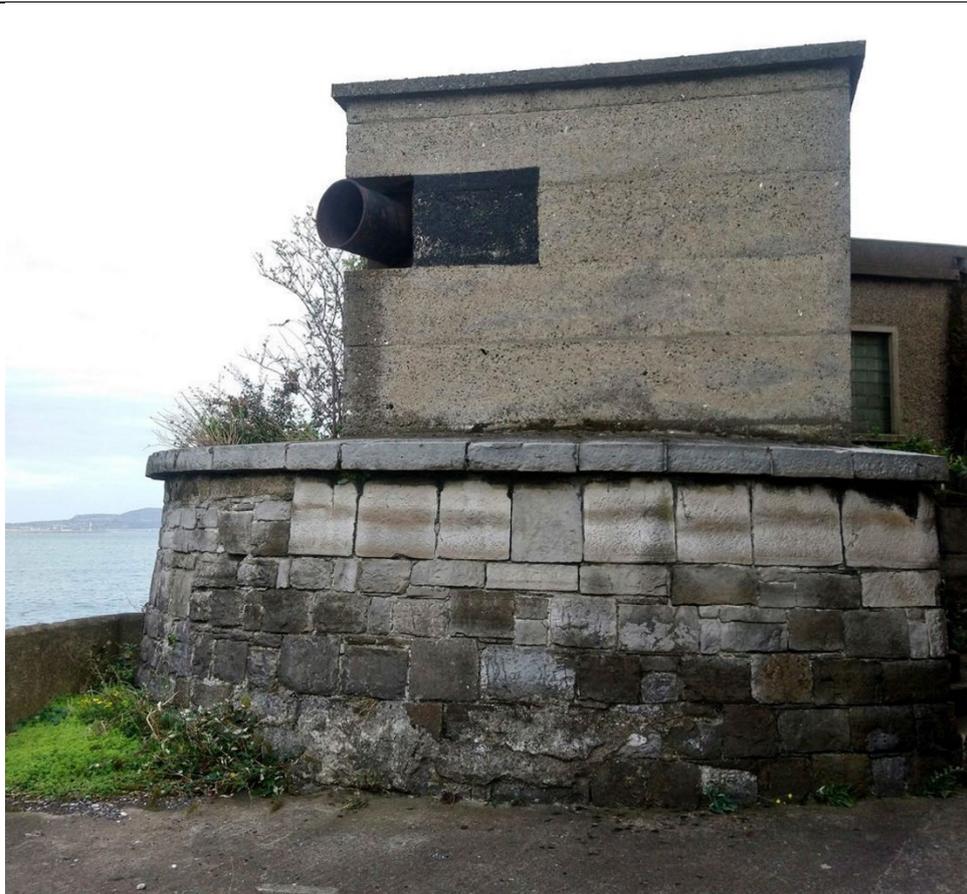
Photograph showing the former gun emplacement located , ADCO STR-03, above the harbour wall. The concrete structure built within the gun emplacement is thought to be a pillbox (guard-post) of twentieth-century date. Image courtesy of Cormac Lowth

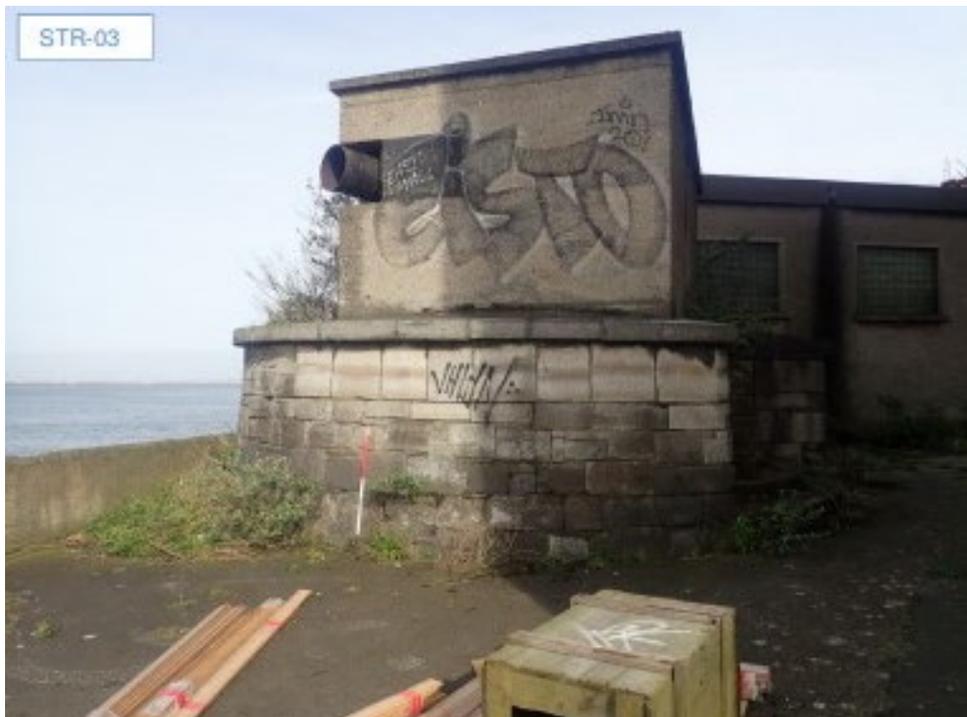
Photograph from UAIA (Appendix 15-5, Plate 51, showing ADCO STR-03 today, where it is subject to graffiti and general neglect

Proximity to development	Within Development area, see Figure 1.2 in EIAR
Likely Impacts	<ul style="list-style-type: none"> • Landscaping to verge of existing road with new perimeter boundaries • New road markings and surfacing with proposed roundabout on location of SE perimeter of fort • Interventions to provide for road safety measures will alter character • SPAR road to access proposed Area N at eastern entrance to Fort • Active travel connection to Area N will traverse along eastern perimeter of fort
Recommended Mitigation	<ul style="list-style-type: none"> • Detailed archaeological survey prior to undertaking • Appropriately scaled and detailed drawings of proposed Area N bridge interaction with quay wall • Designed to avoid direct and indirect impacts with all standing elements of the Fort <p><u>At Western Gate:</u></p> <ul style="list-style-type: none"> • Change in surface and creation of raised table at location of western gate to mark entry into the precinct. • Interpretative/ wayfinding proposal to be provided in this location • Archaeological monitoring of demolition and excavation of below ground elements • General repair works to the GSW in DPC ownership • Site specific boundary treatments which recognize the character of this location <p><u>At Eastern Gate:</u></p> <ul style="list-style-type: none"> • Change in surface and creation of raised table (bridge) at location of eastern gate to mark entry into the precinct. • Archaeological monitoring of demolition and excavation of ground and seabed works. • General repair works to the GSW in DPC ownership.

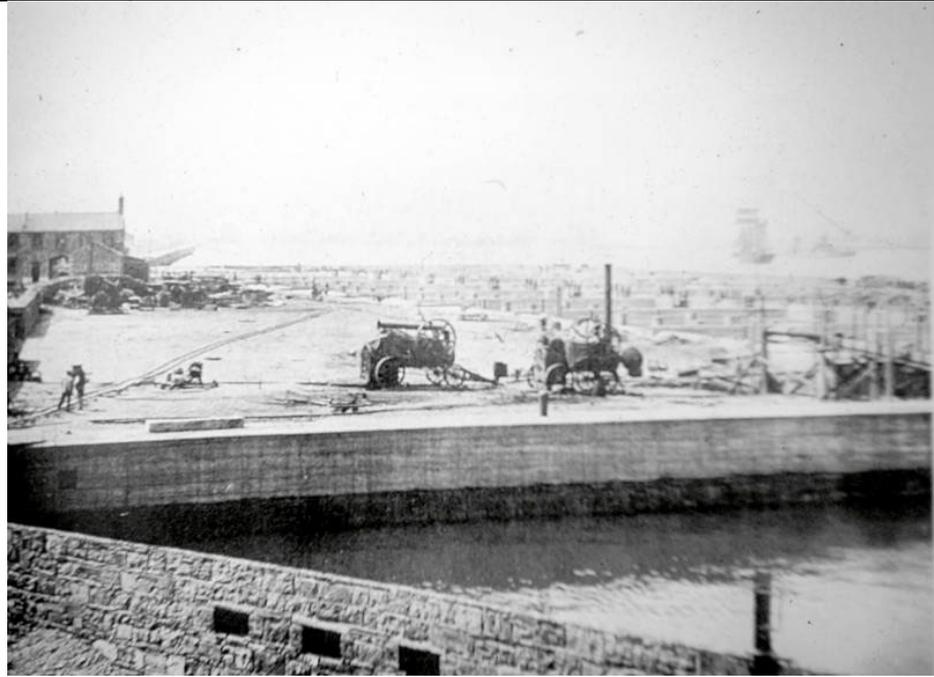
Sewer works under construction 1904

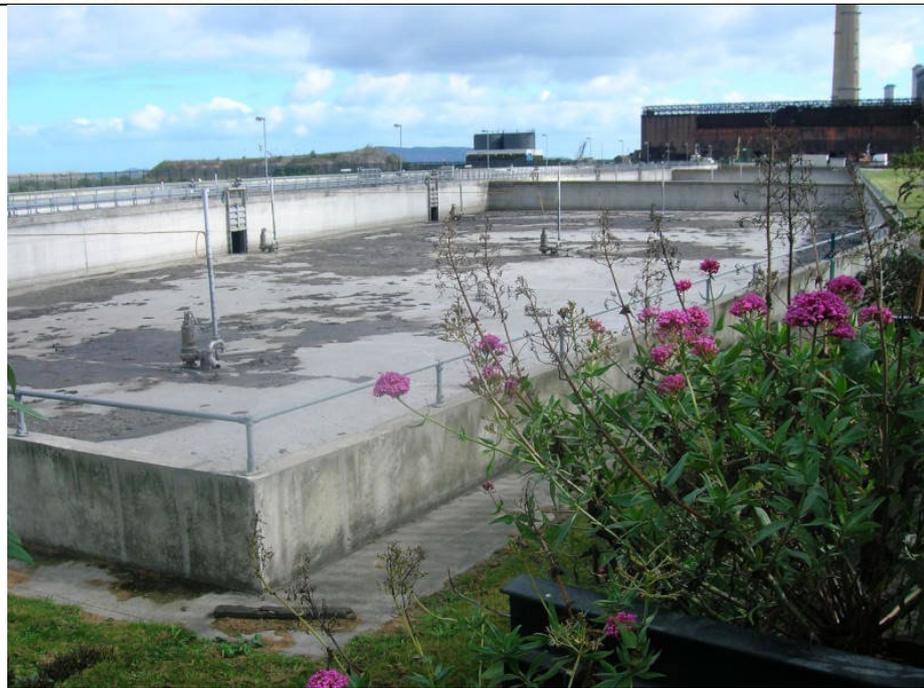
Settlement tanks today

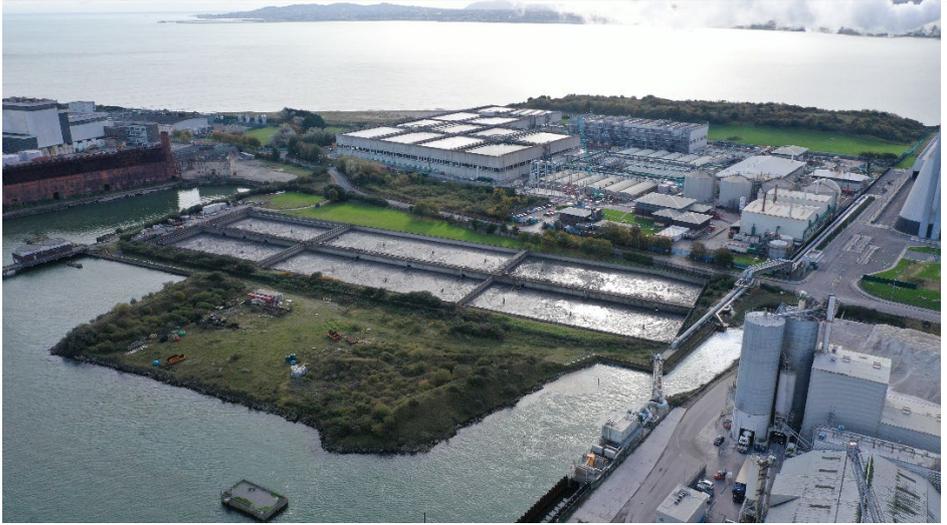
<p data-bbox="443 719 1390 770">Aerial view looking south across the reclamation area north of Pigeon House Harbour and across the settlement tanks</p>
Proximity to development	Adjacent to Development area, see Figure 1.2 in EIAR.
Likely Impacts	None
Recommended Mitigation	None

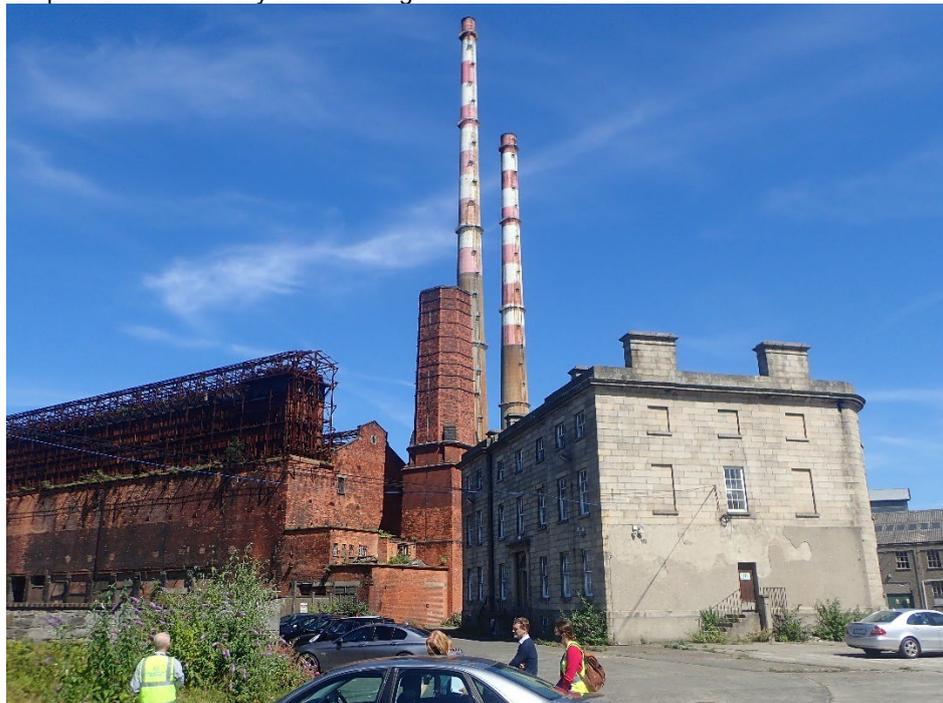
View looking north towards the redbrick Electricity Works site with the base of its distinctive octagonal chimney. Pigeon House Hotel (RPS 6795) stands to the right, and the later Pigeon House Chimneys in the background

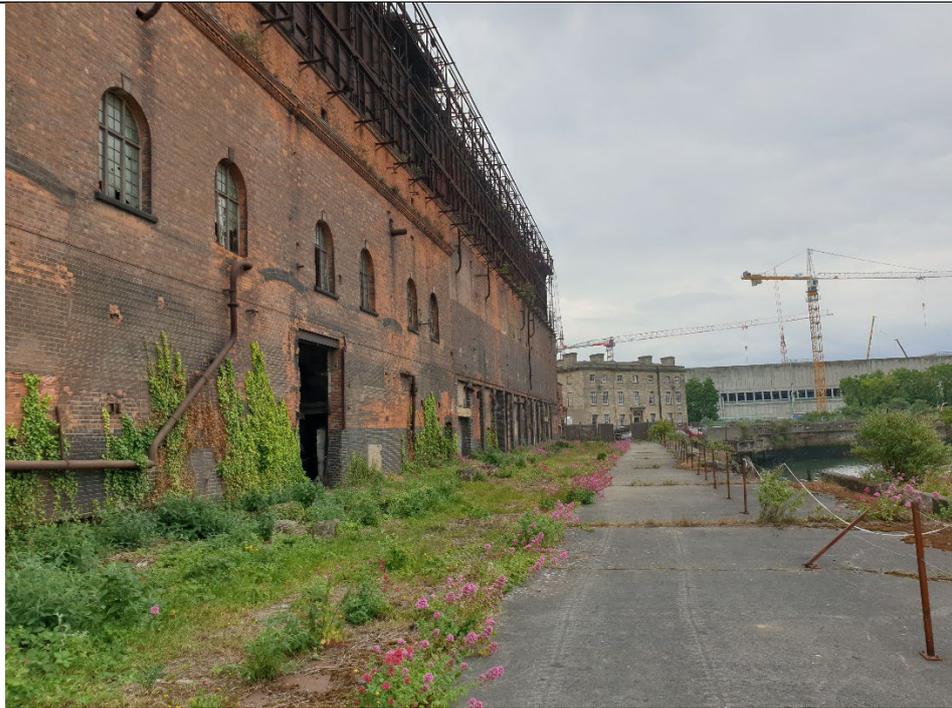
View looking south along the west-facing façade of the Electricity Works building, and the concrete quayside likely added to the original line of the GSW to facilitate the generating station

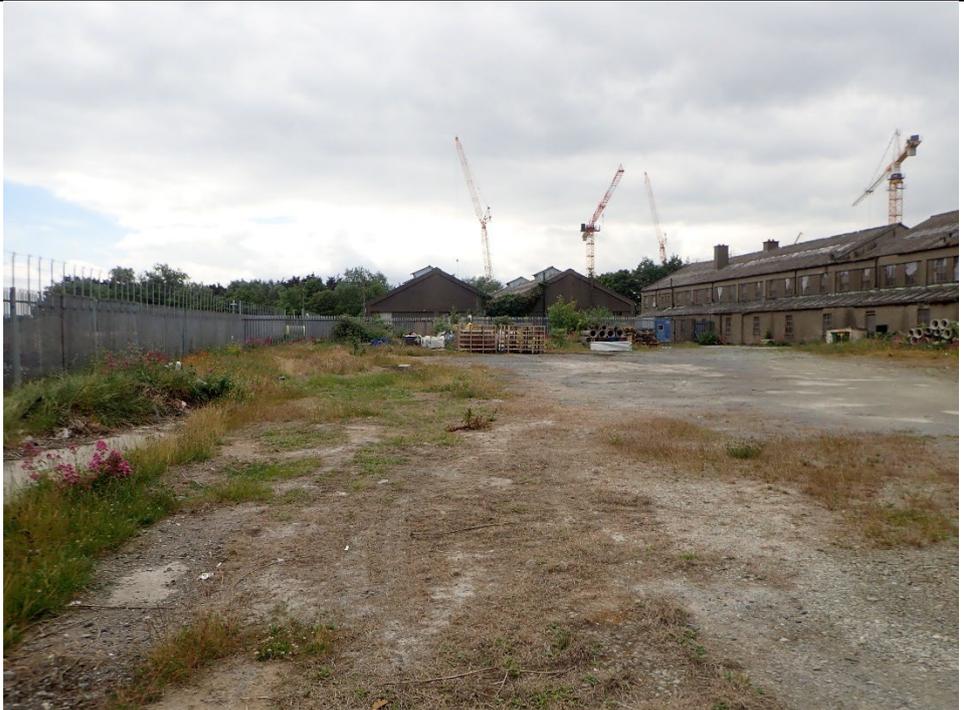
View looking south along open space to east of electricity works building, showing large workshop on right side of picture that was added to the southeast corner of the power station c. 1945. Two gable ends of the former GSI laboratories are visible in the middle of the picture. The proposed new access road to Area N requires the demolition of the GSI laboratories and will run north across the open space in this picture

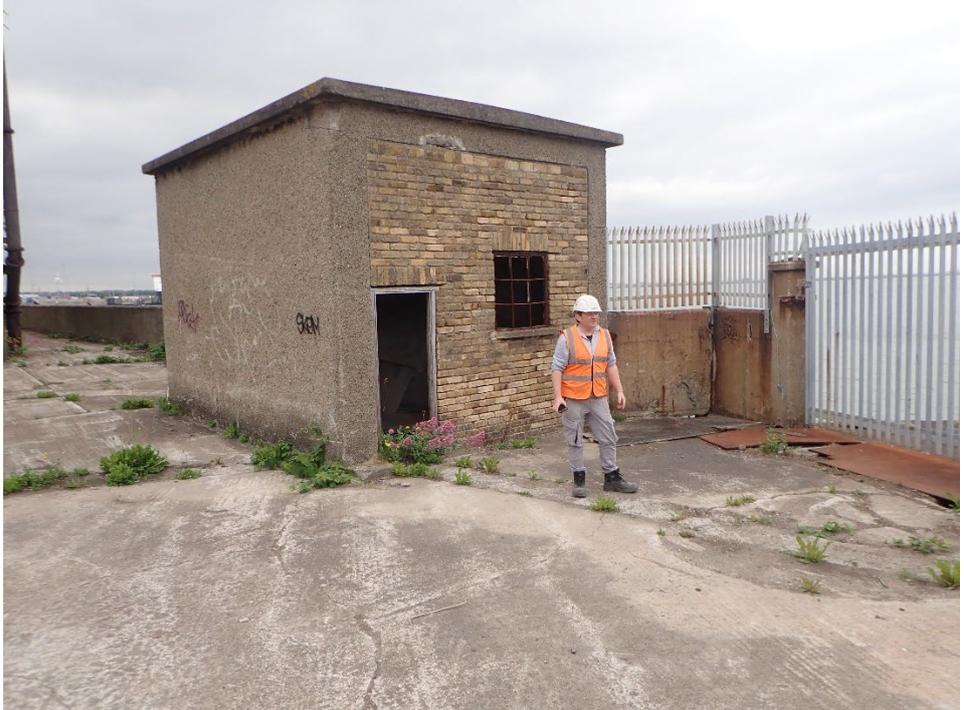
View of eastern gateway from Pigeon House Precinct on to the GSW today. Formerly this retained a draw bridge from the Fort

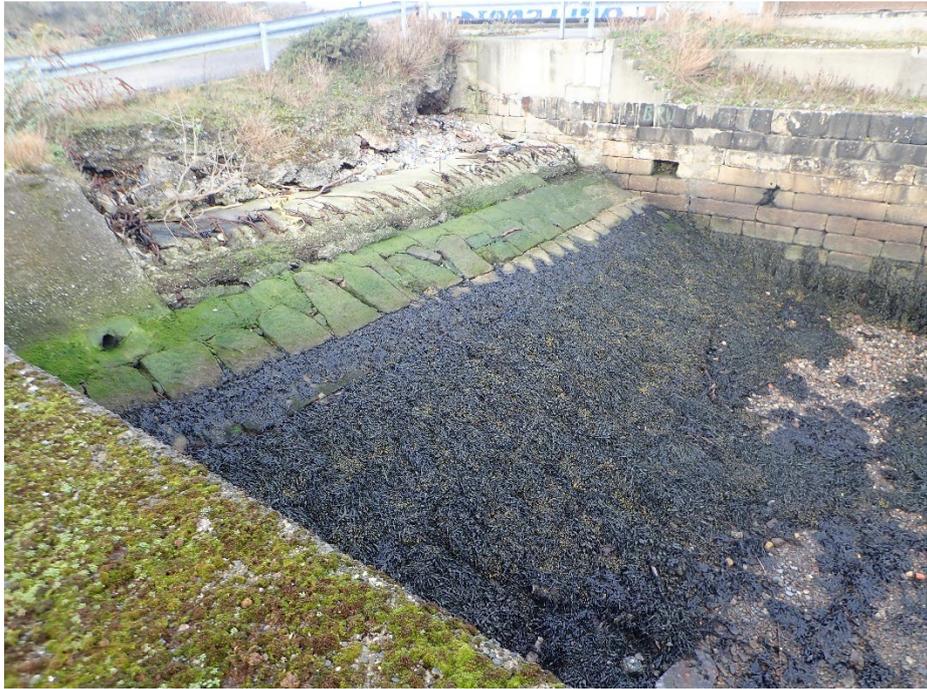
View looking north today at location of former slip that has been infilled

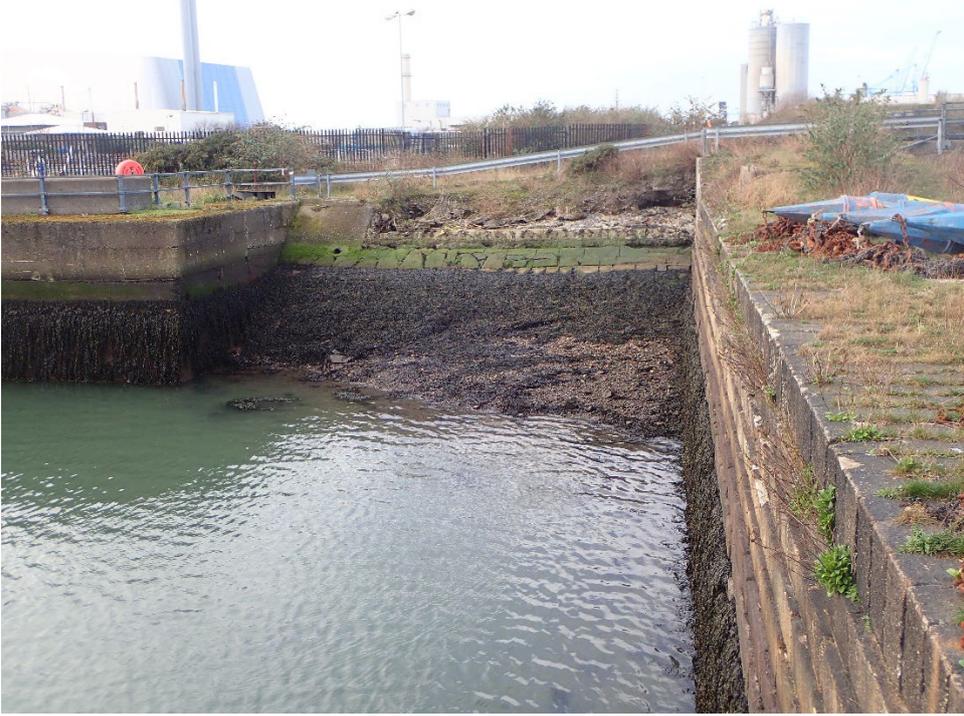
<p data-bbox="421 913 1385 965">View looking west today at location of former slip that has been infilled</p>
Proximity to development	Adjacent to Development area, see Figure 1.2 in EIAR.
Likely Impacts	None
Recommended Mitigation	None

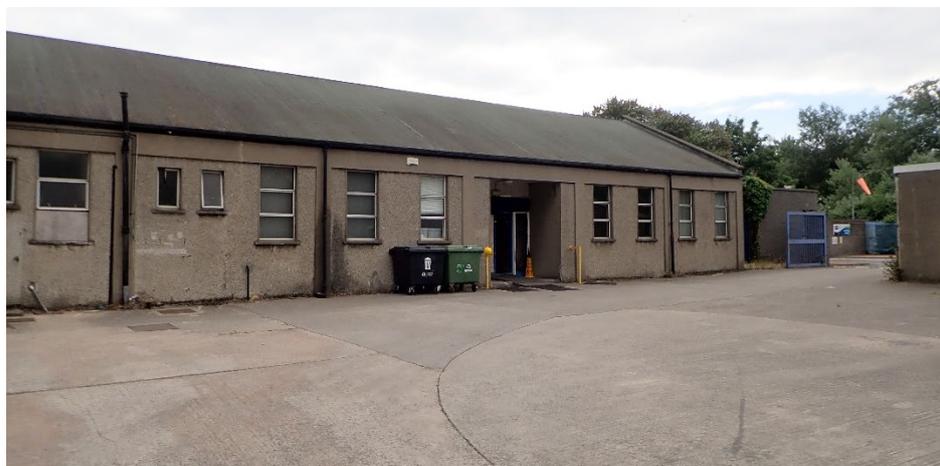
View looking east at former sheds/GSI laboratory building

Proximity to development	Within development area, see Figure 1.2 in EIAR.
Likely Impacts	<ul style="list-style-type: none"> • The building complex will be demolished to facilitate HGV access road to Area N
Recommended Mitigation	<ul style="list-style-type: none"> • Detailed archaeological survey prior to construction phase • Site specific boundary treatments which recognize the character of this location • Removal of the formalization of the IW/DCC construction access rout • Archaeological monitoring and resolution during construction

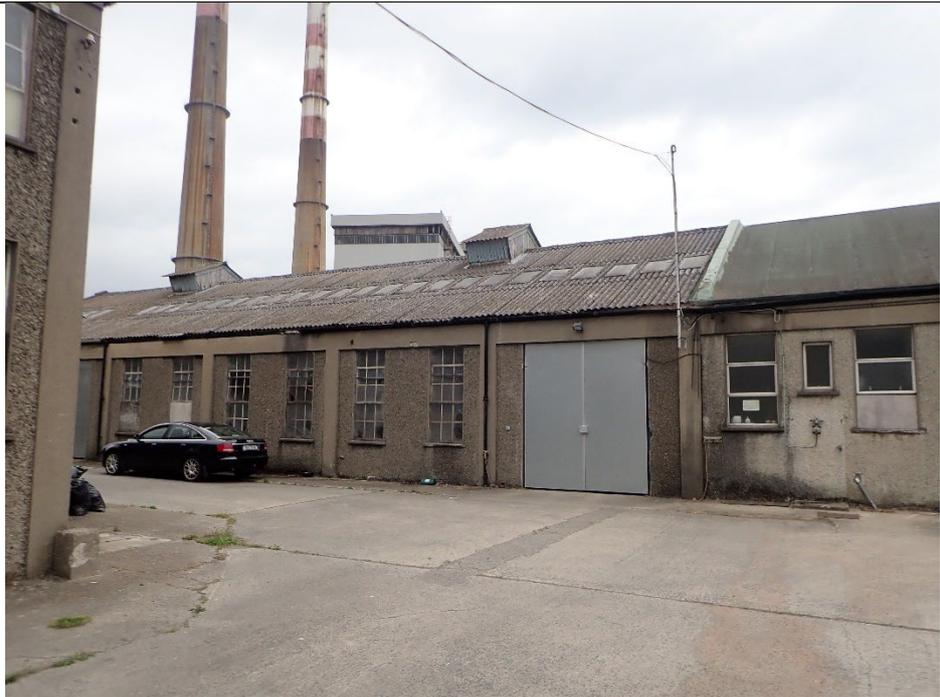
View looking northeast at conjoined building of the former sheds/GSI laboratory building

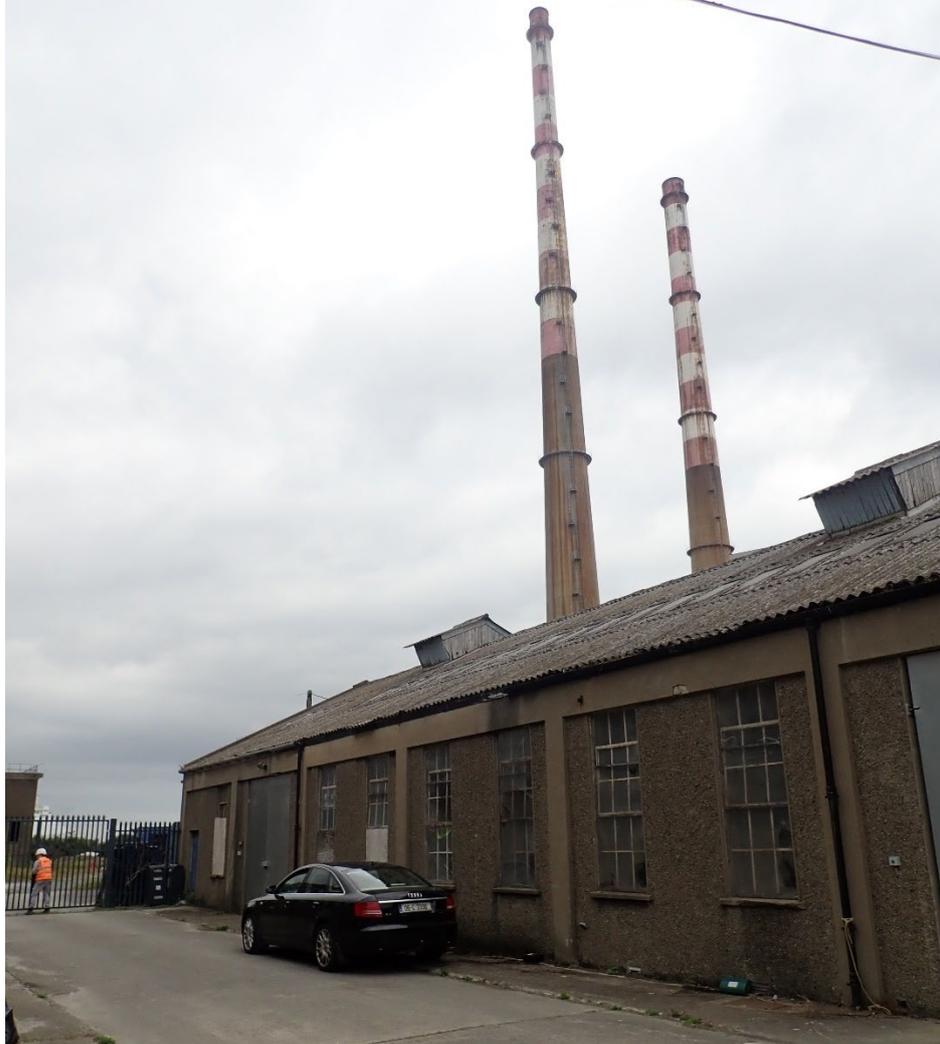
View looking north at conjoined building of the former sheds/GSI laboratory building

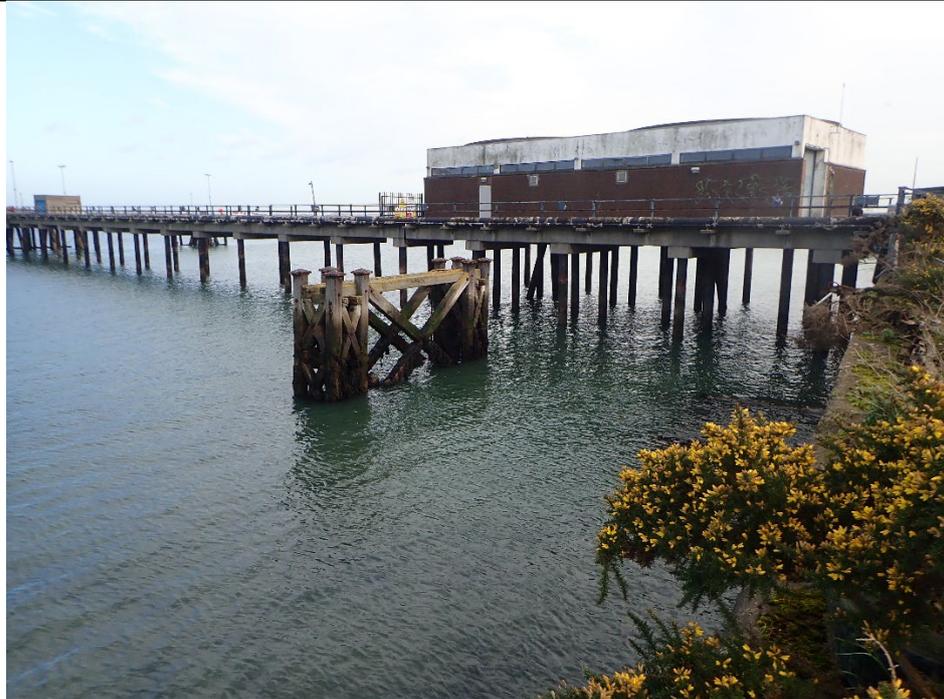
View looking east at Sludge Jetty. The timber structure in the foreground is described below as STR-01 and is separate from the Sludge Jetty

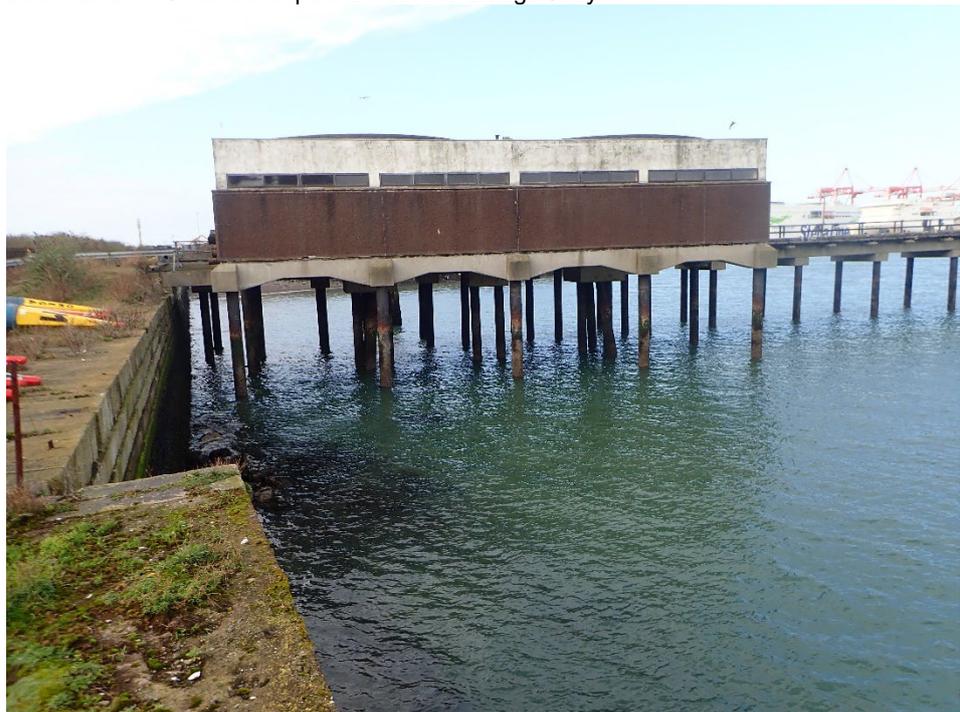
View looking west at Sludge Jetty, with the service buildings in the foreground

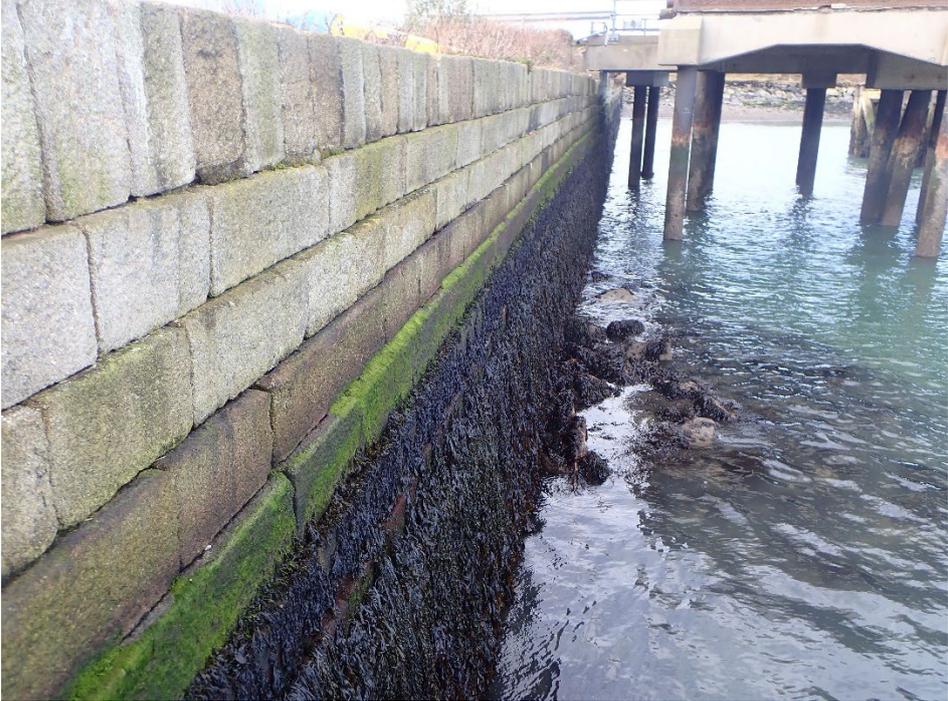
<p data-bbox="427 902 1331 954">View looking west at where Sludge Jetty is built on to the north wall of Pigeon House Harbour</p>
Proximity to development	Within development area, see Figure 1.2 in EIAR.
Likely Impacts	<ul style="list-style-type: none"> • The Sludge Jetty will be demolished to accommodate the turning circle, and repairs to north wall of Pigeon House Harbour made good
Recommended Mitigation	<ul style="list-style-type: none"> • Detailed archaeological survey prior to undertaking • Archaeological monitoring and resolution during demolition • Building conservation-led rehabilitation and rebuild of north wall of Pigeon House Harbour

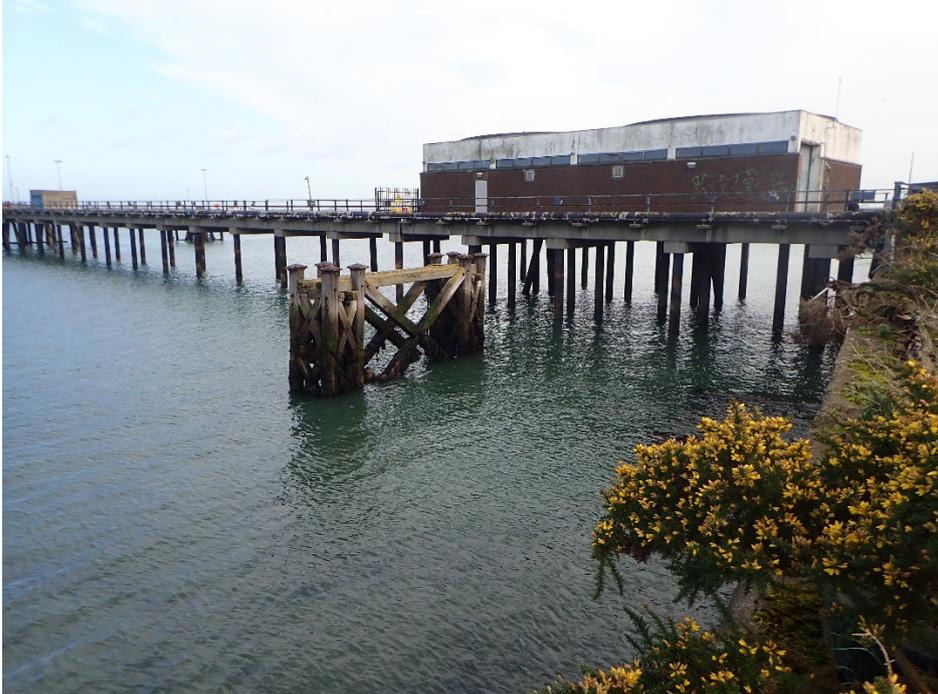
Reference	Site Name	Site Type	ITM Easting	ITM Northing
ADCO STR-01	Timber structure	Jetty, site of	720262	733622
Description	<p data-bbox="434 1326 1382 1572">STR-01 was recorded as part of the underwater archaeology impact assessment for 3FM (Appendix 15-5, Figures 29-30). It comprises a timber structure that is positioned c. 14 m north (channel side of the culvert associated with the Pigeon House outfall works. The structure is formed by two square-shaped timber columns, spaced 5 m apart, conjoined by a horizontal timber frame. Each column is composed of four vertically-set timber posts (measuring 300 mm x 300 mm) with a lattice-work of internal cross-beams forming the sides. Each element is fastened together using large (recessed) iron-bolt fastenings. Each of the piles is protected by an iron pile-cap. The overall structure measures 8.32 m east-west by 1.35 m north-south.</p> <p data-bbox="434 1599 1382 1733">The exact function of STR-01 remains unclear. However, it appears to retain some age and is depicted on OS 25-inch Map of the area. Moreover, the adjacent culvert, having undergone modern repair as part of the modernisation of the outfall works in c. 2003, most certainly formed part of the earlier works at this location. It is likely that STR-01 is associated with the original culvert and is of a similar date.</p>

<p>View looking east at the timber structure STR-01, with the Sludge Jetty in the background</p>
<p>Proximity to development</p>	<p>Within development area, see Figure 1.2 in EIAR.</p>
<p>Likely Impacts</p>	<ul style="list-style-type: none"> • ADCO STR-01 will be demolished in order to facilitate the Turning Circle
<p>Recommended Mitigation</p>	<ul style="list-style-type: none"> • Archaeological monitoring and resolution during demolition

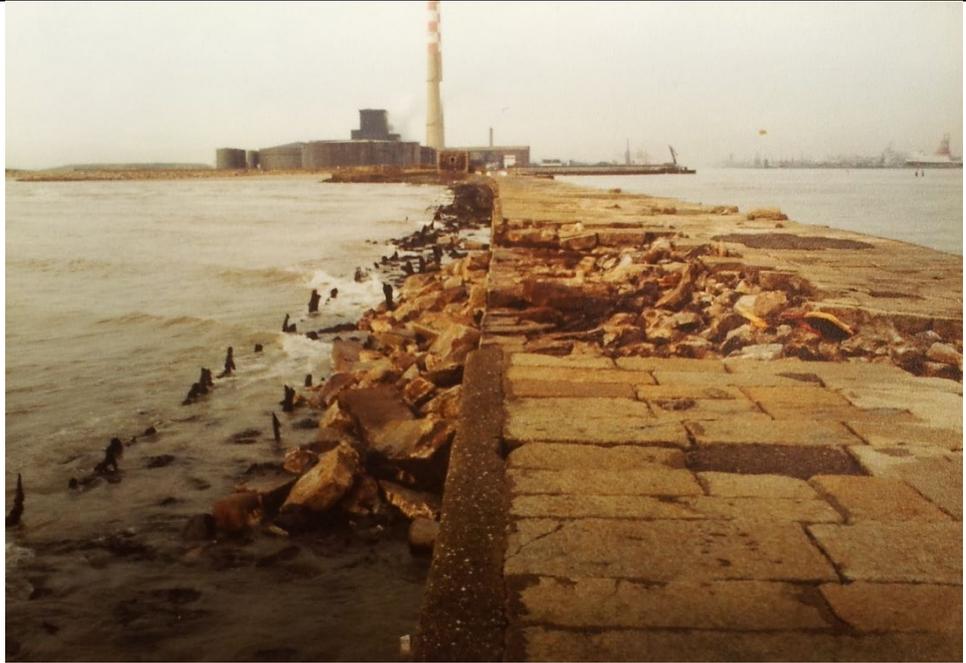
Photograph taken after the storm in 1981 shows damage to the GSW and a line of timbers off the south side, which appear to be the remains of 'The Piles'. Source: Dublin Port Company, Port Engineer

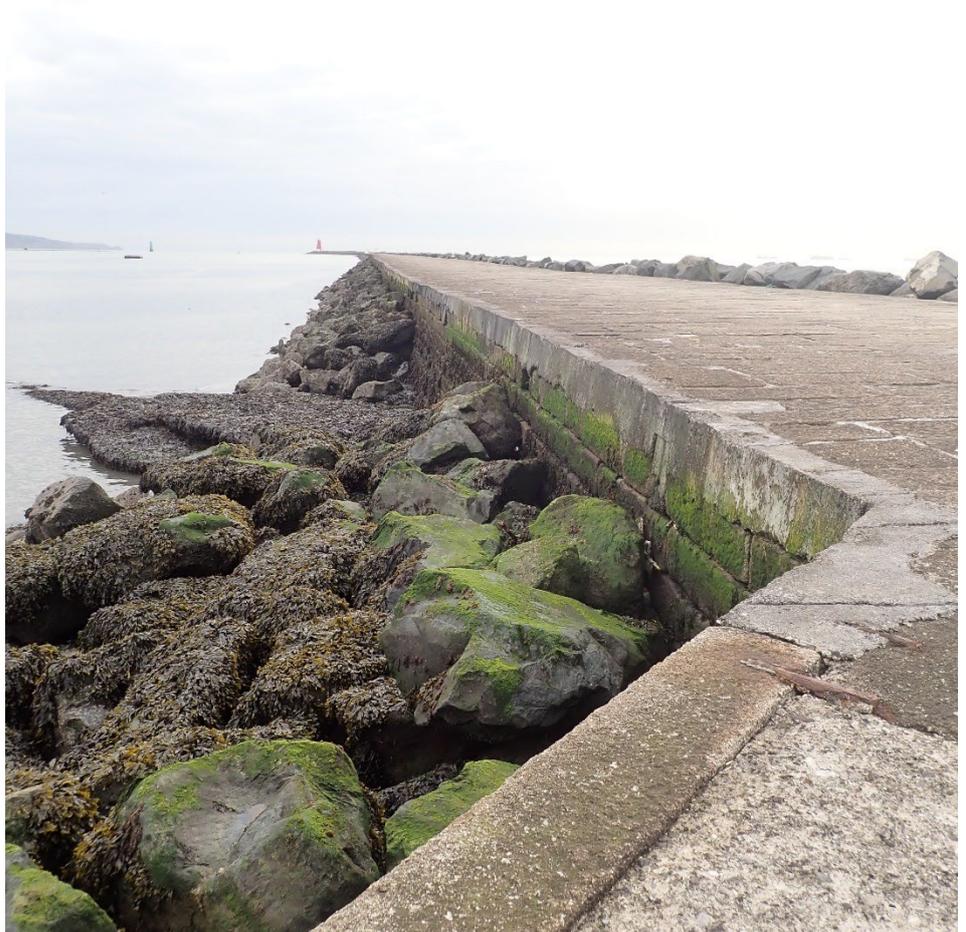
View looking east along GSW today just past White Bank Wharf Slipway ((DCIHR 19_09_011_01). The rock armour protection placed at the base of the wall on the foreshore, and reaching the deck level on the south side are modern interventions

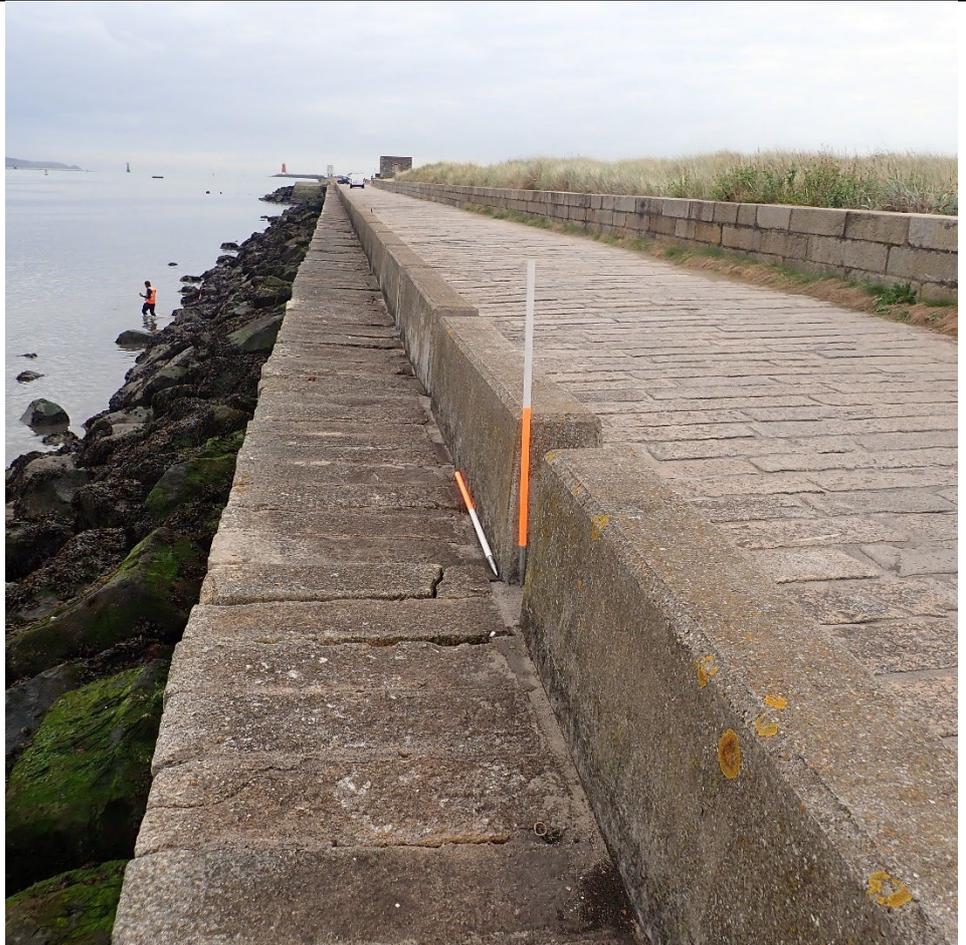
View looking east along GSW today alongside the Lifeboat House site (DCIHR 19_09_008_01). The low concrete barrier supporting the vertical ranging rod is a modern addition

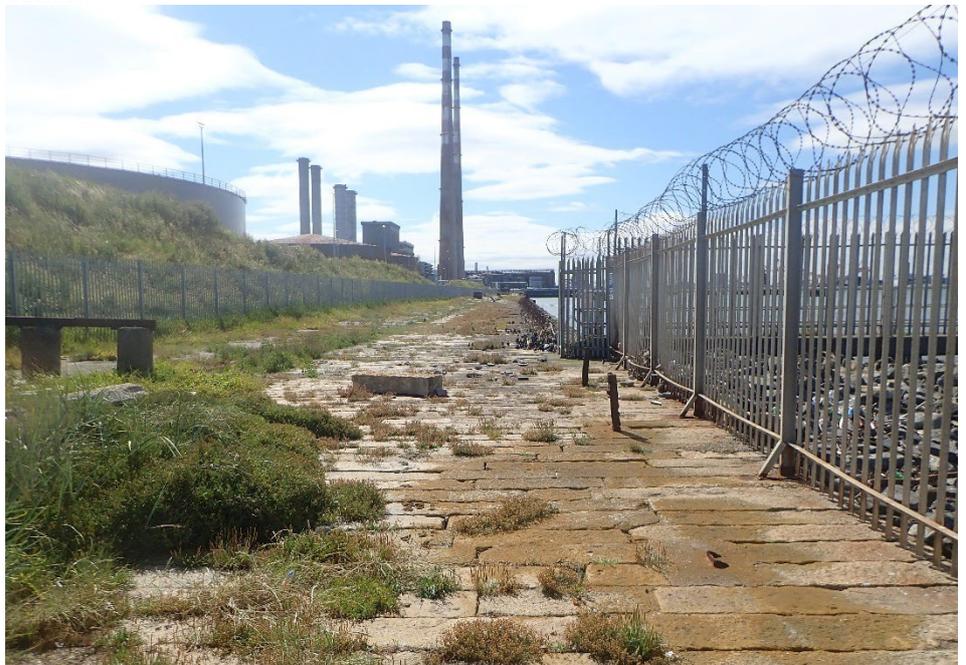
View looking west along GSW at the NORA tanks (left). The new wharf Area N will lie on the channel side (right)

<p data-bbox="432 898 1377 958">North-facing view of the southern side of the GSW, recorded during SI works for the 3FM project, Trench 7 (BH-212)</p>
Proximity to development	Within development area, see Figure 1.2 in EIAR.
Likely Impacts	<ul style="list-style-type: none"> • Proposed signal junction at Pigeon House Rd and Shelly Banks Rd • 3 No. proposed crossings above GSW at proposed Area N. These will restrict potential for future access from Pigeon House Fort to eastern section of GSW (currently inaccessible)
Recommended Mitigation	<ul style="list-style-type: none"> • Creation of a physical separation between the new berth and the GSW • Area N designed to be reversible • View corridor to be incorporated along length of inaccessible portion of GSW alongside Area N • New bridge design to be appropriate to the context and designed to be reversible • Design of boundary railings to allow for maximum transparency • Detailed supplementary archaeological survey prior to undertaking • All survey data to be lodged in the Dublin Port Archives • Sample panel for conservation pointing, grouting and reconstruction works to be approved by Heritage team and DCC • Architect conservation inputs into the design elements of the Area N bridges • Architect conservation supervision of the Area N bridges • Archaeological monitoring and resolution of ground and seabed activities • Rehabilitate/ make good the GSW deck surface along its length

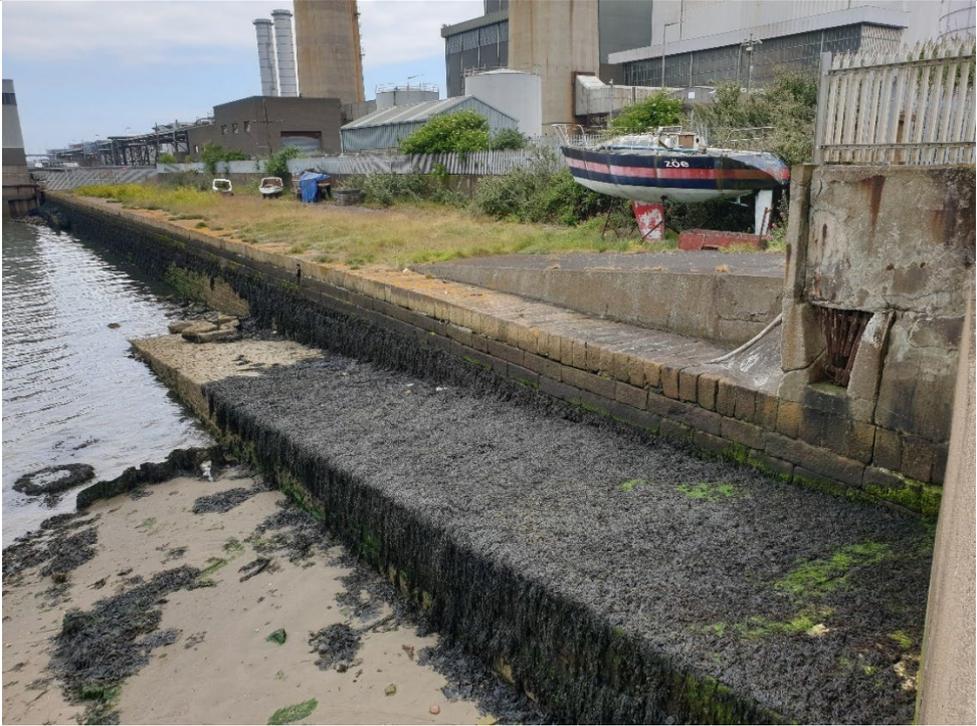
also retains a stepped profile. A series sheet piles protrude (max. height of 500mm) from the silty-sand on the channel side of the slipway.
Image/s

<p>View looking southeast at slipway adjoining GSW outside eastern entrance to Pigeon House Fort</p>
Proximity to development	Within Development area, see Figure 1.2 in EIAR.
Likely Impacts	<ul style="list-style-type: none"> • No direct impacts • Area N main access bridge will traverse above slipway and GSW •
Recommended Mitigation	<ul style="list-style-type: none"> • Avoid impacts direct and indirect • Detailed supplementary archaeological survey prior to undertaking. • All survey data to be lodged in the Dublin Port Archives • Archaeological Monitoring and resolution
