Environmental Impact Assessment Report

Appendix 16.1

Appendix 16-1

Catalogue of Cultural Heritage Assets

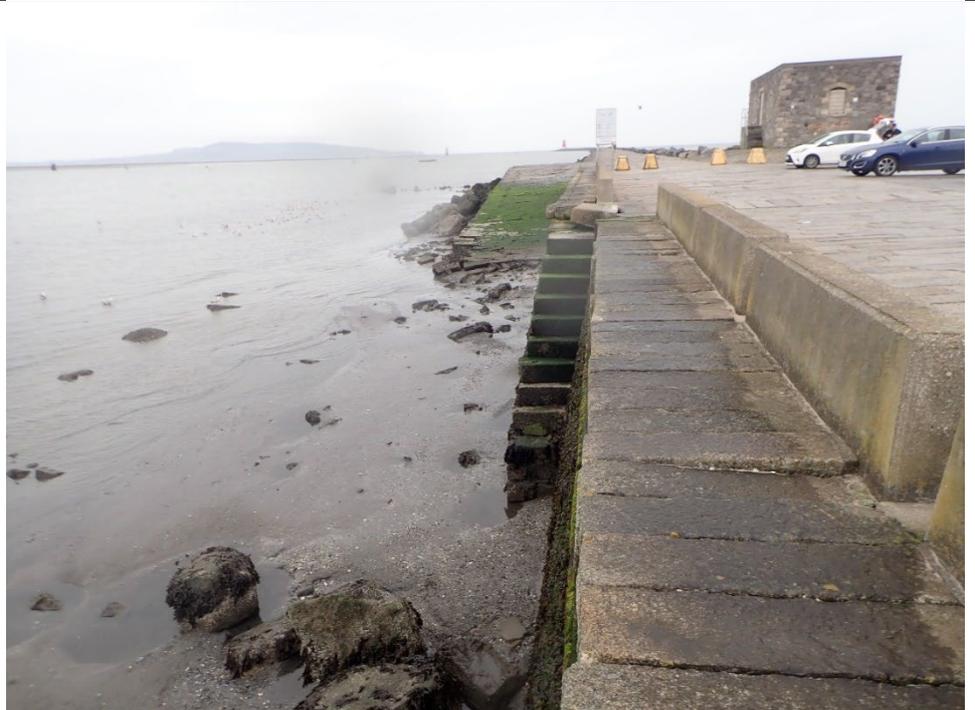
Reference	Site Name	Site Type	ITM Easting	ITM Northing
DCIHR 19-09-011	Slip, White Bank Wharf, South Wall	Slipway	721402	733860
Description	Slip, believed to have been constructed c. 1770 and is recorded on the OS First Edition 6-inch and later maps. The slipway is integrated into the GSW and is close to a flight of access steps located upstream. The stonework on the slipway comprises long lengths of rectangular masonry (measuring between 1m-1.30m long) that have been laid at right angles to the sea wall. The northwest corner of the slipway has suffered erosion and partial collapse. The damage appears to be a direct result of wash from shipping entering/exiting Dublin Port at Low Water			
Image/s

<p data-bbox="408 1937 1383 1966">View looking east at access steps and slipway, with Sluice House in the distance</p>			
Proximity to development	Outside development area

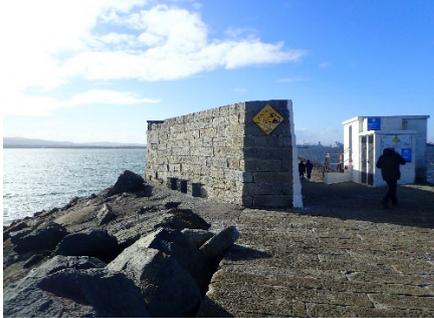
<p>View looking west, showing upstanding south-facing wall element of the former battery that now houses the changing rooms for the swimming club</p> </div> <div data-bbox="865 862 1302 1180">

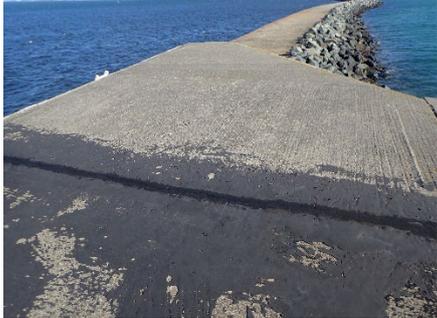
<p>View looking west across the concrete roof of the bathing club, showing bitumen repairs</p> </div> </div>
	<div style="display: flex; justify-content: space-around;"> <div data-bbox="405 1294 839 1868">

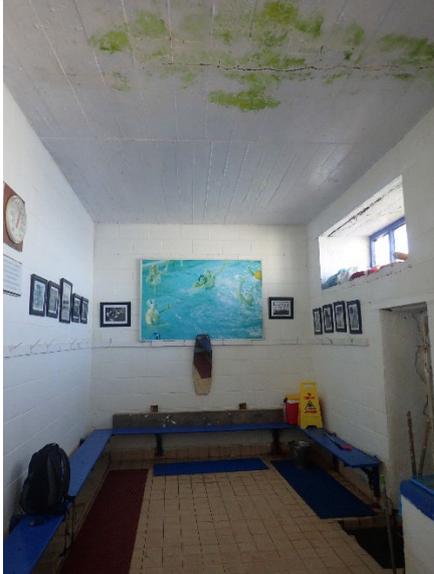
<p>finished in concrete blockwork but the external façades indicate stone work surviving to some height that is likely associated with the battery. The ceiling is a continuous flat concrete pad that is set back from the granite blocks along the south side. The concrete ceiling has cracked and bitumen applied as repairs to fill the cracks but these are now failing with resulting water ingress.</p> <p>The second range of buildings stands on the north side of the site and comprises two small concrete-built and concrete-roofed structures, one of which serves as the office for the swimming club, the other for storage.</p> <p>A stone-built slipway extends westwards from the west end of the battery, and is recorded on the OS First Edition map series.</p>
<p>Image/s</p>	<div style="display: flex; justify-content: space-around;"> <div data-bbox="405 506 839 824">

<p>Interior view of the Men's changing rooms, showing blockwork interior and concrete roof</p> </div> <div data-bbox="865 1294 1388 1868">

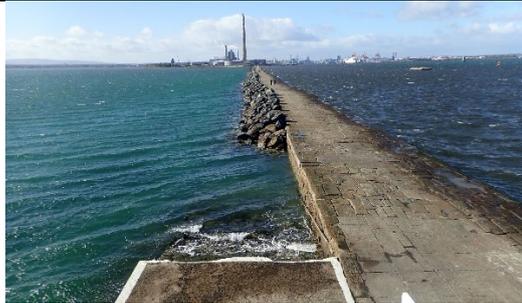
Detail from OS First Edition map showing extent of slipway associated with the battery	
	View looking west with element of stone slipway showing	
Proximity to development	Outside Development area	
Likely Impacts	None	
Recommended Mitigation	None
