GEOTECHNICAL AND PEAT STABILITY ASSESSMENT REPORT

Seskin Wind Farm
Geotechnical Investigation Report

Person responsible	Manasvi Srivastava, Liam Power
Company	AFRY Ireland Limited
Address	The Hyde Building, The Park, Carrickmines, Dublin 18, Ireland
E-mail	manasvi.srivastava@afry.com , Liam.power@afry.com
Project Number	ICPRI268
Revision Number	REV 2
Date	May 2024

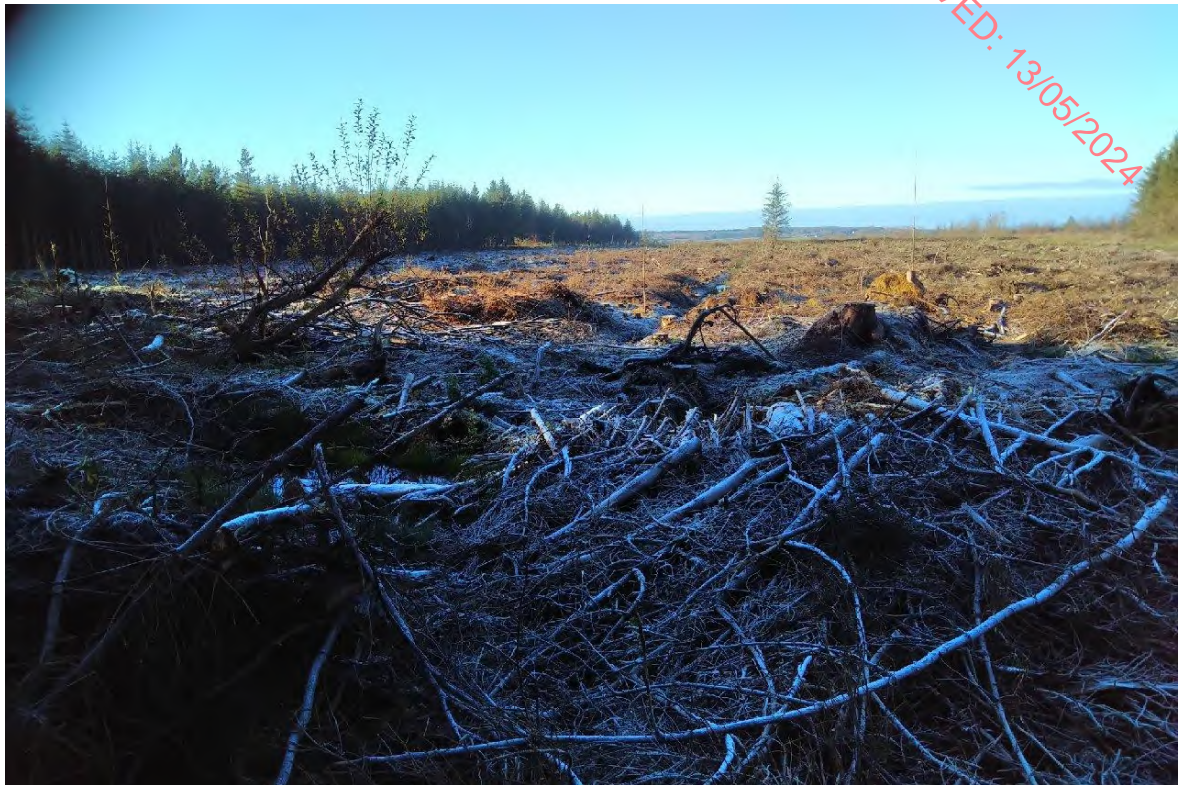
Photo 1: Access to T5 covered with brash, with uneven and soft to very soft ground surface

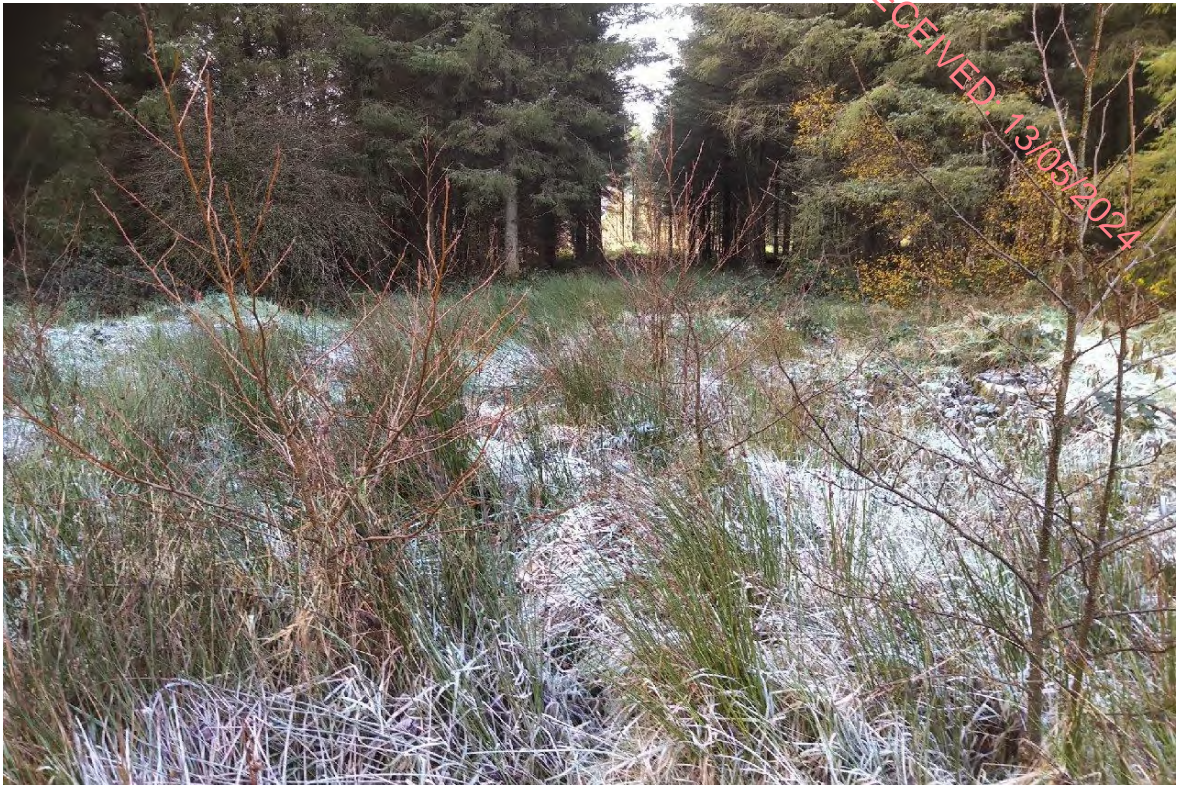
Photo 5: Area around T7 shows replanted fir and hardwood trees, with soft, uneven ground and tree stumps
