“Deer Park, Howth”  
Large-scale Residential Development (LRD)  
for lands adjoining Howth Demesne  
Deer Park, Howth  
Co. Dublin

**VOLUME III**  
APPENDICES TO  
ENVIRONMENTAL IMPACT ASSESSMENT REPORT

Client	GLL PRS Holdco Limited			
Project Title	Deer Park, Howth			
Document Title	EIAR Volume III Appendices			
Document No.	4692			
Document	DCS	TOC	Text	Appendices
Comprises	1	1	-	28
Prepared by	RC	Checked by	PG

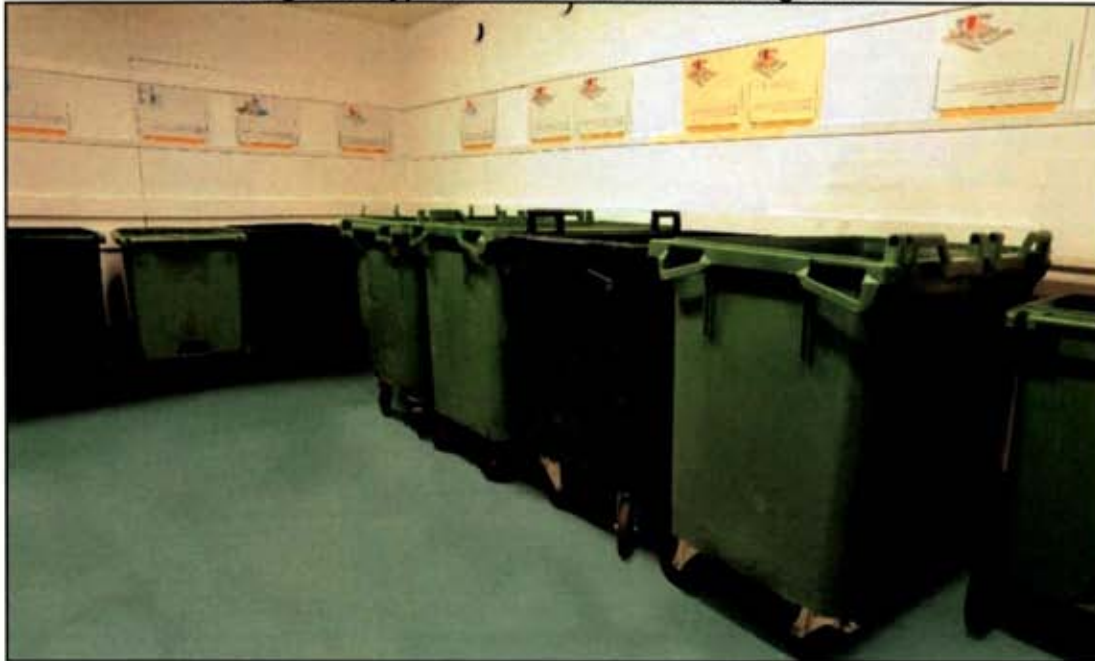
Image of a typical communal waste storage area

- The communal waste storage area shall contain a brown organic waste bulk bins. Appropriate signage shall be placed on all brown bins informing residents of the exact nature of organic waste that can be placed in the bin. Signage will also state that all organic waste must be placed within biodegradable bags before placing in the bulk bin.

- The communal waste storage area shall contain a biodegradable waste bag dispenser which will facilitate and encourage residents of apartments and duplexes to separately segregate food and organic waste within their apartments in a dedicated bin.

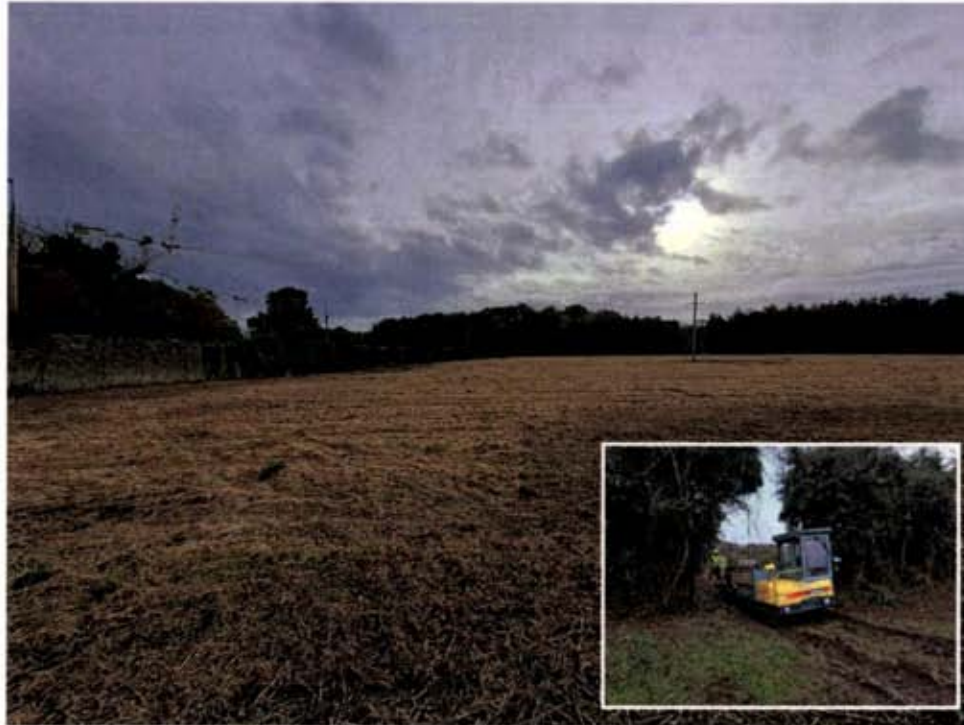
**Figure 2 – View east of site. Inset: Tracked plant required to move equipment on site**

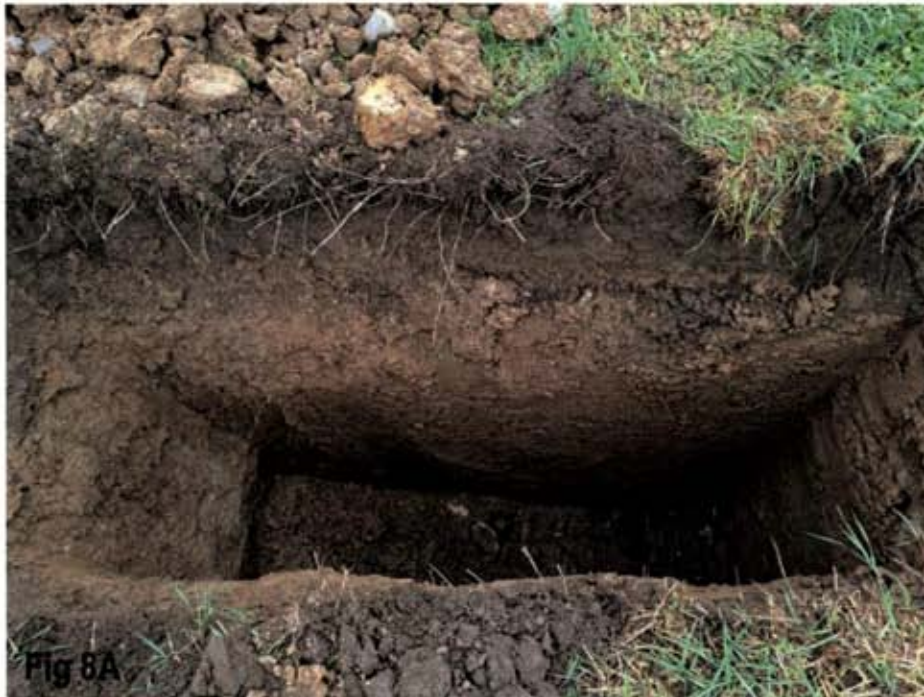
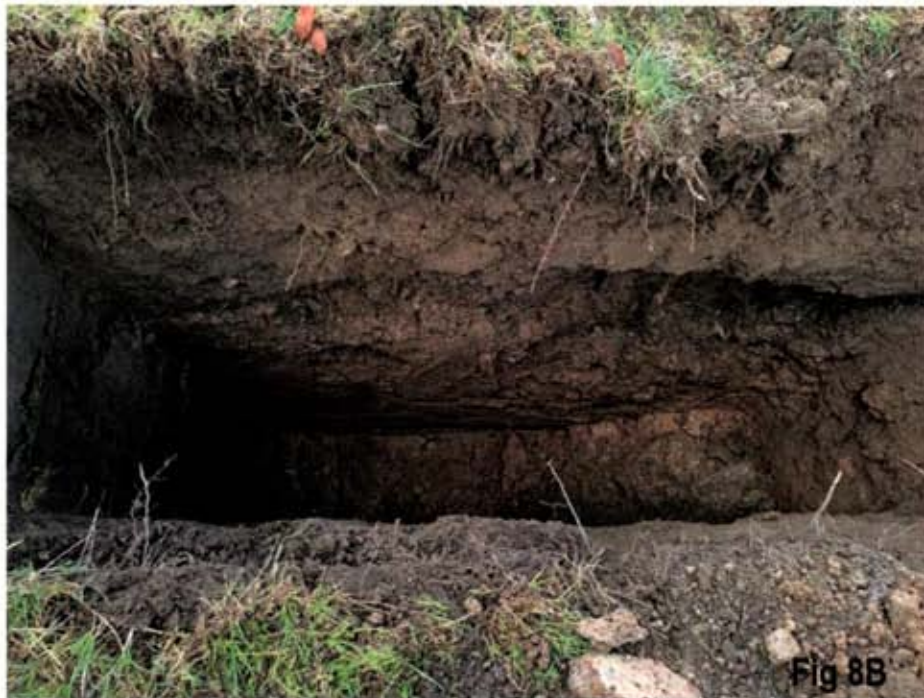
**Figures 8A & 8B – Sidewall profiles photographed during trial pitting.** **Fig 8A** TP01 Topsoil over firm brownish grey locally mottled grey orange gravelly sandy SILT with cobbles to 1.60m bgl (5.27m OD). A firm to stiff slightly sandy gravelly CLAY was found to the pit end depth at 2.50m (4.37m OD). **Fig 8B** At TP02, Topsoil covers a gravelly silty SAND to 1.50m underlain by a firm brown sandy gravelly SILT. A firm to stiff brown slightly sandy slightly gravelly CLAY completes the pit from 2.20m to 2.50m (5.13m OD).
