Knockshanvo Wind Farm

Stage 1 Road Safety Audit

Futureenergy Ireland

June 2024

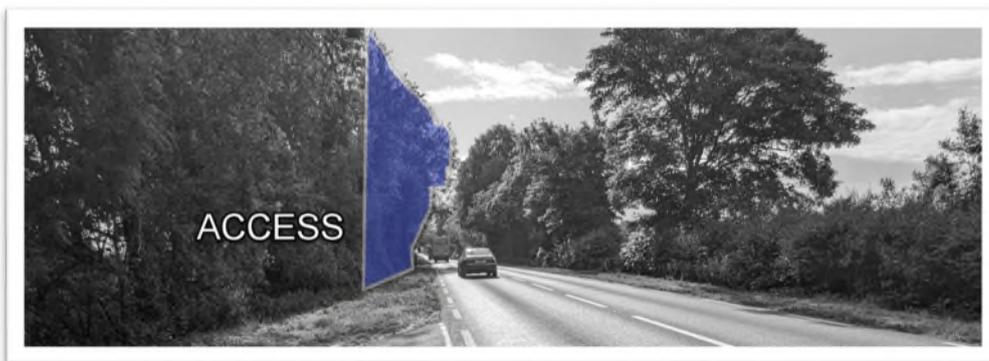
Figure 2.1 – N69 Looking Eastbound – With Access to Transition Zone on Left

Location: Transition Zone | Field Boundary Flanking Accesses

Sightlines to the left appear to be partially obscured by the existing field boundary, which includes ditch foliage and some trees. This could lead to side impact type collisions within the access junction's conflict zone.

The ditch should be modified to ensure that an appropriate sightline is provided at the location described.

It is acknowledged that visibility splays are constrained at the location of the proposed Temporary Transition Compound. Appropriate traffic management measures are set out in Section 15.1.2.3 of the EIAR. During the construction of the proposed TTC access to and from the site off the N69 will be controlled by traffic management measures, including temporary signage in accordance with the “Traffic Signs Manual, Section 8 – Temporary Traffic Measures and Signs for Road Works” (DoT now DoTT&S) and “Guidance for the Control and Management of Traffic at Roadworks” (DoTT&S). Construction staff (flagman) will be present at this location during all times that deliveries are made to and from the site. The site will be closed to all traffic by means of fencing at all other times.

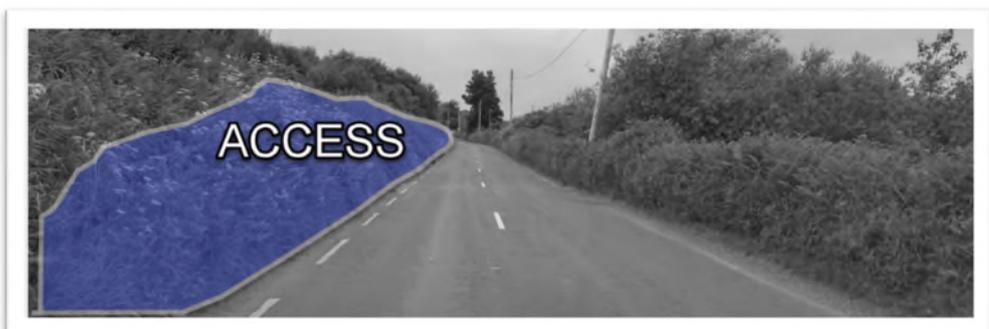
Figure 2.2 – R465 Looking Northbound – With Access Junction A Location on Left

Location: Location 28 – Access Junction A | Field Boundary Flanking Accesses

The access sightlines appear to be obscured by the existing field boundary, which includes ditch foliage and some trees. This could lead to side impact type collisions within the access junction's conflict zone.

The ditch should be modified to ensure that an appropriate sightline is provided at the location described.

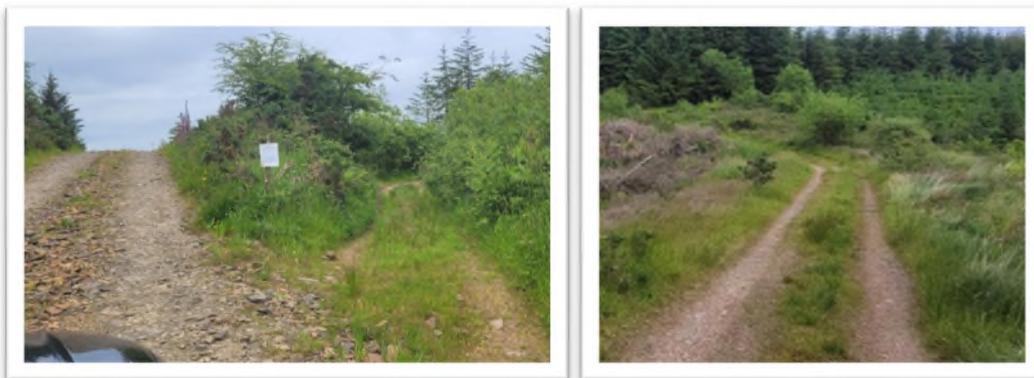
Figure 2.3 – Constrained Geometry of Roads Serving Access Junctions 30 & 31

Location: Locations 30 & 31 – Access Junctions C & D | Narrow Forestry Roads

The forestry access roads were constrained in terms of cross section, horizontal alignment and also vertical alignment. This could lead to loss of control type collisions and opposition type conflicts (where opposing vehicles have difficulty passing each other) for wind farm construction traffic, including abnormal loads.

The geometry of the roads should be improved to accommodate the anticipated wind farm construction traffic. The road improvements should be supported by suitable temporary traffic management interventions to further mitigate the risks described.

All construction, operational and decommissioning traffic requiring access to turbines Nos 1 to 3 will require to cross the L-30144-0 local road at Access Junction C, with the proposed junction layout shown in Figure 15-11 of the EIAR. At present there is an existing agricultural/forest access that links into the L-30144-0 local road from the east. It is proposed to retain this access, with 6m junction radii proposed in accordance with the existing access.

A new access is proposed on the west side of the L-30144-0 local road. This access is for the purpose of development generated traffic only, with no turning movements permitted. Nominal junction radii of 3m proposed at this location. It is proposed that the access on the western side is gated and opened during construction periods and for maintenance visits only.

The junction layout proposed at Access Junction D, also shown in Figure 15-11, takes the form of 2 staggered priority junctions with the L-30426-23 local road that will be in place permanently during the operational phase, with temporary routes through the junction to be used during the construction phase only.

The gravel track nature of the L-30426-23, together with alignment of the existing road, results in speeds being very low (ie approx. 30 km/h). For the assessment of visibility splays a design speed of 50 km/h is adopted at this location, with 2.4m x 70m visibility splays shown in Figure 15-12.

Both of these junctions will be managed by site staff during the construction of the Proposed Development.
